# Inspection Report

Permit Number:	<b>C0070019</b>
Inspection Type:	PARTIAL
Inspection Date:	Thursday, July 16, 2020
Start Date/Time:	7/16/2020 8:30:00 AM
End Date/Time:	7/16/2020 3:00:00 PM
Last Inspection:	Tuesday, June 9, 2020

Permittee: **ANDALEX RESOURCES INC**  
 Operator: **ANDALEX RESOURCES INC**  
 Site: **CENTENNIAL MINE**  
 Address: **PO BOX 910, EAST CARBON UT 84520-0910**  
 County: **CARBON**  
 Permit Type: **PERMANENT COAL PROGRAM**  
 Permit Status: **INACTIVE**

Centennial Mine Degas Well Inspection 7/16/2020

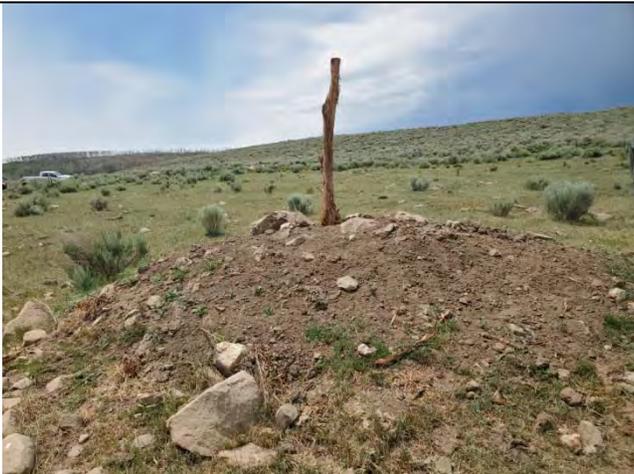
Grazing is causing considerable damage to the revegetation of sites 3, 4, 7, 7A, 8, 8A, 9, 15, 16, and 17 (see attached photos). These sites are fenced, but the fences have been breached. Cows have grazed the grasses down to the crown, limiting their ability to develop into robust, reproducing plants in the short growing season. Cows also carry the thistle and stickseed from site to site. Heavy grazing of desirable plants is selecting for less desirable species, such as squirrel tail grass. Ms. Madsen has contacted the landowner to no avail.

GVH 16. Buried Culvert Location is similarly marked at all GVH sites.
