Inspection Report

Permit Number:	C0070020
Inspection Type:	PARTIAL
Inspection Date:	Wednesday, July 15, 2015
Start Date/Time:	7/15/2015 11:00:00 AM
End Date/Time:	7/15/2015 11:45:00 AM
Last Inspection:	Thursday, June 11, 2015

Permitee: **HIDDEN SPLENDOR RESOURCES**

Site: **HORIZON MINE**

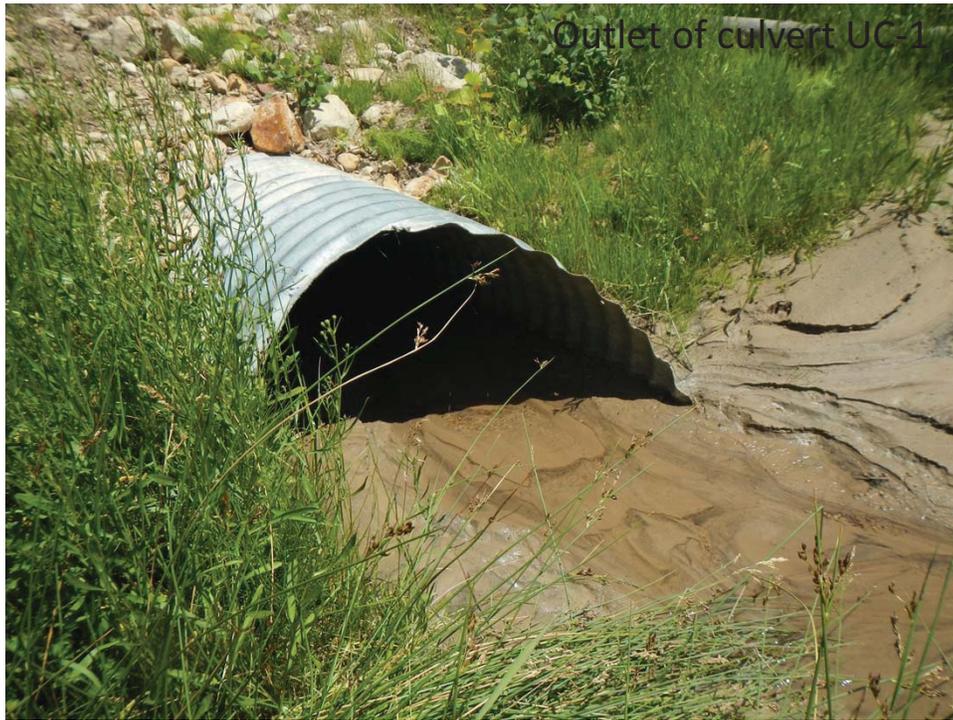
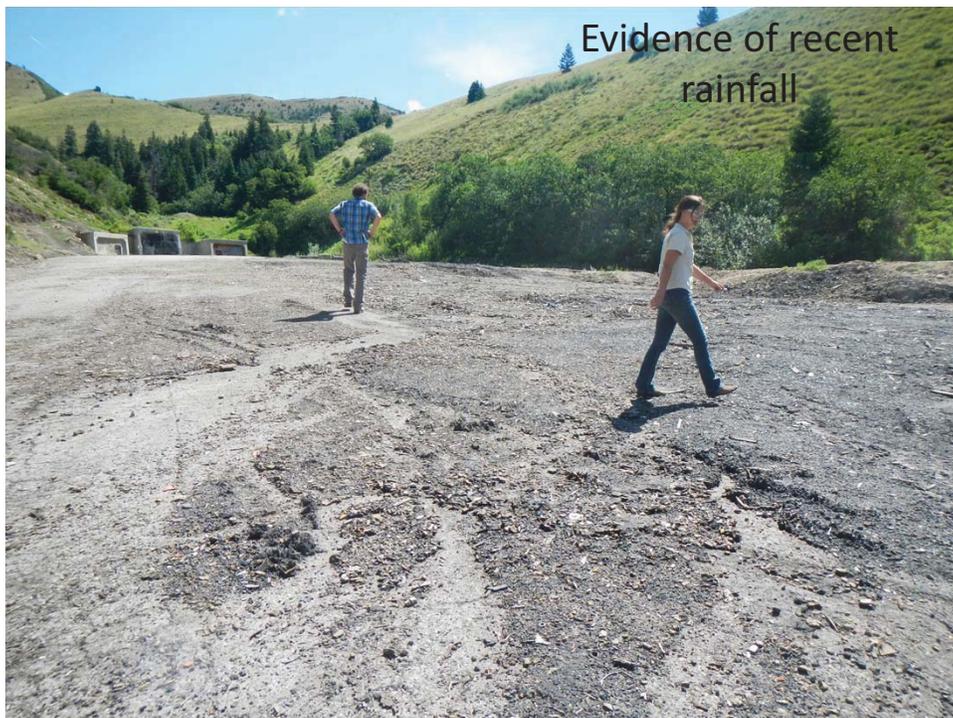
The inlet to DC-2 was completely buried by mud. The culvert was blocked completely and there was evidence that stormwater had exceeded the capacity of the inlet structure, and then flowed down over the lower disturbed area. NOV 21151 was issued for failing to maintain this inlet as well as the outlet of UC-1, which was partially filled with sediment. The inlet to DC-2 should be corrected as soon as possible, and the outlet of UC-1 should be cleared.

Overflow from blocked
culvert DC-2

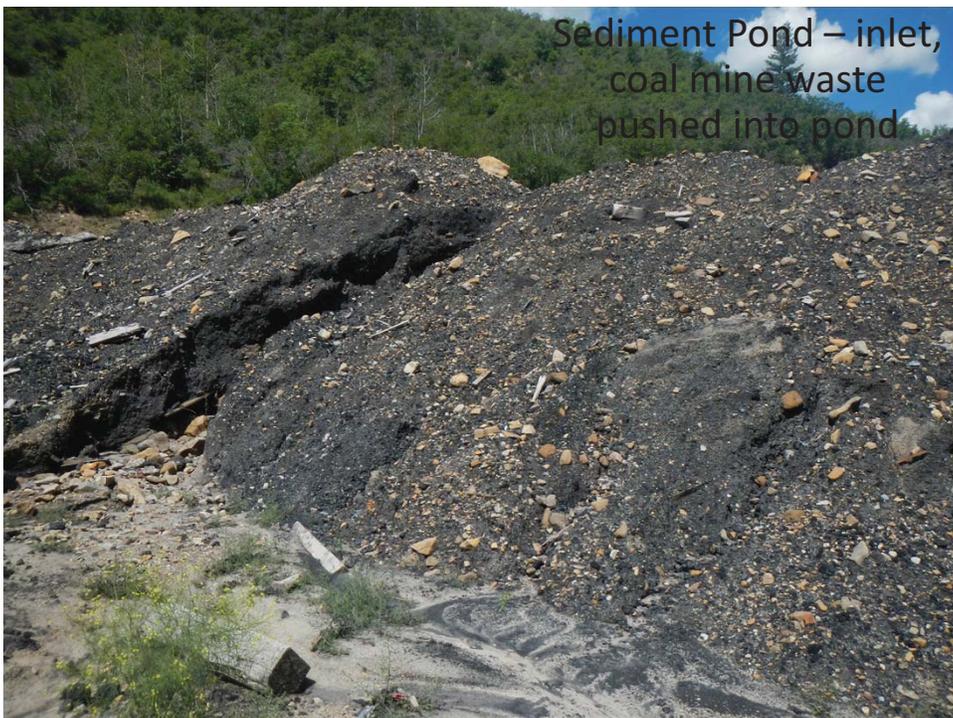
The pond continues to fall into more and more disrepair. The inlets continue to erode and become more unstable. The banks have larger and larger erosion rills, and there is evidence of animal burrowing in the banks of the pond, that should be repaired. FTACO 12147, issued August 5, 2014, is still outstanding.

Sediment Pond – inlet,
coal mine waste
pushed into pond
