**WILDCAT COAL FINES ISSUE
DIVISION ORDER-04 (WIND BLOWN FINES)
FIRST QUARTER 2014**

March 28, 2014

WILD WEST EQUIPMENT & HAULING, LLC

**J. T. Paluso, P.E.
EIS ENVIRONMENTAL & ENGINEERING CONSULTING
31 NORTH MAIN**

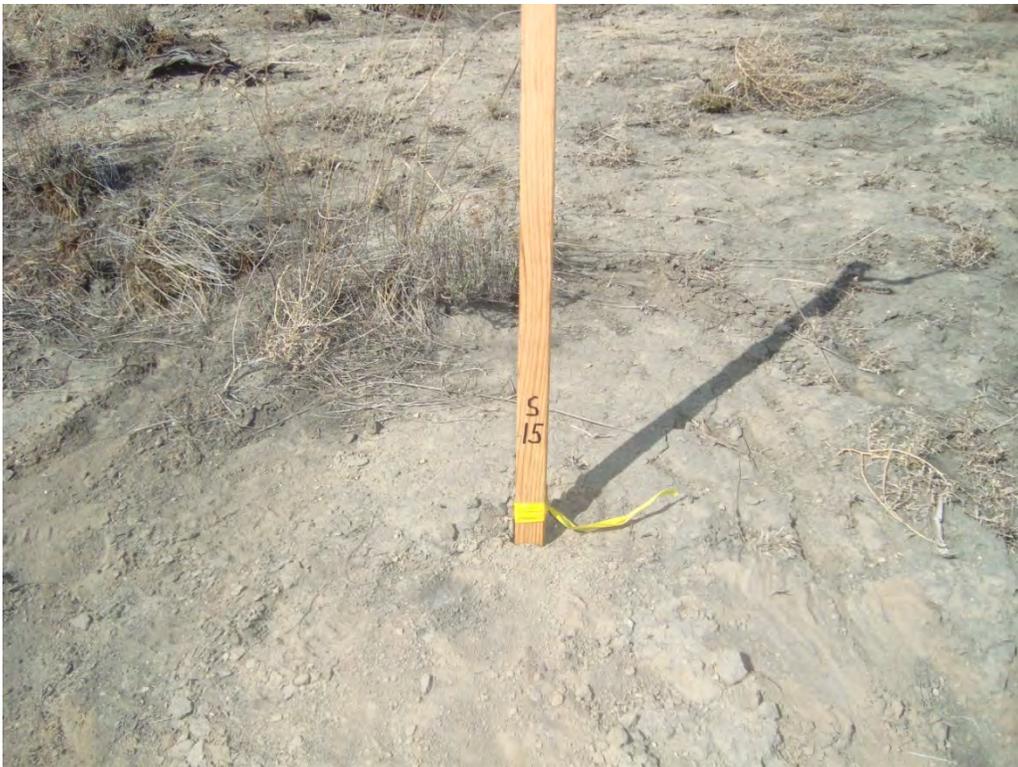
S15	0.00	0.00	New stake location		
S16	0.50	0.50	New stake location		
AVERAGE		0.63
