Wild West Equipment & Hauling, LLC
Wildcat Load Out
5495 West 3550 North, Helper, Utah 84526
Phone: (435) 472-3988 – Fax: (435) 472-3456

Re: C/007/030 Wildcat Load Out 2014 Annual Report

Annual Report

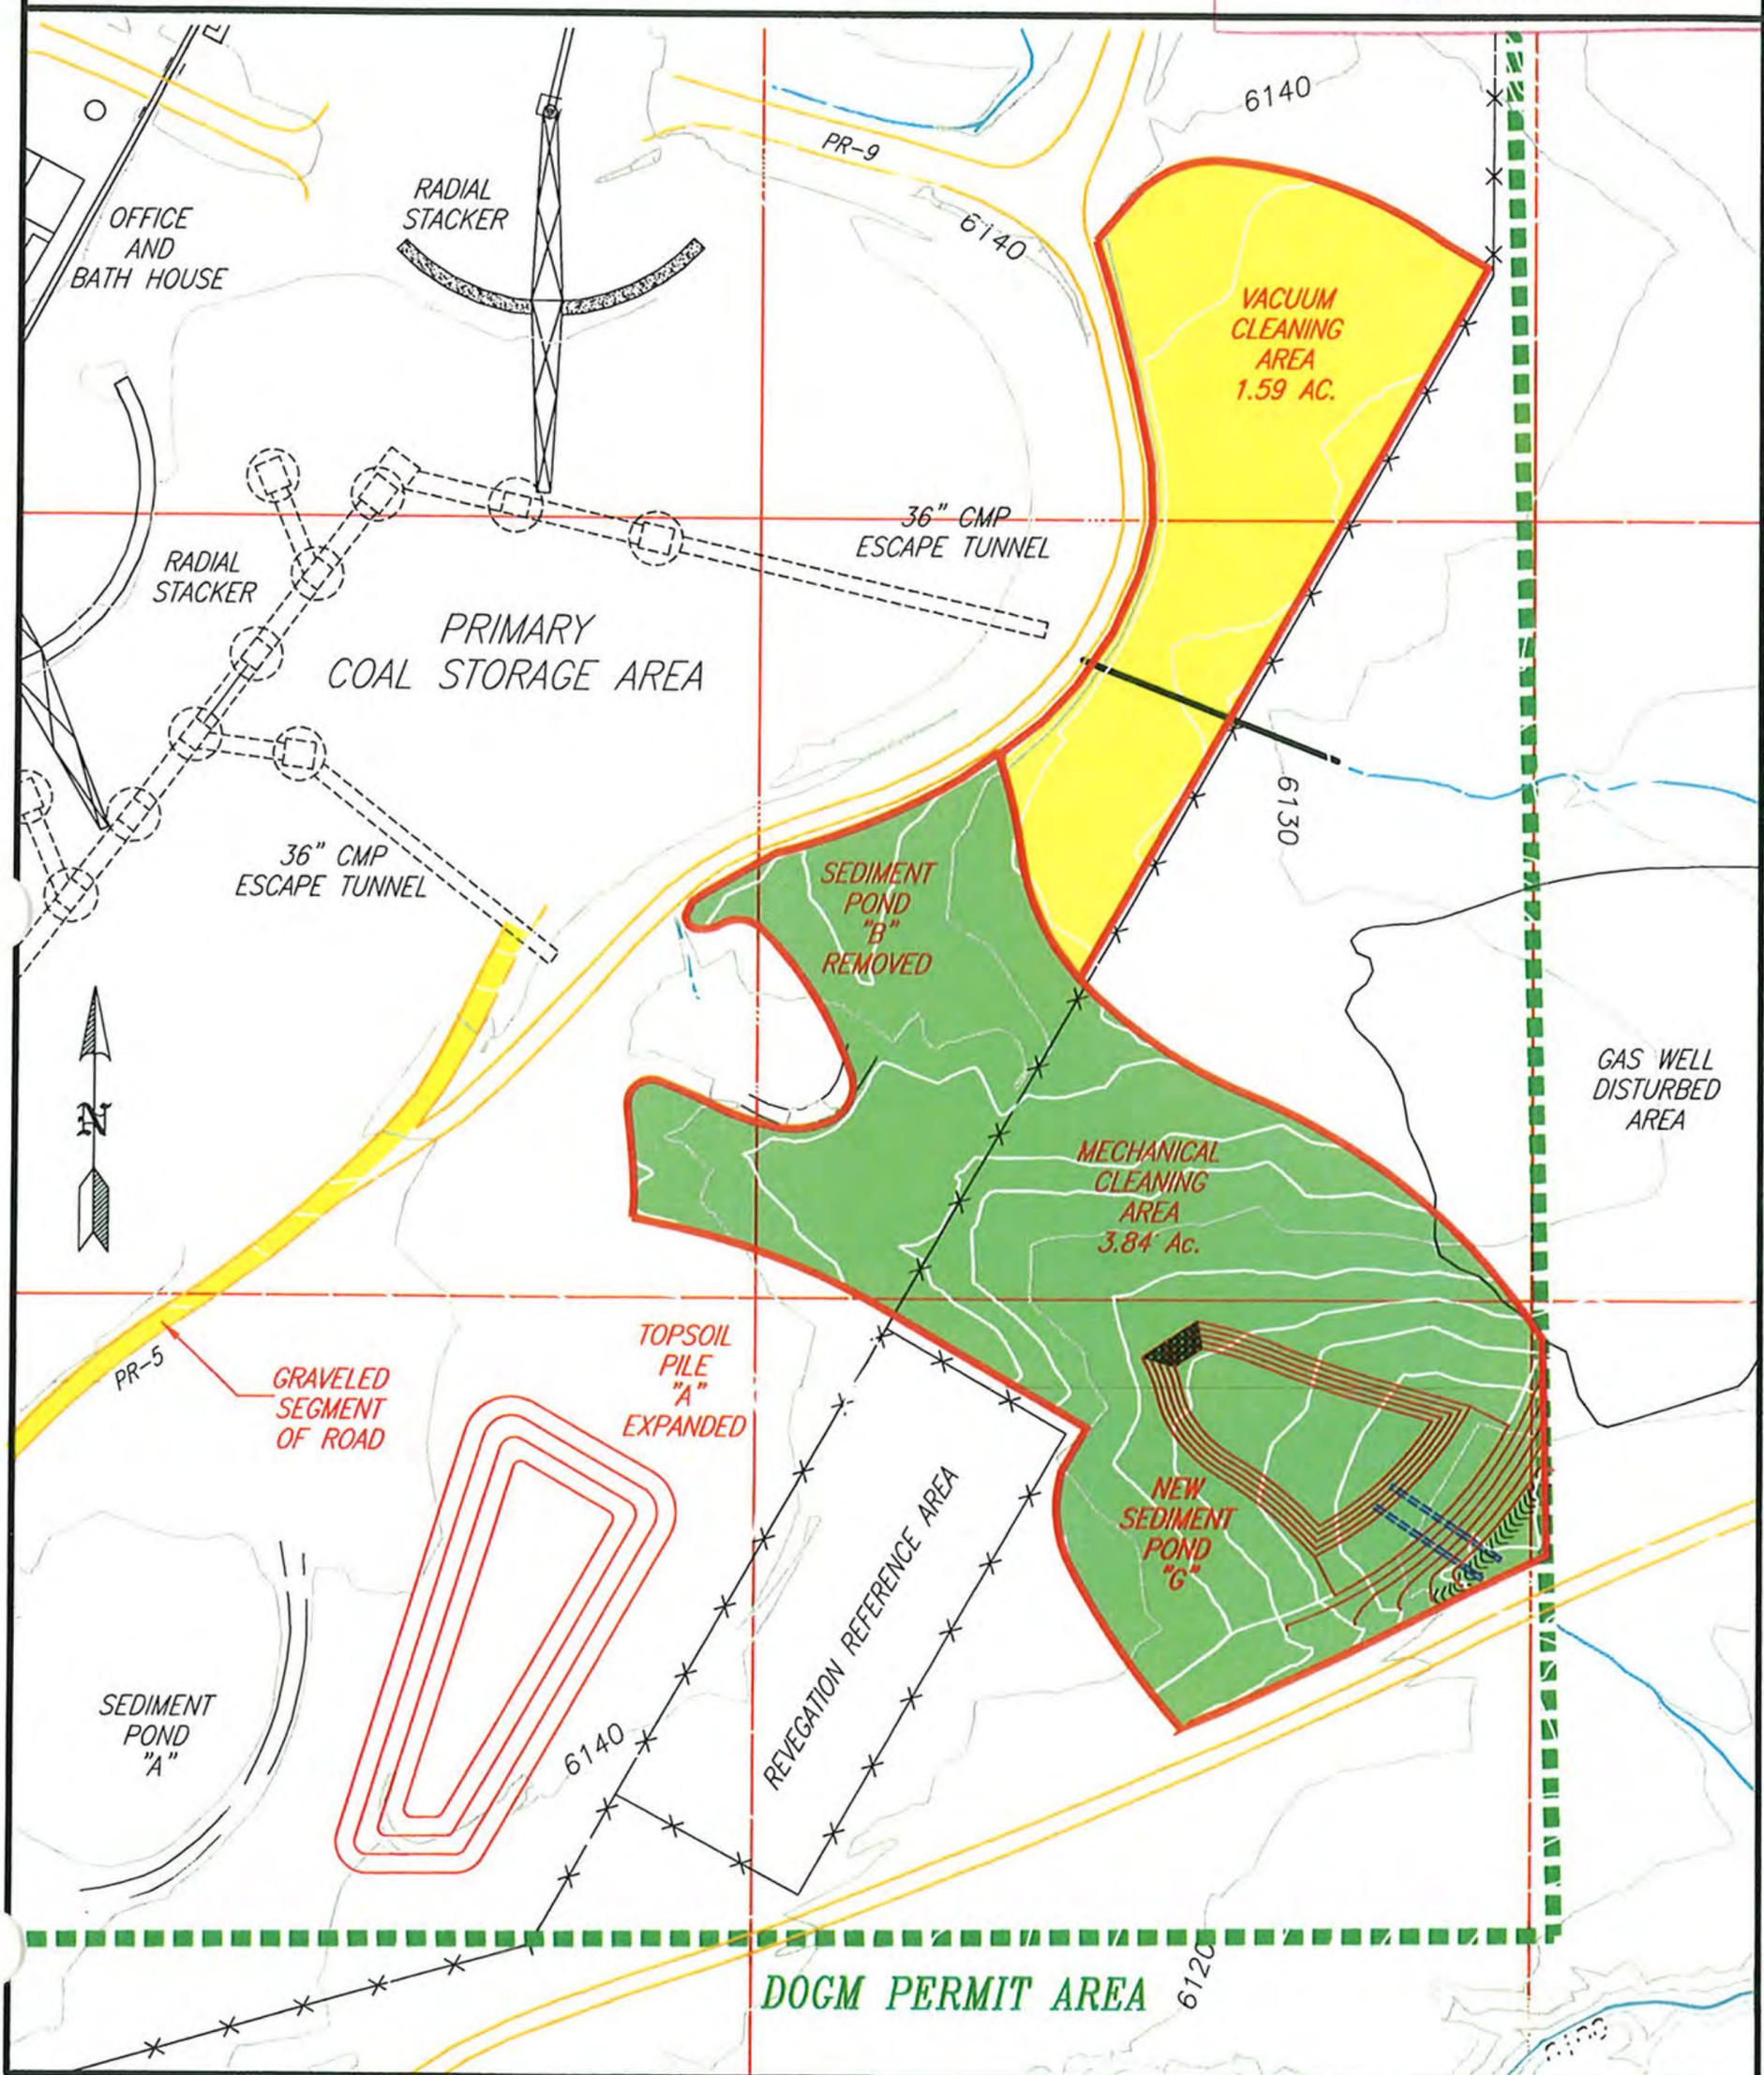
WILDCAT LOADOUT
COAL FINES CLEAN-UP AREA
RESPONSE TO D0-04
FIGURE 2

There are now 21 sampling points on the north area and 16 sampling points on the south area. Figure 1 shows the sampling points and Figure 2 shows the areas that are of concern. Each point was located with a GPS. Refer to Appendix 1 for the GPS coordinate location of each point.

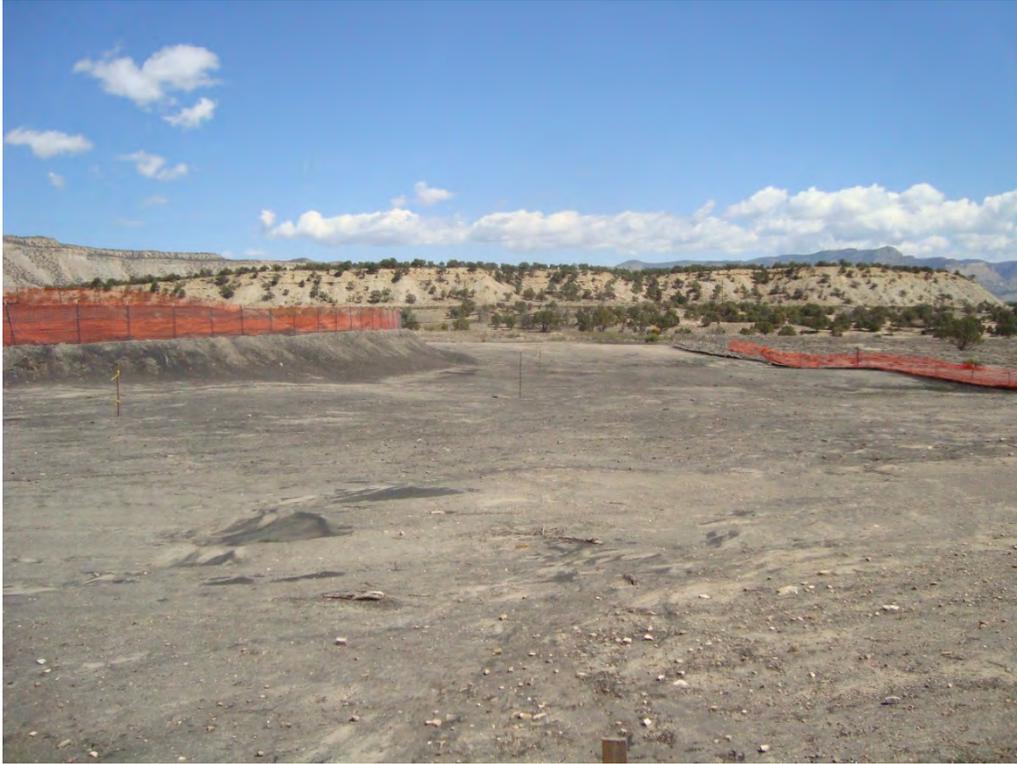
NORTHERN AREA LOOKING FROM N4 TOWARDS N1

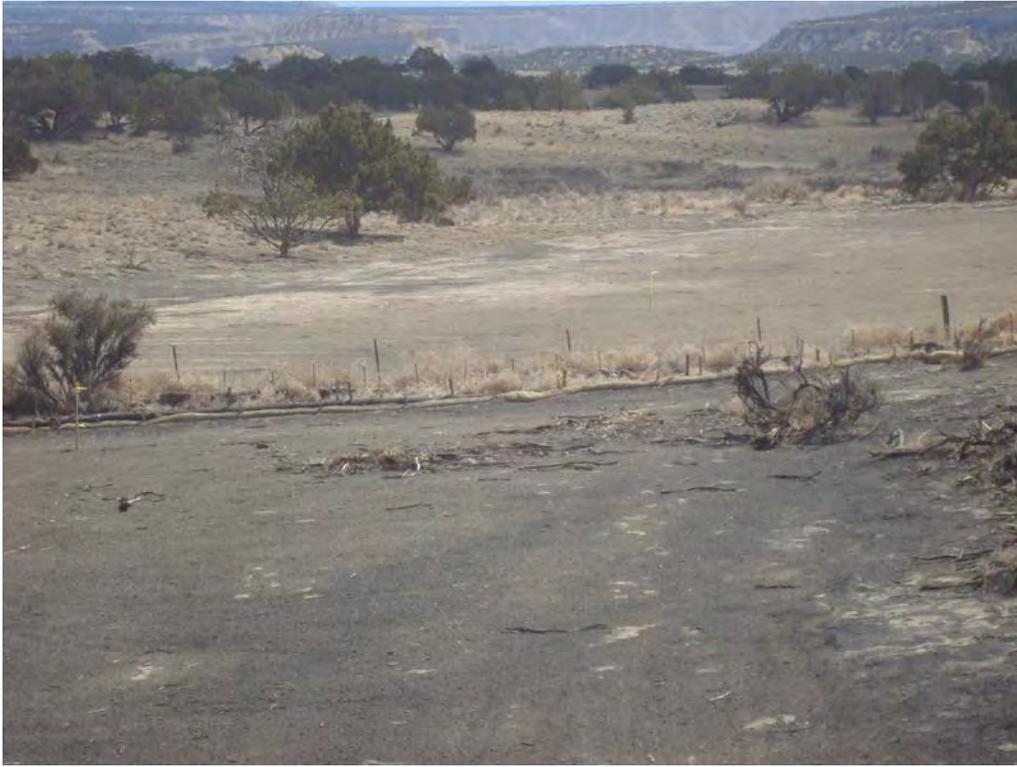
LOOKING EAST NEAR TRUCK ENTRANCE

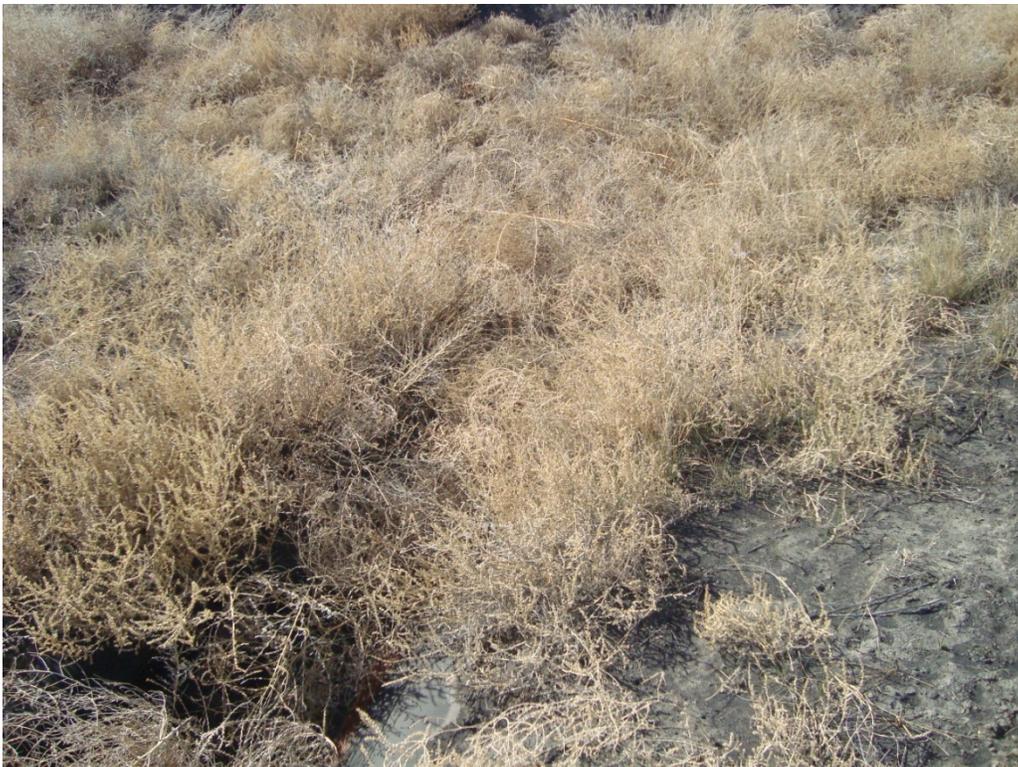
Weeds in West Inlet

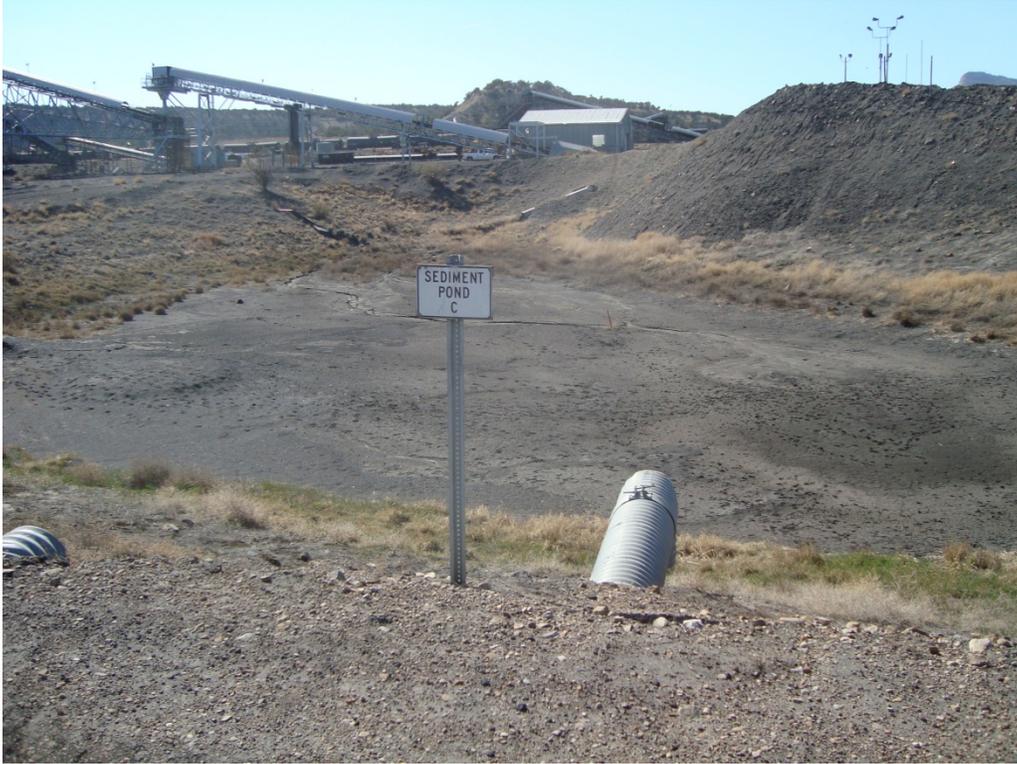
Sediment Pond C

WEST INLET CULVERT BAND IS COMING OFF. PIPE
IS LEAKING & SHOULD BE REPAIRED

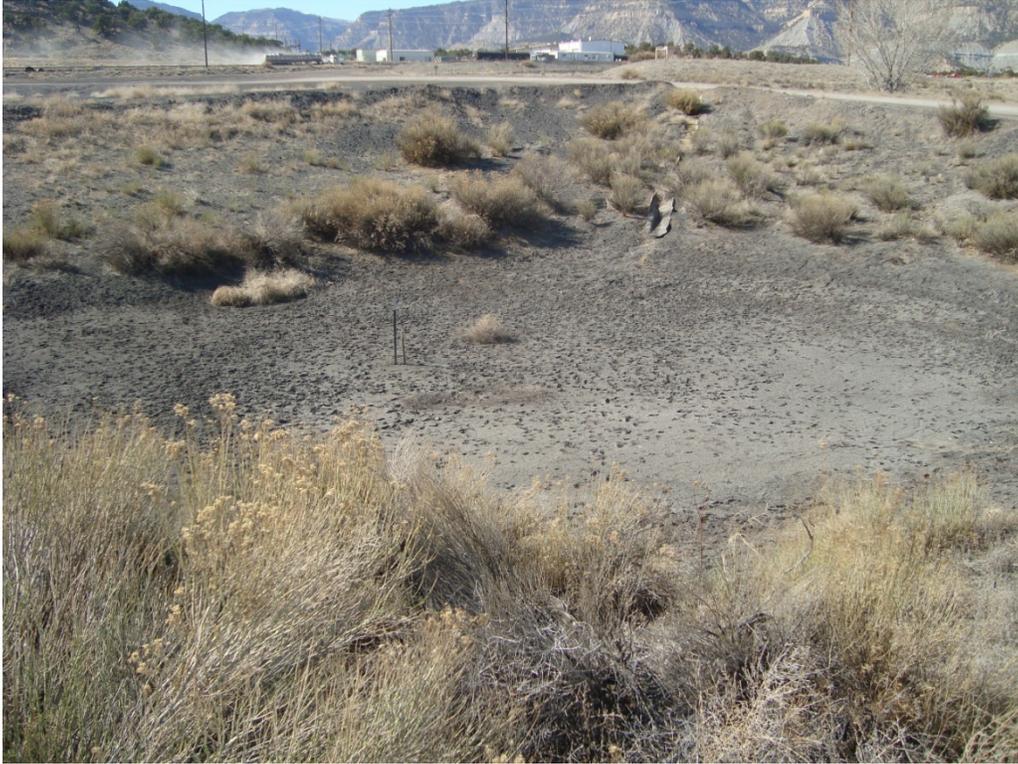
Sediment Pond D

SOUTH INLET ERODING AND SHOULD BE REPAIRED

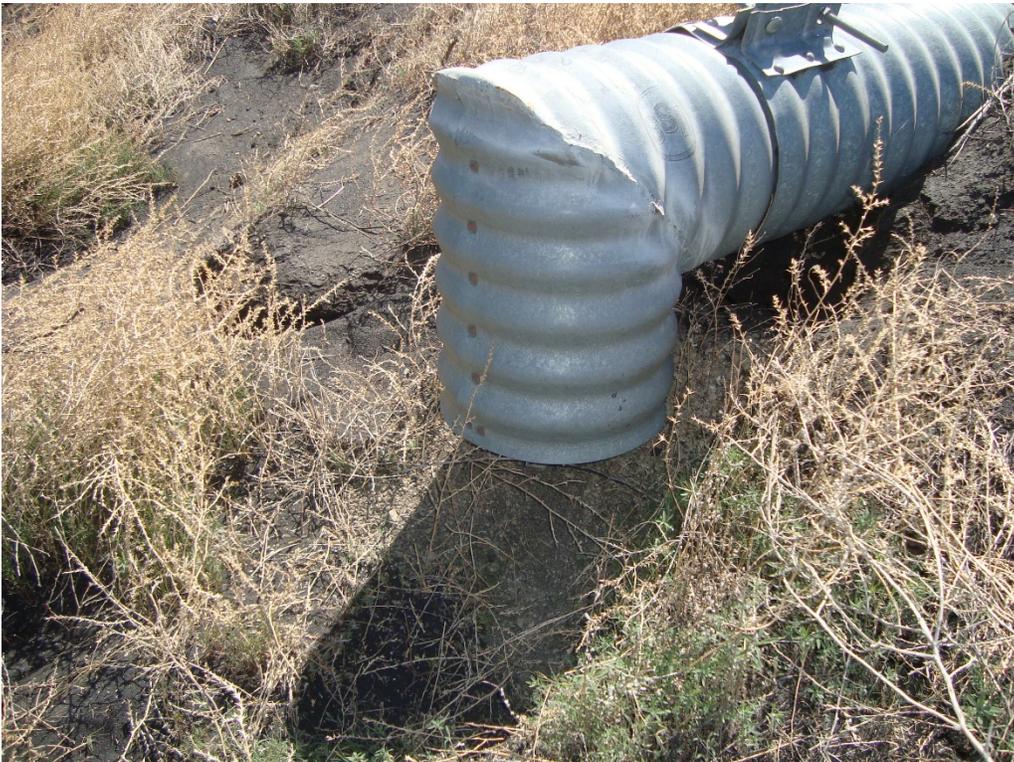
WEEDS AT INLET

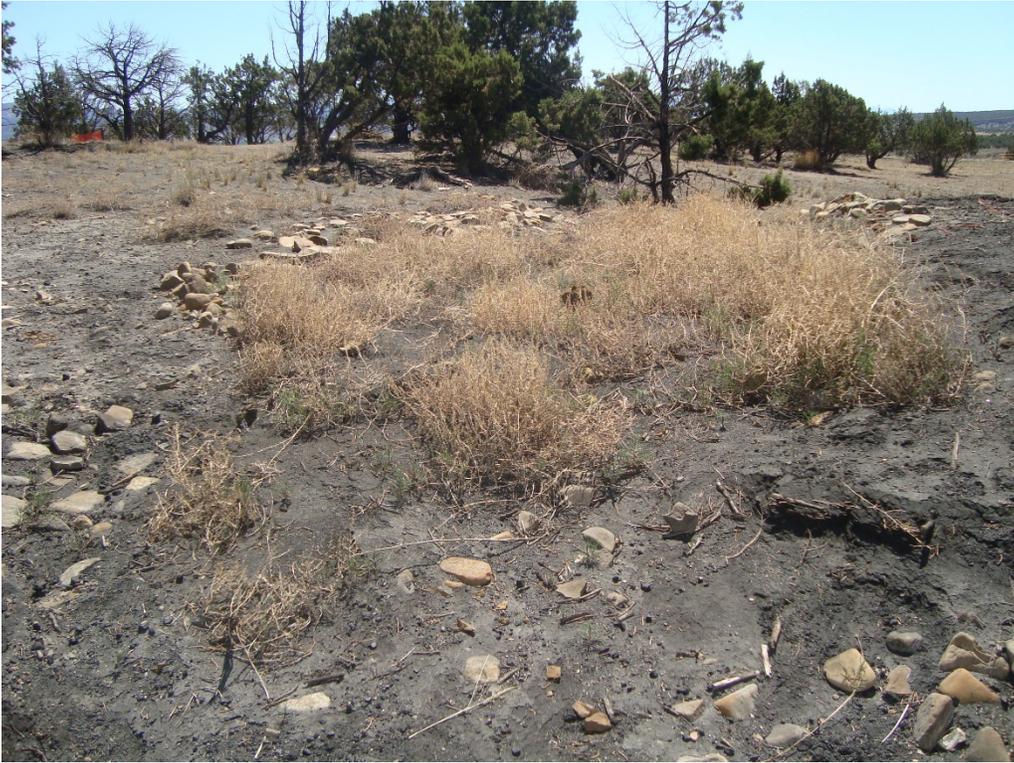
COAL & WEEDS IN EMERGENCY SPILLWAY

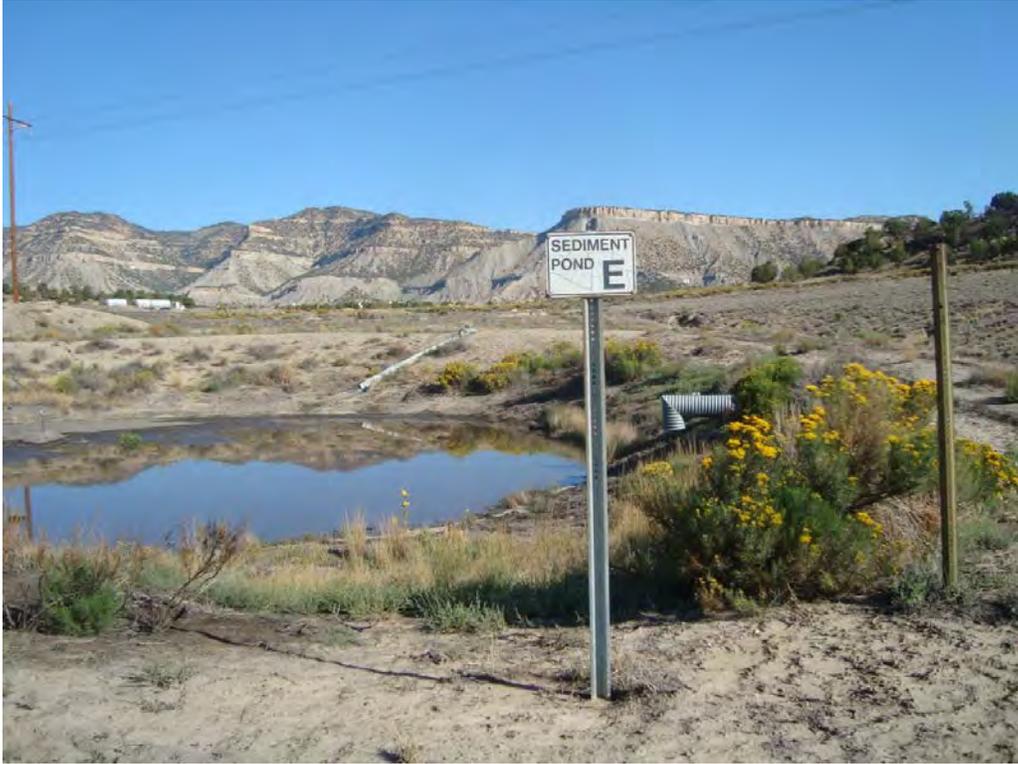
SEDIMENT POND E

CANNOT SEE SEDIMENT LEVEL DUE TO WATER.

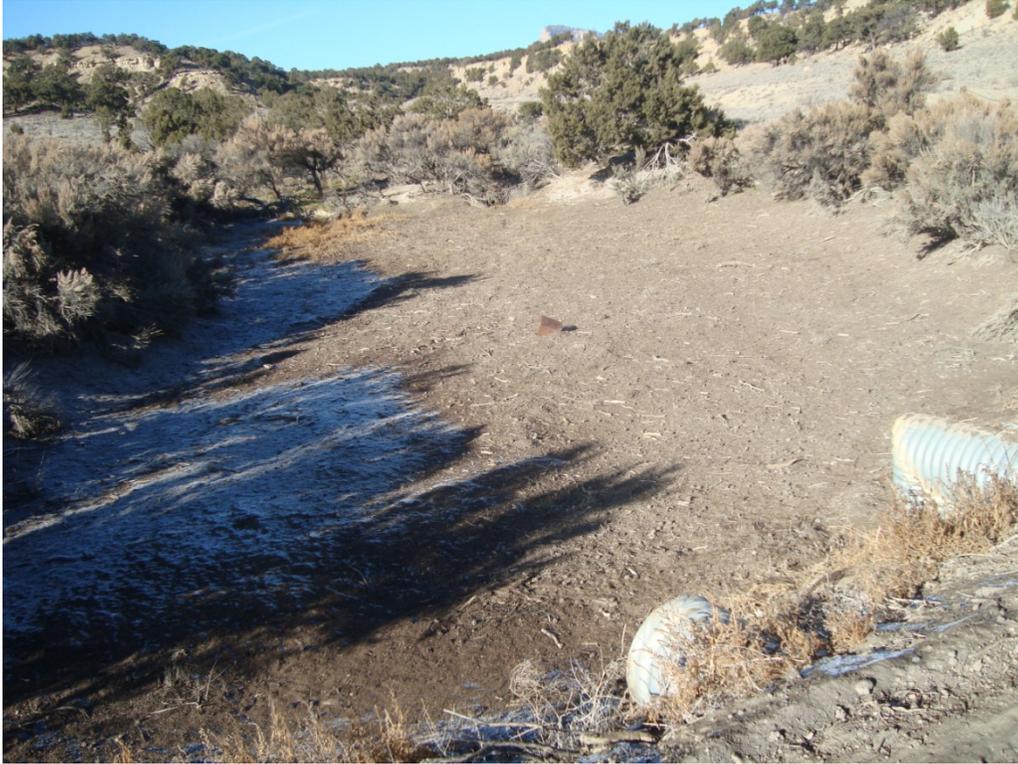
PERMANENT IMPOUNDMENT (UPPER CELL)

The pond's dam shows no signs of structural instability or other hazardous conditions.

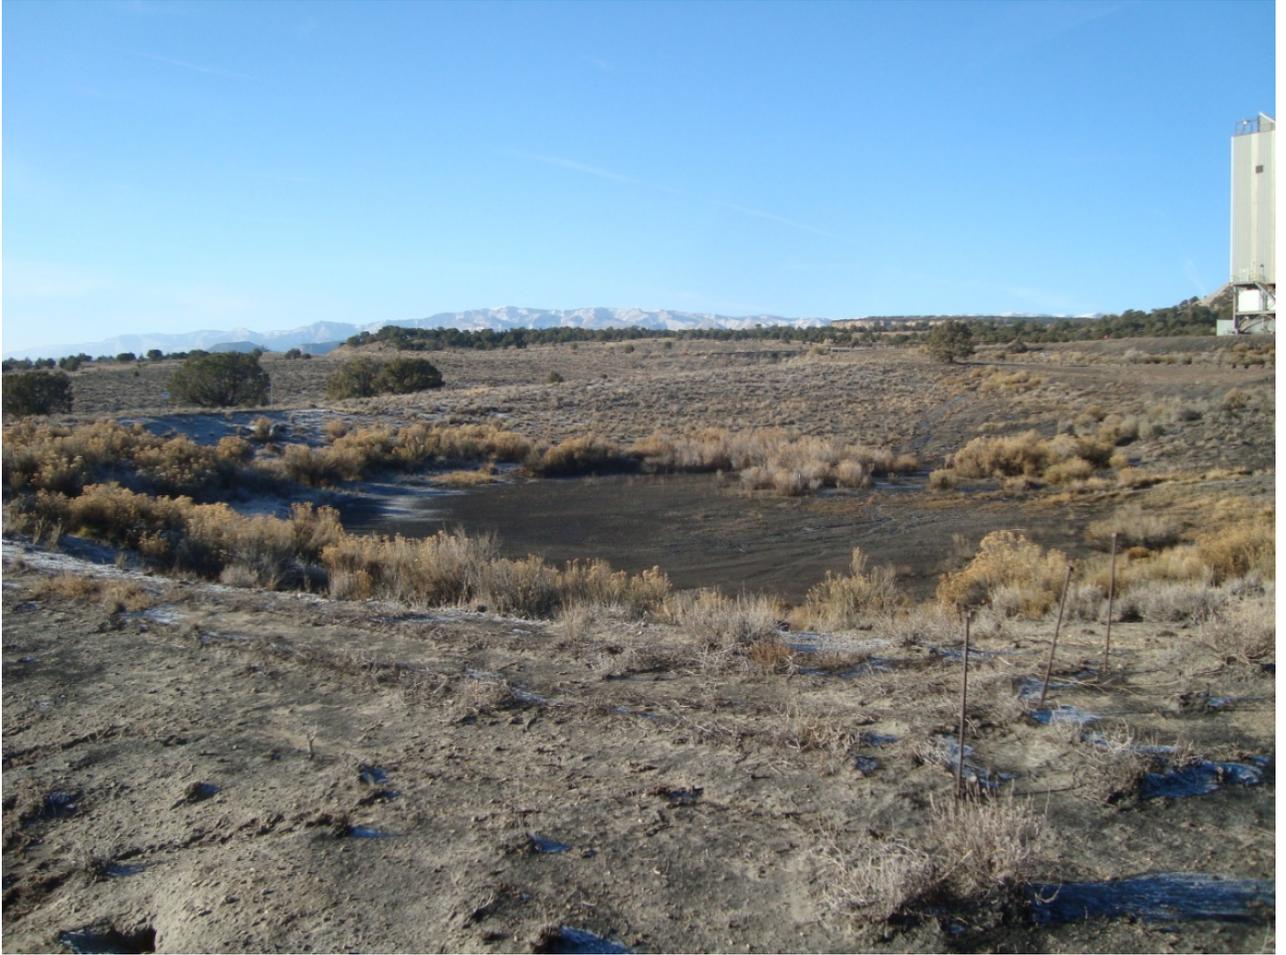
SEDIMENT POND A

1. Describe any appearances of any instability, structural weakness, or any other hazardous condition.			
The pond's dam shows no signs of structural instability or other hazardous conditions.			
Required for an impoundment which functions as a SEDIMENTATION POND	2. Sediment storage capacity and storage volumes.		
	Existing Storage Capacity: 2.9 ac-ft		
	Existing Sediment Storage Capacity (To Cleanout): .48 ac-ft

3. Principle and emergency spillway elevations		
	Principle spillway elevation: 6,149.0'		
	Emergency spillway elevation: 6,150.0'		
4. Field Information: Provide current water elevation, whether pond is discharging, type and number of samples taken, monitoring/instrumentation information, inlet/outlet conditions or other related activities associated with the pond including but not limited to sediment cleanout, pond decanting, embankment erosion/repairs, monitoring information, vegetation on out slopes of embankment erosion/repairs, monitoring information, vegetation on out slopes of embankments, etc.			
During the annual inspection, December 9, 2014, the vegetative cover looked good with no signs of erosion. Both spillways look good with no signs of stability problems.

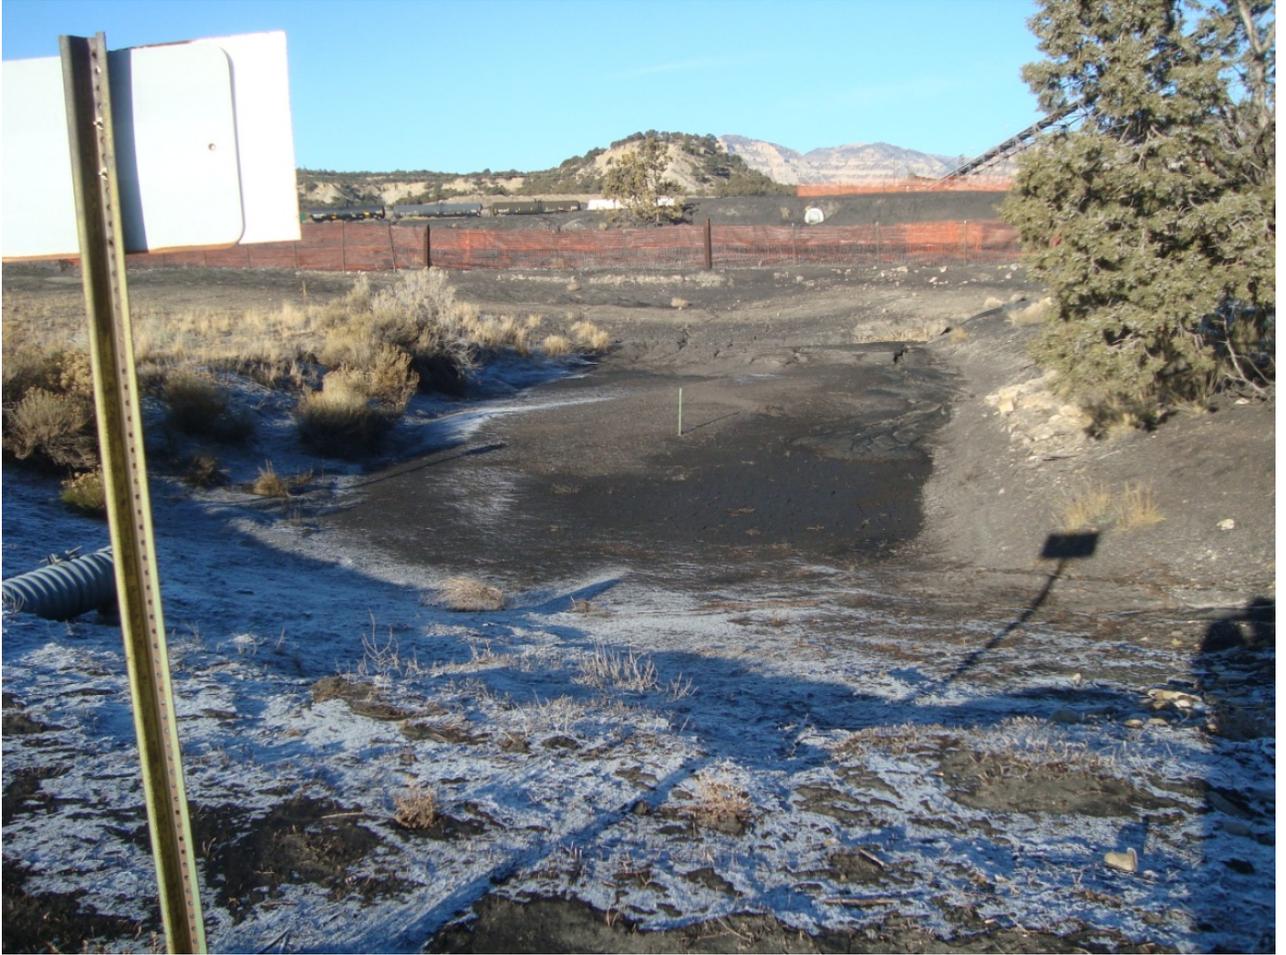
SEDIMENT POND B

1. Describe any appearances of any instability, structural weakness, or any other hazardous condition.			
The pond's dam shows no signs of structural instability or other hazardous conditions.			
Required for an impoundment which functions as a SEDIMENTATION POND	2. Sediment storage capacity and storage volumes.		
	Existing Storage Capacity: 0.41 ac-ft		
	Existing Sediment Storage Capacity (To Cleanout): 0.10 ac-ft

3. Principle and emergency spillway elevations		
	Principle spillway elevation: 6,138.0'		
	Emergency spillway elevation: 6,139.0'		
4. Field Information: Provide current water elevation, whether pond is discharging, type and number of samples taken, monitoring/instrumentation information, inlet/outlet conditions or other related activities associated with the pond including but not limited to sediment cleanout, pond decanting, embankment erosion/repairs, monitoring information, vegetation on out slopes of embankment erosion/repairs, monitoring information, vegetation on out slopes of embankments, etc.			
During the annual inspection, December 9, 2014, the vegetative cover looked good with no signs of erosion.

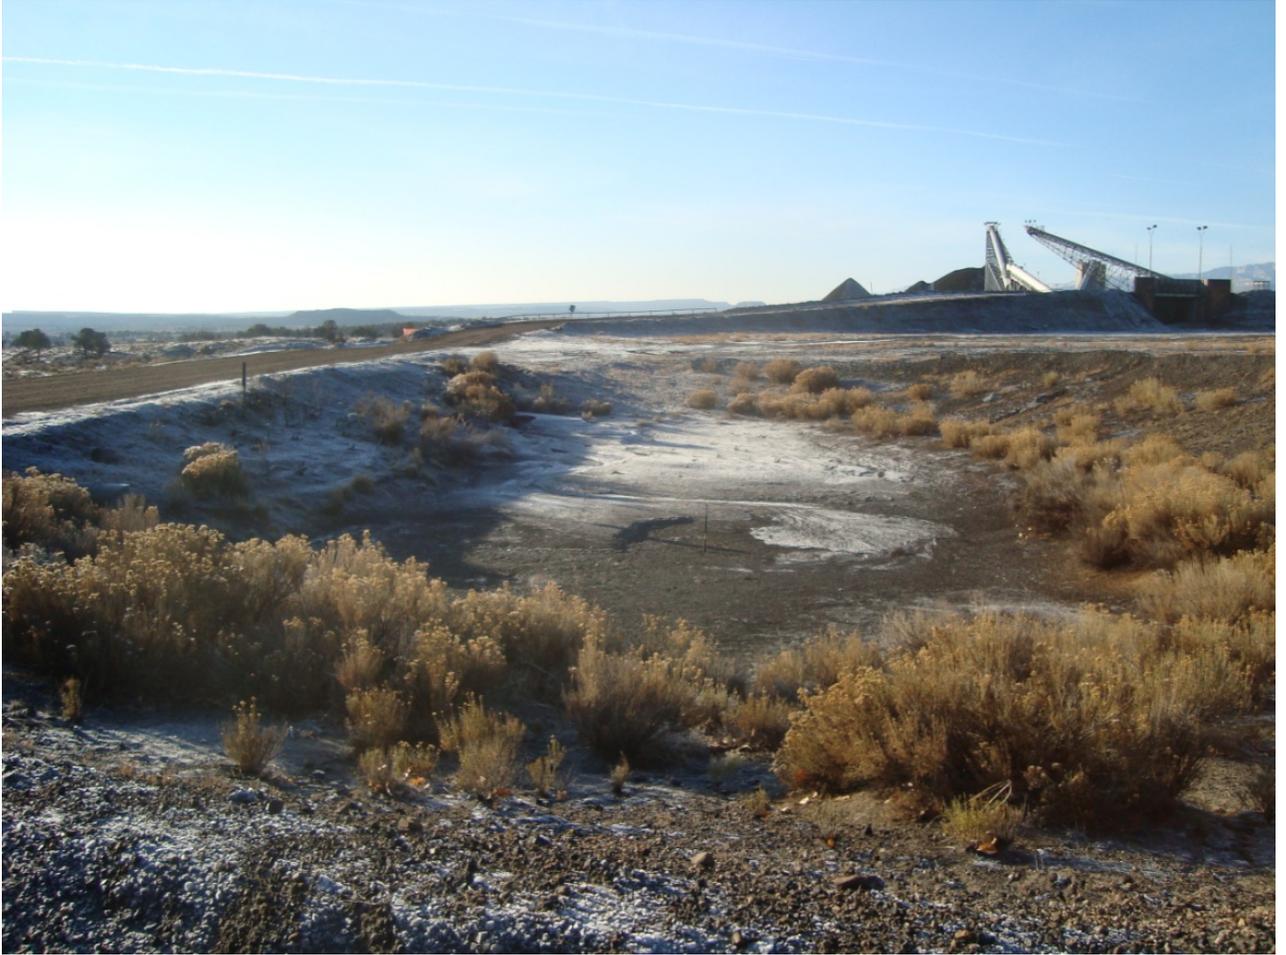
SEDIMENT POND D

1. Describe any appearances of any instability, structural weakness, or any other hazardous condition.			
The pond's dam shows no signs of structural instability or other hazardous conditions.			
Required for an impoundment which functions as a SEDIMENTATION POND	2. Sediment storage capacity and storage volumes.		
	Existing Storage Capacity: 1.131 ac-ft		
	Existing Sediment Storage Capacity (To Cleanout): 0.09 ac-ft

3. Principle and emergency spillway elevations		
	Principle spillway elevation: 6,139.0'		
	Emergency spillway elevation: 6,140.0'		
4. Field Information: Provide current water elevation, whether pond is discharging, type and number of samples taken, monitoring/instrumentation information, inlet/outlet conditions or other related activities associated with the pond including but not limited to sediment cleanout, pond decanting, embankment erosion/repairs, monitoring information, vegetation on out slopes of embankment erosion/repairs, monitoring information, vegetation on out slopes of embankments, etc.			
During the annual inspection, December 9, 2014, the vegetative cover looked good with no signs of erosion.

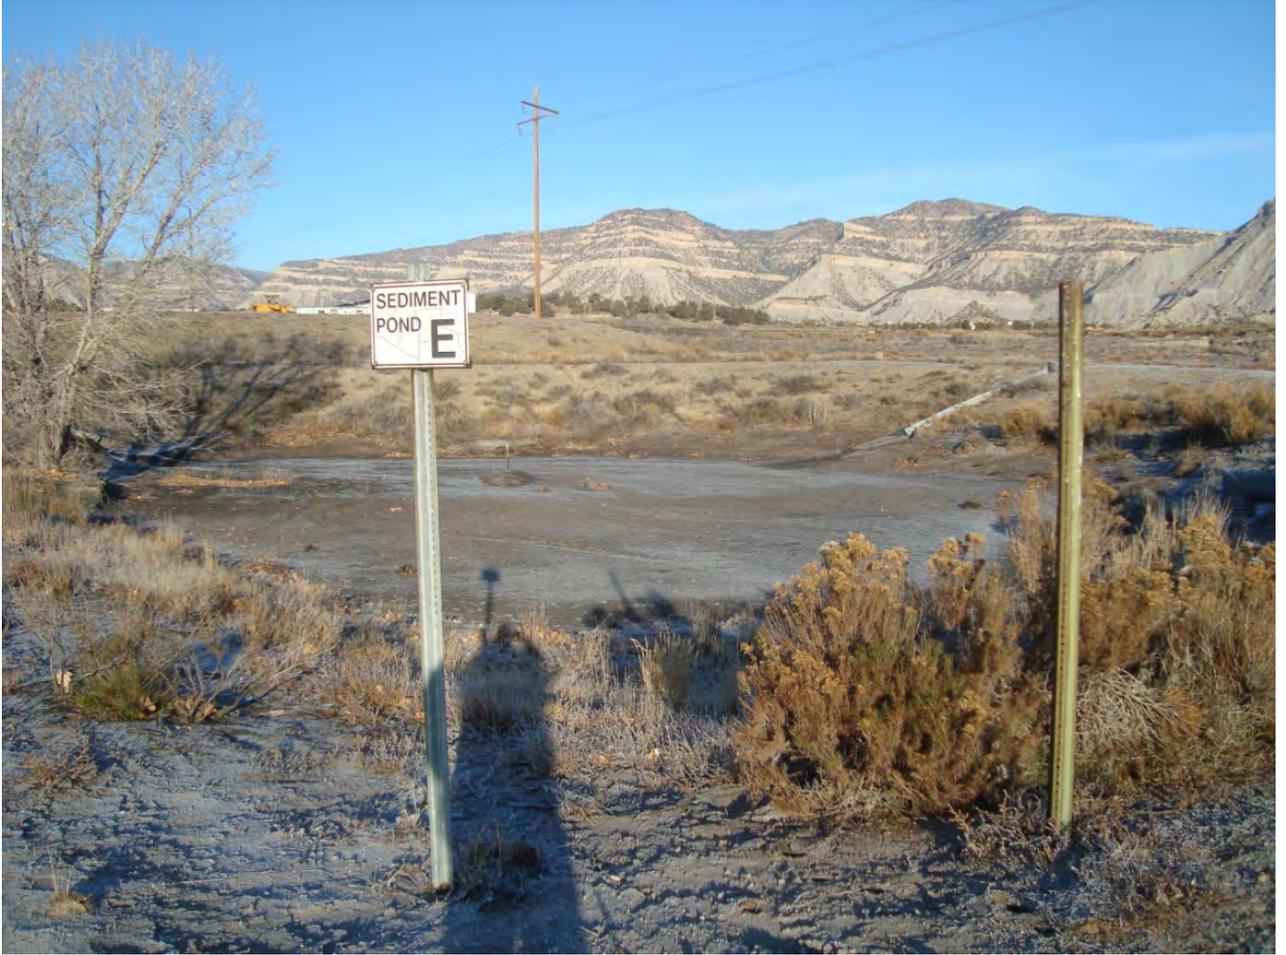
SEDIMENT POND E

1. Describe any appearances of any instability, structural weakness, or any other hazardous condition.			
The pond's dam shows no signs of structural instability or other hazardous conditions.			
Required for an impoundment which functions as a SEDIMENTATION POND	2. Sediment storage capacity and storage volumes.		
	Existing Storage Capacity: 1.092 ac-ft		
	Existing Sediment Storage Capacity (To Cleanout): 0.18 ac-ft

3. Principle and emergency spillway elevations		
	Principle spillway elevation: 6,145.0'		
	Emergency spillway elevation: 6,146.0'		
4. Field Information: Provide current water elevation, whether pond is discharging, type and number of samples taken, monitoring/instrumentation information, inlet/outlet conditions or other related activities associated with the pond including but not limited to sediment cleanout, pond decanting, embankment erosion/repairs, monitoring information, vegetation on outslopes of embankment erosion/repairs, monitoring information, vegetation on outslopes of embankments, etc.			
During the annual inspection, December 9, 2014, the vegetative cover looked good with no signs of erosion.

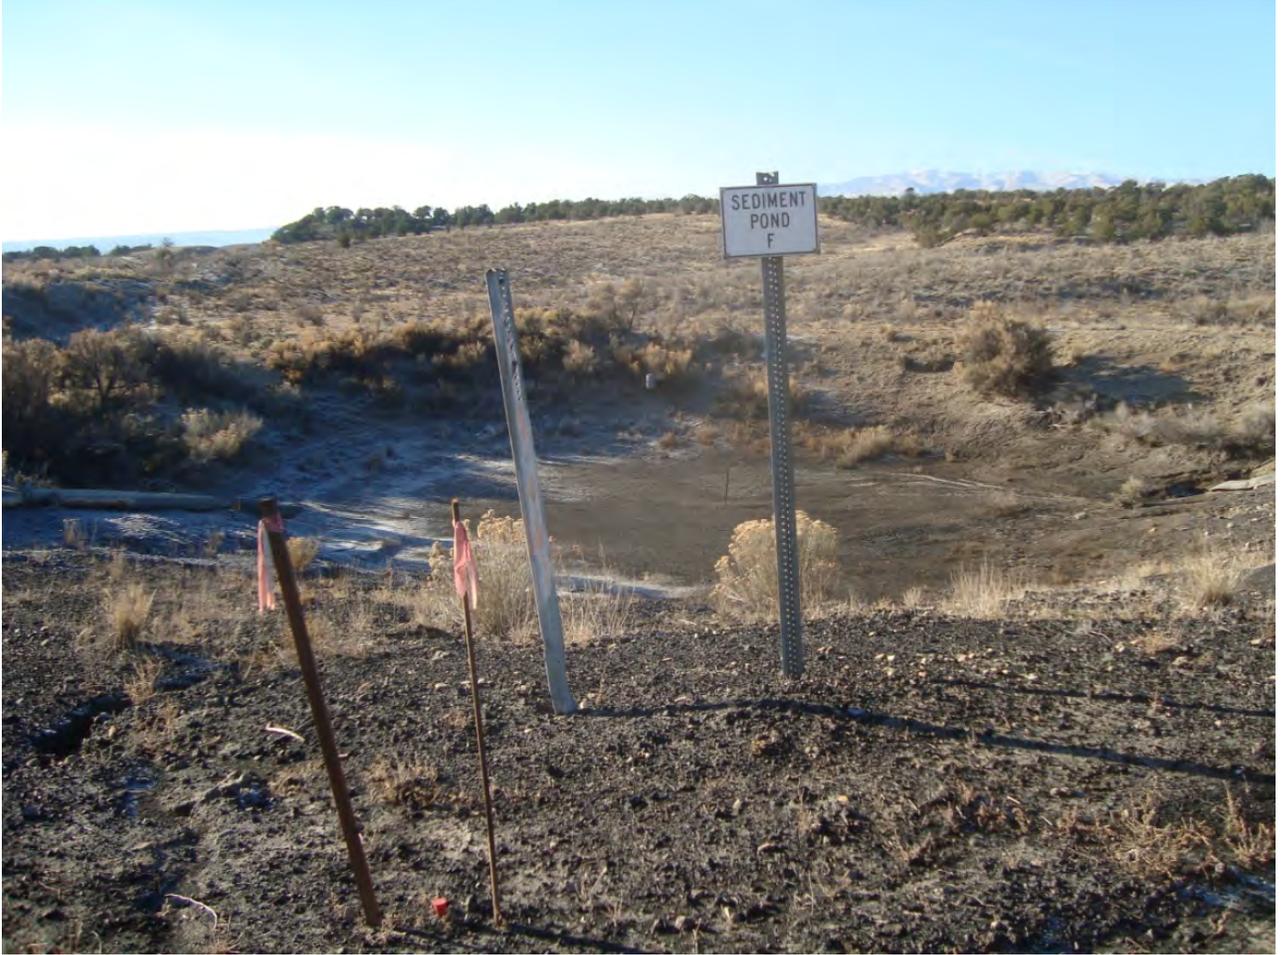
SEDIMENT POND F

1. Describe any appearances of any instability, structural weakness, or any other hazardous condition.			
The pond's dam shows no signs of structural instability or other hazardous conditions.			
Required for an impoundment which functions as a SEDIMENTATION POND	2. Sediment storage capacity and storage volumes.		
	Existing Storage Capacity: 0.869 ac-ft		
	Existing Sediment Storage Capacity (To Cleanout): 0.15 ac-ft

3. Principle and emergency spillway elevations		
	Principle spillway elevation: 6,173.0'		
	Emergency spillway elevation: 6,174.0'		
4. Field Information: Provide current water elevation, whether pond is discharging, type and number of samples taken, monitoring/instrumentation information, inlet/outlet conditions or other related activities associated with the pond including but not limited to sediment cleanout, pond decanting, embankment erosion/repairs, monitoring information, vegetation on out slopes of embankment erosion/repairs, monitoring information, vegetation on out slopes of embankments, etc.			
During the annual inspection, December 9, 2014, the vegetative cover looked good with no signs of erosion.

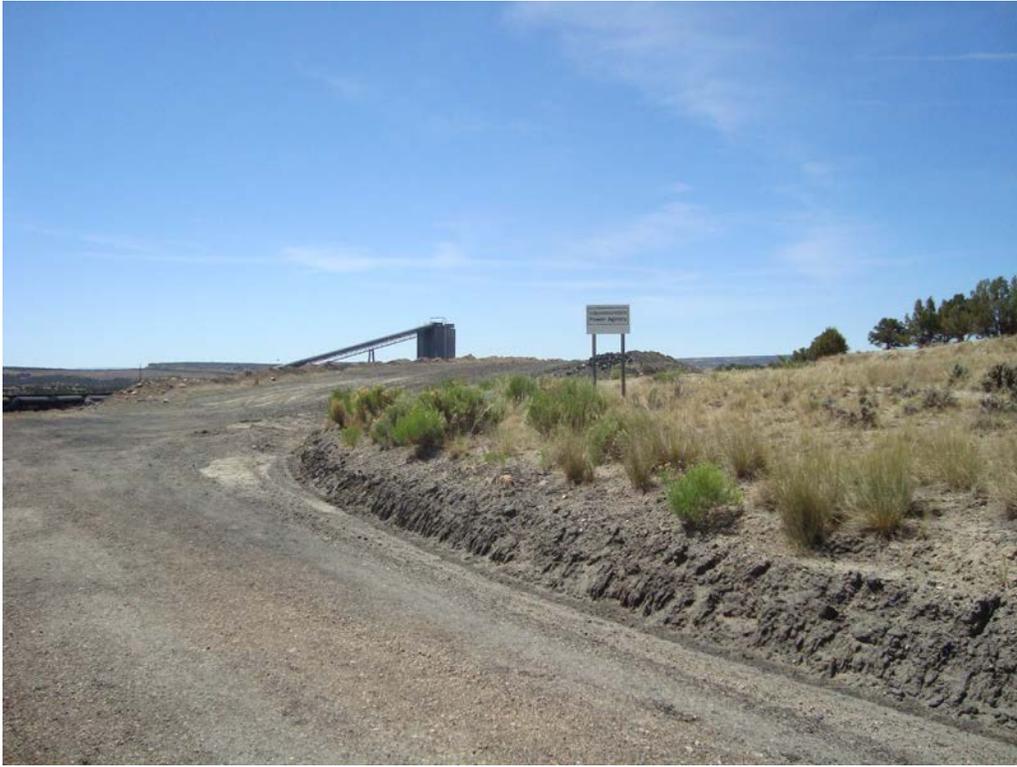
Refuse Pile Entrance

9. Describe any appearances of instability, structural weakness, or other hazardous conditions :
None noticed

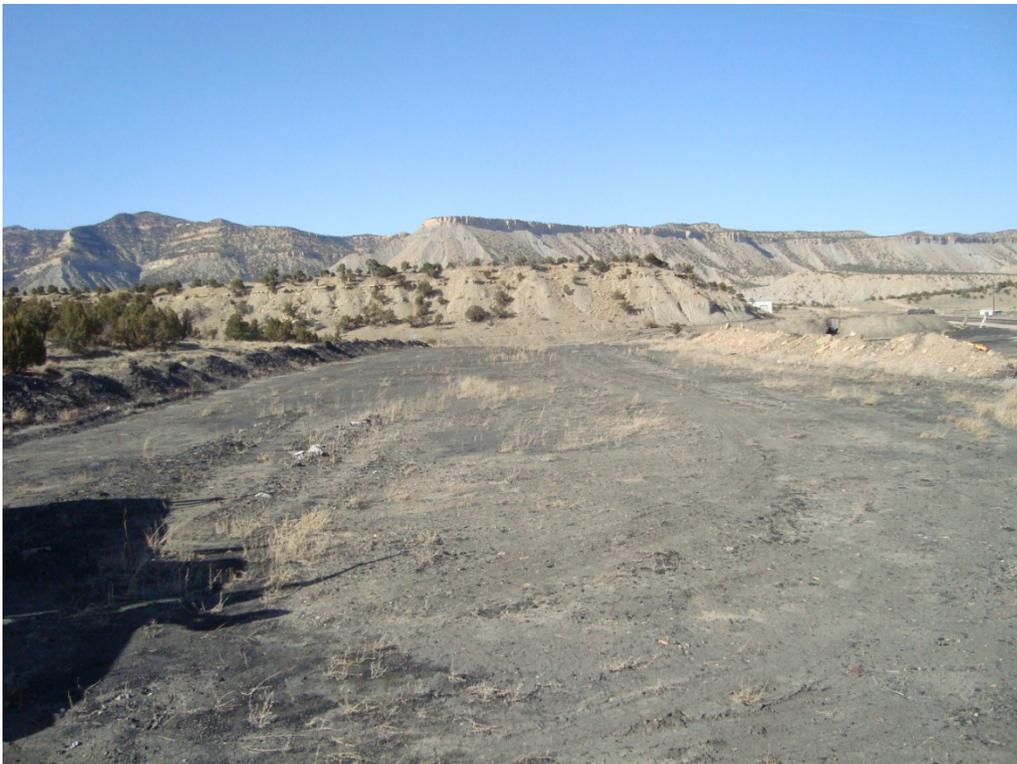
Top of Refuse Pile Looking North

9. Describe any appearances of instability, structural weakness, or other hazardous conditions :
None noticed

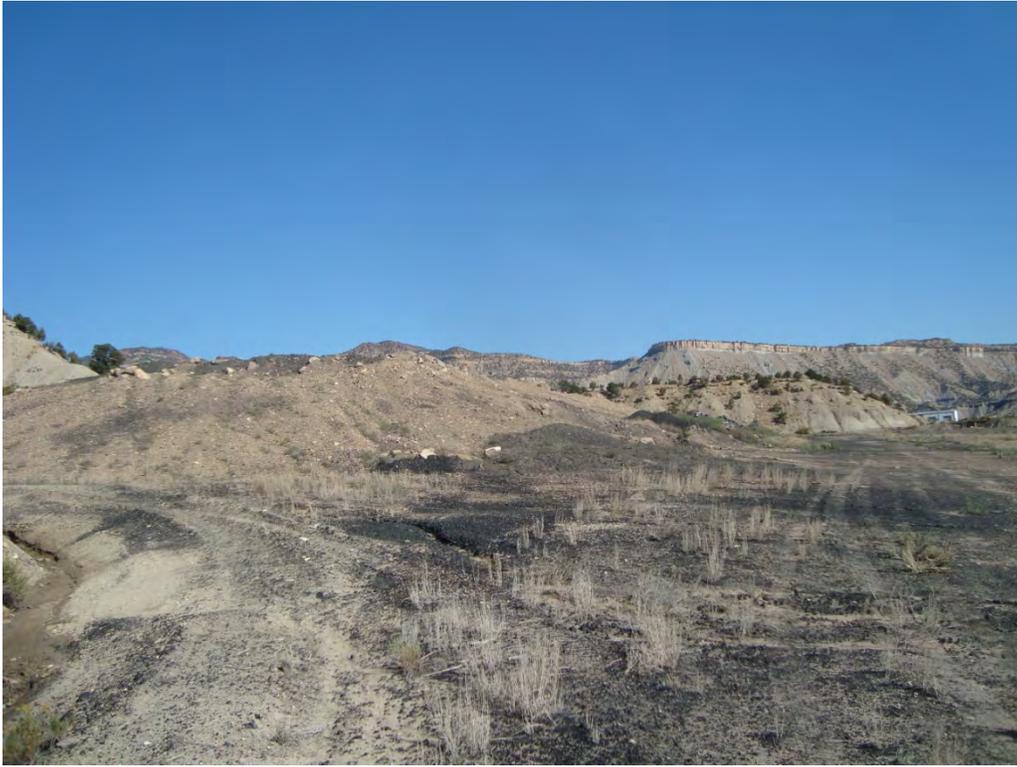
REFUSE PILE LOOKING NORTH

9. Describe any appearances of instability, structural weakness, or other hazardous conditions :
None noticed

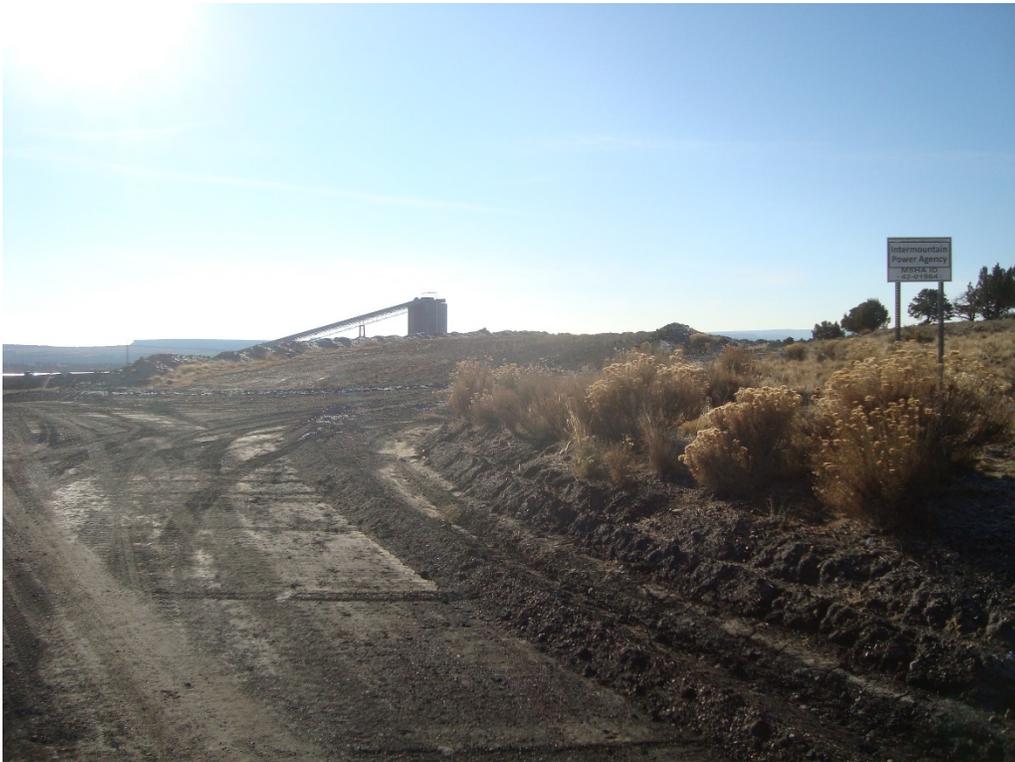
ENTRANCE TO REFUSE PILE (LOOKING SOUTH)

9. Describe any appearances of instability, structural weakness, or other hazardous conditions :
None noticed
