FROM: DUGOUT CANYON MINE, CANYON FUEL COMPANY, LLC, C007/039

RE: STORM EXCEEDENCE

Pace Canyon – Sections 17, 18, 19 & 20, Township 13S Range 13E

Precipitation Event: August 14, 2007

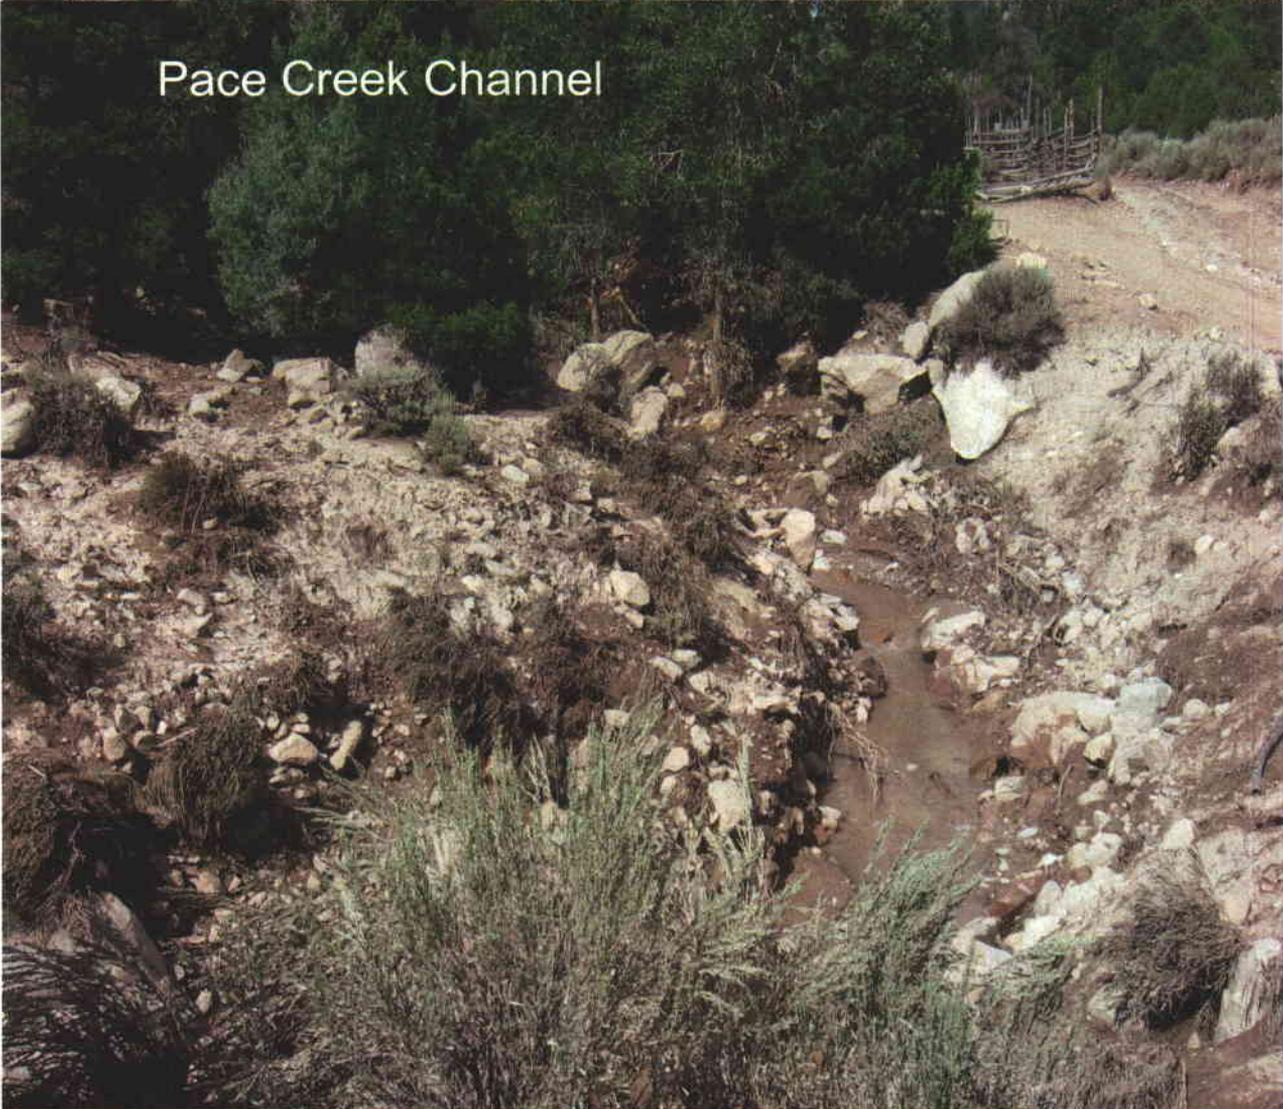
Pace Creek Channel

Hand drawn diagram of Pace Creek channel immediately above access gate from Clarks Valley. The creek topped the bank and ran over the ground for approximately 450' before rejoining the creek channel below the access gate. Pete Hess took picture of this location on Thursday, August 16<sup>th</sup>, high watermarks are visible in the picture.

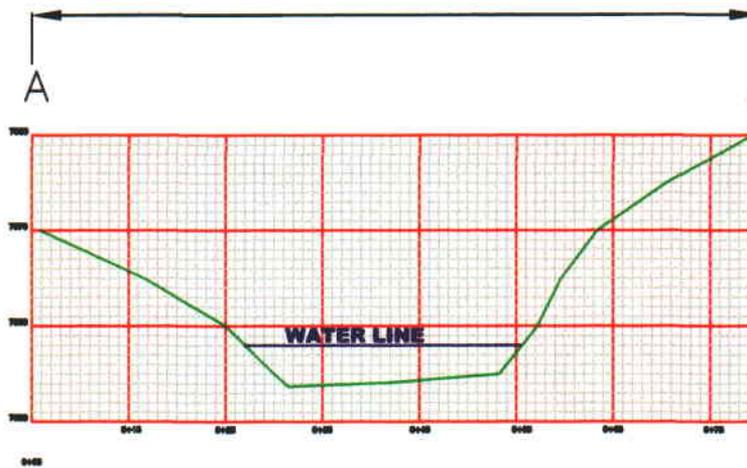
UC-6 (PLATE 7-5)

The inlet of Culvert UC-6 (Plate 7-5) on Dugout Creek was not breached, however the water was 4 feet 3 inches in the channel per markings on the inlet's trash racks.

Cross-sections of the inlets are attached, blue line represents depth of water at its highest observed and recorded level. High watermark photographs are attached.
