Inspection Report

Permit Number:	C0070039
Inspection Type:	PARTIAL
Inspection Date:	Wednesday, August 01, 2012
Start Date/Time:	8/1/2012 6:30:00 AM
End Date/Time:	8/1/2012 4:00:00 PM
Last Inspection:	Thursday, July 12, 2012

Permitee: **CANYON FUEL COMPANY**
 Operator: **CANYON FUEL COMPANY**
 Site: **DUGOUT CANYON MINE**
 Address: **PO BOX 1029, WELLINGTON UT 84542**
 County: **CARBON**
 Permit Type: **PERMANENT COAL PROGRAM**
 Permit Status: **ACTIVE**

On August 1st, 2012, Division of Oil, Gas and Mining (the Division) staff conducted a field inspection of the gob gas vent hole sites at the Dugout Canyon Mine. The purpose of the field inspection was to document the condition of the gob gas vent hole sites and associated access roads. All but three of the 25 gob gas vent hole sites depicted on Figure 1-1, Methane Degas Bore Hole Locations, were constructed. Sites G-1, G-8 and G-29 were permitted but never drilled/constructed. Of the remaining 22 gob gas vent hole sites, 11 have been reclaimed. Based upon information provided by the Operator, the underground mine workings below 8 of the 11 un-reclaimed sites have been sealed and no longer require active ventilation in order to ma

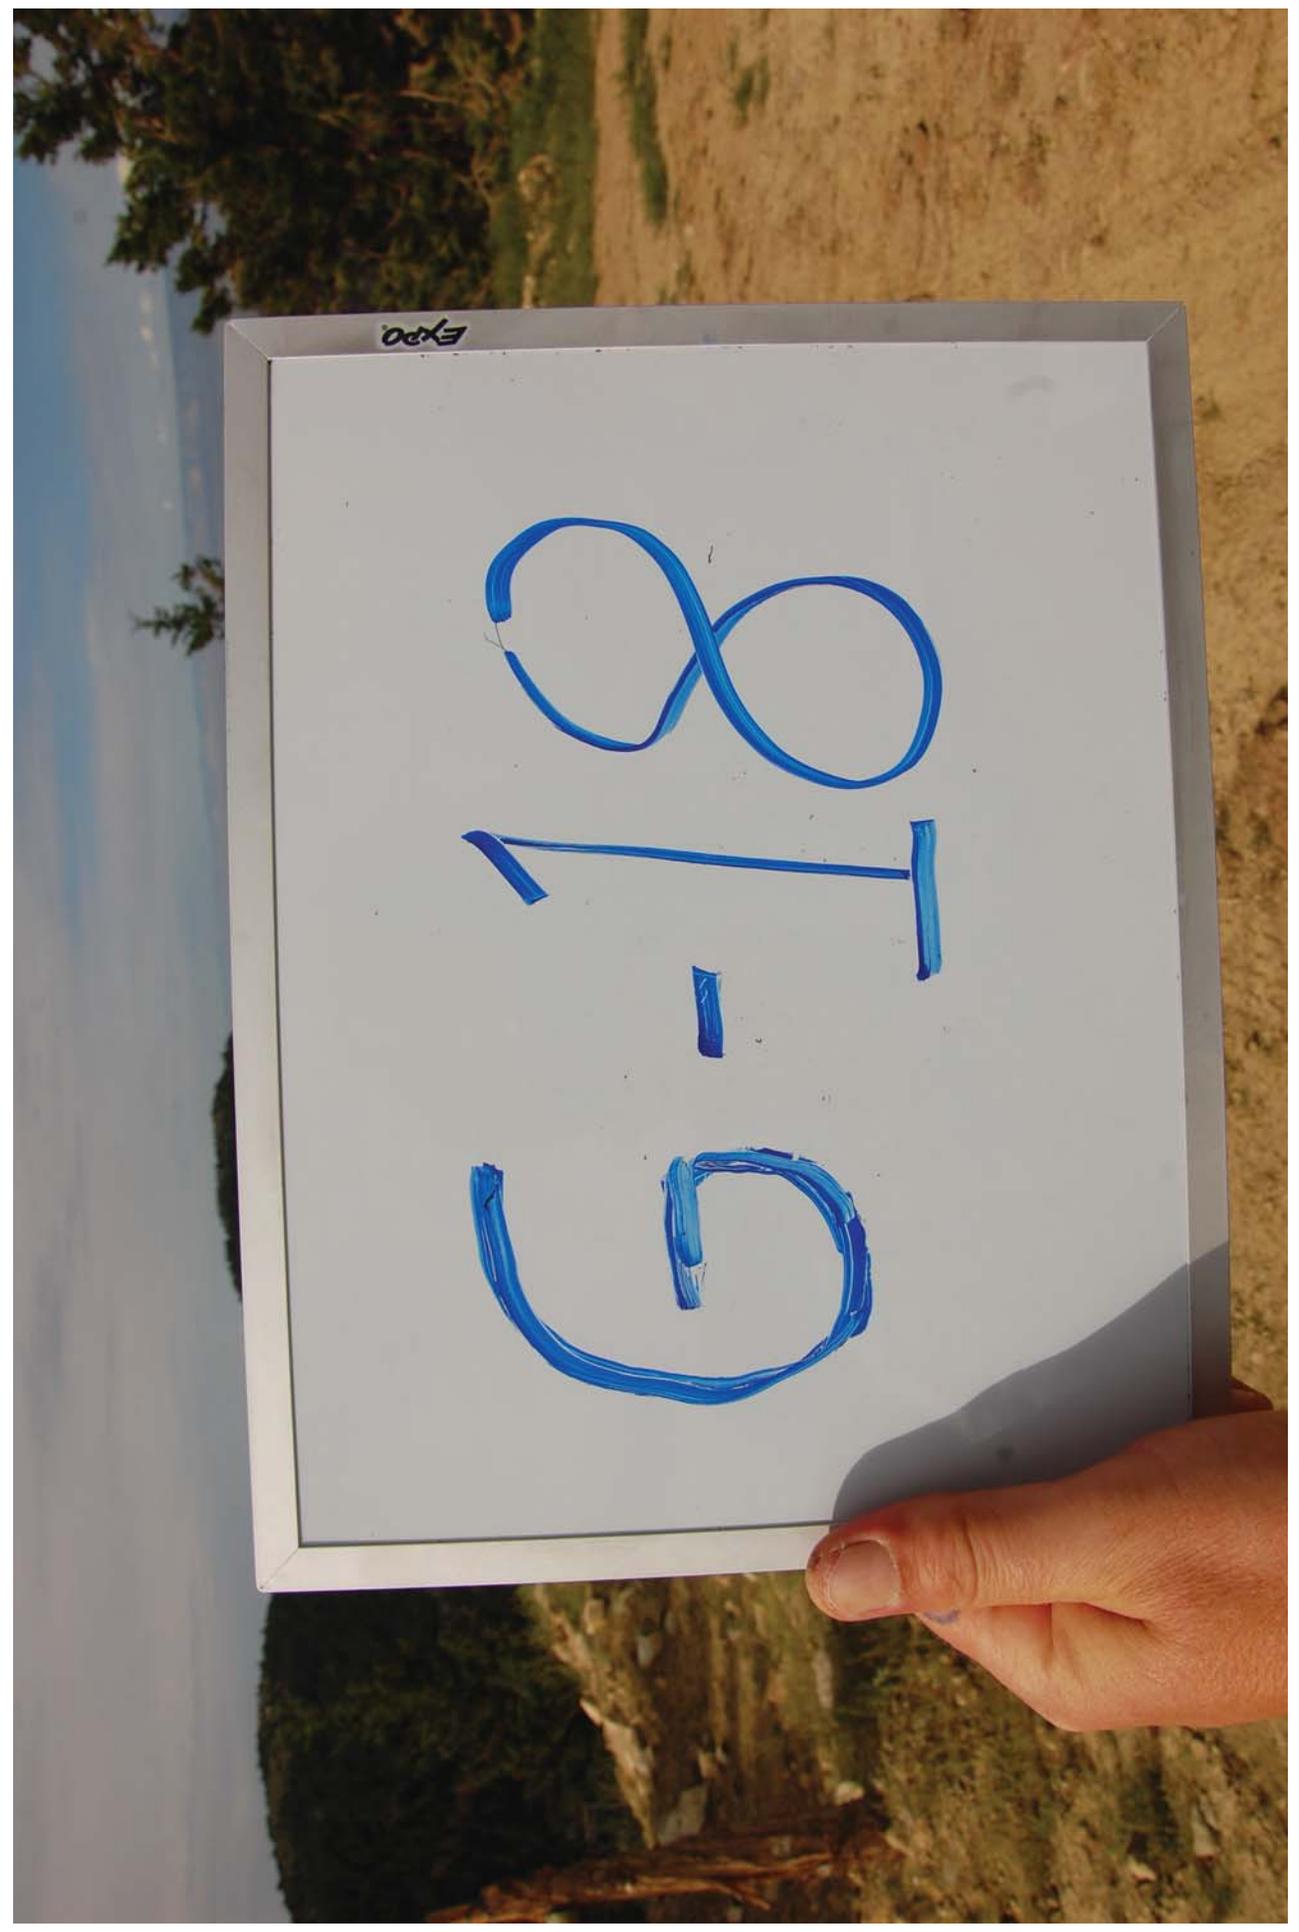
8-19

G-19: The G-19 pad has been reclaimed. Some vegetation has already been established on the reclaimed slopes. The pre-existing skid road was observed during the inspection. Evidence of erosion on the skid road was observed. The Division acknowledges that the skid road was a pre-existing feature of the property prior to the construction/reclamation of Site G-19. However; the Permittee is prohibited from contributing additional suspended solids and sediment to streamflow or runoff outside the permit area (See R645-301-742.111, -742.211) as a result of coal mining activity. Division staff observed evidence of instability on the skid road during the field inspection (See photos below). However; a conclusive determination cannot be made at this time. Going forward, additional and more frequent inspections of the skid road will be conducted in order to verify if additional off-site impacts are occurring. In the interim, the Permittee should address the immediate stability issues associated with the skid road as soon as possible. Failure to do may result in enforcement action.

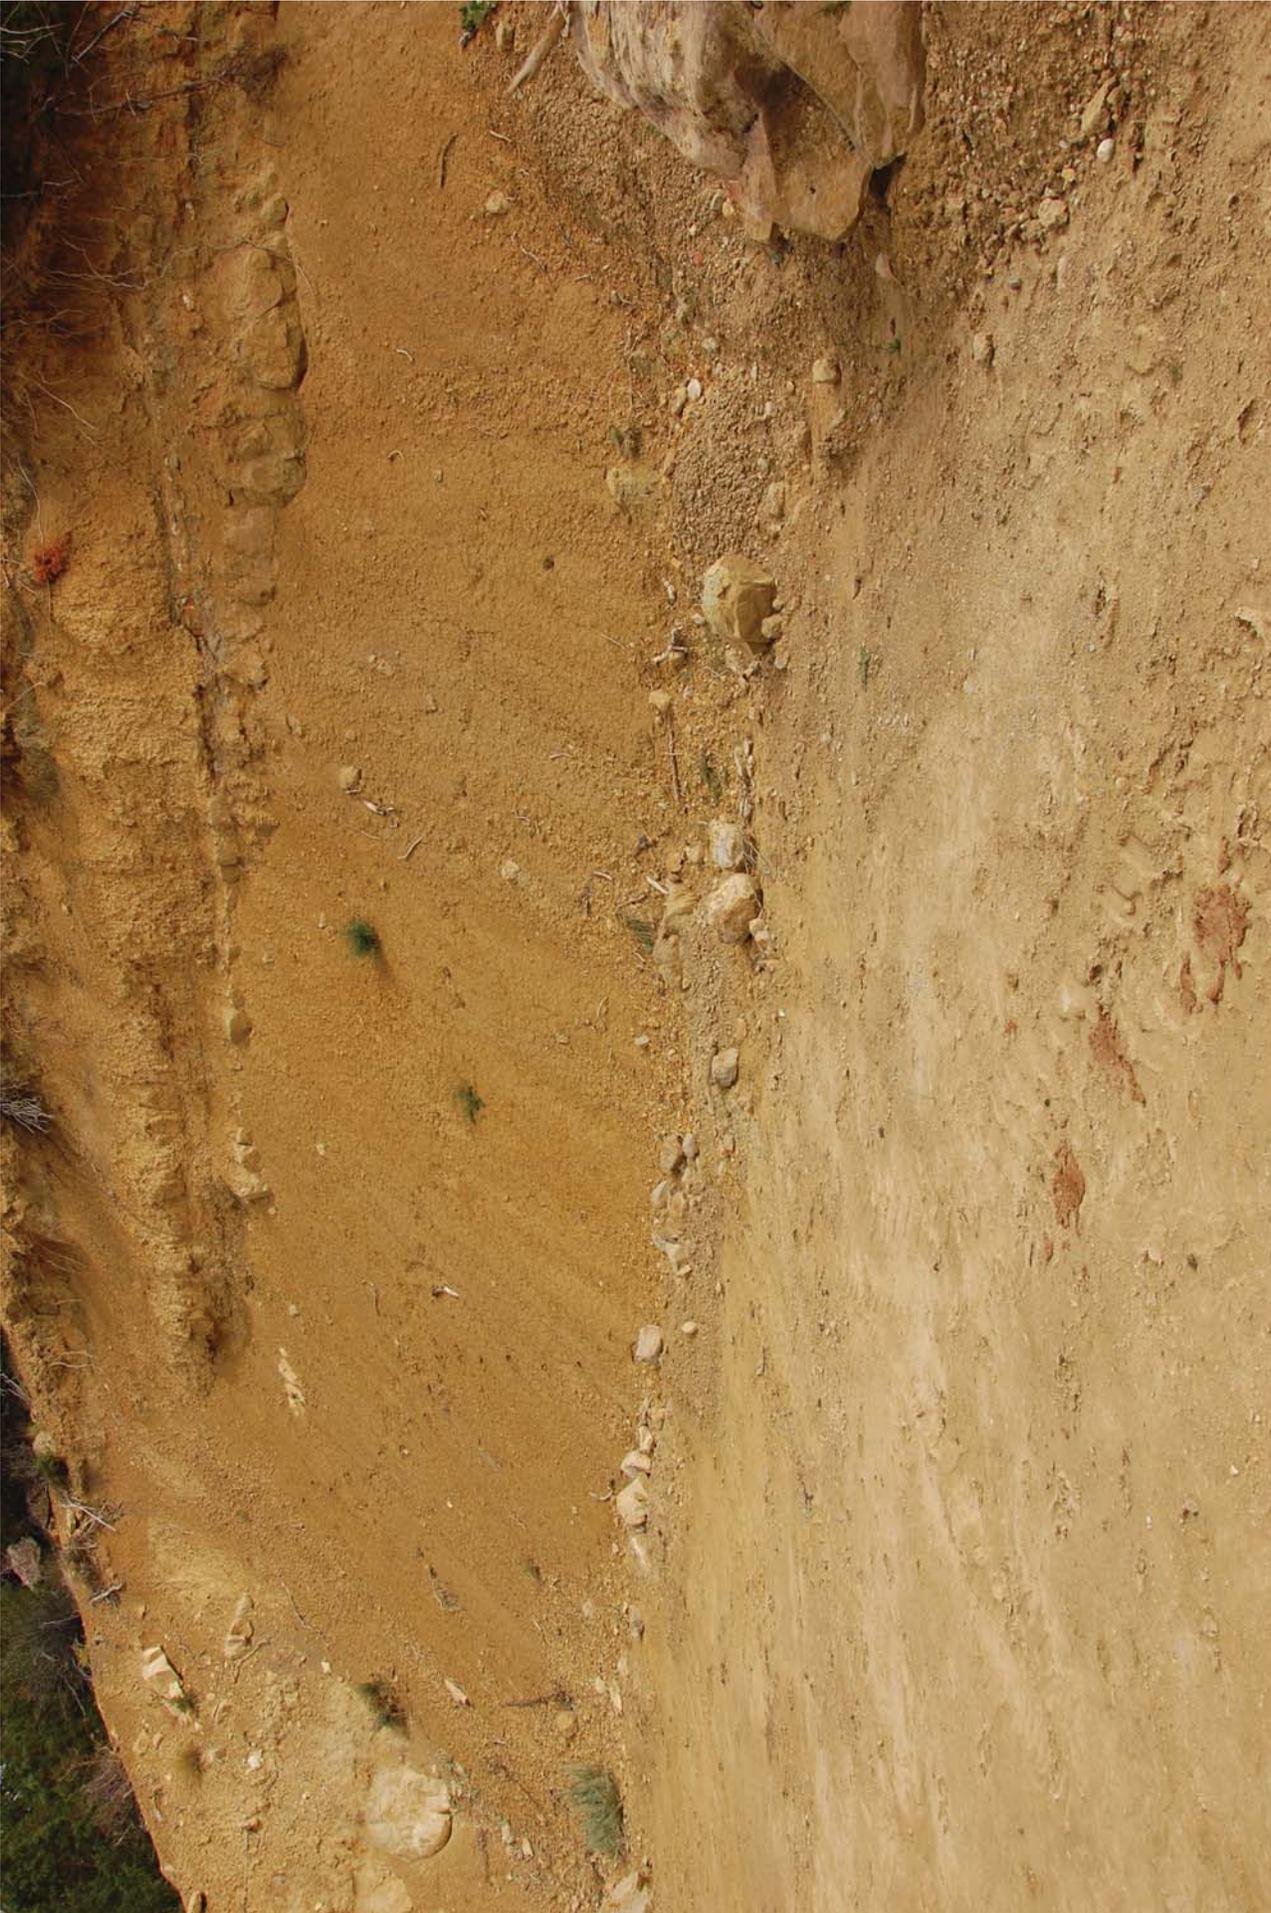
There is a 40 ft. cut slope at site G-11. Fill to partially reclaim site G 11 is in the road embankment. Site G-12 is completely occupied by topsoil. Fill to reclaim G-11 and G-12 was noted as being elsewhere on the property. The storage location for this fill material should be noted in the narrative or on a map within the MRP.

Summary: The following sites must be reclaimed as soon as possible: G-11, G-12, G-15, G-16, G-17, G-22 (and associated access road) and the AMV Access Road. As these sites are no longer required for on-going mining activity, they must be reclaimed (See R645-301-541.300). Prior to the onset of winter, additional sediment control measures must be installed on the G-19 skid road as well as the AMV Access road. Failure to do so may in enforcement action.
