Inspection Report

Permit Number:	C0070039
Inspection Type:	PARTIAL
Inspection Date:	Wednesday, October 12, 2016
Start Date/Time:	10/12/2016 7:30:00 AM
End Date/Time:	10/12/2016 4:00:00 PM
Last Inspection:	Tuesday, September 13, 2016

Permitee: **CANYON FUEL COMPANY**
 Operator: **CANYON FUEL COMPANY**
 Site: **DUGOUT CANYON MINE**
 Address: **PO BOX 1029, WELLINGTON UT 84542**
 County: **CARBON**
 Permit Type: **PERMANENT COAL PROGRAM**
 Permit Status: **ACTIVE**

Dugout Canyon Mine
Degas Facilities Inspection
10/12/2016

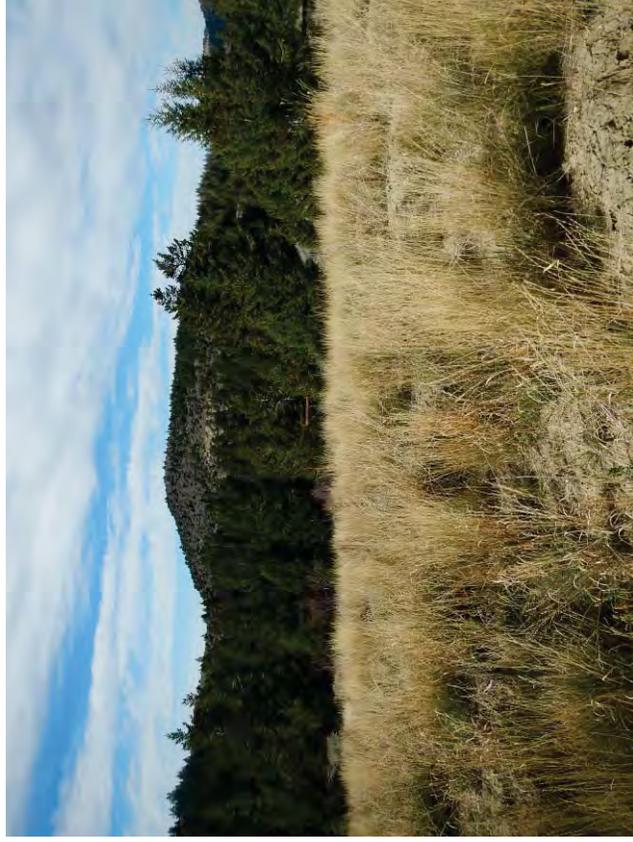
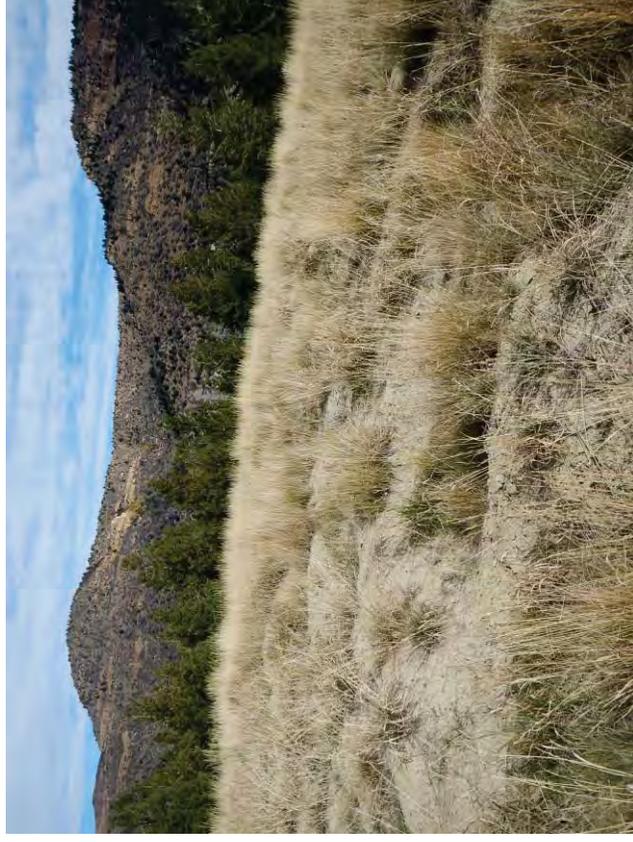
G-25: Site G-25 was reclaimed in June of 2013 and received Phase I bond release in 2014. The approximate original contour has been re-established and the site has been pocked. No evidence of off-site impacts was noted during the inspection.

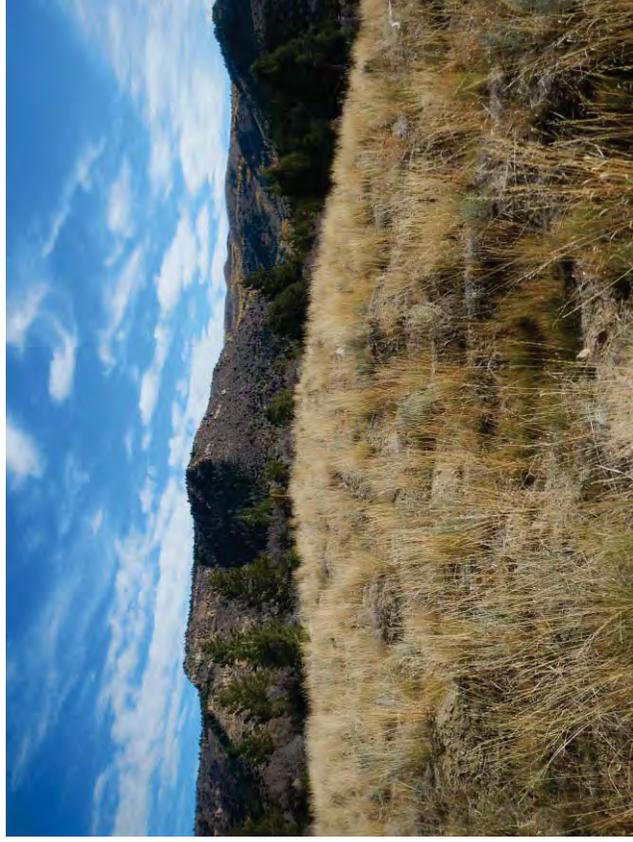
Site G-26

Site G-26: The site has been returned to original contour and pocked. Final reclamation of the site was completed in June of 2013 and received Phase I bond release in 2014. No sign of off-site impacts/erosion were observed during the time of the inspection.

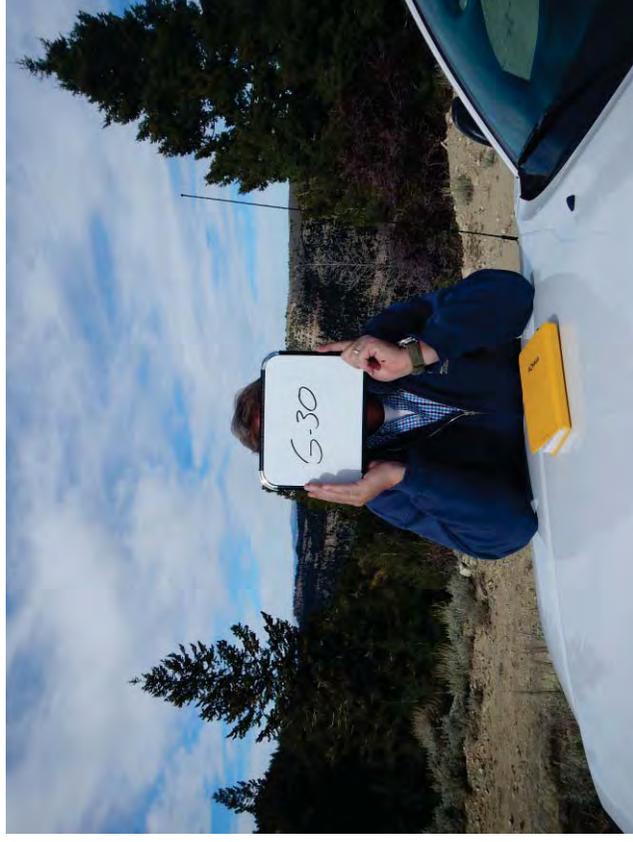
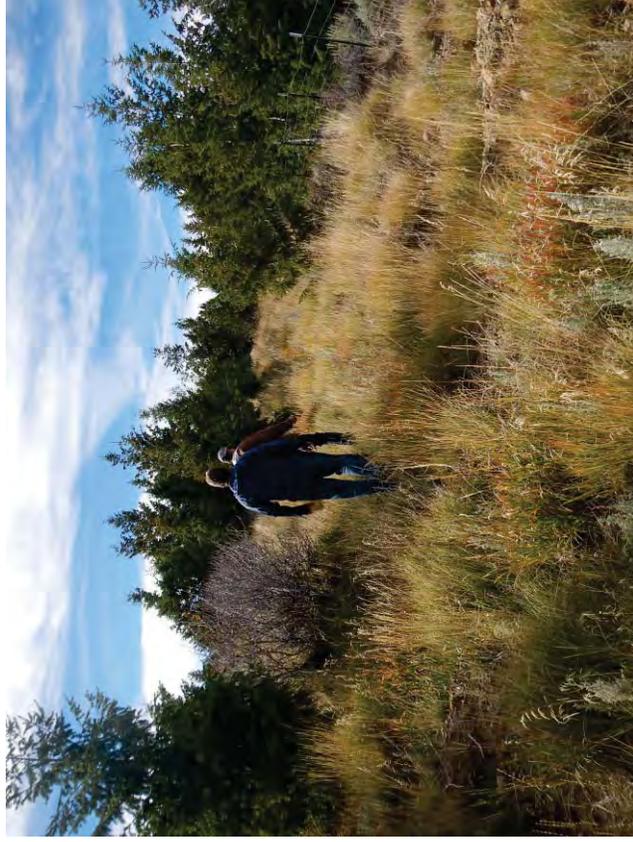
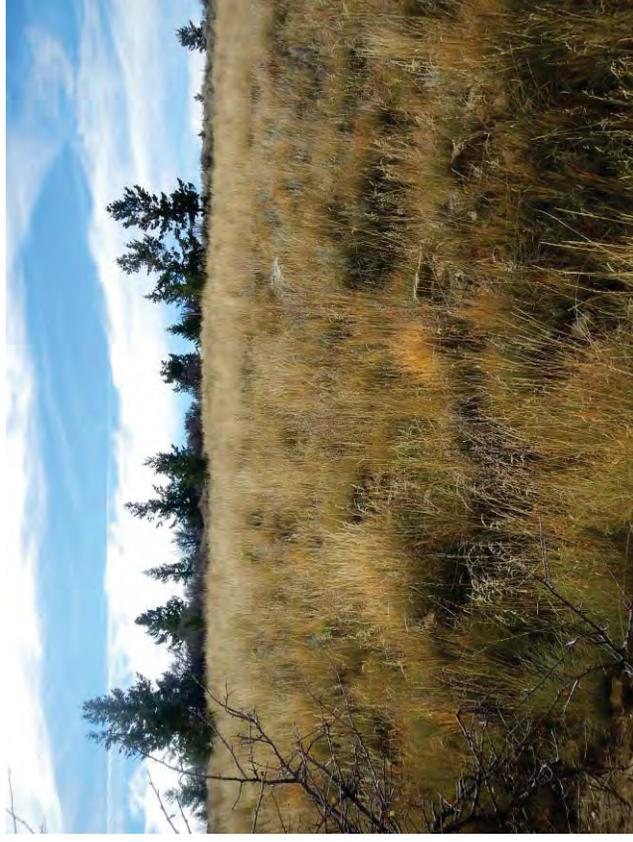
Site G-30

Site G-30: Final reclamation of the site was completed in June of 2013. Phase I bond release was approved in 2014. The area has been pocked and approximate original contour has been re-established. The site was stable. No signs of excessive erosion or sedimentation off the disturbed area were noted during the inspection.

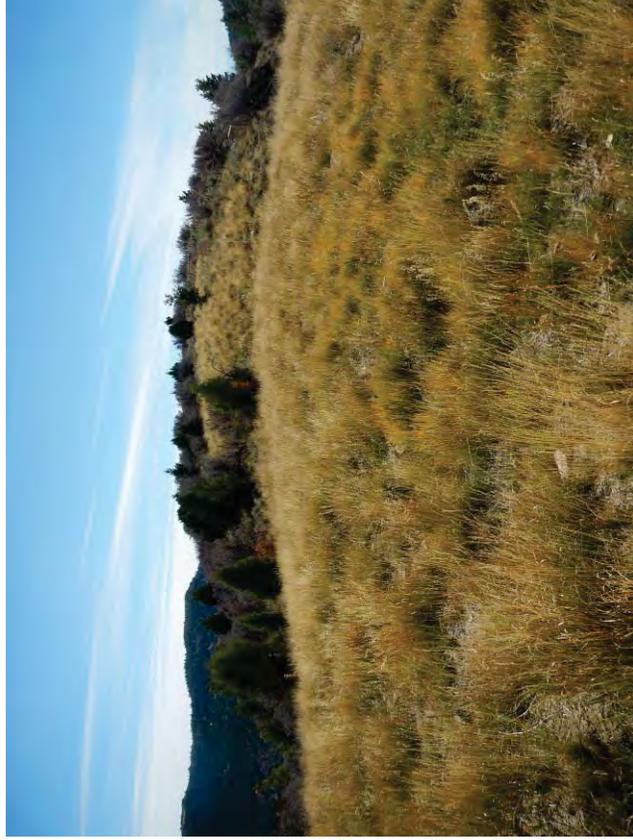
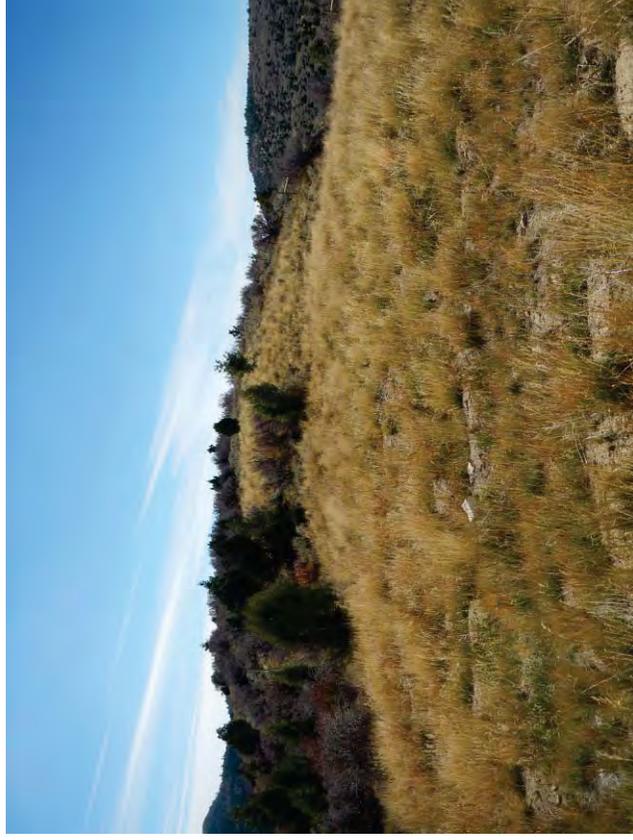
Site G-16

G-16: The degas pad was reclaimed in June of 2013. The access road to the pad was reclaimed in 2014. Phase I bond release was approved in 2014. The access spur road to G-16 was observed to be stable with no signs of erosion or off-site impacts. The degas pad was found to be in similar condition (i.e. stable, no off-site impacts observed). The access road between G-16 and degas pad G-22 has been reclaimed and found to be in stable condition (i.e. no off-site impacts and/or erosion were noted during the field visit). The access road between G-16 and G-22 was reclaimed in 2013.

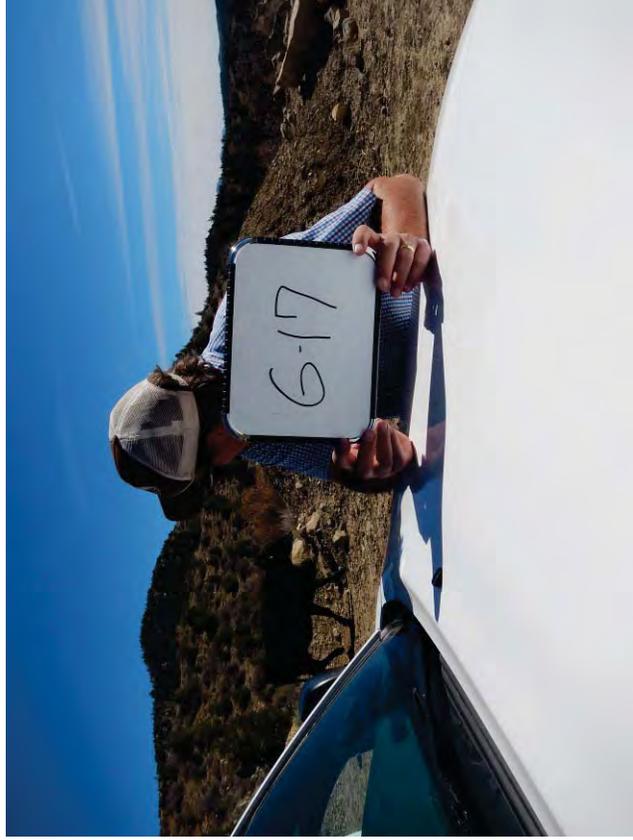
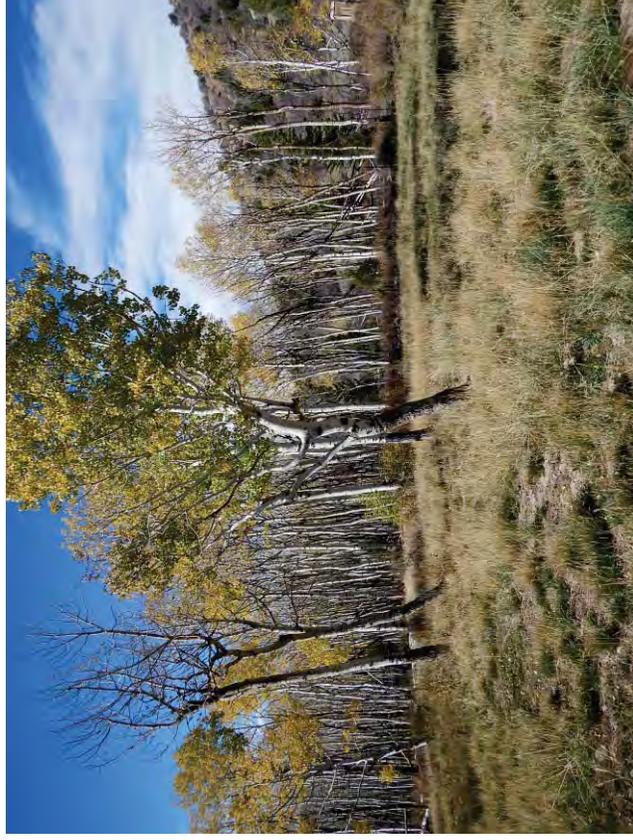
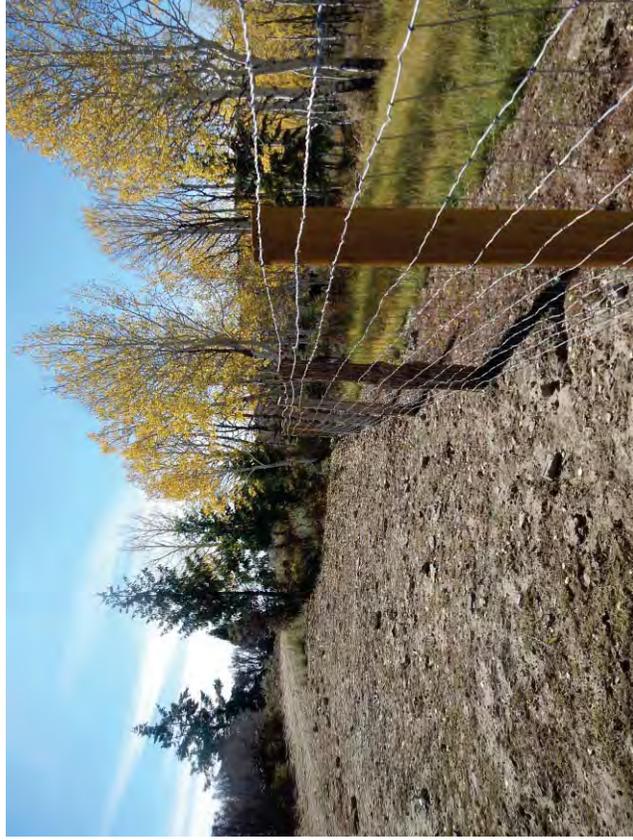
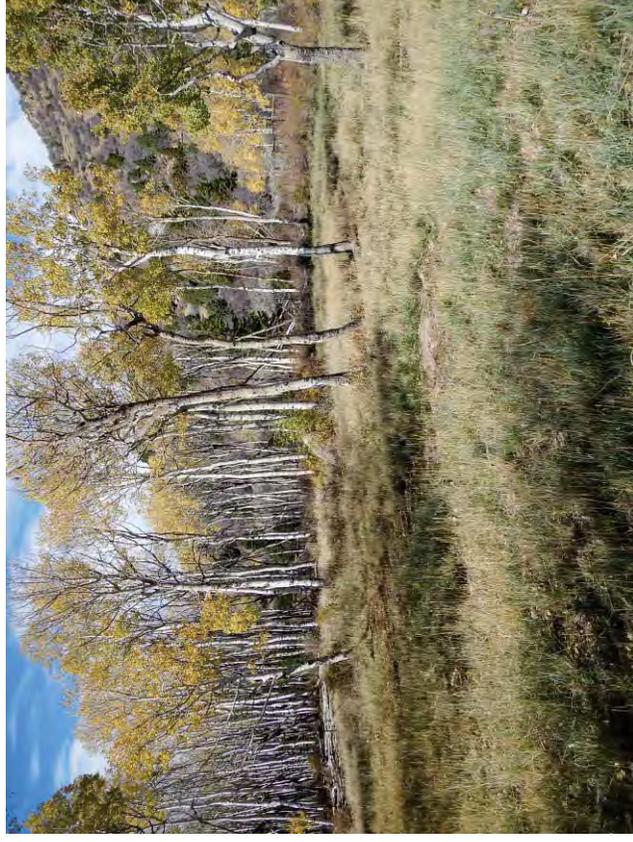
Site G-17

G-17: The site was fully reclaimed in October of 2014. The site has not received any bond release. The site had been utilized as a storage area for topsoil from degas pad G-22. The site was observed to be in stable condition (i.e. well vegetated, no evidence of off-site impacts were noted during the field inspection).

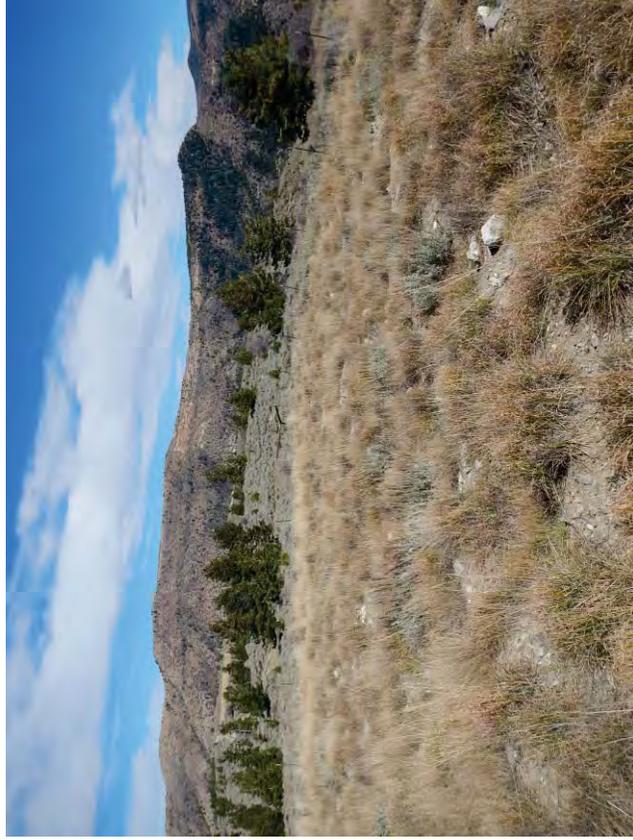
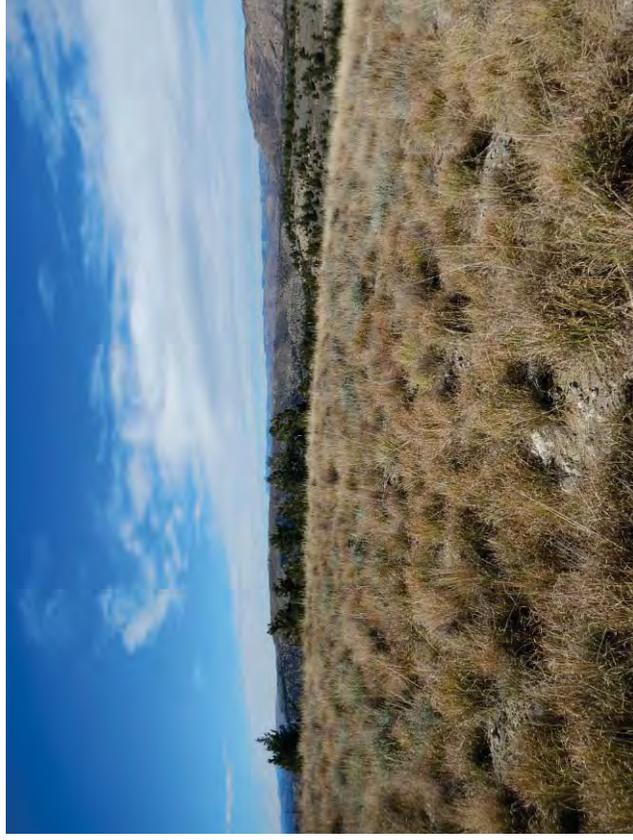
Site G-7

G-7: The site was reclaimed in 2009 and received Phase II bond release in 2014. No evidence of off-site impacts was observed during the field inspection. The site is well vegetated.

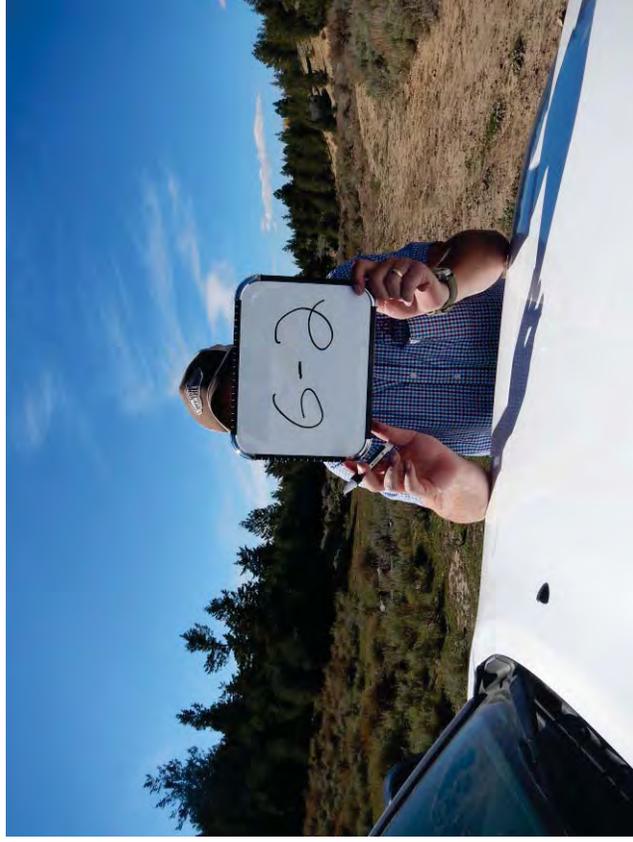
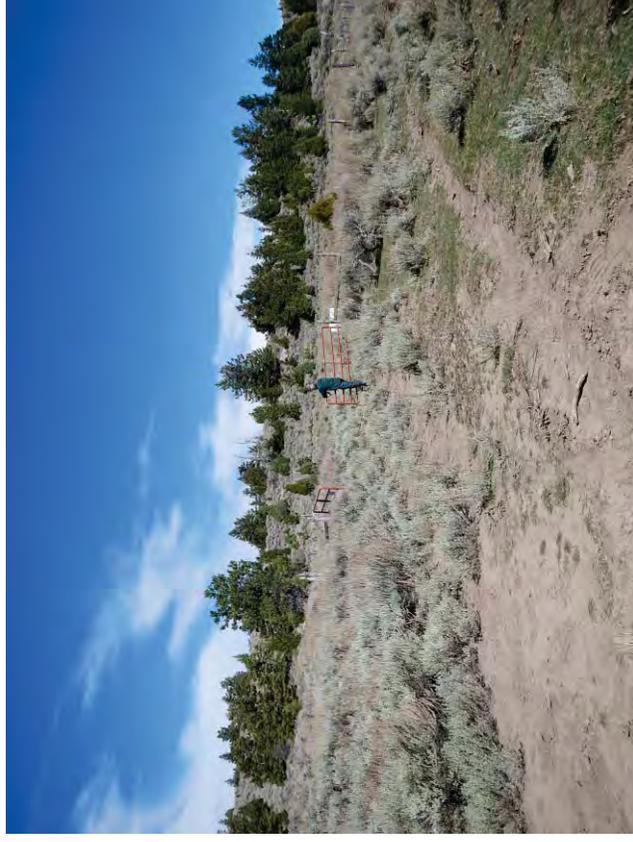
Site G-2

G-2: The site was reclaimed in June of 2009. No evidence of off-site impacts was observed during the field inspection. Musk thistle had been an issue at this site in years past. However; during the field inspection no evidence of musk thistle was observed. The site was noted to be in stable condition with no evidence of erosion or off-site impacts.
