Inspection Report

Permit Number: C0070041
Inspection Type: TECHNICAL
Inspection Date: Thursday, July 12, 2007
Start Date/Time: 07/12/2007 7:00:00 AM
End Date/Time: 07/12/2007 4:00:00 PM
Last Inspection: Friday, June 22, 2007

Permittee: **WEST RIDGE RESOURCES**
Operator: **WEST RIDGE RESOURCES**
Site: **WEST RIDGE MINE**
Address: **PO BOX 1077, PRICE UT 84501**
County: **CARBON**
Permit Type: **PERMANENT COAL PROGRAM**
Permit Status: **ACTIVE**

The purpose of the site visit was to inspect the condition of the Bear Canyon drainage following undermining by longwall mining that began in November 2006 for panel #8, and April 2007 for panel #9. The ephemeral stream channel is approximately 325 feet above panel #8 at the point of shallowest cover. As a condition of the West Ridge MRP, noted in chapter 7, page 7-12C, the Permittee must visually inspect the stream channel following undermining and mitigate any adverse impacts to the hydrologic balance caused by subsidence. In addition, the Permittee must conduct a pre- and post-mining subsidence survey of the canyon bottom. A report is to be submitted to the Division within 30 days of the inspection. The pre and post-mining subsidence su

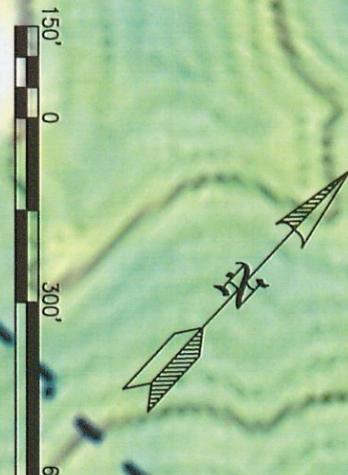
SUBSIDENCE SURVEY	
WEST RIDGE RESOURCES, INC.	794 NORTH "C" CANYON ROAD EAST CARBON, UTAH 84520
MSHA MINE ID # 42-02233	
DRAWN BY PJ	SCALE 1" = 300'
APPROVED BY DS	DATE 25 MAY 2007
SHEET	PLATE #1 of 1

2007 BEAR CANYON SUBSIDENCE SURVEY					
STATION	NORTHING	EASTING	ELEVATION 9/30/2005	ELEVATION 5/24/2007	VERTICAL DIFFERENCE
BC-1	42888	23723	7159.00	7157.18	1.82
BC-2	42910	23713	7180.74	7178.81	1.93
BC-3	42843	23648	7159.90	7157.88	2.02
BC-4	42804	23580	7146.48	7144.07	2.41
BC-5	42768	23524	7136.87	7134.58	2.29
BC-6	42742	23452	7137.37	7134.91	2.46
BC-7	42720	23490	7142.32	7140.07	2.25
BC-8	42678	23421	7132.41	7130.33	2.08
BC-9	42620	23389	7125.67	7124.80	0.87
BC-10	42545	23347	7118.71	7118.60	0.11
BC-11	42474	23300	7116.04	7116.31	-0.27
BC-12	42460	23322	7113.42	7113.55	-0.13
BC-13	42403	23268	7109.38	7109.38	0.00
BC-14	42348	23238	7110.28	7110.19	0.09
BC-15	42268	23195	7103.53	7103.56	-0.03
BC-16	42228	23173	7094.68	7094.64	0.04
BC-C	41706	22642	7028.15	7028.15	0.00
