Re: West Ridge Mine C/007/041
WR17-001 Seismic Monitoring

RB&G
ENGINEERING, INC.

OCTOBER 2016 TO OCTOBER 2017

**MINING-INDUCED SEISMICITY
NEAR GRASSY TRAIL DAM AND RESERVOIR**
Carbon County, Utah

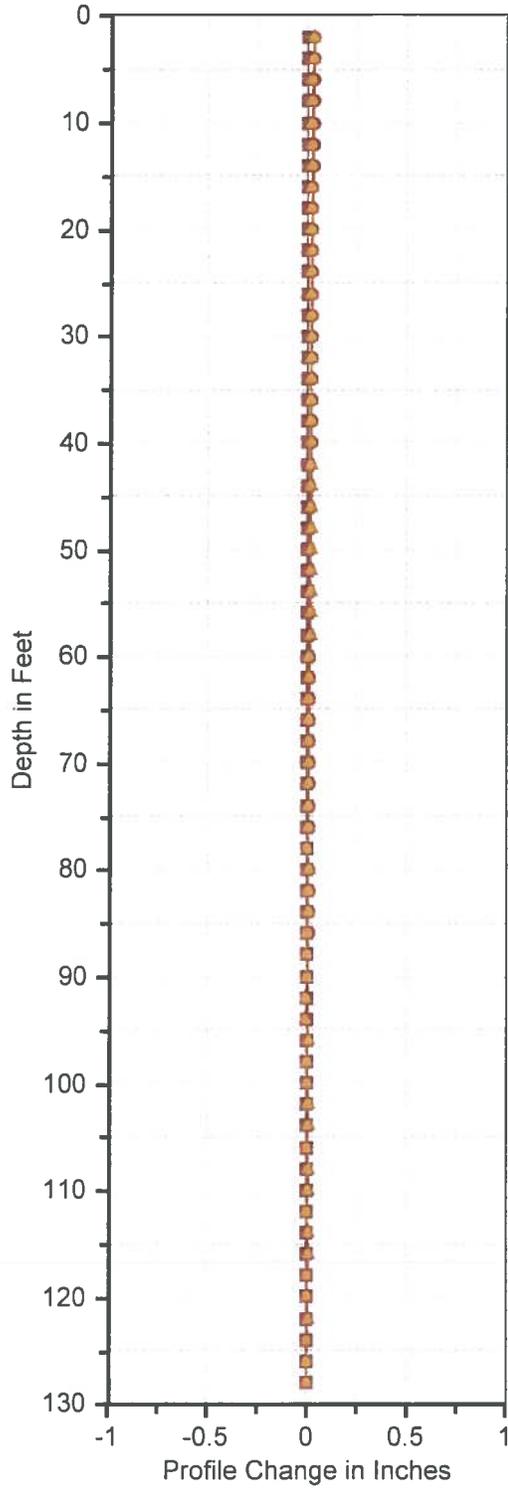
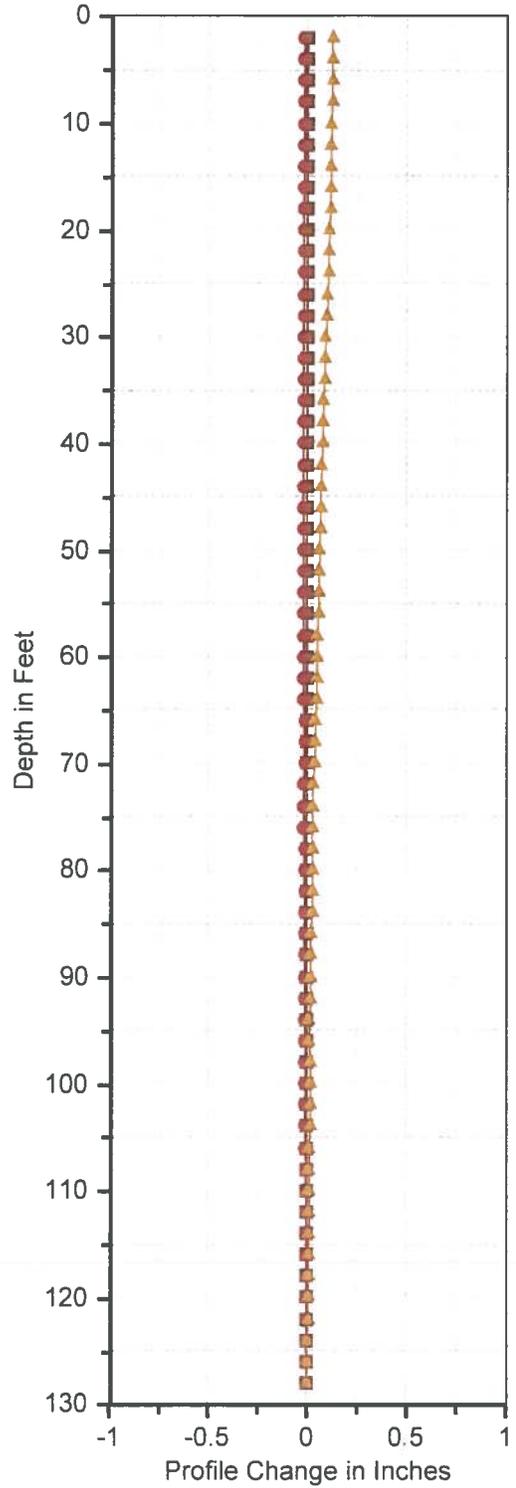
Figure B-6 GrassyTrail old I-2 A

readings. It is likely that this inclinometer did not extend deep enough into the bedrock to fix the tip below the slide. Based on the movement which occurred during mining, it was determined that Inclinometer I-2 should be replaced with new inclinometer casing which has not been strained, and that Inclinometer I-3 should be replaced with an inclinometer extending deeper into the bedrock.

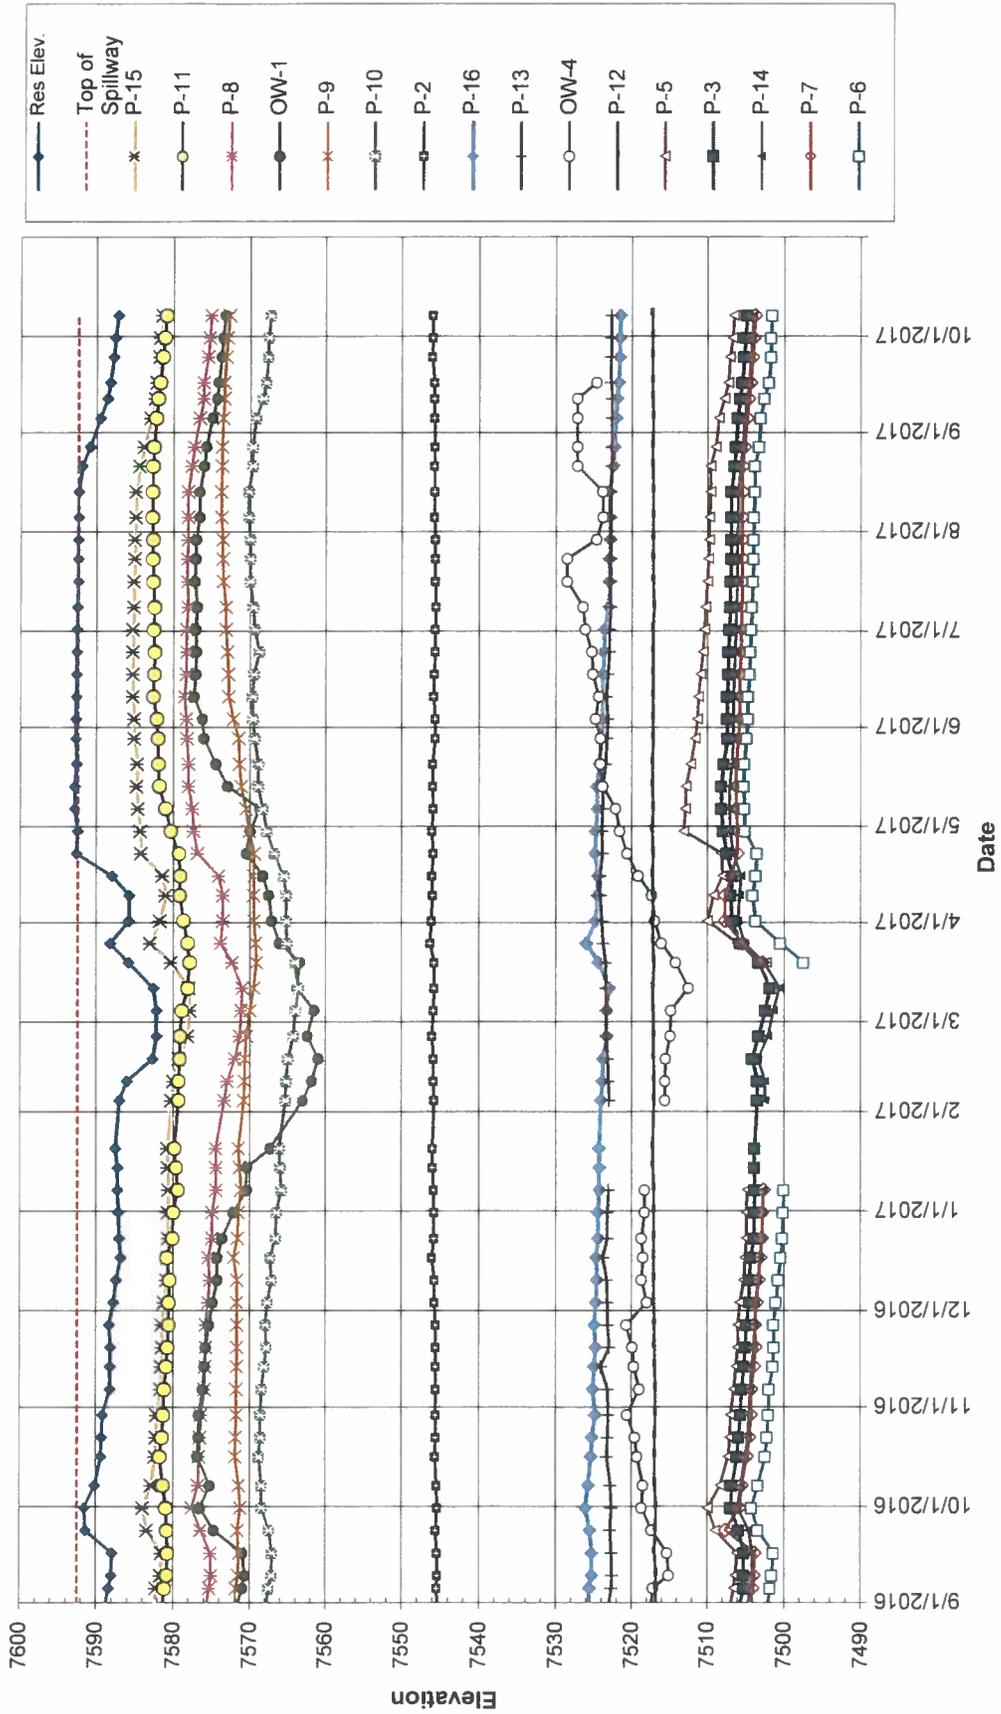
Figure C-1B
Reservoir Elevation and Piezometer Readings
Sept 2016 to Oct, 2017 (taken by RB&G Eng)

Water levels recorded in piezometers and observation wells appear to be functioning normally with respect to the elevation of the water in the reservoir. No evidence of internal erosion has been observed in seepage collected and monitored downstream of the dam and abutments. Seepage rates coincide with changes in reservoir water elevation. The highest seepage rates occur when the reservoir is near full, above elevation 7590 feet. Seepage rates in excess of 20 gallons per minute were recorded in 2007 and 2008. The highest level recorded between October 2016 and October 2017 was 15 gallons per minute.
