Re: West Ridge Mine C/007/041
WR17-001 Seismic Monitoring

GRASSY TRAIL DAM MONITORING/INSPECTION PLAN

West Ridge Mine Project Area
 Grassy Trail Reservoir Mining Induced Seismicity
 Near East Carbon, Carbon County, Utah

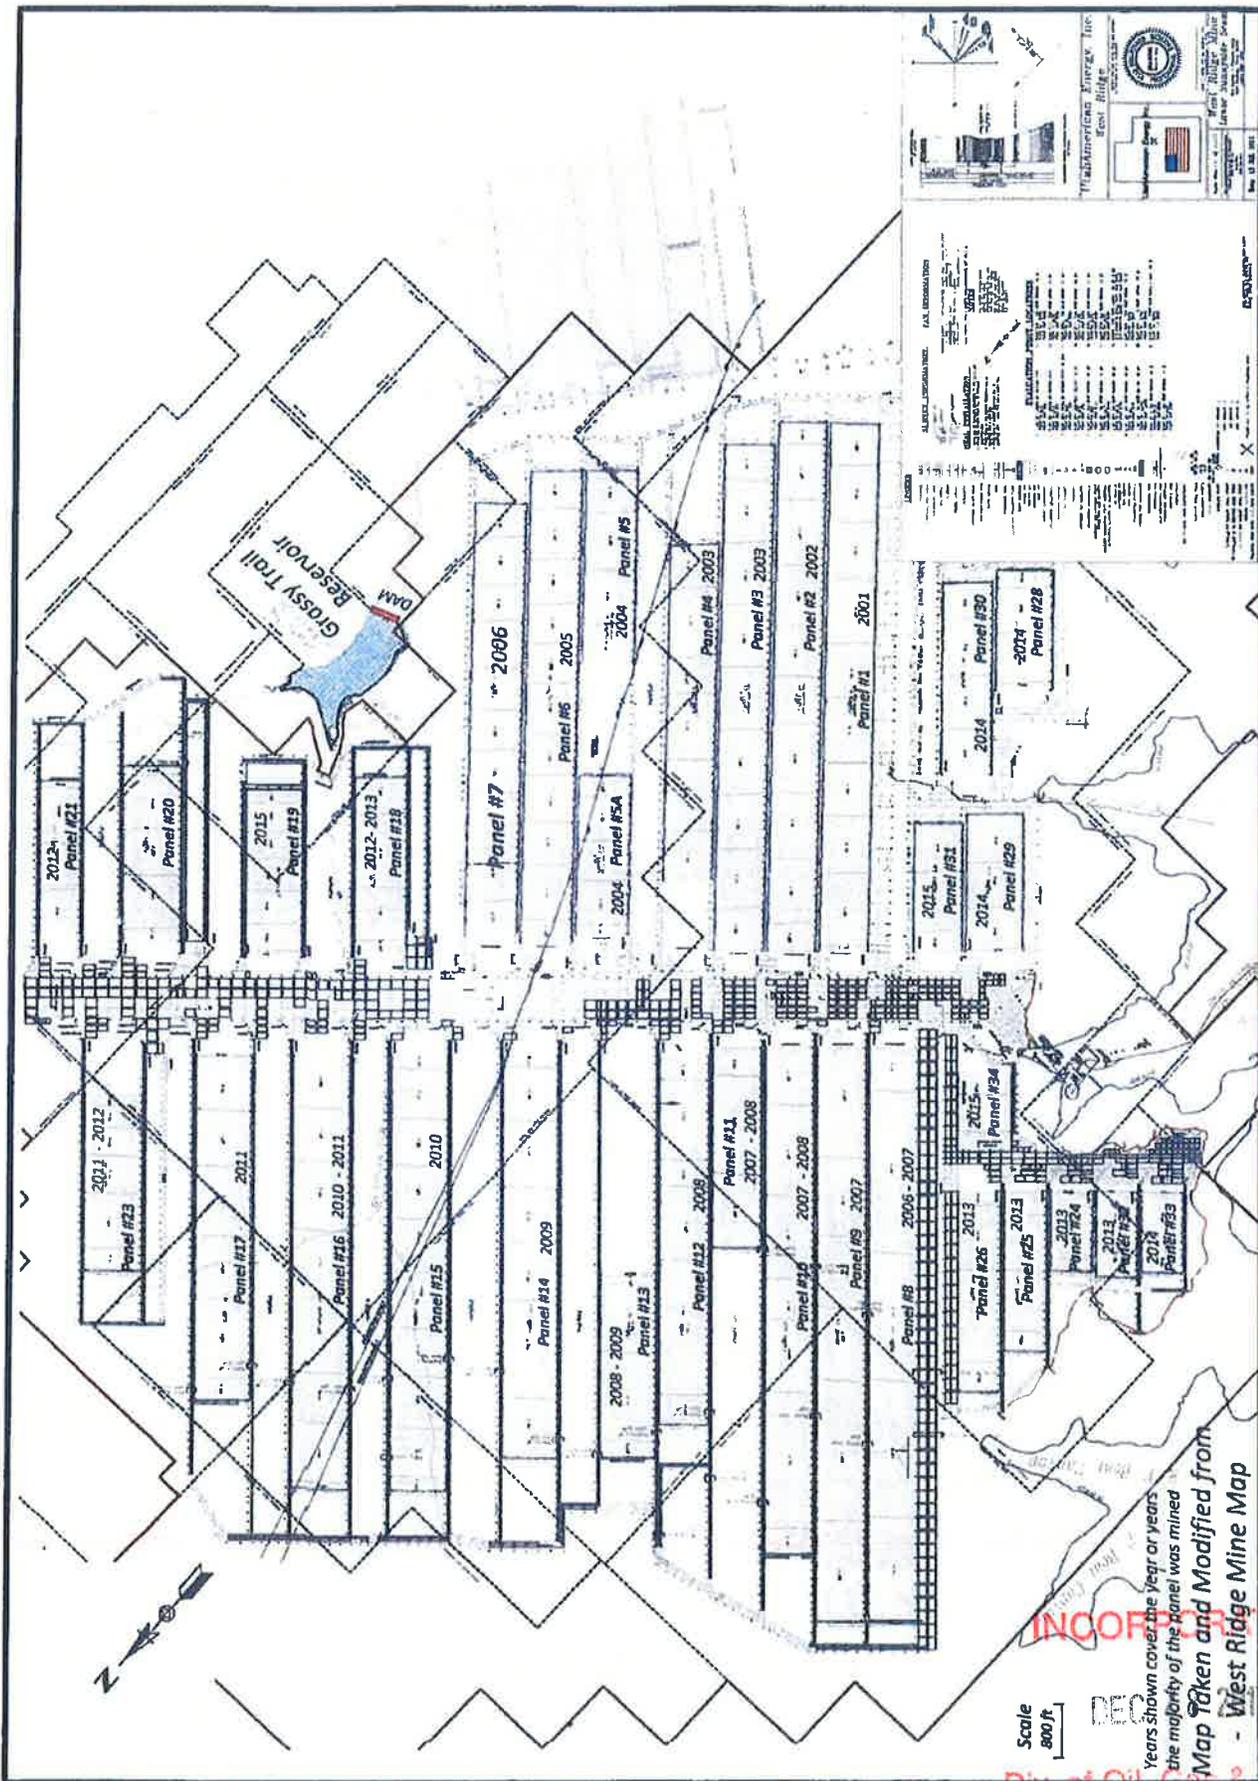
Figure 1
 Project
 Location

At the time of this report, mining has been completed at the West Ridge Mine for approximately 23 months with operation ceasing after completion of Panel 34 in November 2015. Figure 1 shows the location of the West Ridge Mine operation relative to Grassy Trail Dam and Reservoir.
