# Inspection Report

Permit Number:	<b>C0150007</b>
Inspection Type:	PARTIAL
Inspection Date:	Monday, February 28, 2005
Start Date/Time:	2/28/2005 2:30:00 PM
End Date/Time:	2/28/2005 5:30:00 PM
Last Inspection:	Thursday, January 27, 2005

Permitee: **CONSOLIDATION COAL CO**  
 Operator: **CONSOLIDATION COAL CO MID-CONTINENT REGION**  
 Site: **HIDDEN VALLEY MINE**  
 Address: **PO BOX 566, SESSER IL 62884**  
 County: **EMERY**  
 Permit Type: **PERMANENT COAL PROGRAM**  
 Permit Status: **RECLAIMED**

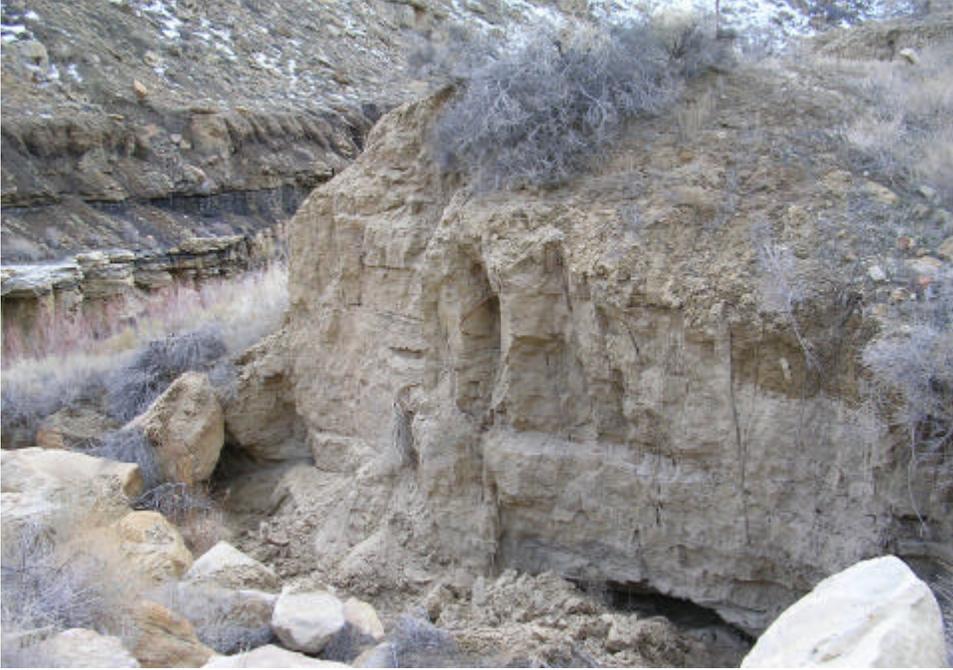
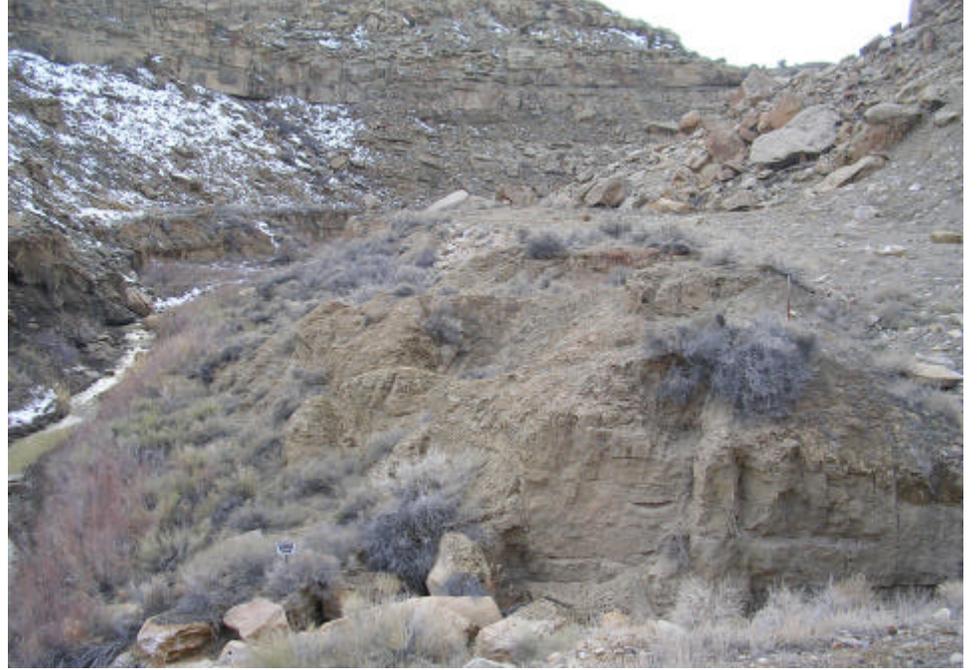
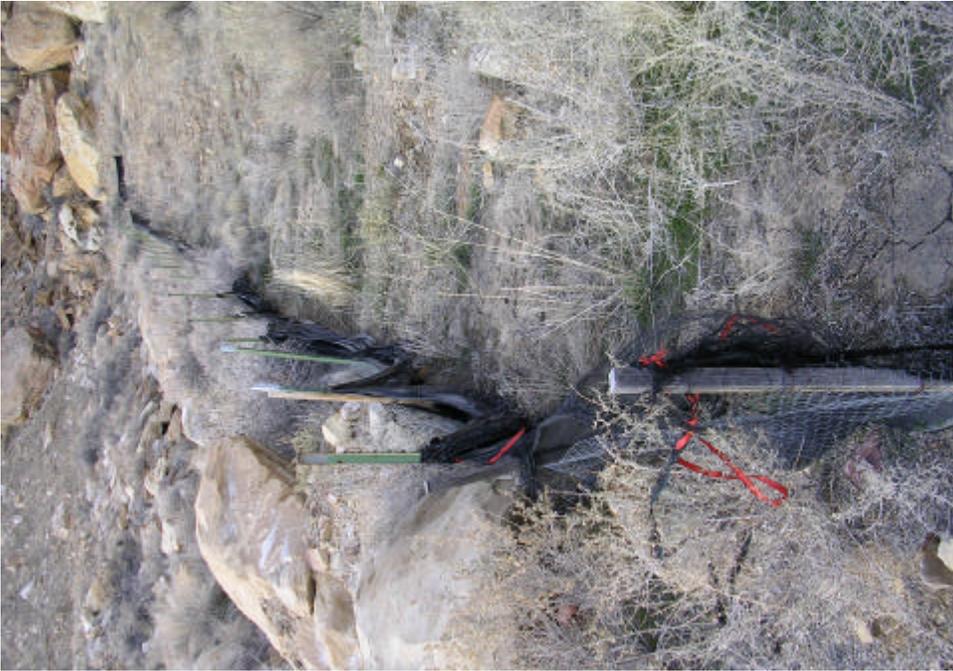
Ground failure of the land within the Ivie Creek buffer zone on the B seam side has occurred recently (immediately outside the disturbed area) at the location of the mouth of the ephemeral channel (see photos 492, 493, 494). Closer inspection indicates that the land in the stream buffer zone has failed previously at other locations along its length. The failure locations are 50 ft distant from Ivie Creek and outside of the disturbed area.
