UTAH POWER & LIGHT COMPANY
SUBSIDENCE MONITORING PROGRAM
ANNUAL REPORT FOR 1986

April 1987

Submitted to: United States Department of the Interior
Office of Surface Mining
Minerals Management Service
Utah Division of Oil, Gas and Mining

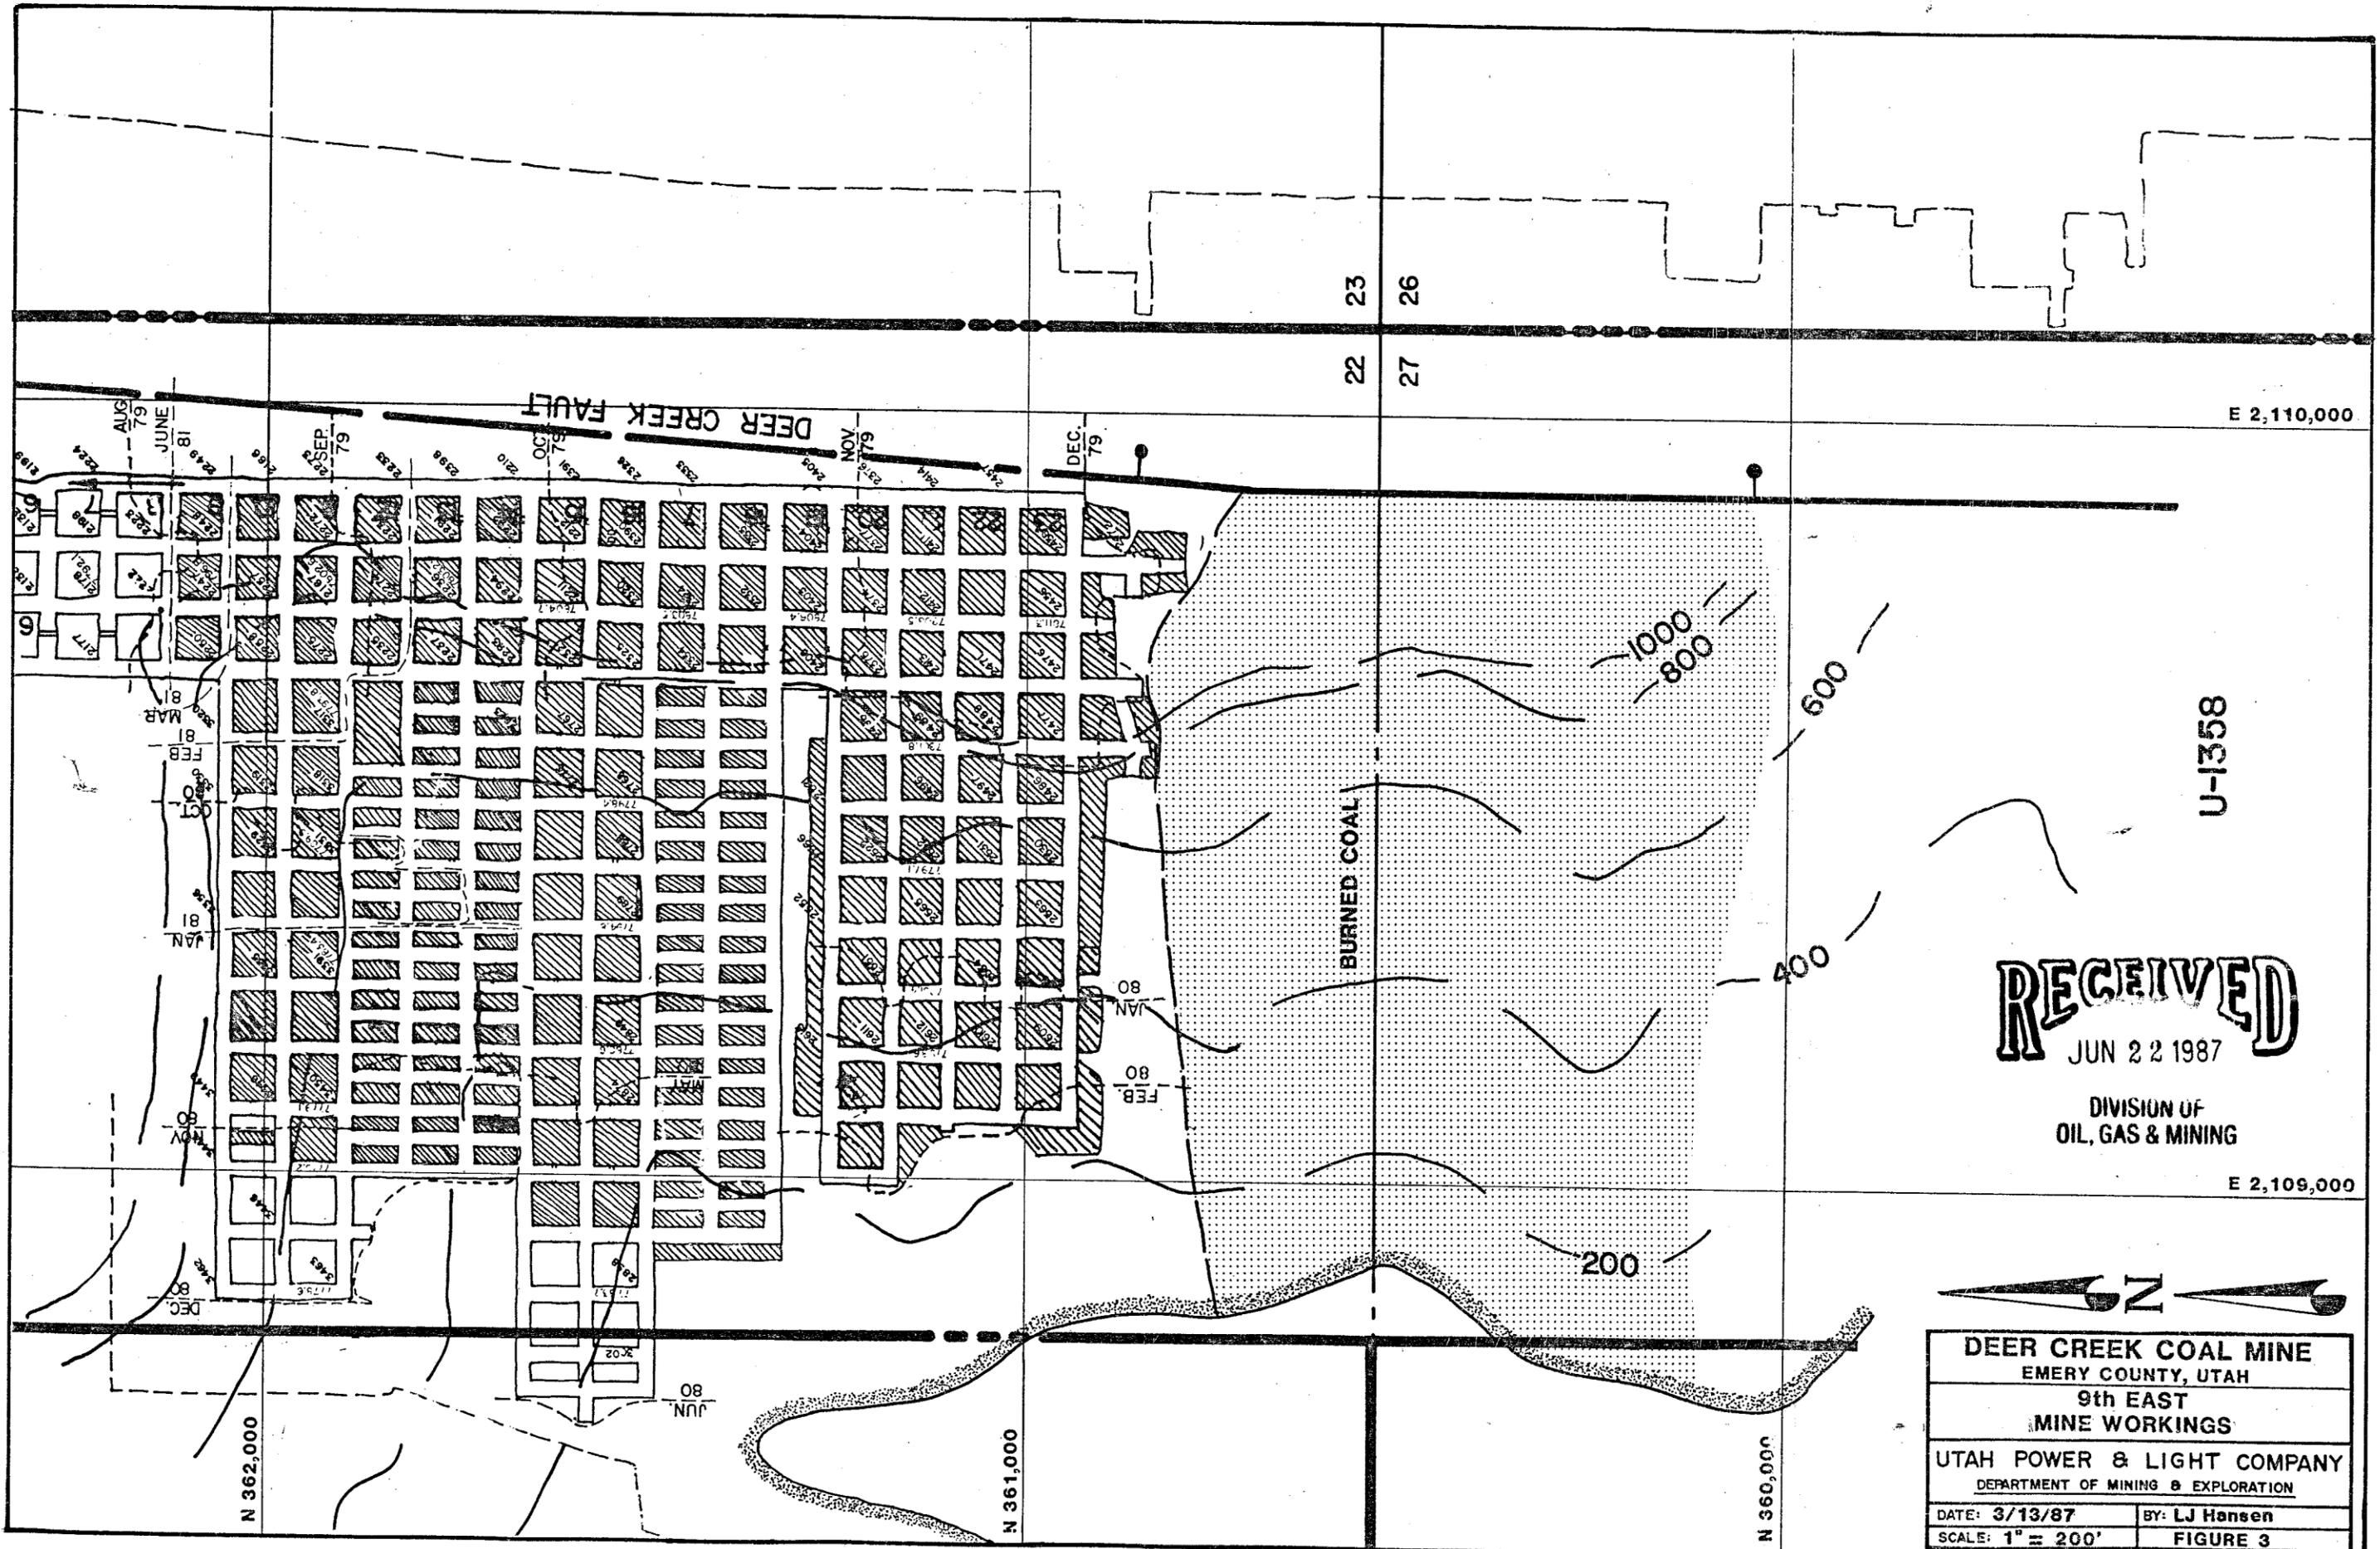
DEER CREEK COAL MINE	
EMERY COUNTY, UTAH	
9th EAST MINE WORKINGS	
UTAH POWER & LIGHT COMPANY	
DEPARTMENT OF MINING & EXPLORATION	
DATE: 3/13/87	BY: LJ Hansen
SCALE: 1" = 200'	FIGURE 3

Subsidence in this area was first documented in the 1981 subsidence monitoring report submitted in December 1982. The relationship of the area of subsidence with the present Deer Creek and Wilberg Mine workings is shown in Figures 3, 4, and 5. The Deer Creek 9th East workings in this area have been abandoned since 1981 but pillar extraction in Wilberg 1st Right proceeded until June 1984.

Subsidence monitoring during 1986 showed little or no change in subsidence from 1985. The maximum subsidence observed to date is 25 feet and occurs on a steep slope about 200 feet south of the southernmost mined-out area in 1st Right Wilberg over an area in which both the Hiawatha and Blind Canyon Seams are burned. This supports the theory that the clinker beds have been crushed, allowing subsidence to occur well outside the area of mine workings. An on-the-ground inspection of this area revealed that some of the fractures have begun to heal spontaneously with the soils filling in and smoothing out the fractures.

The angle-of-draw of subsidence in this area appears to be influenced by the Deer Creek Fault plane. On the east side of the mine workings the subsidence abruptly stops about 200 feet east of the mine workings, which coincides with the Deer Creek Fault surface trace. In this area the mine workings are covered with 1200 feet of overburden, indicating a 9.5° angle of draw on subsidence.

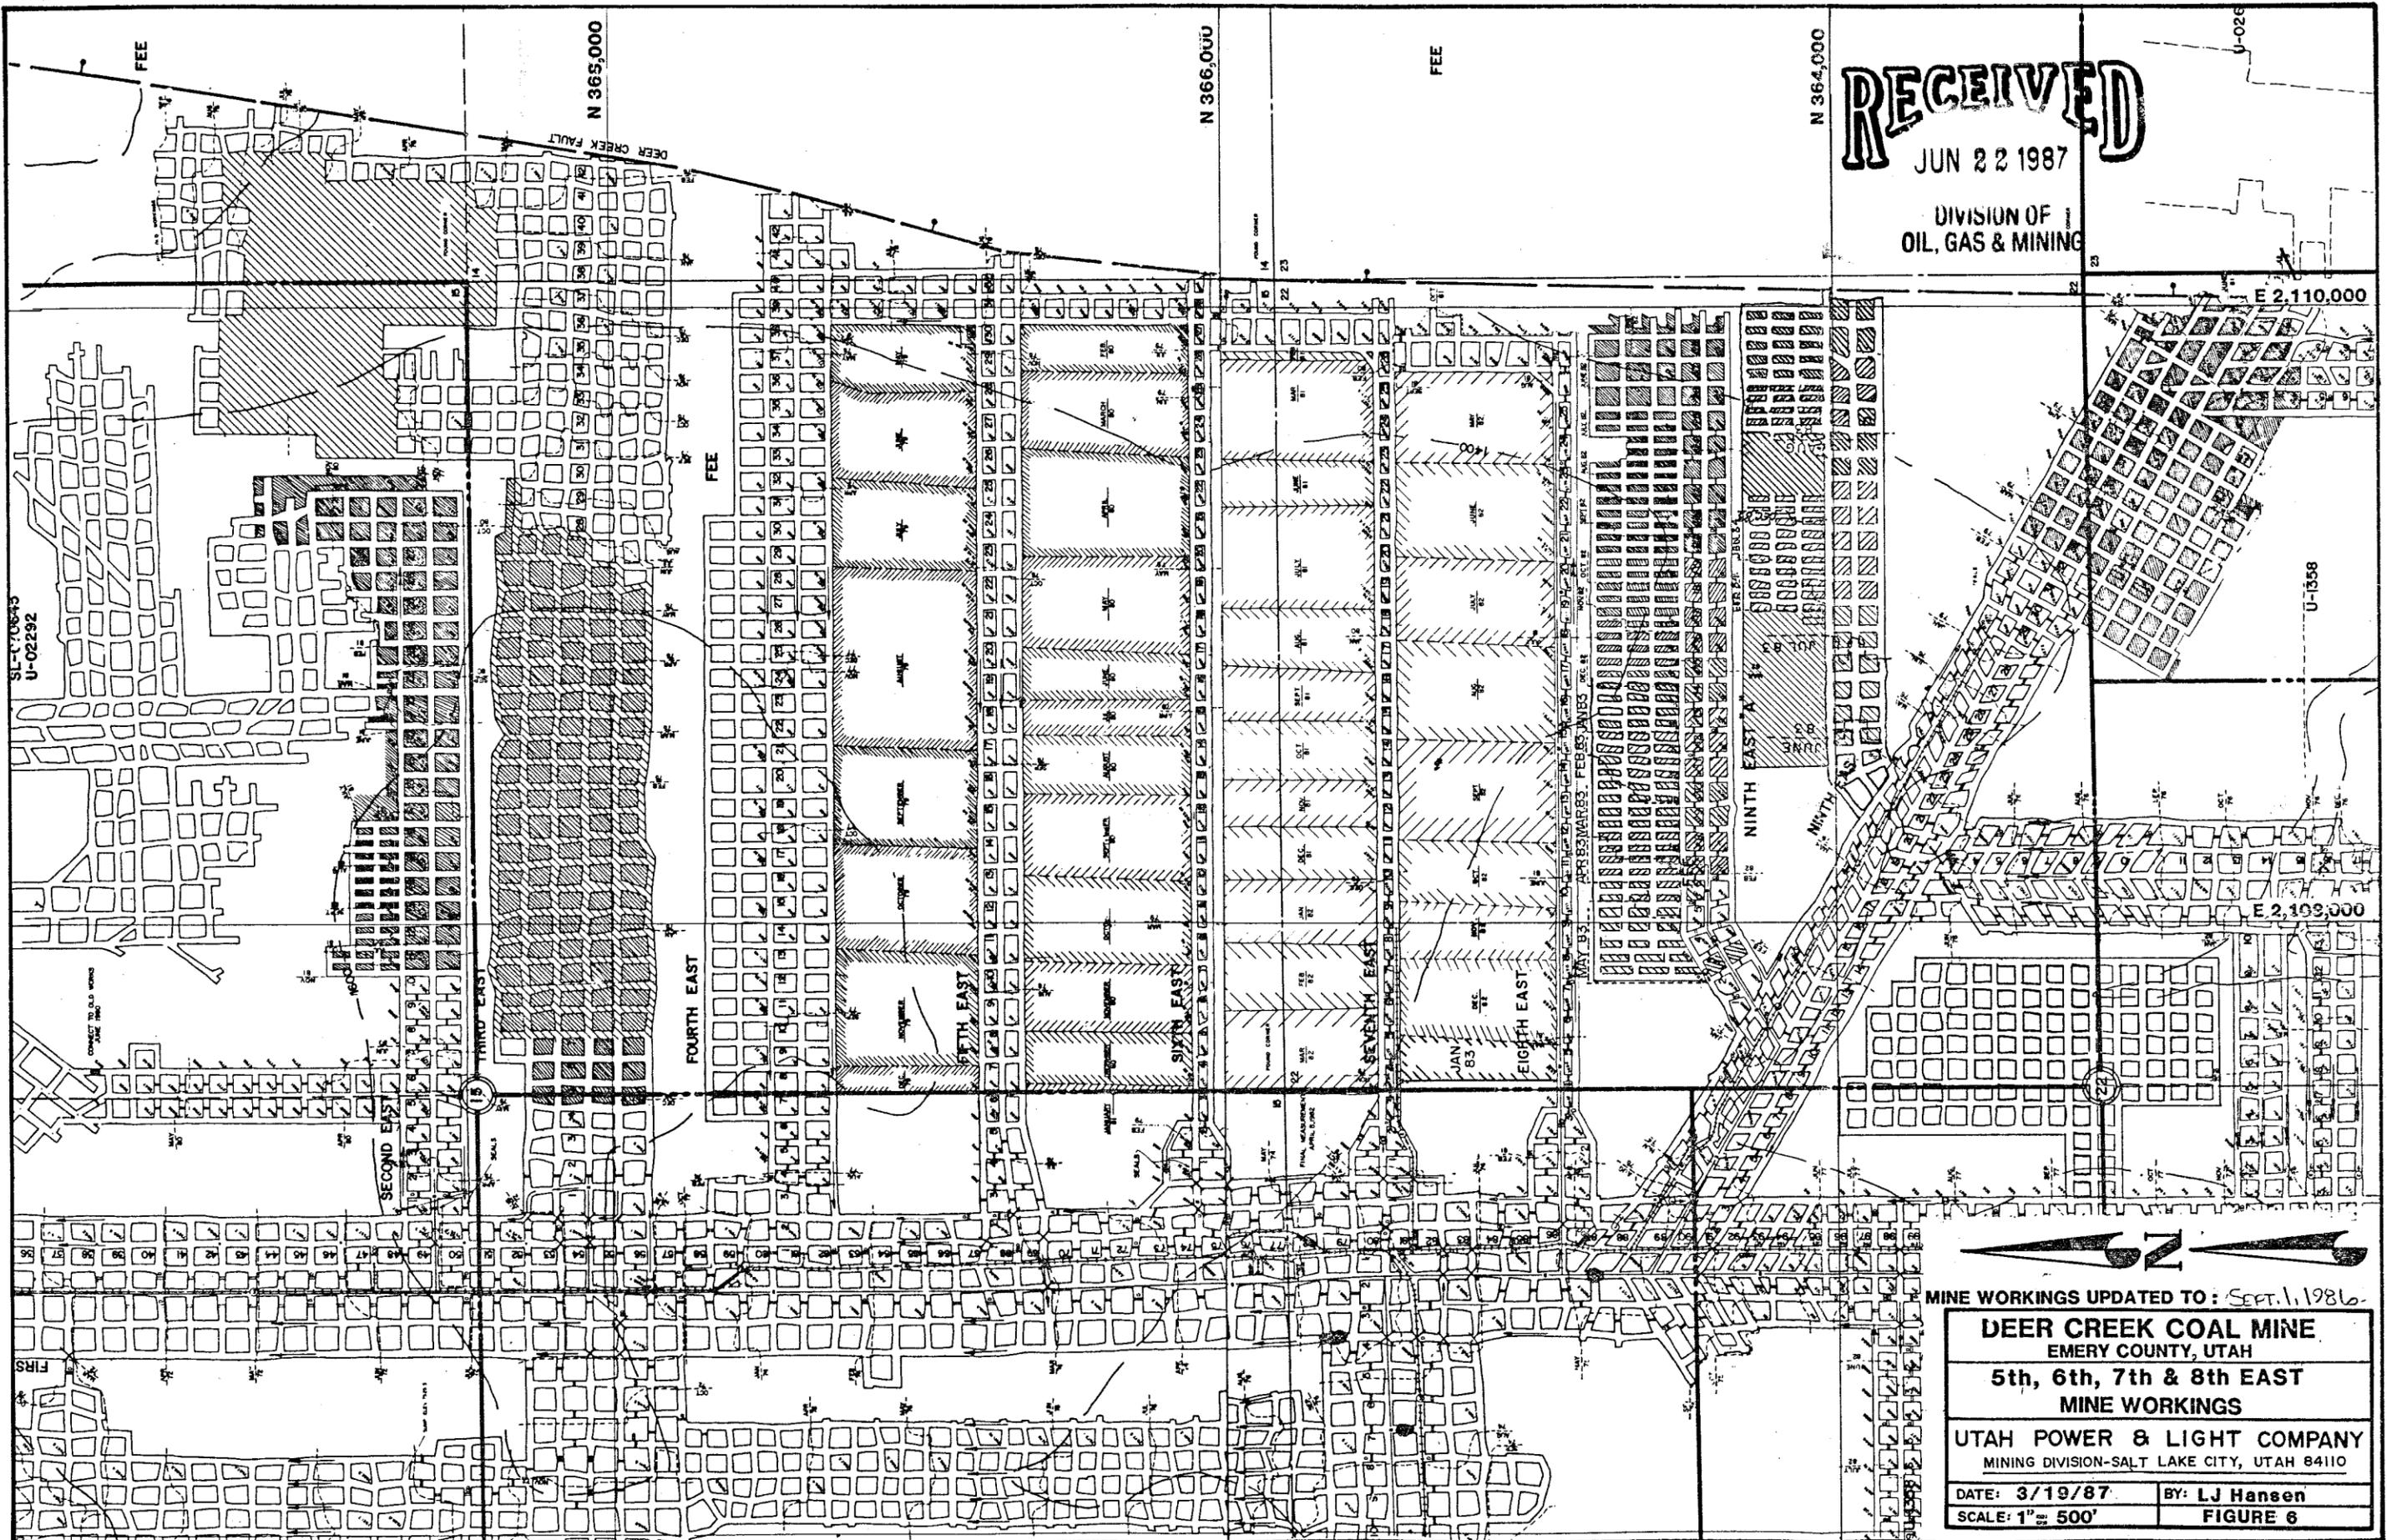
DEER CREEK COAL MINE EMERY COUNTY, UTAH	
5th, 6th, 7th & 8th EAST MINE WORKINGS	
UTAH POWER & LIGHT COMPANY MINING DIVISION-SALT LAKE CITY, UTAH 84110	
DATE: 3/19/87	BY: LJ Hansen
SCALE: 1" = 500'	FIGURE 6

Mining in the Deer Creek Mine in this area had been completed by February 1985. Underlying this seam coal extraction in the Wilberg Mine continued from September 1, 1984 until December 19, 1984, when mining was interrupted due to a fire. During this time the 6th Right panel, 620 feet of the 5th Right panel, and 1000 feet of the 13th Right panel were completed. From July through December 1985 new main entries were driven around the fire area (Figures 6 and 7).

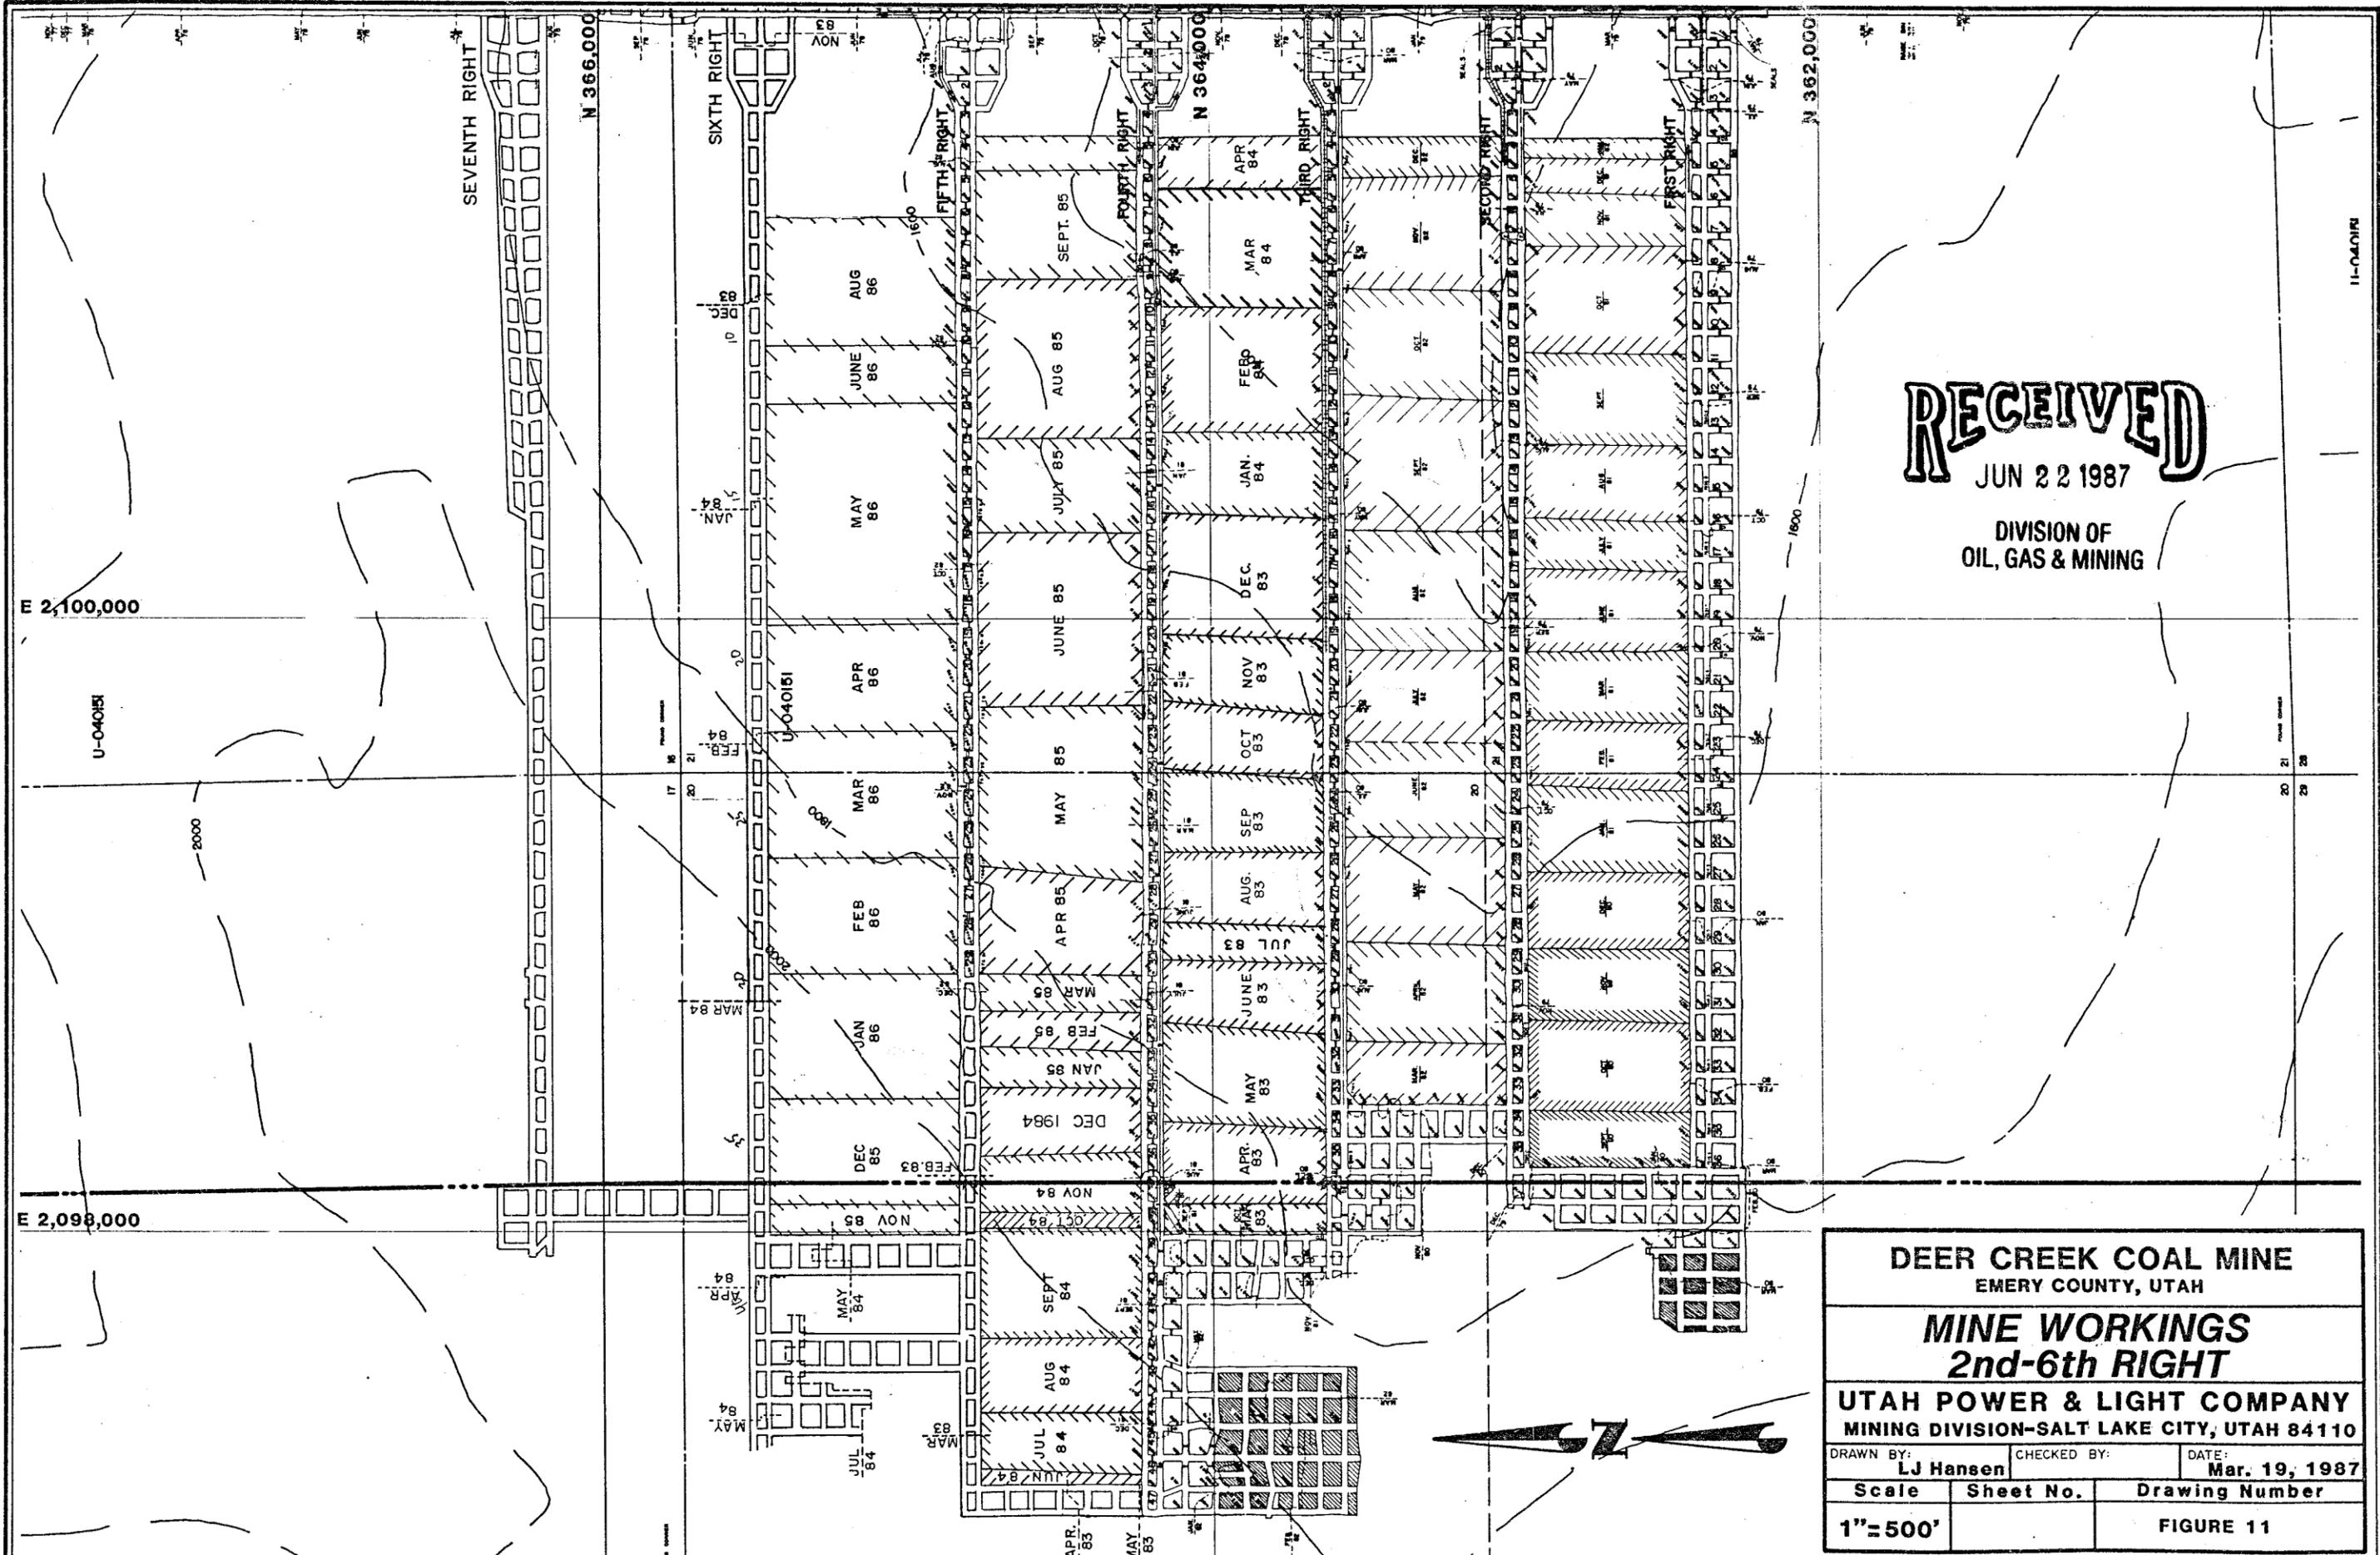
DEER CREEK COAL MINE		
EMERY COUNTY, UTAH		
1986 SUBSIDENCE		
2nd-6th RIGHT		
UTAH POWER & LIGHT COMPANY		
MINING DIVISION-SALT LAKE CITY, UTAH 84110		
DRAWN BY:	CHECKED BY:	DATE:
LJ Hansen		Feb. 25, 1987
Scale	Sheet No.	Drawing Number
1" = 500'		FIGURE 12

The maximum subsidence yet noted is nearly 7 feet over the 3rd and 4th Right longwall panels (Figure 12). Curiously, where subsidence of up to 5 feet was measured in 1985 over two (2) room-and-pillar sections to the west of these panels, 1986 measurement shows only 3 feet. The surface above these sections forms steep slopes, and it is assumed that some type of ground movement has caused the original depressions to fill slightly. However, no slumping or fractures have been noted in any part of the area, either on the ground or from the air. The calculated angle-of-draw of the subsidence ranges from near vertical to about 22° , but more meaningful estimates may be possible when subsidence has stabilized.

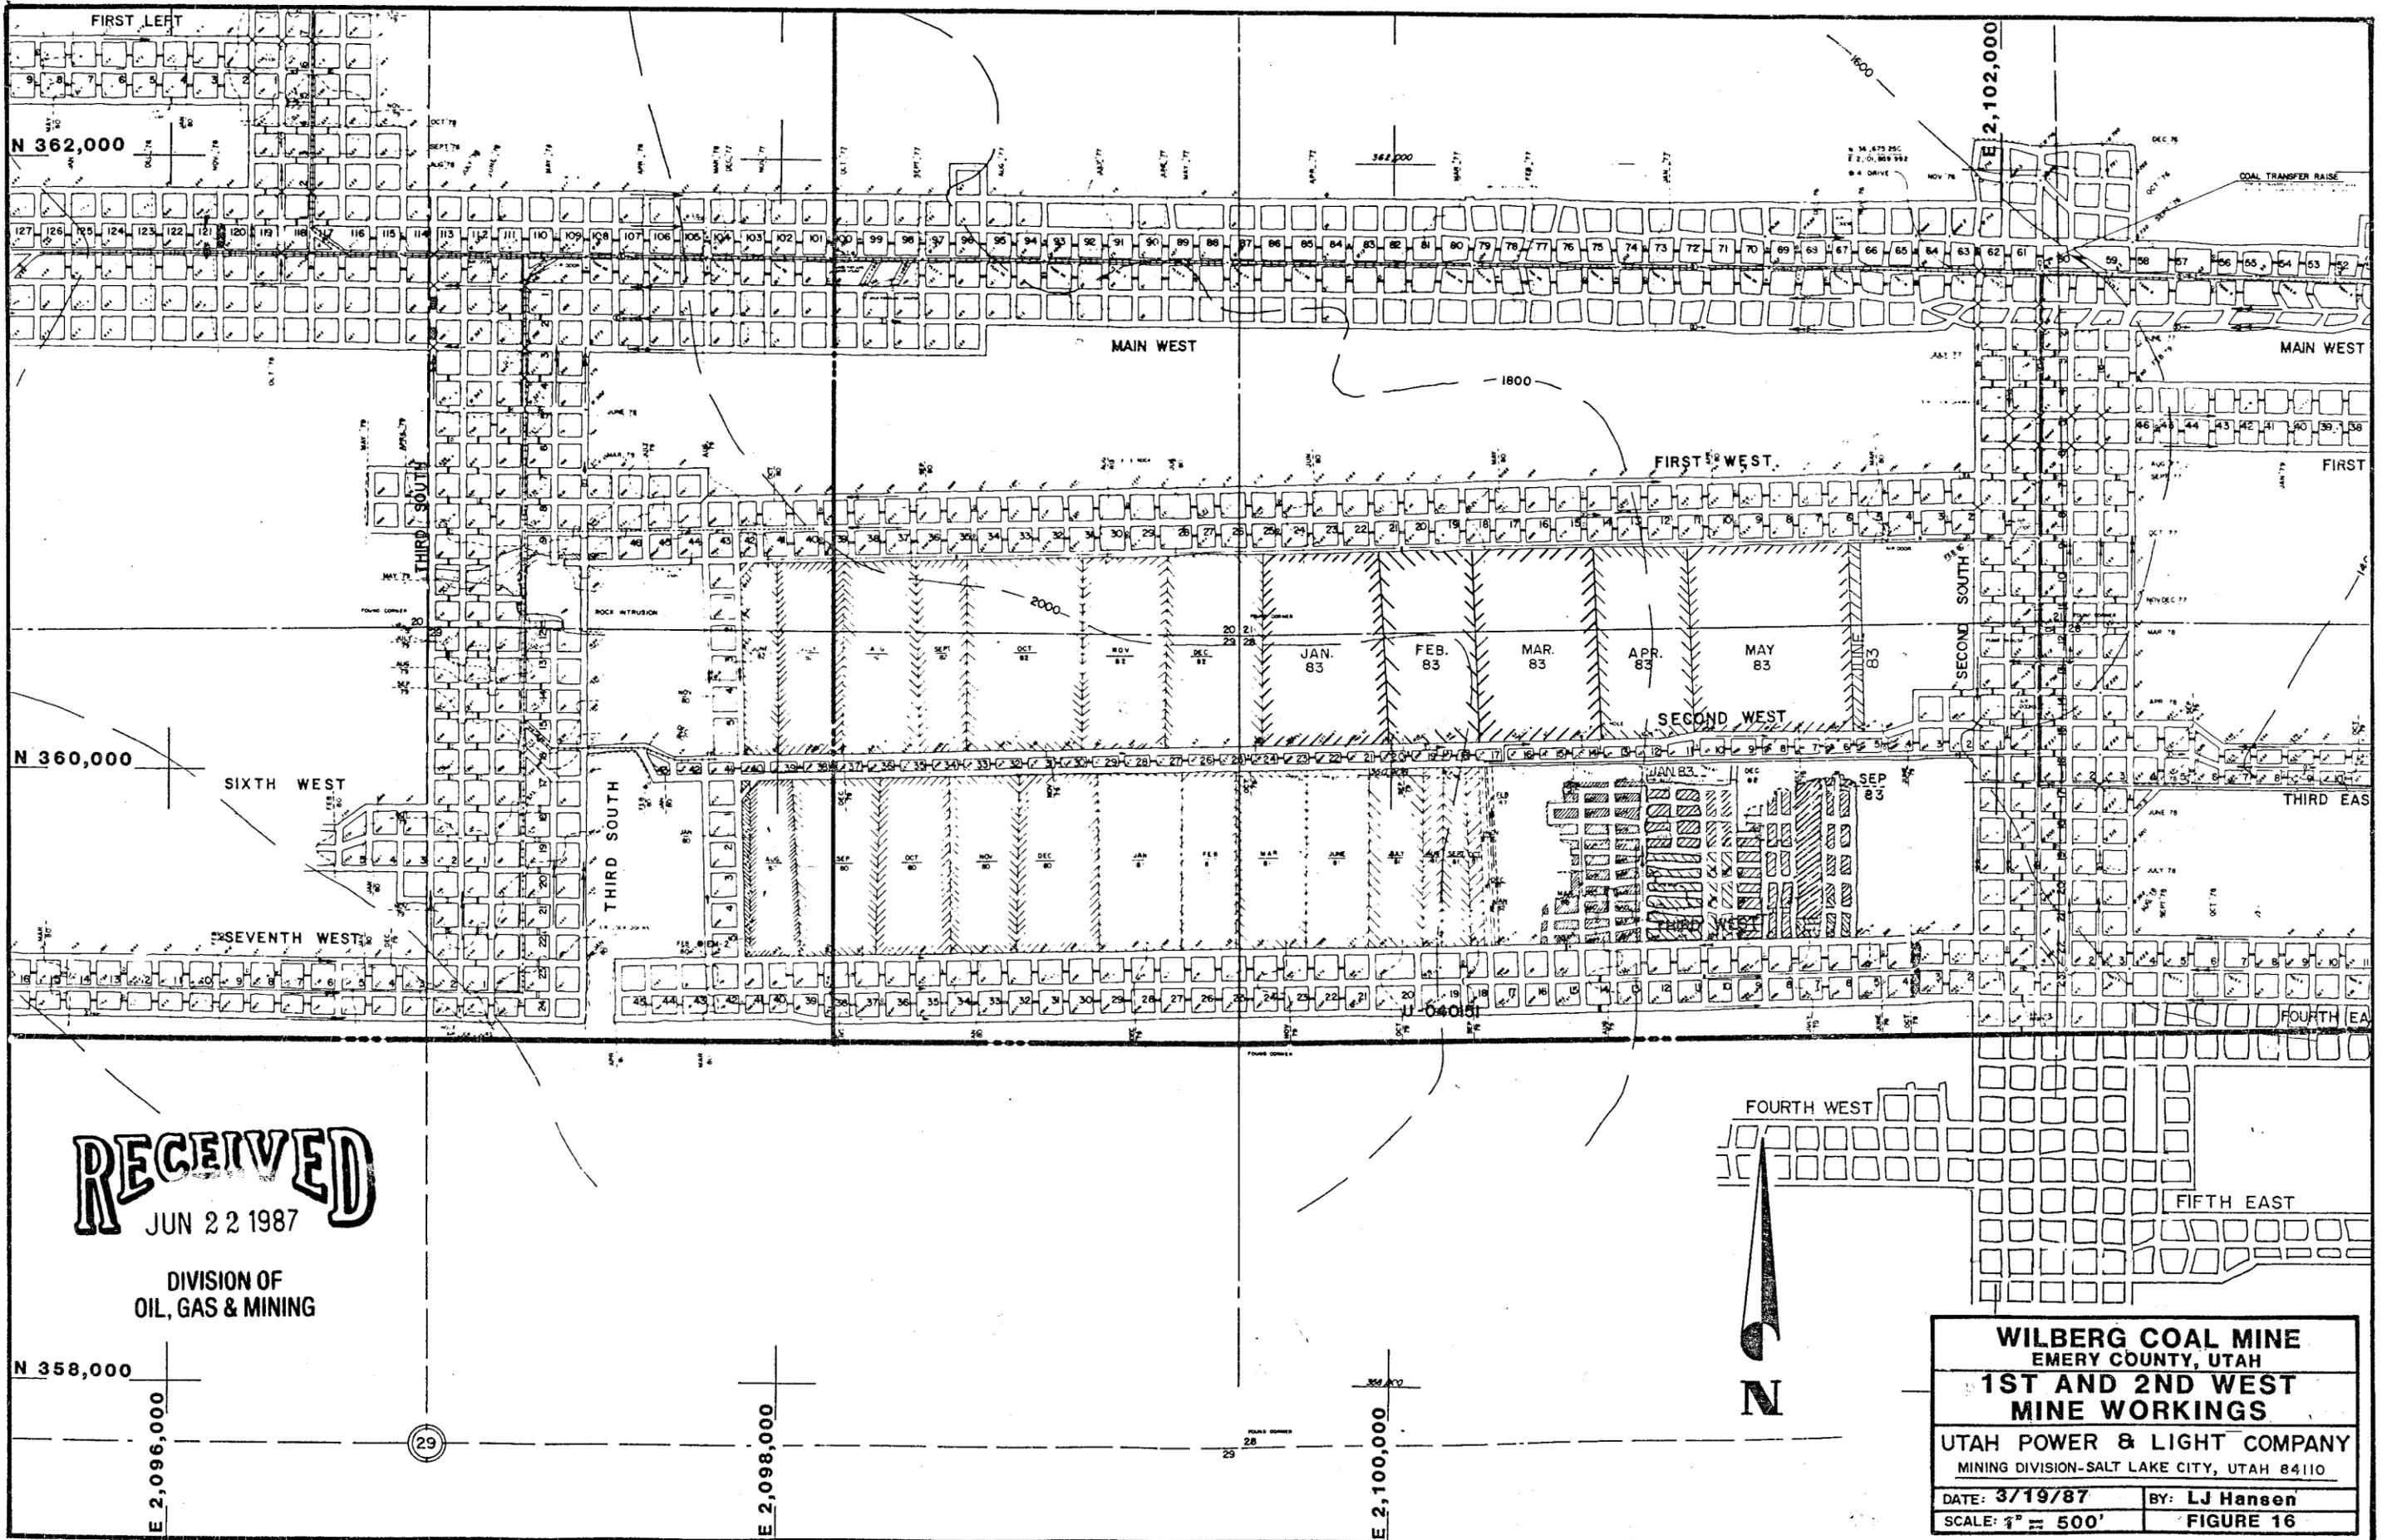
WILBERG COAL MINE		
EMERY COUNTY, UTAH		
1986 SUBSIDENCE		
1st & 2nd WEST		
UTAH POWER & LIGHT COMPANY		
MINING DIVISION-SALT LAKE CITY, UTAH 84110		
DRAWN BY:	CHECKED BY:	DATE:
LJ Hansen		Feb. 25, 1987
Scale	Sheet No.	Drawing Number
1" = 500'		FIGURE 17

Maximum subsidence reached just over 5 feet (Figure 17); no surface disturbance of any kind has been found. On the south side of the workings the subsidence diminishes to less than 0.5 feet within 1200 feet. With 2000 feet of overburden this equates to an angle-of-draw of 21 degrees.

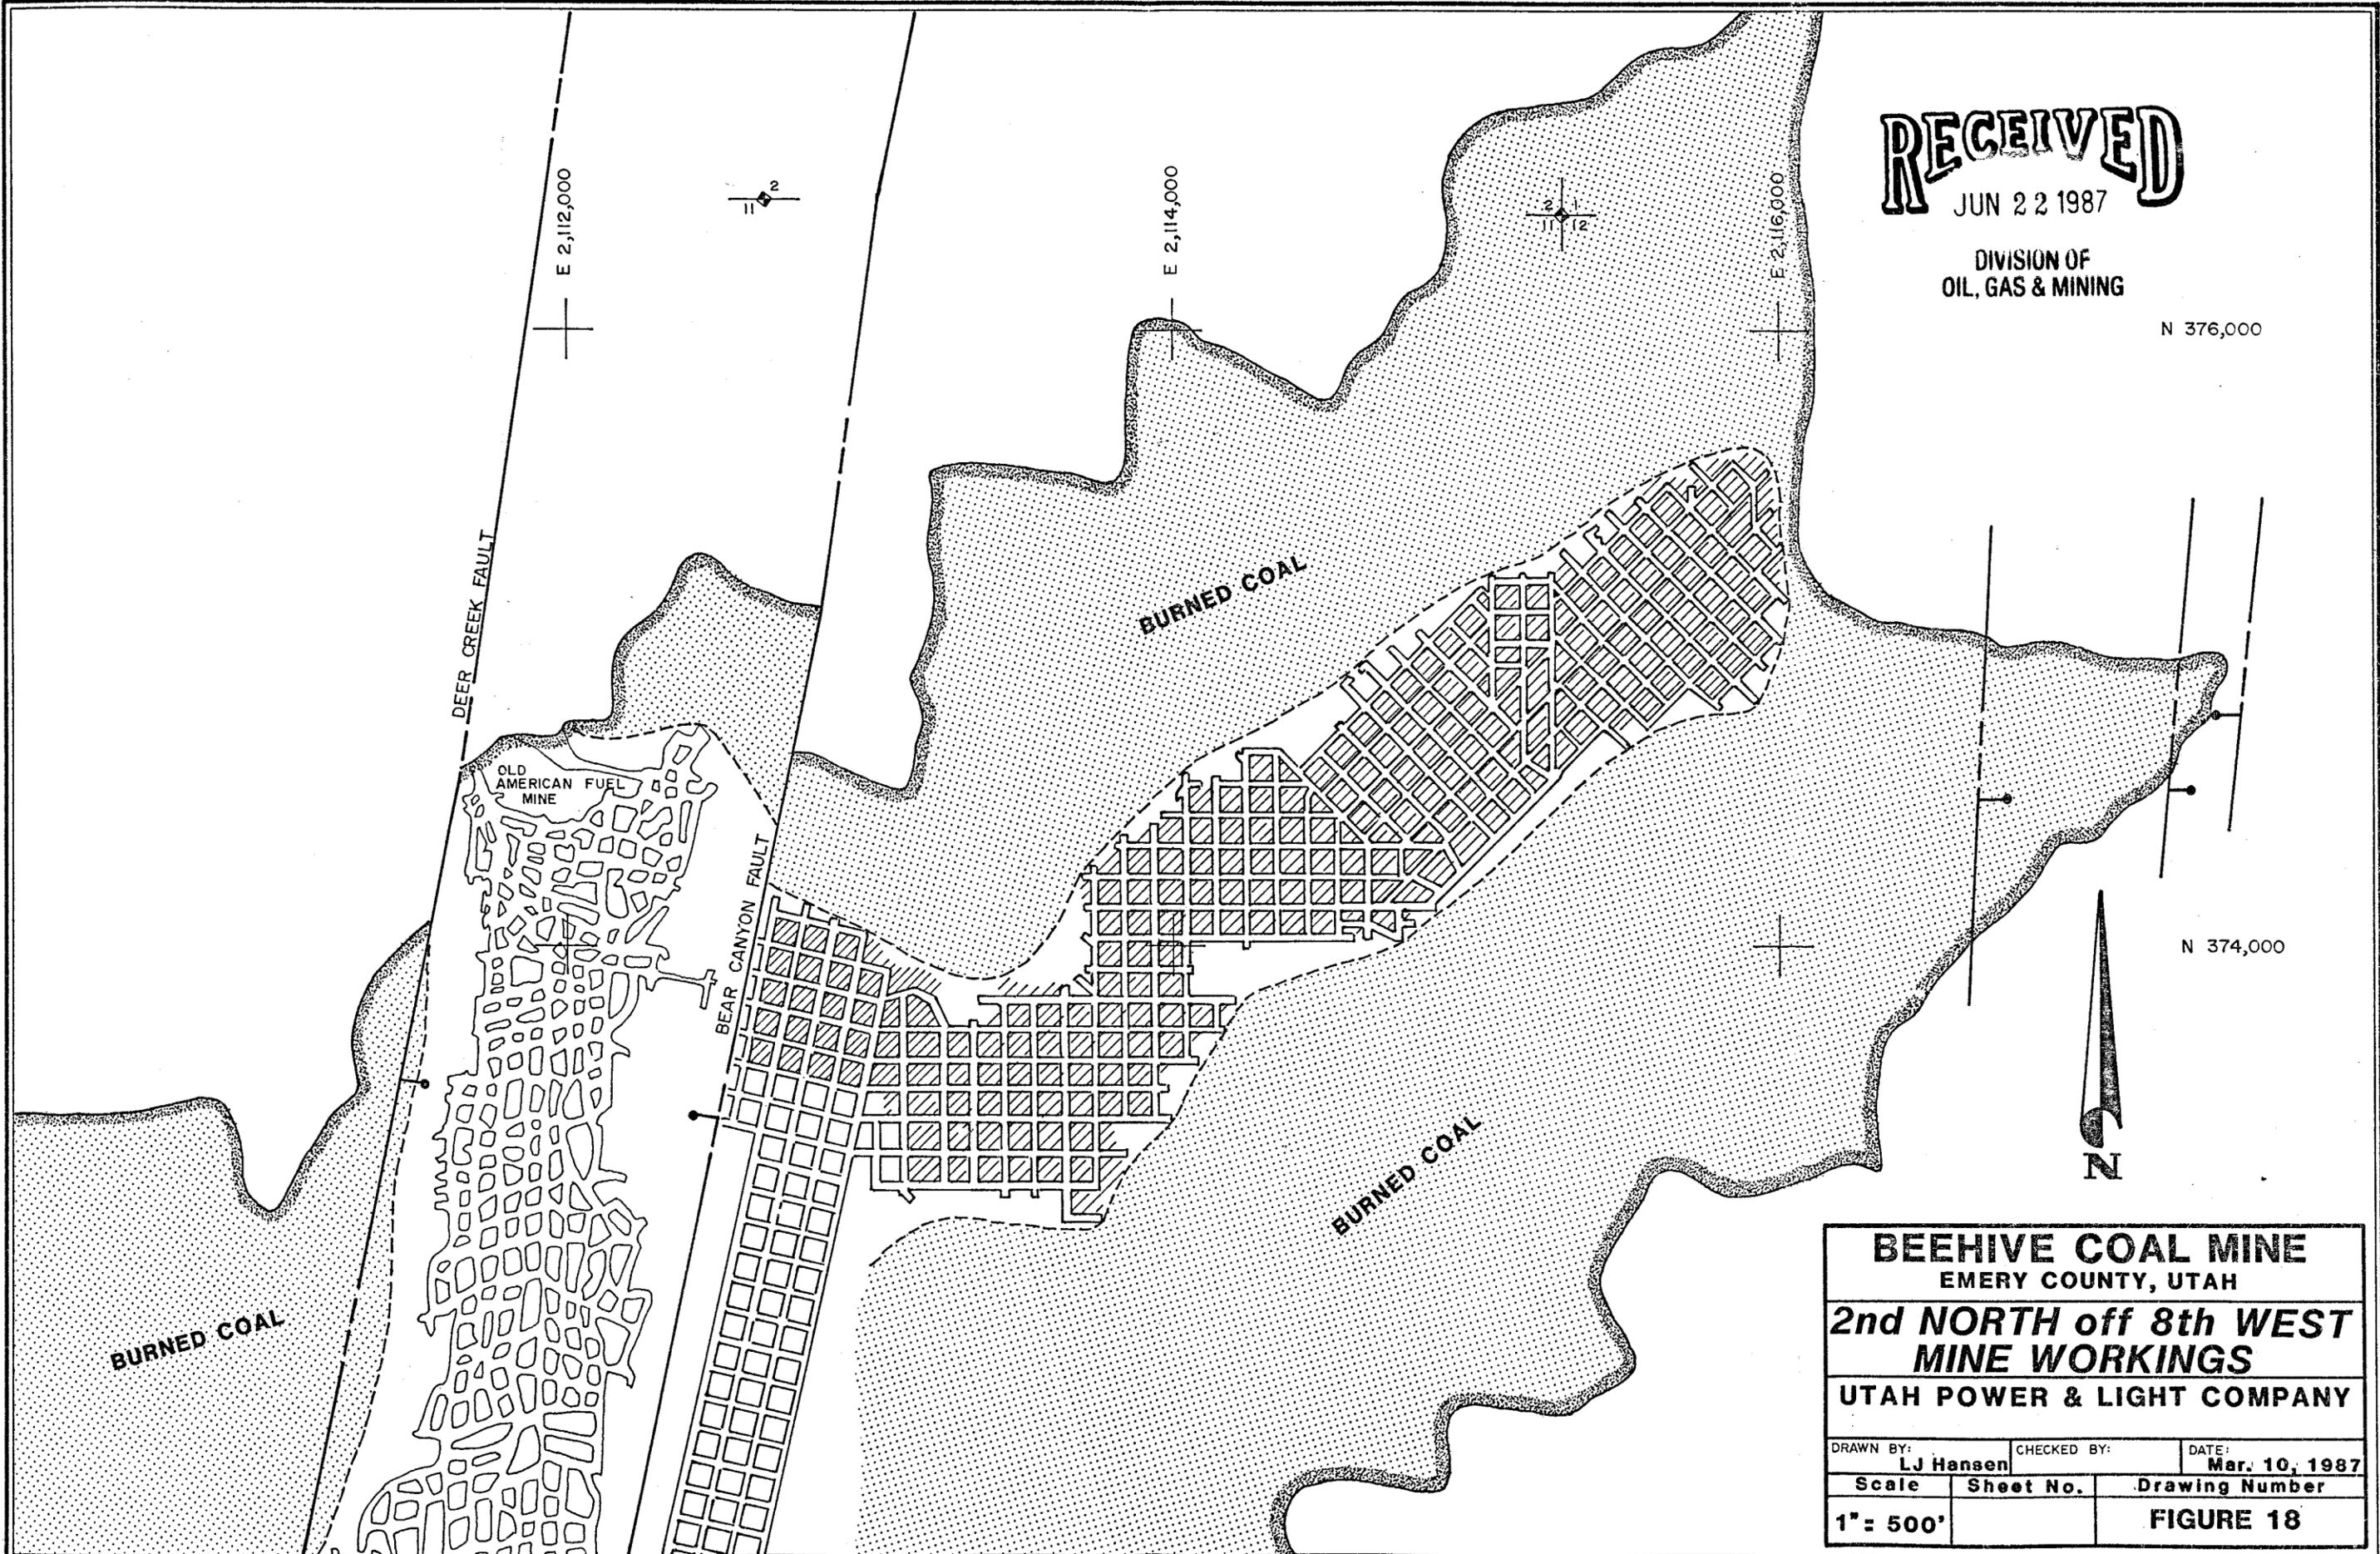
BEEHIVE COAL MINE		
EMERY COUNTY, UTAH		
2nd NORTH off 8th WEST		
MINE WORKINGS		
UTAH POWER & LIGHT COMPANY		
DRAWN BY: LJ Hansen	CHECKED BY:	DATE: Mar. 10, 1987
Scale 1" = 500'	Sheet No.	Drawing Number FIGURE 18

Pillar extraction mining was terminated in December 1983 in this section of the Beehive Mine. The area is surrounded by burned coal (Figure 18).

Since late 1984 little additional subsidence has occurred over the workings. Maximum subsidence reached 6 feet and appears to have stopped. Subsidence in this area will now be monitored every second year instead of annually due to the stabilization. Mass wasting of some type, probably movement of large boulders or blocks of sandstone cliff material (Figure 19), occurred at two locations. The rocks on the ridge overlying the workings were highly fractured prior to mining, and, given the fractured nature of the strata on the surface and the fact that the area overlies burned coal, it is probable that other instances of movement may occur.
