UTAH POWER & LIGHT COMPANY
SUBSIDENCE MONITORING PROGRAM
ANNUAL REPORT FOR 1986

April 1987

Submitted to: United States Department of the Interior
Office of Surface Mining
Minerals Management Service
Utah Division of Oil, Gas and Mining

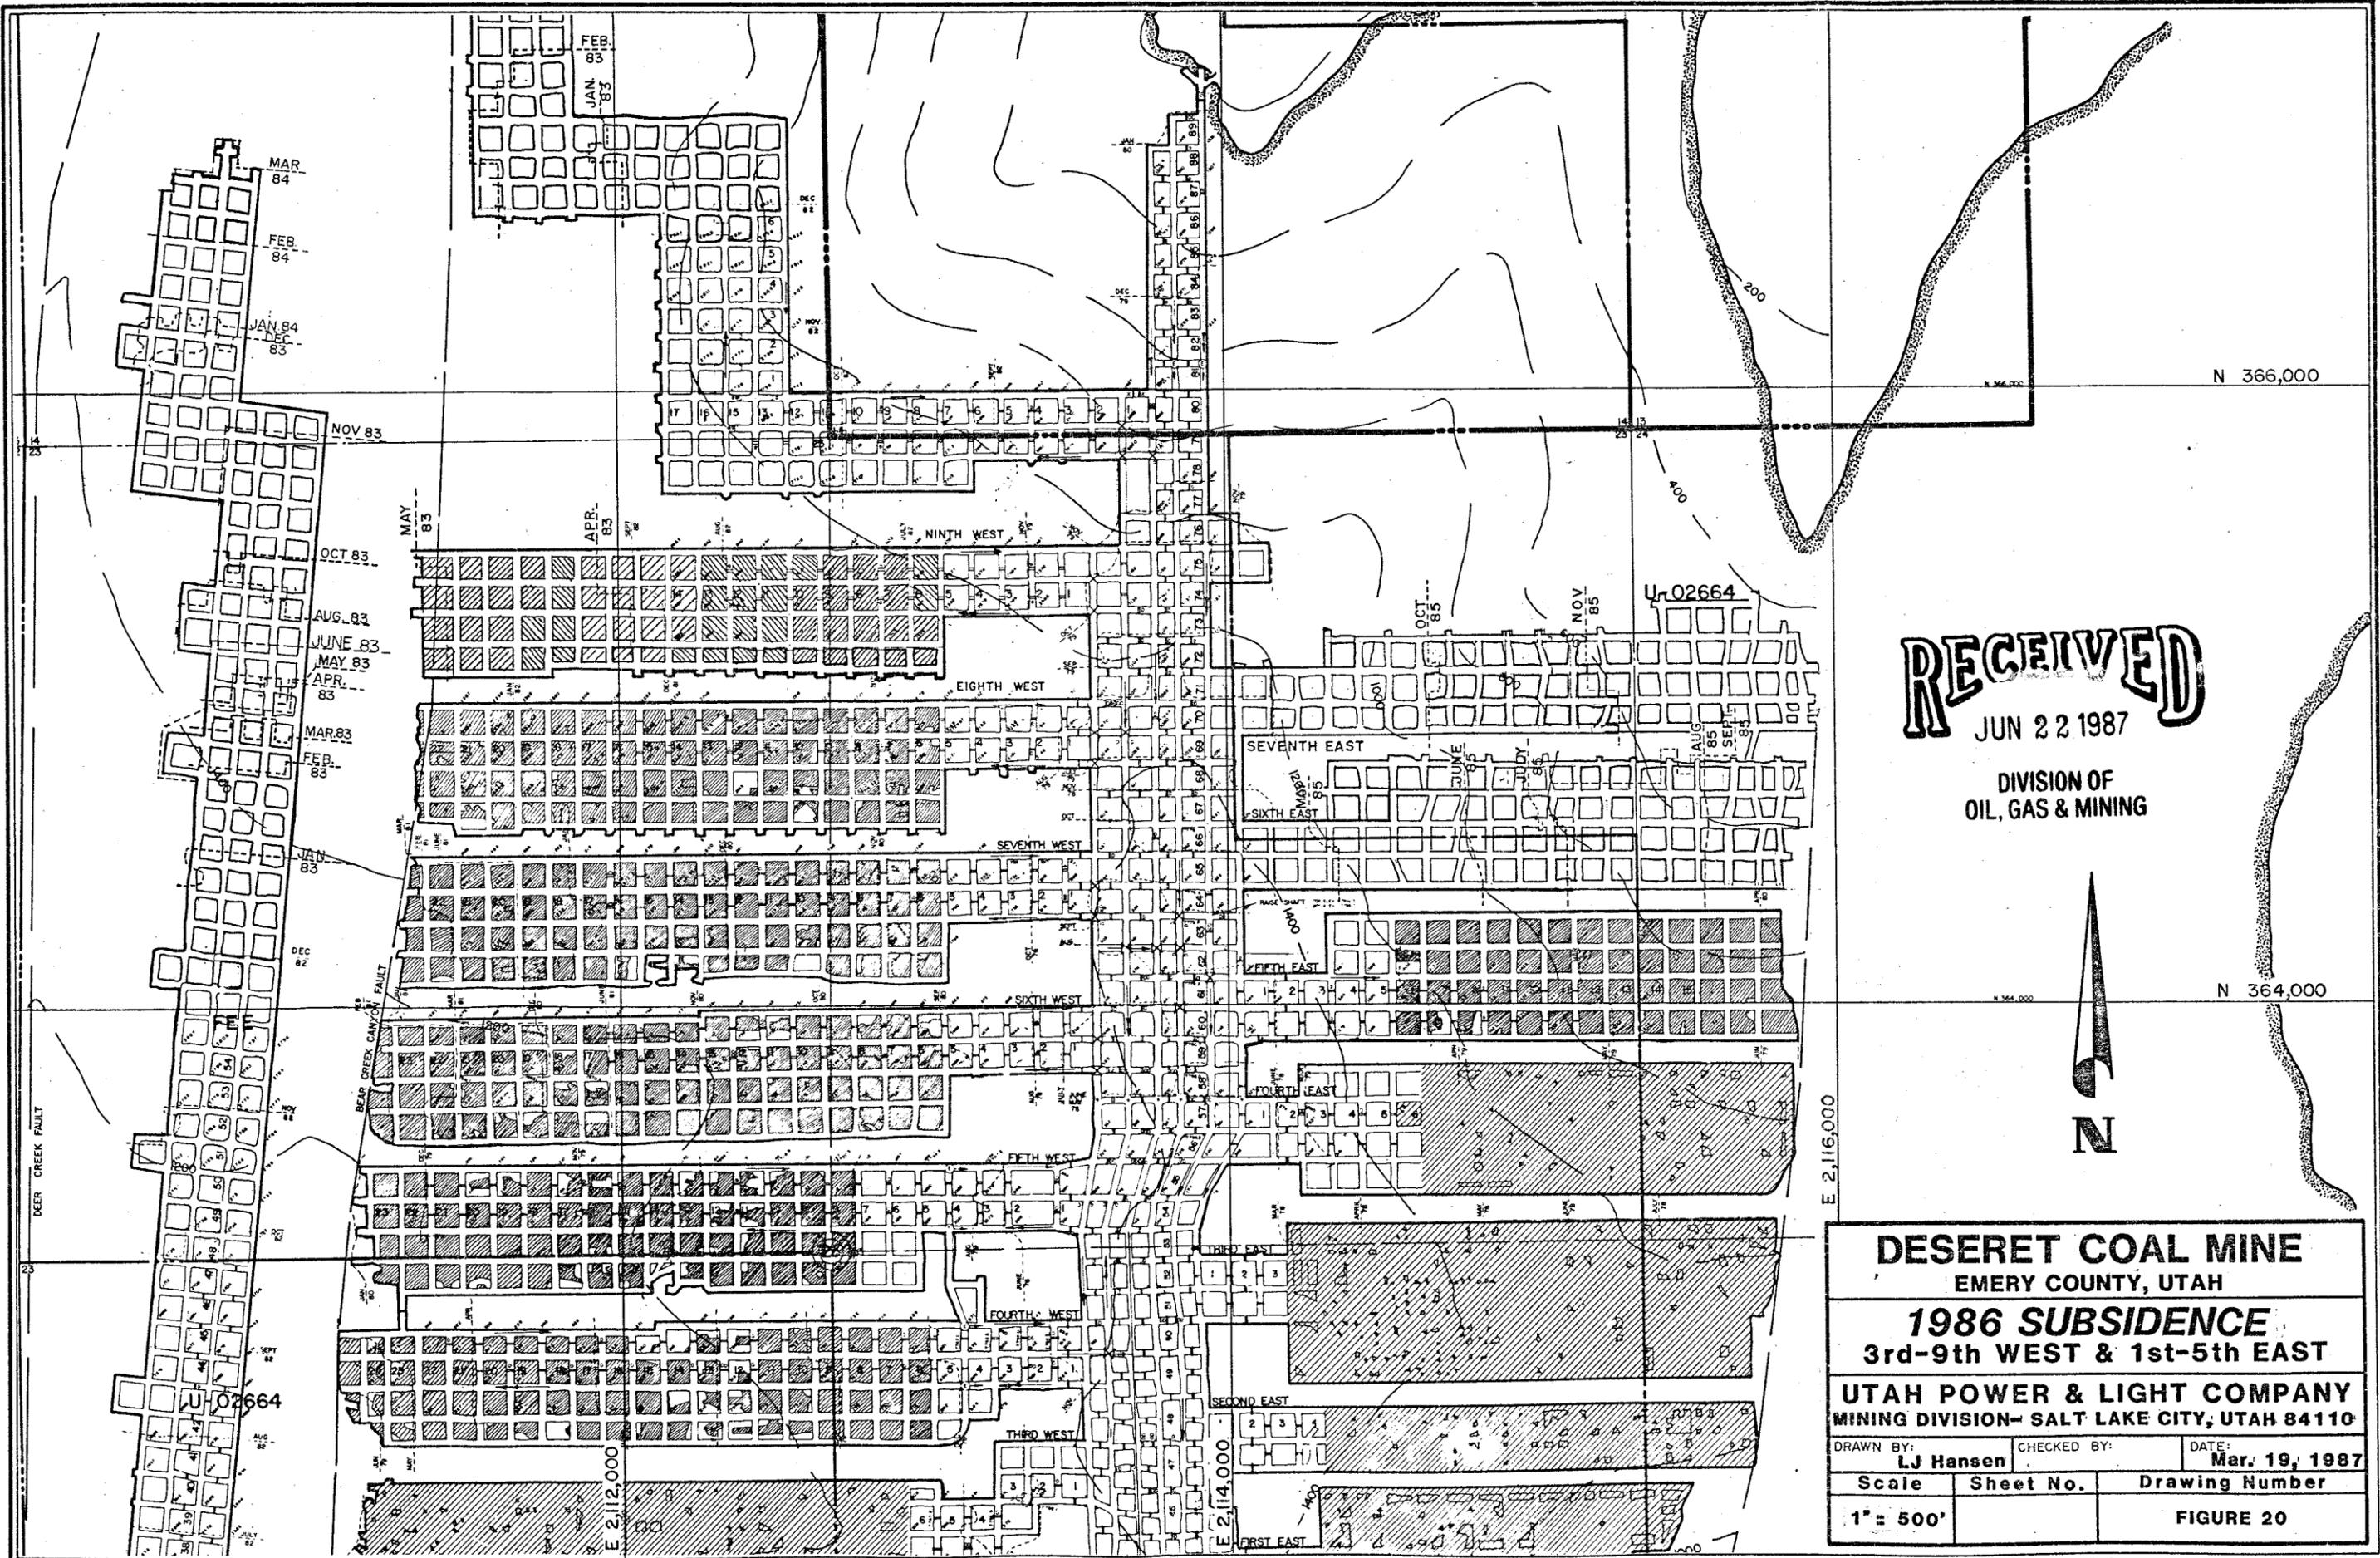
DRAWN BY: LJ Hansen	CHECKED BY:	DATE: Mar. 19, 1987
Scale 1" = 500'	Sheet No.	Drawing Number FIGURE 20

Some of the subsidence in this area may have gone undetected because pillar extraction, and presumable subsidence, in part of the Beehive Mine occurred before the establishment of baseline elevation data (Figures 20 and 21). The only measurable subsidence would be due to pillar extraction in the underlying Deseret Mine and would not be a true indication of total subsidence.

Subsidence in the southern part of the area is somewhat less than expected, probably due to the above reasons. Further north, where mining in both seams has been more recent, observed subsidence reached 5 feet in 1985 and did not increase in 1986. The extent of the subsidence appears to have spread westward over the 1st North Little Dove workings (Figure 22). Pillar extraction mining was active in the 1st North section during the monitoring period.

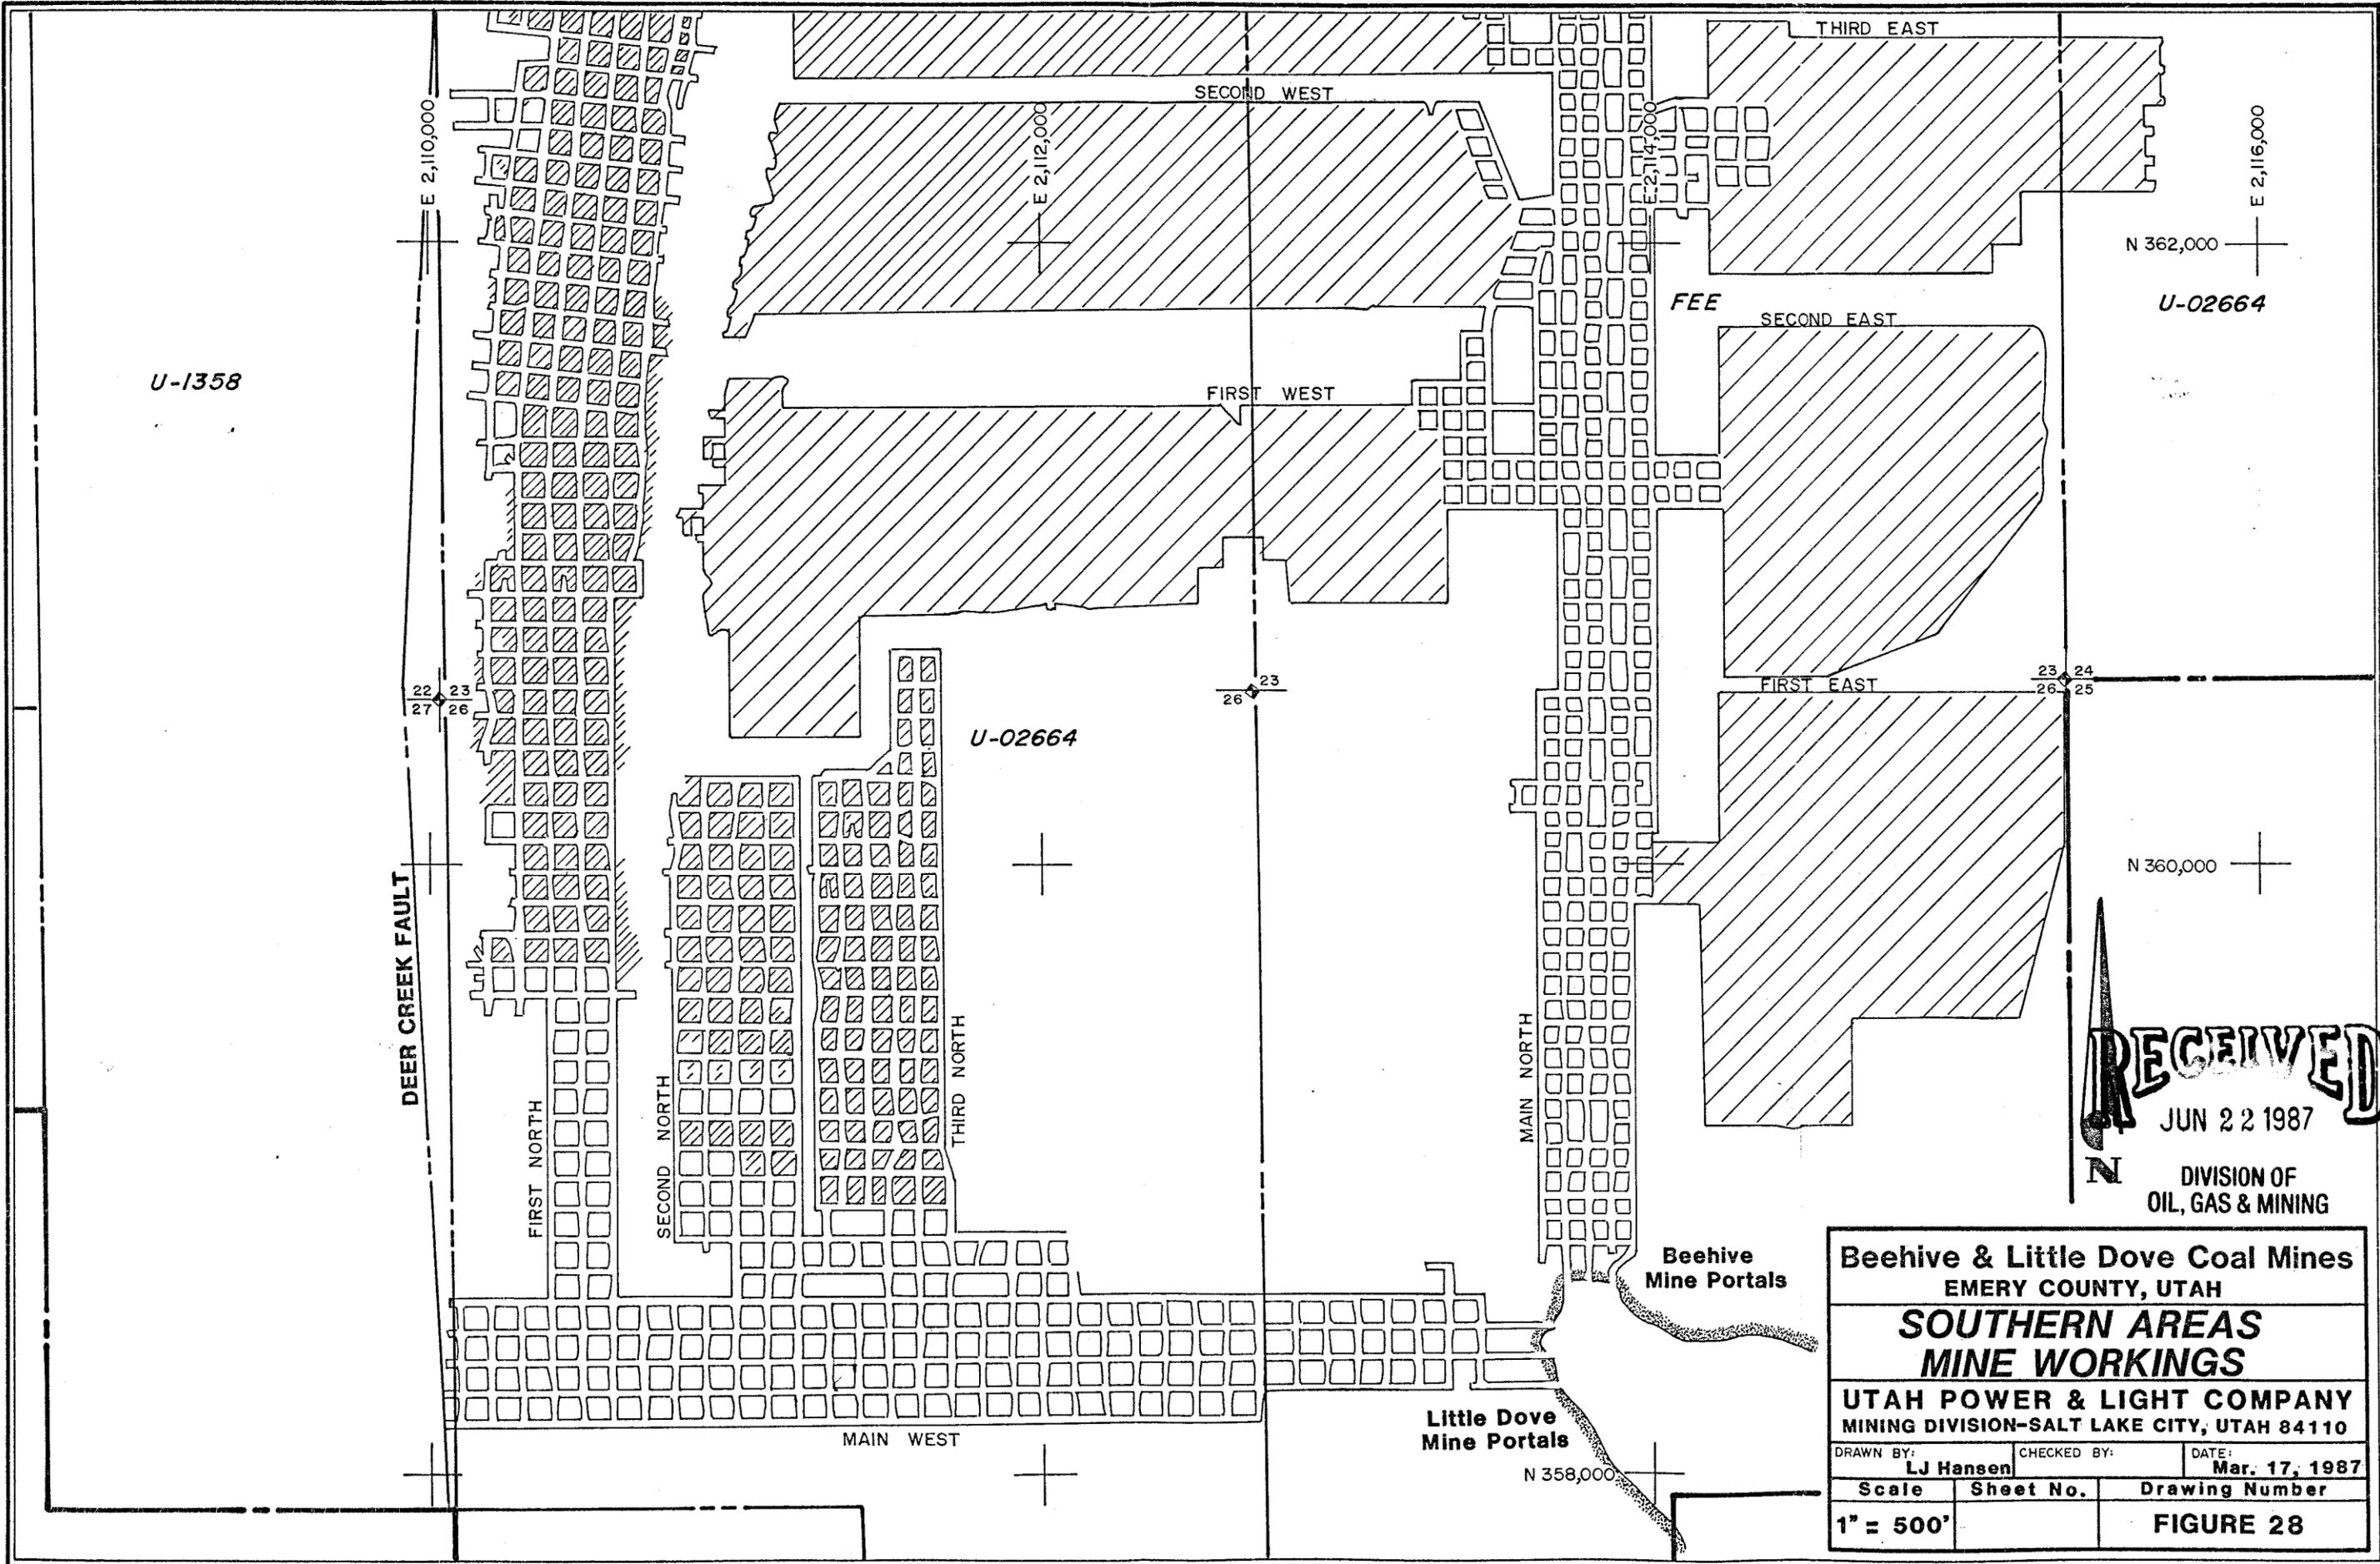
Beehive & Little Dove Coal Mines		
EMERY COUNTY, UTAH		
SOUTHERN AREAS		
MINE WORKINGS		
UTAH POWER & LIGHT COMPANY		
MINING DIVISION-SALT LAKE CITY, UTAH 84110		
DRAWN BY: LJ Hansen	CHECKED BY:	DATE: Mar. 17, 1987
Scale 1" = 500'	Sheet No.	Drawing Number
FIGURE 28

To date the maximum observed subsidence over 1st North is a little over 3 feet, occurring over some of the most recently extracted pillars (Figures 28 and 30). The remaining portions of the 1st North workings and subsidence can be seen in Figures 21, 22, and 23.

This area was first monitored for subsidence in 1986. The area covers the southern portions of the Deseret, Beehive, and Little Dove Mines. Some of the sections in the area were mined before baseline elevation data were established; therefore, subsidence measured over these sections will not likely represent what actually occurred. In other areas, such as 1st, 2nd, and 3rd North, Little Dove, pillar extraction was active during the time since baseline elevations were established and measured subsidence should represent true subsidence (Figures 28 and 29).
