UTAH POWER & LIGHT COMPANY
SUBSIDENCE MONITORING PROGRAM
ANNUAL REPORT FOR 1988

March 1989

United States Department of the Interior
Office of Surface Mining
Minerals Management Service
Utah Division of Oil, Gas and Mining

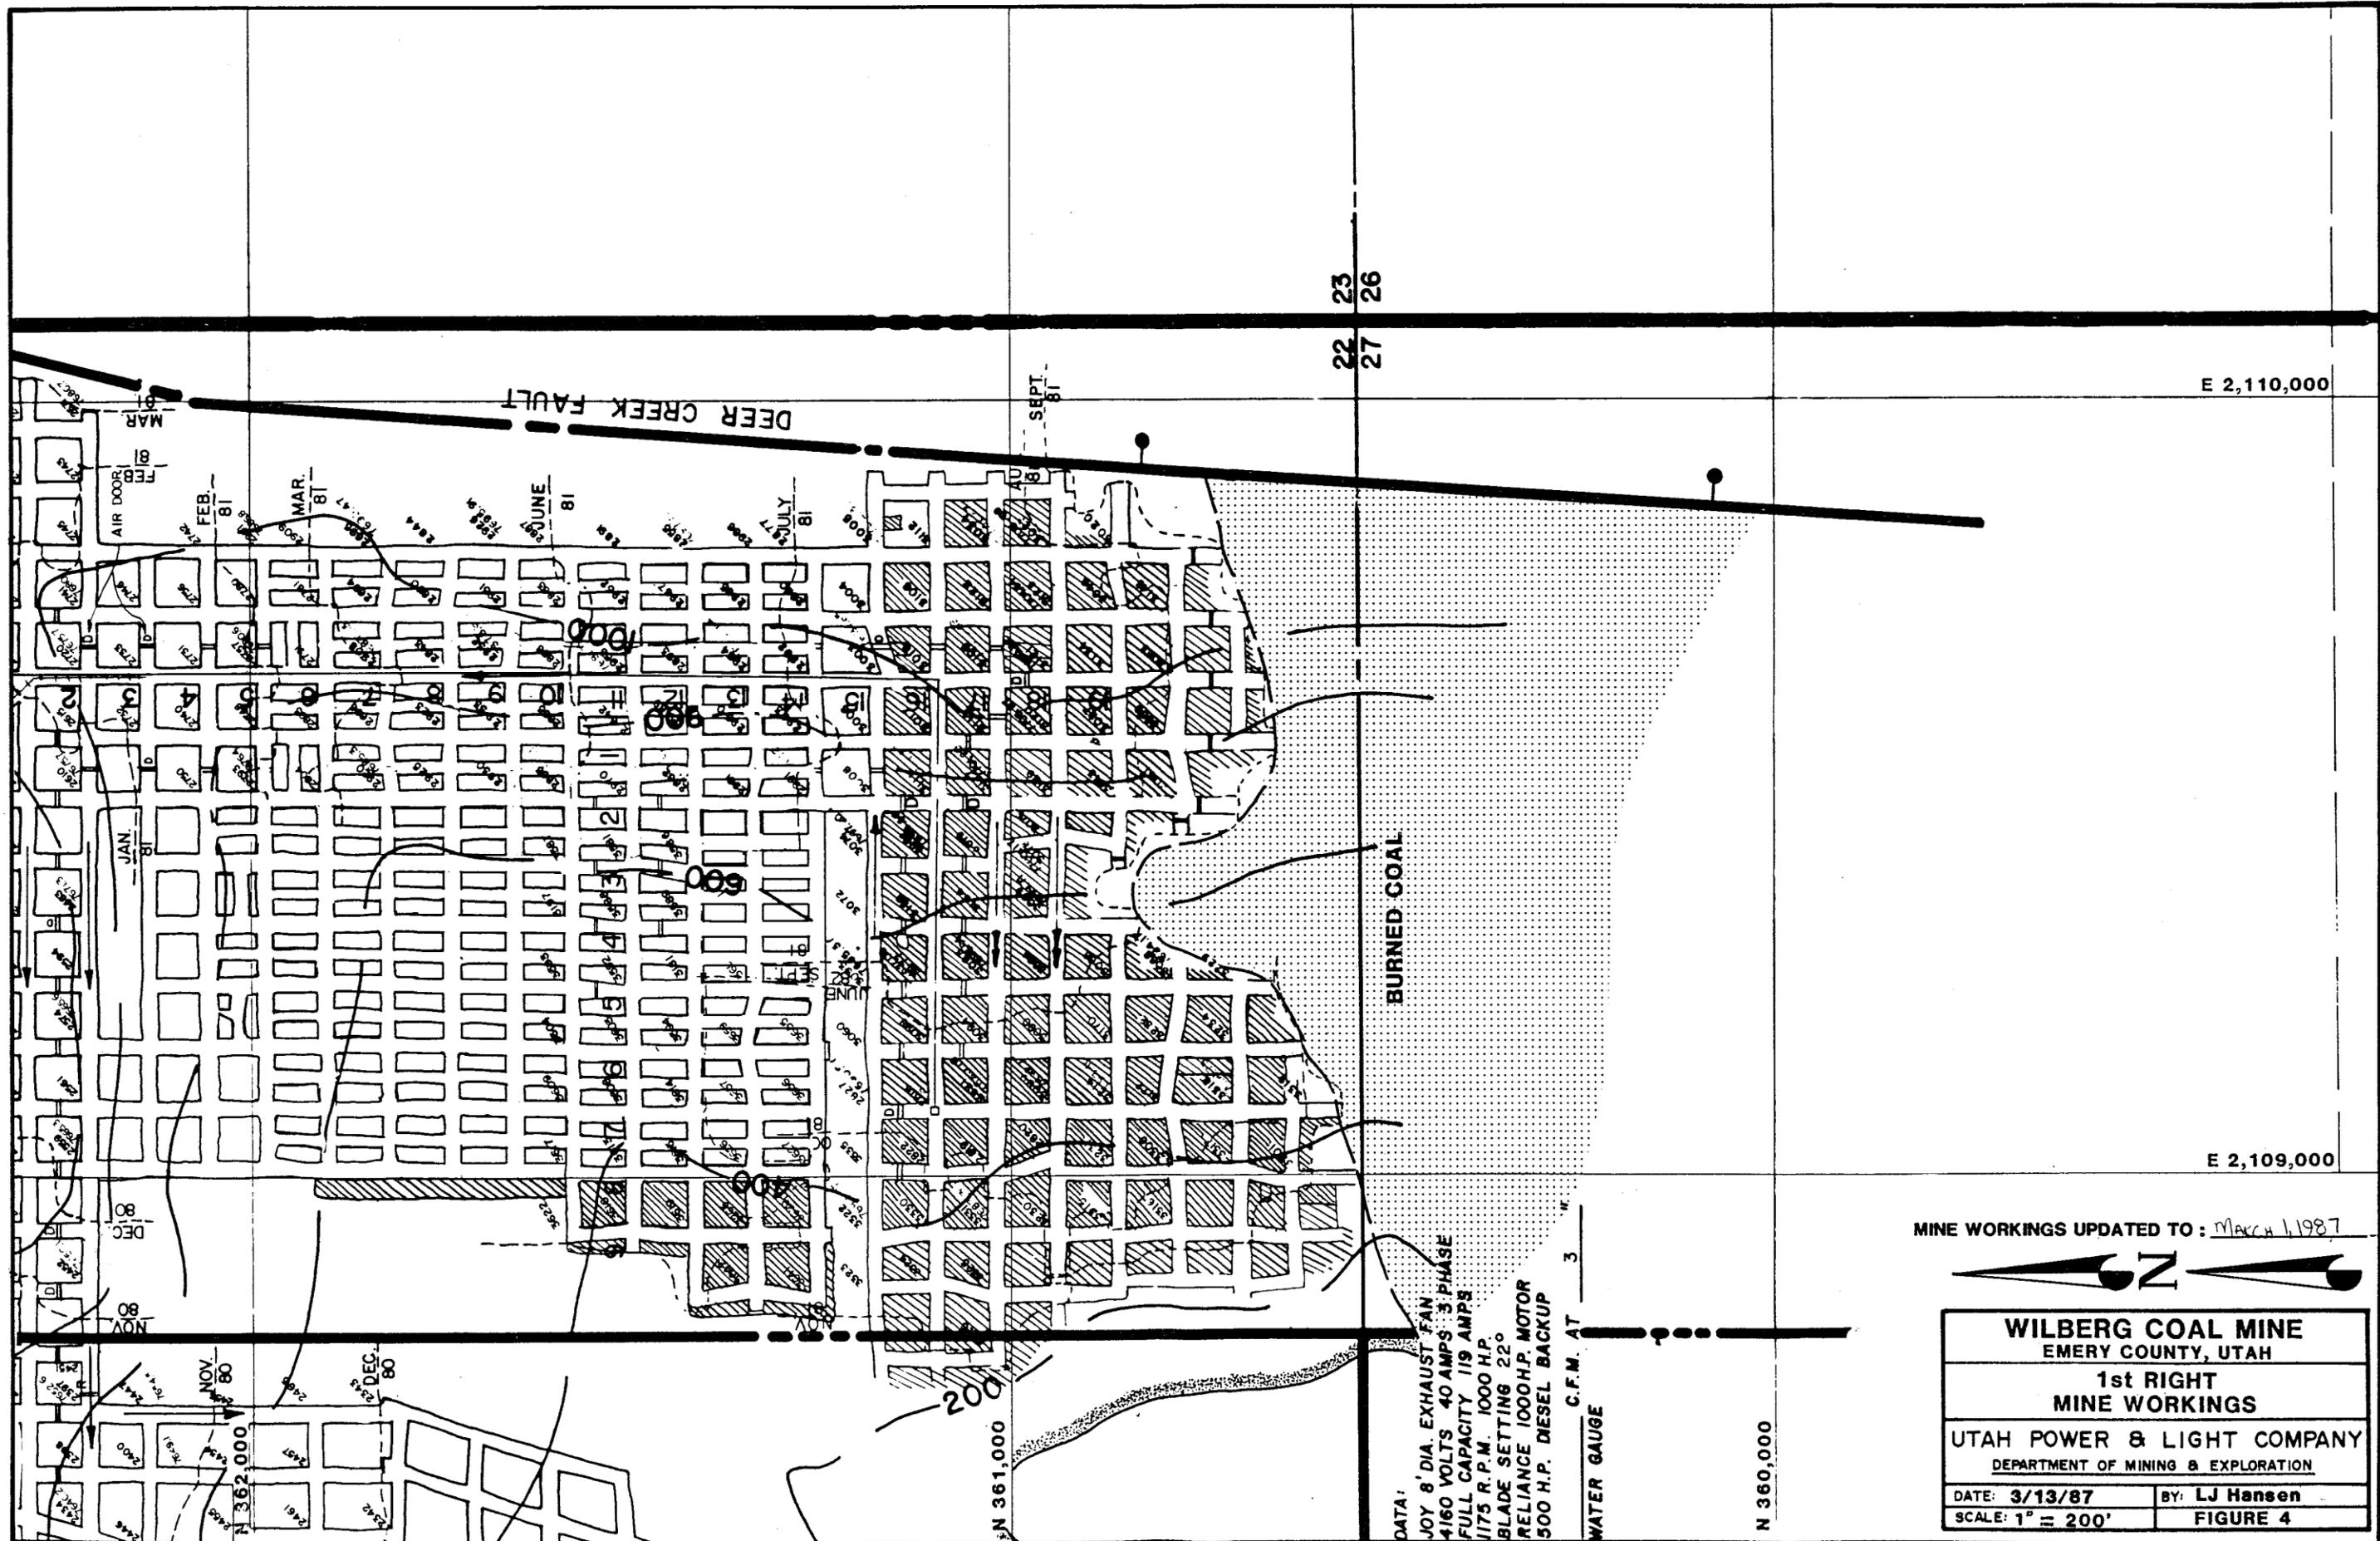
DEER CREEK/WILBERG COAL MINES EMERY COUNTY, UTAH		
1988 SUBSIDENCE DEER CREEK 9th EAST WILBERG 1st RIGHT		
UTAH POWER & LIGHT COMPANY MINING DIVISION		
DRAWN BY: K. LARSEN	CHECKED BY:	DATE: MAR. 2, 1989
Scale 1" = 200'	Sheet No.	Drawing Number FIGURE 5

Subsidence in Area 1 was first documented in the 1981 Subsidence Monitoring Report submitted in 1982. The relationship of the subsidence to the underlying Deer Creek and Wilberg mine workings is shown in Figures 3, 4, and 5. Each map covers the same area, Figure 5 being a contour map of subsidence on the surface over the mine workings depicted in the other two figures. The most recent mining in this area occurred in the Wilberg 1st Right section in June 1984.

Figures 6 and 7 are north to south and west to east profiles showing the amount of subsidence in this area during the past seven years. The location of each line is shown on Figure 5. The area has seen little change since 1985. Maximum subsidence remains at about twenty-five (25) feet. A detailed look from a helicopter revealed that the subsidence maximum is located on a steep slope, about 200 feet south of the southernmost mining, where a good-sized rotational slump has occurred. The workings here are also surrounded by burned coal. It is probable that the combination of steep slopes and crushing of clinker beds has allowed subsidence to occur well outside the area of mine workings. An inspection of the area from the ground indicates that many of the open fractures forming the graben-like structure have begun to heal and fill in with soil.

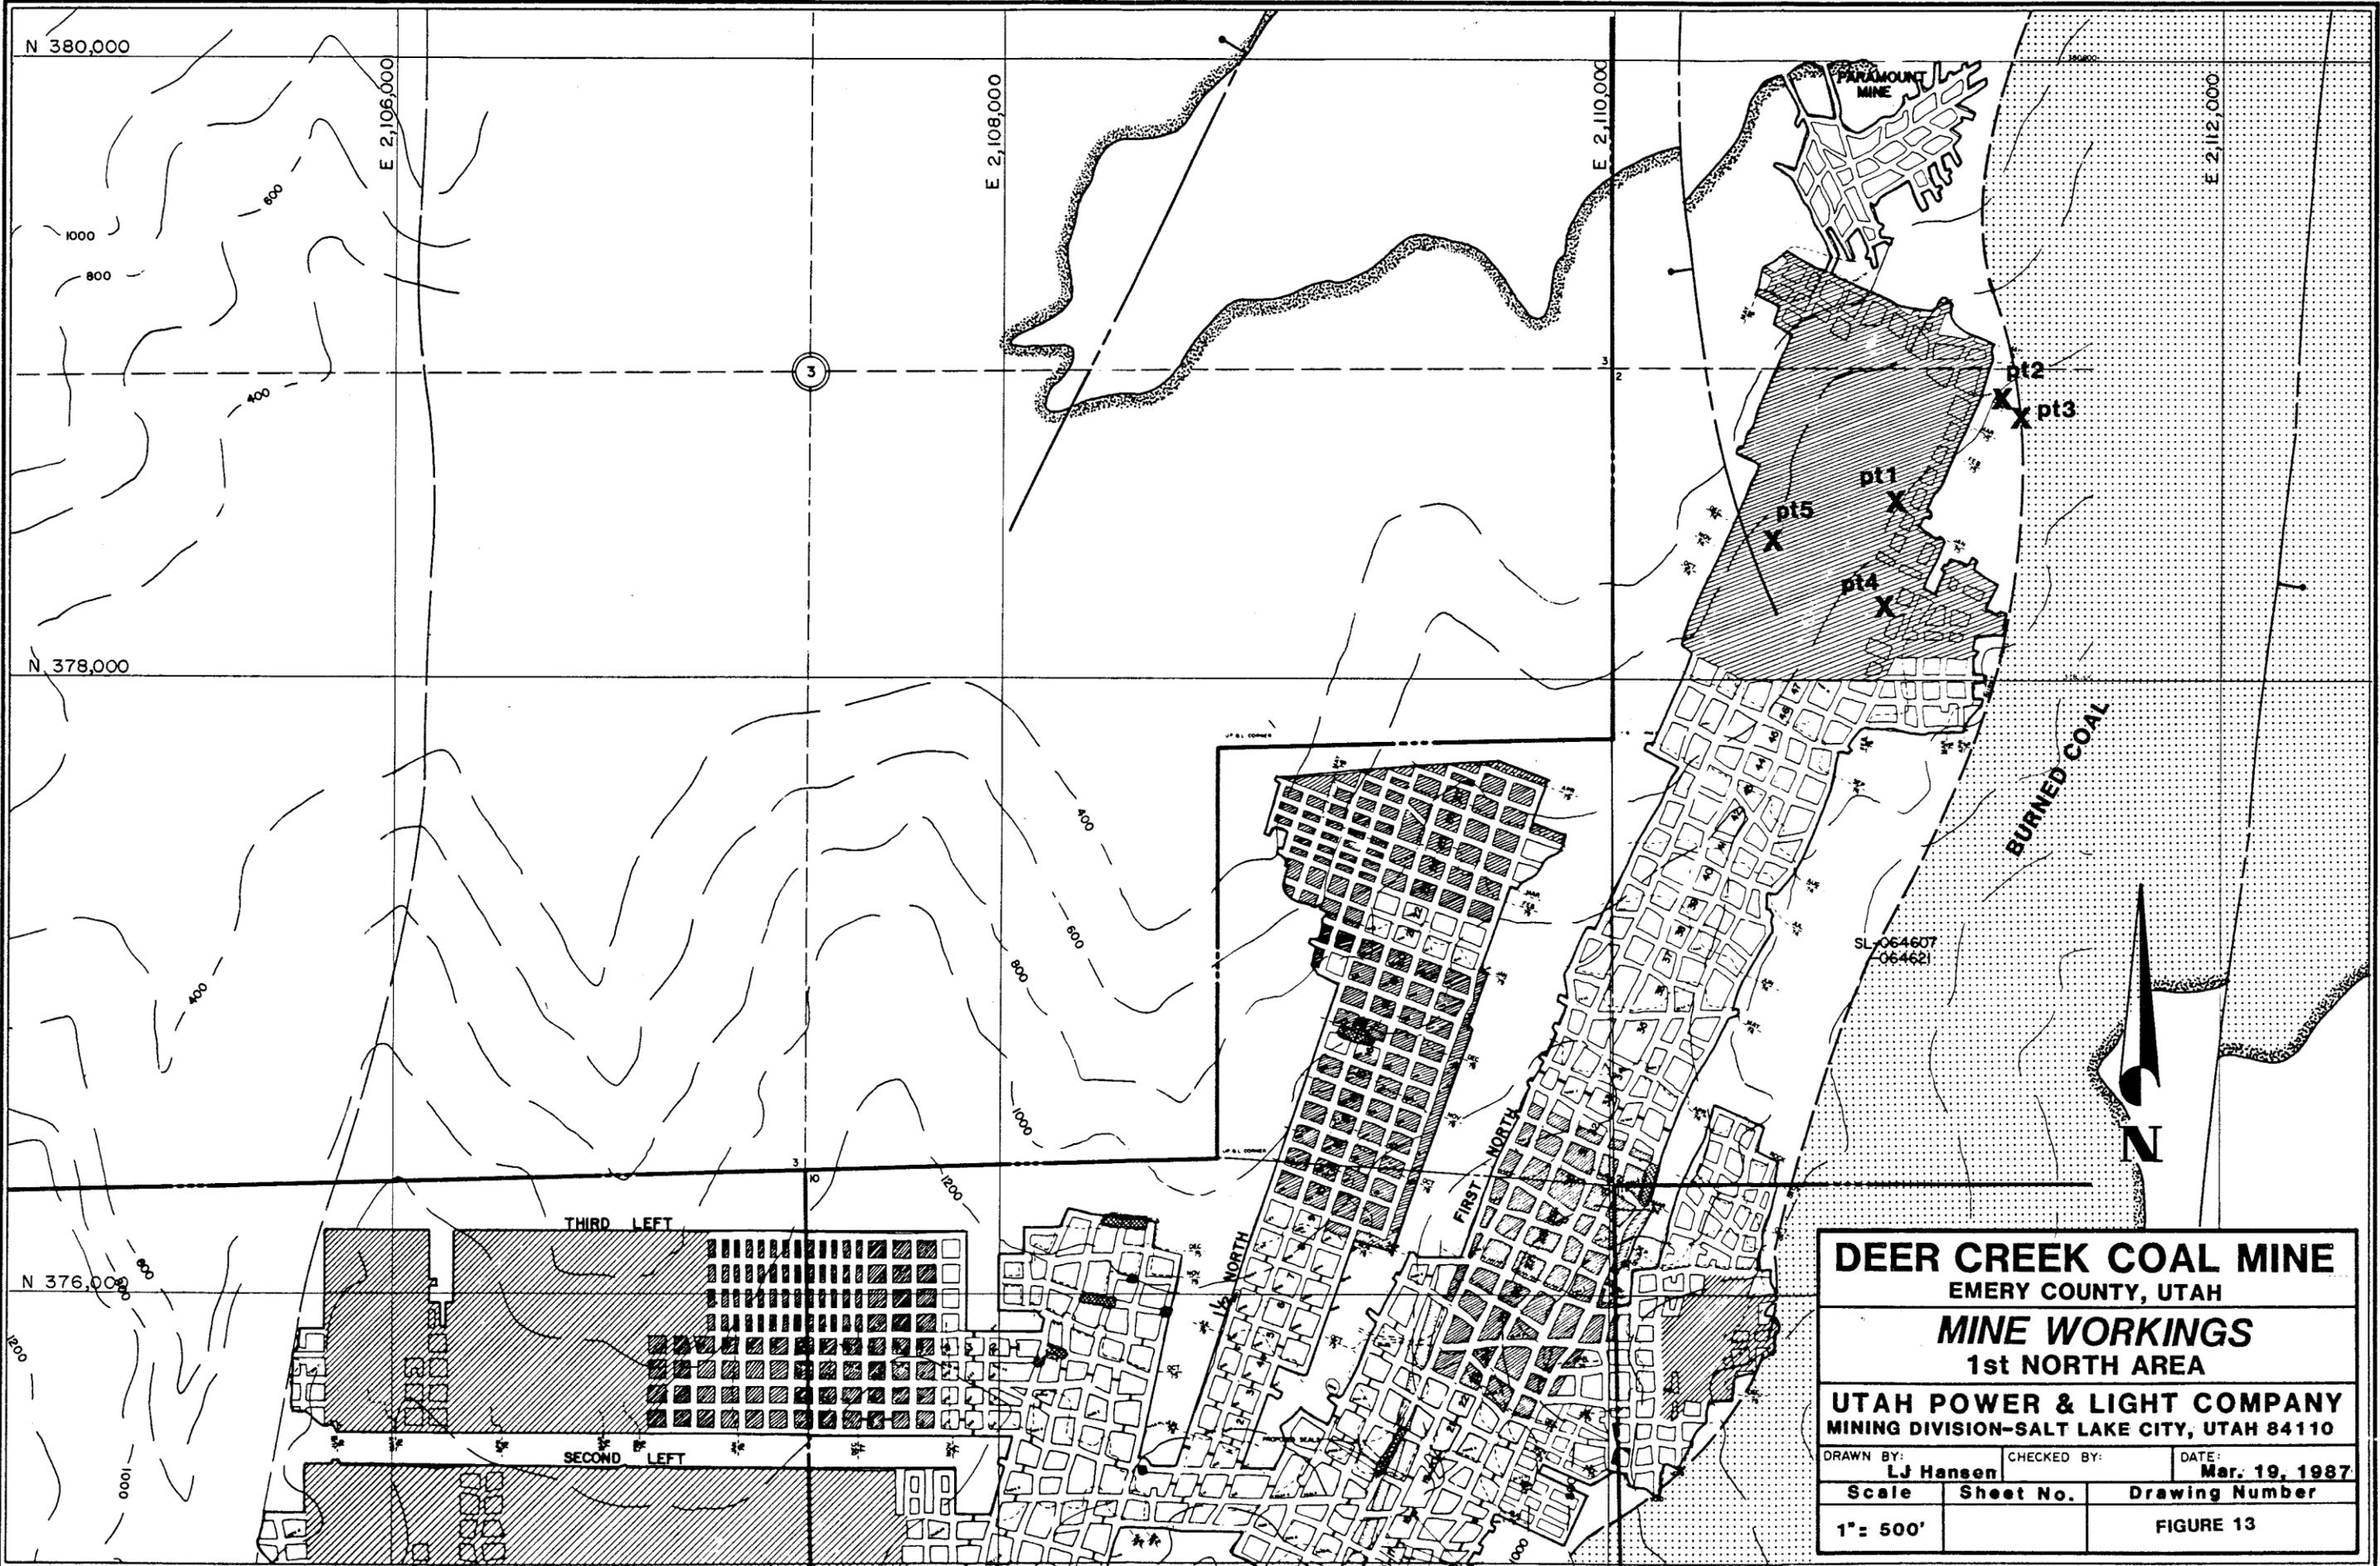
DEER CREEK COAL MINE		
EMERY COUNTY, UTAH		
MINE WORKINGS		
1st NORTH AREA		
UTAH POWER & LIGHT COMPANY		
MINING DIVISION-SALT LAKE CITY, UTAH 84110		
DRAWN BY:	CHECKED BY:	DATE:
LJ Hansen		Mar. 19, 1987
Scale	Sheet No.	Drawing Number
1" = 500'		FIGURE 13

Most of the 1st North section of the Deer Creek Mine was abandoned and sealed in 1978 after being mined out. The southern portion is still open and may be used for access to a block of coal which lies to the west. Pillar extraction in the 3rd Left and 1-1/2 North sections was completed early in 1980 (Figure 13). The greatest subsidence measured over these points was over seven (7) feet. The large change at that point may be due to a localized cliff or ledge failure since it appears so anomalous.

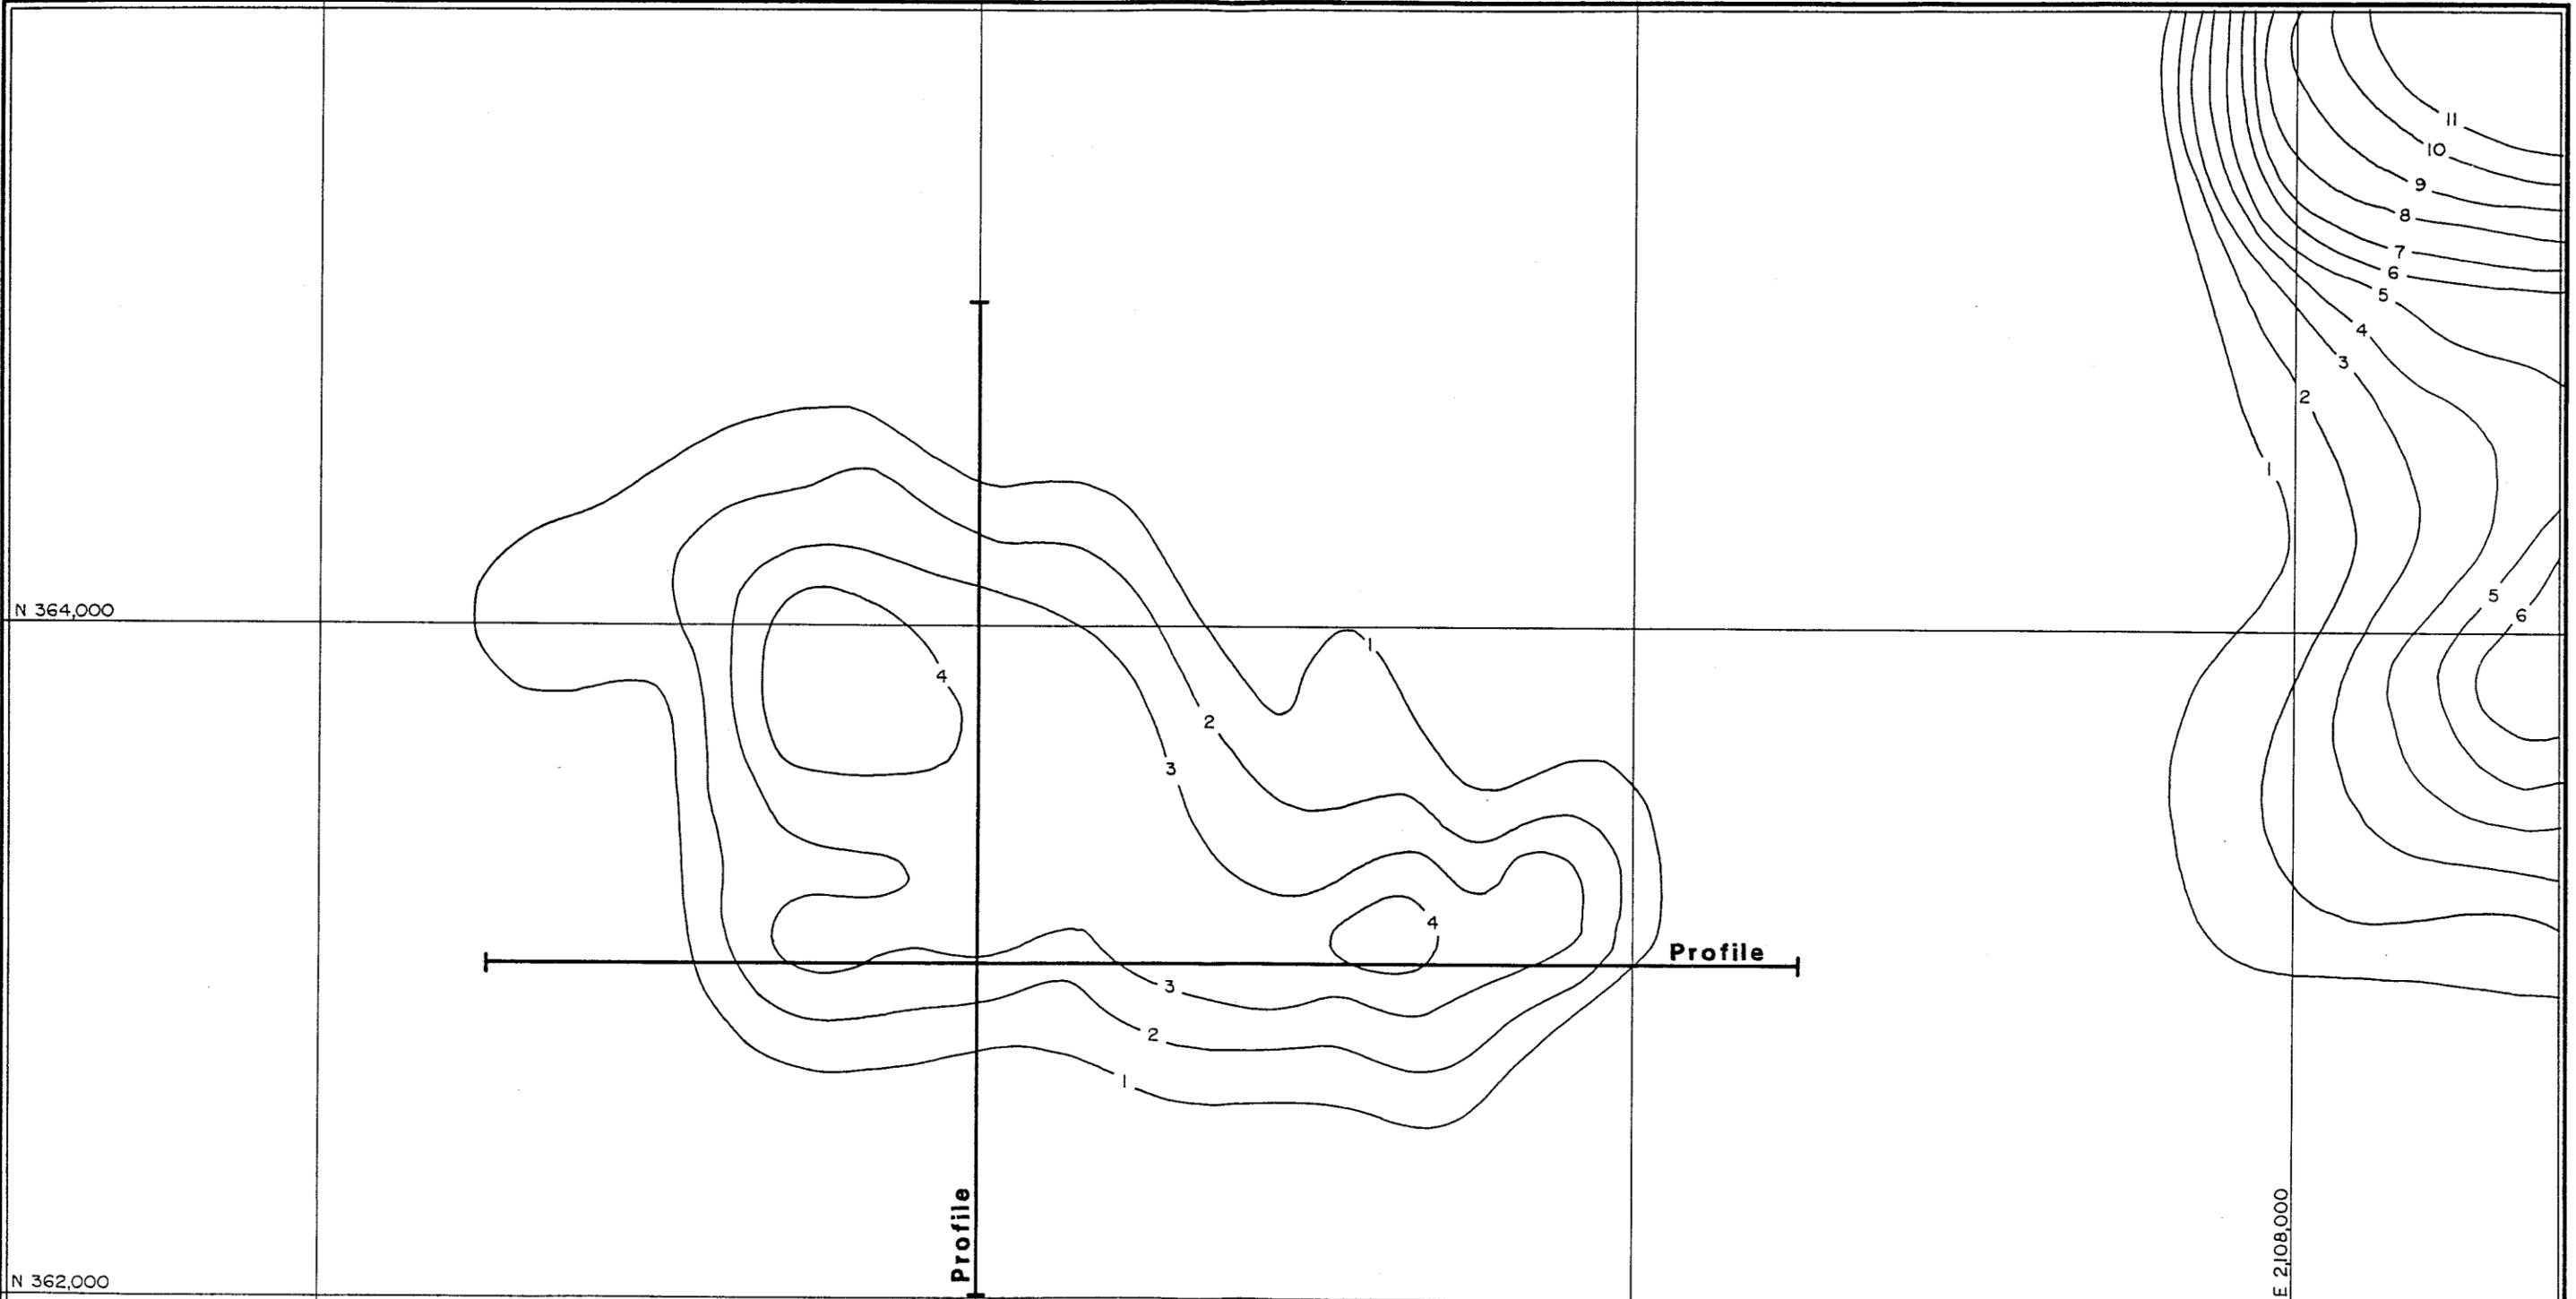
For the third consecutive year the maximum subsidence over the panels is about five (5) feet and occurs over the 3rd and 4th Left longwall panels (Figure 20). Little change has occurred in the area since 1986 (Figures 21 and 22). Since subsidence appears to have stabilized, with DOGM approval readings of subsidence will no longer be performed annually; but the area will be photographed yearly and readings can be made of the photos if deemed necessary. No surface disturbance has been identified over the panels.

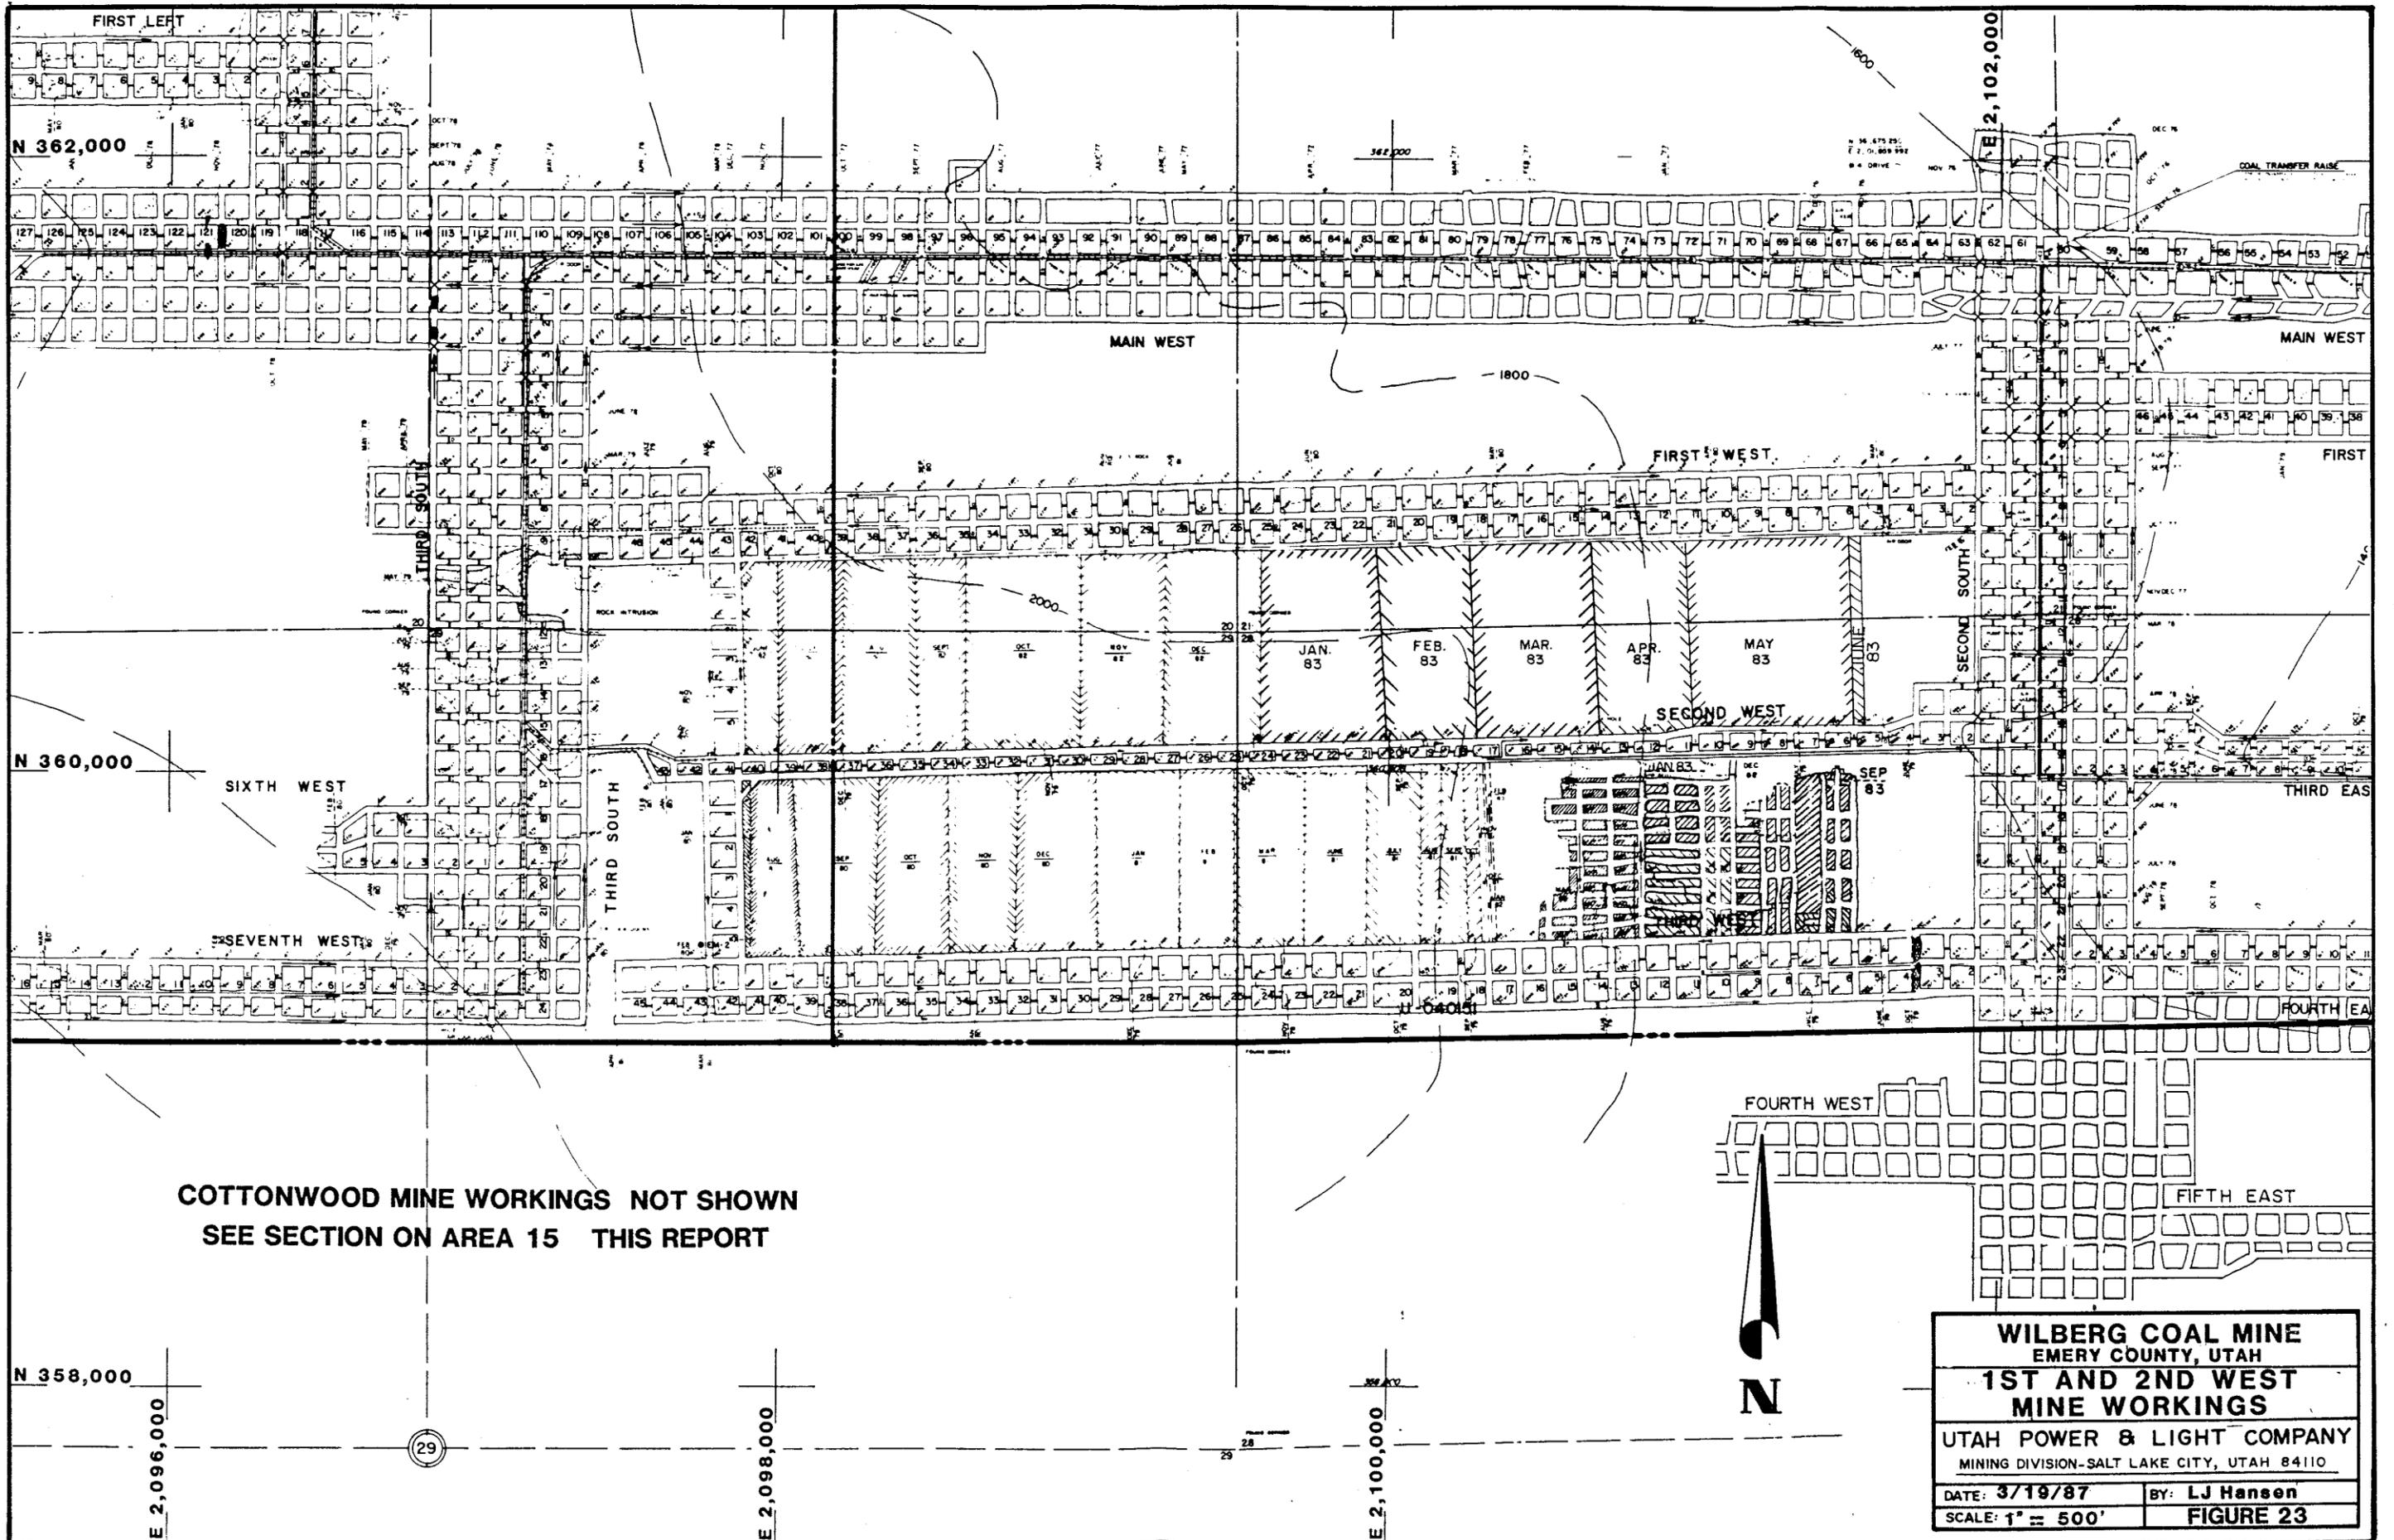
WILBERG COAL MINE EMERY COUNTY, UTAH	
1ST AND 2ND WEST MINE WORKINGS	
UTAH POWER & LIGHT COMPANY MINING DIVISION-SALT LAKE CITY, UTAH 84110	
DATE: 3/19/87	BY: LJ Hansen
SCALE: 1" = 500'	FIGURE 23

Mining in the Wilberg 1st and 2nd West longwall panels was completed in June 1983, and subsidence continued into the 1984 monitoring period (Figure 23). Since late 1984 no significant additional movement has been detected and the area appears to have stabilized with approximately three (3) feet of subsidence (Figure 24). Upon approval, Area 6 will no longer be monitored annually, but aerial photos will be available to measure subsidence for any year when readings were not made. The subsidence profiles (Figures 25 and 26) show some irregularity from year to year, but the variation is within the margin of error in the photogrammetric method (± 0.7 feet).

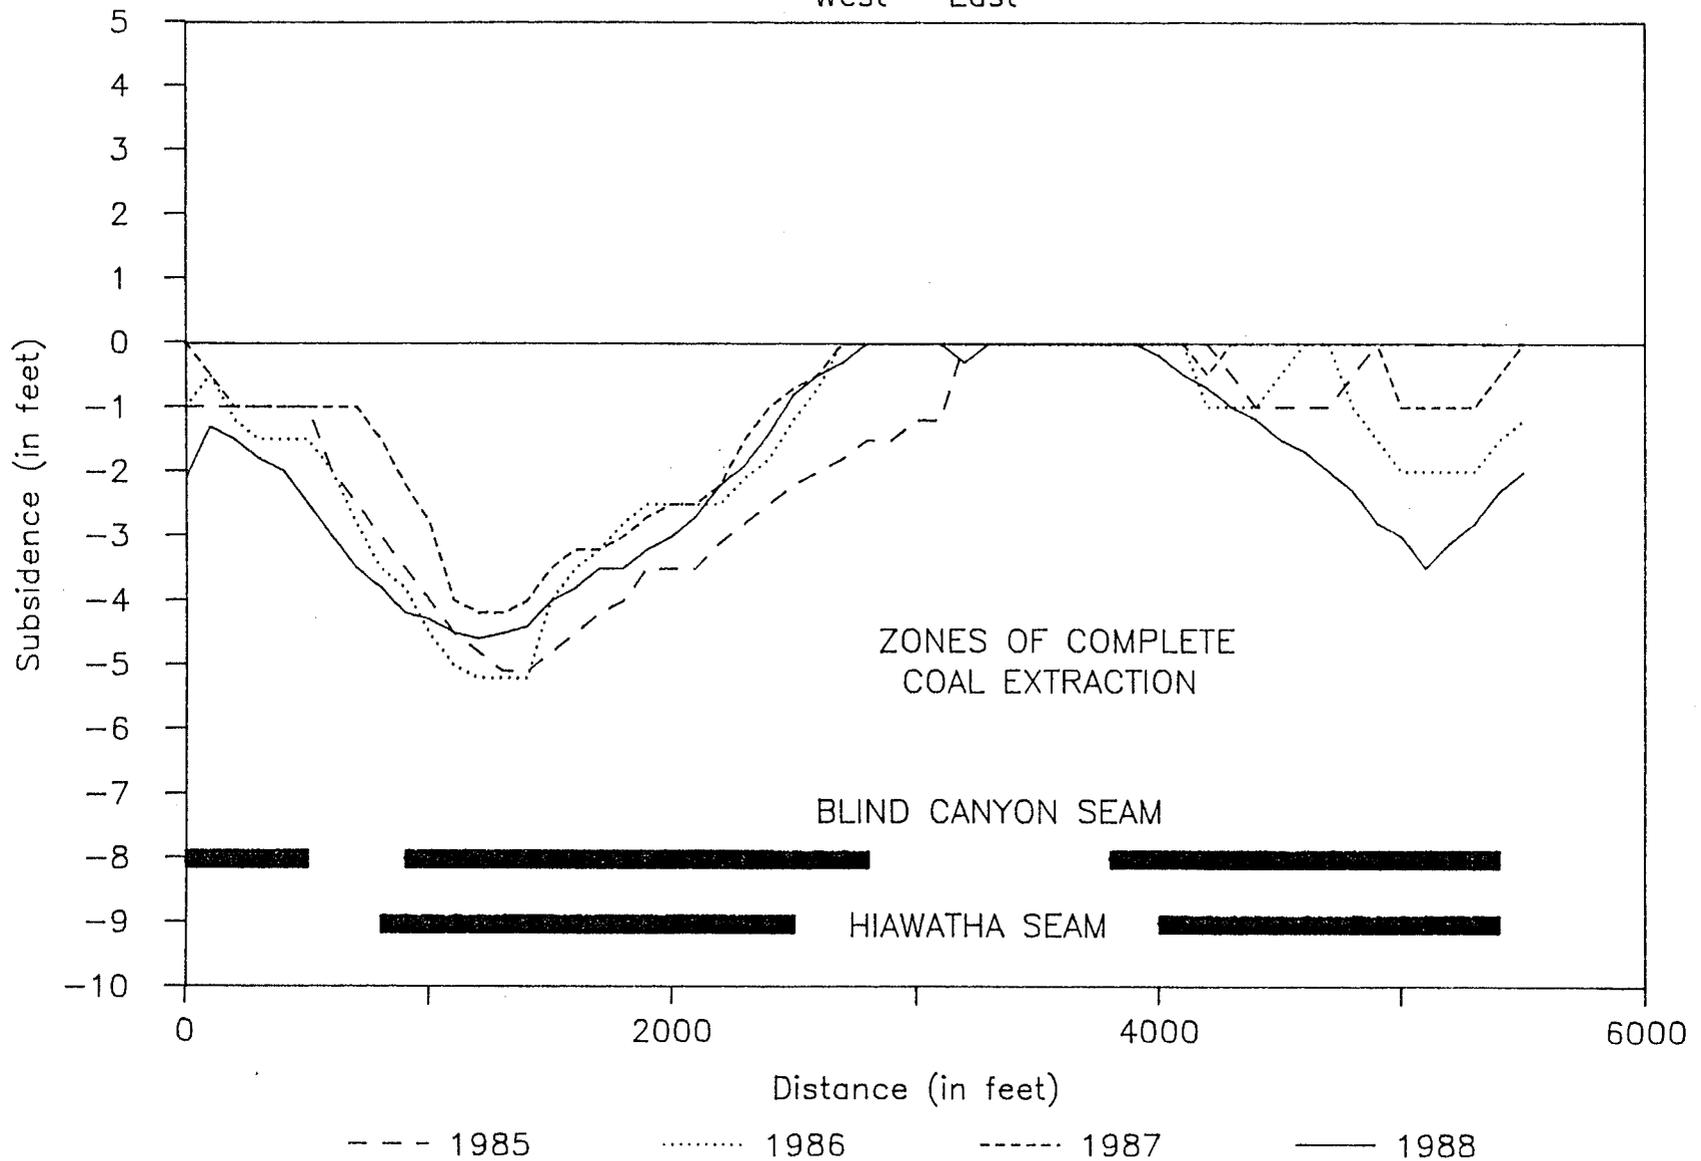
FIGURE 32

Some of the subsidence in Area 8 may have gone undetected because pillar extraction, and presumably subsidence, in part of the area was completed before the establishment of baseline survey data (Figures 30 and 31). The west to east subsidence profile of the area depicted in Figure 32 indicates it had reached a stable state, at near 4.5 feet of subsidence, by 1986. With DOGM approval, annual monitoring will no longer be performed in the area, but aerial photographs will continue to be taken and periodic checks of the photos will be made. The 1986 Subsidence Monitoring Report gives the most recent detailed discussion of ground movement in Area 8.

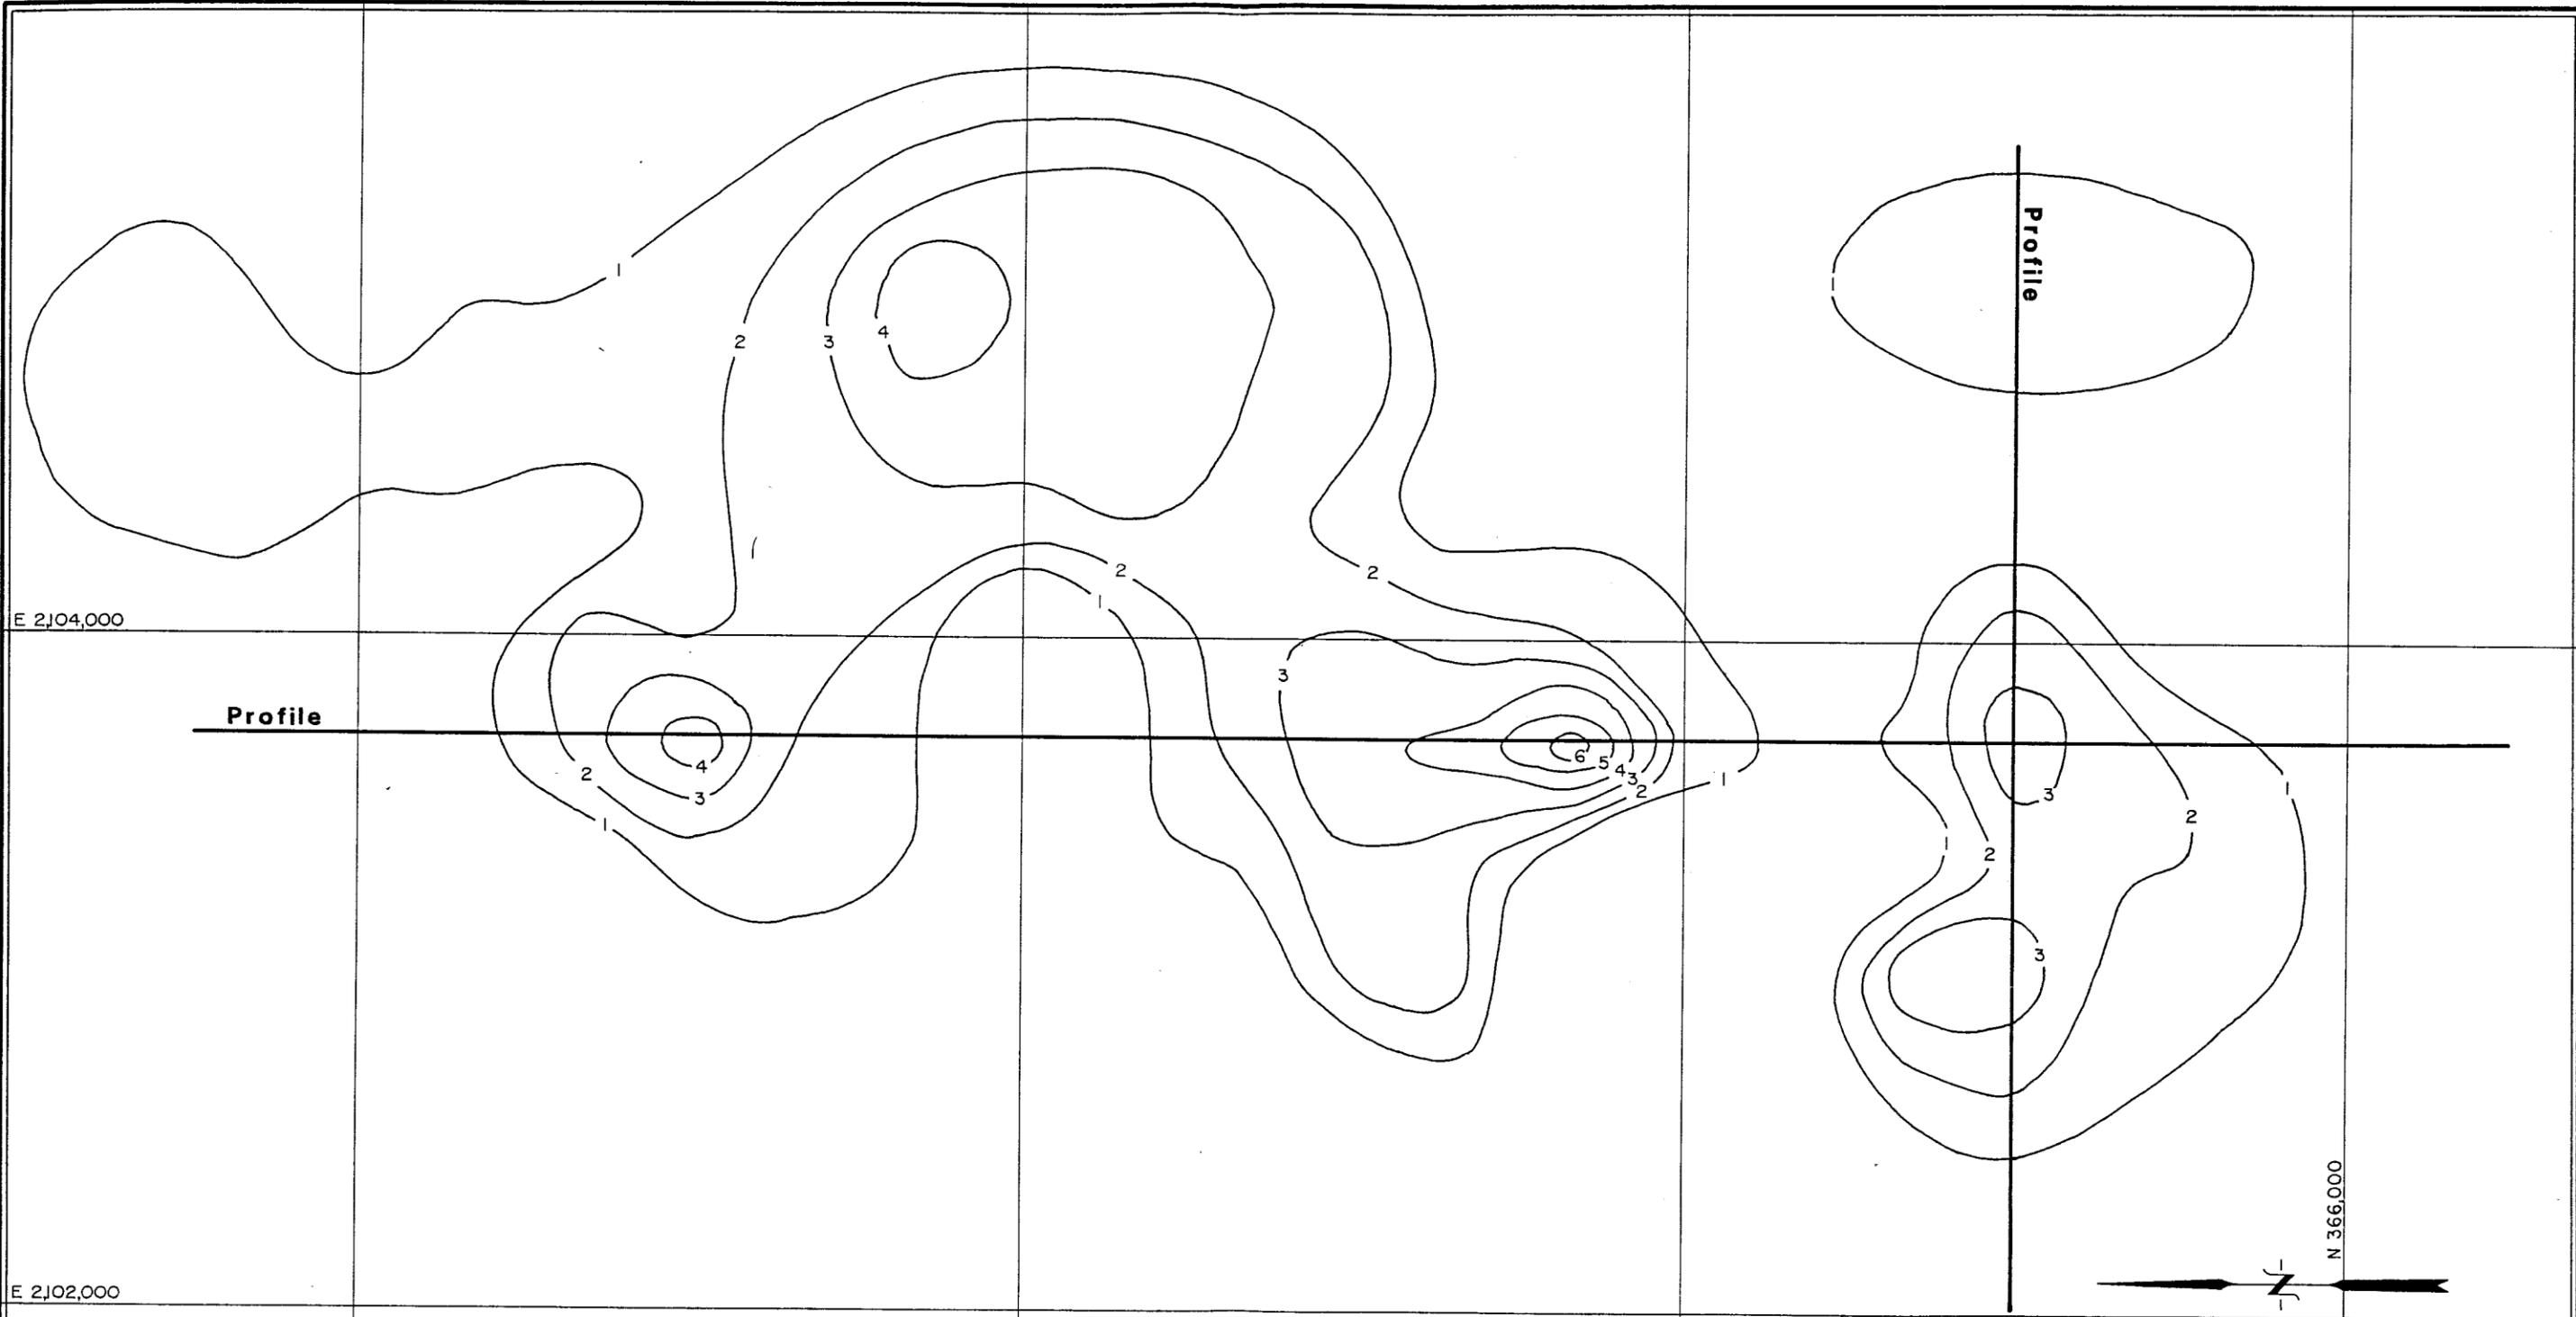
DEER CREEK COAL MINE		
EMERY COUNTY, UTAH		
1988 SUBSIDENCE		
C & D NORTH LONGWALL PANELS		
AND ADJACENT SECTIONS		
UTAH POWER & LIGHT COMPANY		
MINING DIVISION		
DRAWN BY: K. LARSEN	CHECKED BY:	DATE: MAR. 3, 1989
Scale	Sheet No.	Drawing Number
1" = 500'		FIGURE 35

Longwall mining in the C North panel began in December 1984 and was terminated in April 1986 due to geologic complications. New setup entries were driven further south and mining resumed in September 1986; the panel was completed in March 1987. The D North longwall panel began production in July 1987, but after October 1987 production was limited due to poor coal quality. The panel was terminated in August 1988 at a length of 1750 feet. Pillar extraction mining in A North and A South was completed in June 1983 (Figure 34). Measurable subsidence to date has reached six (6) feet over C North and a little more than four (4) feet over the room-and-pillar sections (Figures 35, 36, and 37).
