UTAH POWER & LIGHT COMPANY
SUBSIDENCE MONITORING PROGRAM
ANNUAL REPORT FOR 1988

March 1989

United States Department of the Interior
Office of Surface Mining
Minerals Management Service
Utah Division of Oil, Gas and Mining

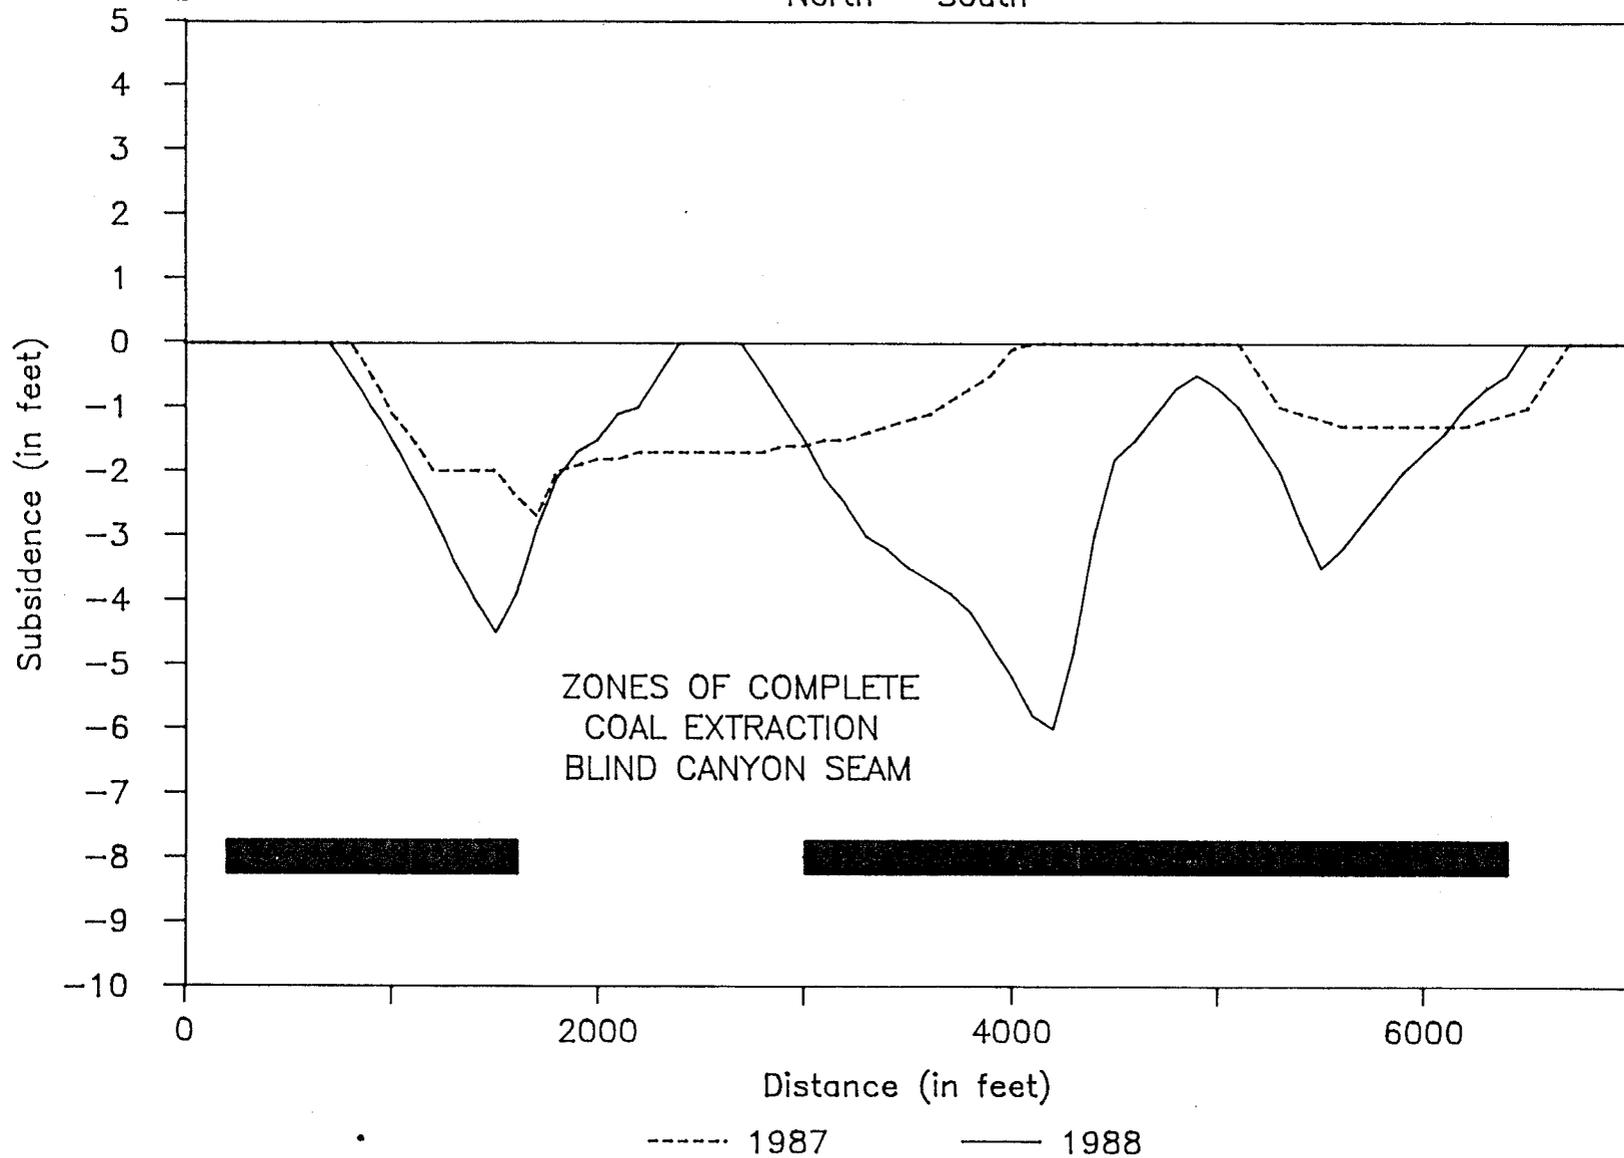
FIGURE 36

Longwall mining in the C North panel began in December 1984 and was terminated in April 1986 due to geologic complications. New setup entries were driven further south and mining resumed in September 1986; the panel was completed in March 1987. The D North longwall panel began production in July 1987, but after October 1987 production was limited due to poor coal quality. The panel was terminated in August 1988 at a length of 1750 feet. Pillar extraction mining in A North and A South was completed in June 1983 (Figure 34). Measurable subsidence to date has reached six (6) feet over C North and a little more than four (4) feet over the room-and-pillar sections (Figures 35, 36, and 37).

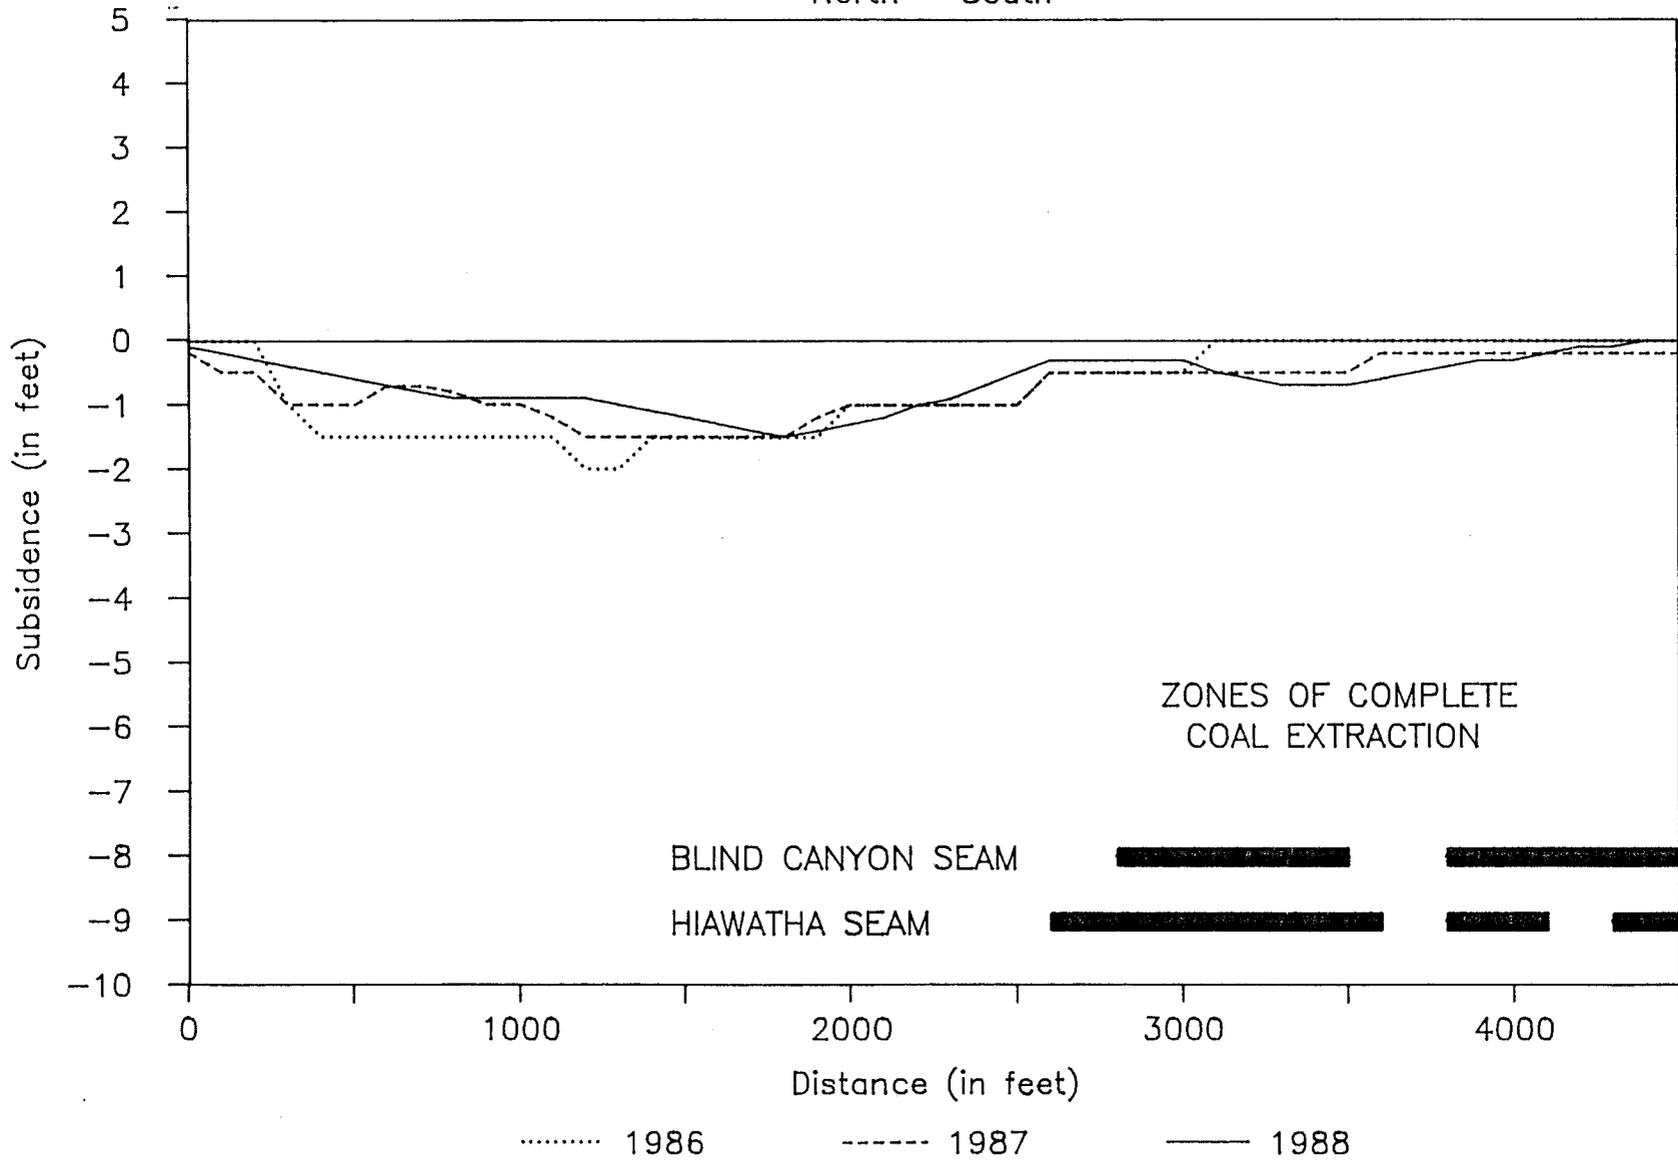
FIGURE 40

Maximum subsidence over the area as of August 1988 was about two (2) feet (Figures 40 and 41).

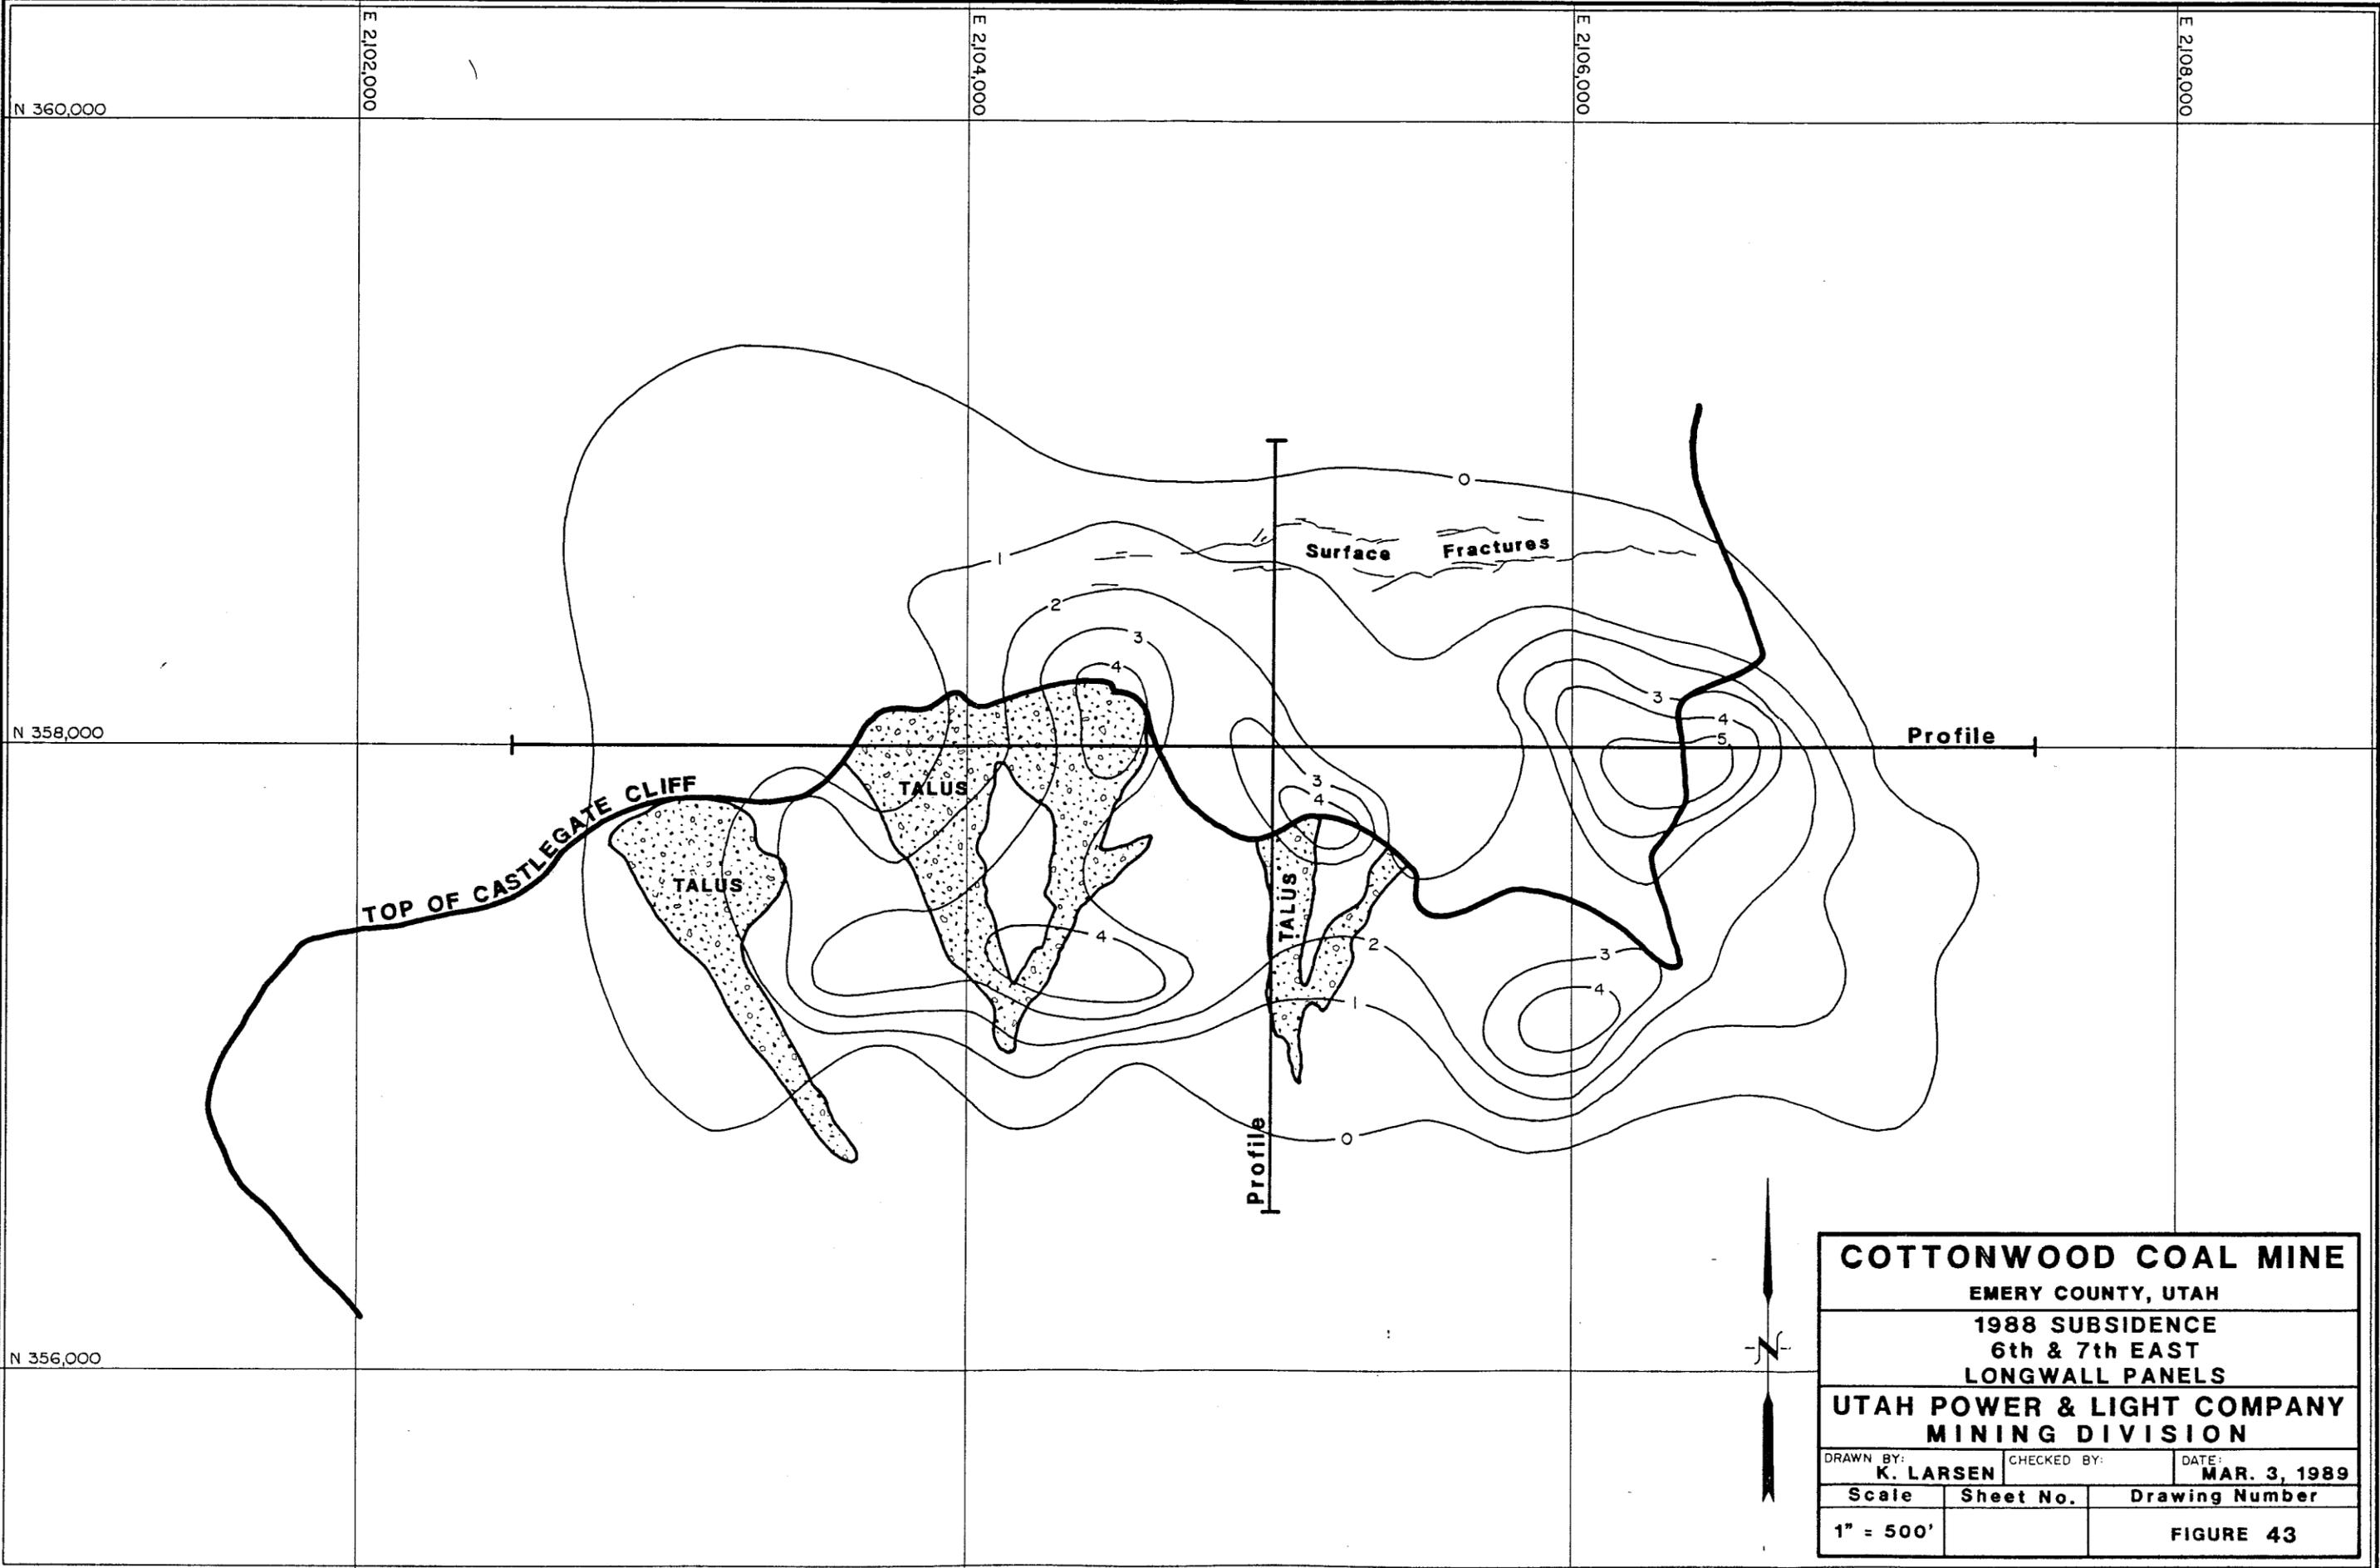
COTTONWOOD COAL MINE		
EMERY COUNTY, UTAH		
1988 SUBSIDENCE		
6th & 7th EAST		
LONGWALL PANELS		
UTAH POWER & LIGHT COMPANY		
MINING DIVISION		
DRAWN BY: K. LARSEN	CHECKED BY:	DATE: MAR. 3, 1989
Scale	Sheet No.	Drawing Number
1" = 500'		FIGURE 43

The Castlegate Sandstone forms a 200-foot high escarpment along the north side of Newberry Canyon with numerous naturally occurring joints and fractures. Stress caused by removal of coal was transferred to the fractures resulting in brittle failure of the cliff face (spalling) in some places. Talus from the spalling has accumulated on the steep slopes below the cliffs on older natural talus slopes. The newer debris remains mostly above the coal outcrop level and reaches the canyon floor in only one location. Surface cracks have been observed and mapped along the ridge above the cliff. The cracks are discontinuous and extend for approximately 2000 feet parallel to the northern edge of the 6th East longwall panel. A few cracks are also found directly on top of the Castlegate Sandstone escarpment.

Maximum subsidence to date is over five (5) feet, occurring over the eastern end of the 6th East panel (Figure 43).

Mitigation of effects due to mining may be required in Area 14. A detailed assessment is given in the Newberry Canyon report. Briefly, mitigation may include 1) backfilling, recontouring, and revegetating surface cracks, where accessible; 2) creating artificial eagle nesting sites; and 3) improvement of habitat for existing species or developing habitat for another desirable species.

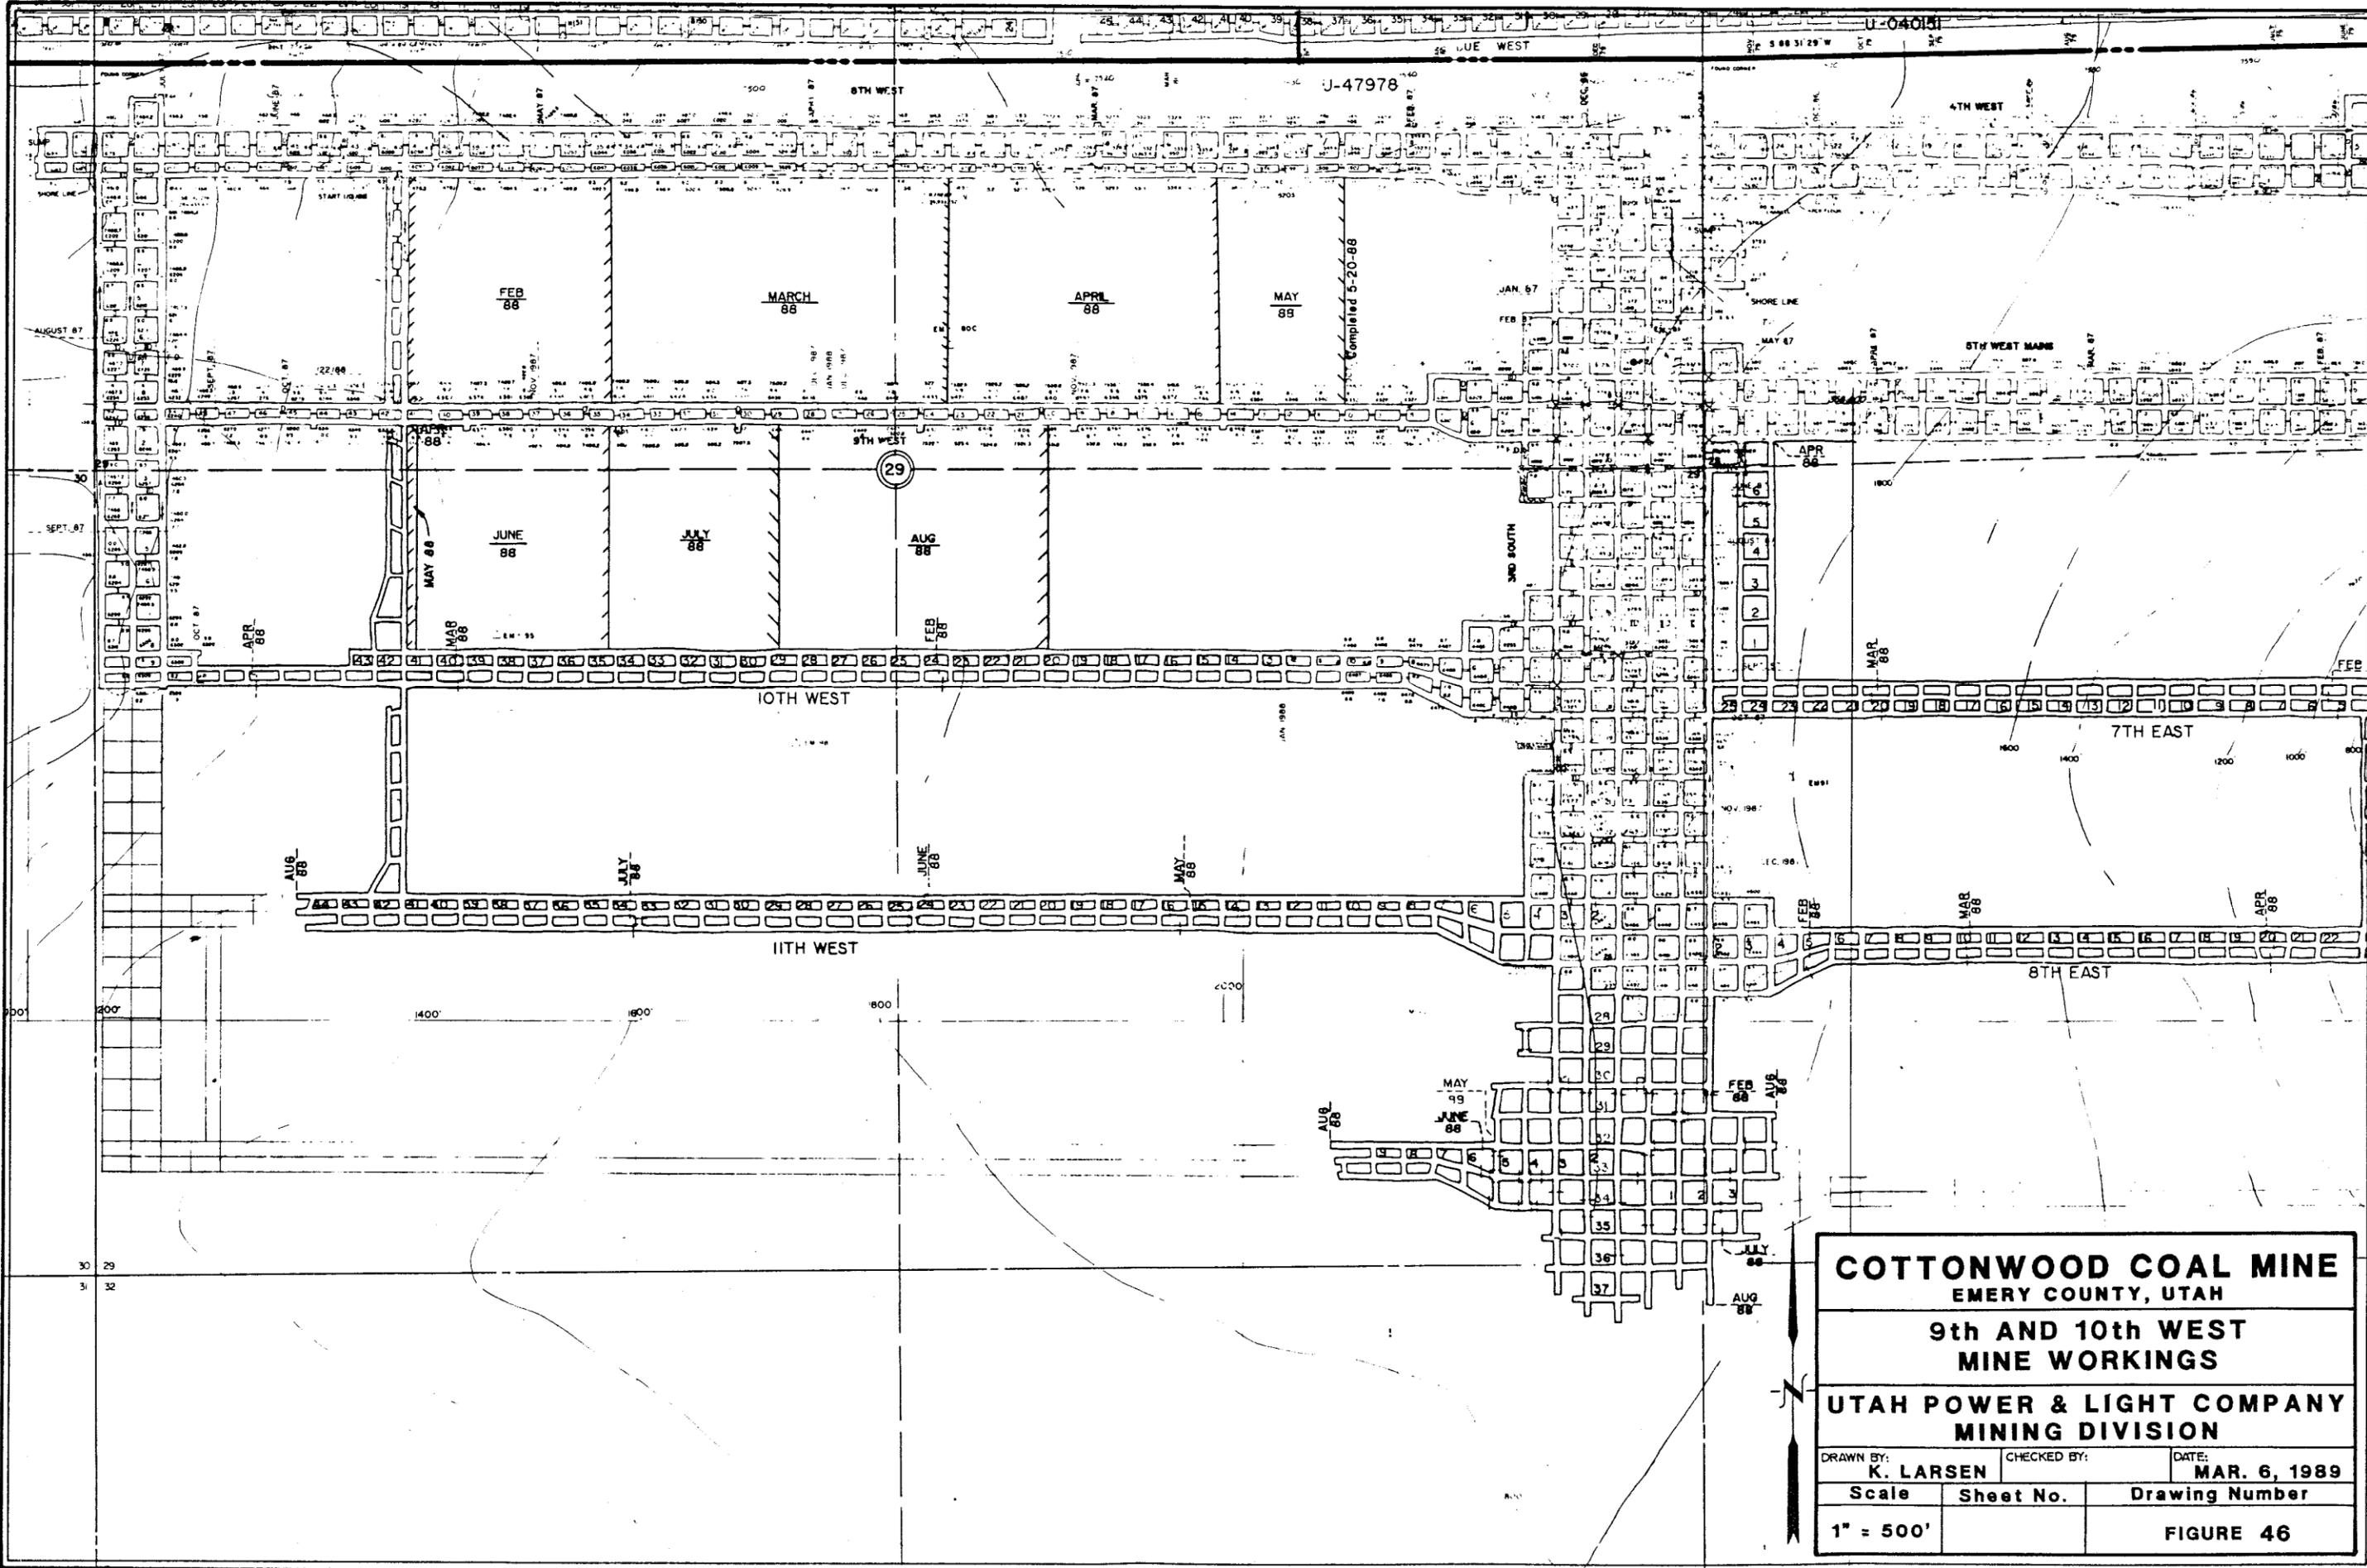
COTTONWOOD COAL MINE		
EMERY COUNTY, UTAH		
9th AND 10th WEST		
MINE WORKINGS		
UTAH POWER & LIGHT COMPANY		
MINING DIVISION		
DRAWN BY:	CHECKED BY:	DATE:
K. LARSEN		MAR. 6, 1989
Scale	Sheet No.	Drawing Number
1" = 500'		FIGURE 46

Subsidence in 9th and 10th West was first monitored and detected in 1988 since longwall extraction there began during this monitoring period. Between February and August 1988 the entire 9th West panel and 2530 feet of the 10th West panel were extracted (Figure 46).
