**CENTRAL ENGINEERING
ANNUAL SUBSIDENCE MONITORING REPORT
EAST MOUNTAIN PROPERTY
1990**

**PACIFICORP - FUEL RESOURCES
SUBSIDENCE MONITORING PROGRAM
ANNUAL REPORT FOR 1990**

**United States Department of the Interior
Office of Surface Mining
Minerals Management Service
Utah Division of Oil, Gas and Mining**

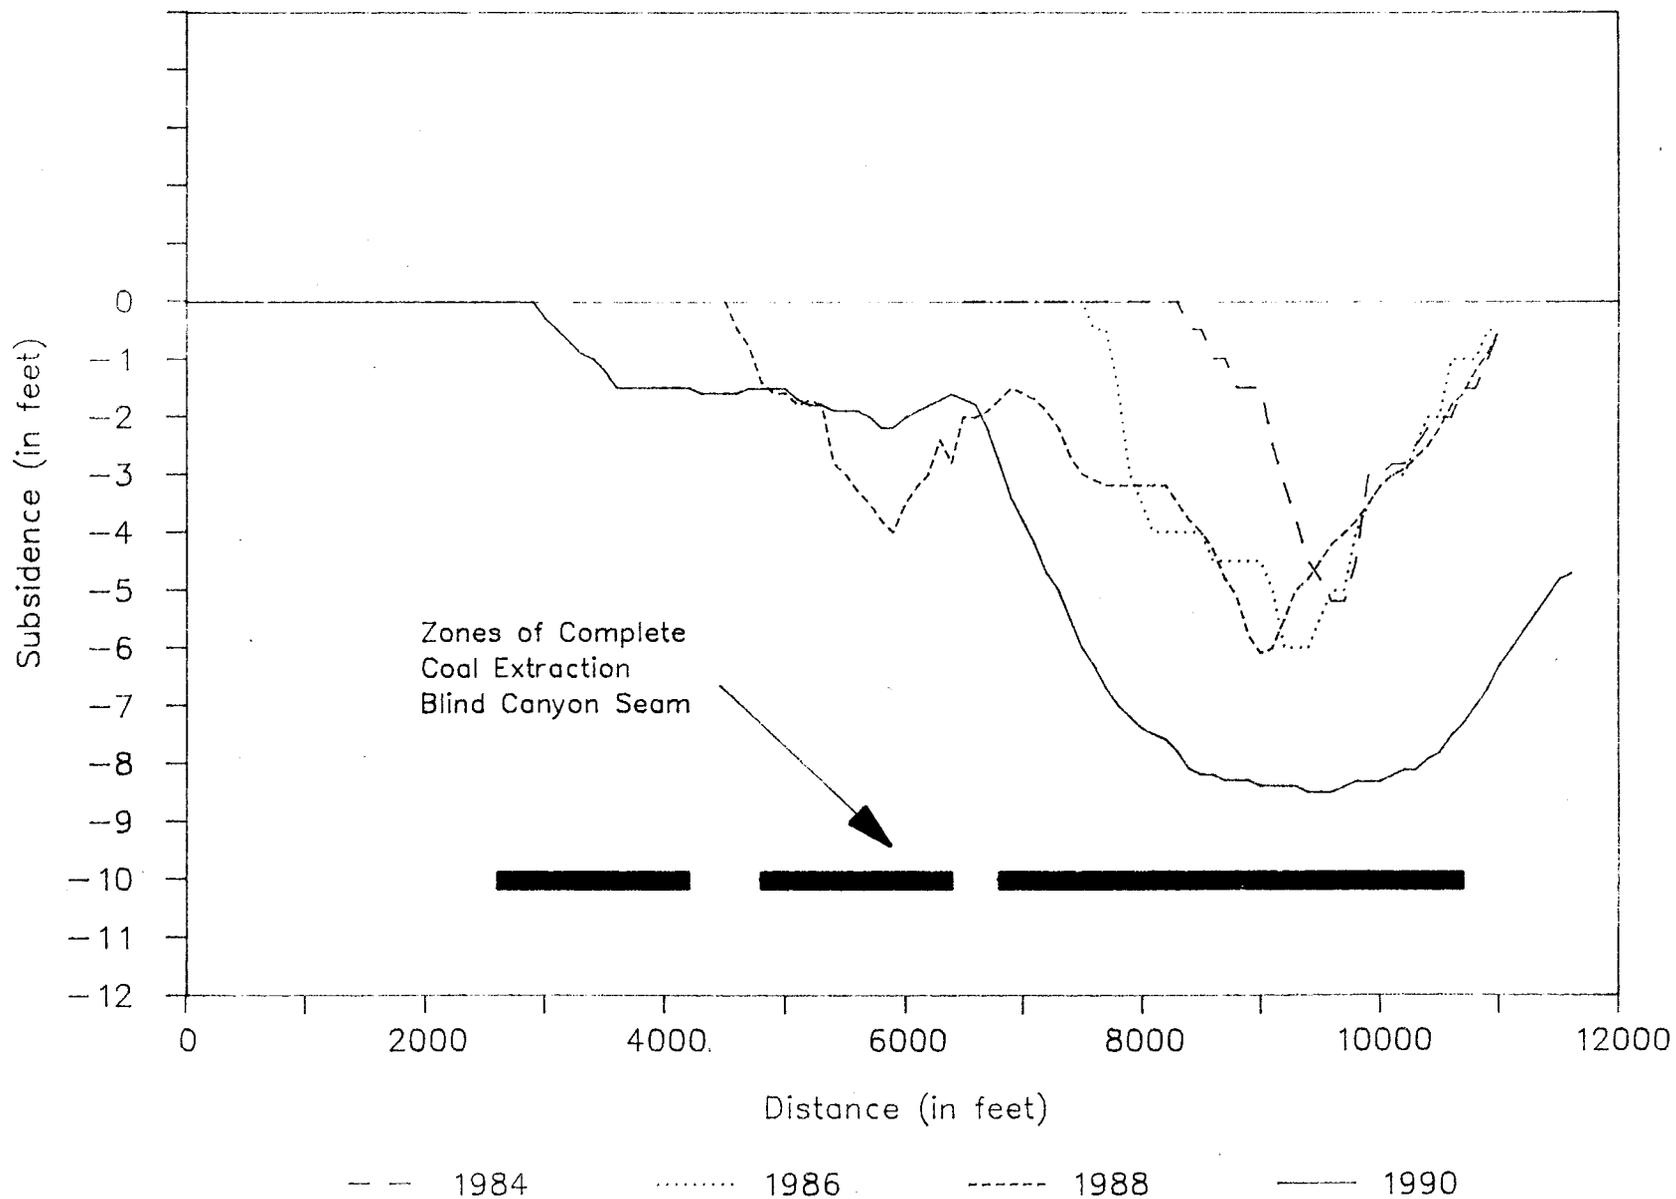
FIGURE 17

Maximum subsidence is just over nine (9) feet over the 1st Right longwall panel (Figure 16). The subsidence trough continues to extend northward over the most recently mined longwall panels (see Subsidence Profiles, Figures 17 and 18). The calculated angle-of-draw of the subsidence ranges from less than zero to 11 degrees.

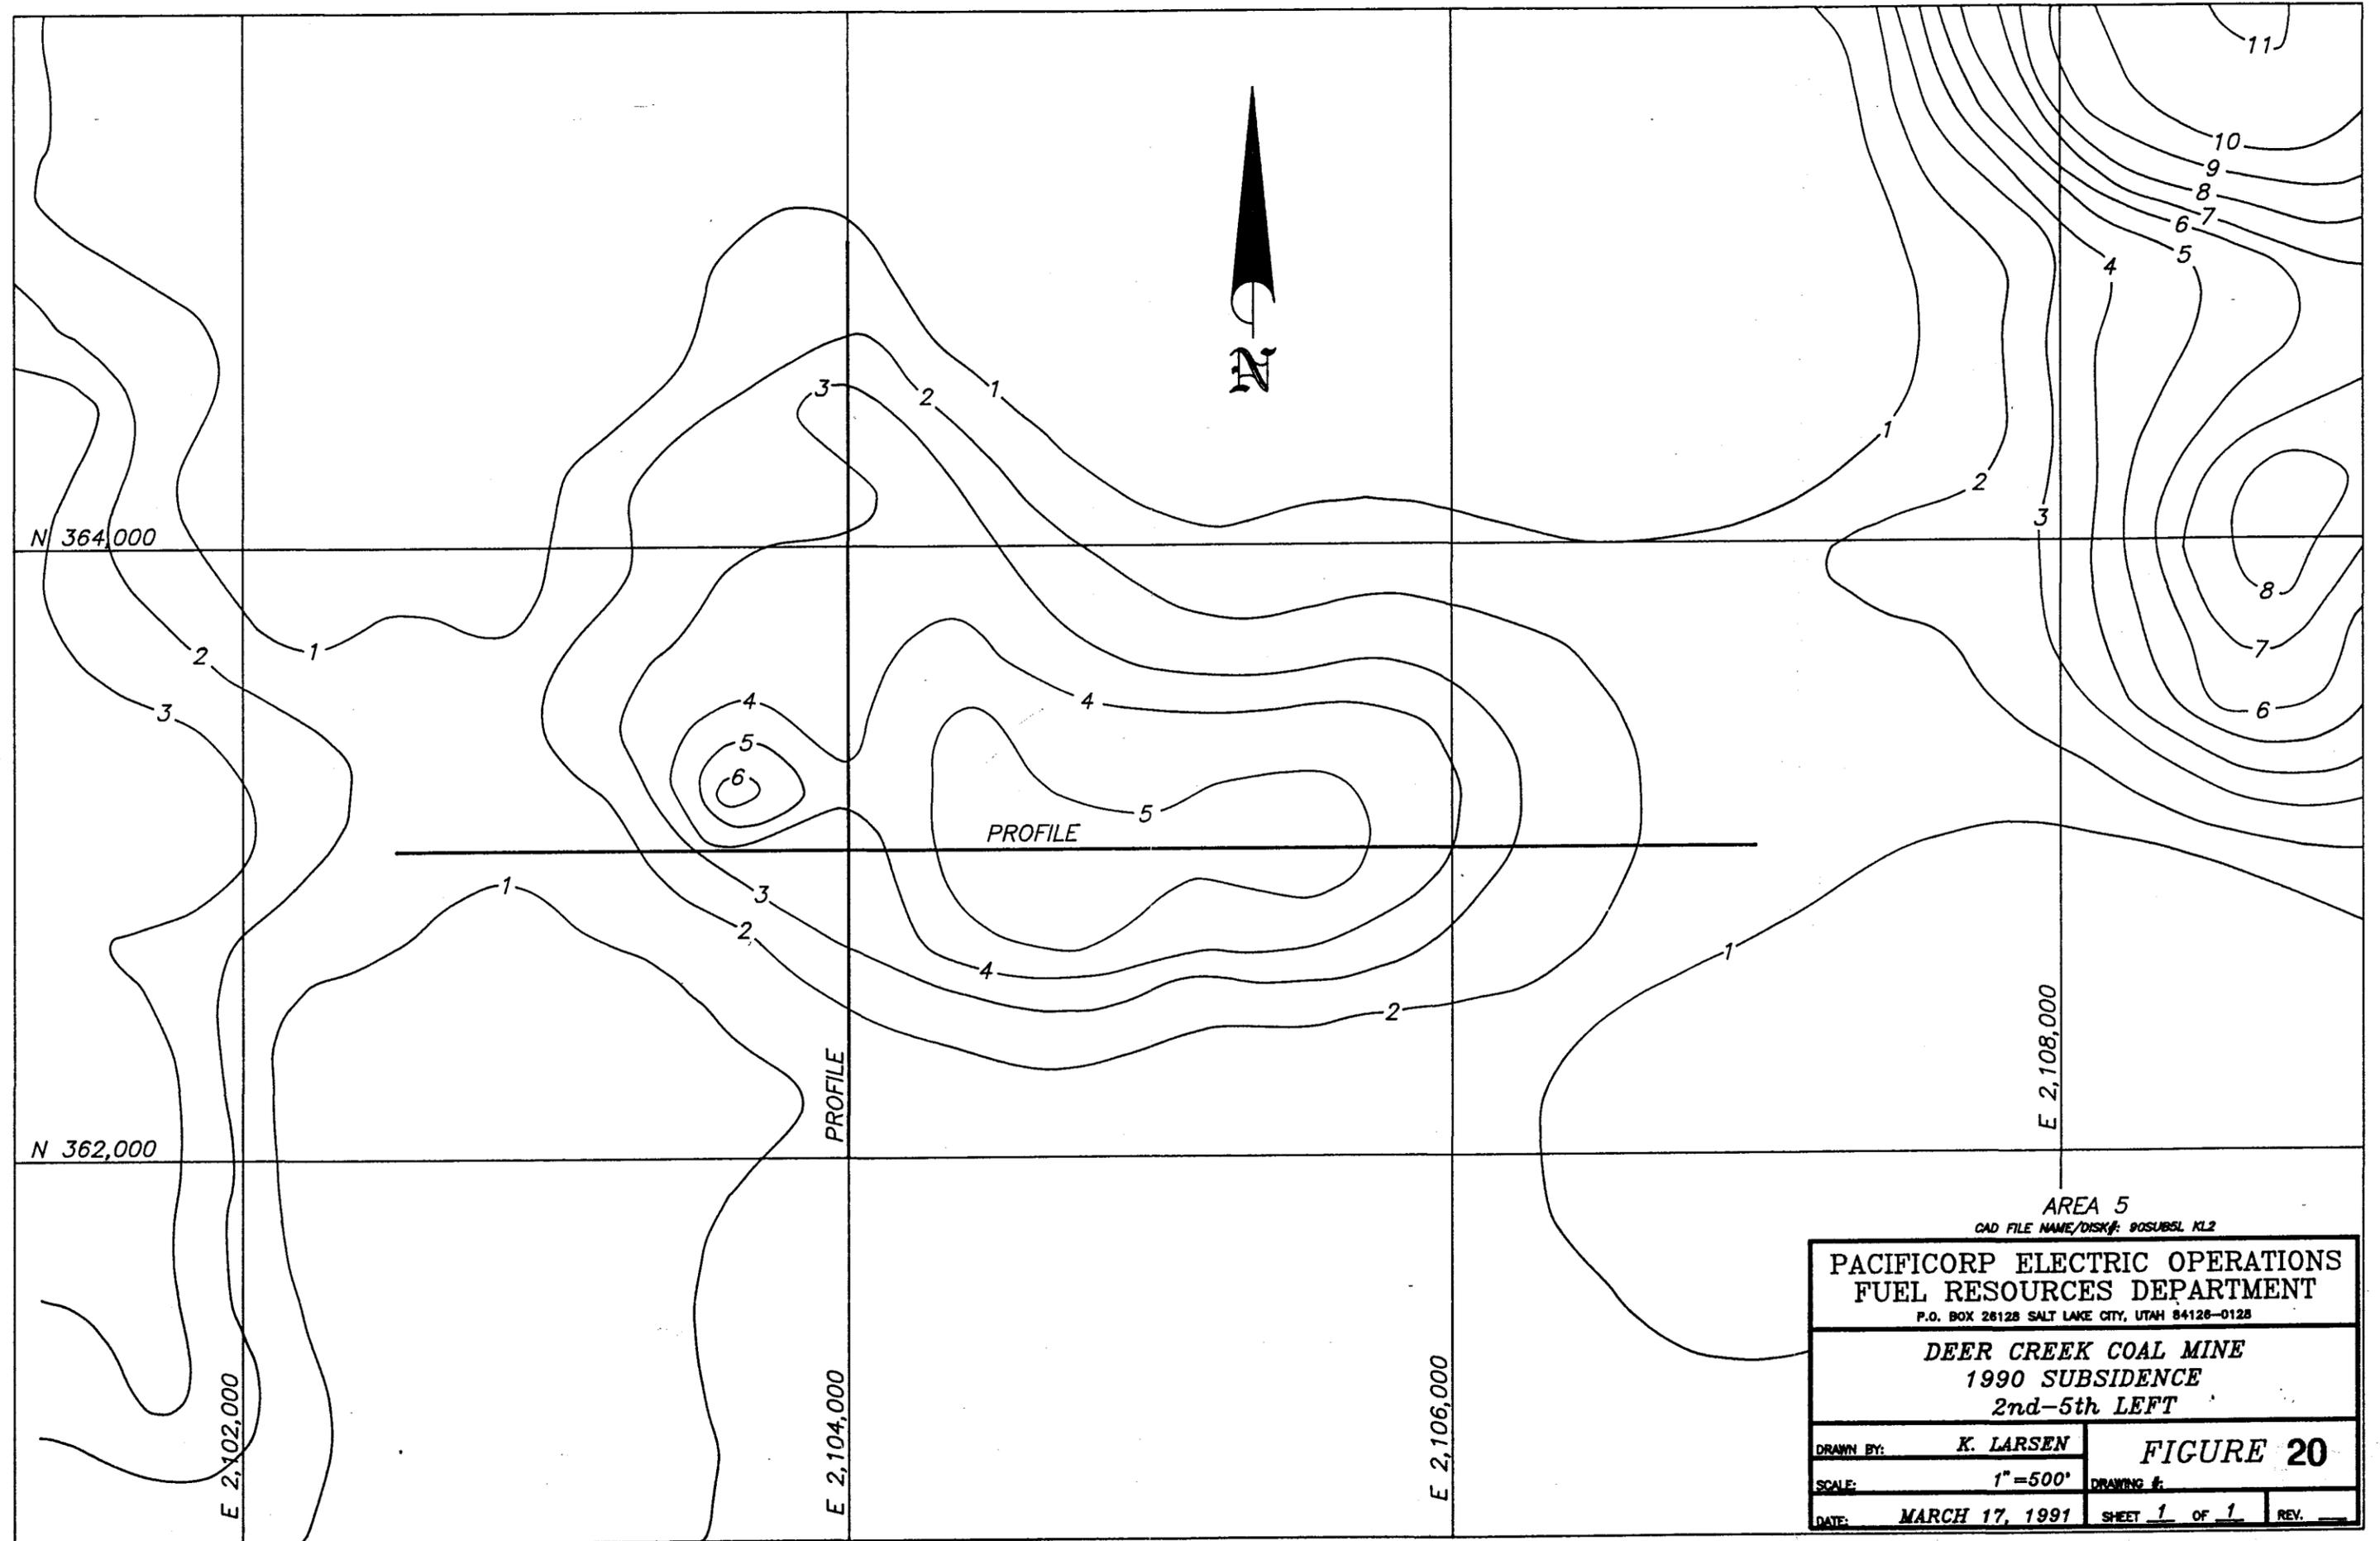
PACIFICORP ELECTRIC OPERATIONS FUEL RESOURCES DEPARTMENT <small>P.O. BOX 28128 SALT LAKE CITY, UTAH 84128-0128</small>	
DEER CREEK COAL MINE 1990 SUBSIDENCE 2nd-5th LEFT	
DRAWN BY: K. LARSEN	FIGURE 20
SCALE: 1"=500'	DRAWING #.
DATE: MARCH 17, 1991	SHEET 1 OF 1 REV.

Maximum subsidence over the panels is about six (6) feet and occurs over the 3rd and 4th Left longwall panels (Figure 20). Little change has occurred in the area since 1986 (Figures 21 and 22). No surface disturbance has been identified over the panels.

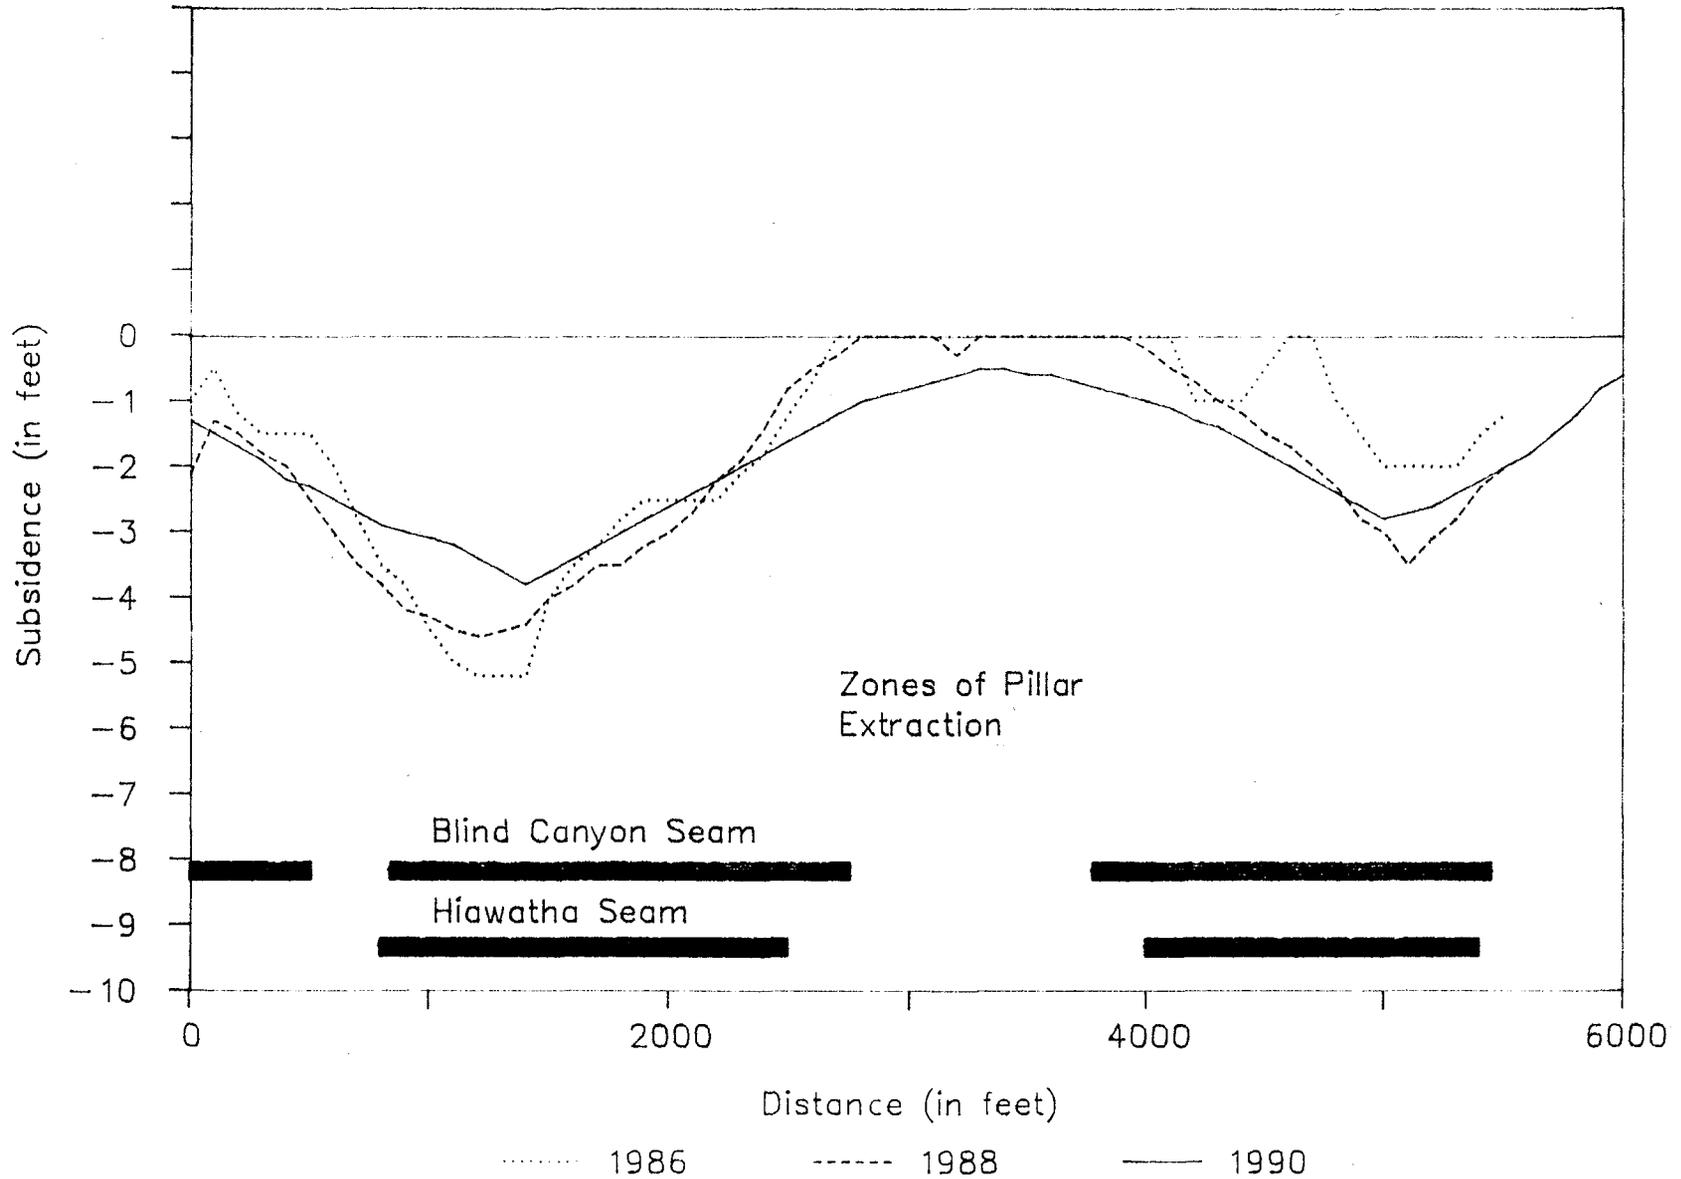
FIGURE 33

Some of the subsidence in Area 8 may have gone undetected because pillar extraction, and presumably subsidence, in part of the area was completed before the establishment of baseline survey data (Figures 30, 31, and 32). The west to east subsidence profile of the area depicted in Figure 33 indicates it had reached a stable state, at near four feet of subsidence, over the western sections by 1986. On the eastern side subsidence has remained at about three feet for the last two years. Where not influenced by other workings, angle-of-draw reached a maximum of 31 degrees on the eastern edge of the area.

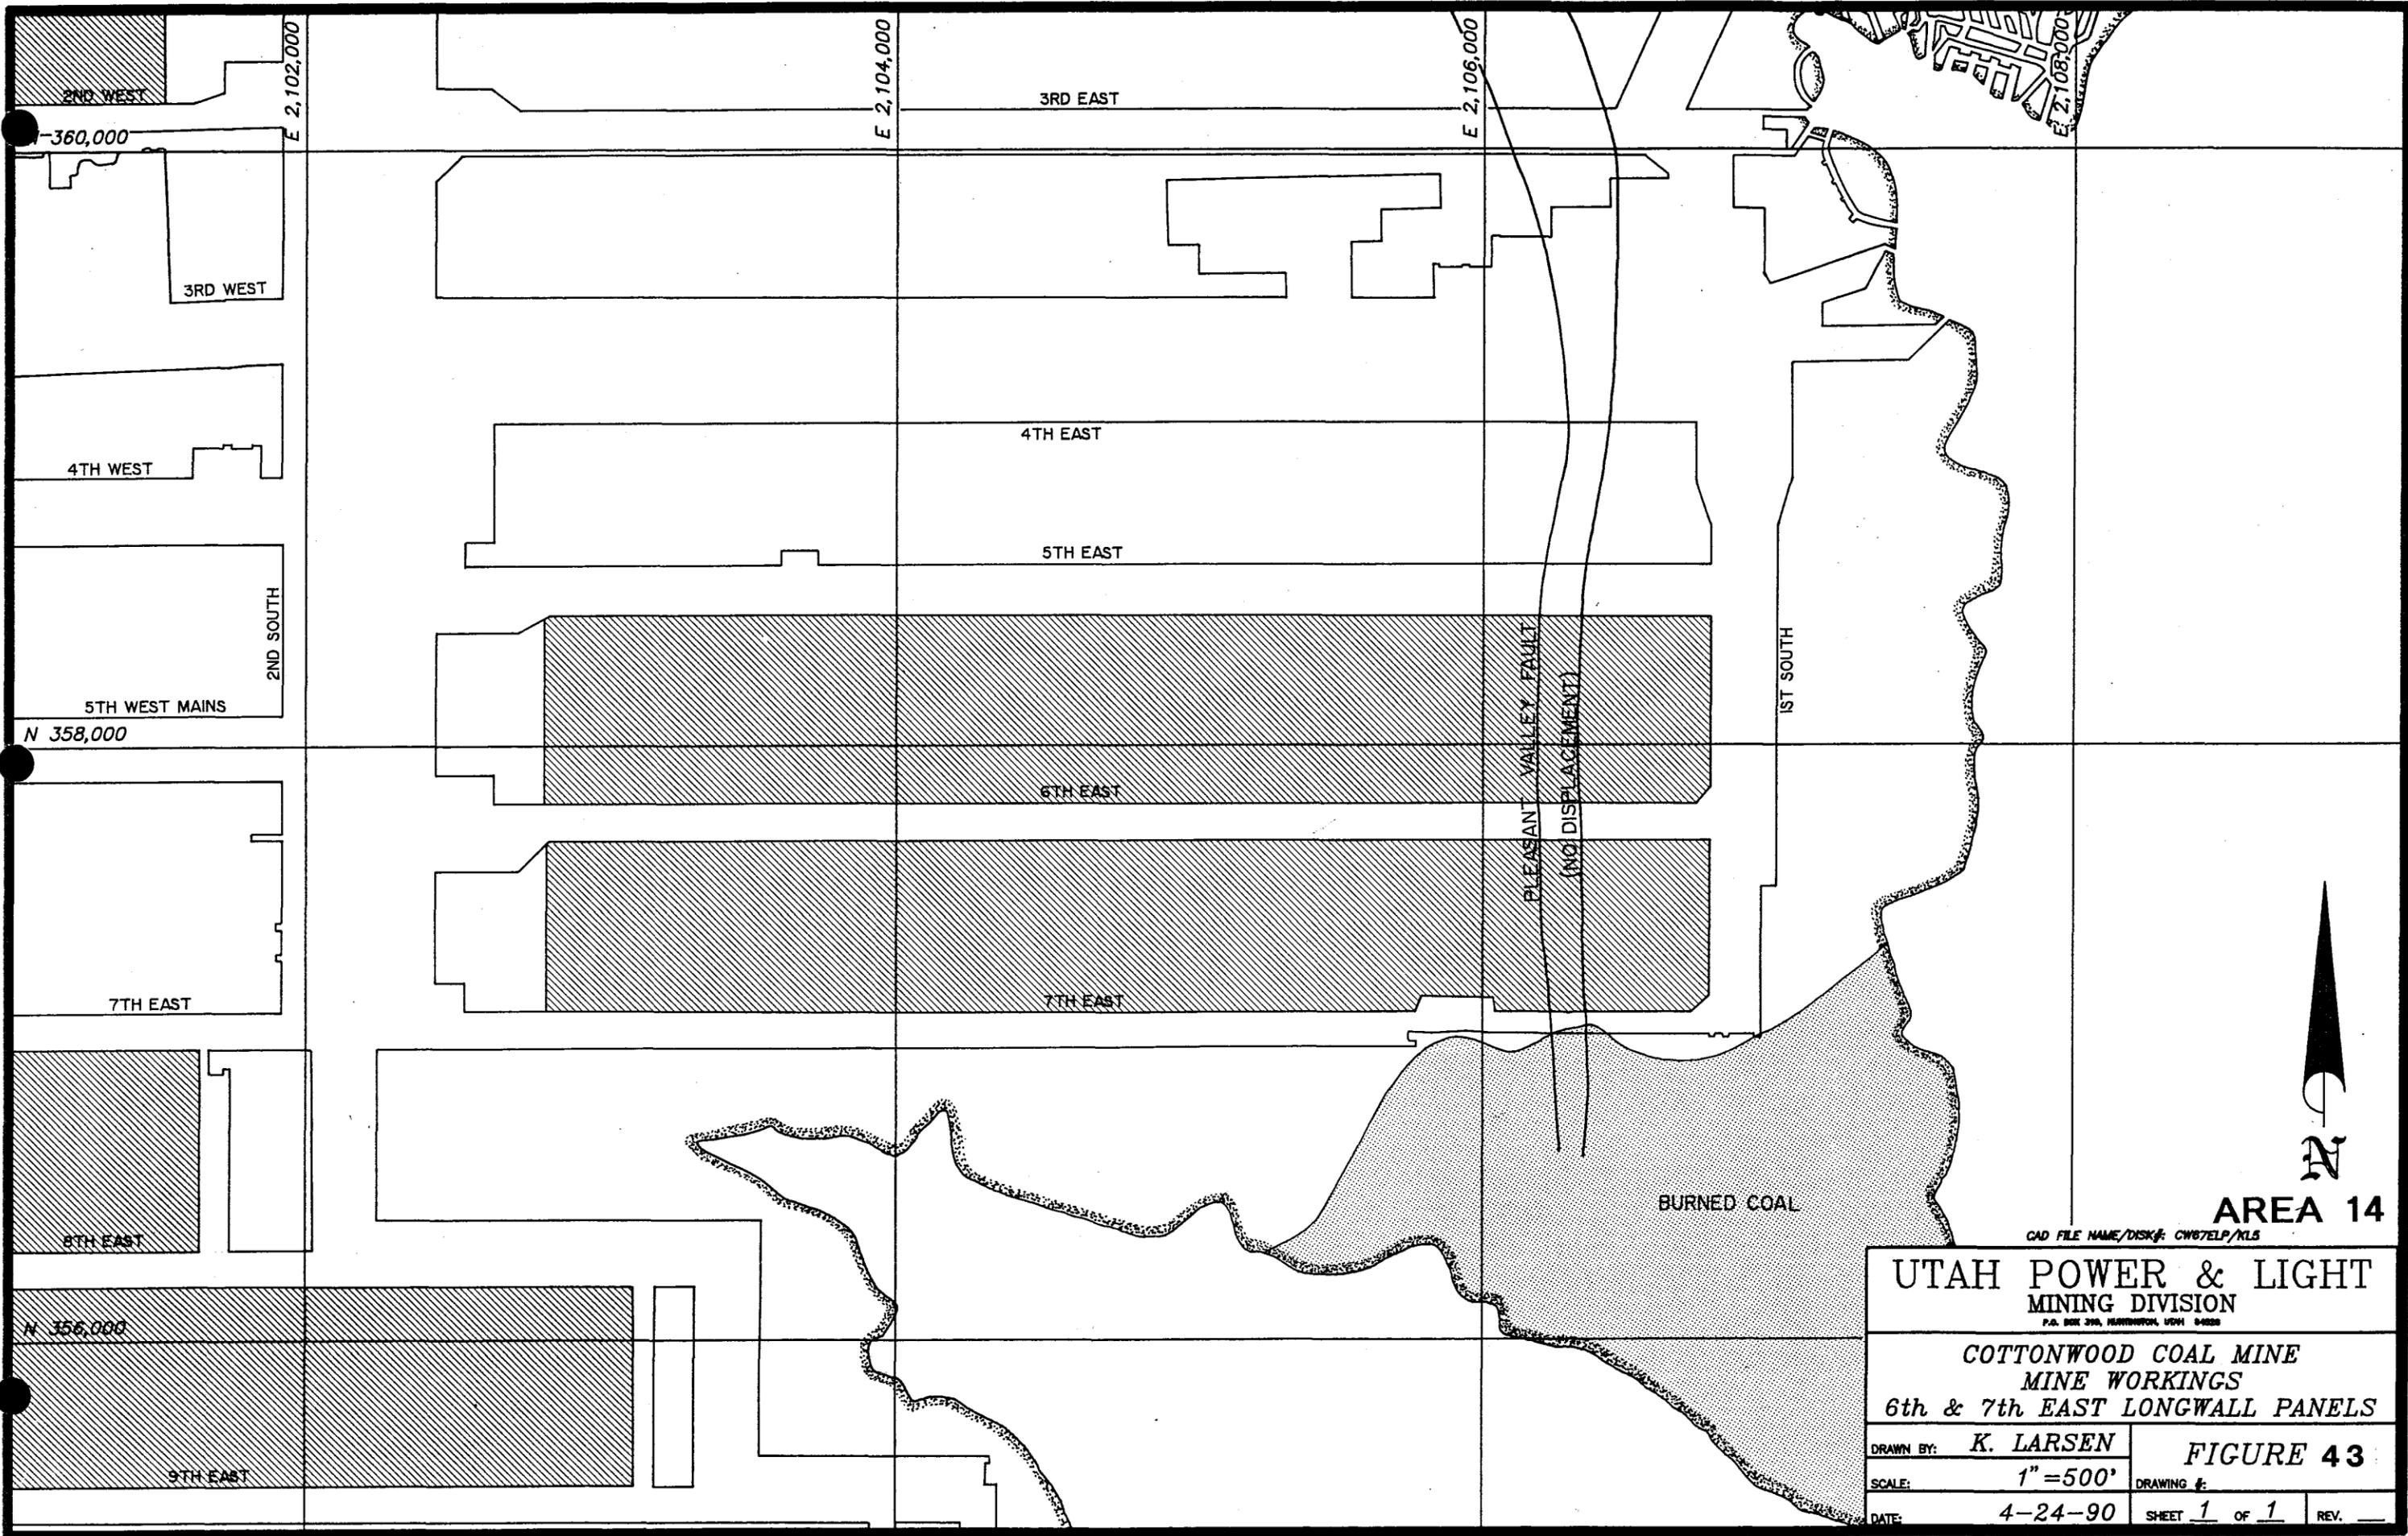
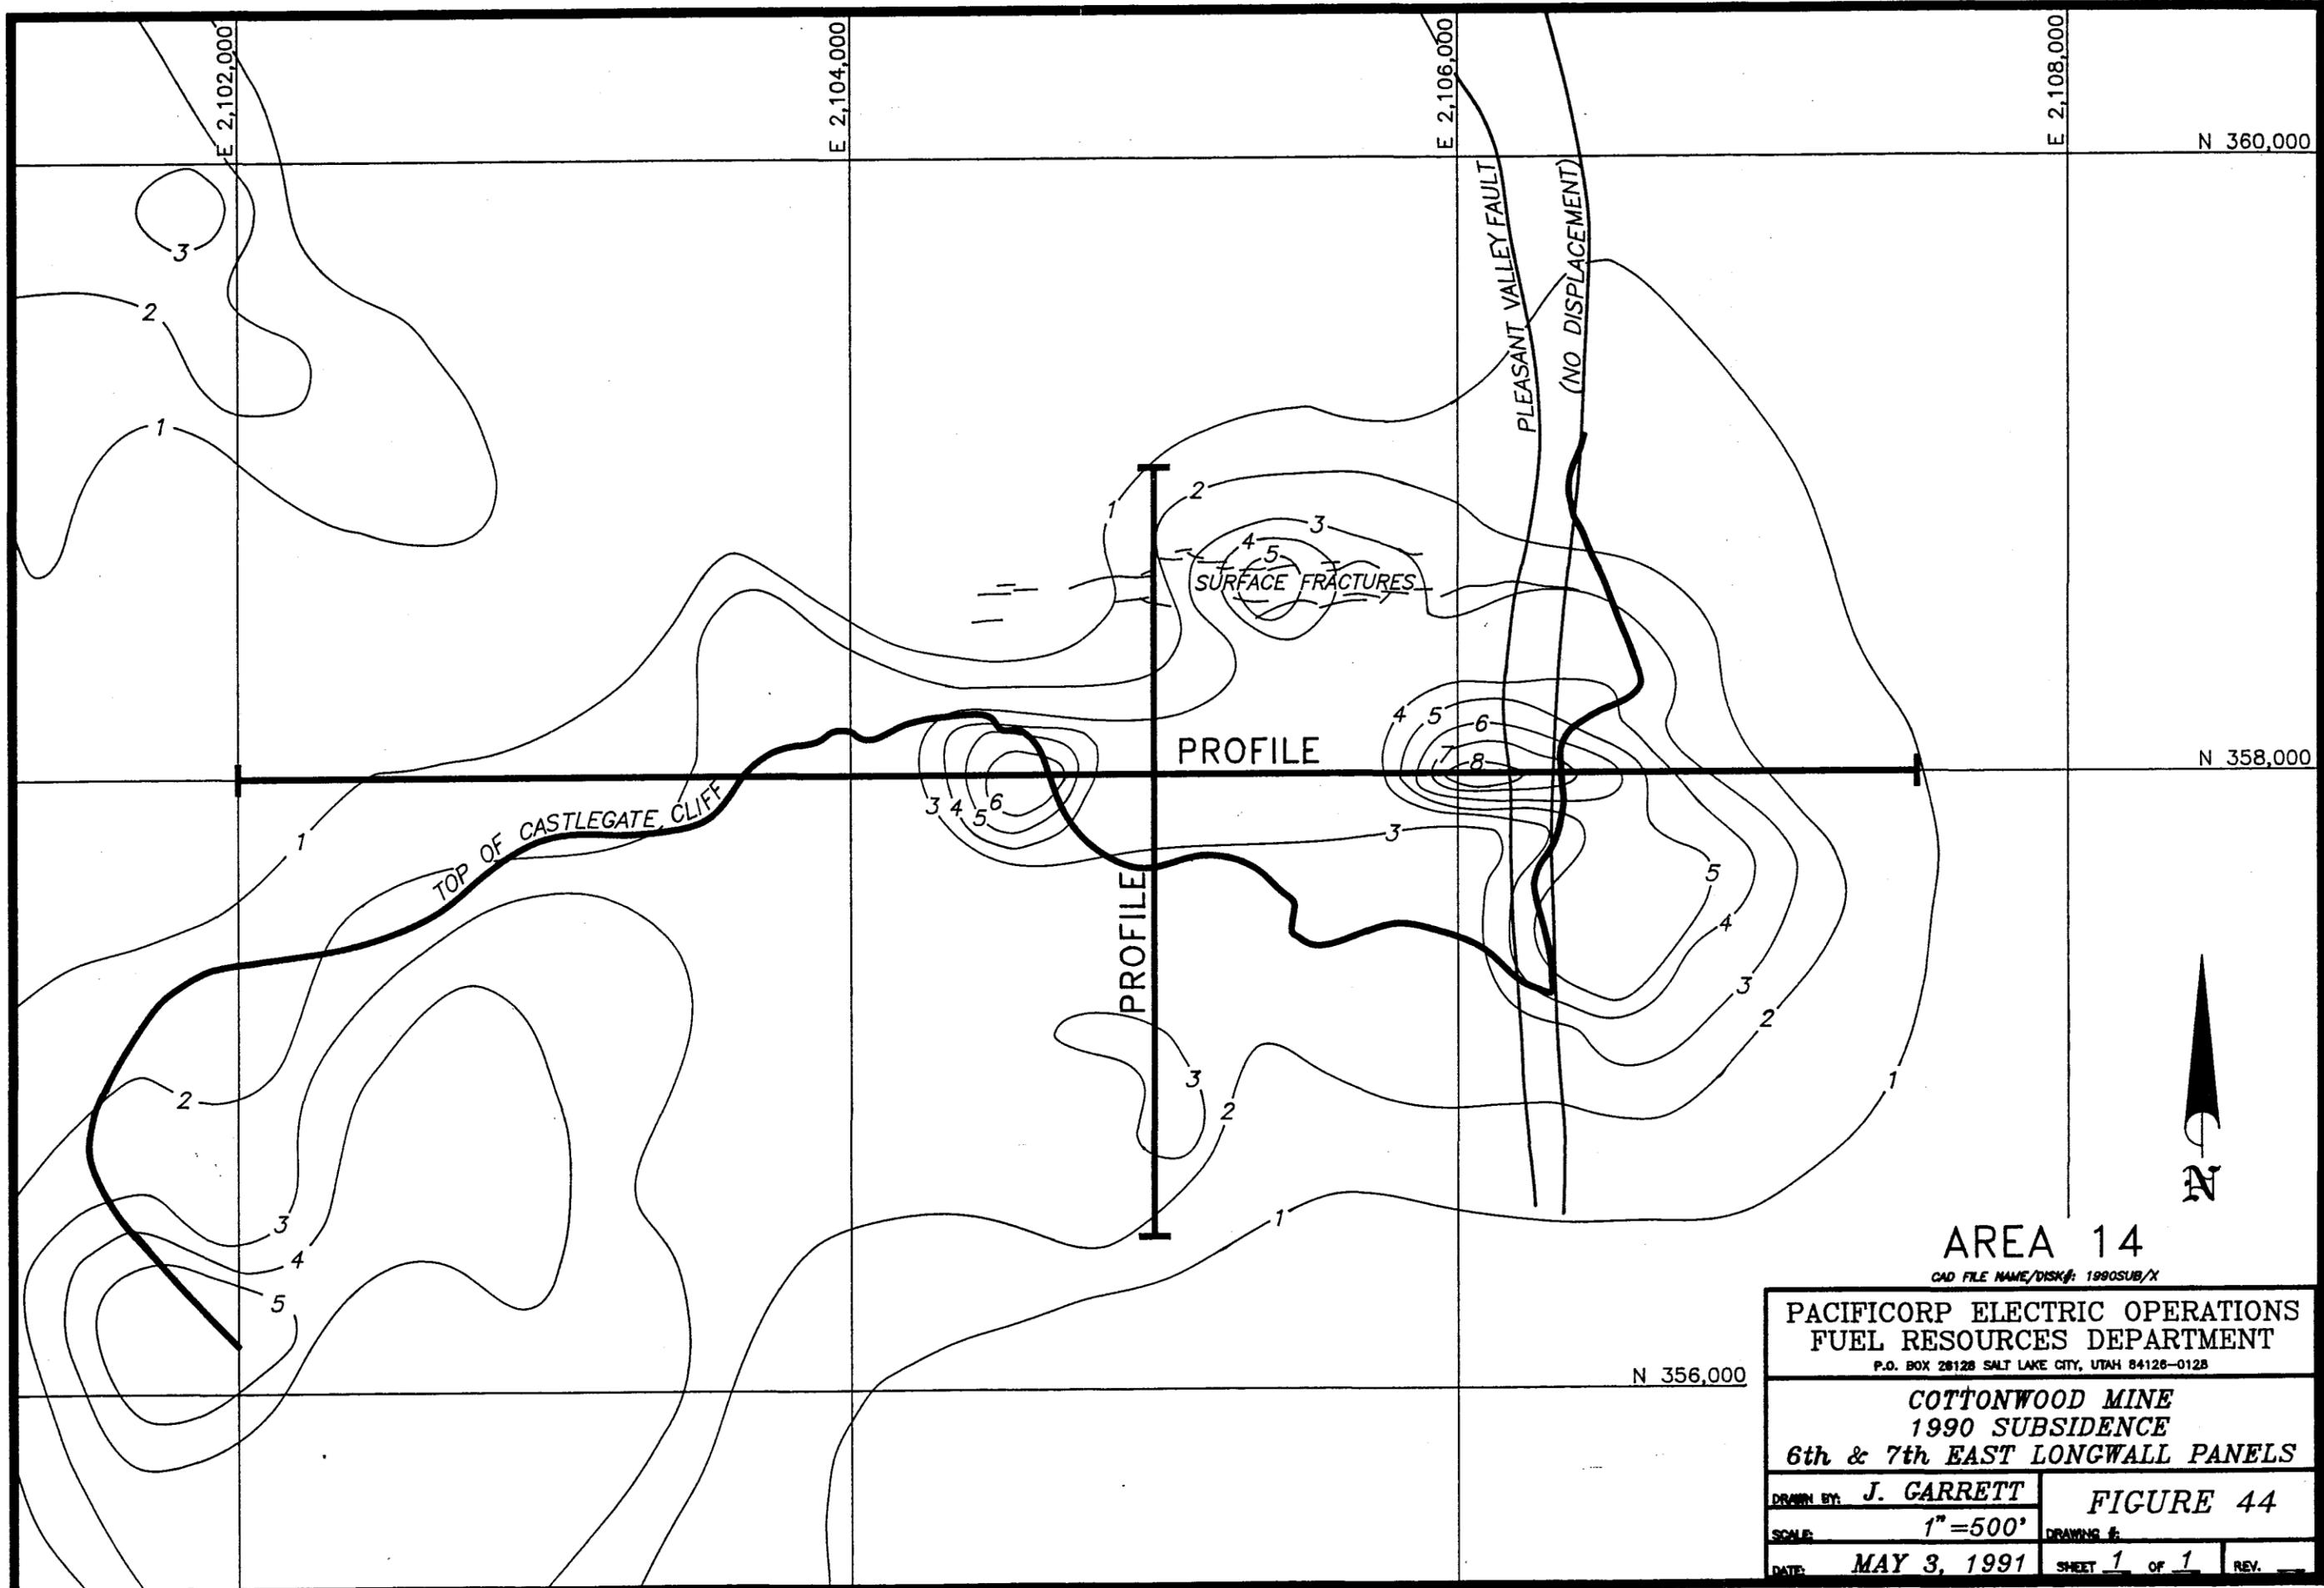
FIGURE 44
DRAWING #:
SHEET **1** OF **1** REV. _____

Maximum subsidence to date is over eight (8) feet over the eastern end of 6th East along the Pleasant Valley Fault (Figure 44).

The major impacts associated with subsidence and resulting cliff failure, surface cracking, and talus deposition in Area 14 are 1) possible loss of golden eagle nests and/or nest sites, 2) disruption of grazing and hunting land use, and 3) loss of wildlife habitat.

Mitigation of effects due to mining may be required in Area 14. A detailed assessment is given in the Newberry Canyon report. Briefly, mitigation may include 1) backfilling, recontouring, and revegetating surface cracks, where accessible; 2) creating artificial eagle nesting sites; and 3) improvement of habitat for existing species or developing habitat for another desirable species.

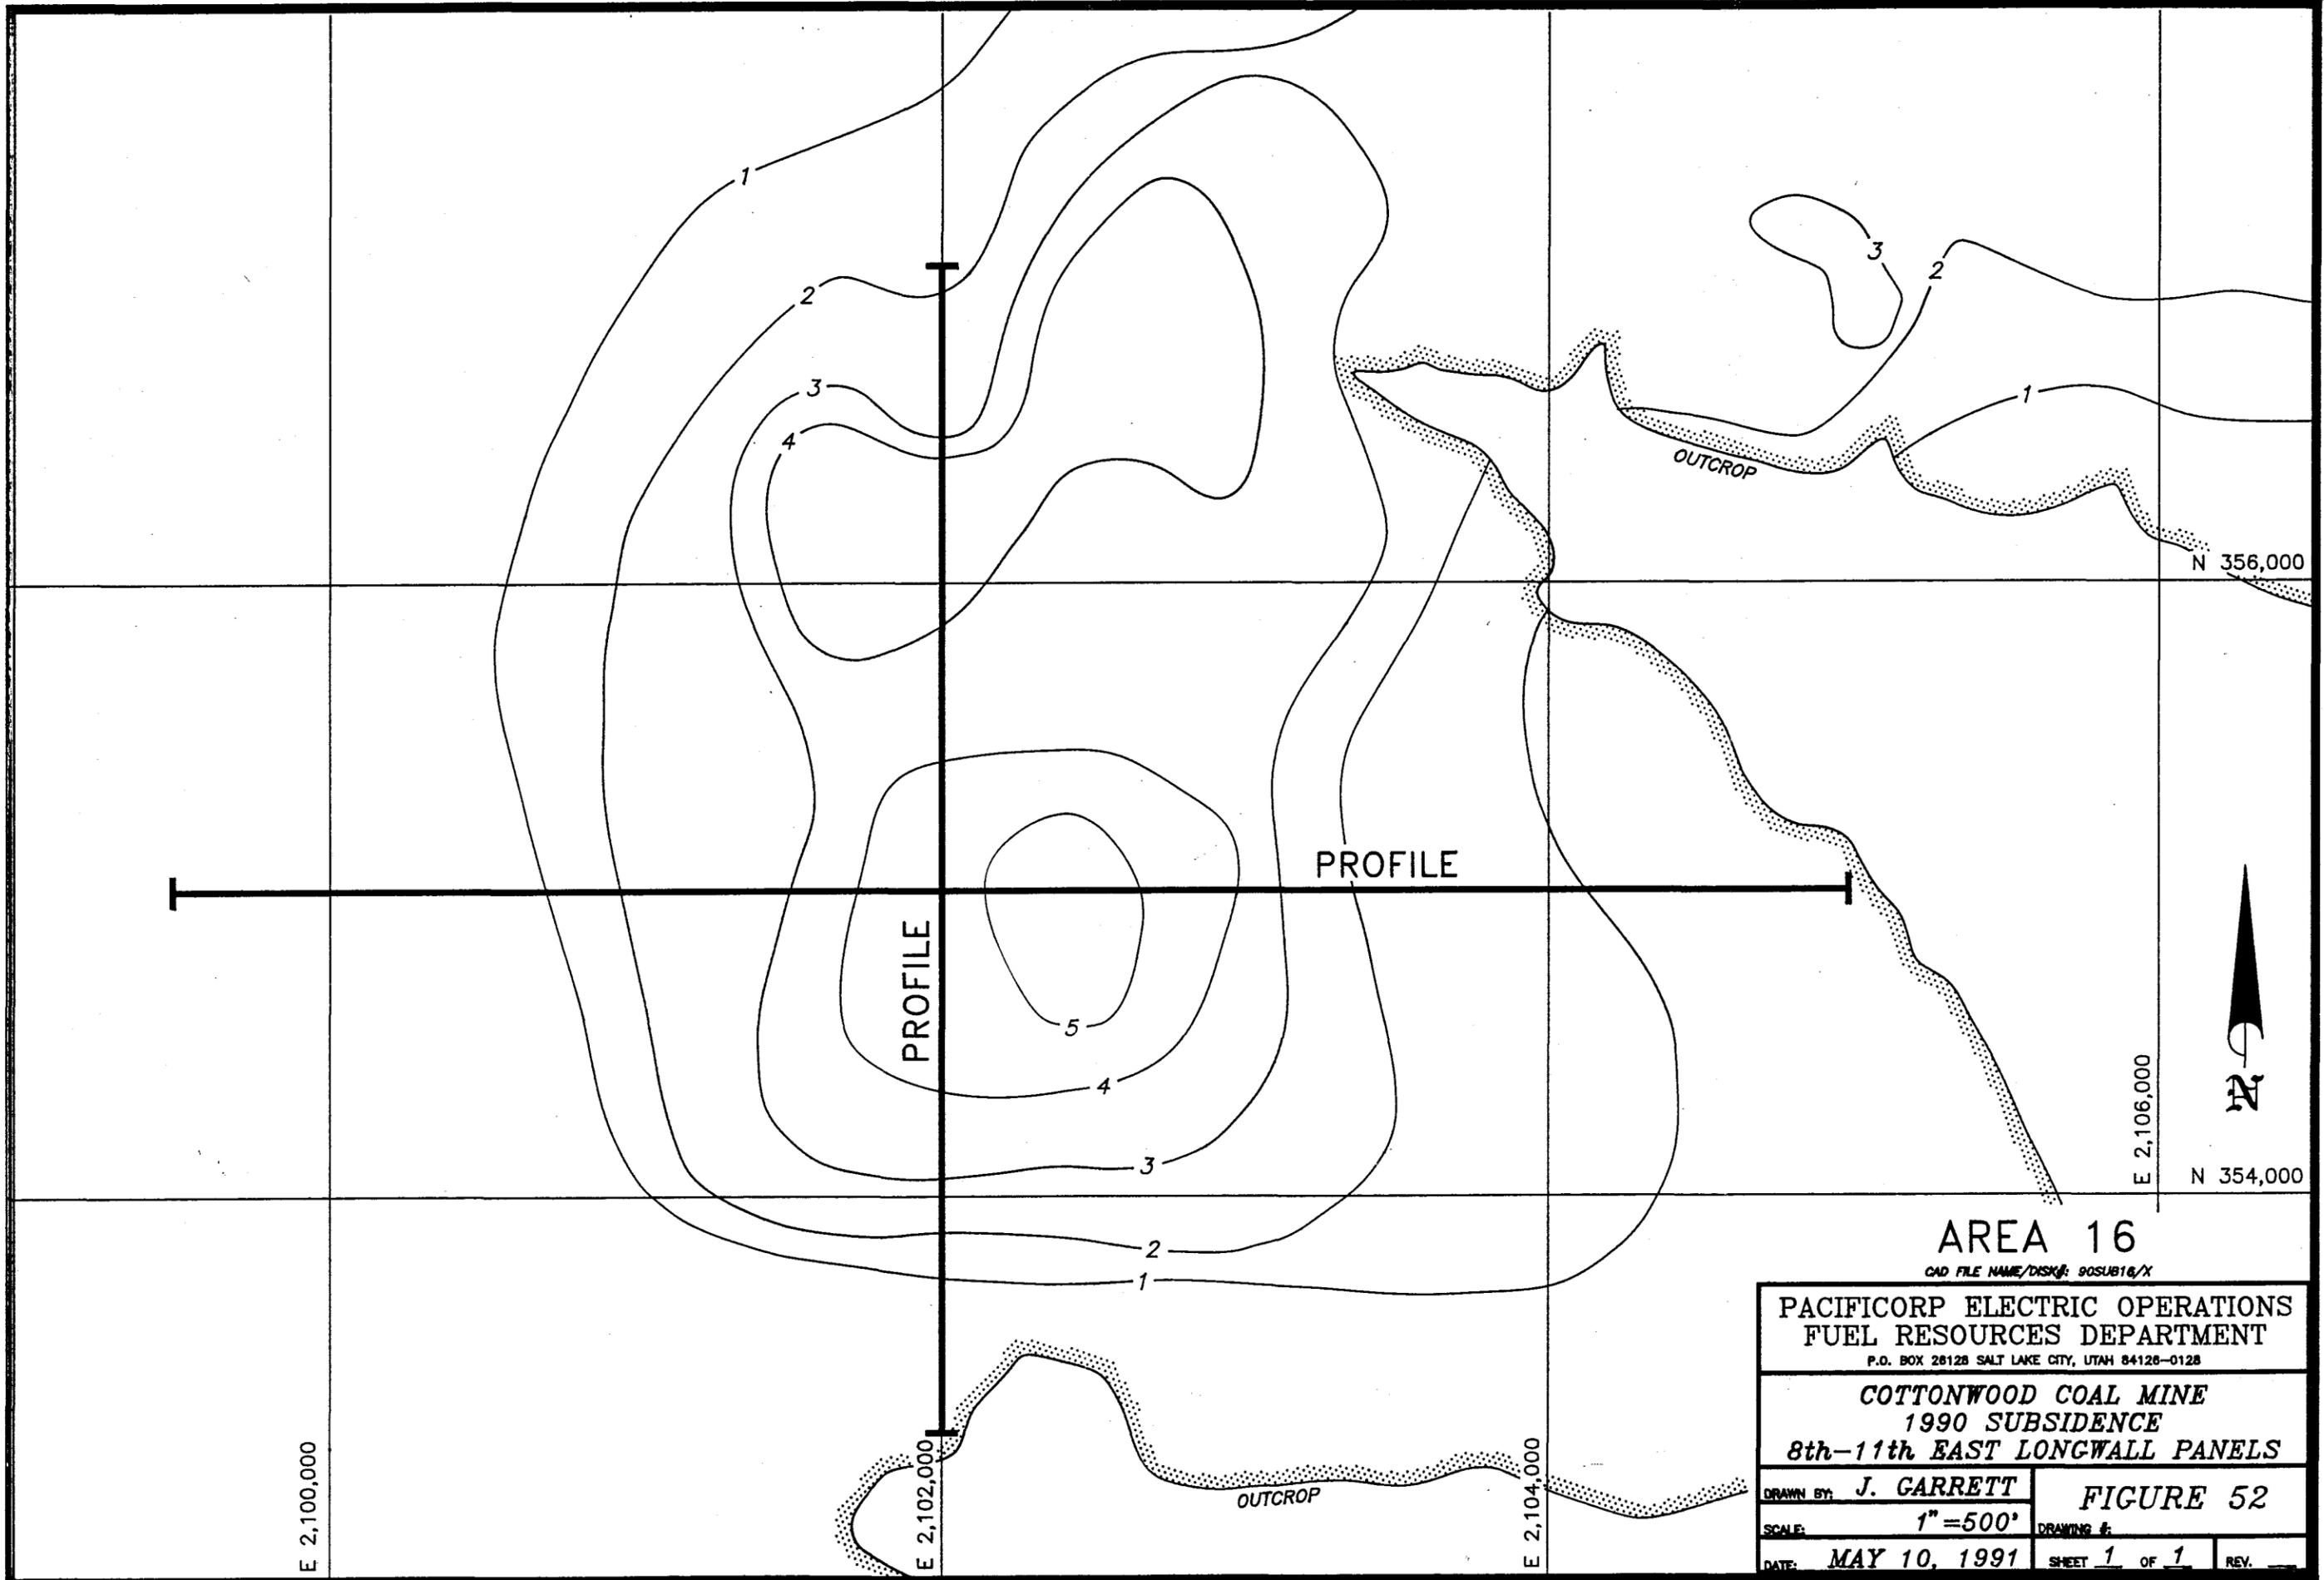
COTTONWOOD COAL MINE
 1990 SUBSIDENCE
 8th-11th EAST LONGWALL PANELS

Maximum subsidence observed to date is five (5) feet and occurs over the 10th East panel (Figure 52, 53, and 54).

Mitigation of other effects due to mining may be necessary in Area 16. See Area 14 in this report for a more detailed discussion of what might be done.

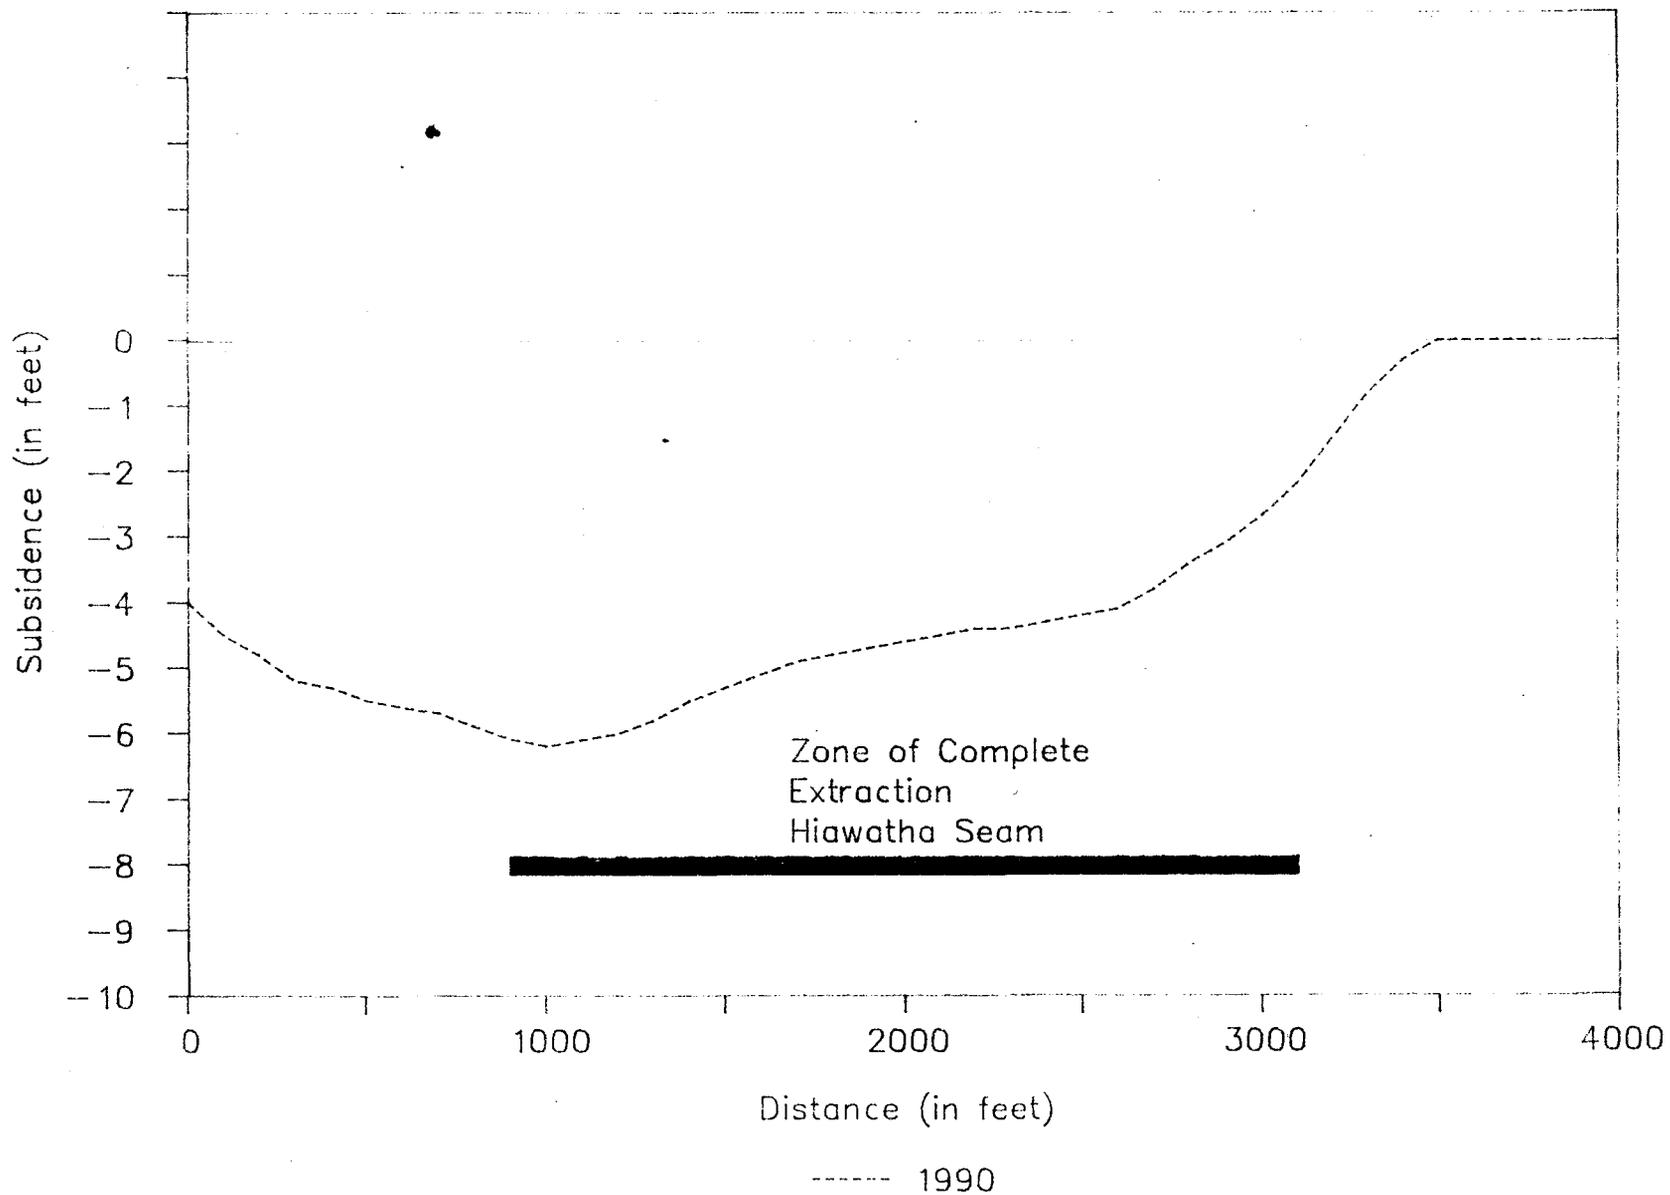
FIGURE 53

AREA 16 SUBSIDENCE PROFILE

North - South
