**CENTRAL ENGINEERING
ANNUAL SUBSIDENCE MONITORING REPORT
EAST MOUNTAIN PROPERTY
1990**

**PACIFICORP - FUEL RESOURCES
SUBSIDENCE MONITORING PROGRAM
ANNUAL REPORT FOR 1990**

**United States Department of the Interior
Office of Surface Mining
Minerals Management Service
Utah Division of Oil, Gas and Mining**

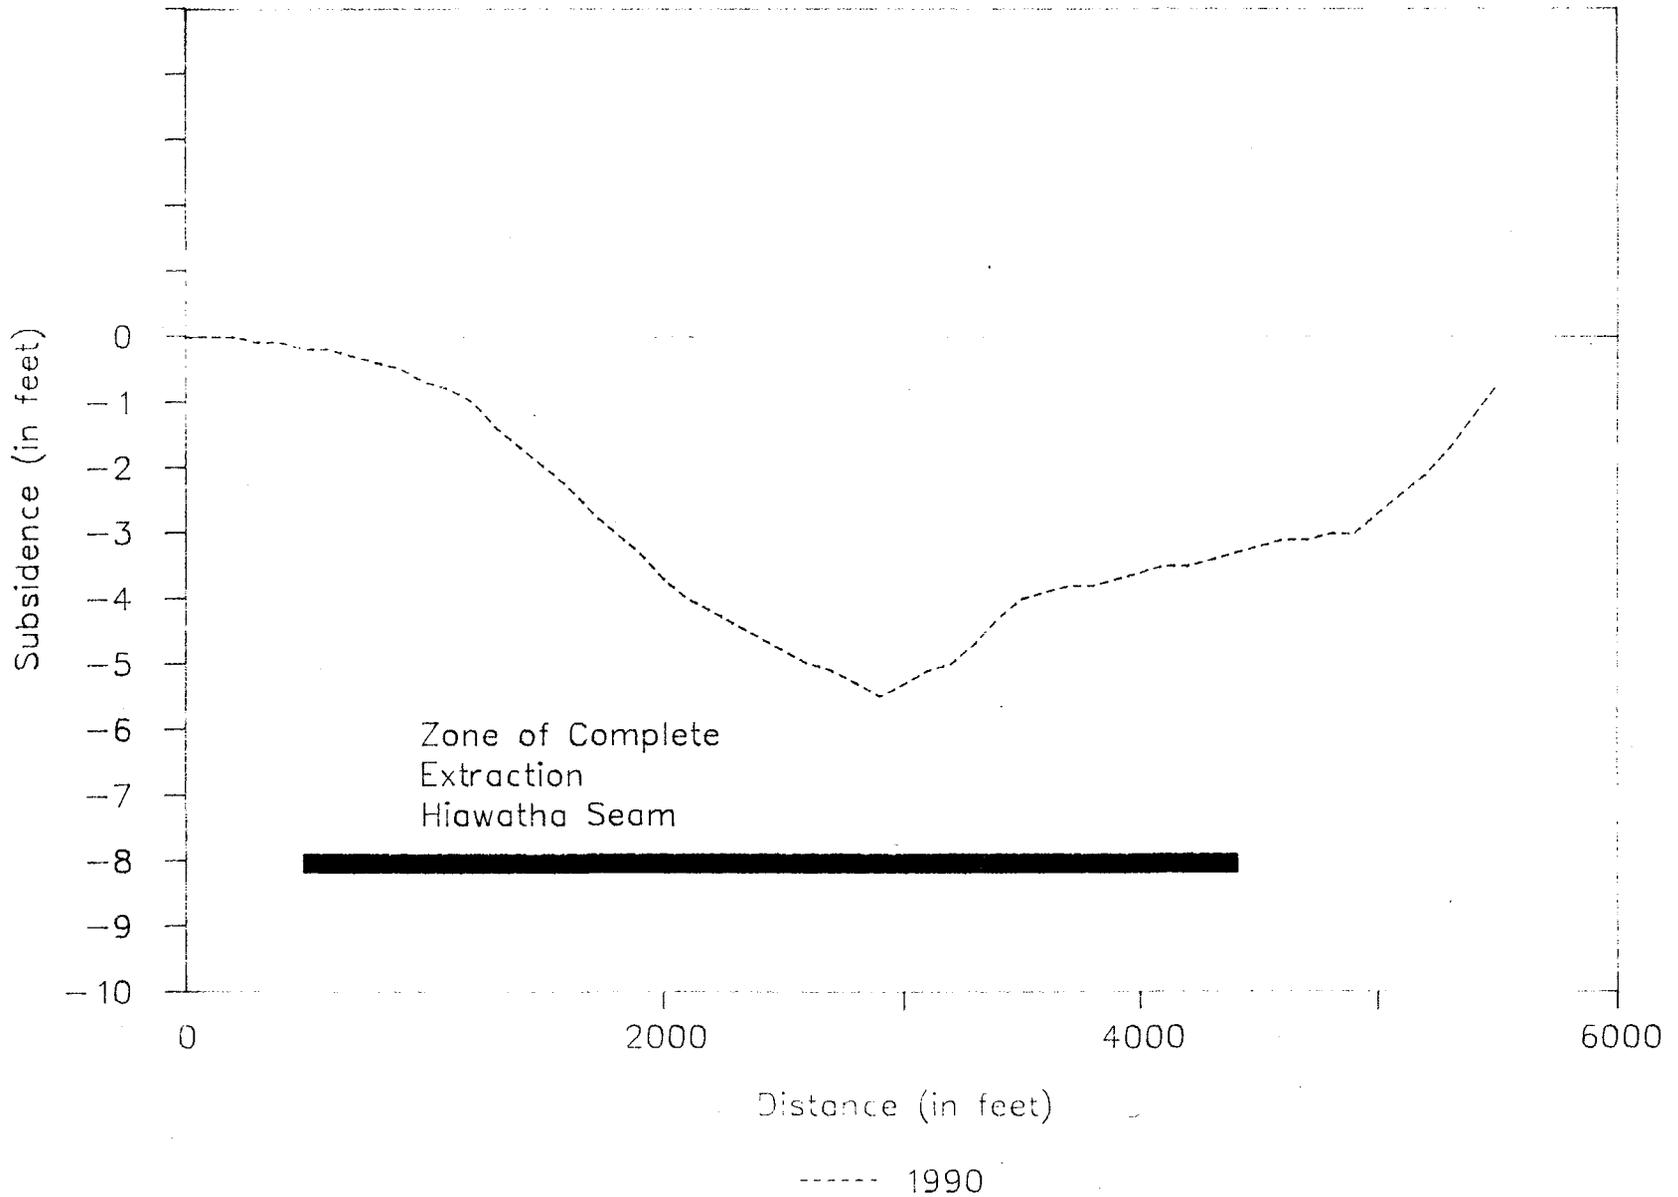
FIGURE 54

Maximum subsidence observed to date is five (5) feet and occurs over the 10th East panel (Figure 52, 53, and 54).

AREA 16 SUBSIDENCE PROFILE

West - East
