ANNUAL SUBSIDENCE MONITORING REPORT
EAST MOUNTAIN PROPERTY
1993

PACIFICORP
TECHNICAL SERVICES REPORT
RODGER C. FRY

PACIFICORP
SUBSIDENCE MONITORING PROGRAM
ANNUAL REPORT FOR 1993

**United States Department of the Interior
Office of Surface Mining
Minerals Management Service
Utah Division of Oil, Gas and Mining**

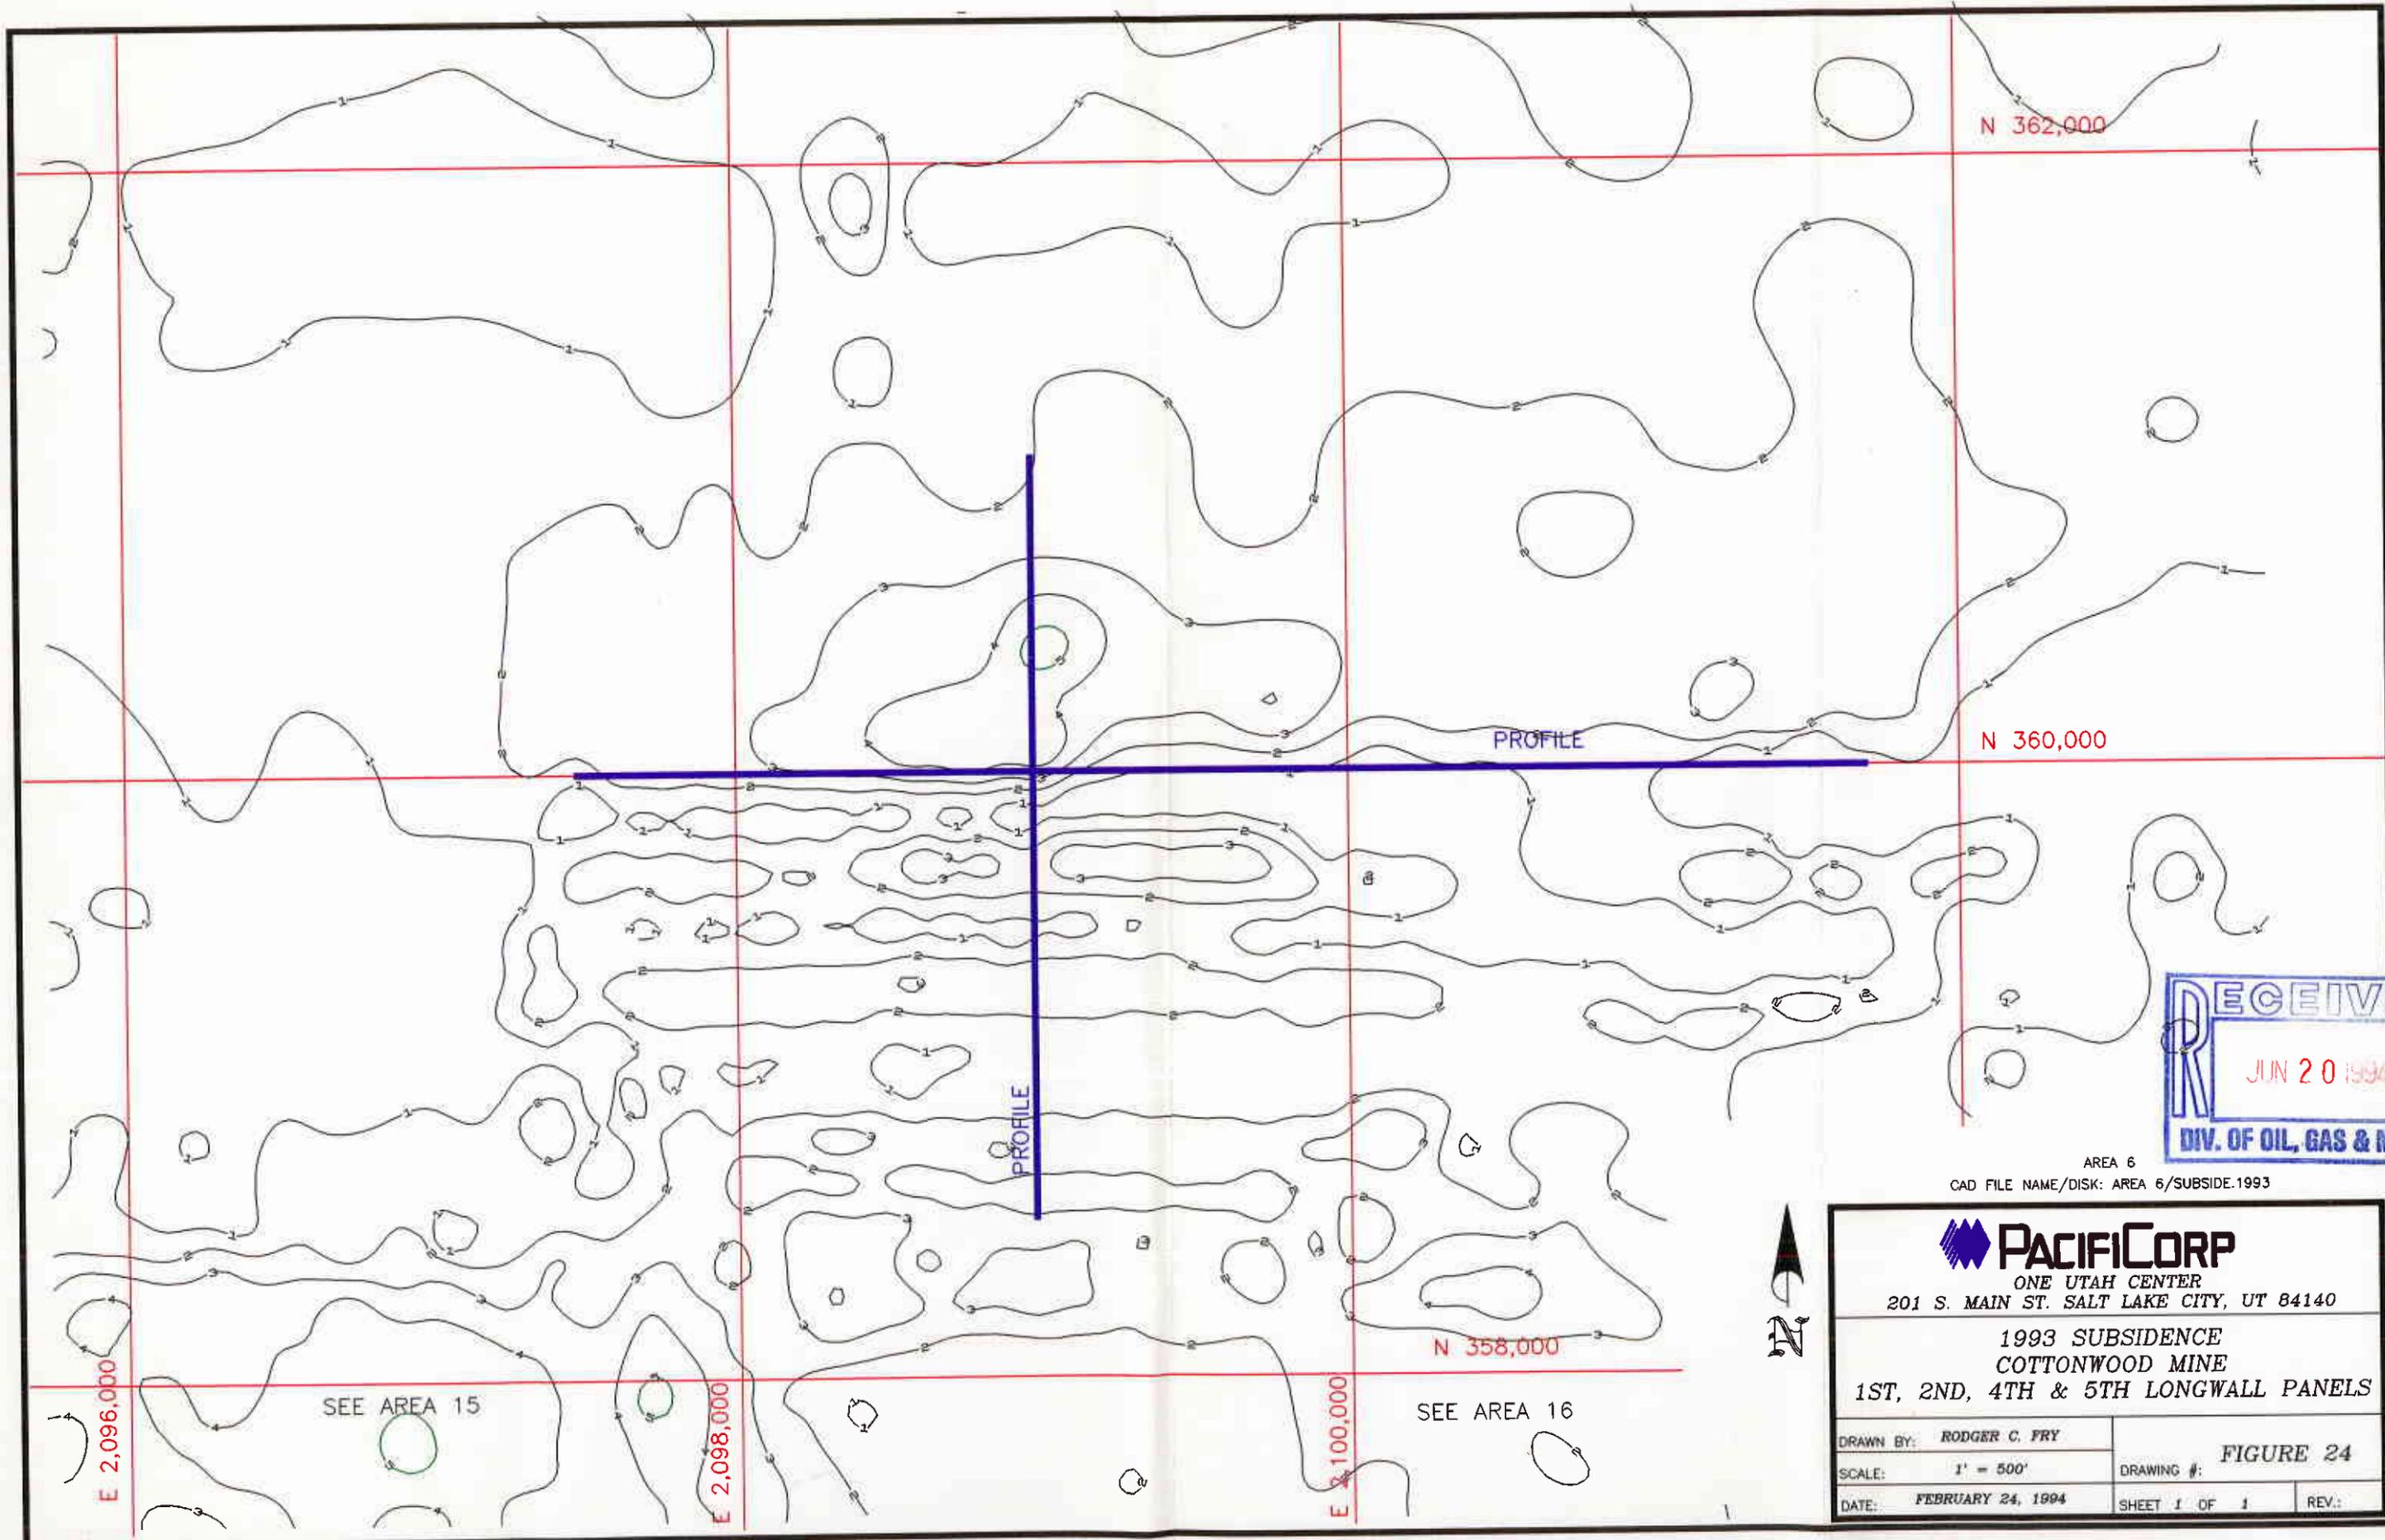
PACIFICORP ONE UTAH CENTER 201 S. MAIN ST. SALT LAKE CITY, UT 84140		
1993 SUBSIDENCE COTTONWOOD MINE 1ST, 2ND, 4TH & 5TH LONGWALL PANELS		
DRAWN BY: RODGER C. FRY	DRAWING #: FIGURE 24	
SCALE: 1" = 500'	SHEET 1 OF 1	REV:
DATE: FEBRUARY 24, 1994	DATE:

Mining in the Wilberg 1st and 2nd West longwall panels was completed in June 1983 (Figure 23). This area of subsidence has now reached a maximum of five (5) feet over the Second West Longwall Panel. The subsidence in this area has been fairly stable with the exception of continued subsidence in the south which is due to the influence of mining in areas 14 and 15 (Figure 24). The subsidence profiles (Figures 25 and 26) show the change in subsidence since 1984.

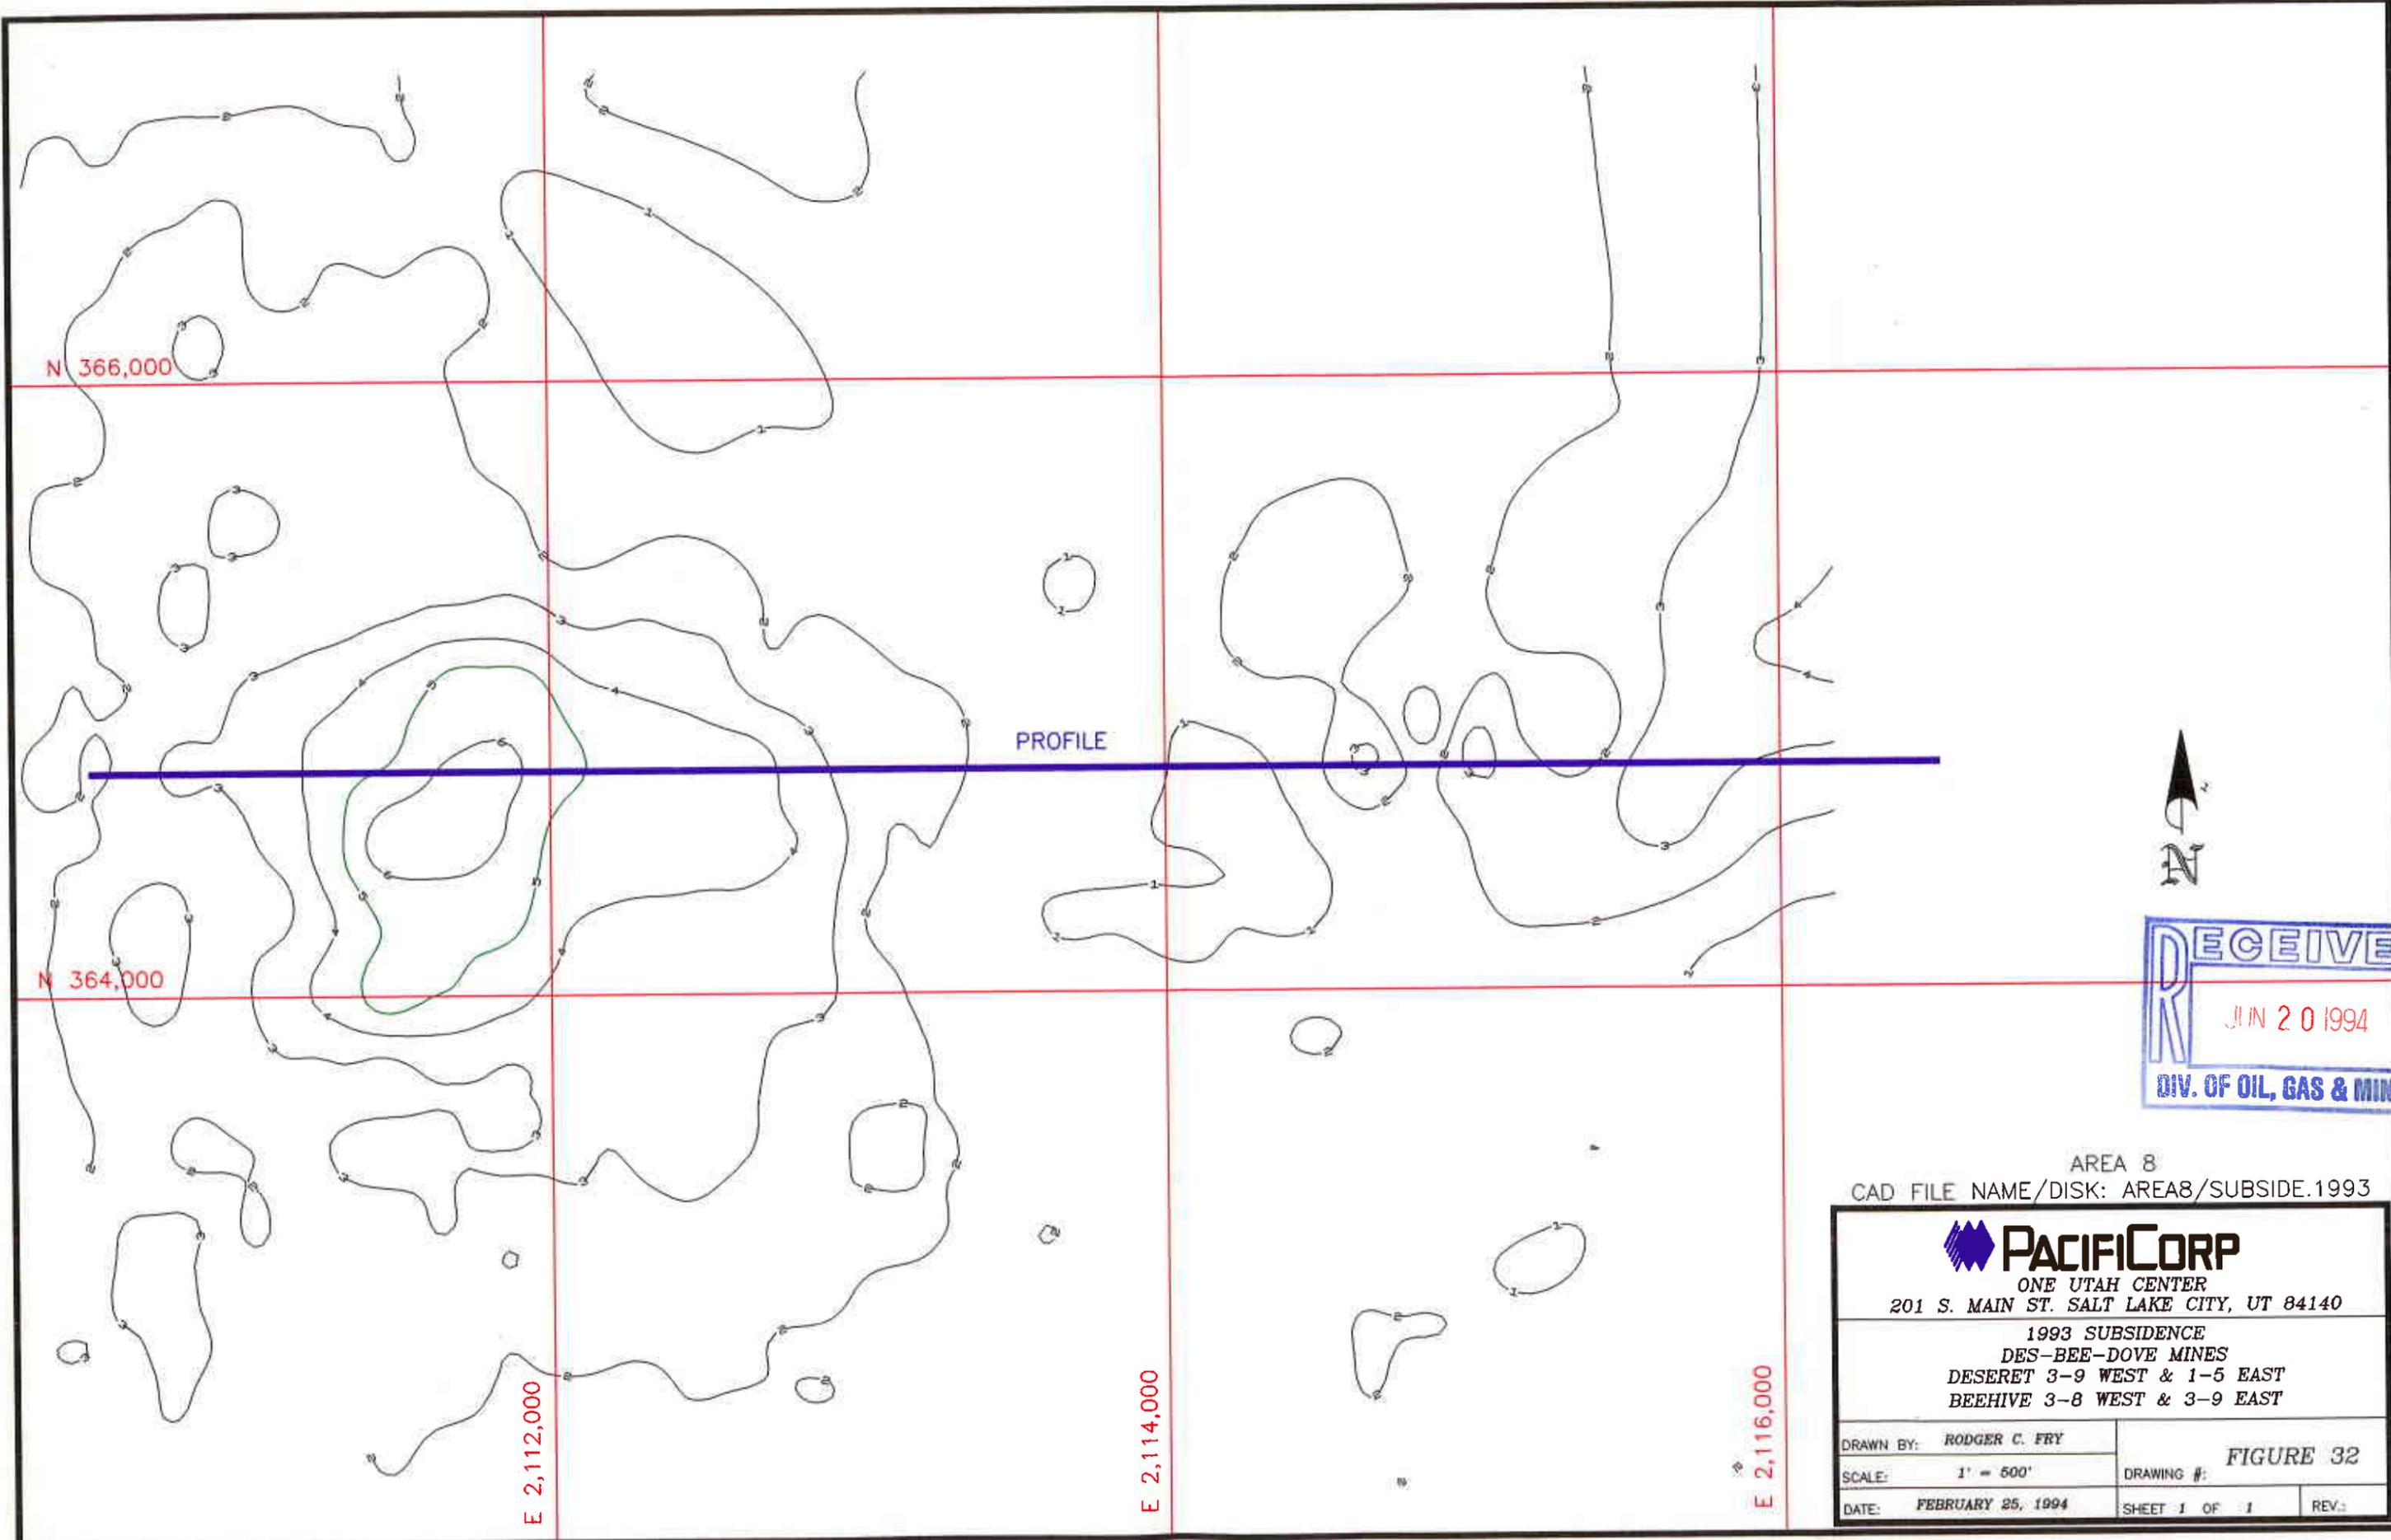
PACIFICORP ONE UTAH CENTER 201 S. MAIN ST. SALT LAKE CITY, UT 84140		
1993 SUBSIDENCE DES-BEE-DOVE MINES DESERET 3-9 WEST & 1-5 EAST BEEHIVE 3-8 WEST & 3-9 EAST		
DRAWN BY: RODGER C. FRY	FIGURE 32	
SCALE: 1" = 500'	DRAWING #:	REV.:
DATE: FEBRUARY 25, 1994	SHEET 1 OF 1

Some of the subsidence in Area 8 may have gone undetected because pillar extraction, and presumably subsidence, in part of the area was completed before the establishment of baseline survey data (Figures 30, 31, and 32). The west to east subsidence profile of the area depicted in Figure 33 indicates that subsidence up to slightly over six (6) feet has occurred. On the eastern side subsidence has remained at two feet or less for the last four years. Where not influenced by other workings, the angle-of-draw reached a maximum of 31 degrees on the eastern edge of the area.

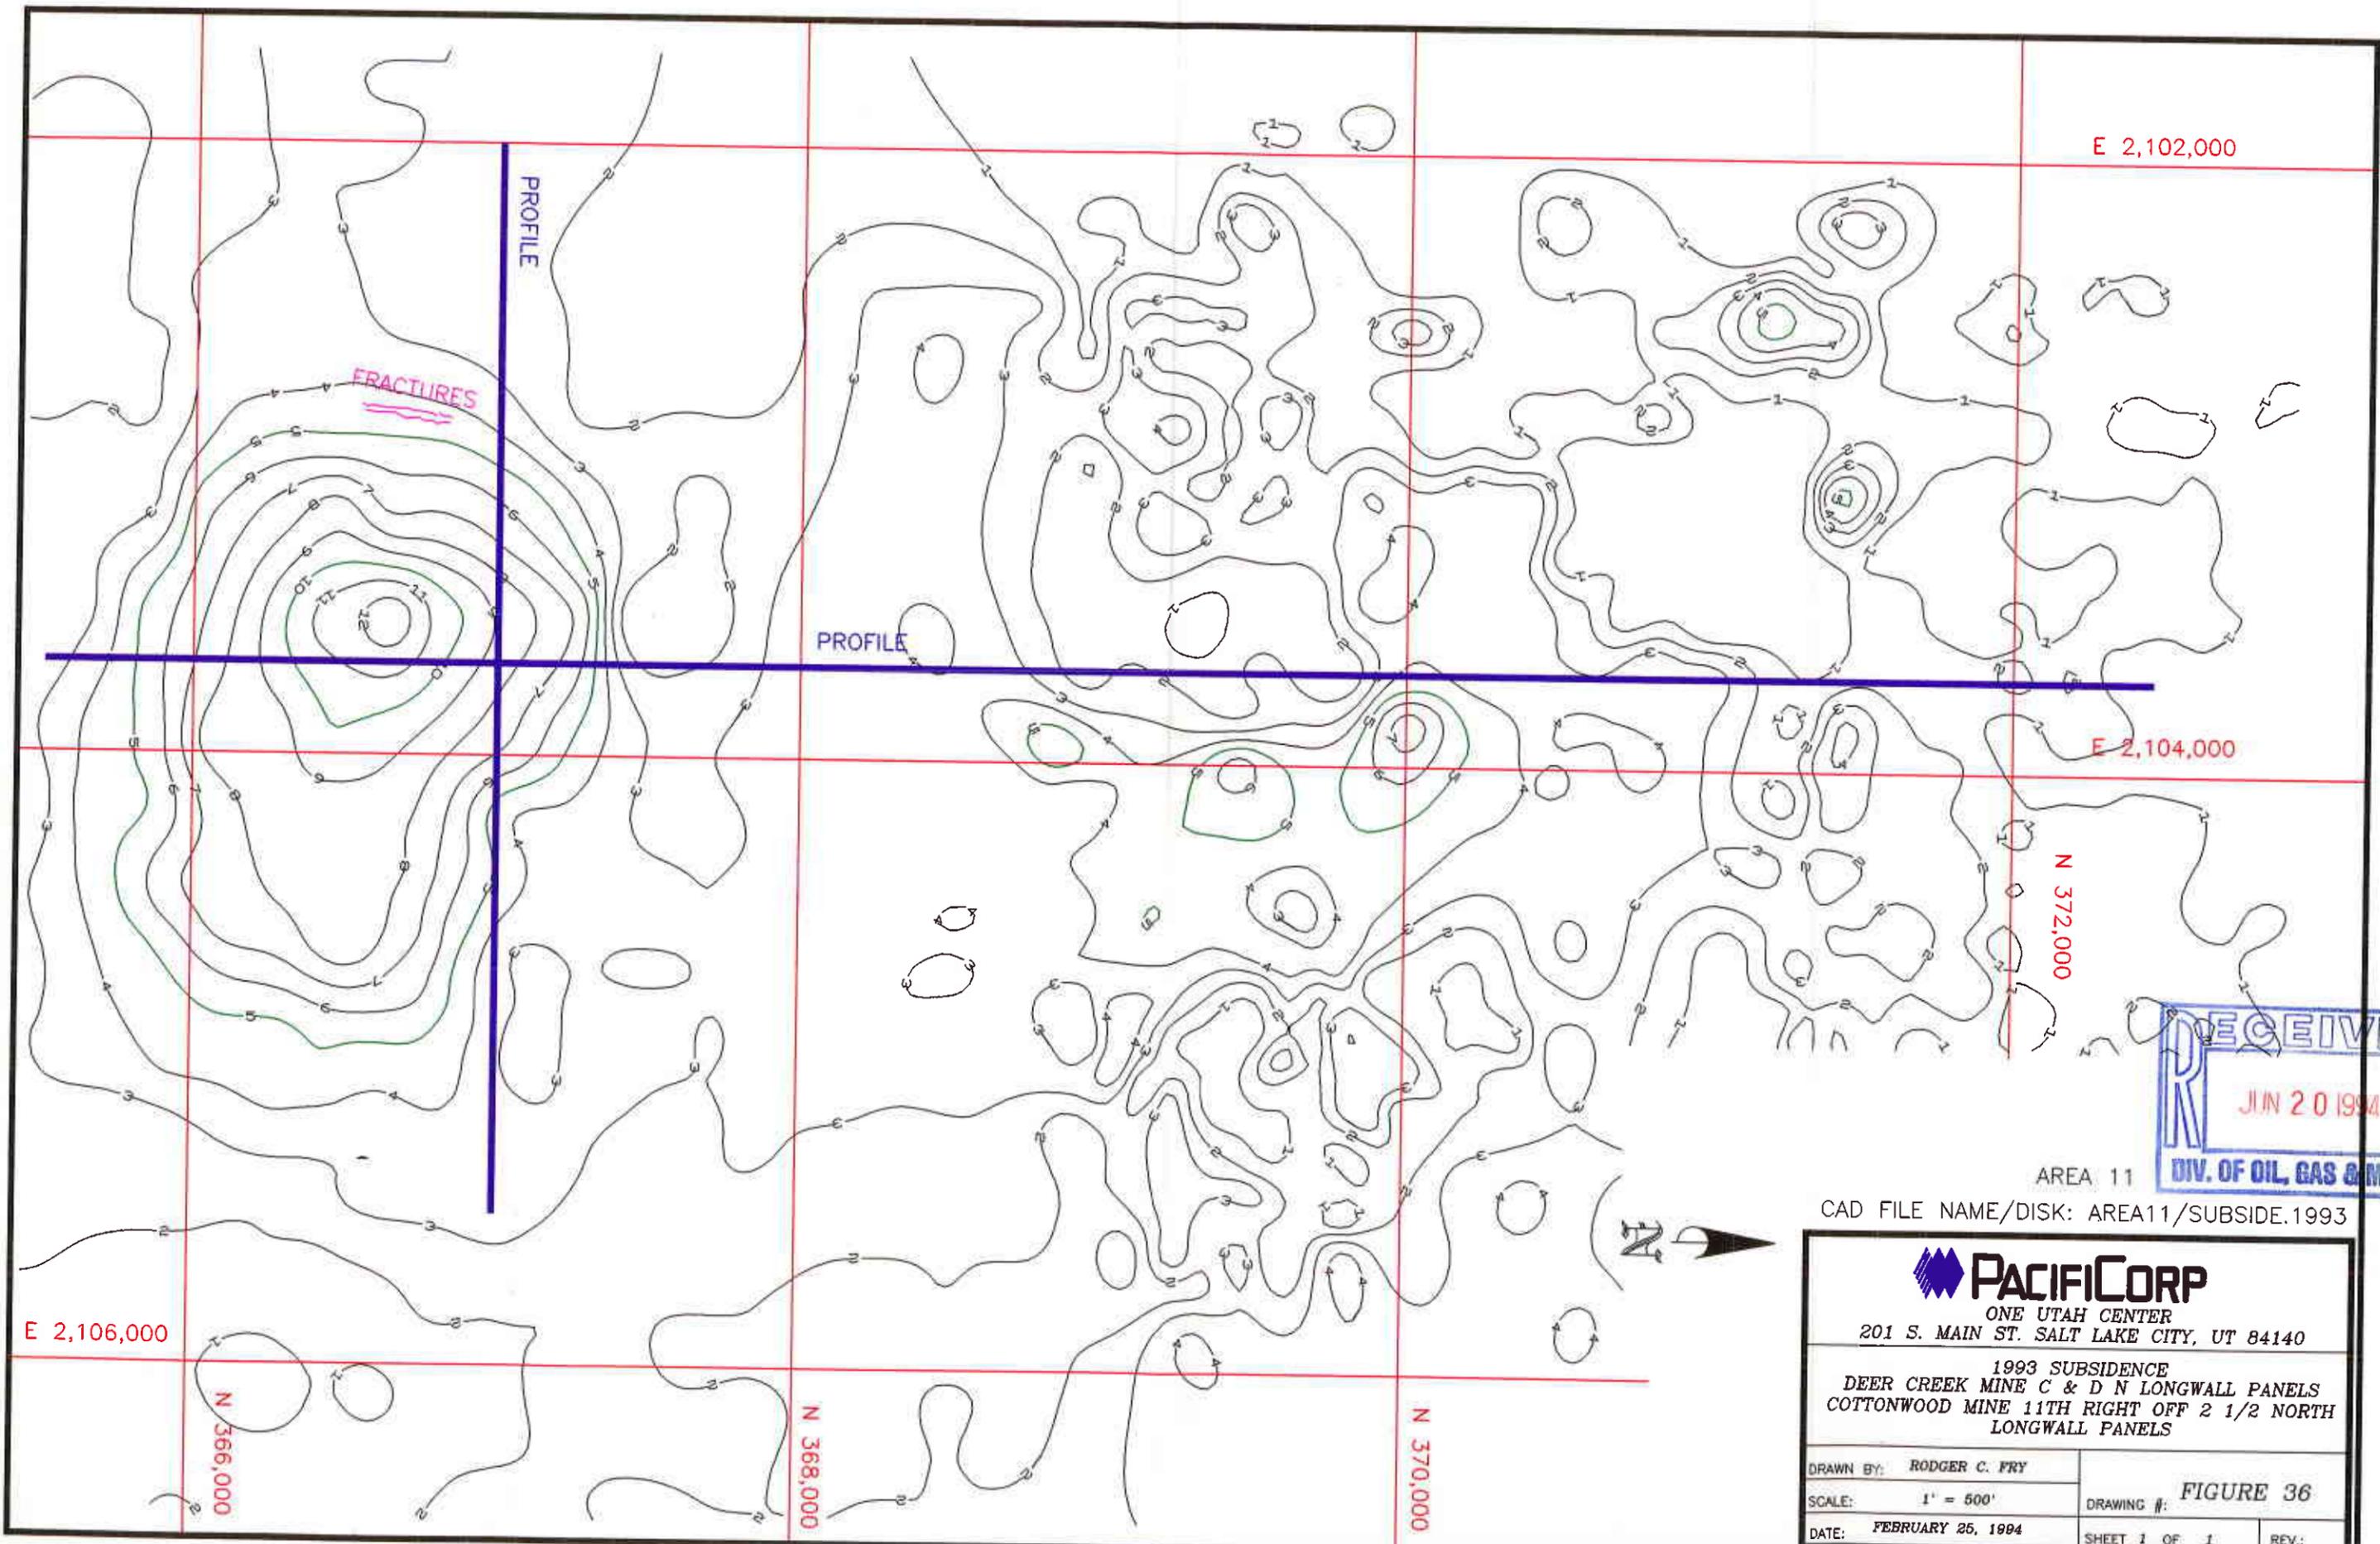
DRAWING #: **FIGURE 36**

Measurable subsidence to date has exceeded twelve (12) in the area of multiple seam mining above the 6th and 7th Right Longwall Panels in the Cottonwood mine (Figures 36, 37, and 38).

Fractures were discovered at the western end of coal extraction above the 7th Right Longwall Panel. The fractures were first discovered on June 17, 1993. Mining of the longwall panel was completed on May 12, 1993. An aerial reconnaissance of the area on May 18, 1993 revealed no surface fractures at that time. This places the occurrence of the fractures between May 18, 1993 and June 17, 1993. Burnt Tree Springs is located approximately 800 feet to the southeast of the fractures. Measurements of the spring discharge throughout the summer of 1993 indicated that the fracturing has had no effect on the spring. The angle-of-draw measured ranges from less than zero to 28 degrees.

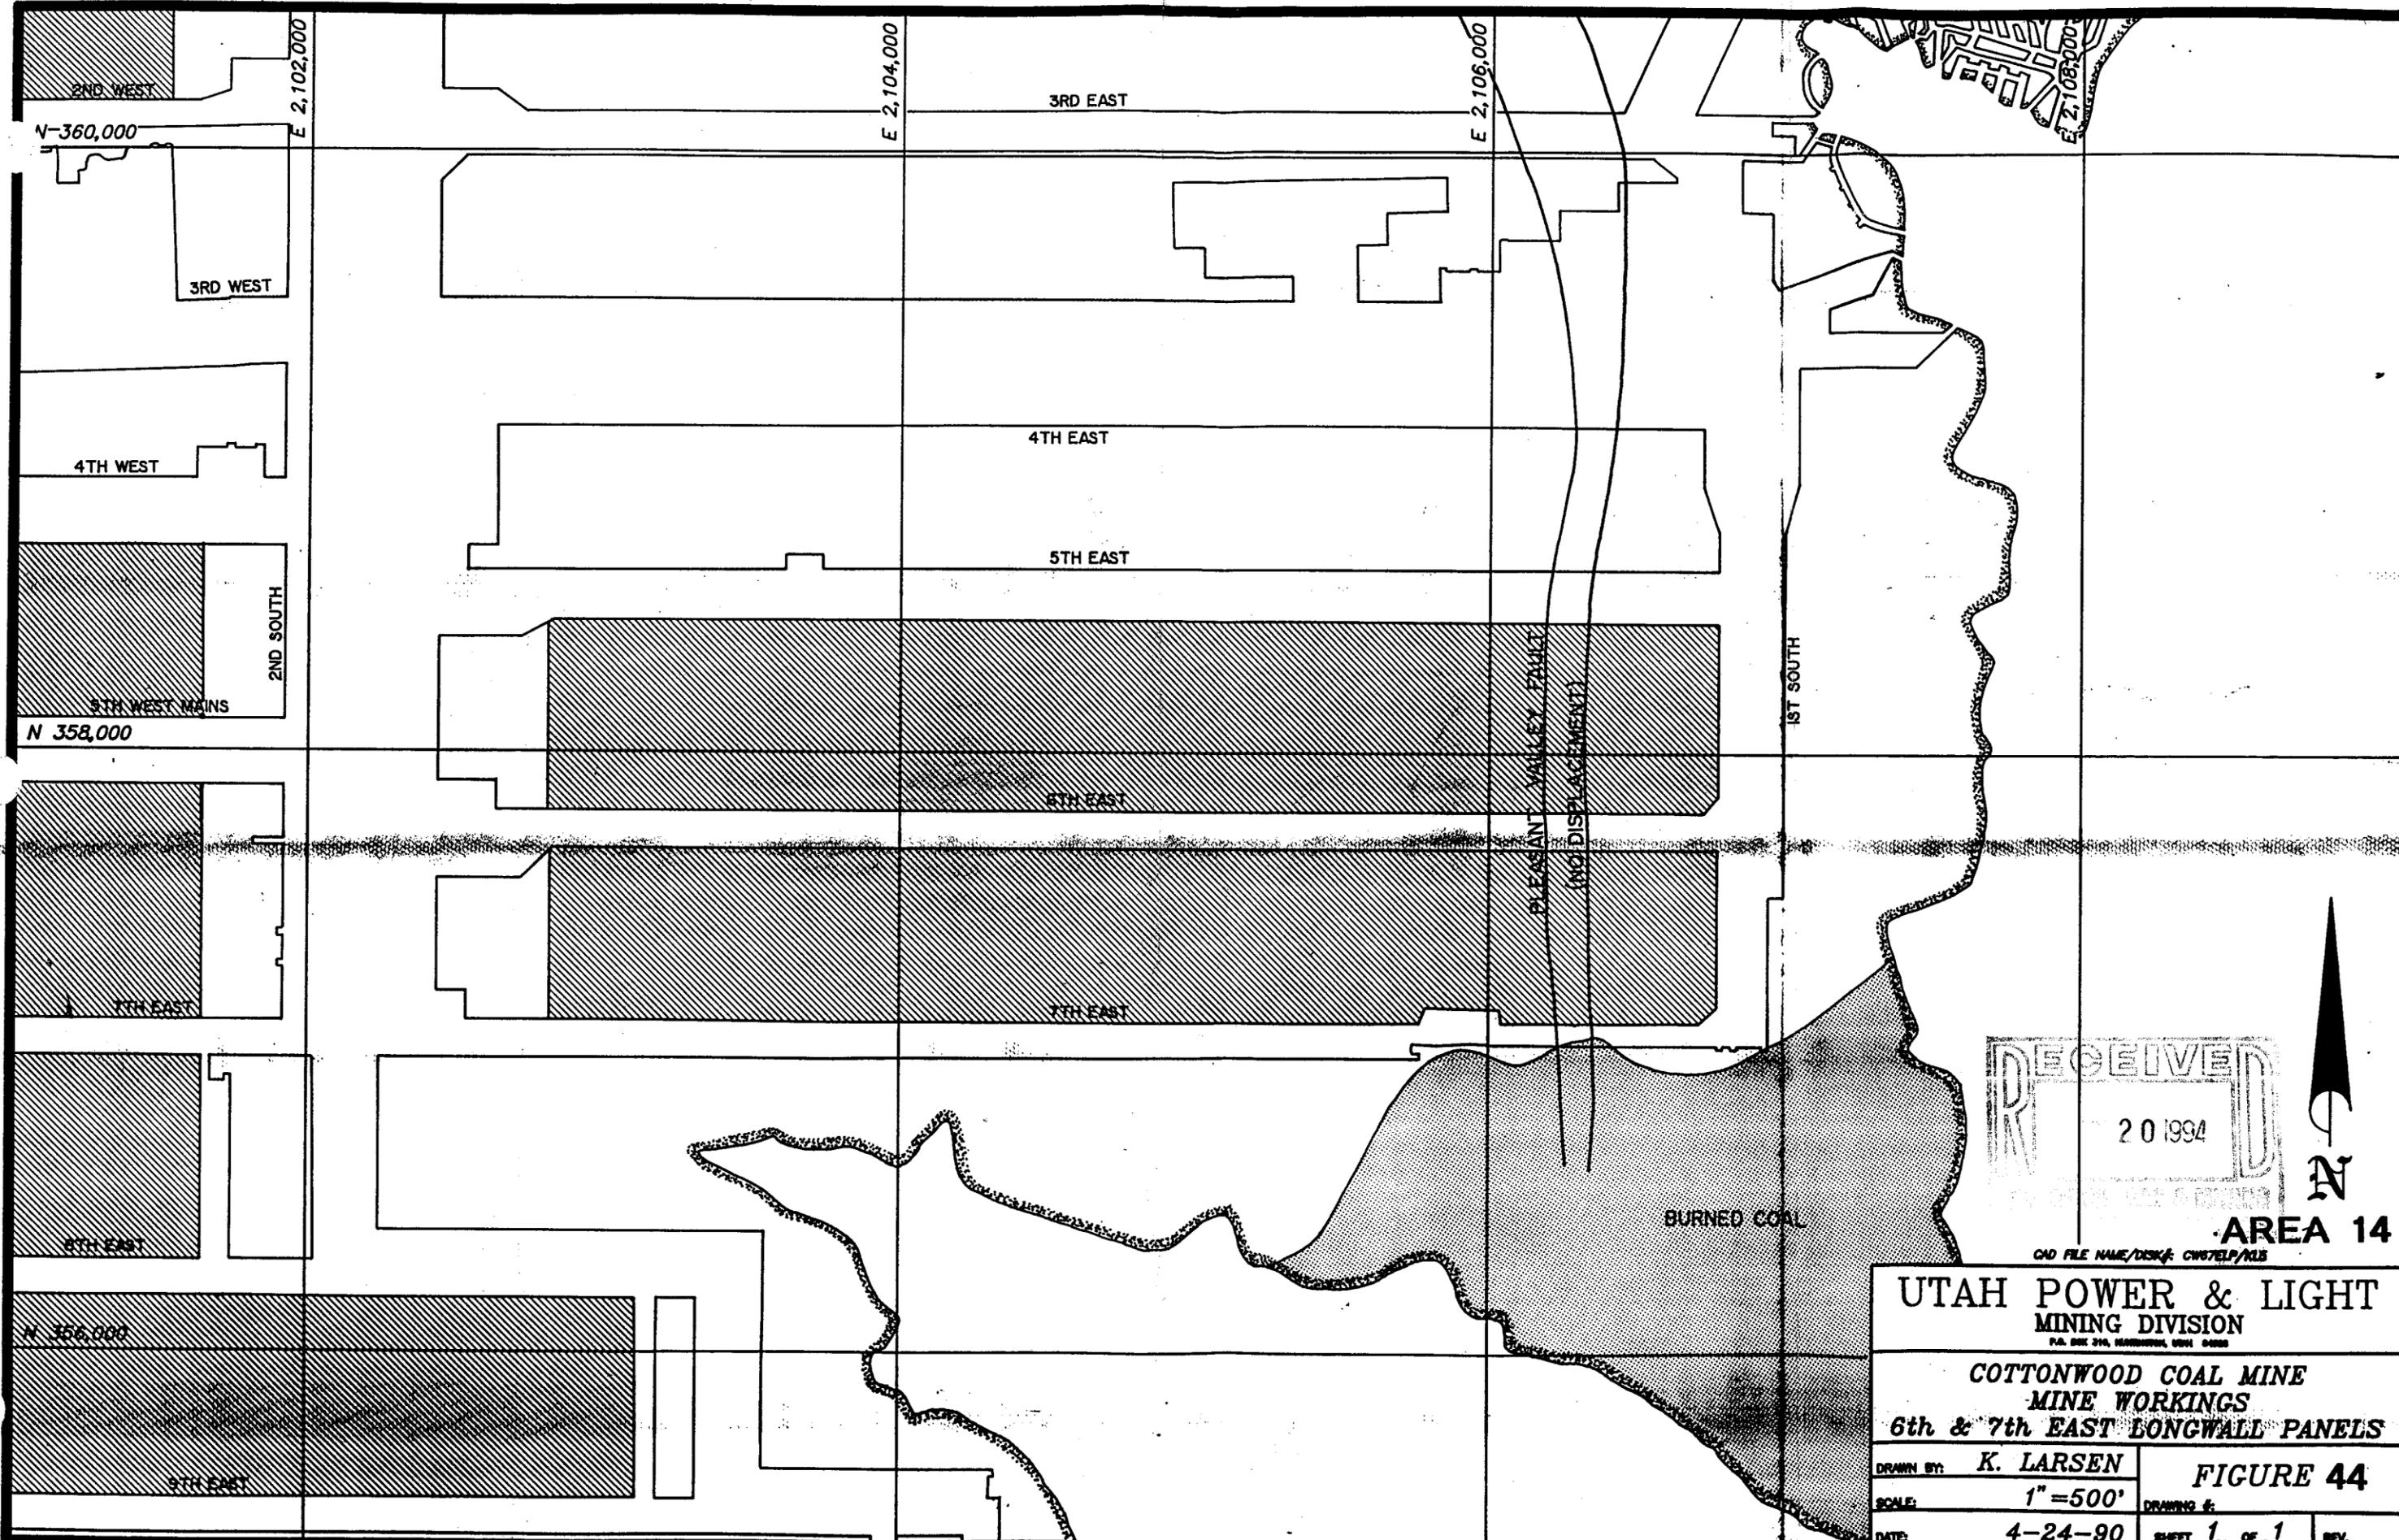
DRAWN BY:	K. LARSEN	FIGURE 44
SCALE:	1" = 500'	
DATE:	4-24-90	SHEET 1 of 1

The Castlegate Sandstone forms a 200-foot high escarpment along the north side of Newberry Canyon with numerous naturally occurring joints and fractures. Stress caused by removal of coal was transferred to the fractures resulting in brittle failure of the cliff face (spalling) in some places. Talus from the spalling has accumulated on the steep slopes below the cliffs on older natural talus slopes. The newer debris remains mostly above the coal outcrop level and reaches the canyon floor in only one location. Surface cracks have been observed and mapped along the ridge above the cliff. The cracks are discontinuous and extend for approximately 2000 feet parallel to the northern edge of the 6th East longwall panel. A few cracks are also found directly on top of the Castlegate Sandstone escarpment. Maximum subsidence to date is over nine (9) feet above the western end of the 7th East Longwall Panel and five (5)

The major impacts associated with subsidence and resulting cliff failure, surface cracking, and talus deposition in Area 14 are 1) possible loss of golden eagle nests and/or nest sites, 2) disruption of grazing and hunting land use, and 3) loss of wildlife habitat.

PacifiCorp will continue to monitor subsidence to assess the significance of related impacts in this area.
