ANNUAL SUBSIDENCE MONITORING REPORT
EAST MOUNTAIN PROPERTY
1993

PACIFICORP
TECHNICAL SERVICES REPORT
RODGER C. FRY

PACIFICORP
SUBSIDENCE MONITORING PROGRAM
ANNUAL REPORT FOR 1993

June 1994

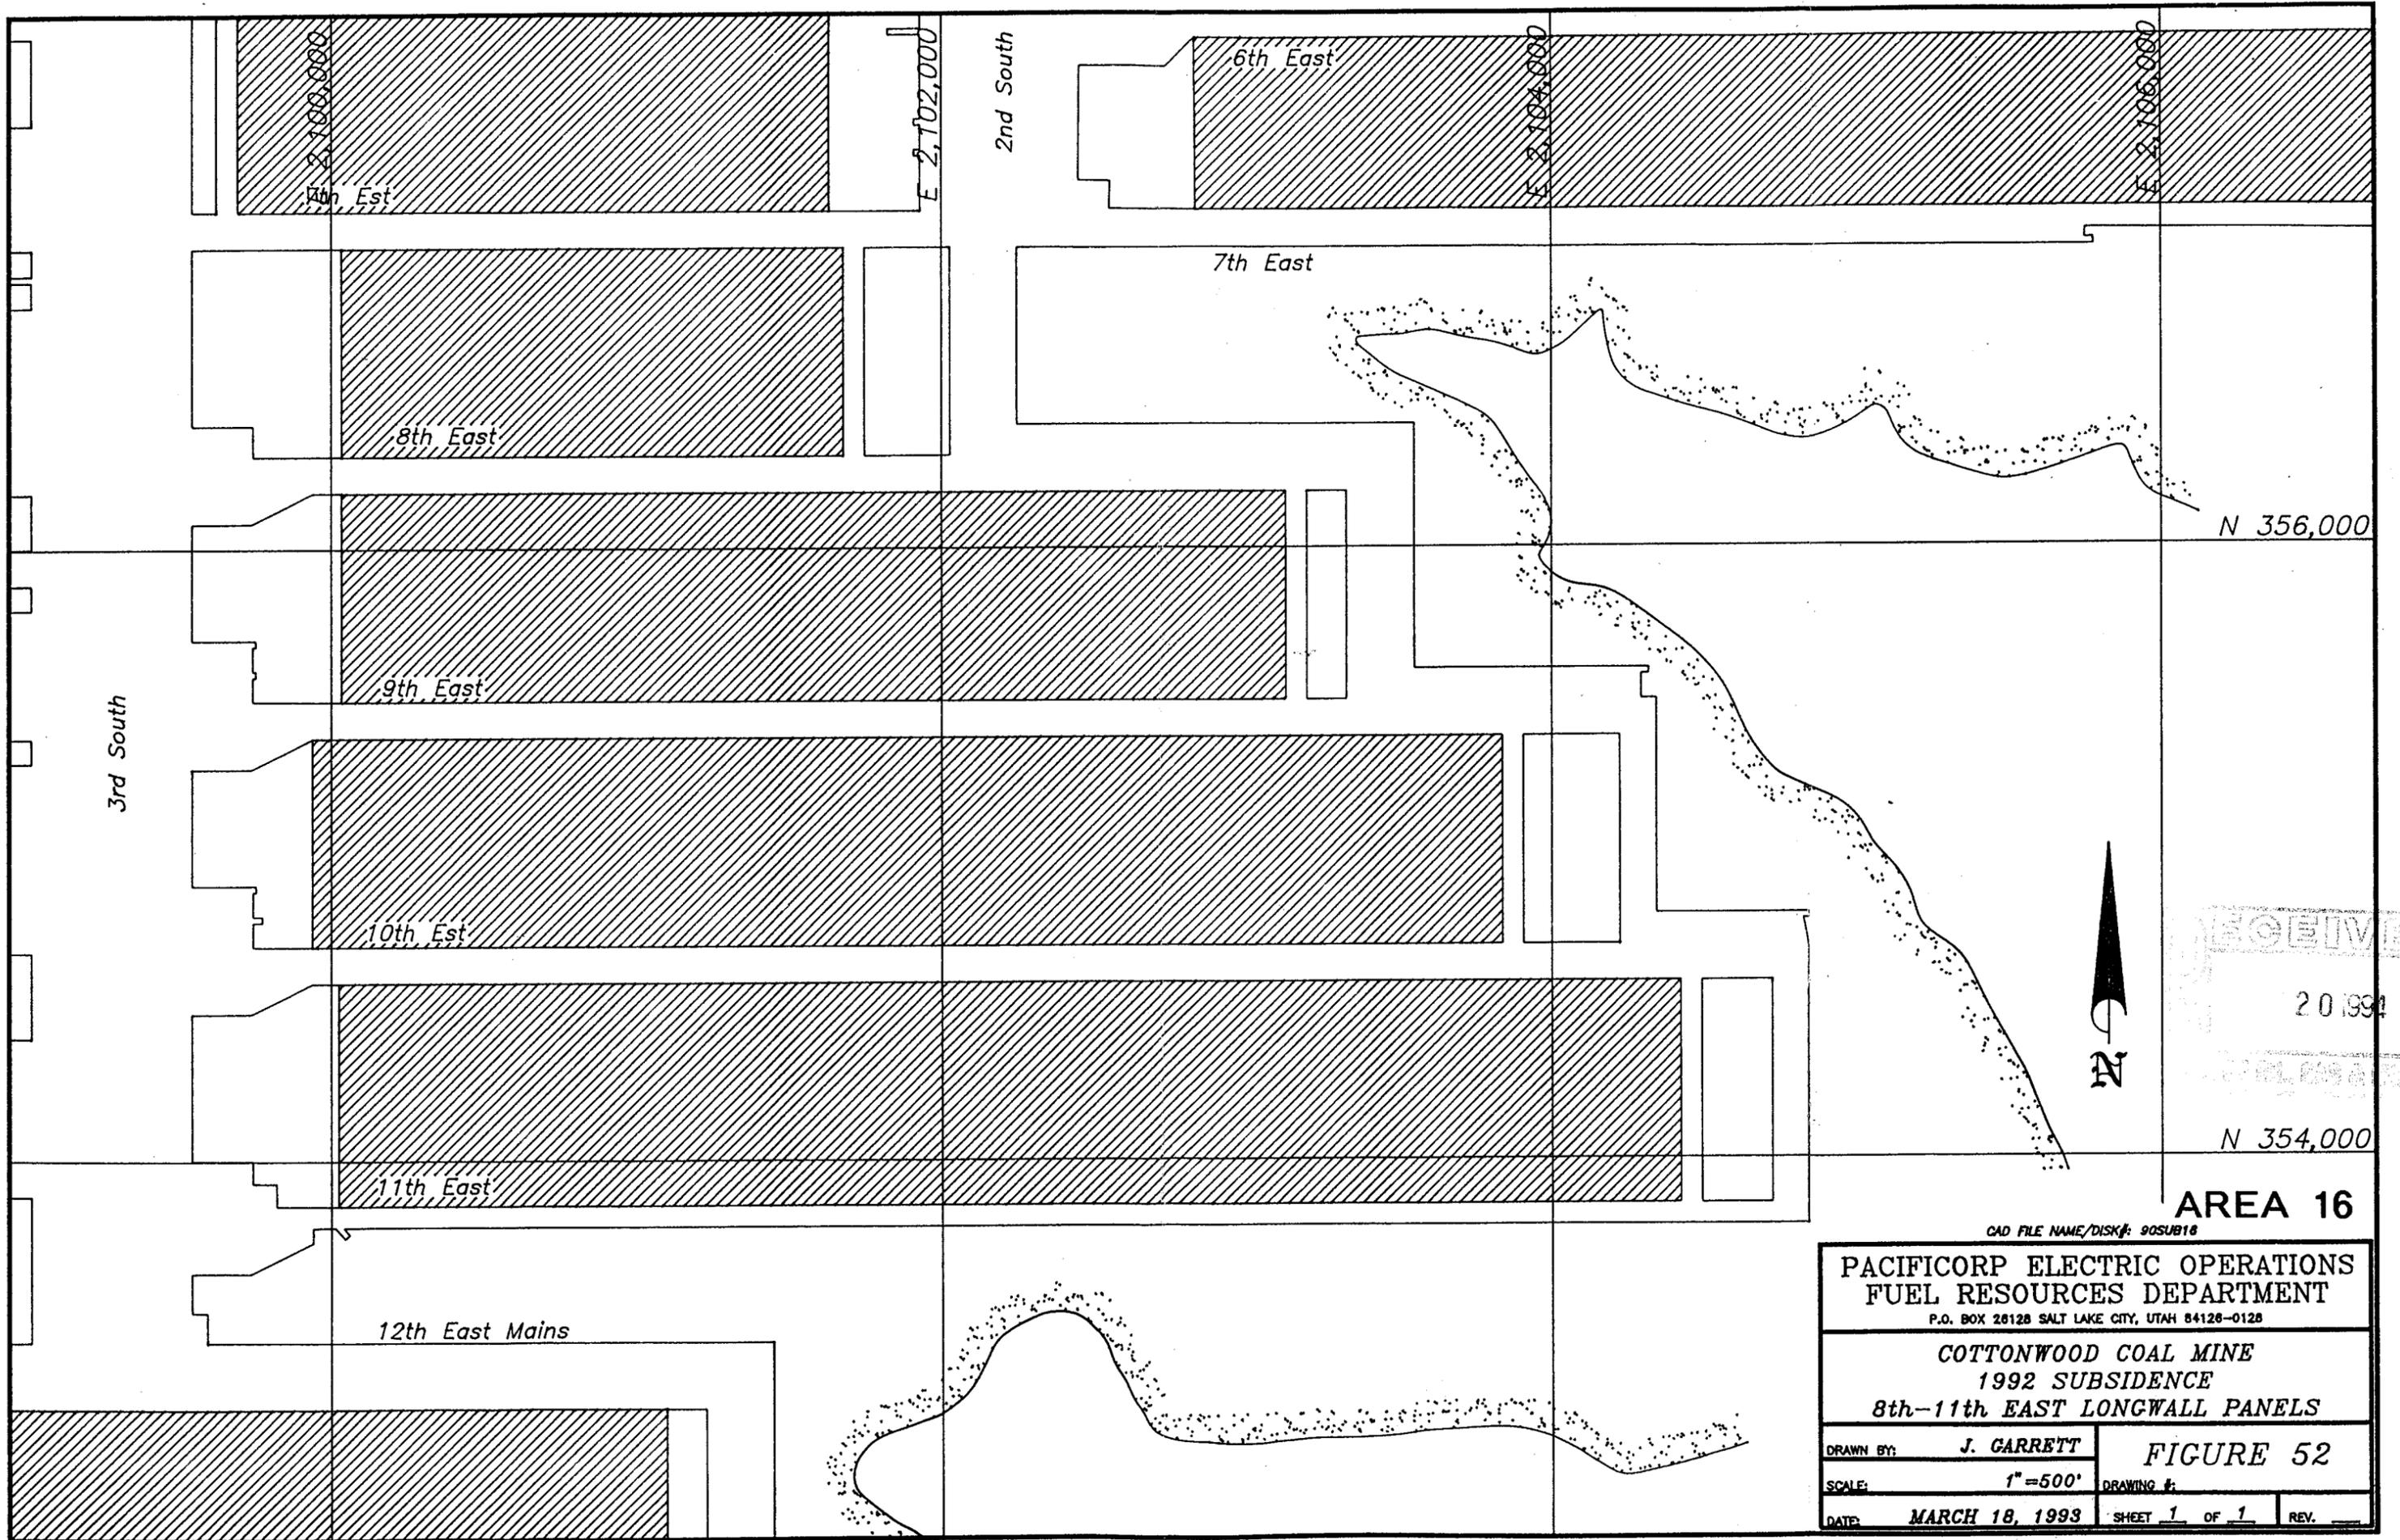
AREA 16

As with Area 14 cliff spalling has occurred in places and the resulting talus has accumulated on the steep slopes below the cliffs. No surface cracks have been observed to date.

Maximum subsidence observed to date is eleven (11) feet and occurs over the 11th East panel where the overburden is less than 600 feet (Figure 53, 54, and 55).

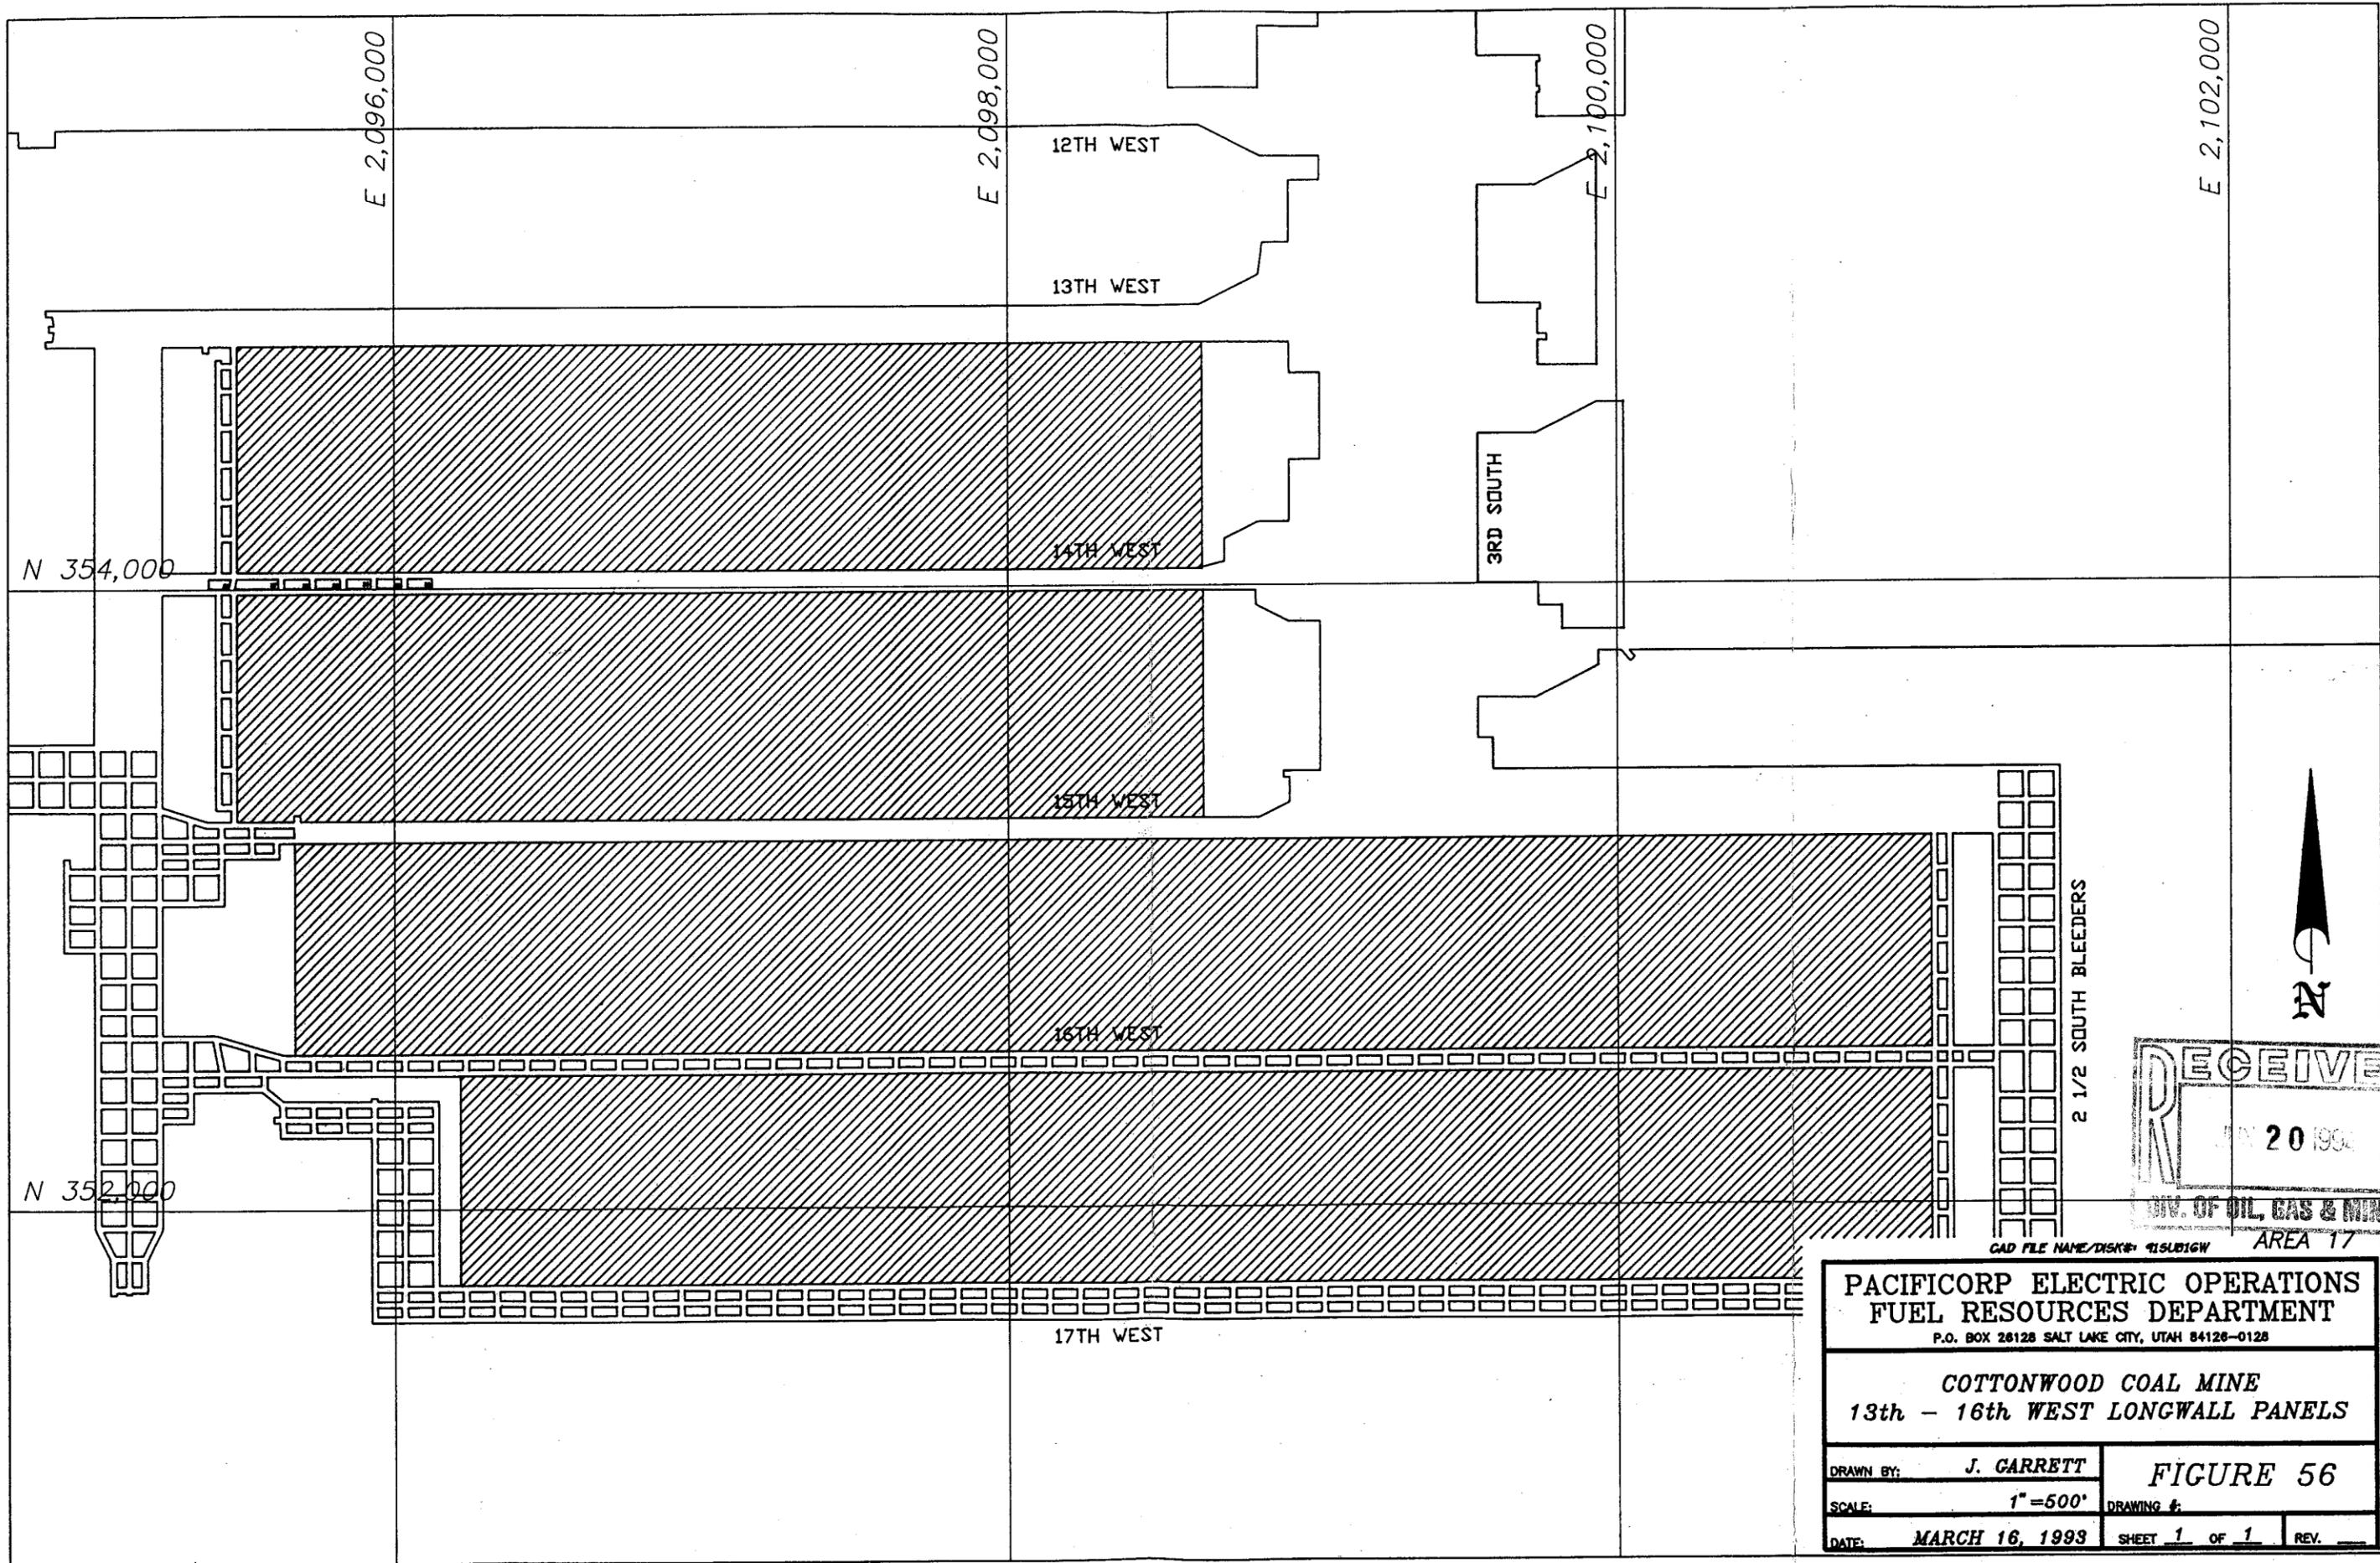
DRAWN BY:	J. GARRETT	DRAWING #:	FIGURE 56
SCALE:	1" = 500'		
DATE:	MARCH 16, 1993	SHEET 1 OF 1	REV.

Mining in the 16th West longwall panel began in October 1990 and the panel was completed in March 1991. Mining in the area was completed in March, 1992 with the completion of the 13th West longwall panel (figure 56).

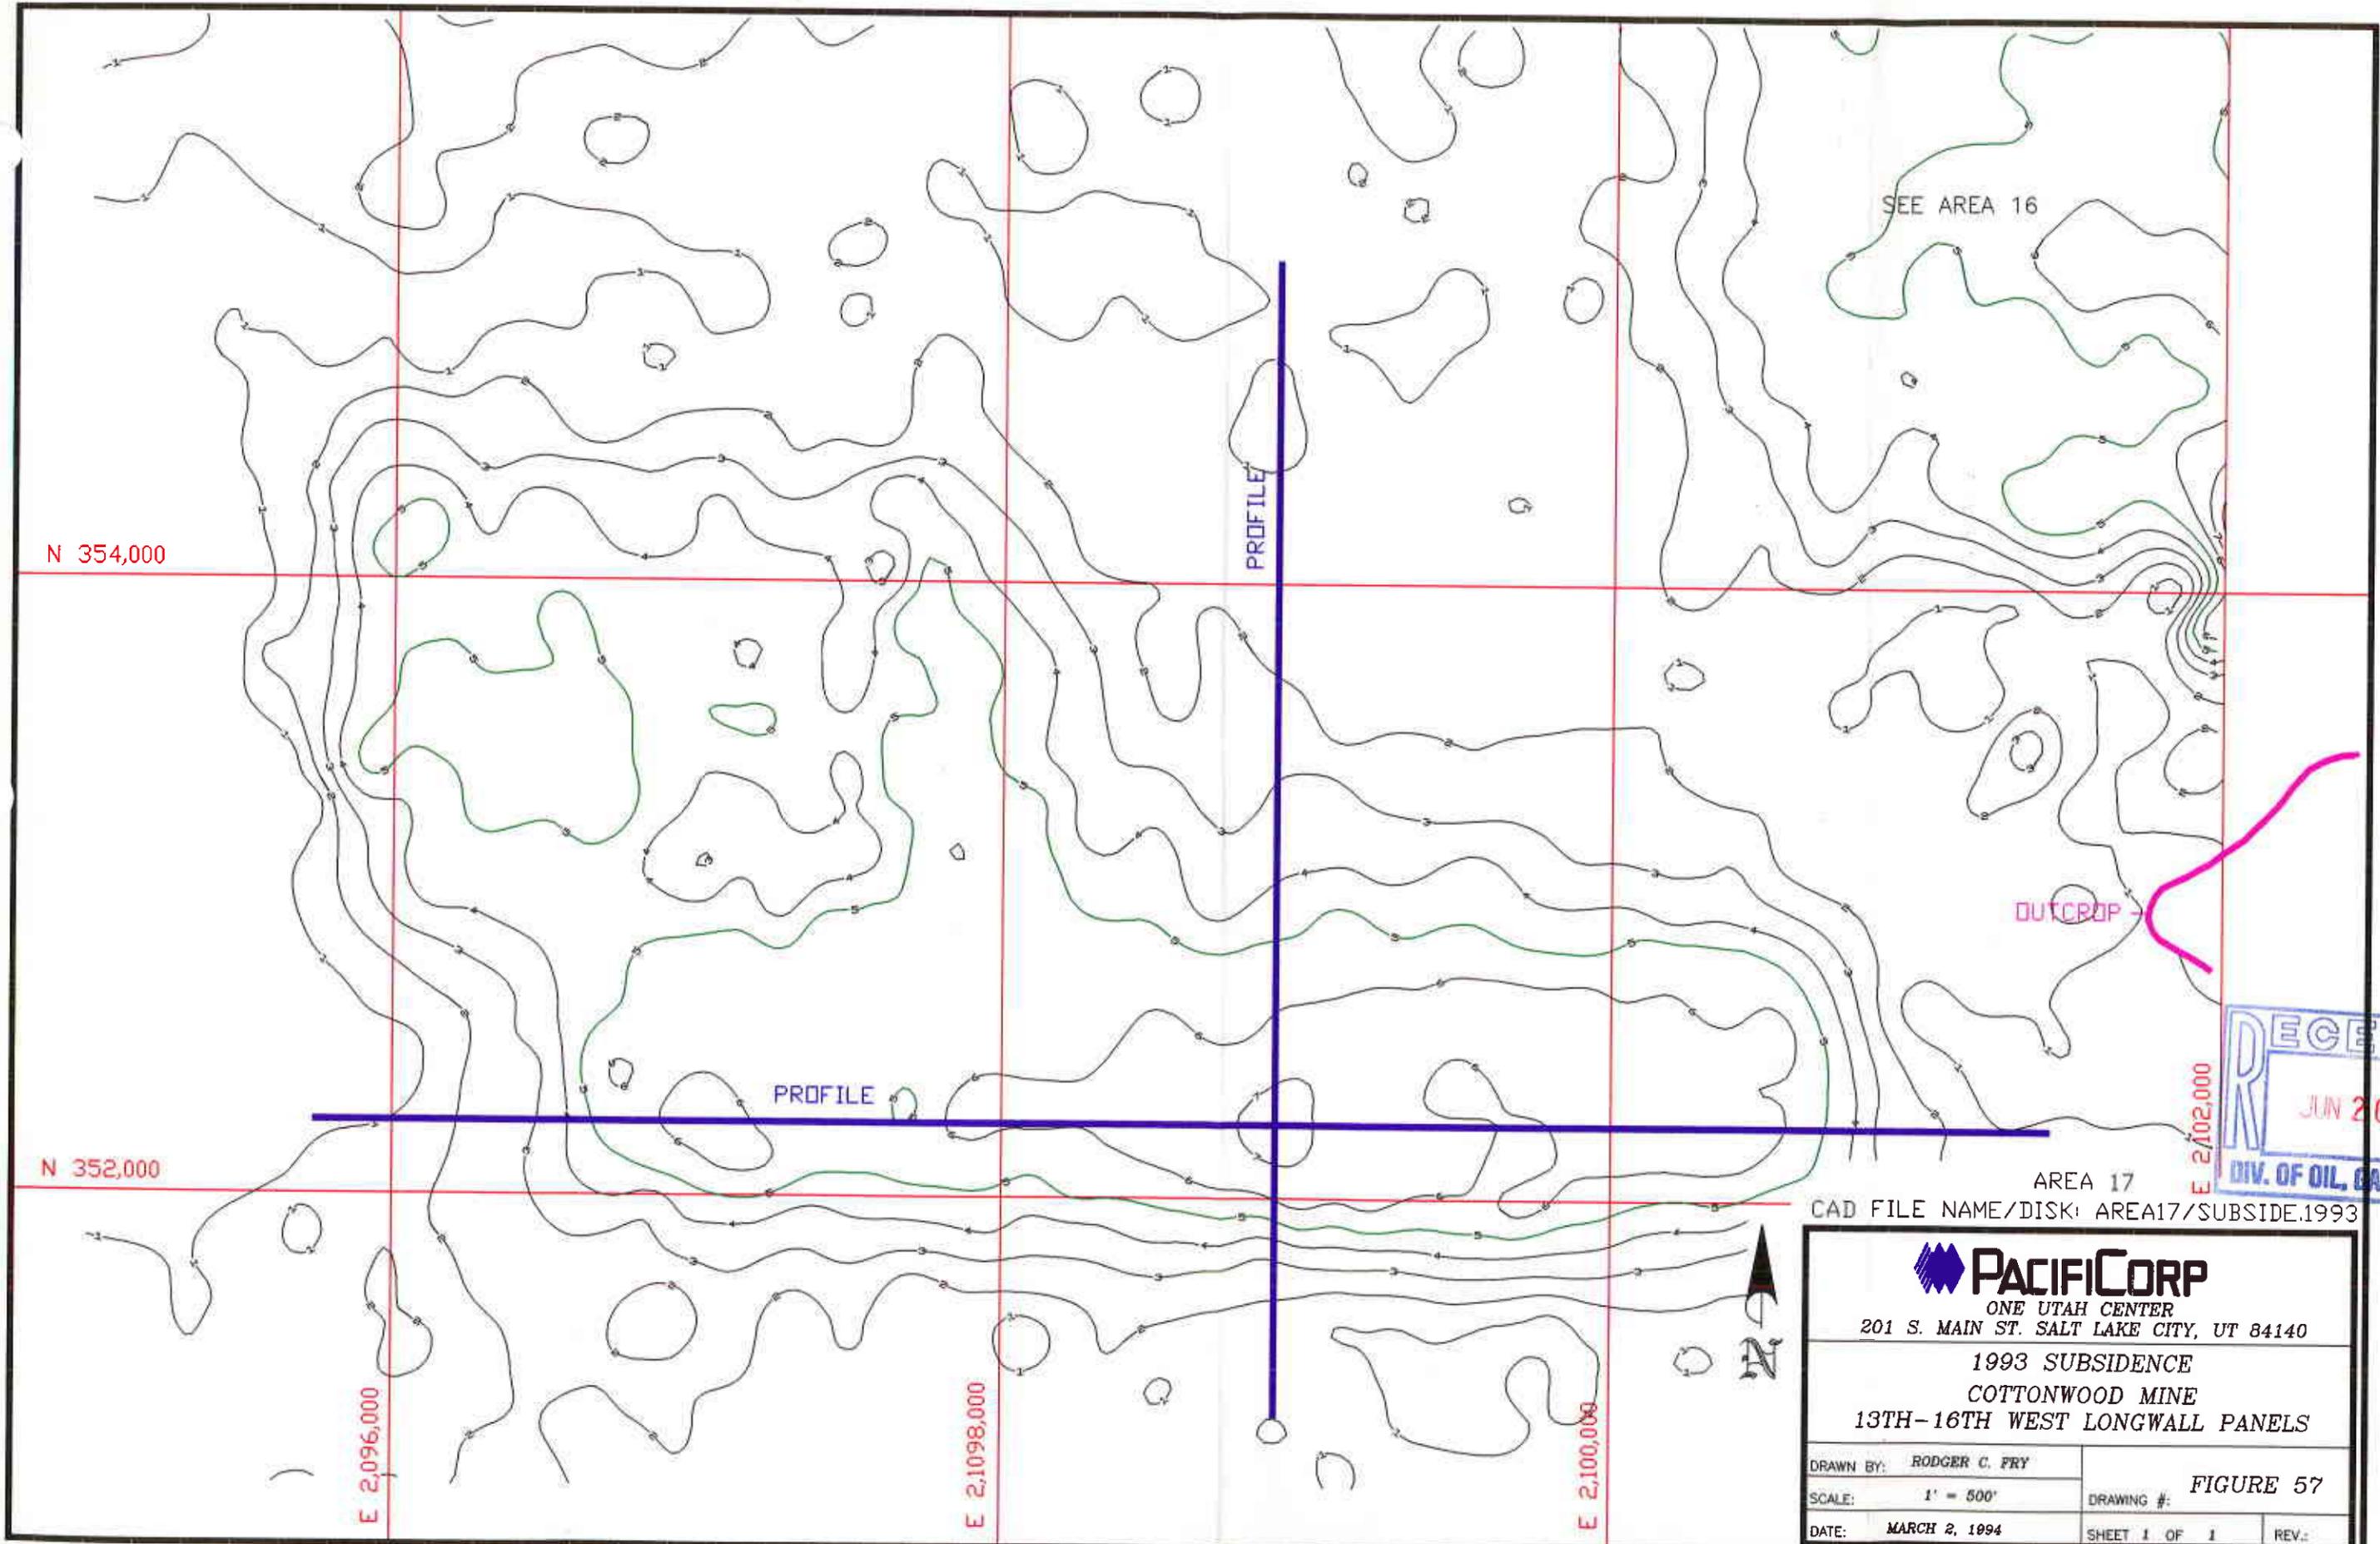
ONE UTAH CENTER 201 S. MAIN ST. SALT LAKE CITY, UT 84140		
1993 SUBSIDENCE COTTONWOOD MINE 13TH-16TH WEST LONGWALL PANELS		
DRAWN BY: RODGER C. FRY	DRAWING #: FIGURE 57	
SCALE: 1" = 500'	DATE: MARCH 2, 1994	SHEET 1 OF 1
		REV.:

The measured subsidence exceeds seven (7) feet in an area above the 16th west panel. The subsidence zone follows a narrow east-west trending trough centered above the two longer panels and then extends north above the 14th and 13th west longwall panels (figures 57, 58, and 59). No surface fractures have been observed in the area above these longwall panels.

On the south side of the subsidence zone, the angle of draw is less than 10 degrees.

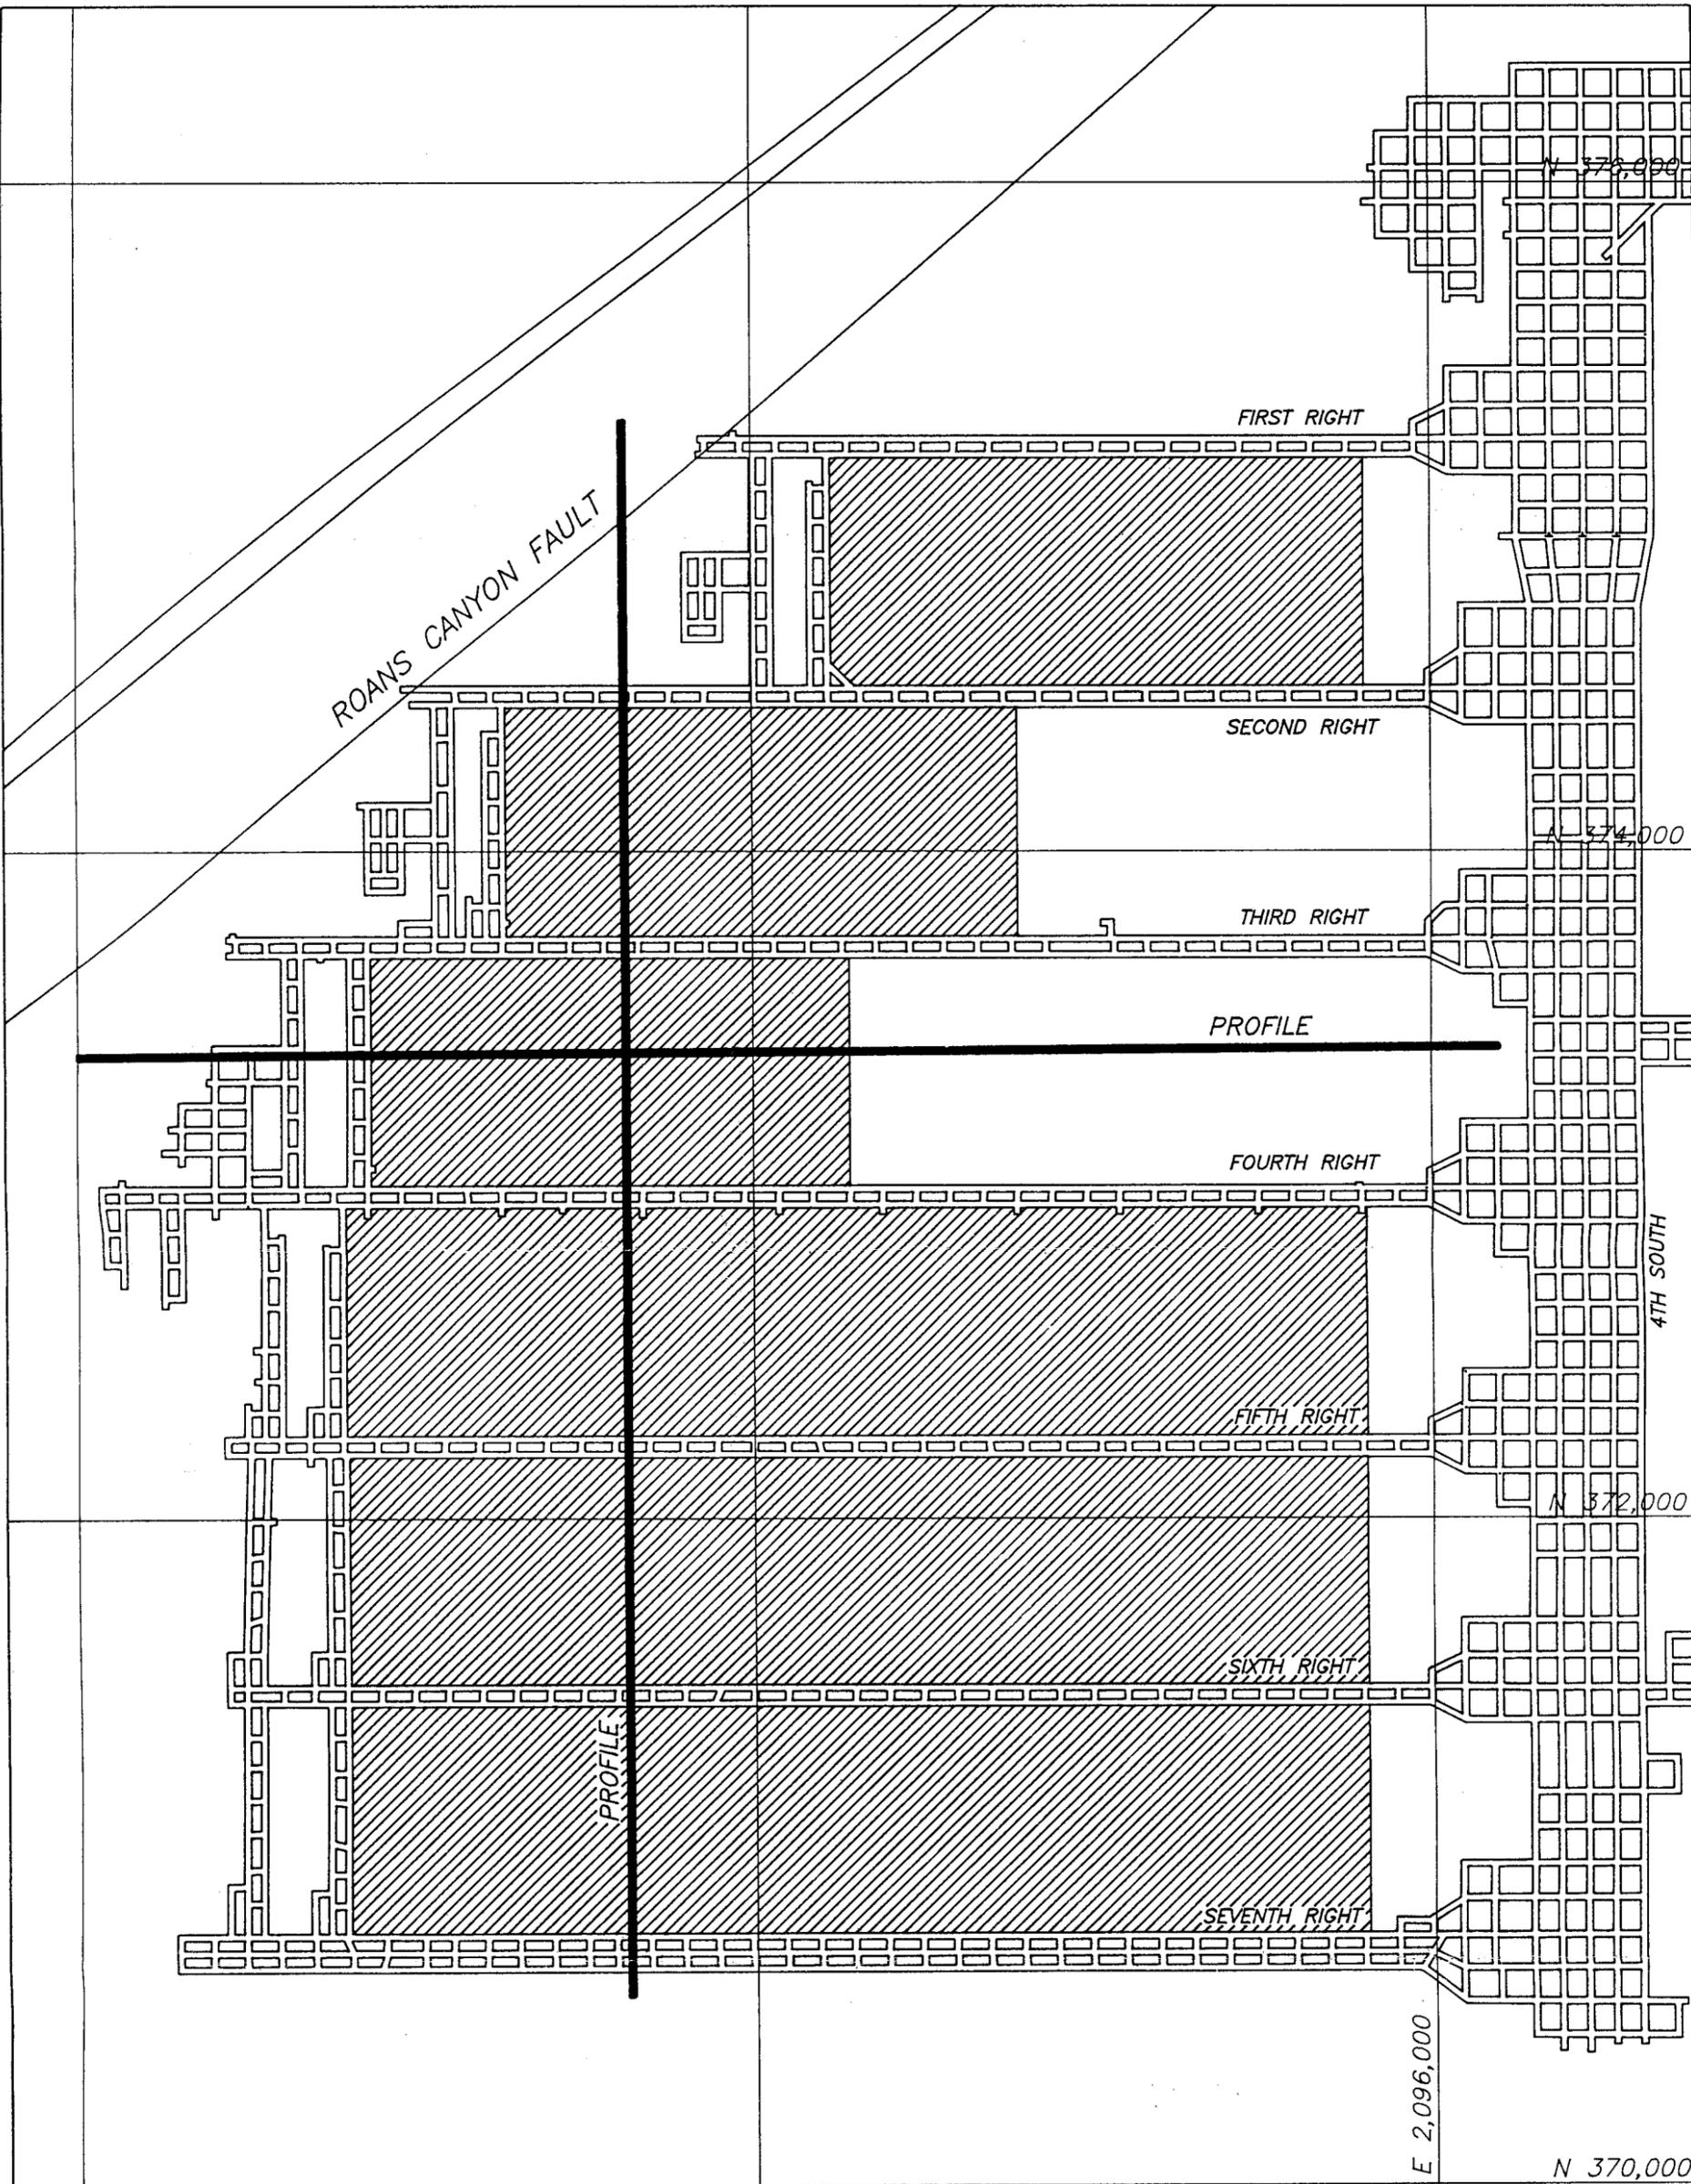
DRAWN BY: RODGER C. FRY	FIGURE 61	
SCALE: 1" = 500'	DRAWING #:	
DATE: MARCH 8, 1994	SHEET 1 OF 1	REV.:

Subsidence in this area has reached a maximum of eight (8) feet (Figures 61, 62, and 63). The subsidence zone is a broad trough running in a north - south direction. This area is overlain by several springs. Monitoring of these springs has shown no change in the quality or quantity of water discharged from these springs (see appendix and the 1992 Hydrologic Monitoring report).

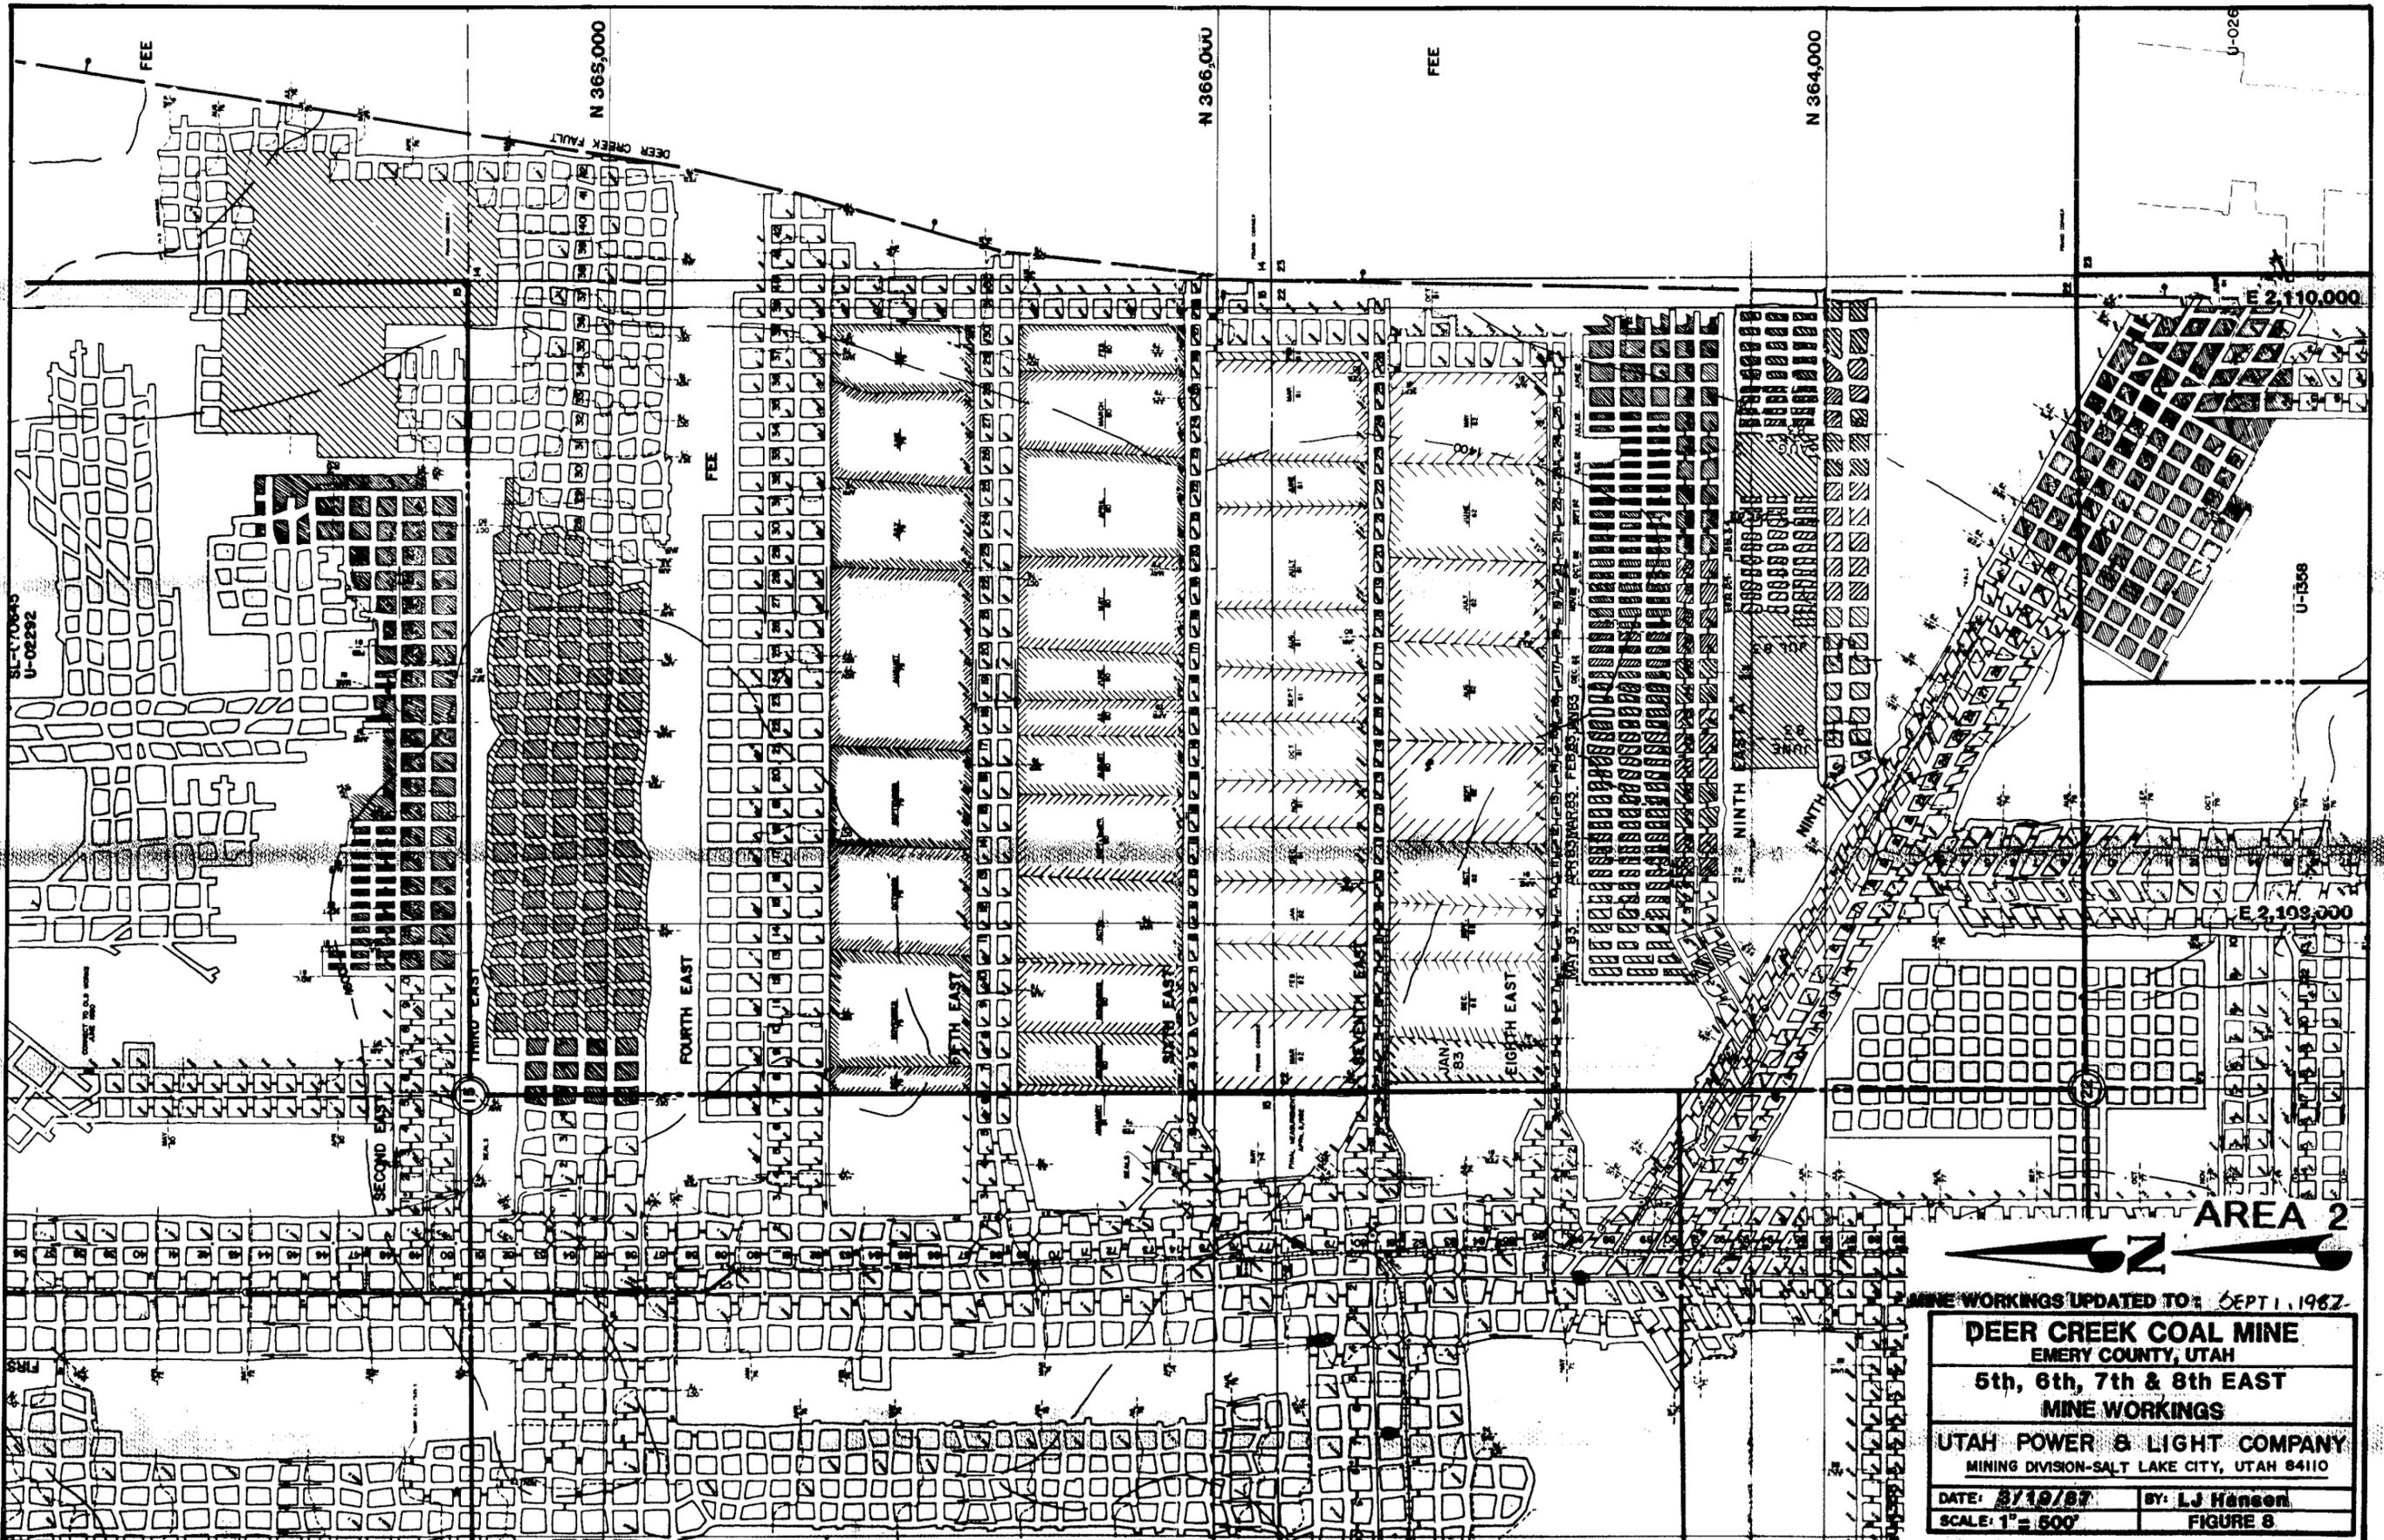
DEER CREEK COAL MINE	
EMERY COUNTY, UTAH	
5th, 6th, 7th & 8th EAST	
MINE WORKINGS	
UTAH POWER & LIGHT COMPANY	
MINING DIVISION-SALT LAKE CITY, UTAH 84110	
DATE: 8/10/67	BY: L.J. Hansen
SCALE: 1" = 500'	FIGURE 8

Mining in the Deer Creek Mine in Area 2 was completed by February 1985. Coal extraction in the underlying Wilberg Mine 3rd and 4th Right panels was completed between September 1987 and the end of January 1988 (Figures 8 and 9).

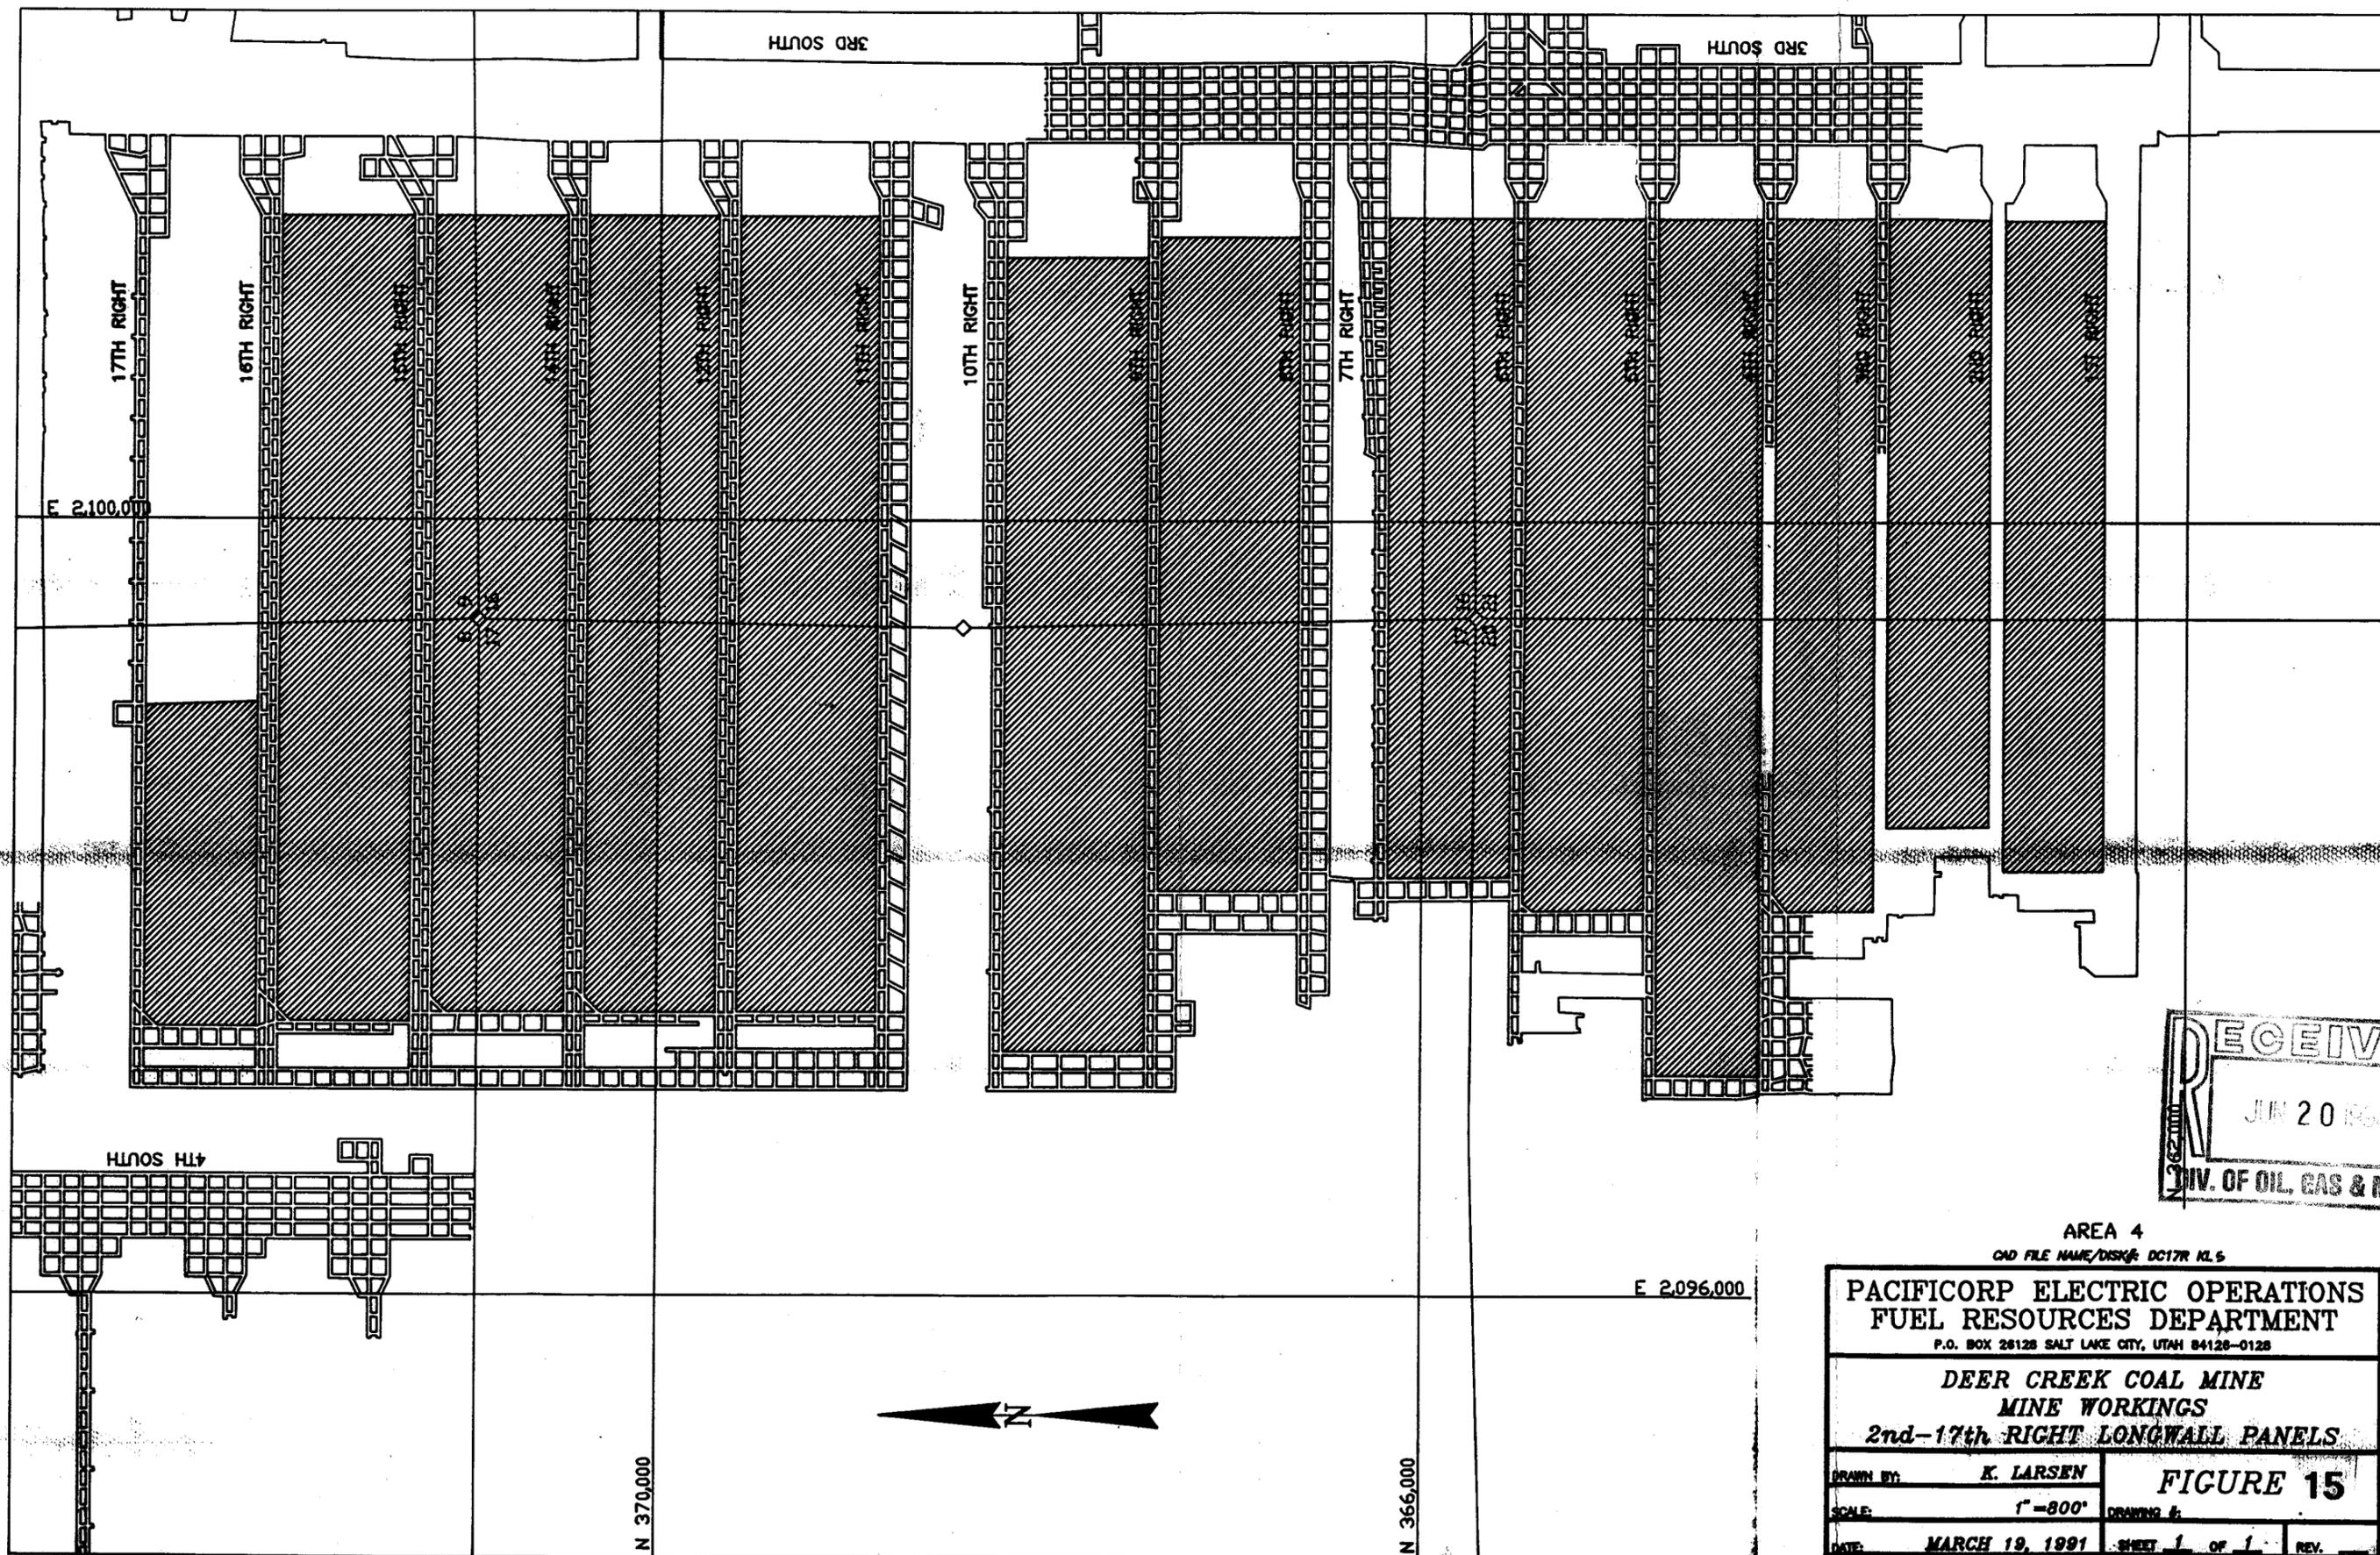
DRAWN BY:	K. LARSEN	FIGURE 15
SCALE:	1" = 800'	
DATE:	MARCH 19, 1991	SHEET 1 of 1 REV.

Subsidence in Area 4 was detected for the first time in 1984 by photogrammetric methods. Longwall mining commenced in the 2nd Right longwall panels in 1980 and by the end of August 1991 the 2nd through 17th Right panels had been completed (Figure 15).
