ANNUAL SUBSIDENCE MONITORING REPORT
EAST MOUNTAIN PROPERTY
1993

PACIFICORP
TECHNICAL SERVICES REPORT
RODGER C. FRY

PACIFICORP
SUBSIDENCE MONITORING PROGRAM
ANNUAL REPORT FOR 1993

June 1994

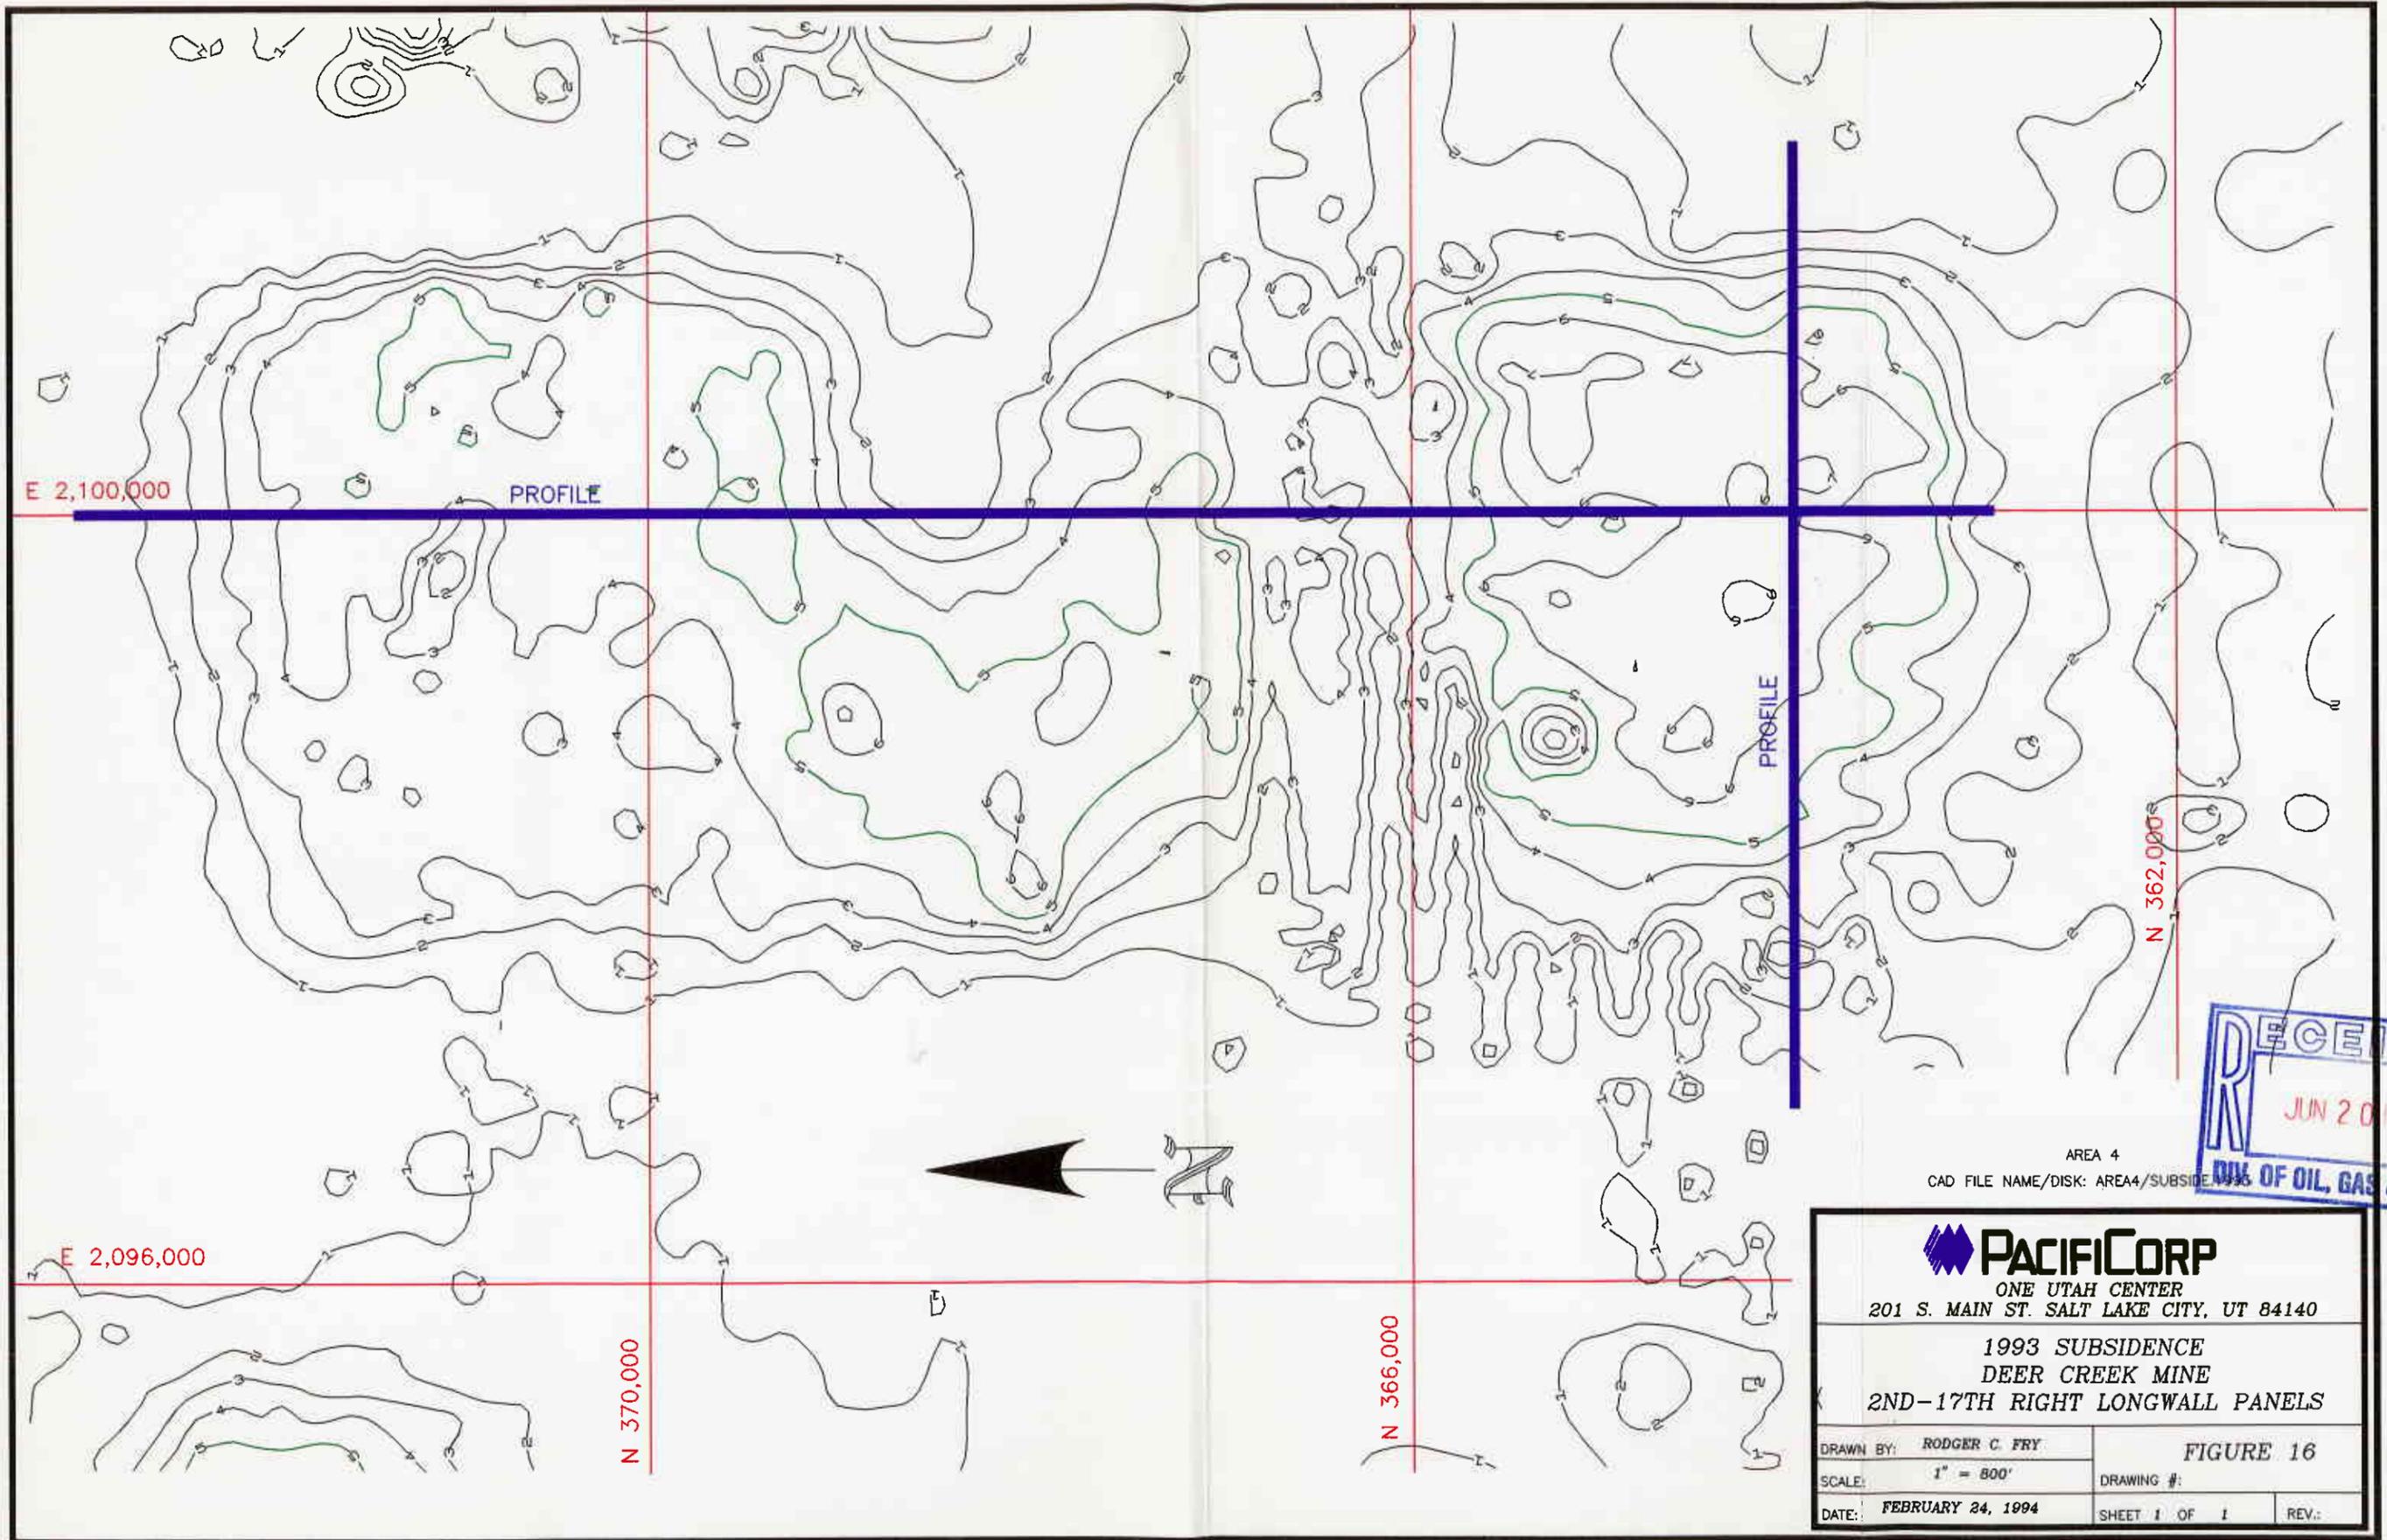
DRAWN BY: RODGER C. FRY	FIGURE 16
SCALE: 1" = 800'	DRAWING #:
DATE: FEBRUARY 24, 1994	SHEET 1 OF 1
	REV.:

Maximum subsidence is just over seven (7) feet over the 5th Right longwall panel (Figure 16). The profiles, Figures 17 and 18 show some variability from year to year. This area is heavily vegetated and it is thought that this creates difficulties in obtaining consistent readings from year to year. The calculated angle-of-draw of the subsidence ranges from less than zero to 22 degrees.

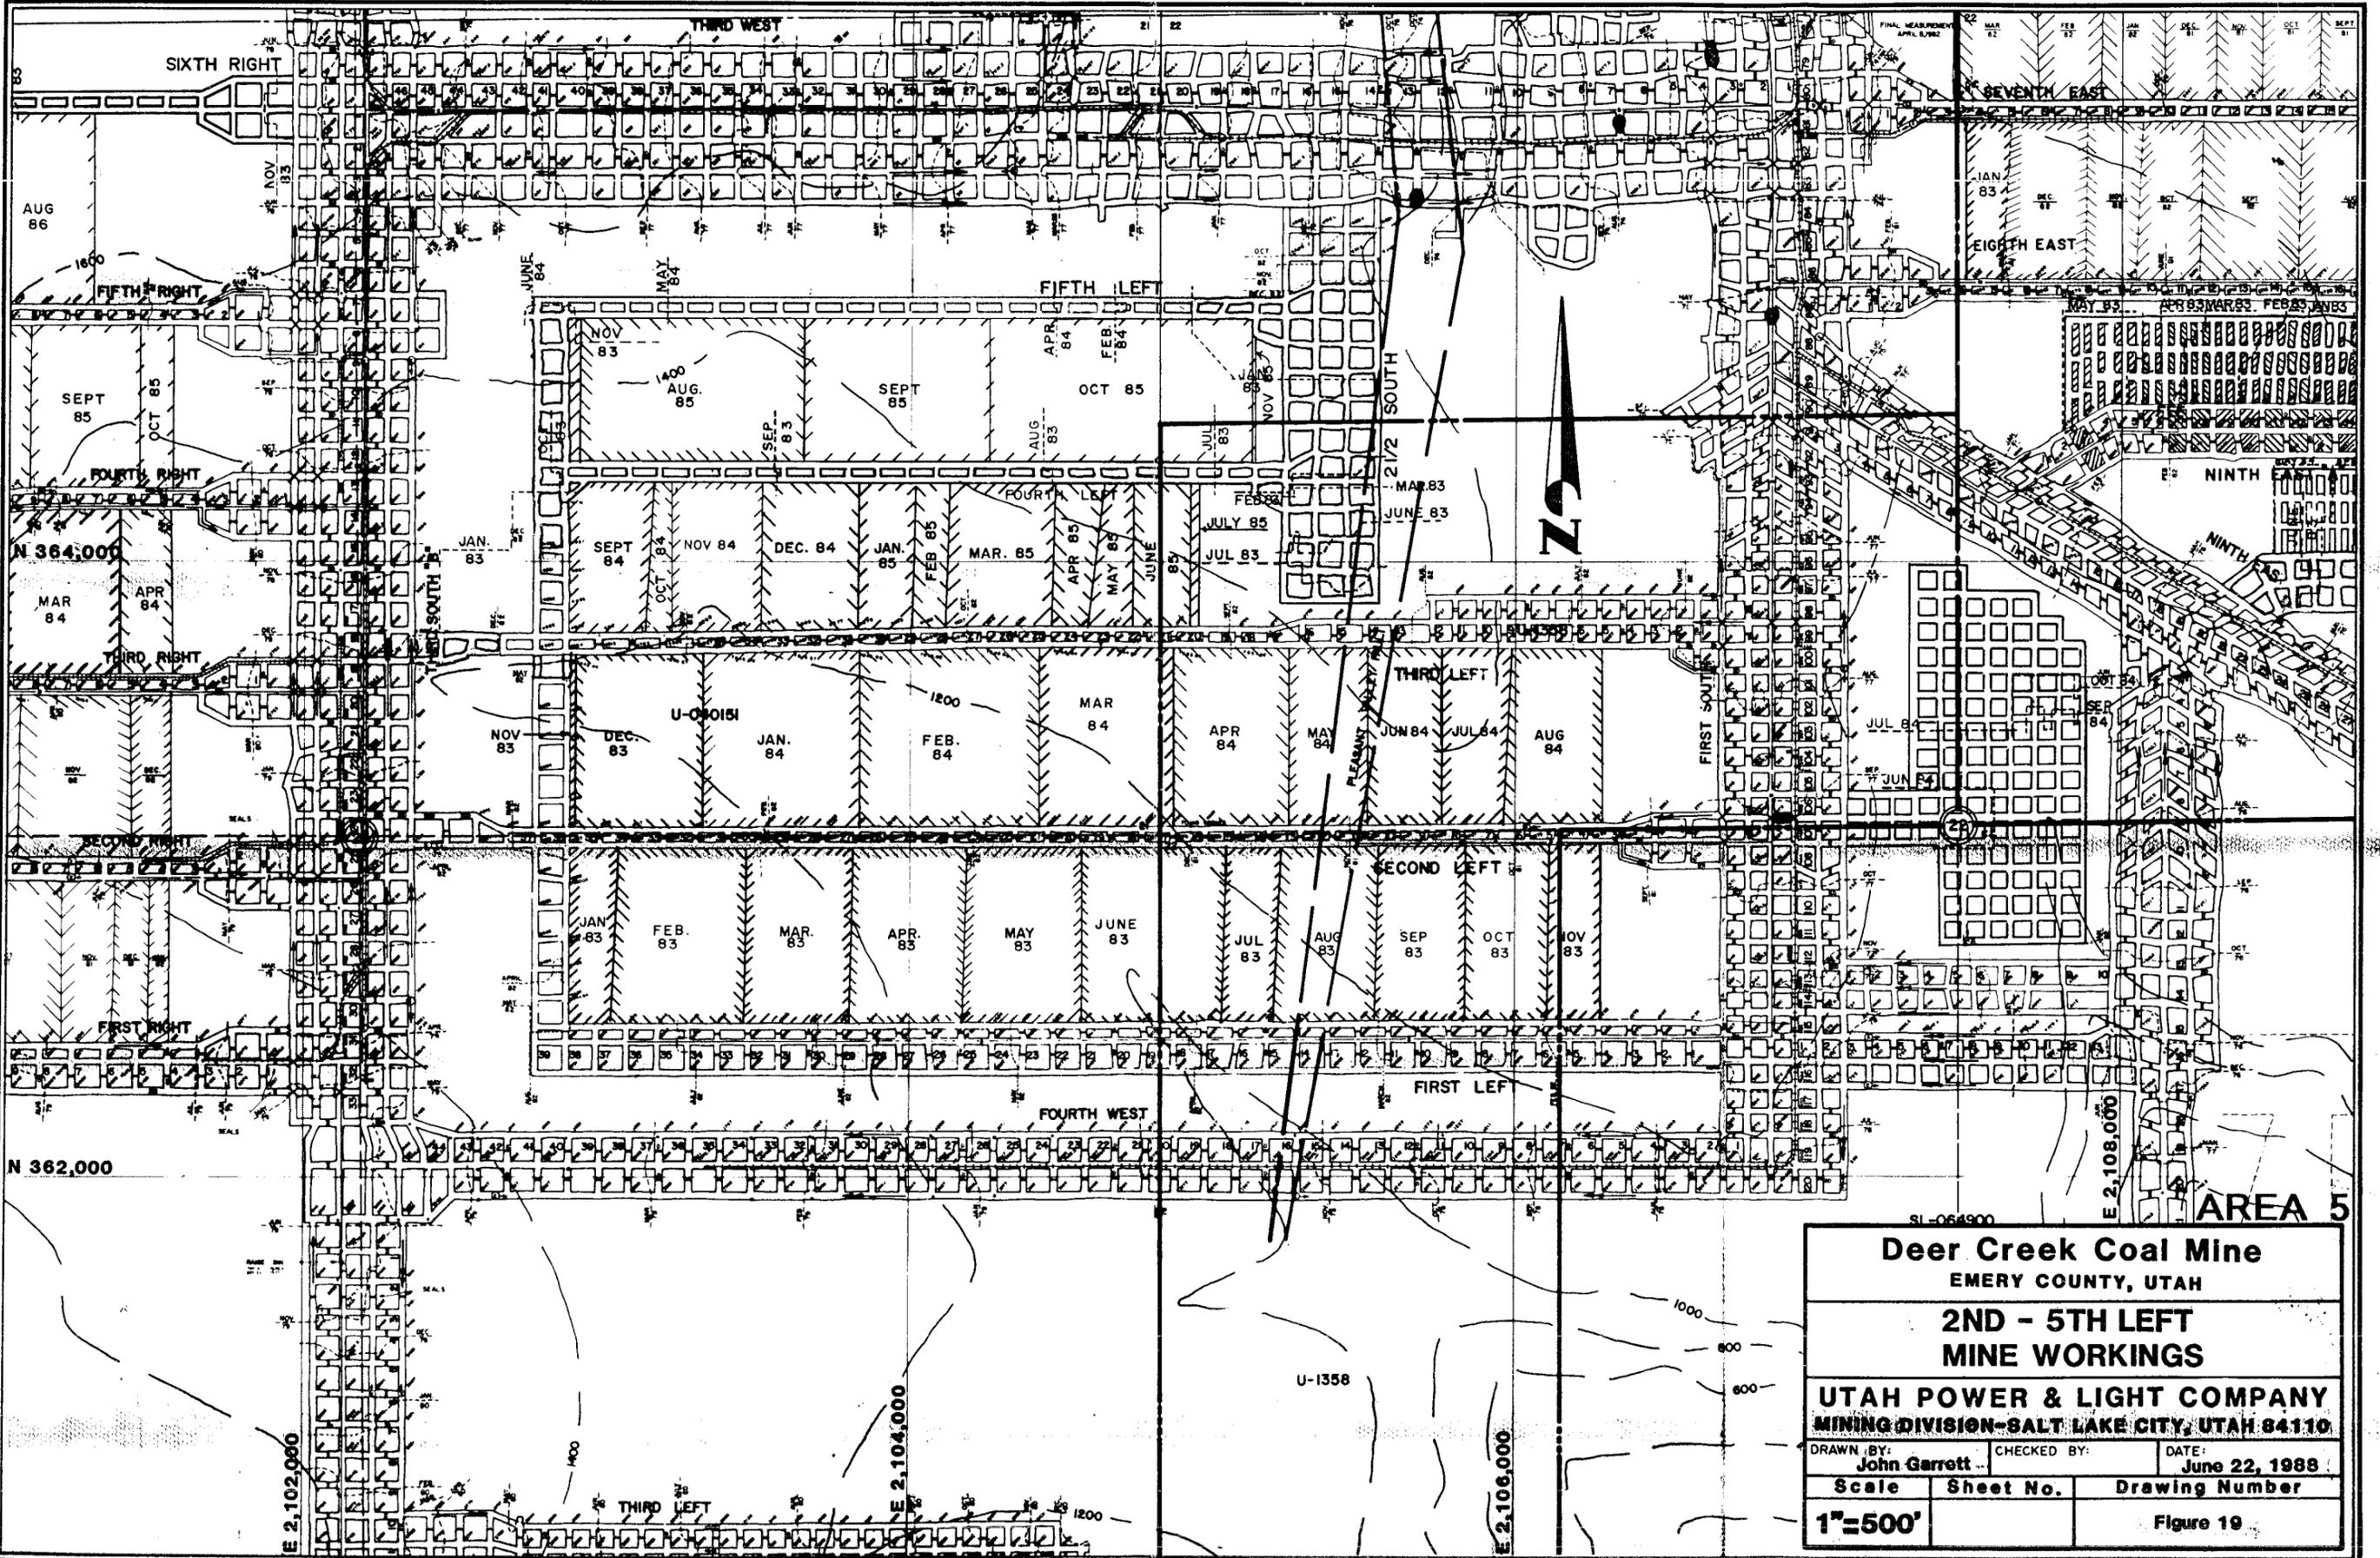
Deer Creek Coal Mine		
EMERY COUNTY, UTAH		
2ND - 5TH LEFT		
MINE WORKINGS		
UTAH POWER & LIGHT COMPANY		
MINING DIVISION-SALT LAKE CITY, UTAH 84110		
DRAWN BY:	CHECKED BY:	DATE:
John Garrett	[Signature]	June 22, 1988
Scale	Sheet No.	Drawing Number
1"=500'		Figure 19

Photogrammetry revealed subsidence in Area 5 for the first time in 1984. Mining of the 2nd Left longwall panel began in January 1983, and by October 1985 all four panels had been completed (Figure 19).

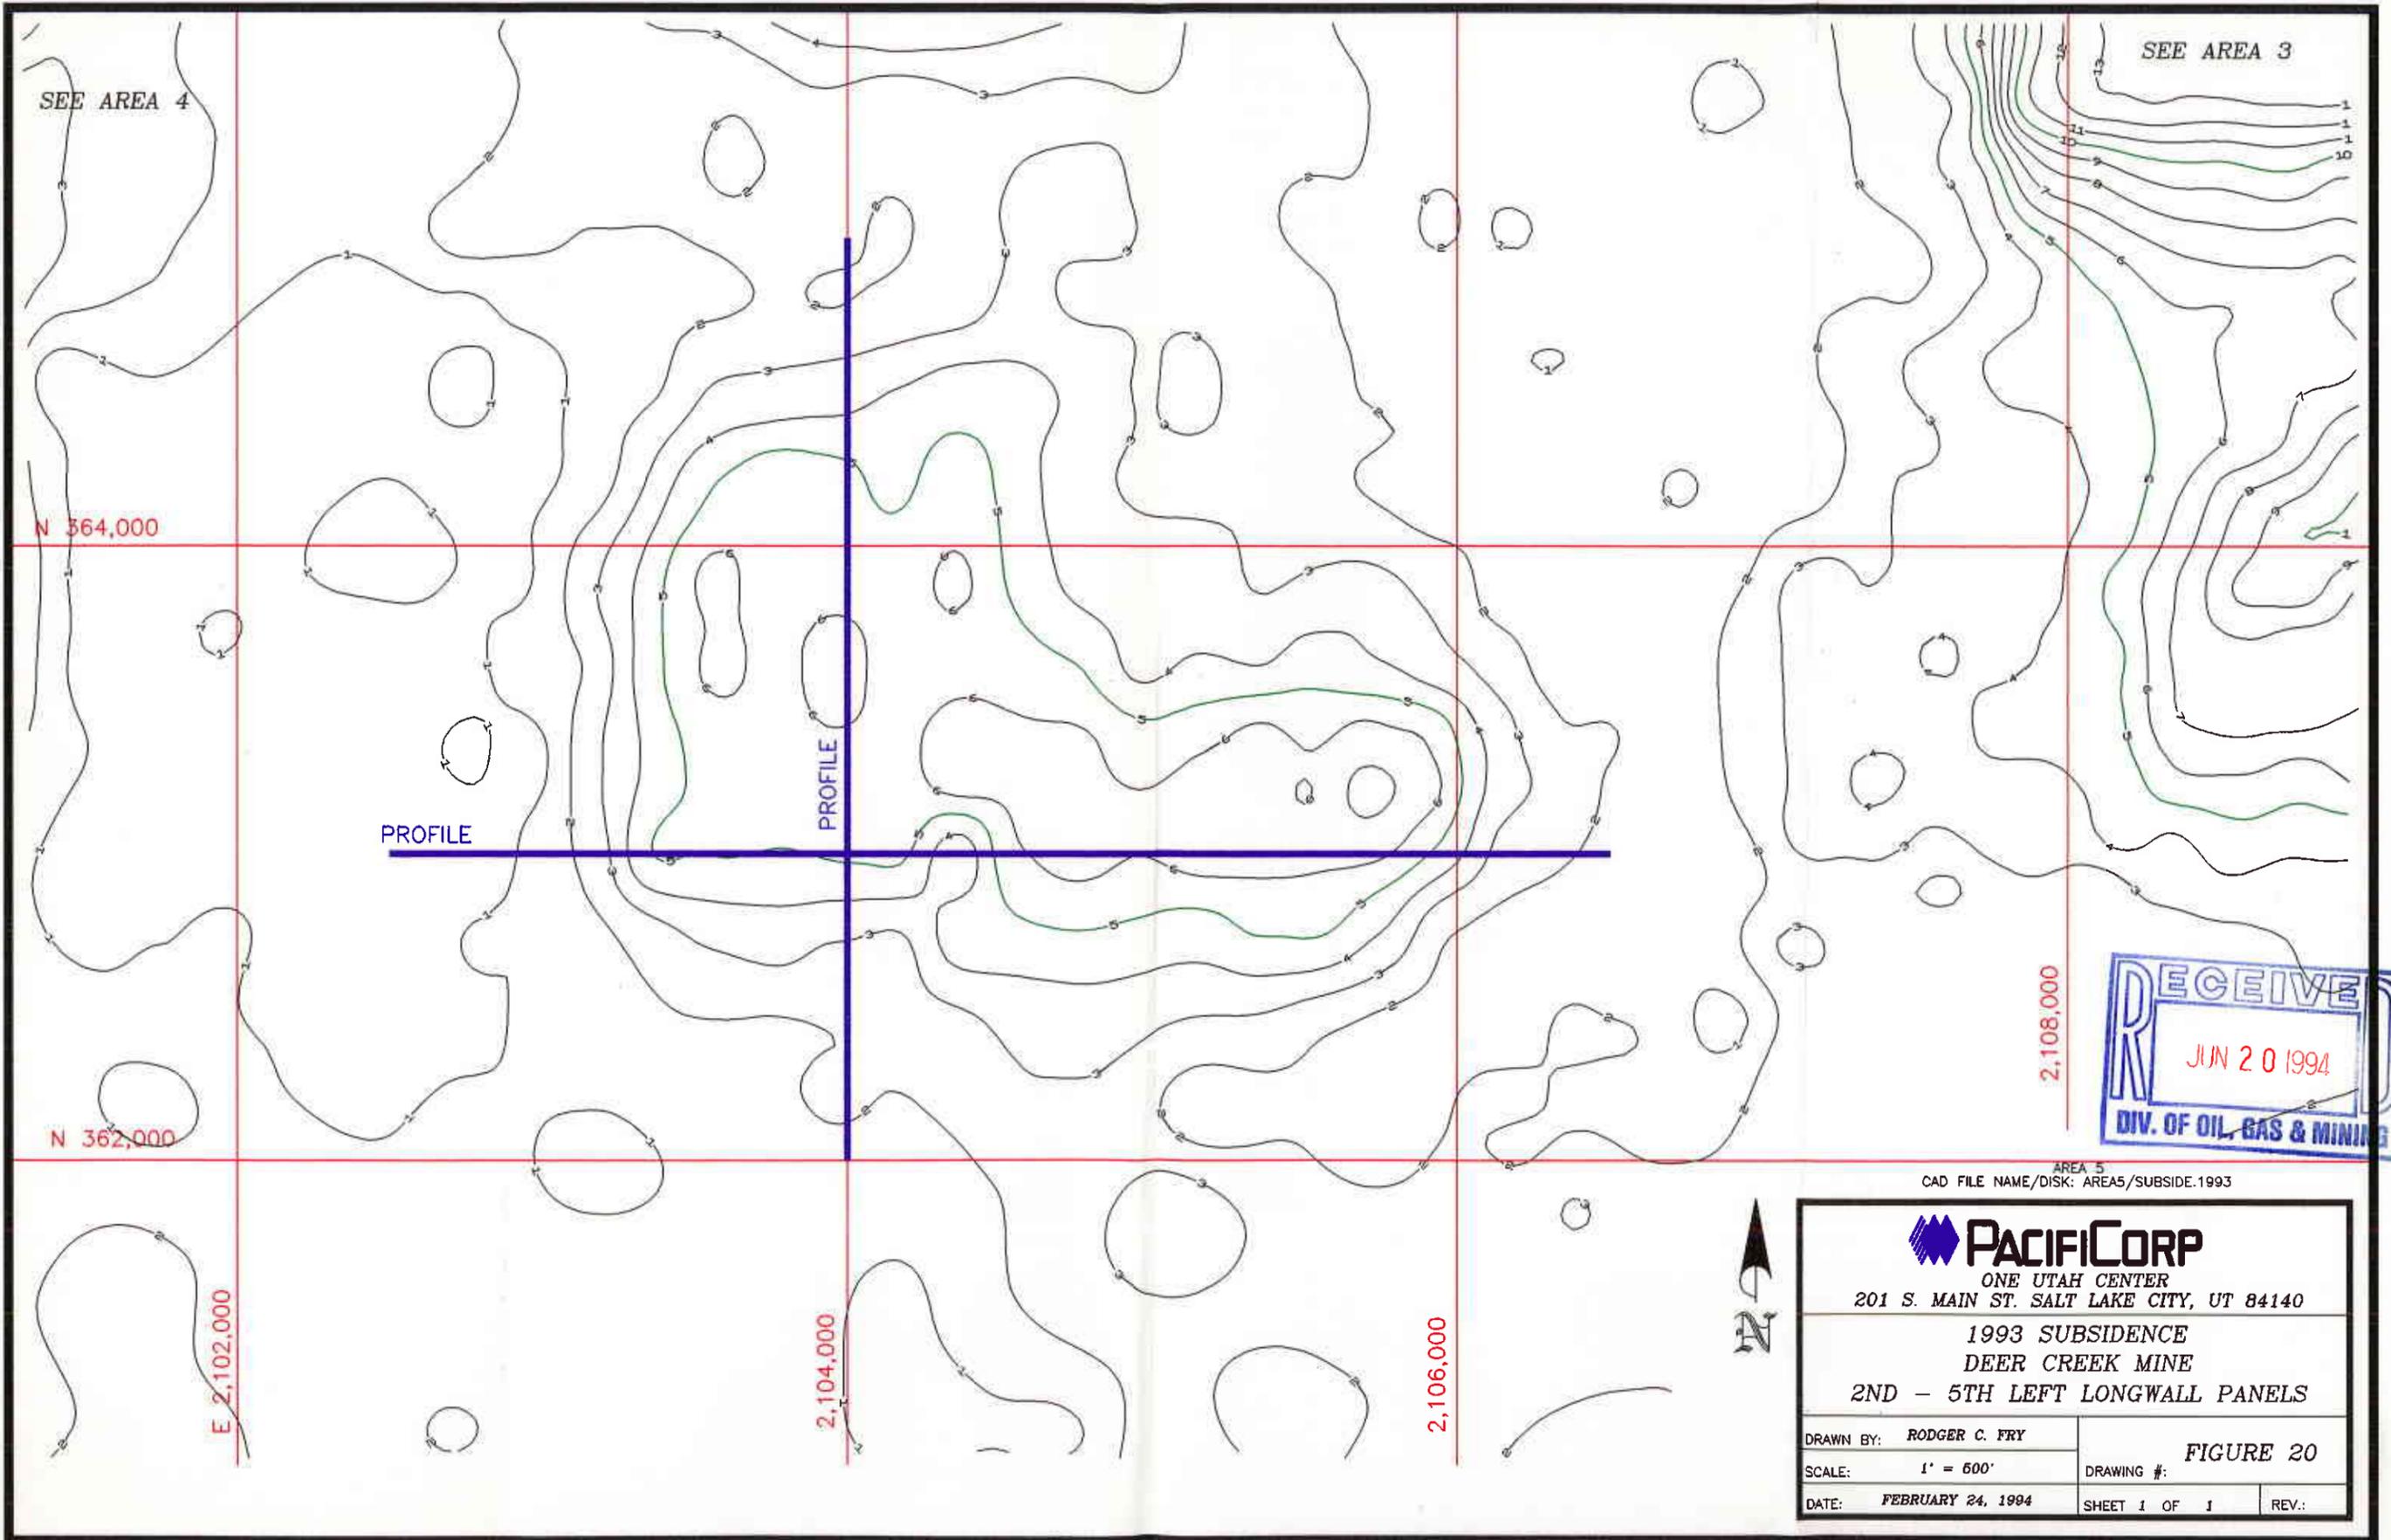
PACIFICORP ONE UTAH CENTER 201 S. MAIN ST. SALT LAKE CITY, UT 84140		
1993 SUBSIDENCE DEER CREEK MINE 2ND - 5TH LEFT LONGWALL PANELS		
DRAWN BY: RODGER C. FRY	FIGURE 20	
SCALE: 1" = 600'	DRAWING #:	
DATE: FEBRUARY 24, 1994	SHEET 1 OF 1	REV.:

Maximum subsidence over the panels is about seven (7) feet (Figure 20). The maximum subsidence shows an increase since 1991 over the center of the panels (Figures 21 and 22). No surface disturbance has been identified over the panels.

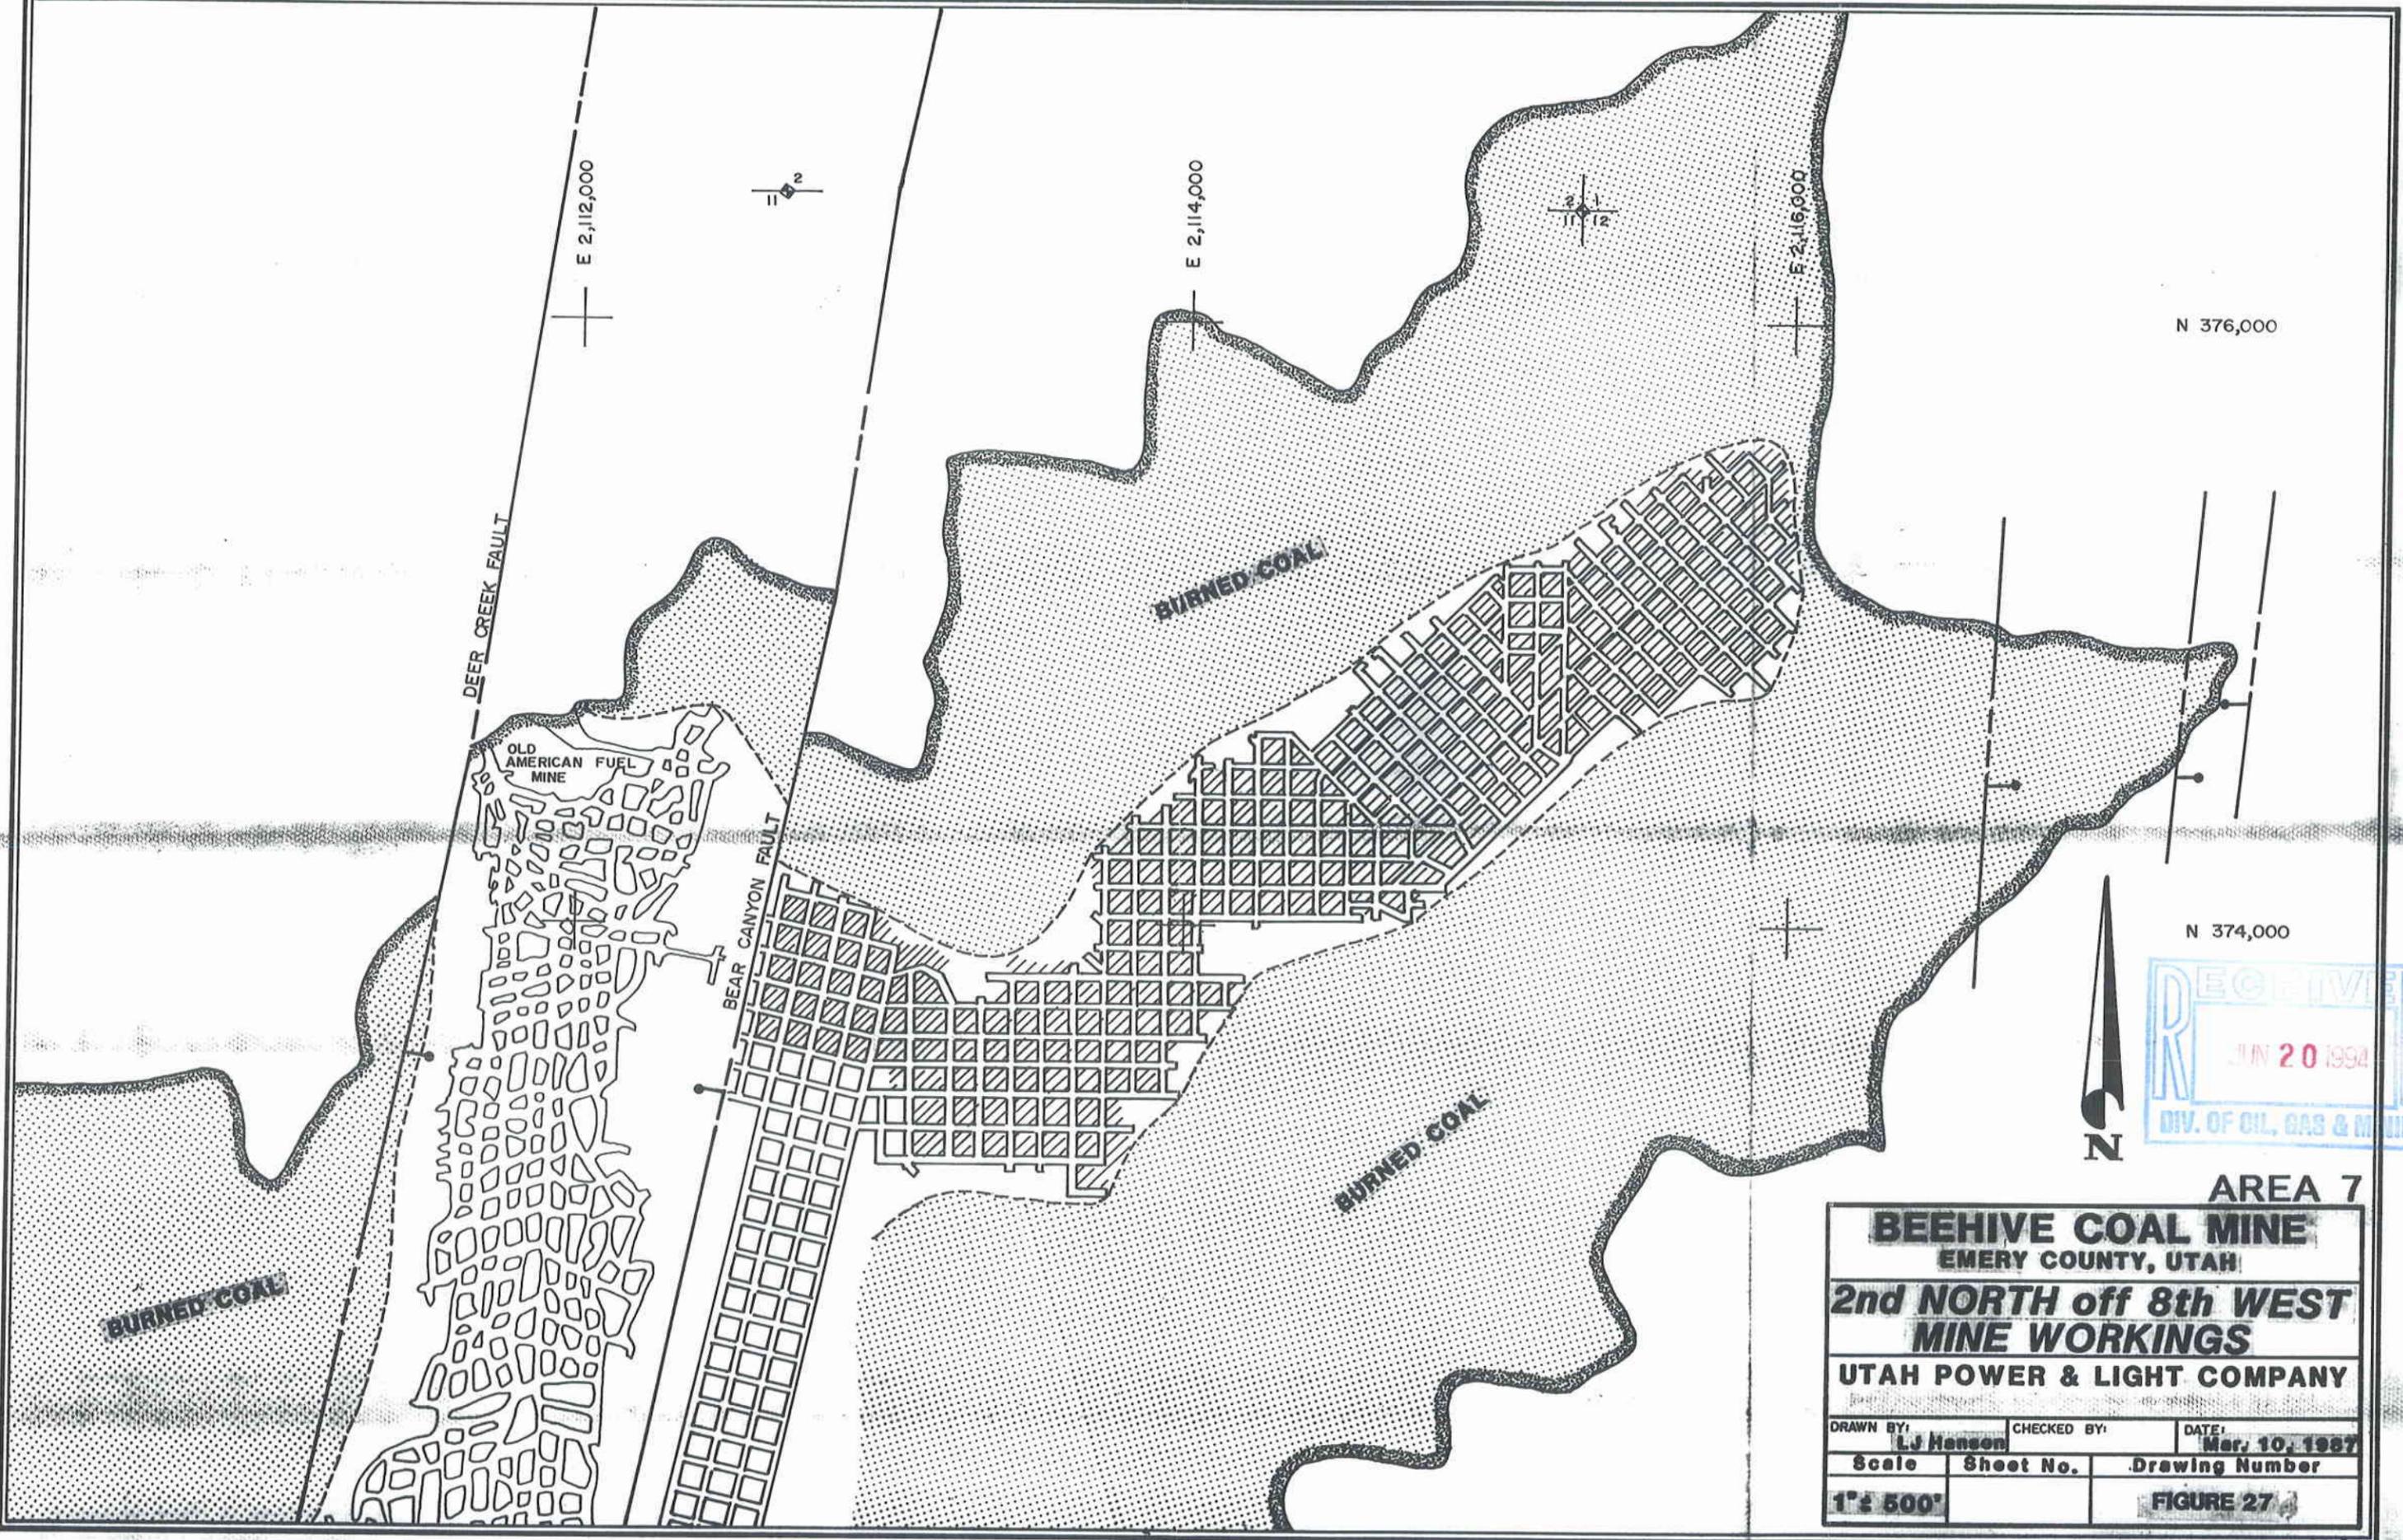
BEEHIVE COAL MINE		
EMERY COUNTY, UTAH		
2nd NORTH off 8th WEST		
MINE WORKINGS		
UTAH POWER & LIGHT COMPANY		
DRAWN BY: L.J. Henson	CHECKED BY:	DATE: Mar. 10, 1987
Scale 1" = 500'	Sheet No.	Drawing Number
		FIGURE 27

Pillar extraction mining in 2nd North was completed in 1983 and, as shown in Figures 27, 28, and 29, little additional subsidence has occurred over the workings since 1984. The workings are surrounded by burned coal.

Maximum subsidence is as much as six (6) feet. In examining the area by helicopter and aerial photography it is apparent that much of the elevation change measured was due to cliff failure and mass wasting on the steep slopes above the workings, where the rocks were highly fractured prior to mining.

It was not possible to get an accurate angle-of-draw because crushing of the surrounding clinker beds allowed subsidence to occur several thousand feet from the mine workings in some cases.
