ANNUAL SUBSIDENCE MONITORING REPORT
EAST / TRAIL MOUNTAIN PROPERTIES
1995

PACIFICORP
TECHNICAL SERVICES REPORT
RODGER C. FRY

MARCH 29, 1996

PACIFICORP
SUBSIDENCE MONITORING PROGRAM
ANNUAL REPORT FOR 1995

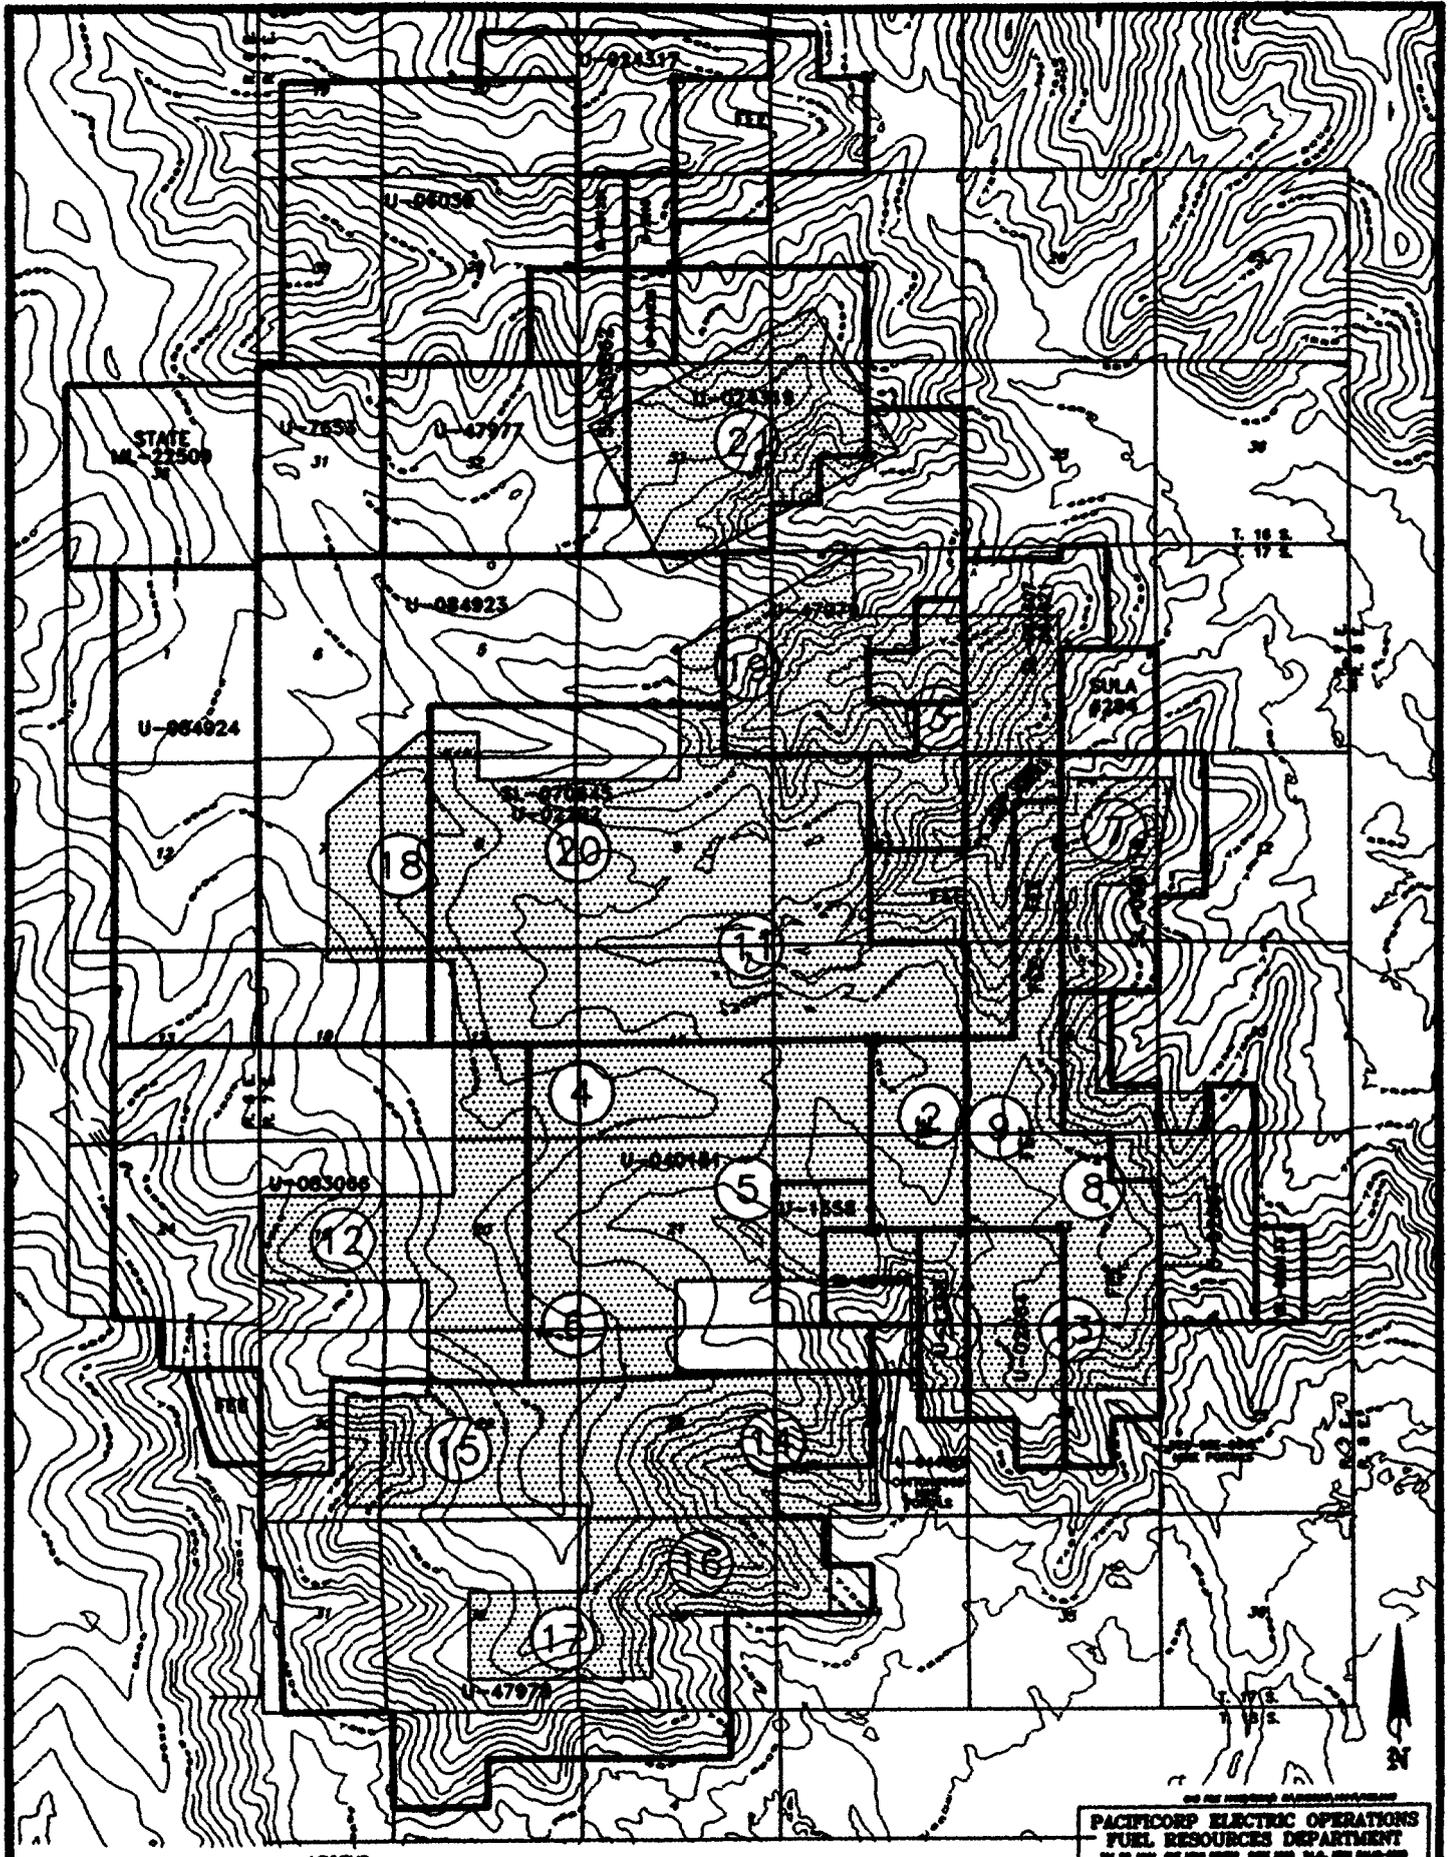
DRAWN BY R. C. FRY	FIGURE 2
SCALE 1" = 1 MILE	
DATE JAN. 20, 1995	DRAWN BY J. J. J.

Figure 2 shows all areas above PacifiCorp's coal mines which have potential for mining-induced subsidence. New fractures were noticed in the field early in 1995 above recently extracted longwall panels in the Cottonwood Mine. These fractures will be discussed in detail latter in the report (see Area 4). A helicopter reconnaissance flight during 1995 revealed no new areas of visible surface disturbance. In areas where subsidence has been detected, data is shown in the form of contour maps and profiles. Both indicate elevation change from pre-mining

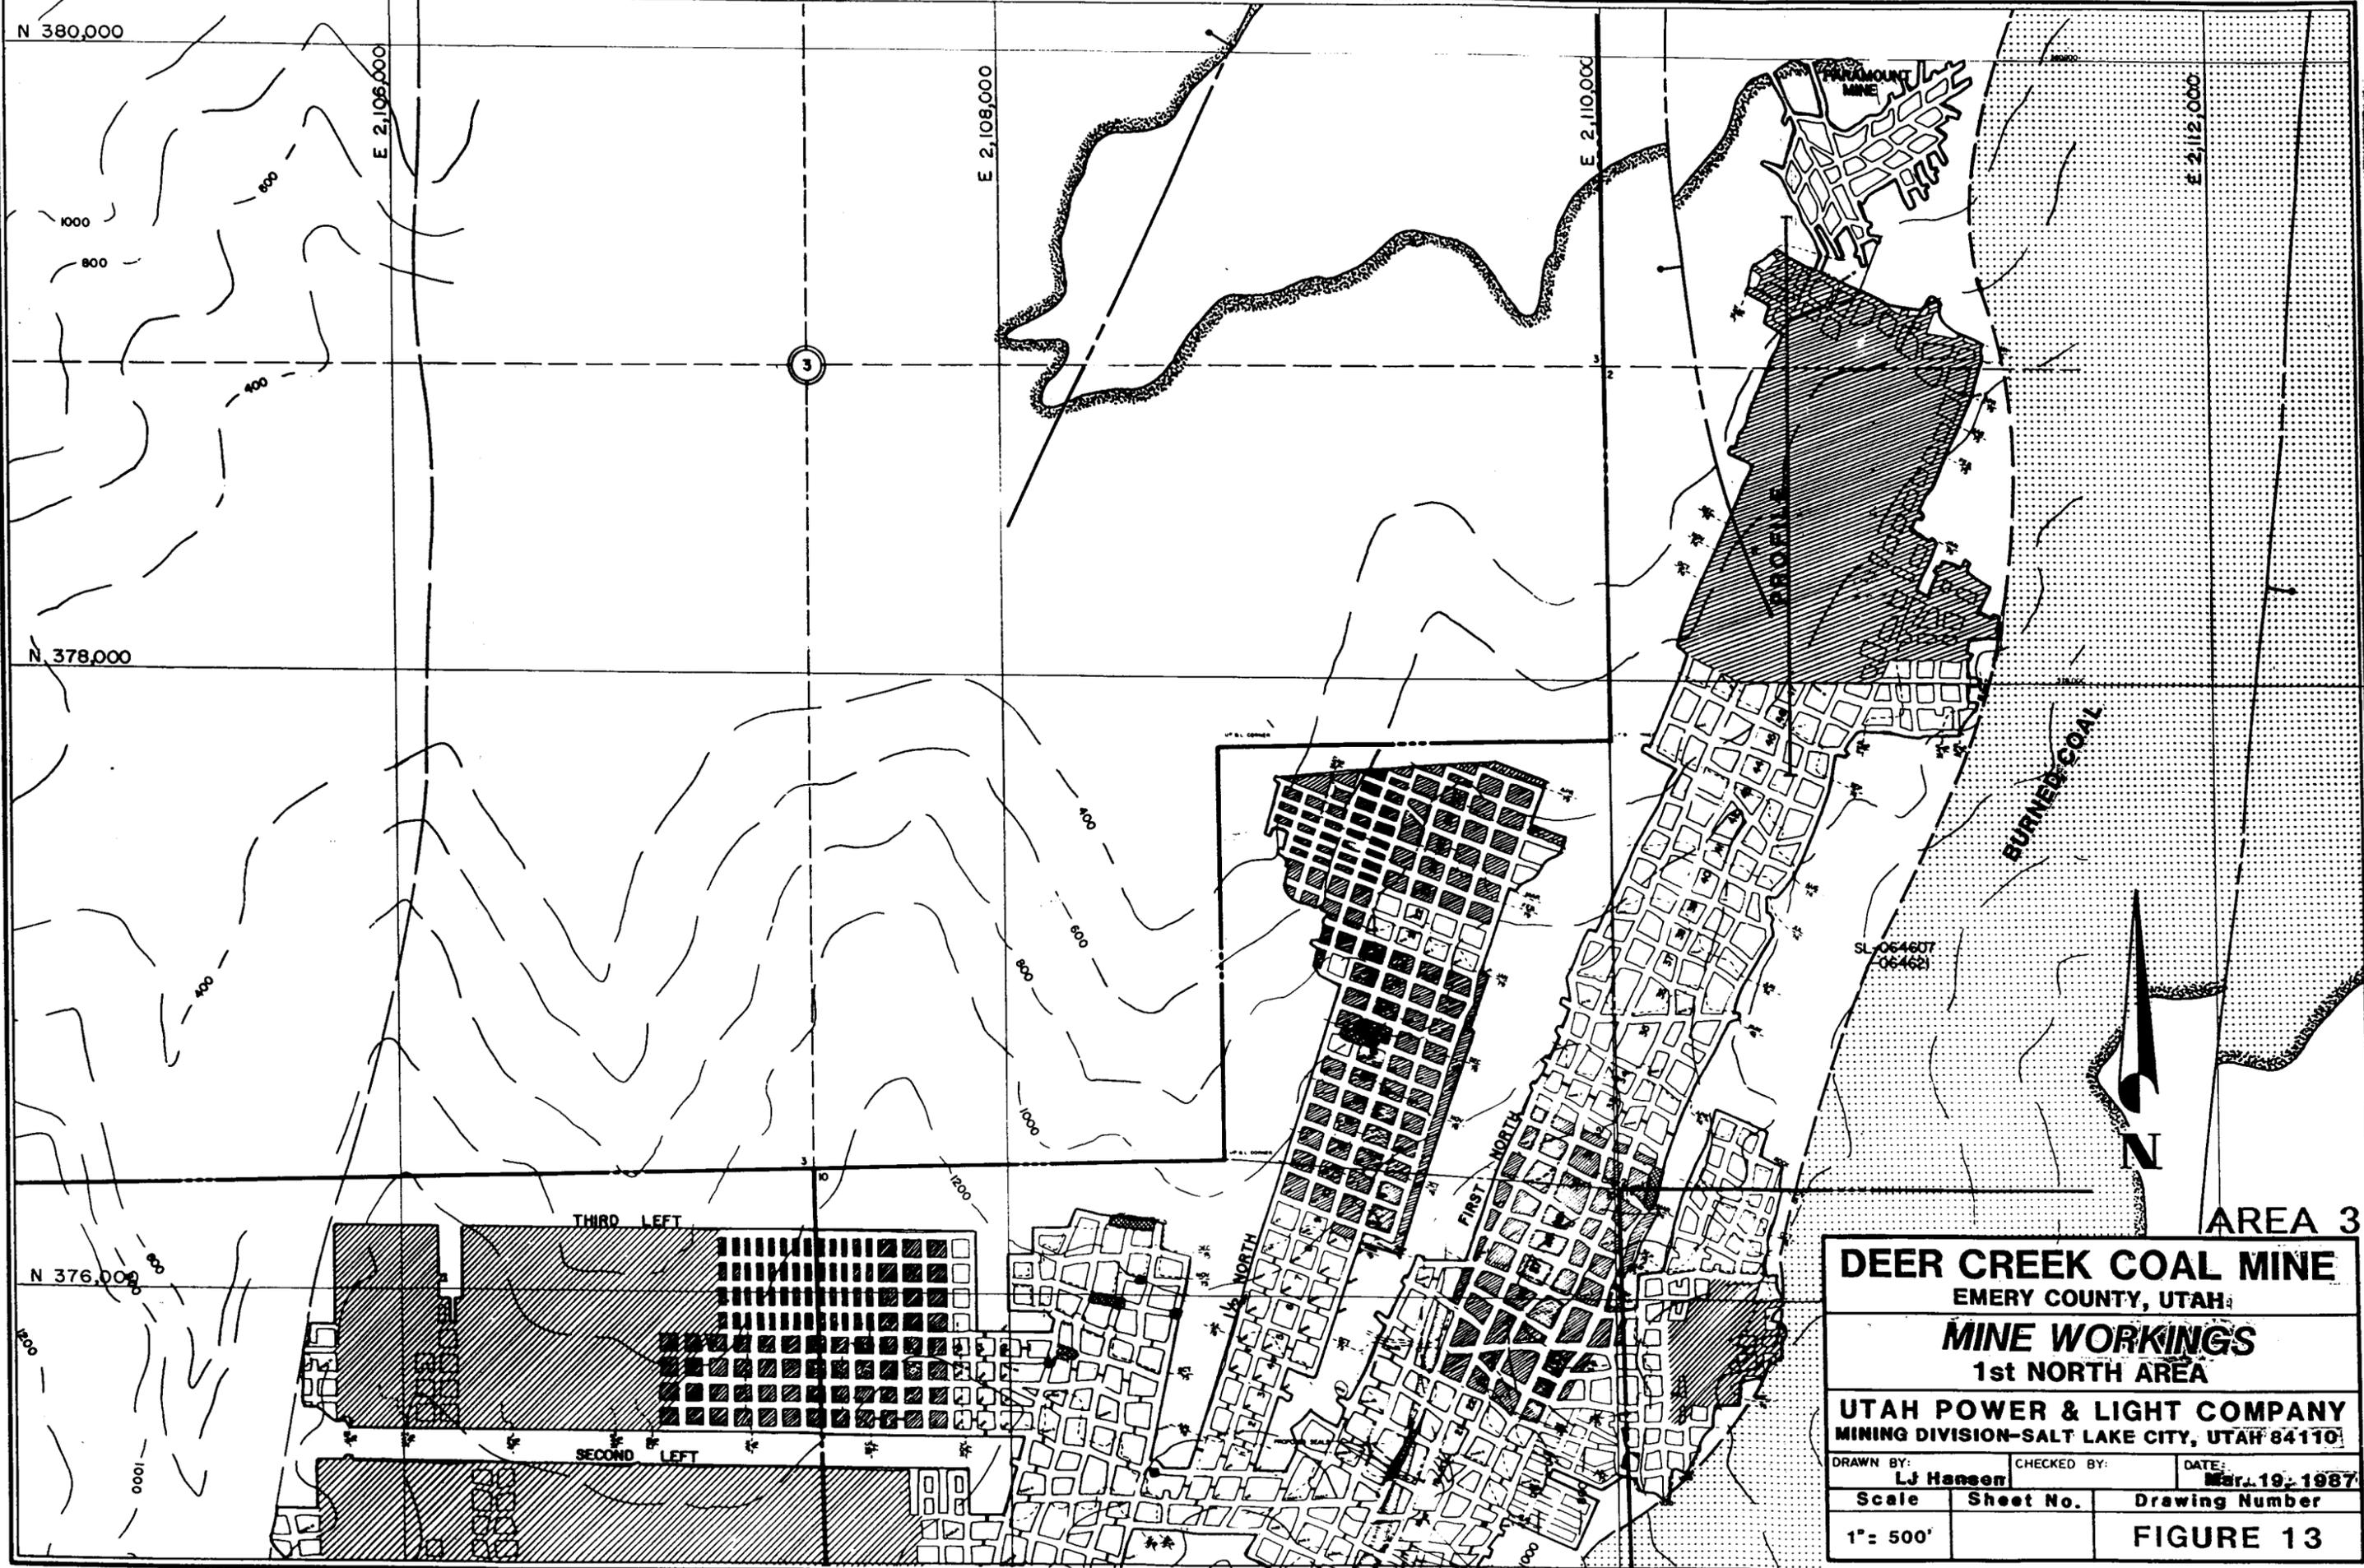
DEER CREEK COAL MINE		
EMERY COUNTY, UTAH		
MINE WORKINGS		
1st NORTH AREA		
UTAH POWER & LIGHT COMPANY		
MINING DIVISION-SALT LAKE CITY, UTAH 84110		
DRAWN BY: Lj Hansen	CHECKED BY:	DATE: Mar. 19, 1987
Scale	Sheet No.	Drawing Number
1" = 500'		FIGURE 13

Most of the 1st North section of the Deer Creek Mine was abandoned and sealed in 1978 after being mined out. The southern portion is still open and may be used for access to a block of coal which lies to the west. Pillar extraction in the 3rd Left and 1-1/2 North sections was completed early in 1980 (Figure 13).

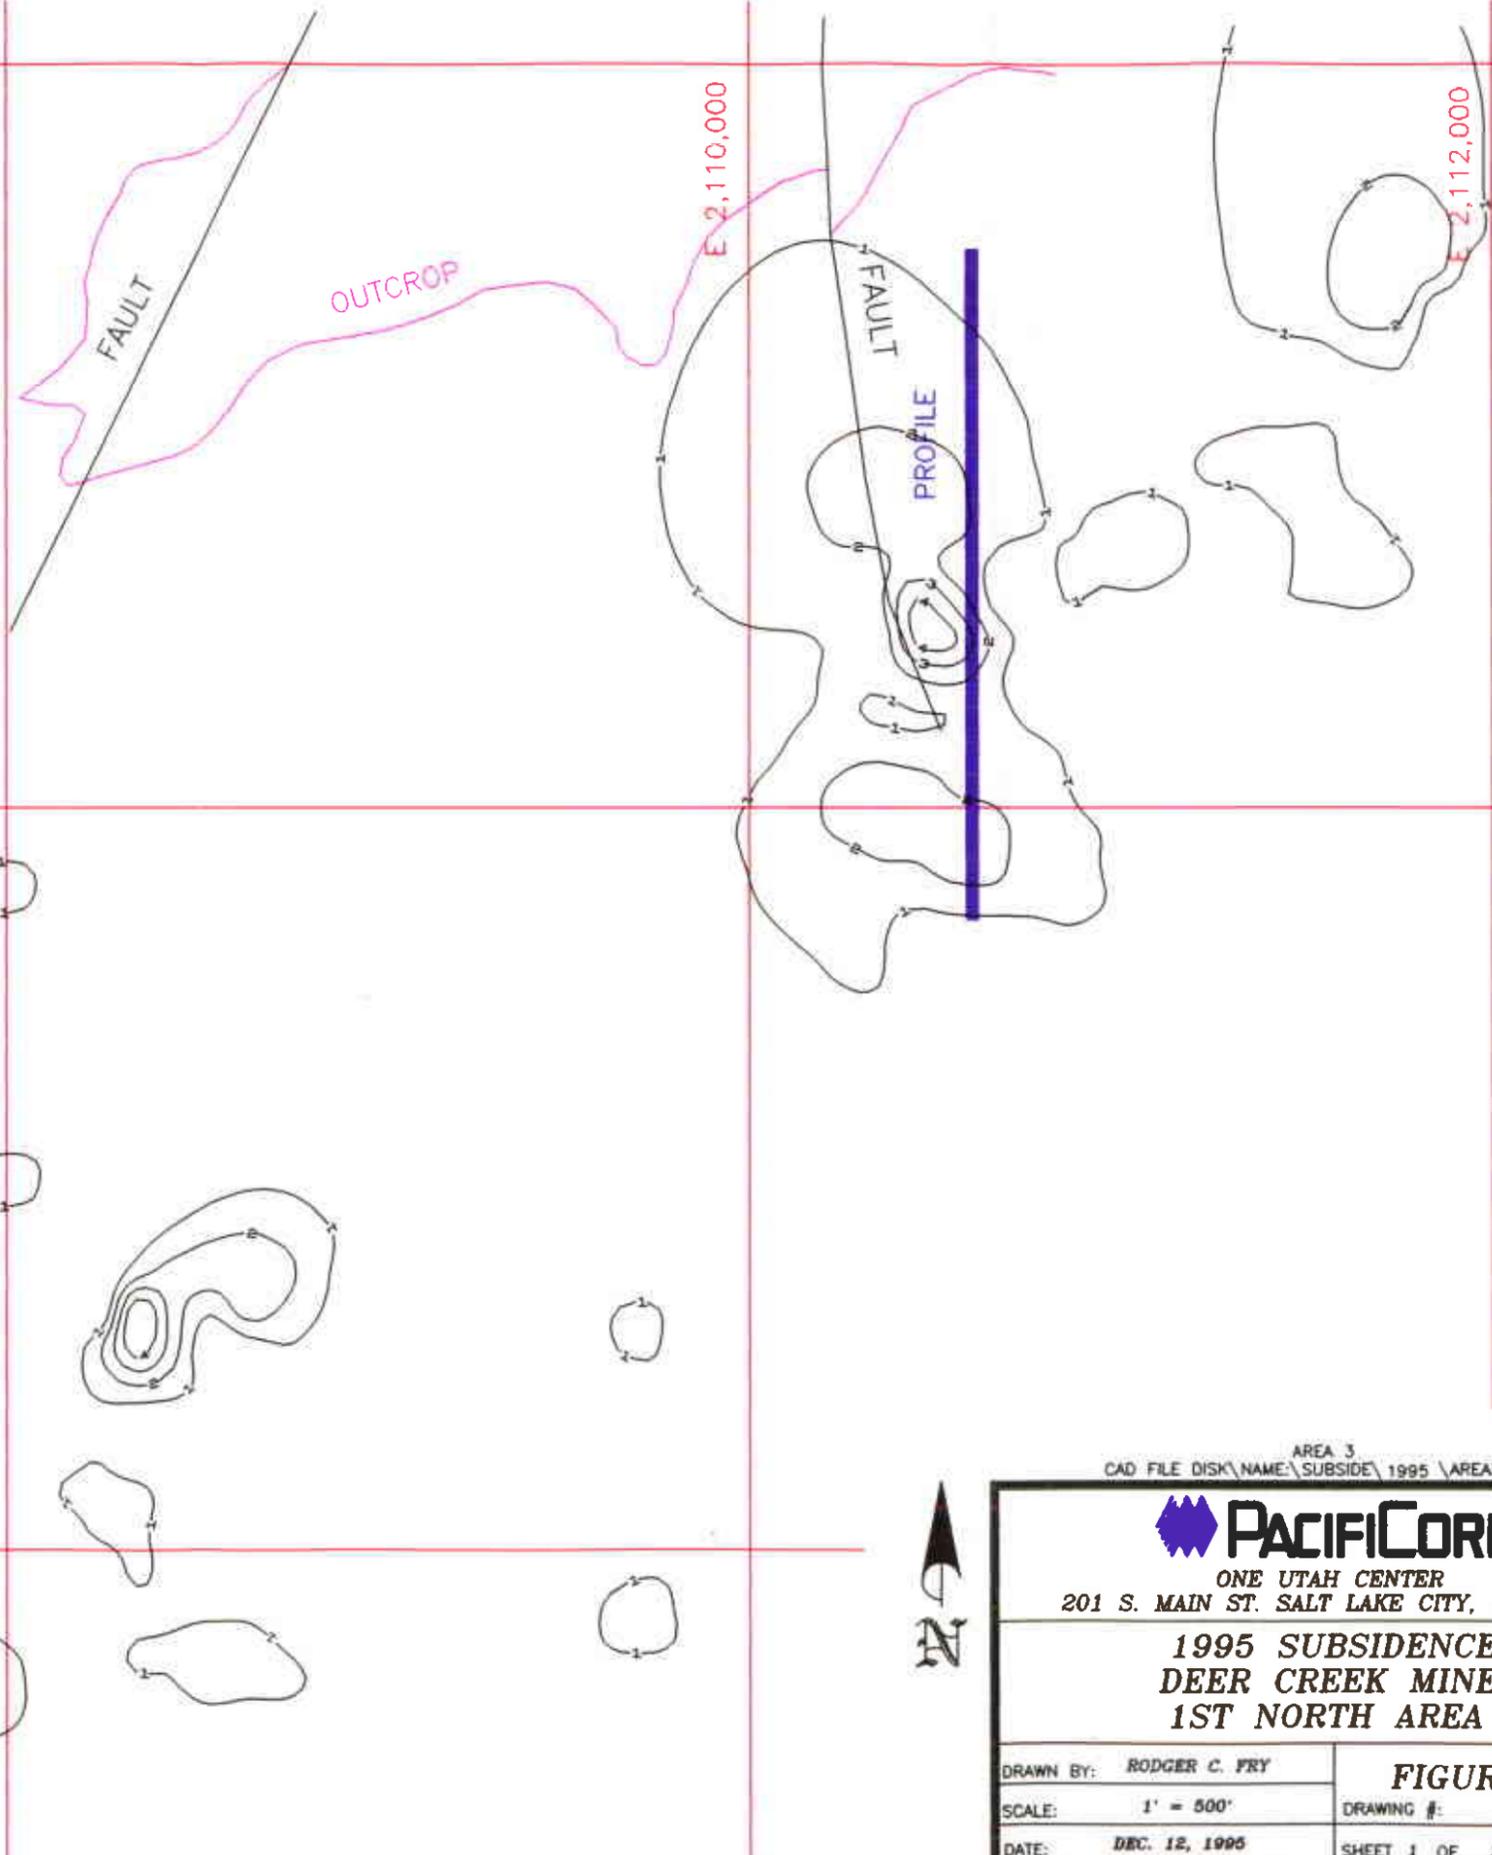
FIGURE 13A

The subsidence above 1st North occurs on a narrow ridge capped by a highly fractured sandstone. The subsidence measured is depicted in Figure 13A. Figure 14 is a profile of total subsidence as it occurred along a line of points above the workings. The subsidence in area 3 has shown no significant change in the past 4 years.

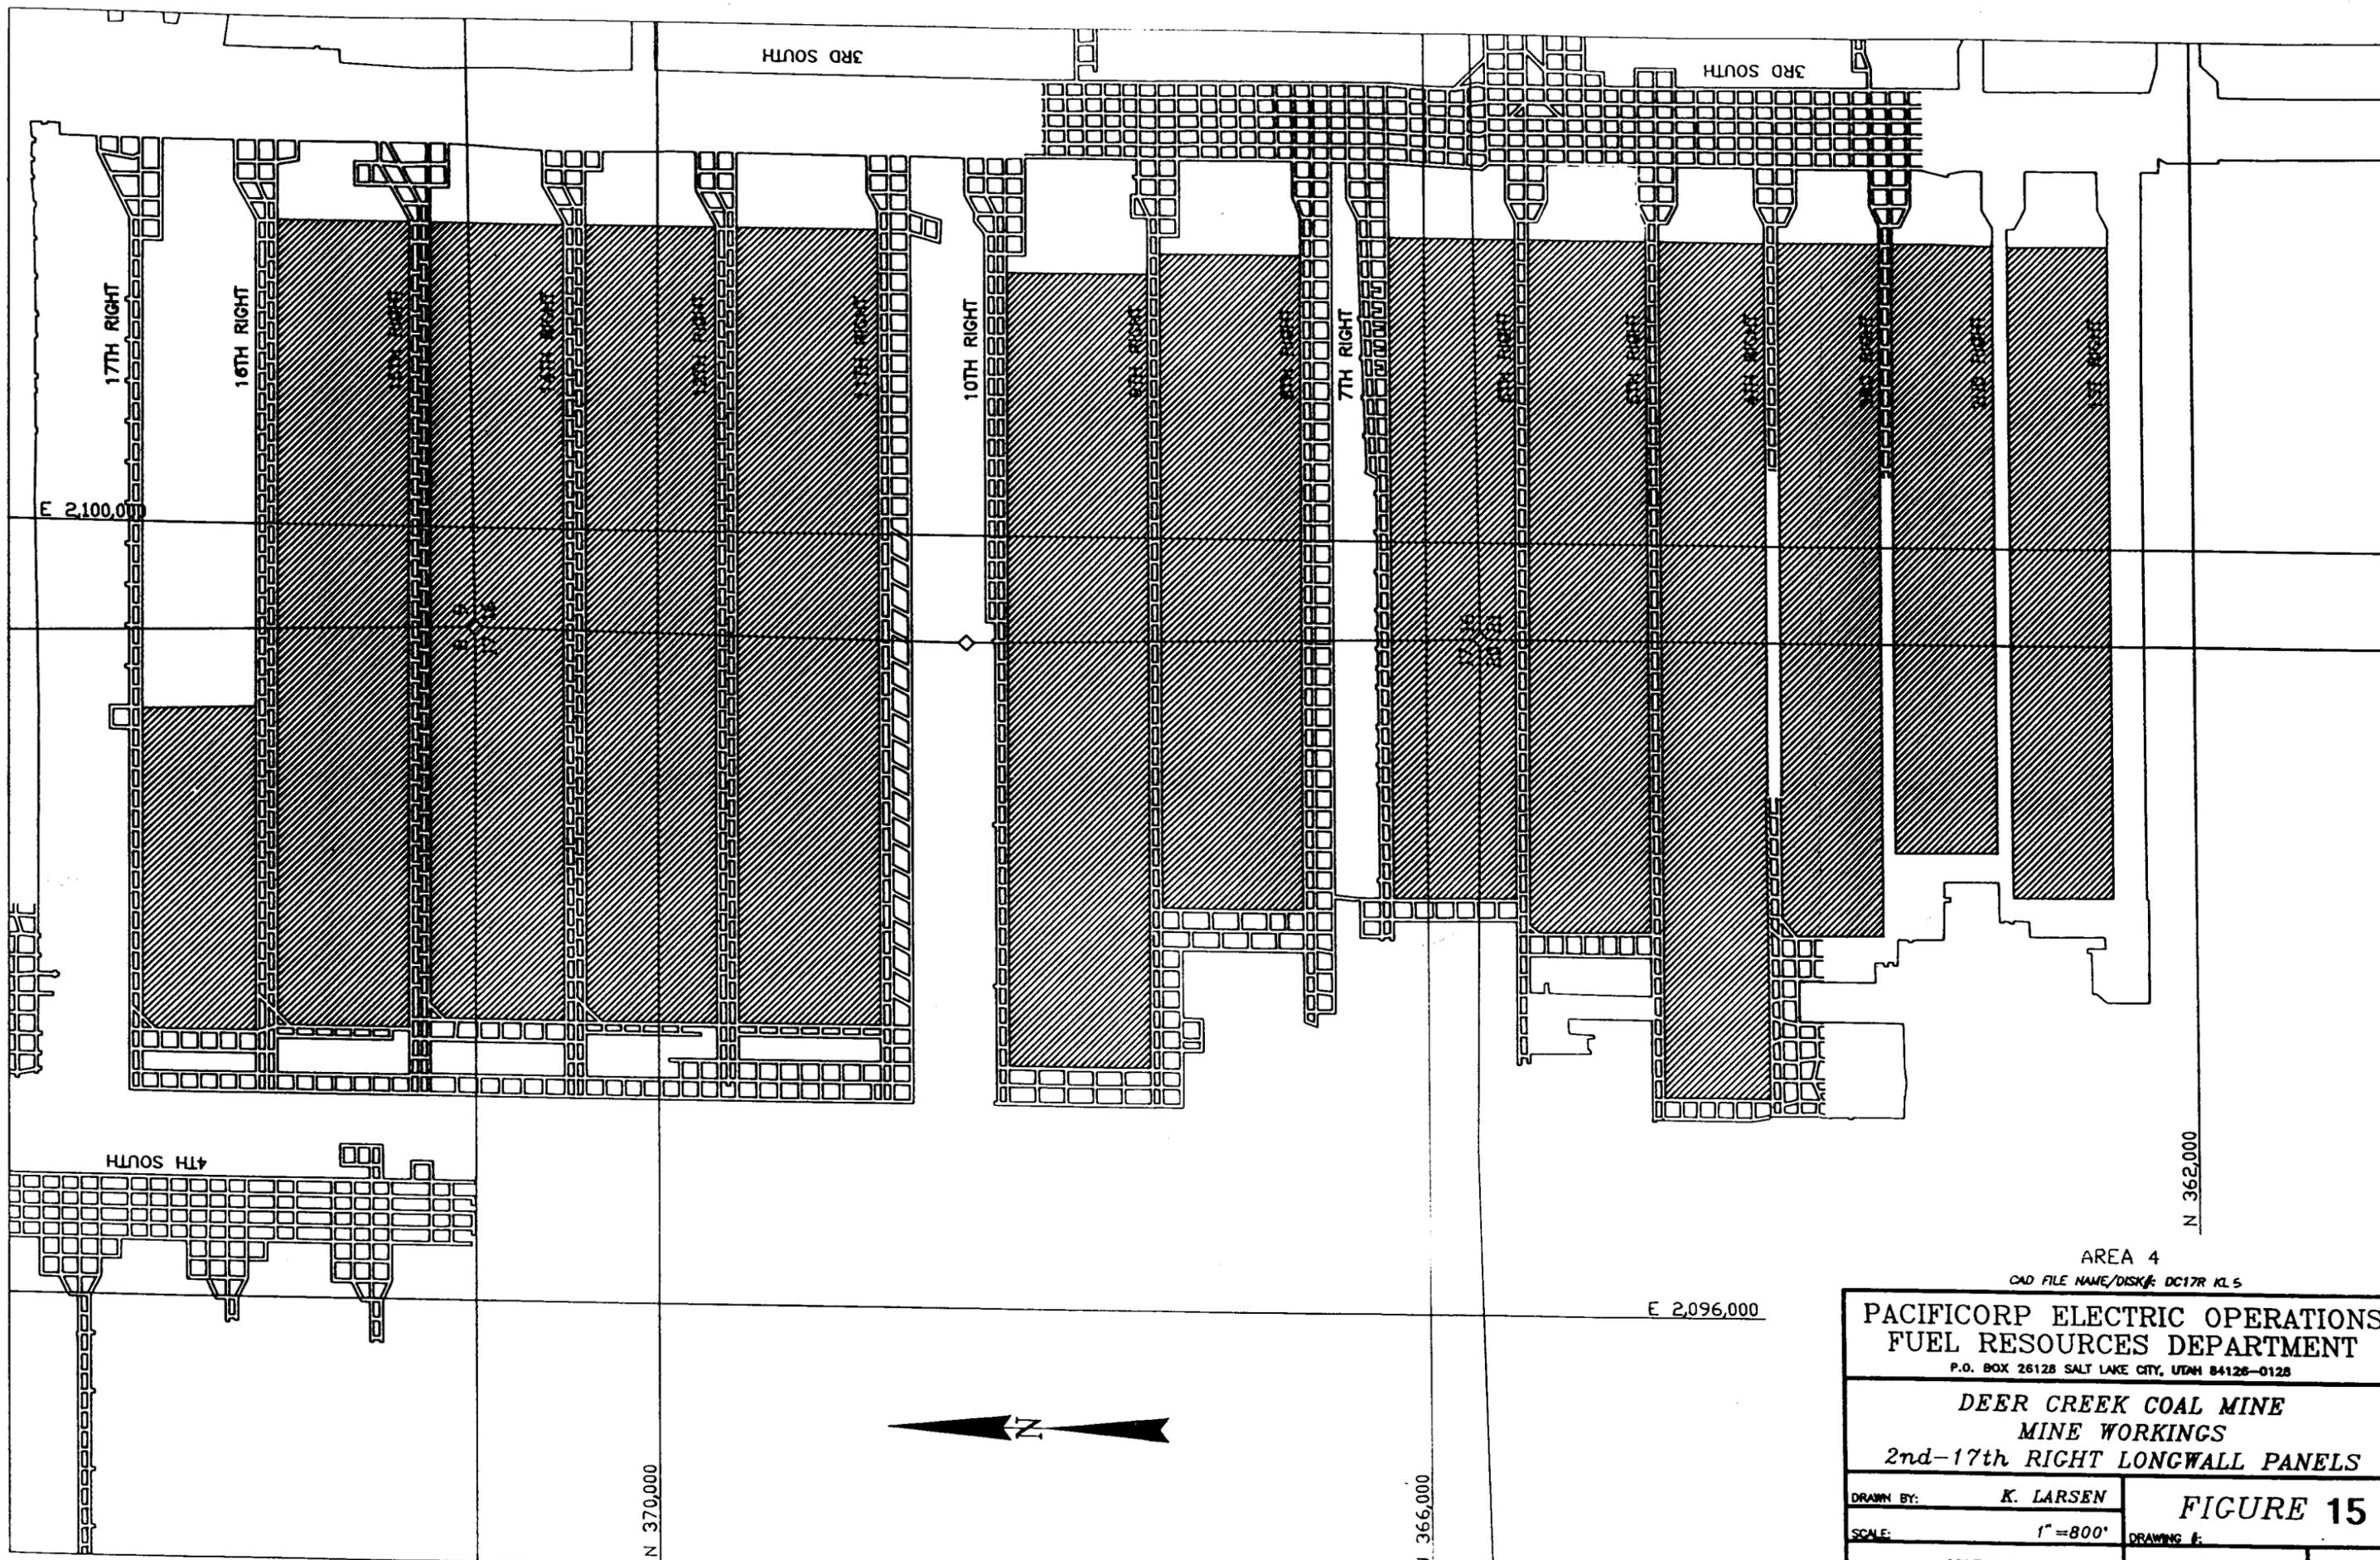
DRAWN BY:	K. LARSEN	FIGURE 15
SCALE:	1" = 800'	
DATE:	MARCH 19, 1991	
		DRAWING #:
		SHEET 1 of 1
		REV.

Subsidence in Area 4 was detected for the first time in 1984 by photogrammetric methods. Longwall mining commenced in the 2nd Right longwall panels in 1980 and by the end of August 1991 the 2nd through 17th Right panels had been completed (Figure 15). In the Cottonwood mine, Longwall mining began in September of 1992 in the 9th Left Panel off 2nd north and the 8th Left Panel was terminated early because of unacceptable coal quality in February 1993. Mining resumed in this area in the 5th Left Longwall Panel in August of 1994 and continued through August of 1995 when mining was active in the 2nd Left Longwall Panel (Figure 15A).

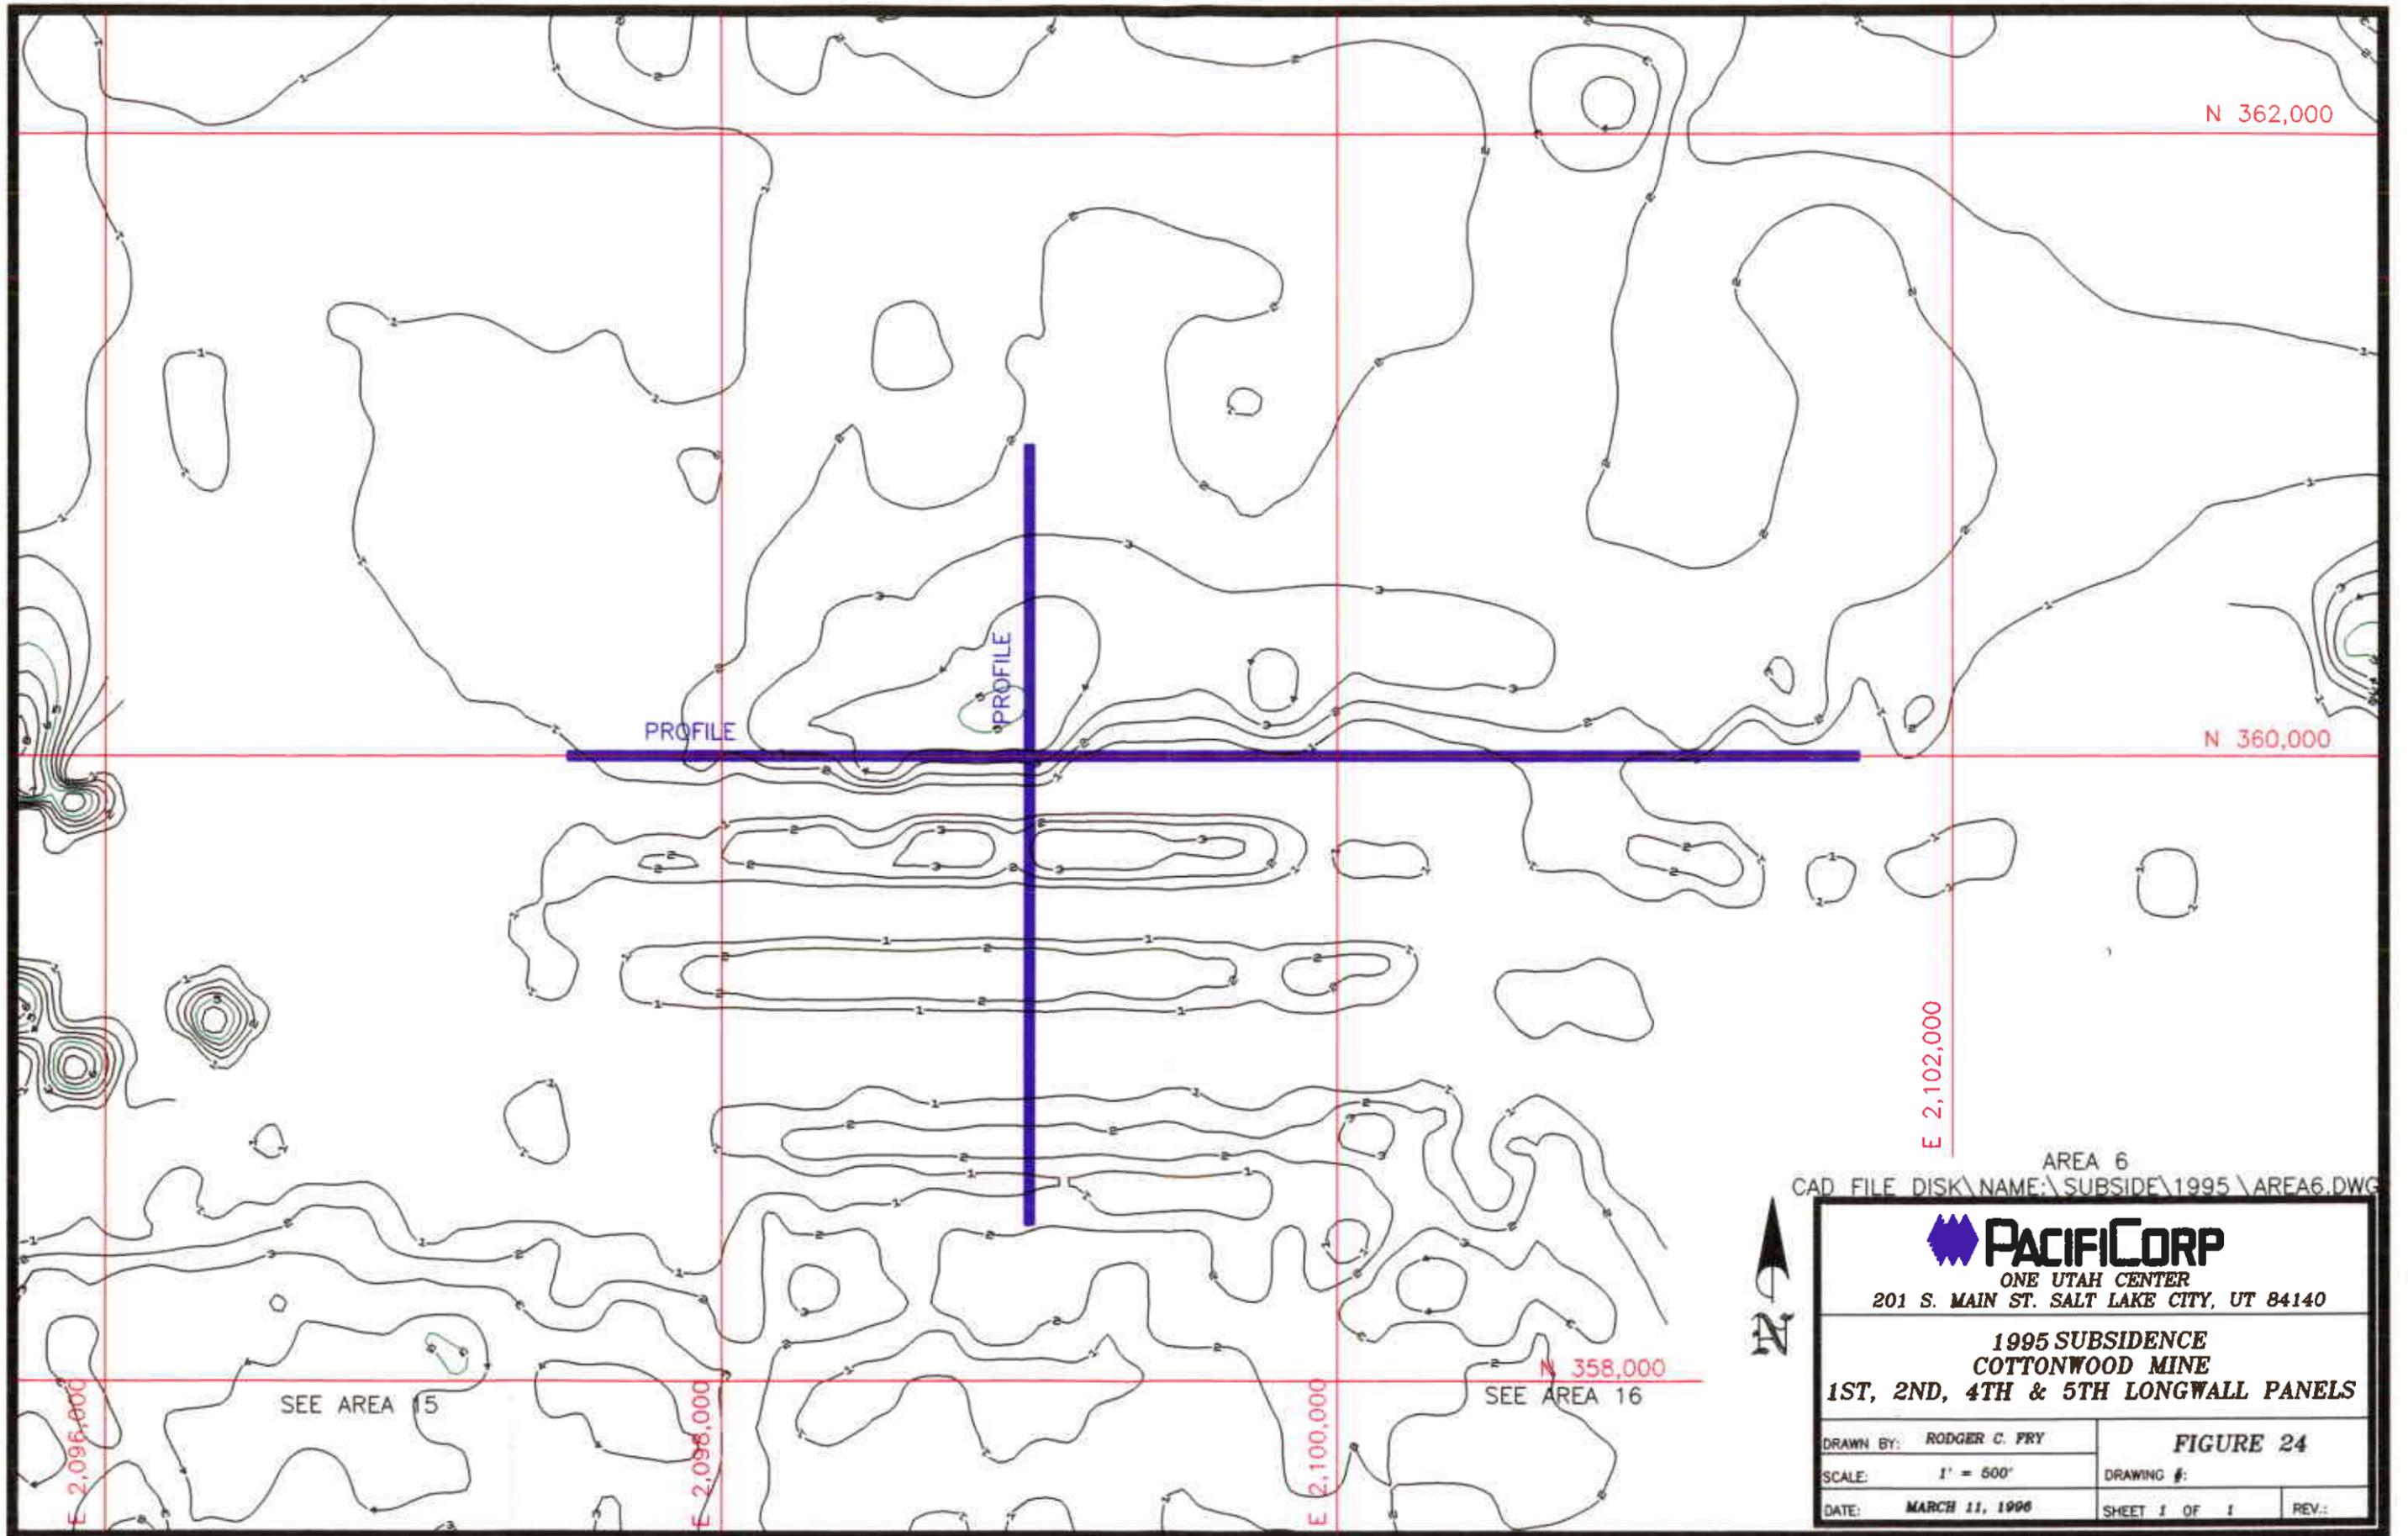
PACIFICORP ONE UTAH CENTER 201 S. MAIN ST. SALT LAKE CITY, UT 84140		
1995 SUBSIDENCE COTTONWOOD MINE 1ST, 2ND, 4TH & 5TH LONGWALL PANELS		
DRAWN BY: RODGER C. PRY	FIGURE 24	
SCALE: 1" = 500'	DRAWING #:	
DATE: MARCH 11, 1996	SHEET 1 OF 1	REV.:

Mining in the Wilberg 1st and 2nd West longwall panels was completed in June 1983 (Figure 23). This area of subsidence has now reached a maximum of five (5) feet over the Second West Longwall Panel (Figure 24). The subsidence in this area has been stable for the past four years. The subsidence profiles (Figures 25 and 26) show the change in subsidence since 1983.

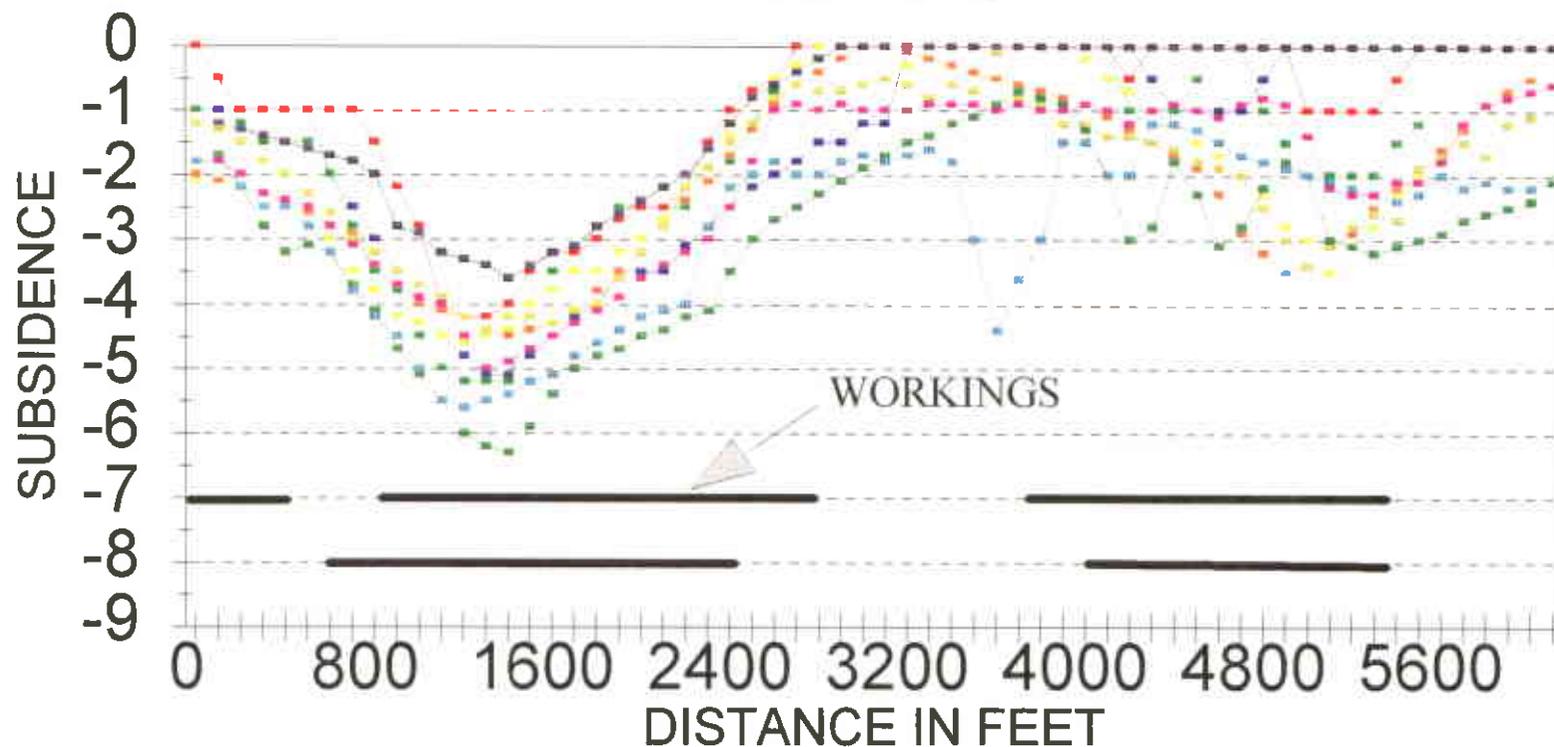
FIGURE 33
AREA 8 SUBSIDENCE PROFILE
WEST- EAST

Some of the subsidence in Area 8 may have gone undetected because pillar extraction, and presumably subsidence, in part of the area was completed before the establishment of baseline survey data (Figures 30, 31, and 32). The west to east subsidence profile of the area depicted in Figure 33 indicates that subsidence up to slightly over six (6) feet has occurred. The profile also indicates that the subsidence has been stable since 1992. On the eastern side subsidence has remained at two feet or less for the last four years. Where not influenced by other workings, the angle-of-draw reached a maximum of 31 degrees on the eastern edge of the area.

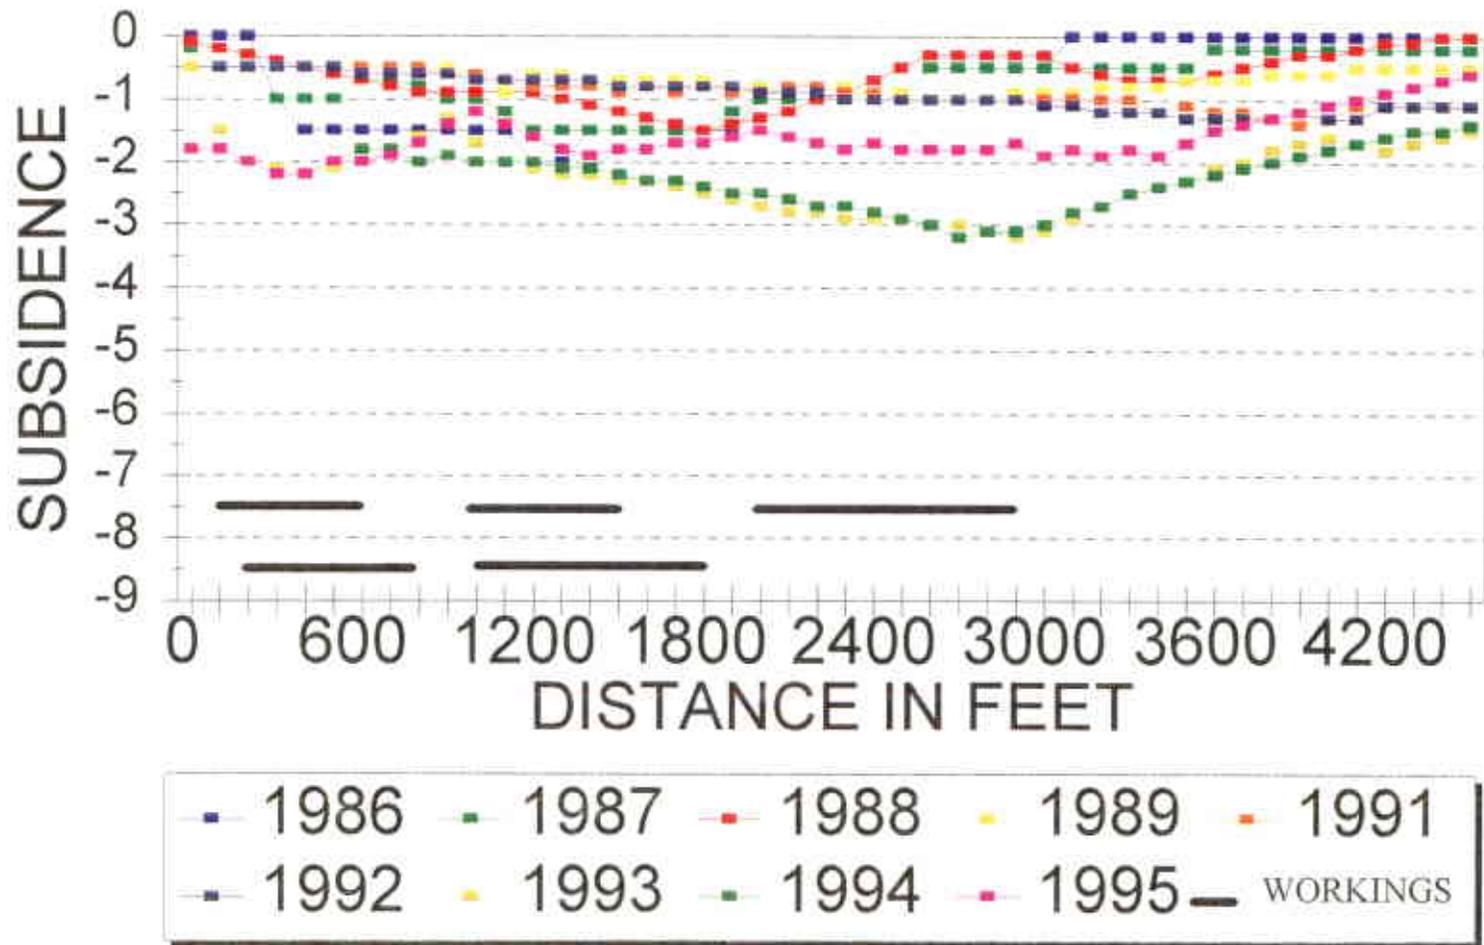
AREA 13 SUBSIDENCE PROFILE NORTH-SOUTH

The subsidence profiles, figures 42 and 43 show subsidence yearly since 1986. These profiles show that the readings in 1993 and 1994 are somewhat lower than in 1995 or in previous years. This is most likely a problem with the aerial triangulation because a comparison of the survey monuments in the area show no change in that time period.
