ANNUAL SUBSIDENCE MONITORING REPORT
EAST / TRAIL MOUNTAIN PROPERTIES
1995

PACIFICORP
TECHNICAL SERVICES REPORT
RODGER C. FRY

MARCH 29, 1996

PACIFICORP
SUBSIDENCE MONITORING PROGRAM
ANNUAL REPORT FOR 1995

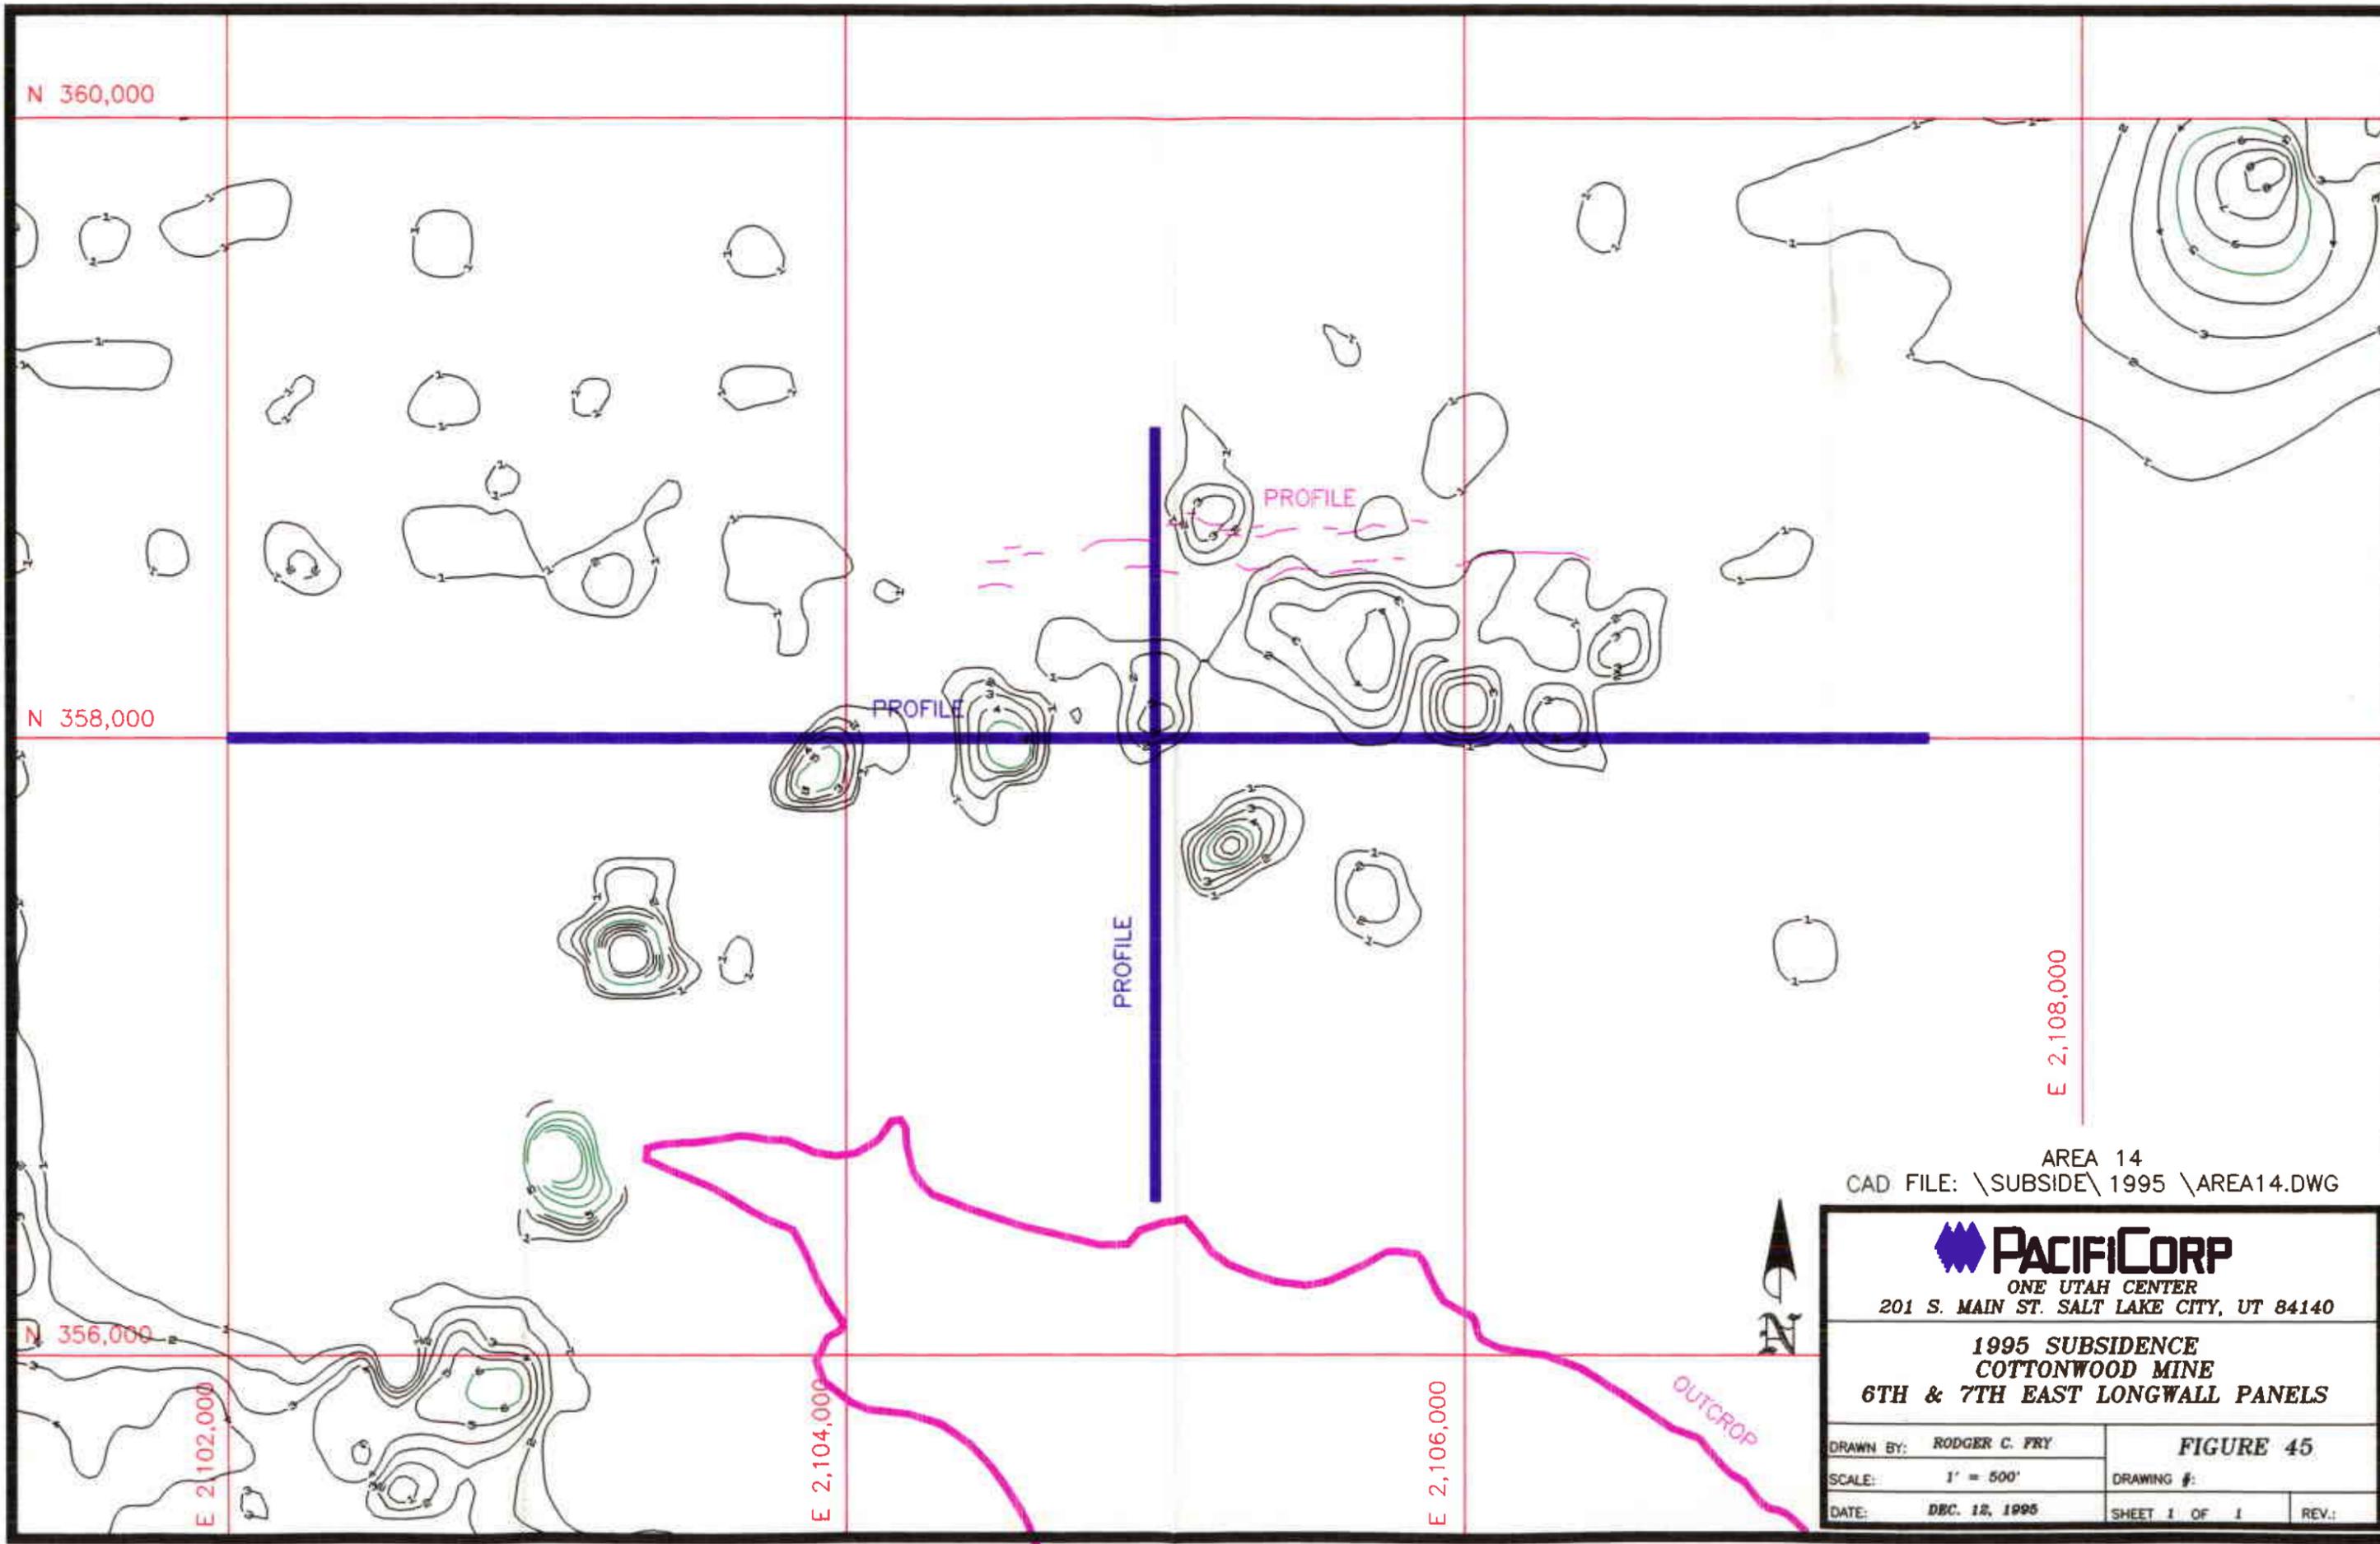
AREA 14
 CAD FILE: \SUBSIDE\1995\AREA14.DWG

The Castlegate Sandstone forms a 200-foot high escarpment along the north side of Newberry Canyon with numerous naturally occurring joints and fractures. Stress caused by removal of coal was transferred to the fractures resulting in brittle failure of the cliff face (spalling) in some places. Talus from the spalling has accumulated on the steep slopes below the cliffs on older natural talus slopes. The newer debris remains mostly above the coal outcrop level and reaches the canyon floor in only one location. Surface cracks have been observed and mapped along the ridge above the cliff. The cracks are discontinuous and extend for approximately 2,000 feet parallel to the northern edge of the 6th East longwall panel. A few cracks are also found directly on top of the Castlegate Sandstone escarpment. Maximum subsidence to date is over seven (7) feet above the western end of the 7th East Longwall Panel and five (5) feet over the eastern end of 6th East along the Pleasant Valley Fault (Figures 45, 46, and 47). Because this area has rugged and steep terrain, it is the most difficult to achieve consistent results using the photogrammetric monitoring. As can be seen on the subsidence map (Figure 45) and the profiles

(Figures 46 and 47) the subsidence appears to vary substantially from one location to another and change up and down in time. This is because the photogrammetric monitoring is difficult in this type of terrain. The profiles for the 1995 data show no area where the measured subsidence is greater than has been read in one or more previous year. Several survey targets were established in this area on the Castlegate cliff and have been surveyed since their emplacement in 1986. This monitoring shows no changes in the last three years. The data from these monitoring sites are located in the appendix to this report.

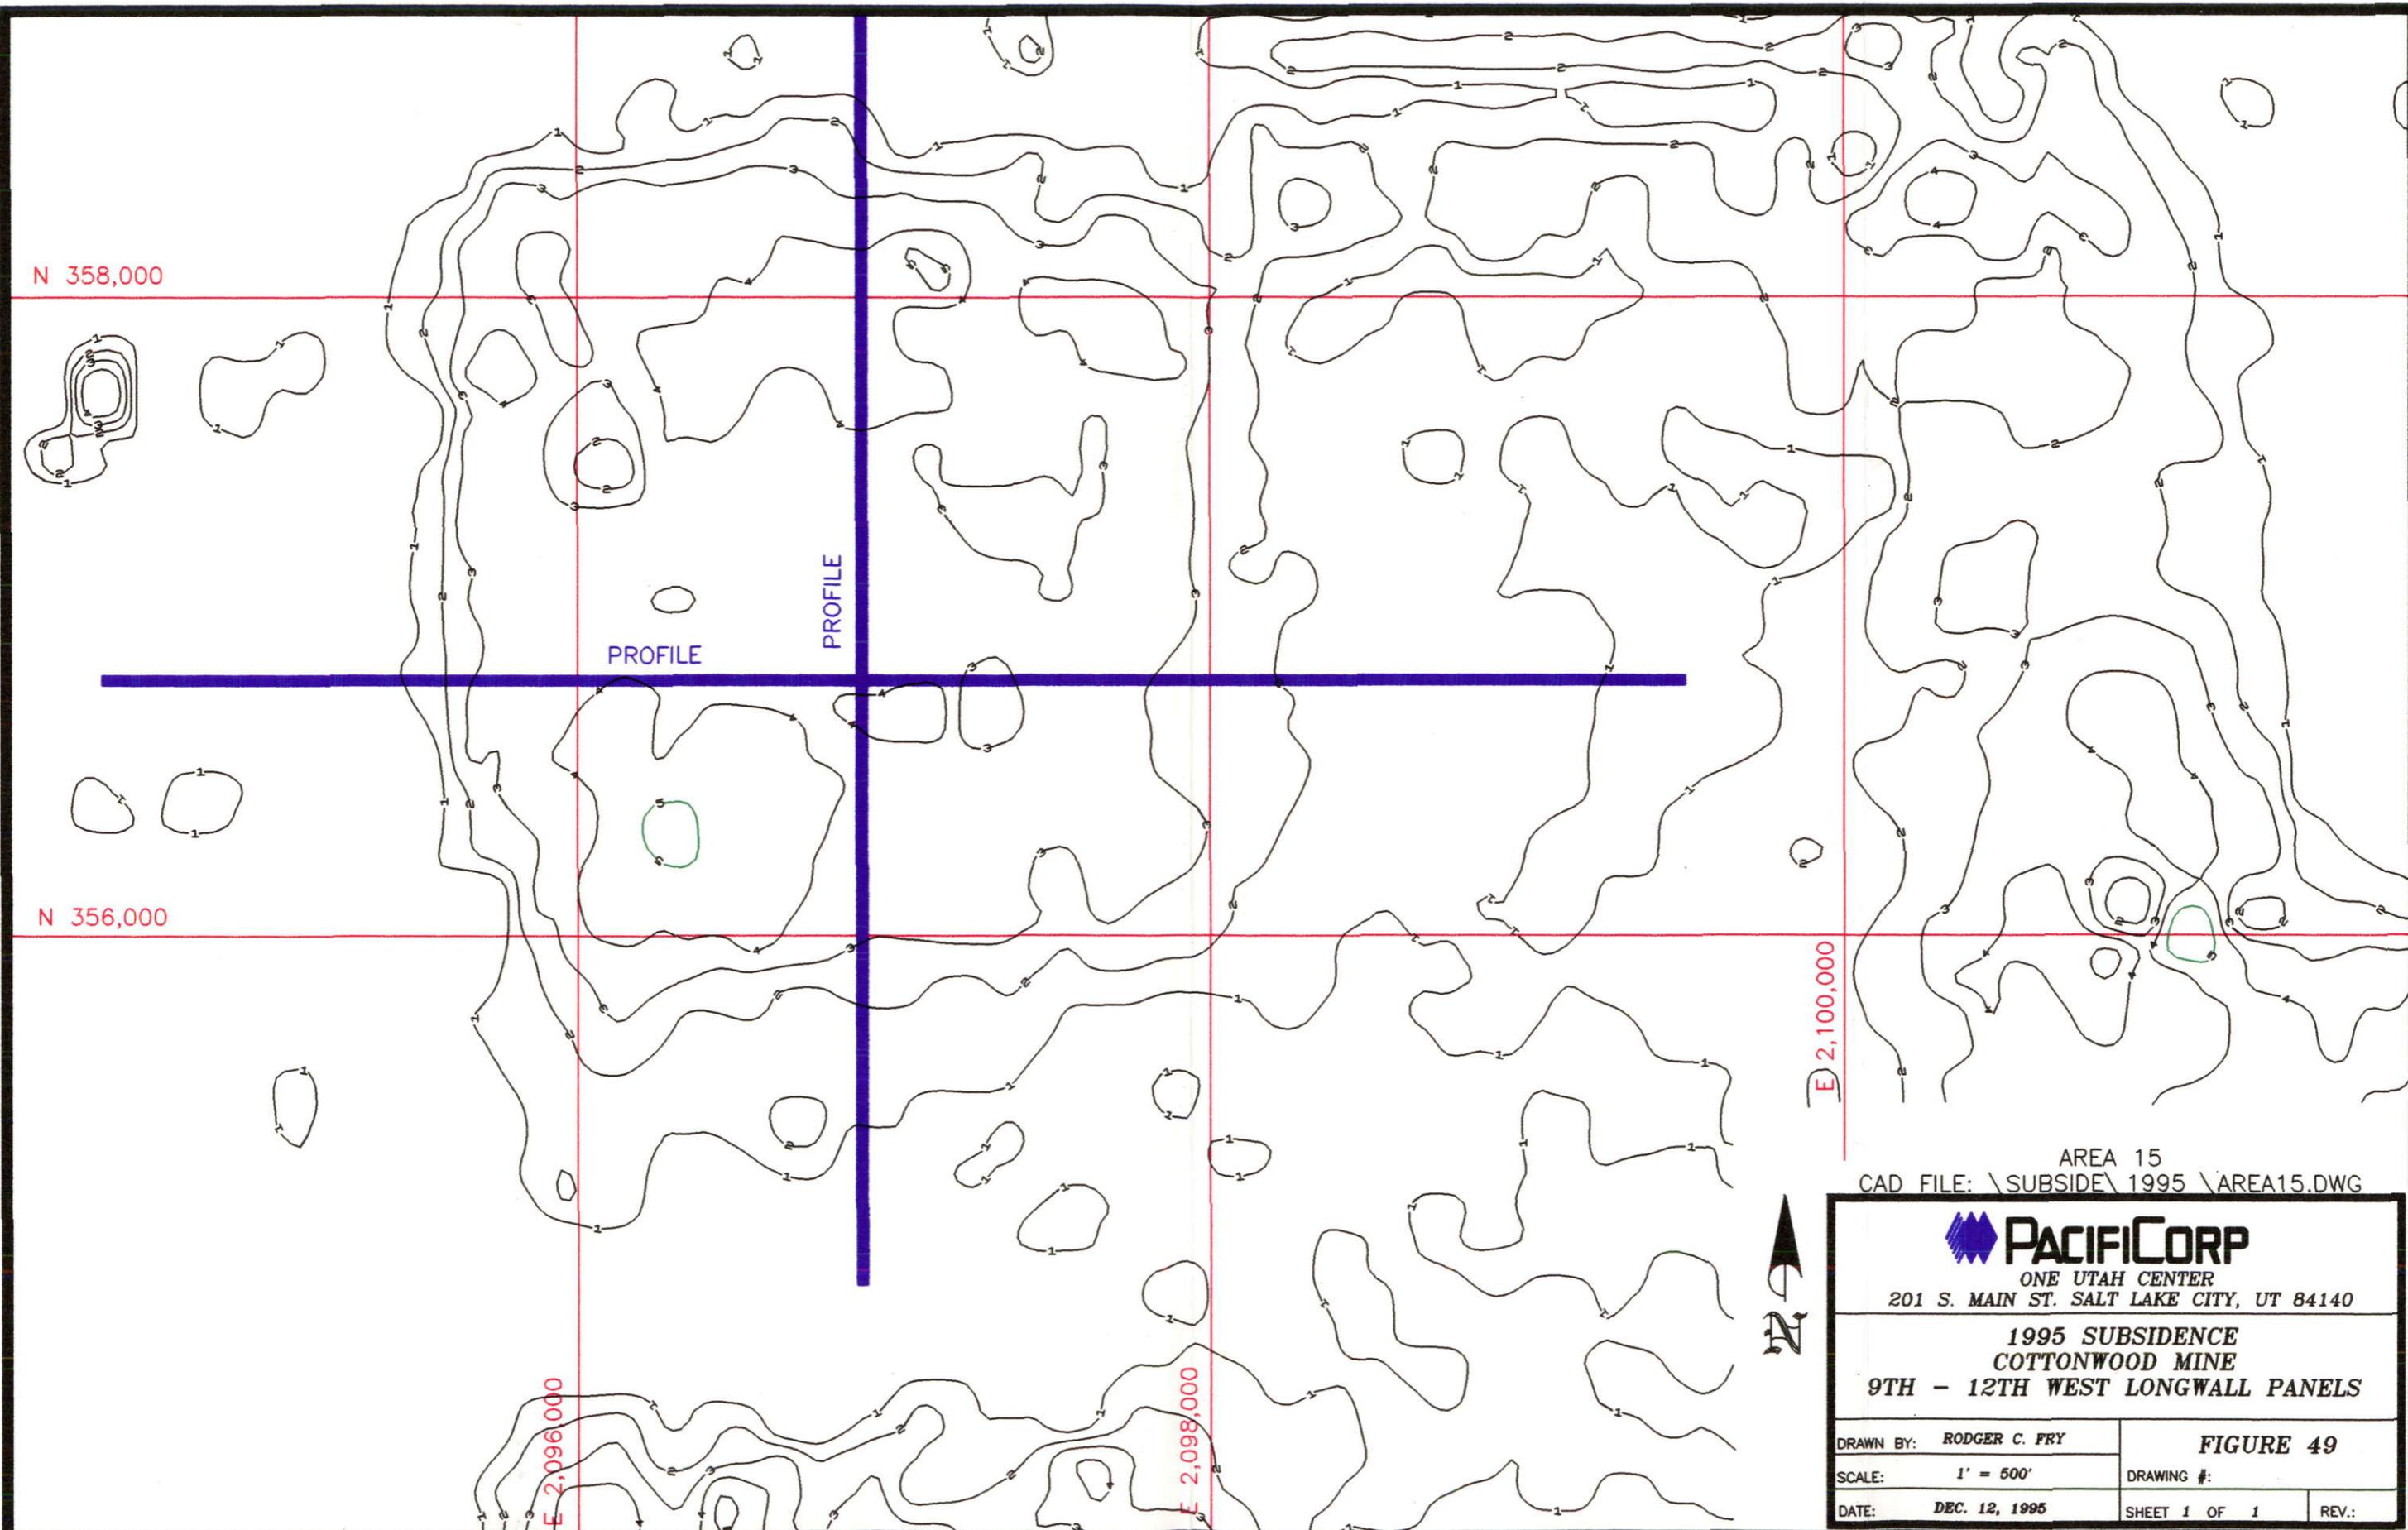
DRAWN BY: RODGER C. FRY	FIGURE 49	
SCALE: 1" = 500'	DRAWING #:	
DATE: DEC. 12, 1995	SHEET 1 OF 1	REV.:

Maximum measured subsidence to date is over five (5) feet above 11th West (Figures 49, 50, and 51). This area has experienced no additional subsidence in the past four years.

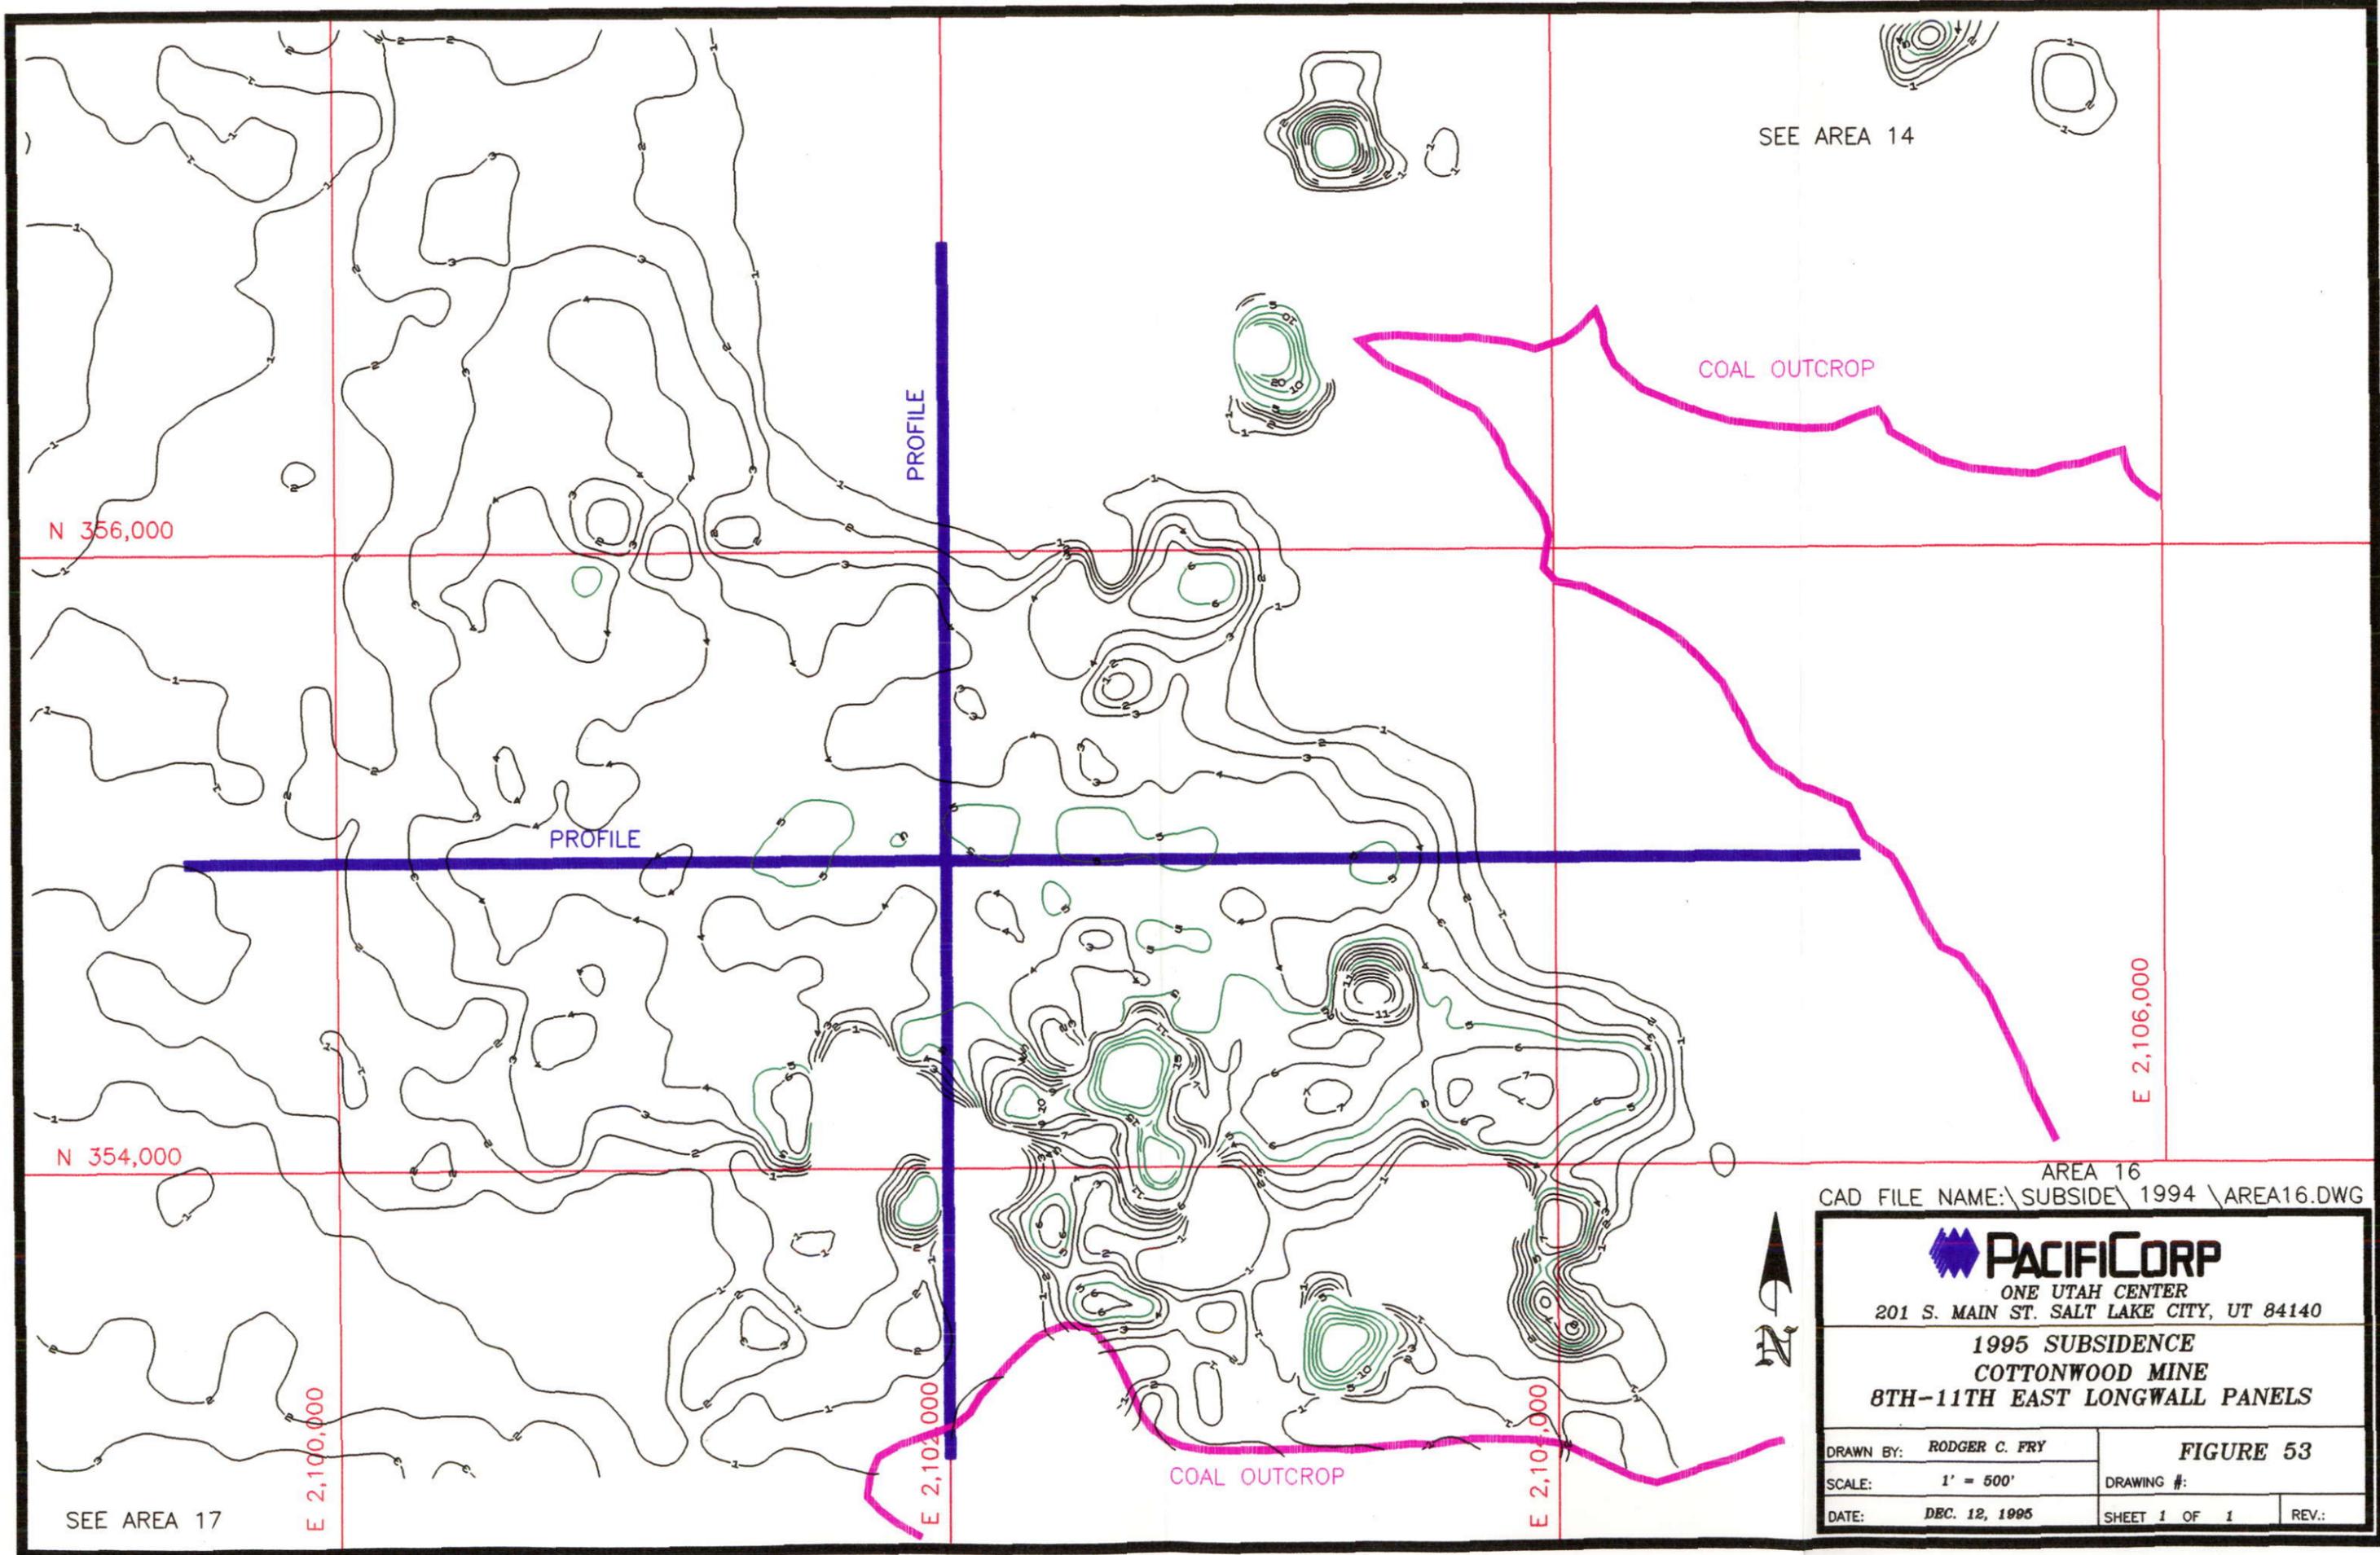
As with Area 14 cliff spalling has occurred in places and the resulting talus has accumulated on the steep slopes below the cliffs. No surface cracks have been observed to date.

Maximum subsidence observed to date exceeds five (5) feet and occurs over the 11th East panel where the overburden is less than 600 feet (Figure 53, 54, and 55). Figure 53 shows several "bulls-eyes" in the area of the Castlegate cliff which are in very steep and rugged areas. The photogrammetric method is not reliable in these areas and it is not felt that the areas have subsided to the extent shown on figure 53. This is supported by the fact that subsidence survey targets placed along the cliff in 1986 have shown no movement in recent years (see appendix).

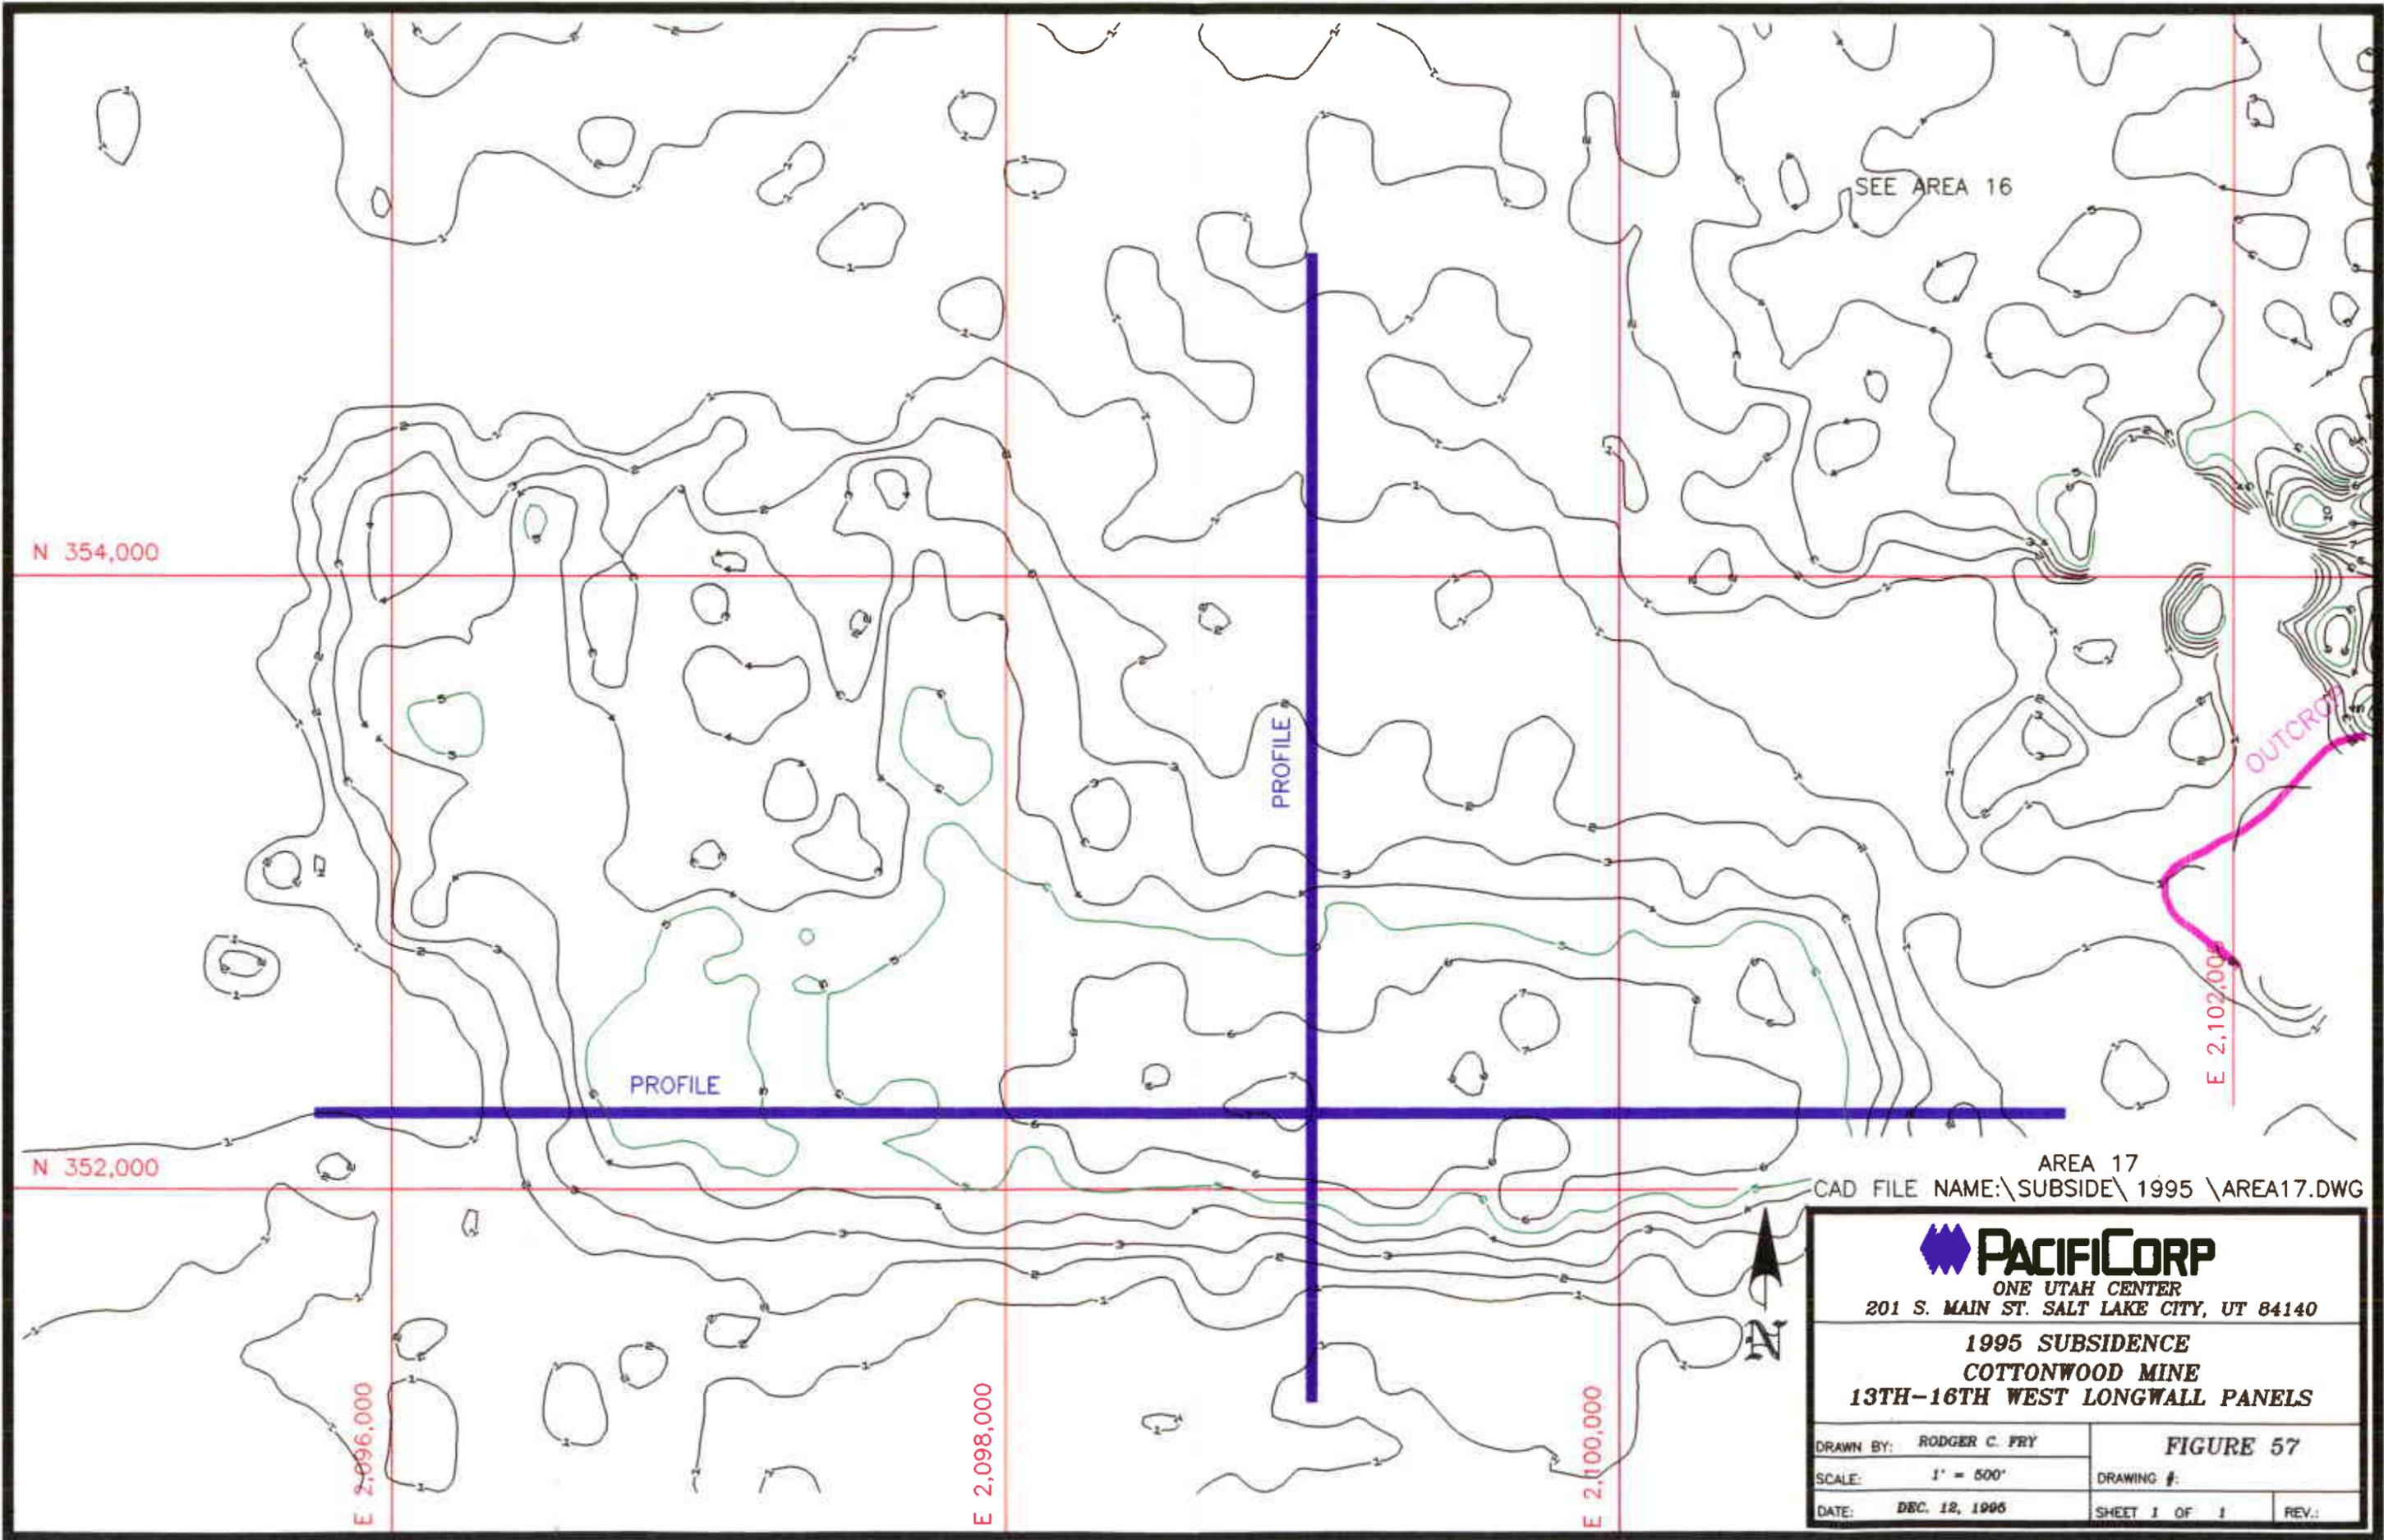
AREA 17
 CAD FILE NAME:\SUBSIDE\1995\AREA17.DWG

The measured subsidence exceeds six (6) feet in an area above the 16th west panel. The subsidence zone follows a narrow east-west trending trough centered above the two longer panels and then extends north above the 14th and 13th west longwall panels (figures 57, 58, and 59). No surface fractures have been observed in the area above these longwall panels. Subsidence in this area has been stable for over four years.

On the south side of the subsidence zone, the angle of draw is less than 10 degrees.
