ANNUAL SUBSIDENCE MONITORING REPORT
EAST /TRAIL MOUNTAIN PROPERTIES
1997

PACIFICORP
SUBSIDENCE MONITORING PROGRAM
ANNUAL REPORT FOR 1997

April, 1998

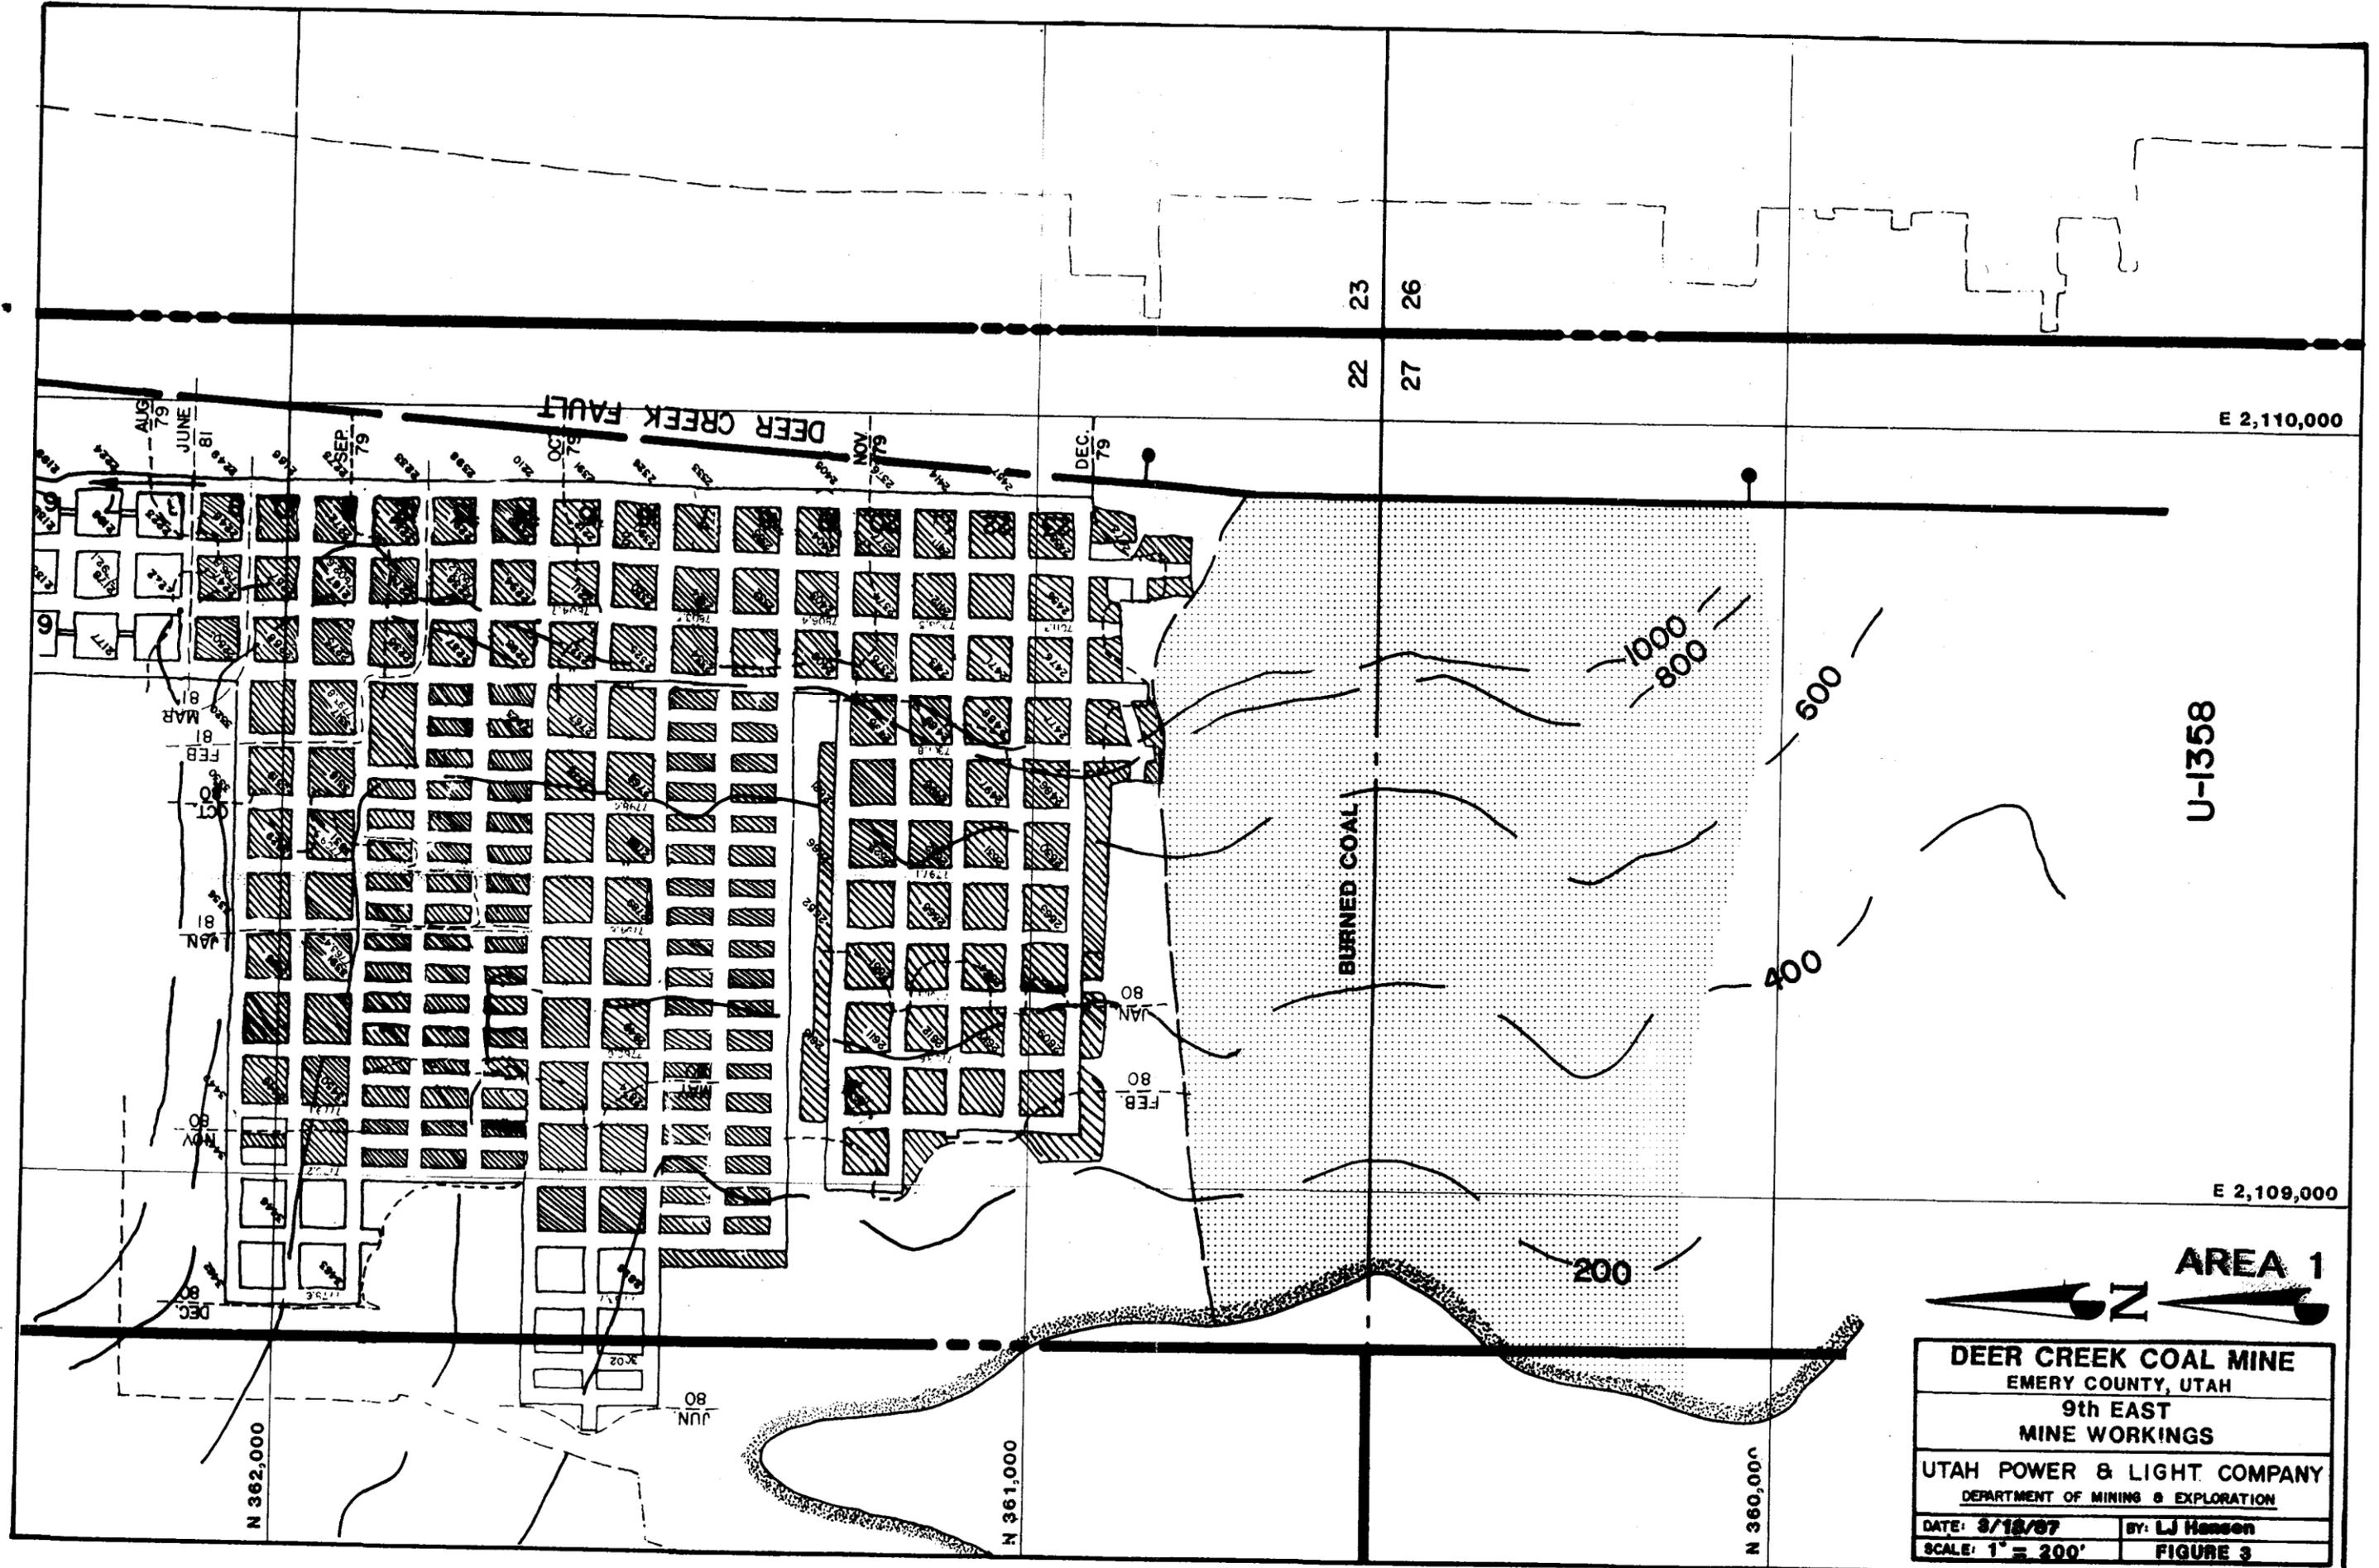
DEER CREEK COAL MINE	
EMERY COUNTY, UTAH	
9th EAST	
MINE WORKINGS	
UTAH POWER & LIGHT COMPANY	
DEPARTMENT OF MINING & EXPLORATION	
DATE: 8/18/87	BY: LJ Henson
SCALE: 1" = 200'	FIGURE 3

Subsidence in Area 1 was first documented in the 1981 Subsidence Monitoring Report submitted in 1982. The relationship of the subsidence to the underlying Deer Creek and Wilberg mine workings is shown in Figures 3, 4, and 5. Each map covers the same area, Figure 5 being a contour map of subsidence on the surface over the mine workings depicted in the other two figures. The most recent mining in this area occurred in the Wilberg 1st Right section in June 1984.

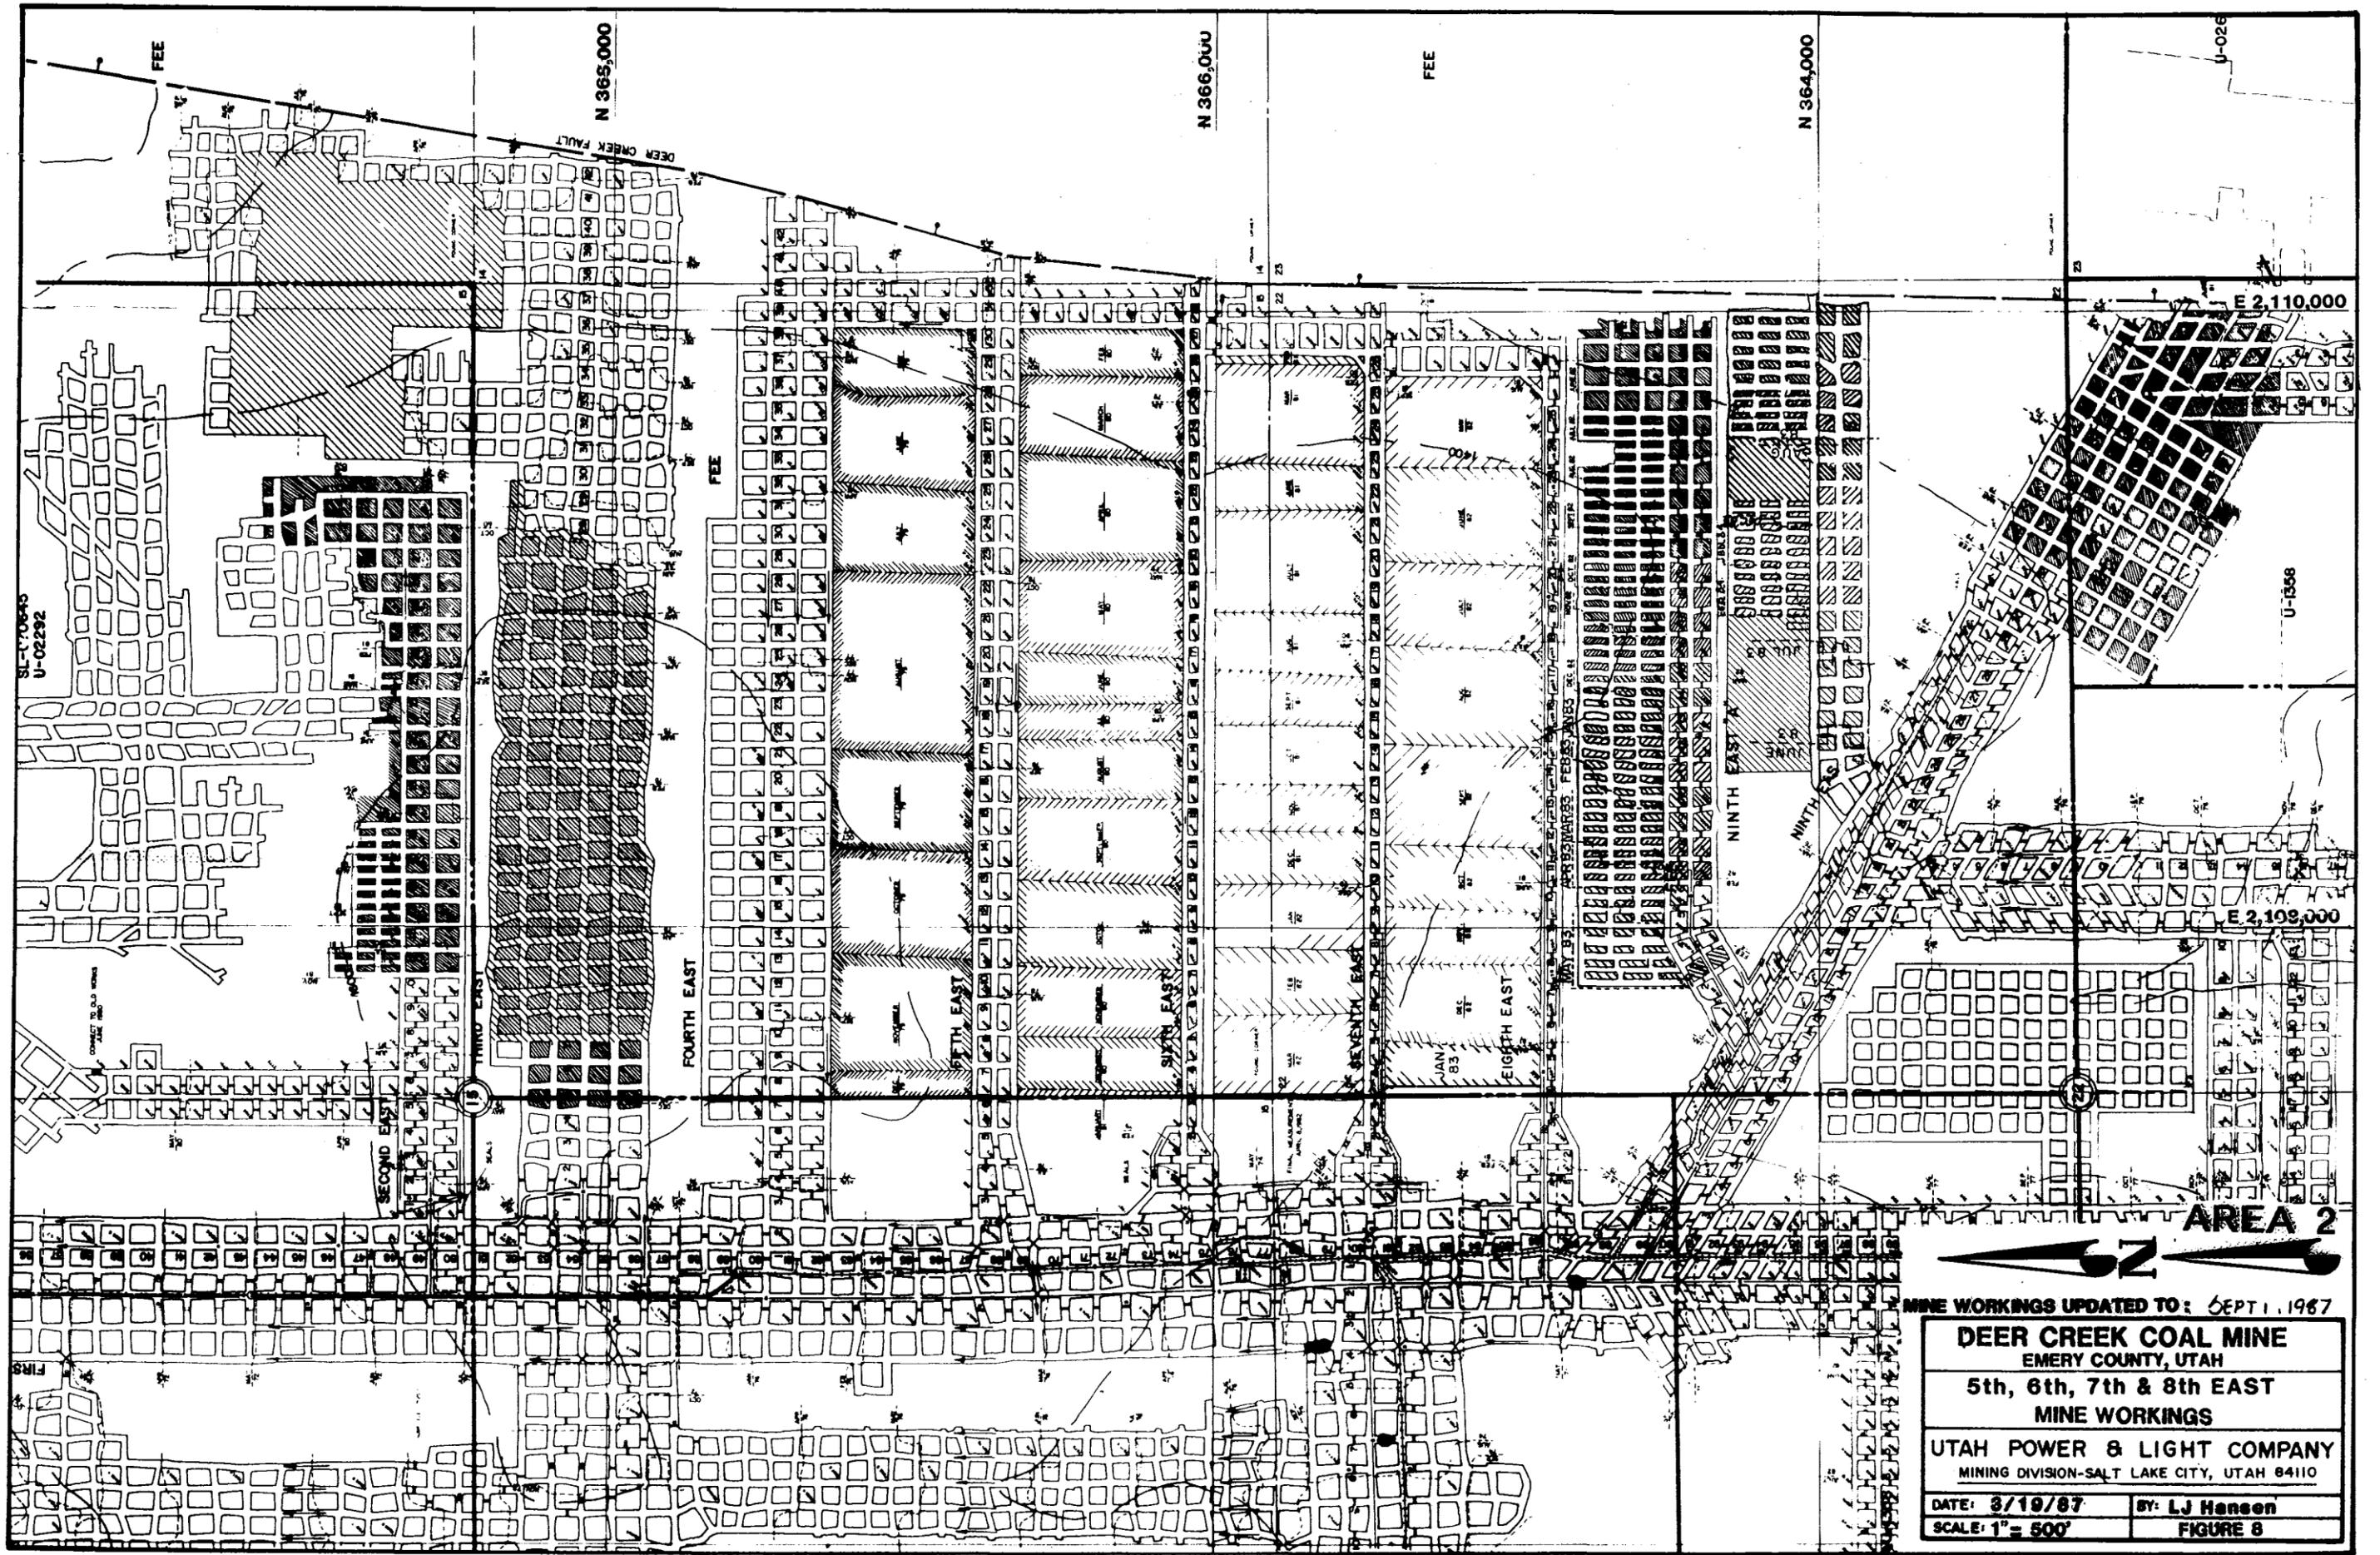
DATE: 3/19/87 BY: LJ Hansen
 SCALE: 1" = 500' FIGURE 8

Mining in the Deer Creek Mine in Area 2 was completed by February 1985 (Figure 8). Coal extraction in the underlying Wilberg Mine 3rd and 4th Right panels was completed between September 1987 and the end of January 1988 (Figure 9).

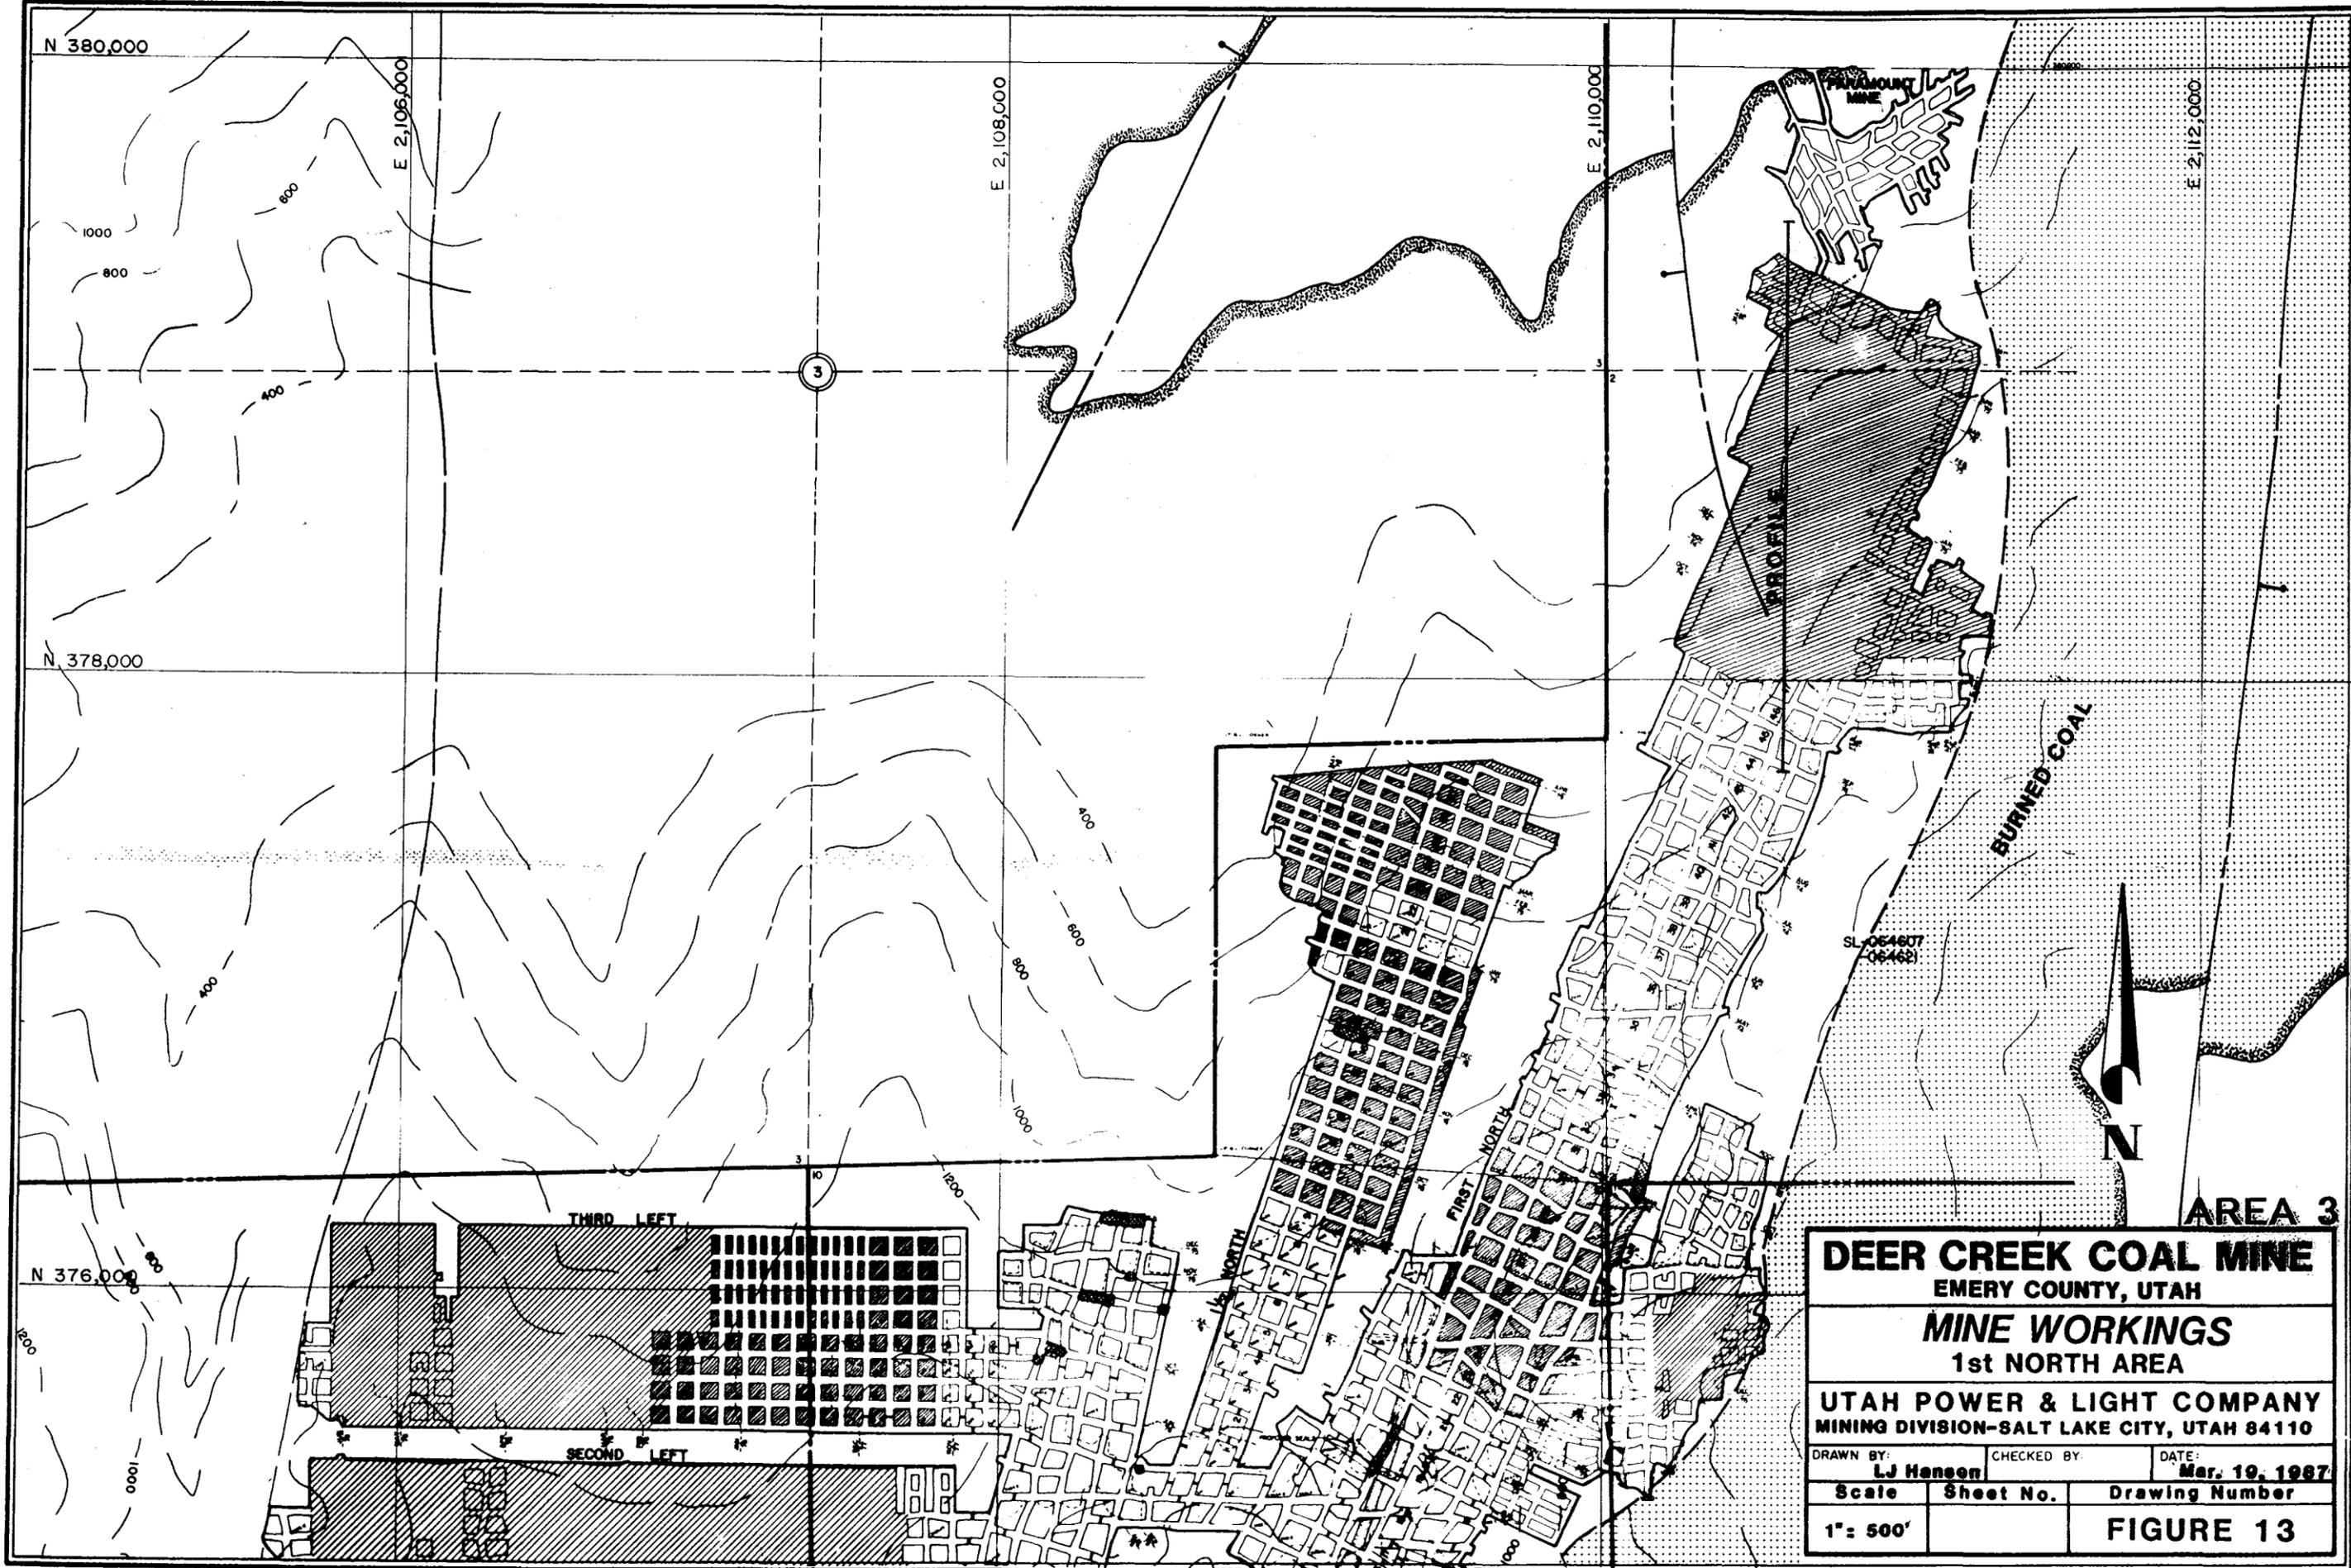
DEER CREEK COAL MINE		
EMERY COUNTY, UTAH		
MINE WORKINGS		
1st NORTH AREA		
UTAH POWER & LIGHT COMPANY		
MINING DIVISION-SALT LAKE CITY, UTAH 84110		
DRAWN BY: LJ Hansen	CHECKED BY:	DATE: Mar. 10, 1987
Scale 1" = 500'	Sheet No.	Drawing Number FIGURE 13

Most of the 1st North section of the Deer Creek Mine was abandoned and sealed in 1978 after being mined out. The southern portion is still open and may be used for access to a block of coal which lies to the west. Pillar extraction in the 3rd Left and 1-1/2 North sections was completed early in 1980 (Figure 13).

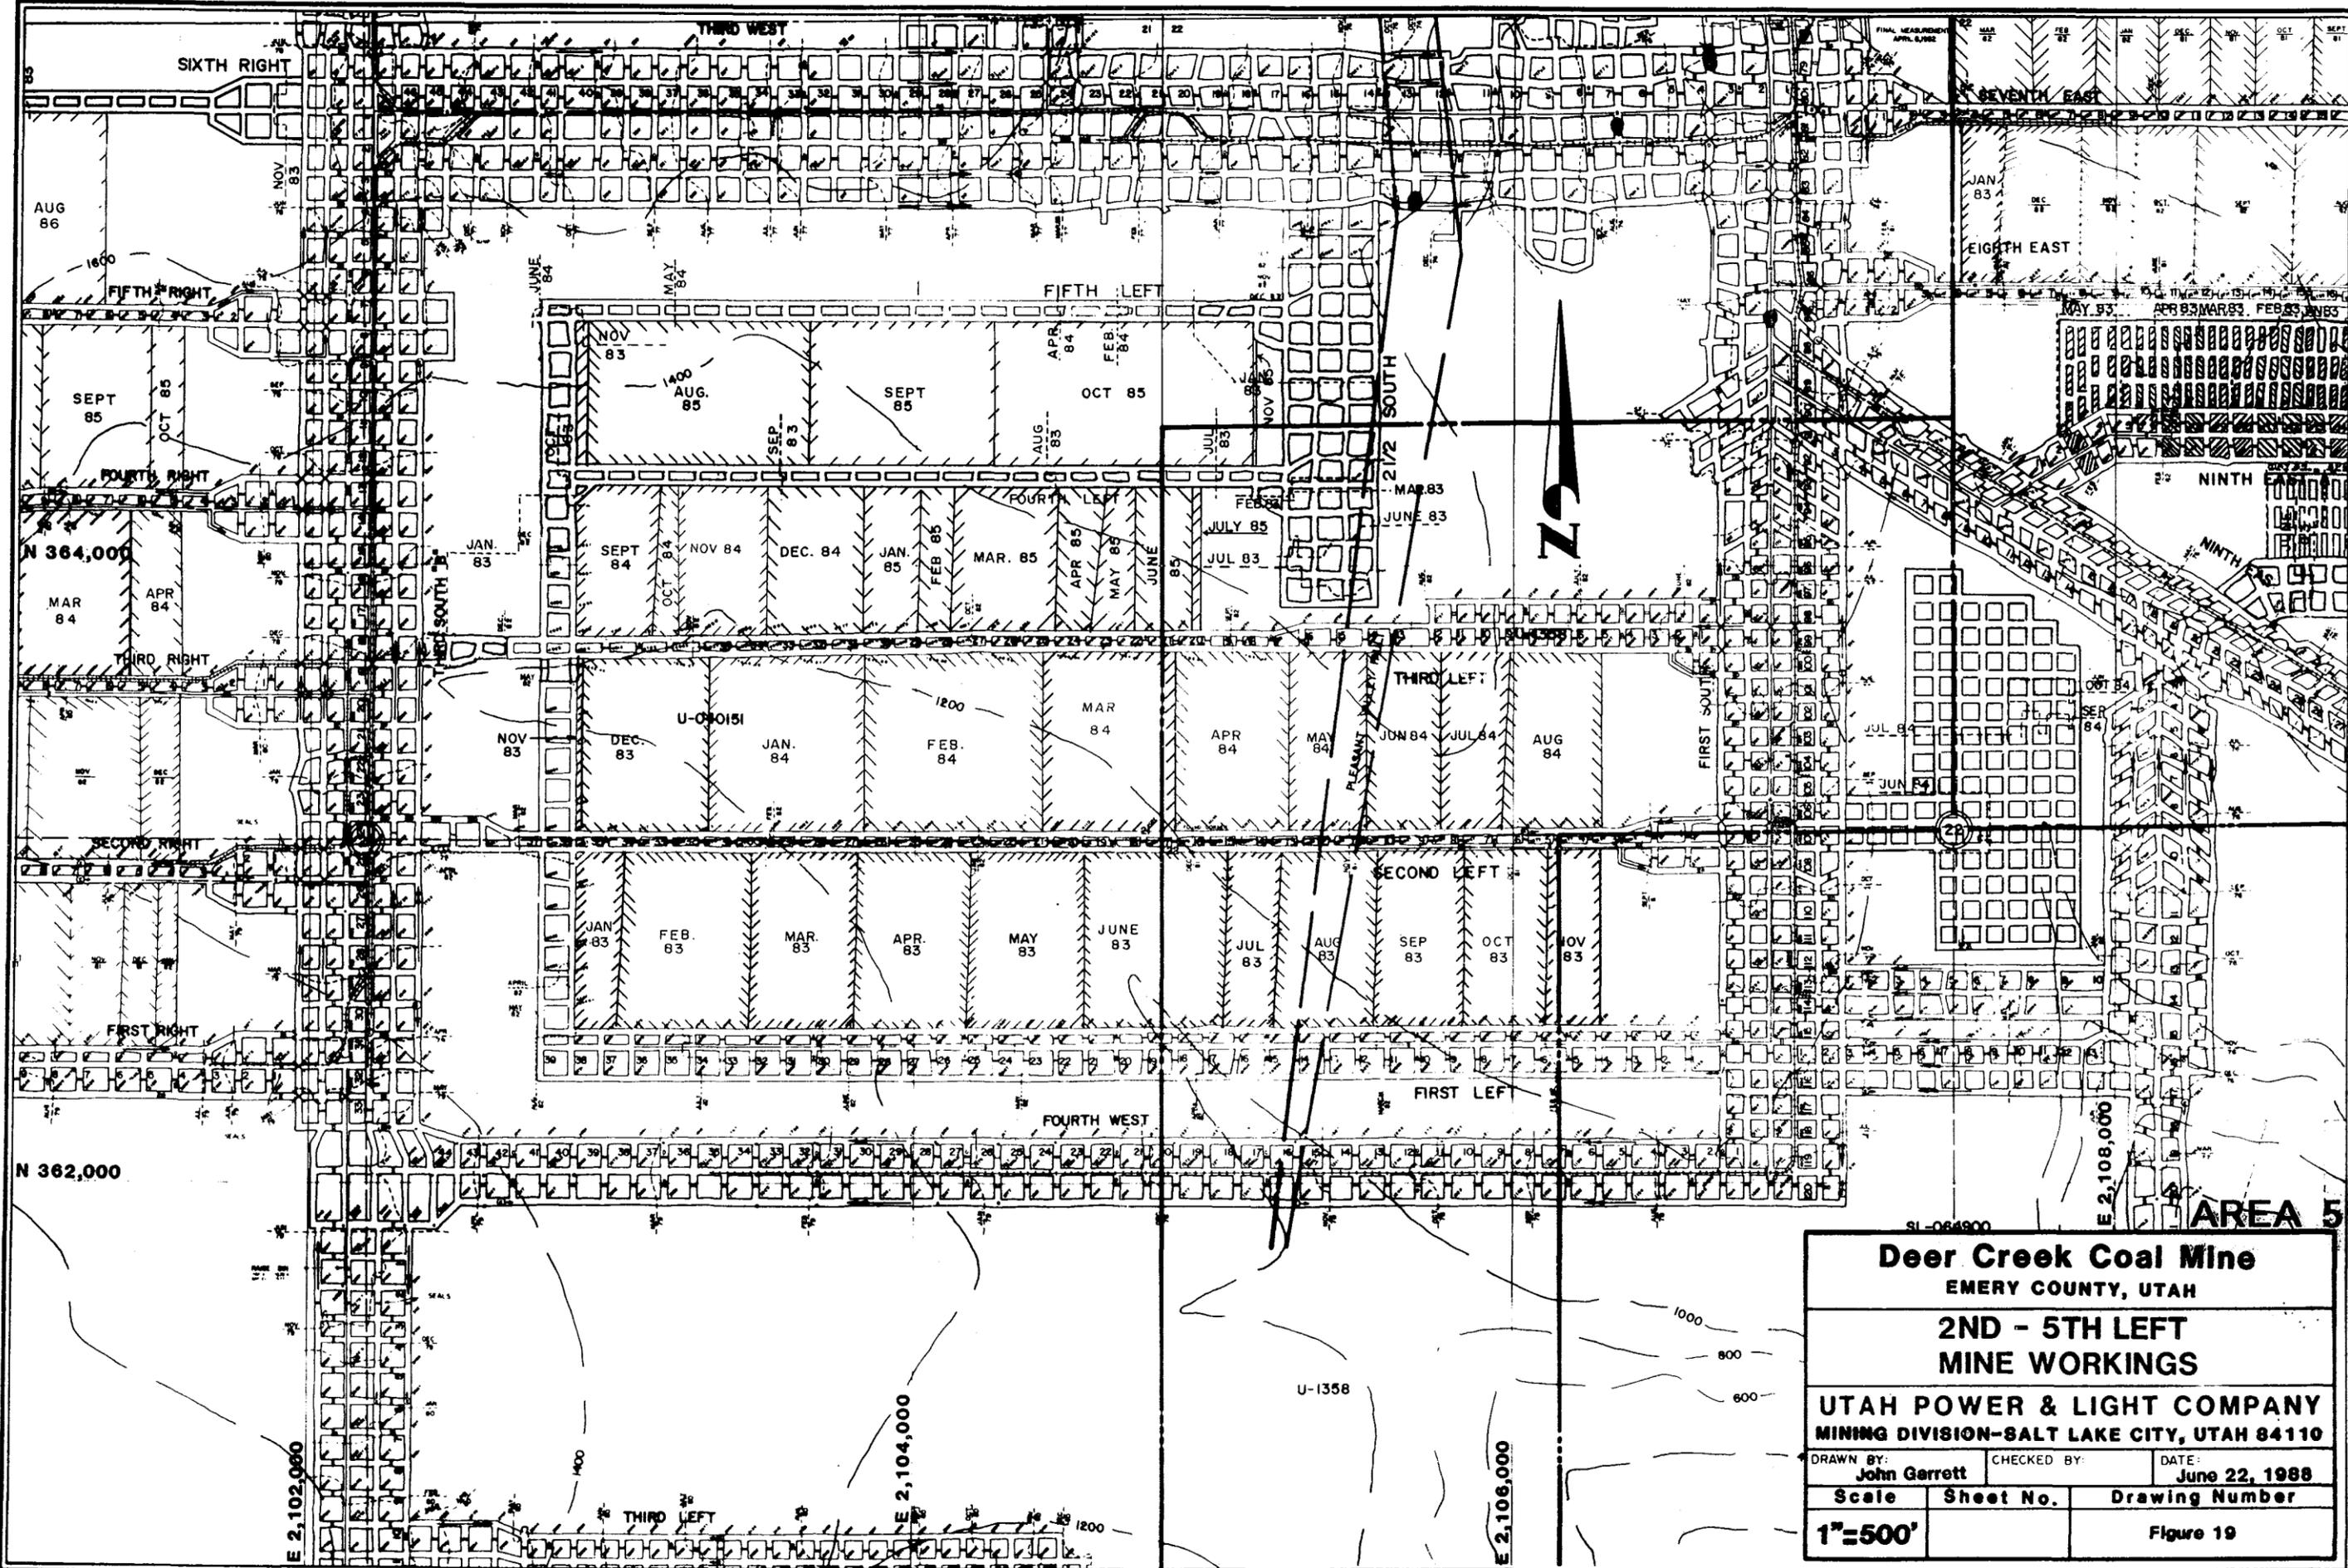
DRAWN BY: John Garrett	CHECKED BY:	DATE: June 22, 1988
Scale 1"=500'	Sheet No.	Drawing Number Figure 19

Photogrammetry revealed subsidence in Area 5 for the first time in 1984. Mining of the 2nd Left longwall panel in the Deer Creek Mine began in January 1983, and by October 1985 all four panels had been completed (Figure 19). In the Cottonwood Mine, longwall mining began in the 6th Right Longwall Panel in February 1993 and the last mining was completed in the 1st Right Longwall Panel in August 1994 completing all mining in this area (Figure 19A).

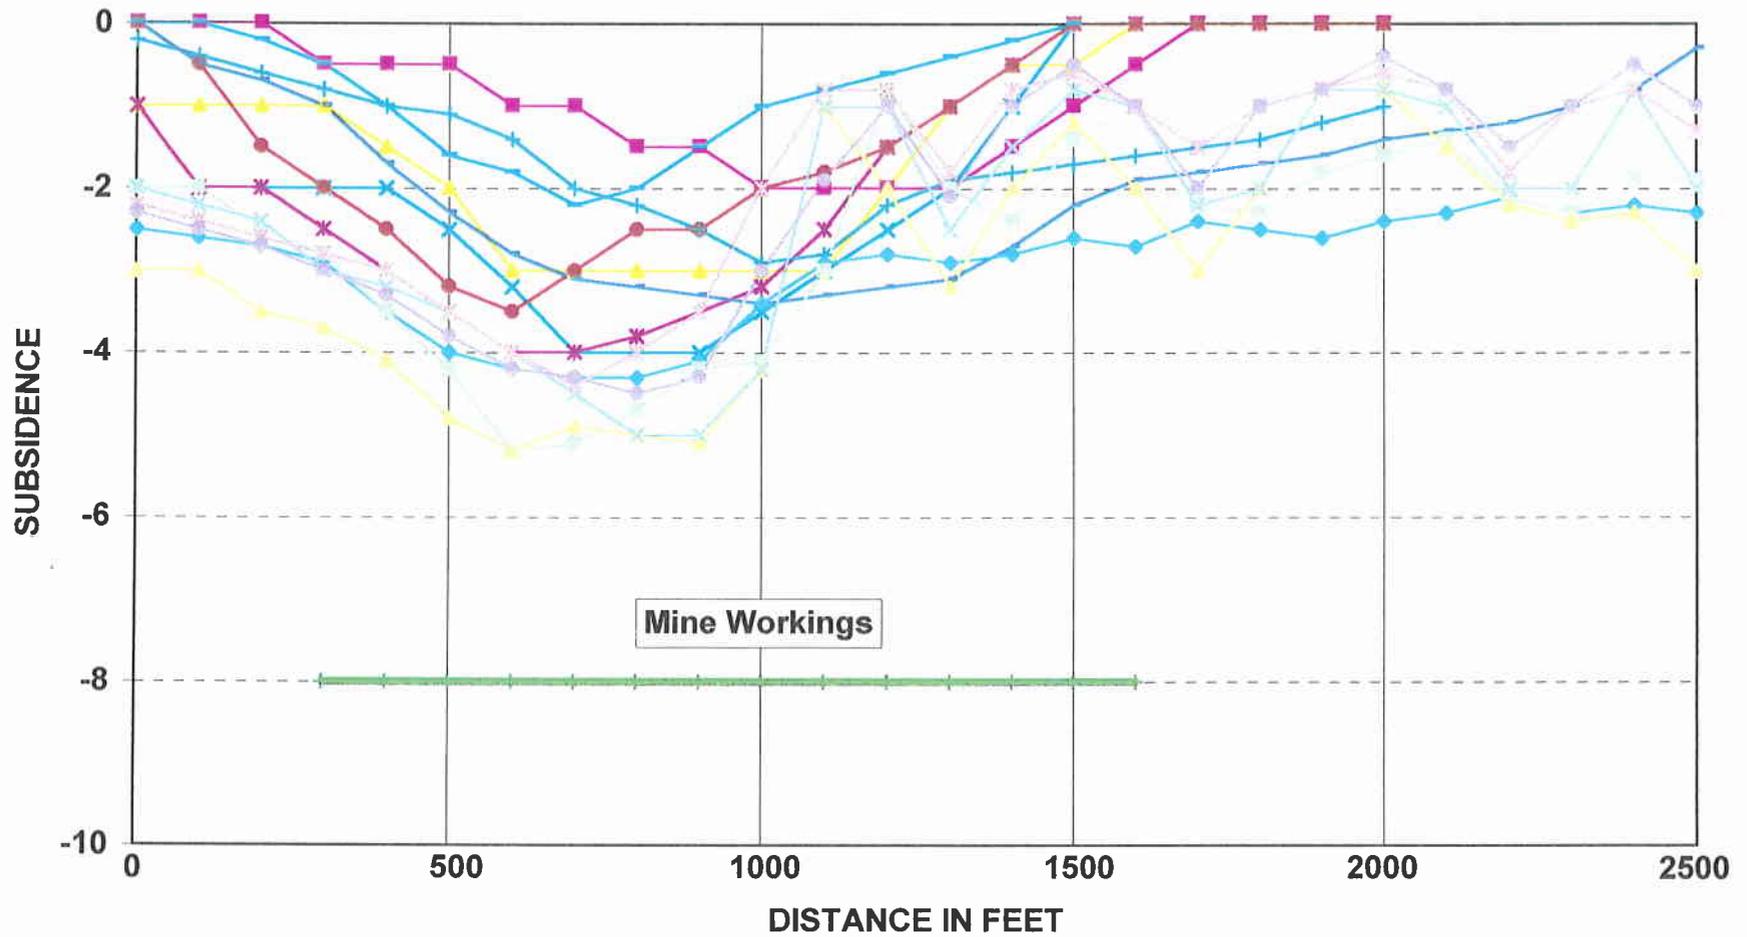
FIGURE 25

Mining in the Wilberg 1st and 2nd West longwall panels was completed in June 1983 (Figure 23). This area of subsidence has now reached a maximum of between four and five feet over the Second West Longwall Panel (Figure 24). The subsidence in this area has been stable for the past four years. The subsidence profiles (Figures 25 and 26) show the change in subsidence since 1983.

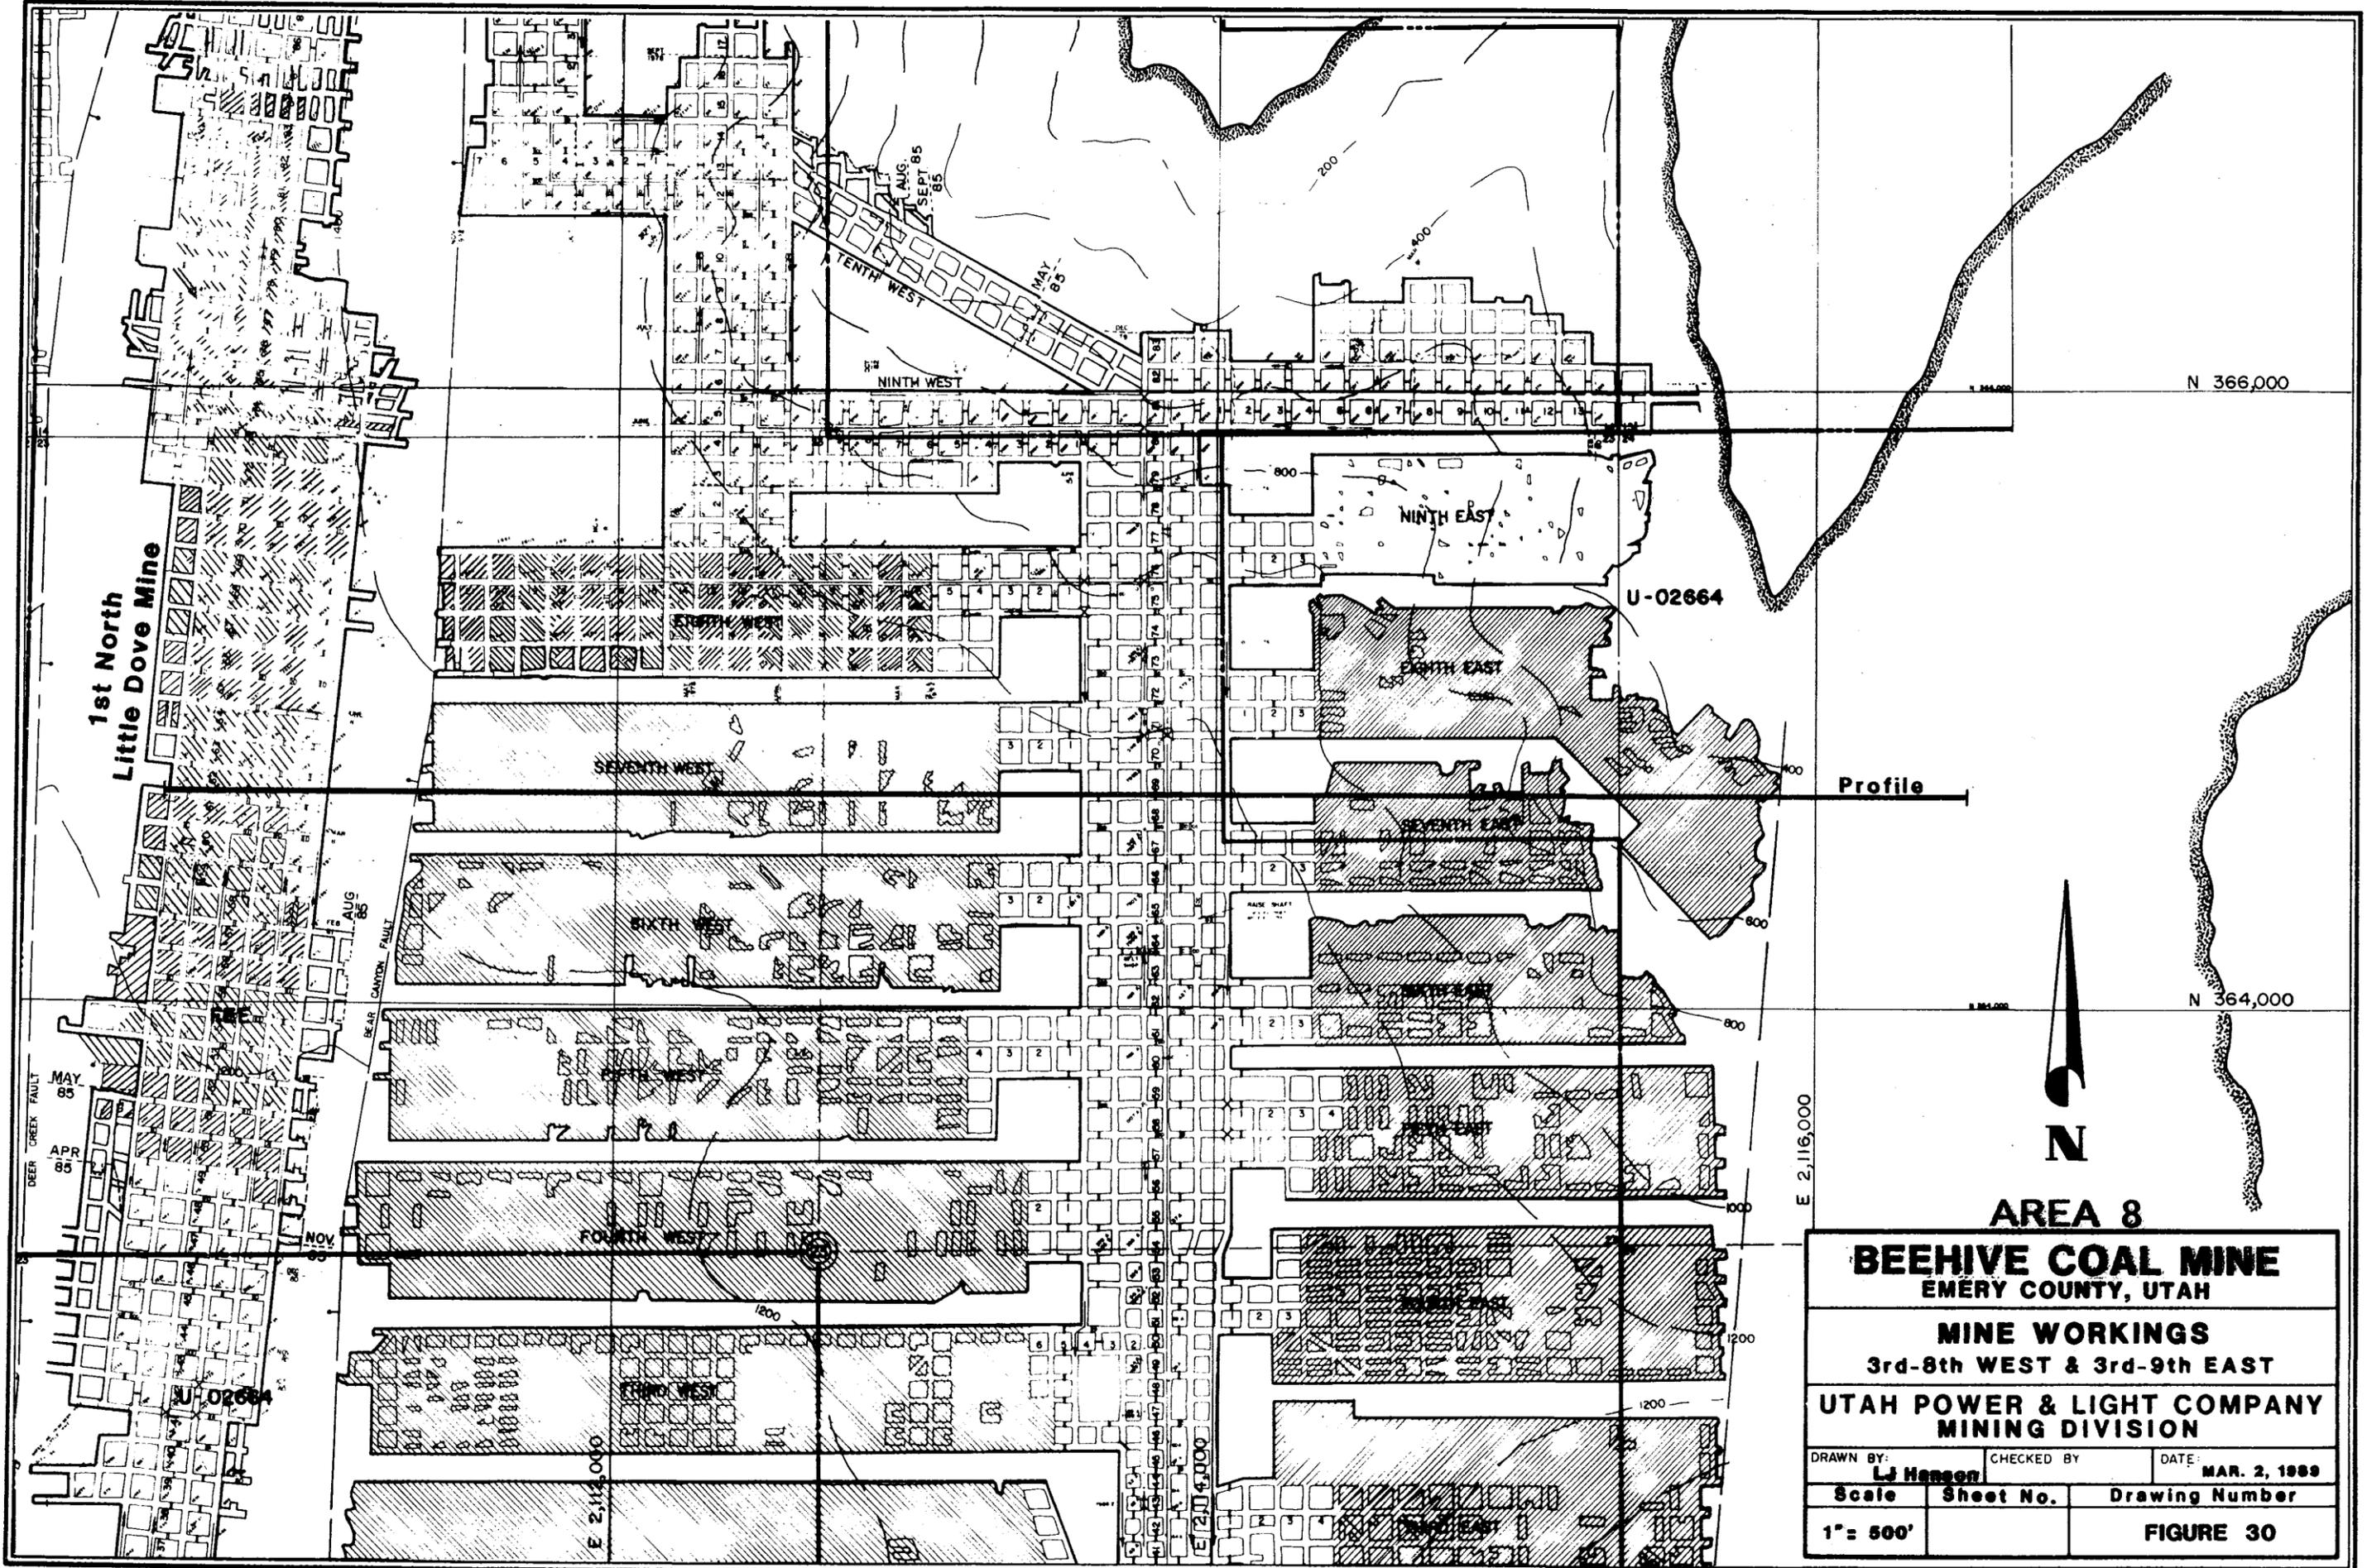
DRAWN BY: LJ Hansen	CHECKED BY:	DATE: MAR. 2, 1989
Scale 1" = 500'	Sheet No.	Drawing Number FIGURE 30

Some of the subsidence in Area 8 may have gone undetected because pillar extraction, and presumably subsidence, in part of the area was completed before the establishment of baseline survey data (Figures 30, 31, and 32). The west to east subsidence profile of the area depicted in Figure 33 indicates that subsidence up to slightly under seven (7) feet has occurred. The profile shows a fair amount of variability. This is due to the rugged terrain in the area. The profile indicates that no detectable change in subsidence has occurred in the past five years. Where not influenced by other workings, the angle-of-draw reached a maximum of 31 degrees on the eastern edge of the area.
