ANNUAL SUBSIDENCE MONITORING REPORT
EAST /TRAIL MOUNTAIN PROPERTIES
1997

PACIFICORP
SUBSIDENCE MONITORING PROGRAM
ANNUAL REPORT FOR 1997

April, 1998

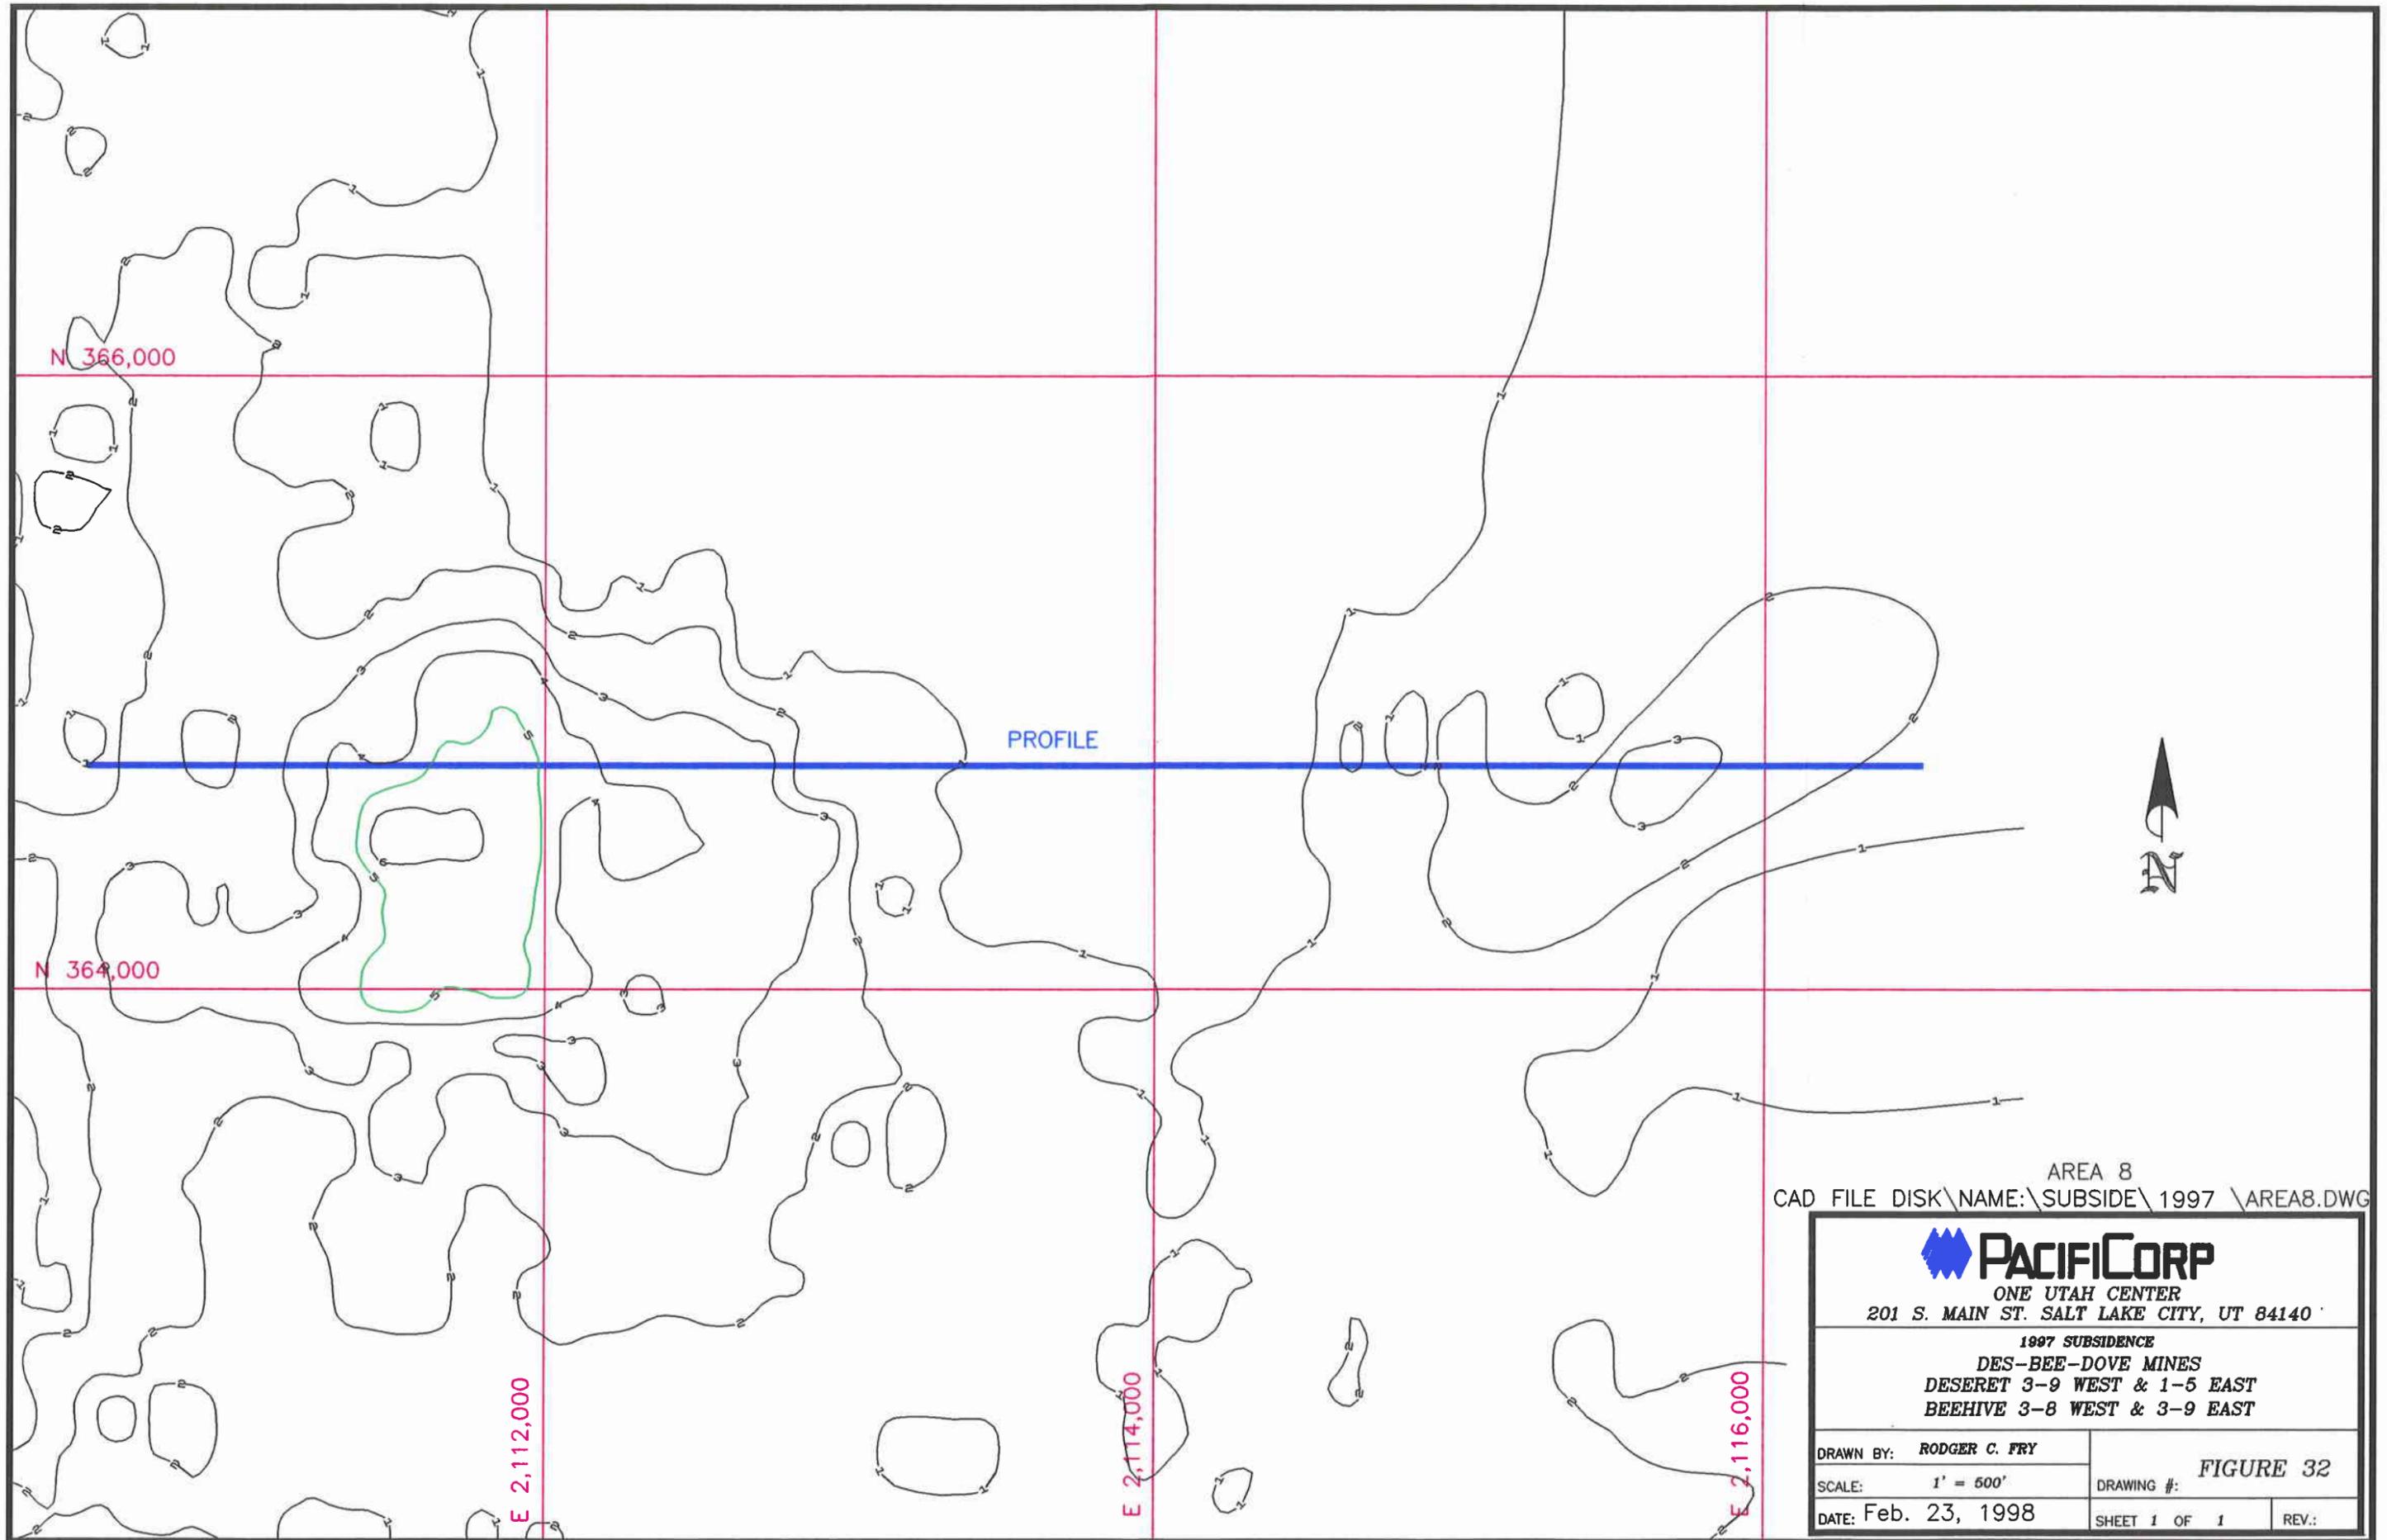
PACIFICORP ONE UTAH CENTER 201 S. MAIN ST. SALT LAKE CITY, UT 84140	
1997 SUBSIDENCE DES-BEE-DOVE MINES DESERET 3-9 WEST & 1-5 EAST BEEHIVE 3-8 WEST & 3-9 EAST	
DRAWN BY: RODGER C. FRY	FIGURE 32
SCALE: 1' = 500'	DRAWING #:
DATE: Feb. 23, 1998	SHEET 1 OF 1 REV.:

Some of the subsidence in Area 8 may have gone undetected because pillar extraction, and presumably subsidence, in part of the area was completed before the establishment of baseline survey data (Figures 30, 31, and 32). The west to east subsidence profile of the area depicted in Figure 33 indicates that subsidence up to slightly under seven (7) feet has occurred. The profile shows a fair amount of variability. This is due to the rugged terrain in the area. The profile indicates that no detectable change in subsidence has occurred in the past five years. Where not influenced by other workings, the angle-of-draw reached a maximum of 31 degrees on the eastern edge of the area.

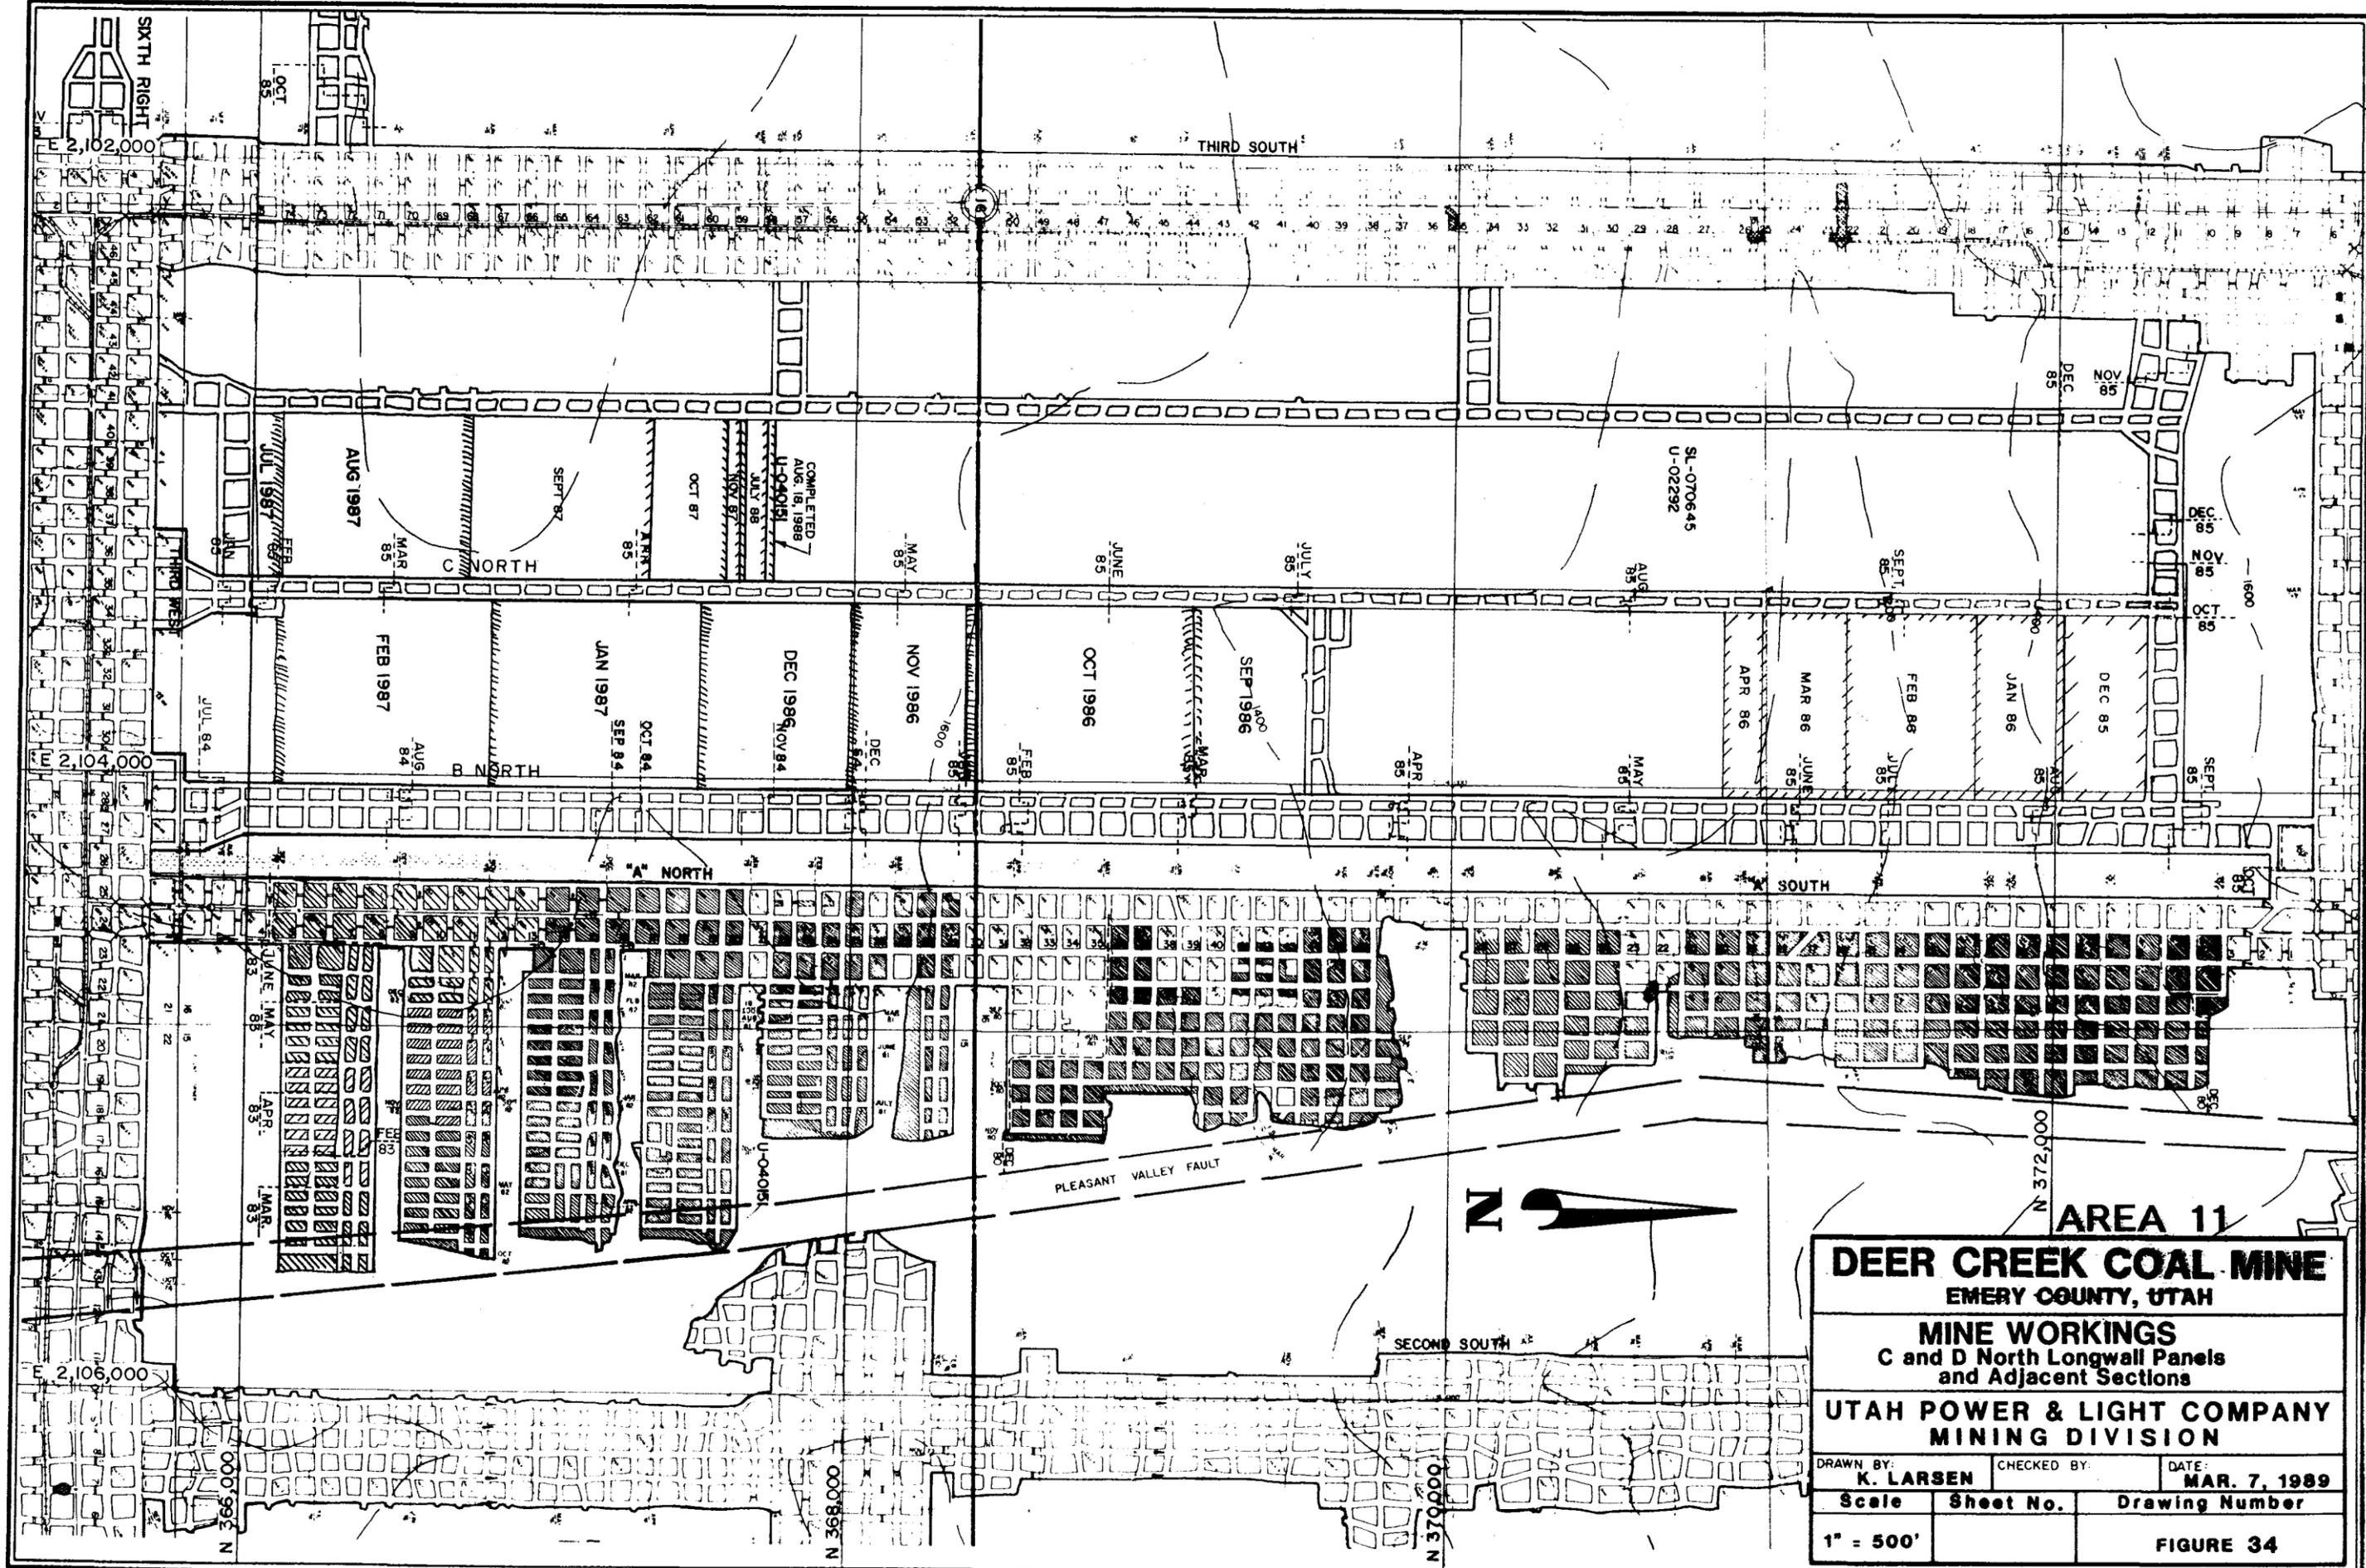
DRAWN BY: K. LARSEN	CHECKED BY:	DATE: MAR. 7, 1989
Scale	Sheet No.	Drawing Number
1" = 500'		FIGURE 34

Longwall mining in the C North panel began in December 1984 and was terminated in April 1986 due to geologic complications. New setup entries were driven further south and mining resumed in September 1986; the panel was completed in March 1987. The D North longwall panel began production in July 1987, but after October 1987 production was limited due to poor coal quality. The panel was terminated in August 1988 at a length of 1750 feet. Pillar extraction mining in A North and A South was completed in June 1983 (Figure 34).

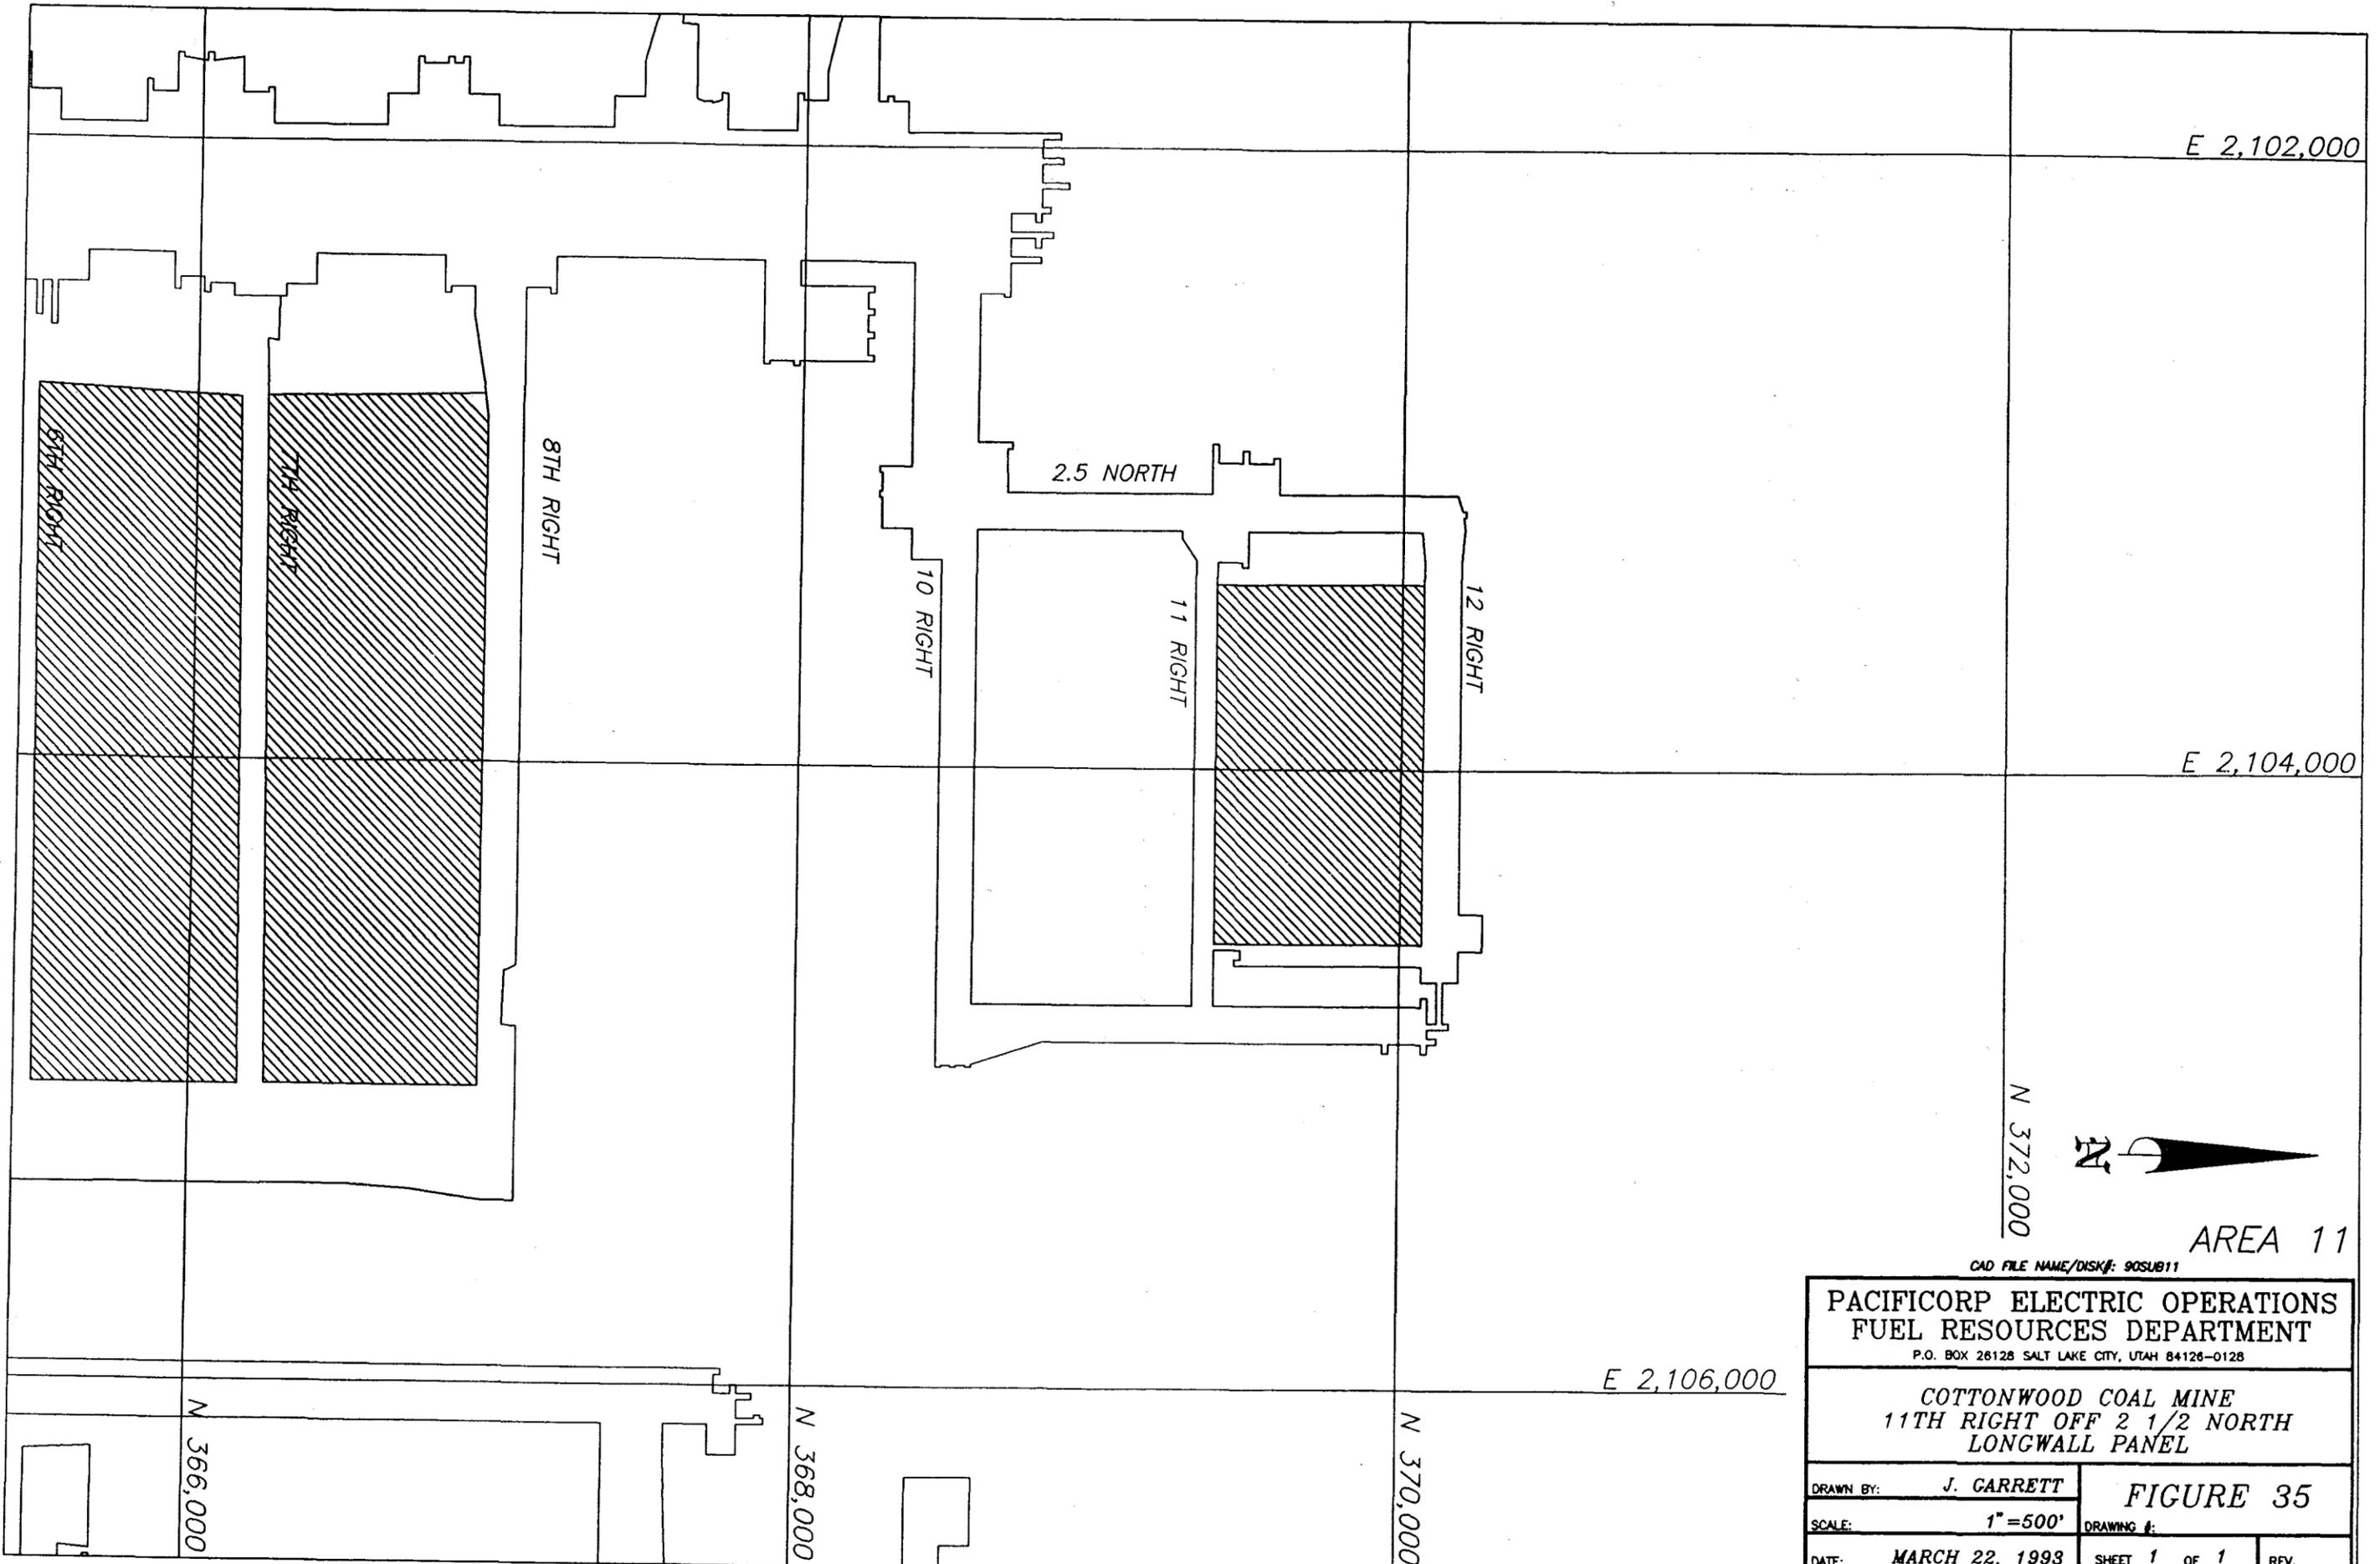
DRAWN BY: J. GARRETT	FIGURE 35	
SCALE: 1" = 500'	DRAWING #:	
DATE: MARCH 22, 1993	SHEET 1 OF 1	REV. _____

Mining in the 11th Right Panel in the Cottonwood Mine began In July of 1992 and was completed in September 1992 (Figure 35). The 10th Right Panel to the south was developed but couldn't be mined with longwall methods because of thin coal and poor coal quality. Mining began in the 7th Right Panel in February 1993 and by August 1993 mining in the 6th Right Panel had been completed.

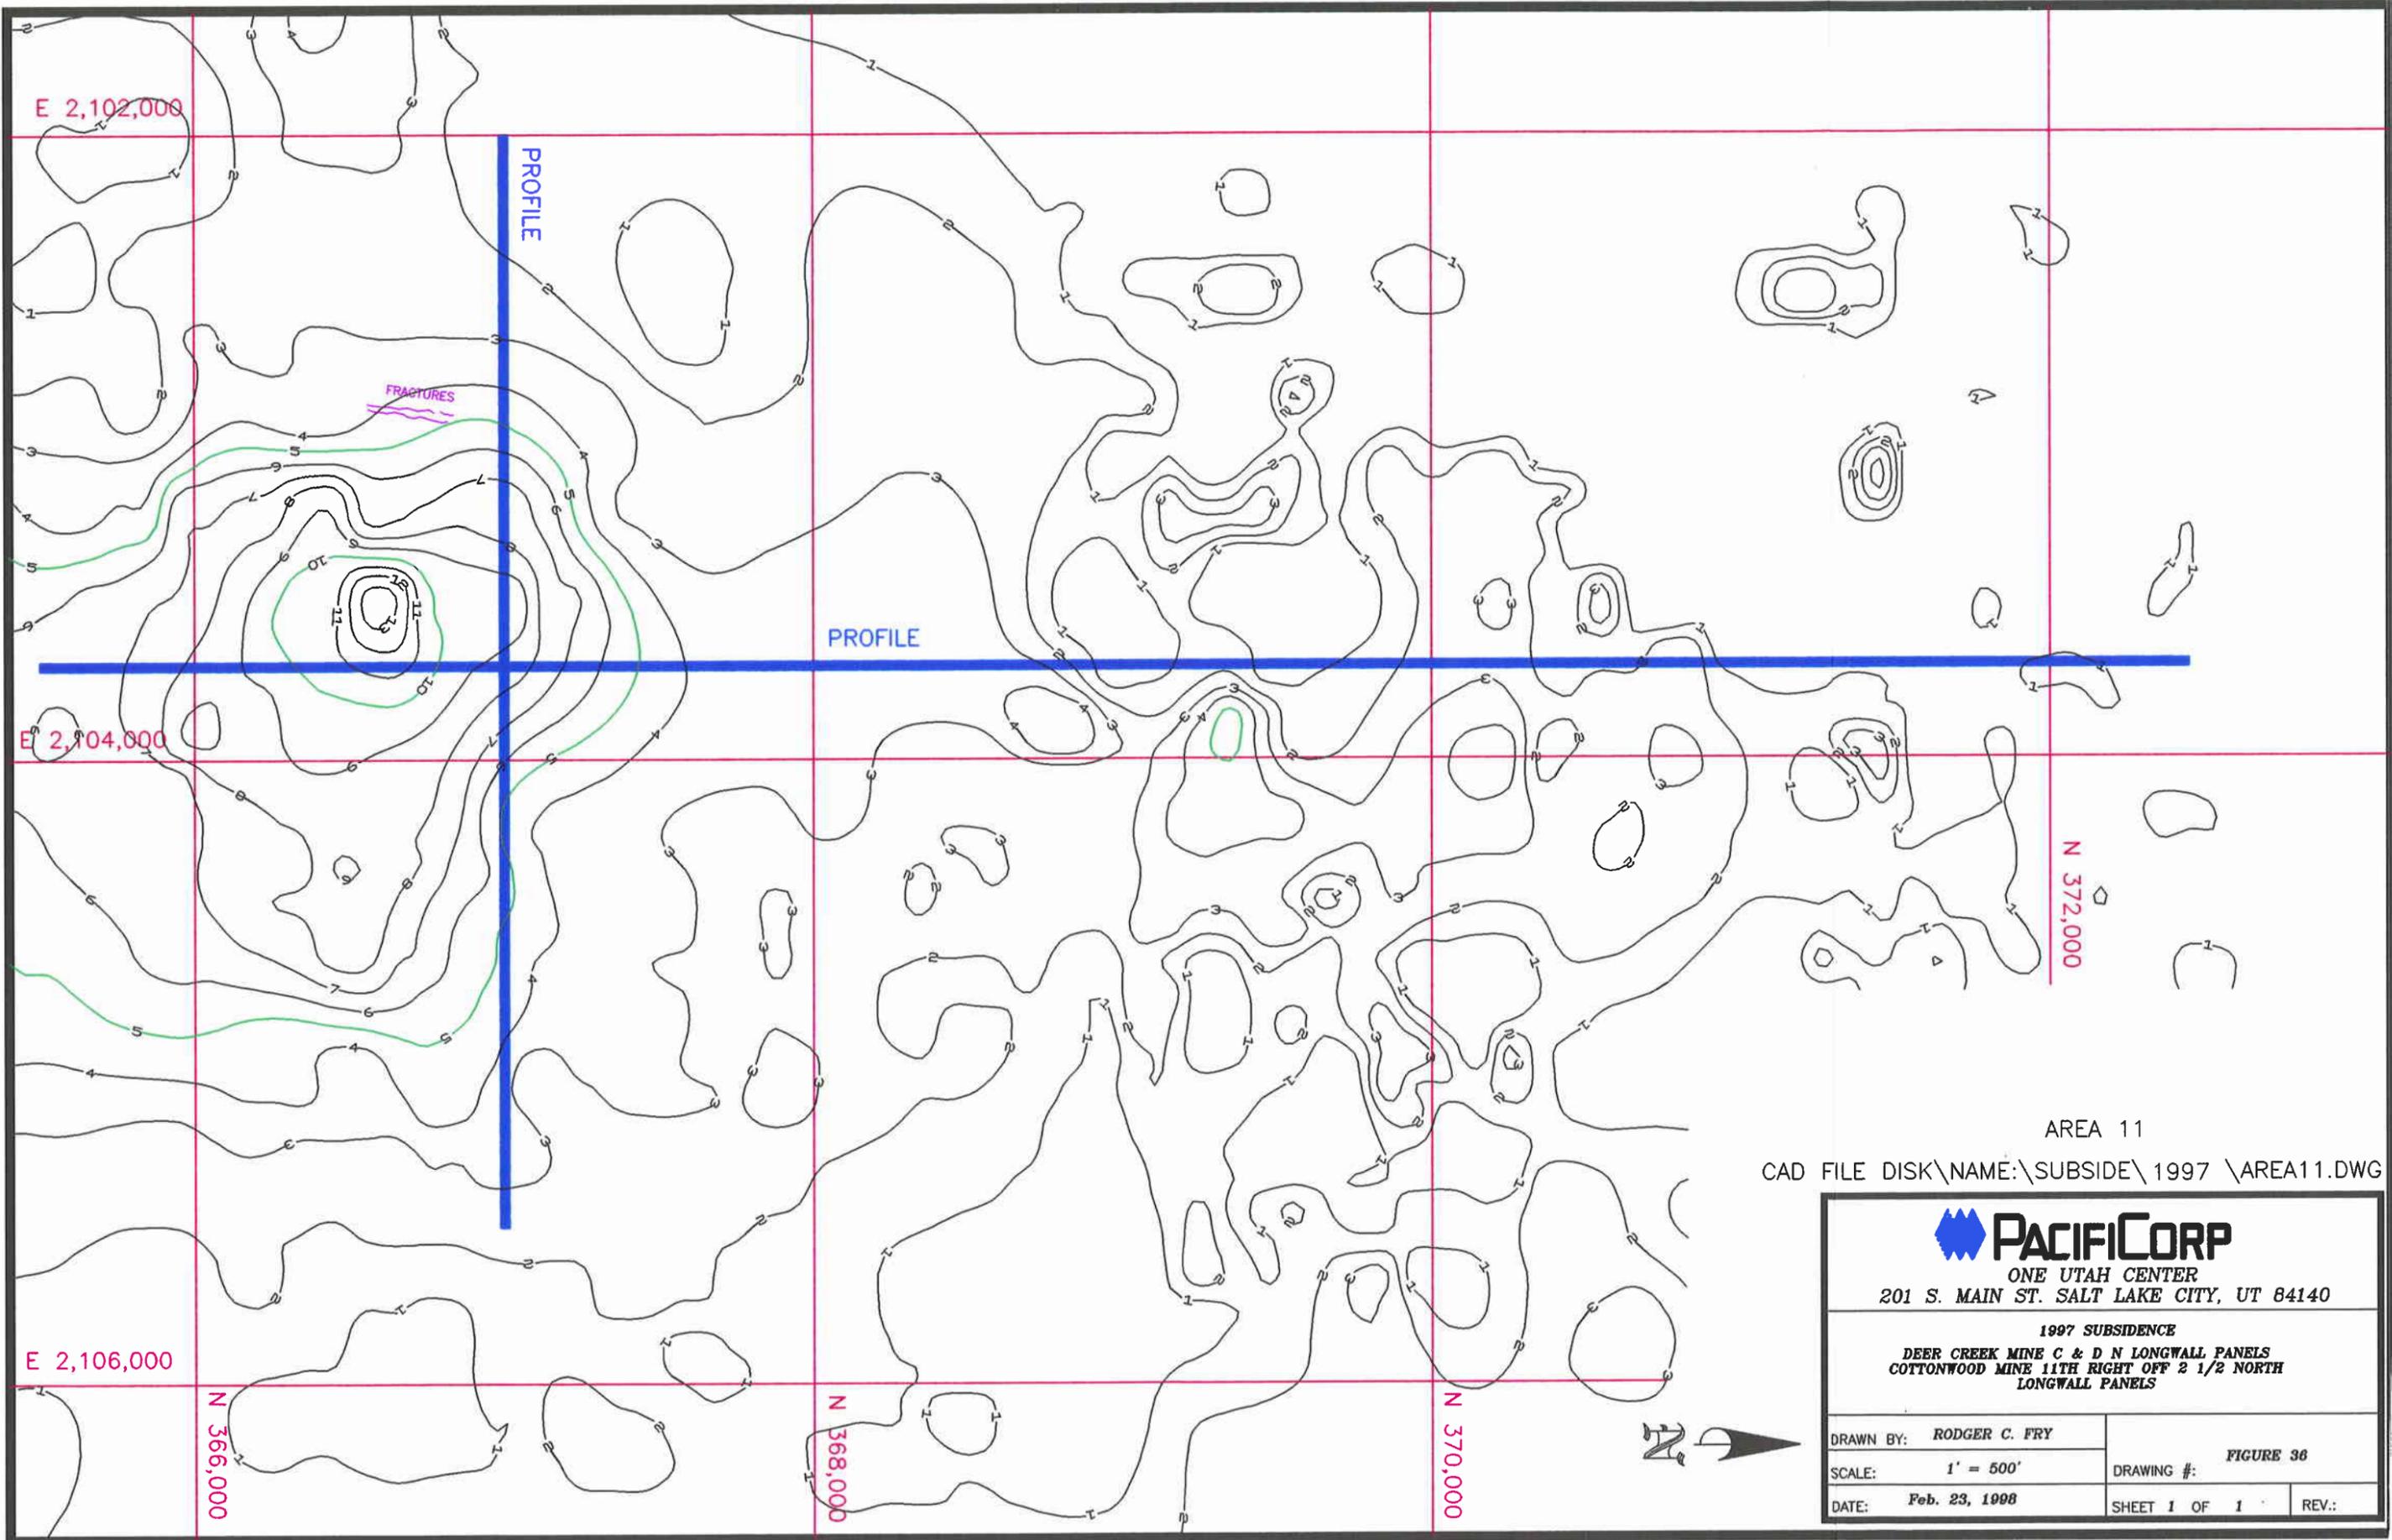
DRAWN BY: RODGER C. FRY	FIGURE 36	
SCALE: 1" = 500'	DRAWING #:	
DATE: Feb. 23, 1998	SHEET 1 OF 1	REV.:

Measurable subsidence to date has exceeded thirteen (13) feet in the area of multiple seam mining above the 6th and 7th Right Longwall Panels in the Cottonwood mine (Figures 36, 37, and 38). The maximum subsidence showed an increase between 1993 and 1994 but has been stable the past four years.

Fractures were discovered at the western end of coal extraction above the 7th Right Longwall Panel. The fractures were first discovered on June 17, 1993. Mining of the longwall panel was completed on May 12, 1993. An aerial reconnaissance of the area on May 18, 1993 revealed no surface fractures at that time. This places the occurrence of the fractures between May 18, 1993 and June 17, 1993. Burnt Tree Springs is located approximately 800 feet to the southeast of the fractures. Measurements of the spring discharge throughout the summer of 1993 through 1997 indicated that the fracturing has had no effect on the spring. The angle-of-draw measured ranges from less than zero to 28 degrees.
