C/015/009 Incoming  
cc: Keenan

RE: Fossil Rock Resources, LLC Permit #C0150009, Waste Rock Site Ditch Evaluation and Request to Terminate NOV #21173

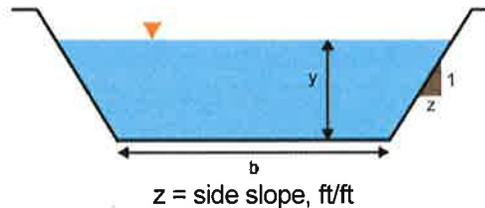
Figure 8: Ditch Section View

For a trapezoidal shaped open channel as shown in Figure 8, the area, hydraulic radius and wetted perimeter are calculated as follows. See the figure 8 below.
