Subject: Findings of Fact, Conclusions, and Order for Violation #21173 Fossil Rock Resources, LLC, Fossil Rock Mine, C/015/0009

**FINDINGS of FACT,
CONCLUSIONS OF LAW
AND ORDER**

RE: Fossil Rock Resources, LLC Permit #C0150009, Waste Rock Site Ditch Evaluation and Request to Terminate NOV #21173

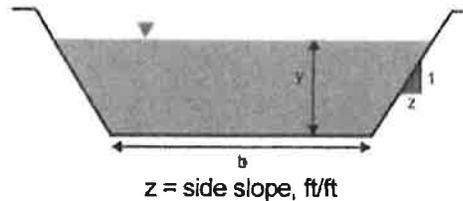
Figure 8: Ditch Section View

For a trapezoidal shaped open channel as shown in Figure 8, the area, hydraulic radius and wetted perimeter are calculated as follows. See the figure 8 below.

The original design required the mean velocity to be a maximum of 5 feet per second in order to reduce the potential for erosion. The original design used a Manning's coefficient of 0.035 and channel slopes of 2% and 12% for ditches DA and DB, listed respectively.
