C/015/0015
Received 3/23/15
Task ID #4821

Annual Report

Company Name	CONSOL Mining Company LLC	Mine Name	Emery Deep Mine
Permit Number	C/015/0015	Permit expiration Date	1/07/2016
Operator Name	CONSOL Mining Company LLC	Phone Number	+1 (724) 485-4267
Mailing Address	1000 CONSOL Energy Drive	Email	kerrygoodballet@consolenergy.com
City	Canonsburg		
State	PA	Zip Code	15317

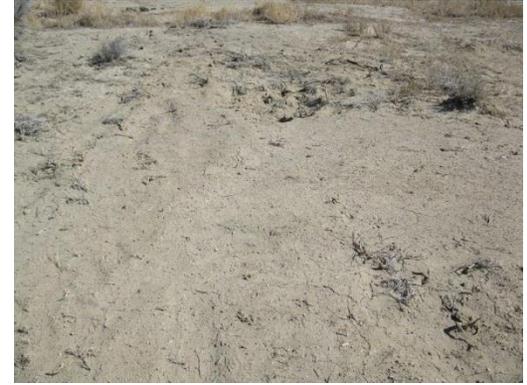
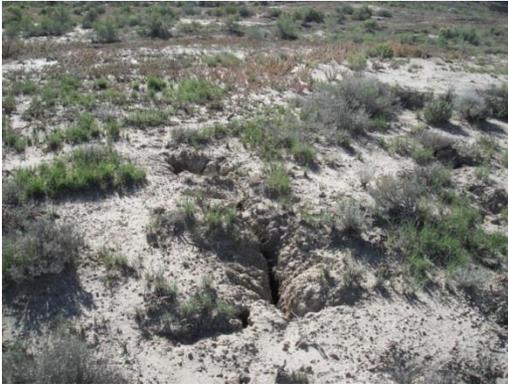
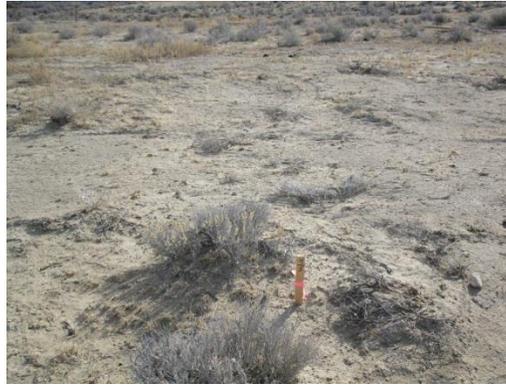
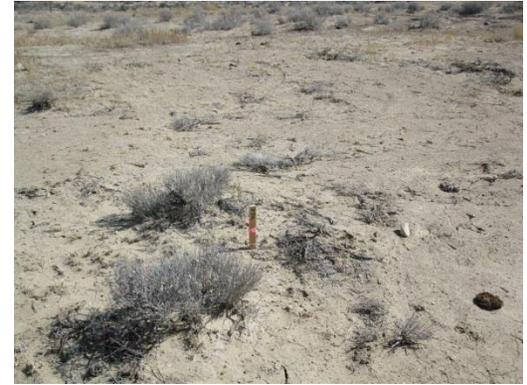
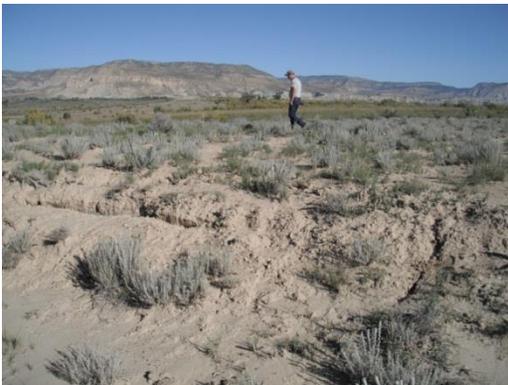
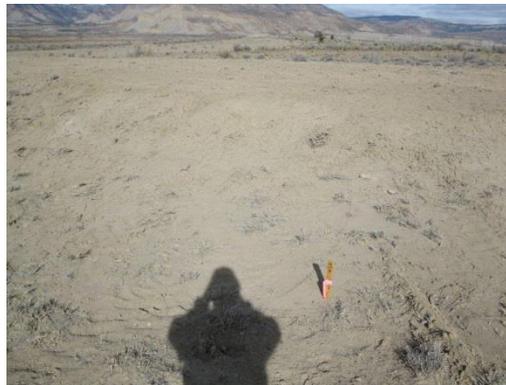
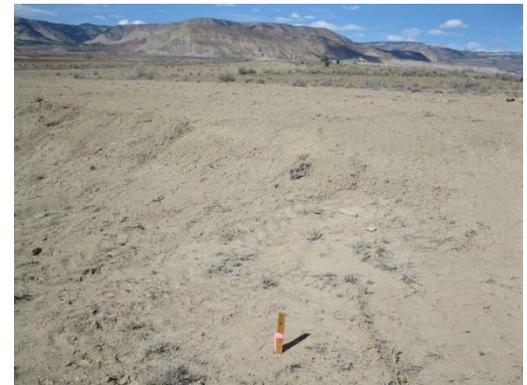
Depression #4 - February 2014

On February 26, 2014, Russel Jensen of Consol Energy walked the area of 6 depressions over the 00 North panel. He observed no recent movement or evidence of subsidence. He also walked the area around the known subsidence depressions and noticed no new depressions or cracks.

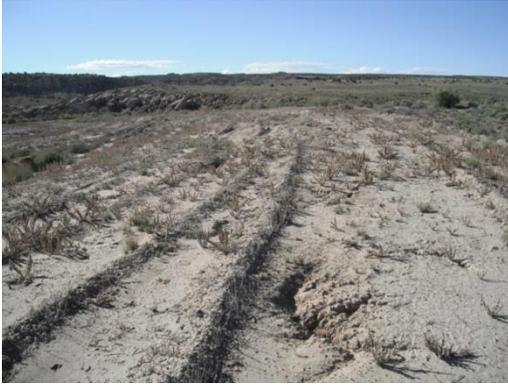
Depression #5 - September 2013

Photographs of the six depressions are provided in Appendix A. Side-by-side photographs are taken from the same general locations in September 2013 (prior to repair) as well as January and February 2014, allowing comparisons to be made between pre- and post-repair dates. No substantial changes have been observed since the subsidence cracks were repaired in October 2013.

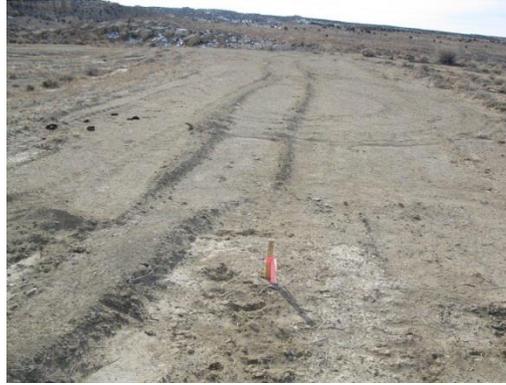
Depression #5 - January 2014

On January 29, 2014, Russel Jensen of Consol Energy walked around all known depressions over the 00 North mine panel. He photographed all staked subsidence areas and did not observe any indication of new movement, settlement, or cracks. He also walked area outside of the known subsidence depressions and did not see any new depressions or cracks.

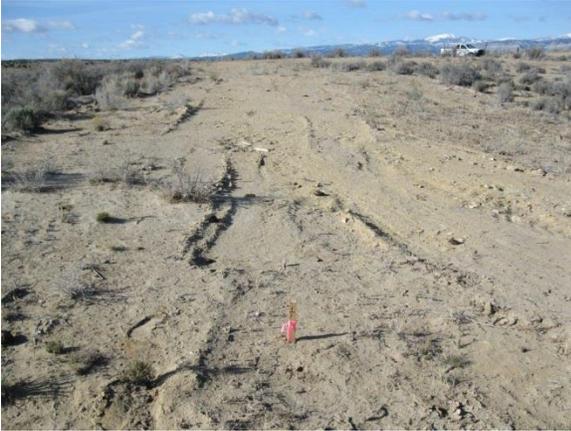
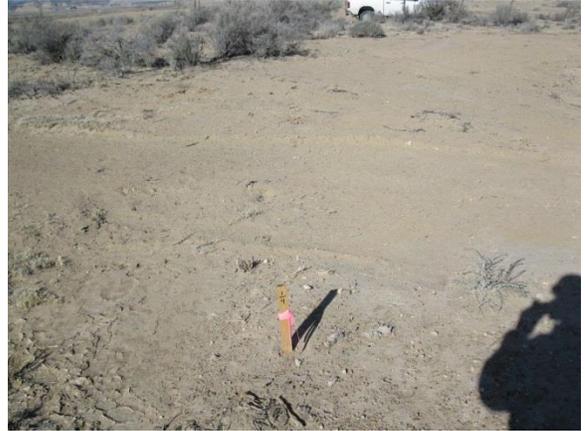
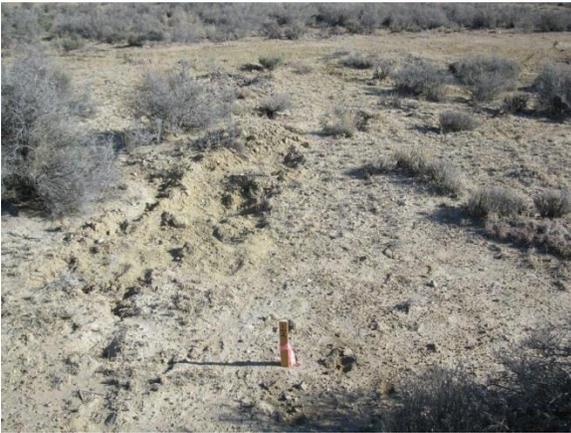
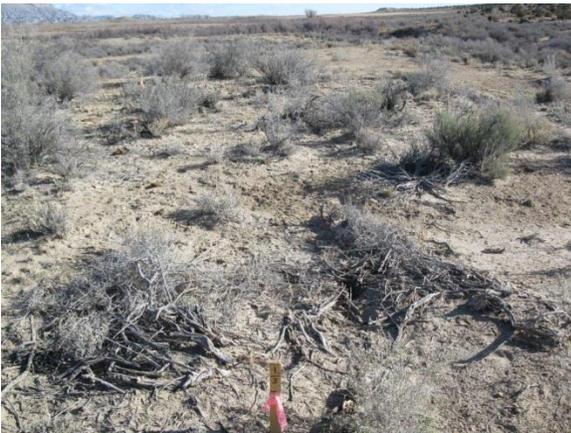
Depression #1 - March 28, 2014

On March 28, 2014, Russel Jensen of Consol Energy walked the area over the 00 North section of the Emery Mine. No new subsidence cracks or additional movement were observed. Mr. Jensen photographed all staked subsidence locations. Copies of these photographs are provided in Attachment A.

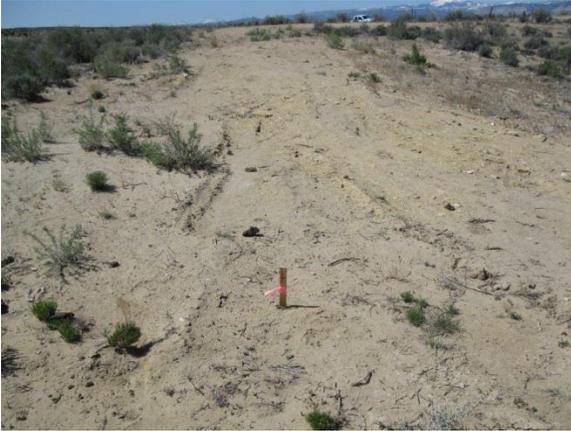
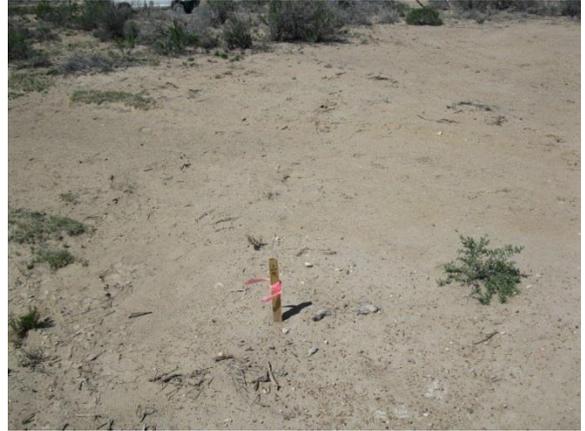
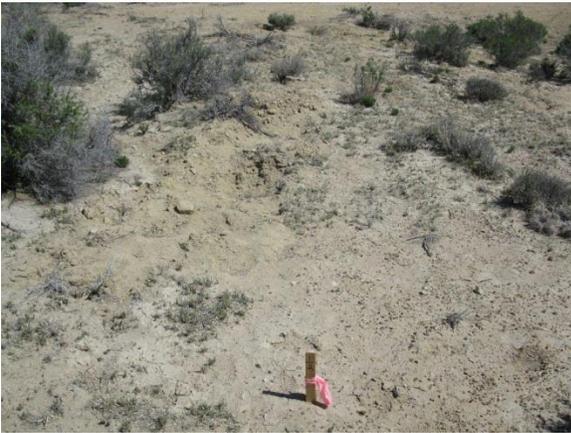
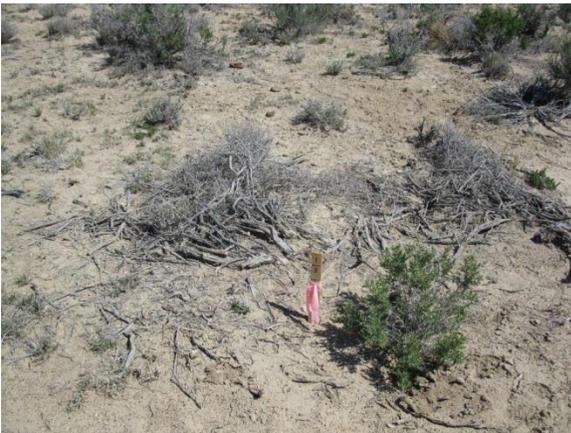
Depression #1 - April 29, 2014

On April 29, 2014, Russel Jensen of Consol Energy walked the area of six known subsidence depressions and photographed all staked areas. No new movement or new cracks were observed. He also walked the entire area around the outside of the known subsidence areas and observed no new depressions or cracks. Copies of the photographs are provided in Attachment A.

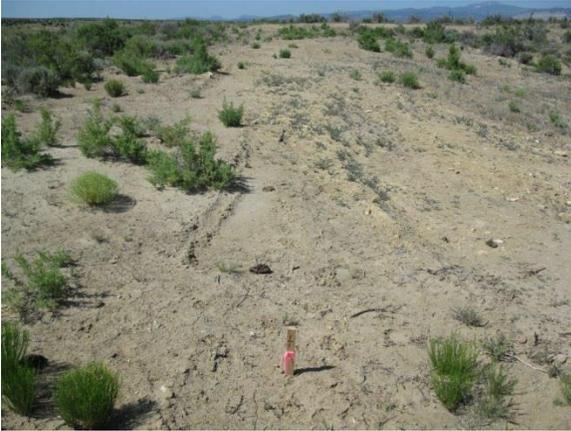
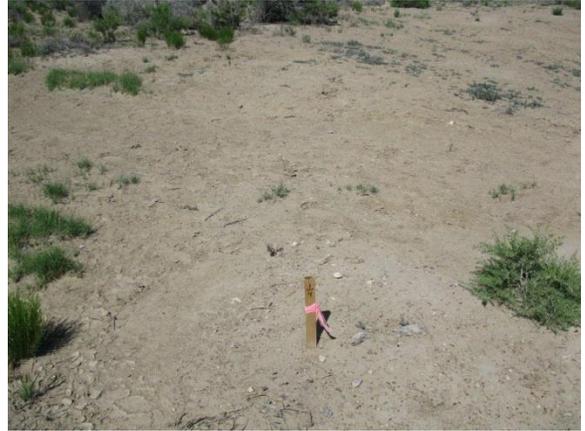
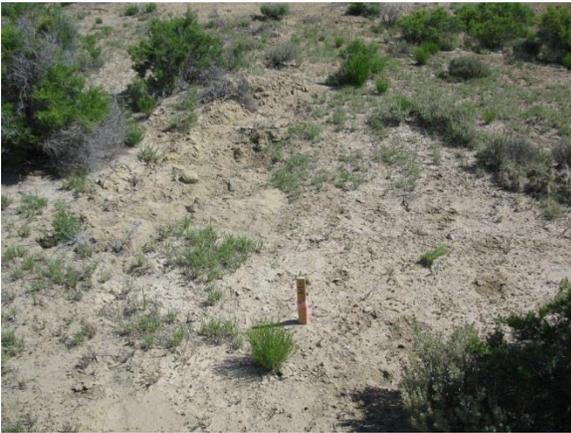
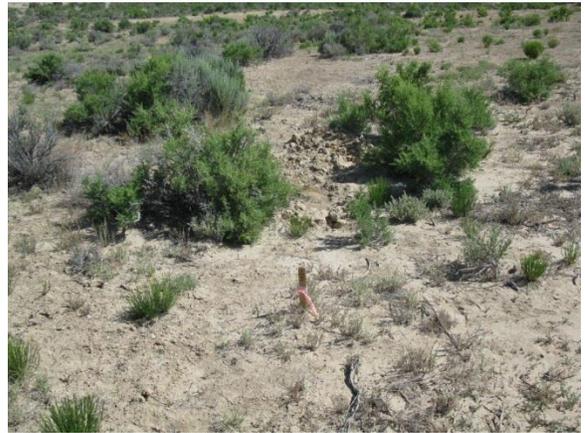
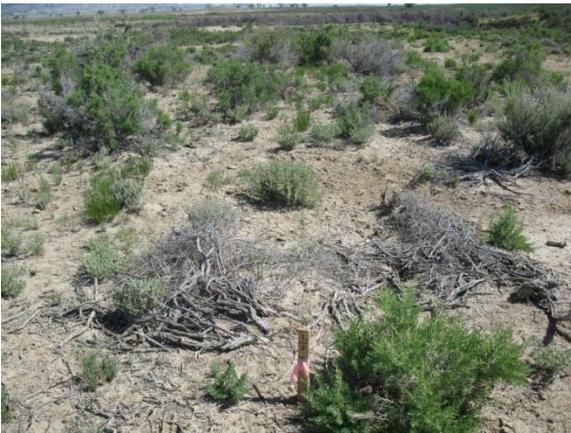
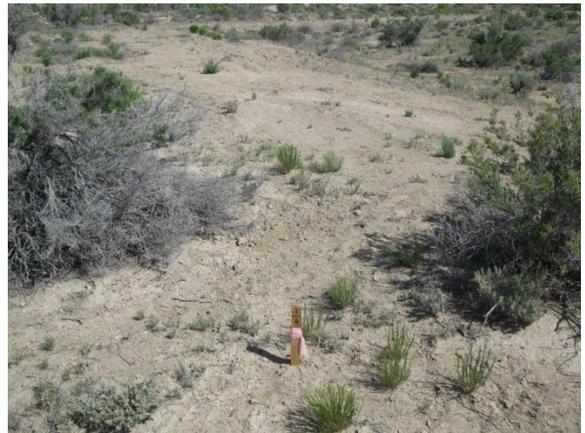
Depression #1 - May 30, 2014

On May 30, 2014, Russel Jensen of Consol Energy walked the area of six known subsidence depressions over 00 North and photographed all staked areas. He observed no new cracks. He also walked the surrounding area and observed no new depressions or cracks. Copies of the photographs are provided in Attachment A.

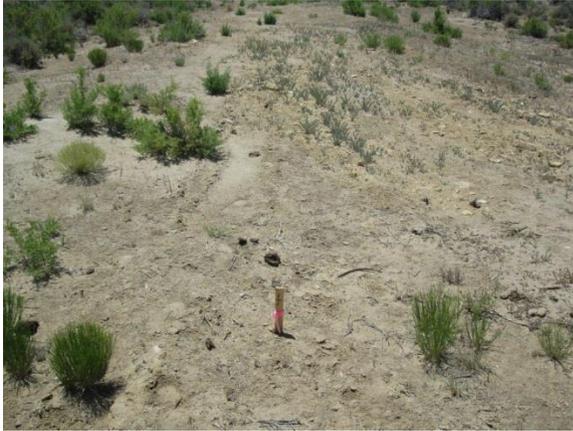
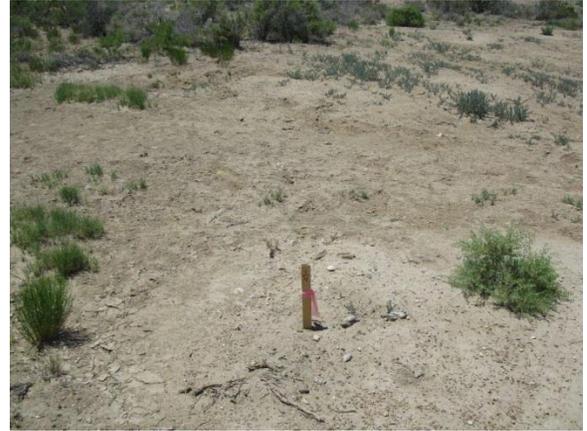
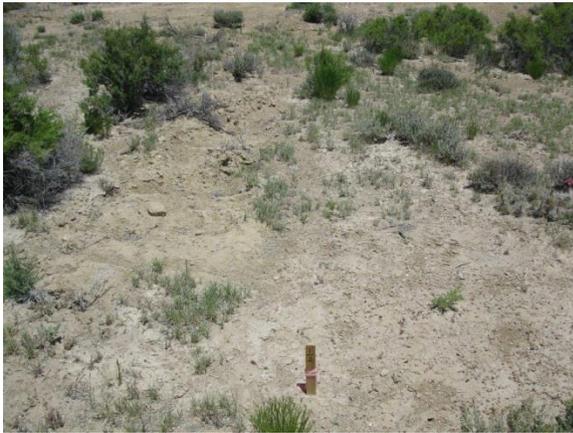
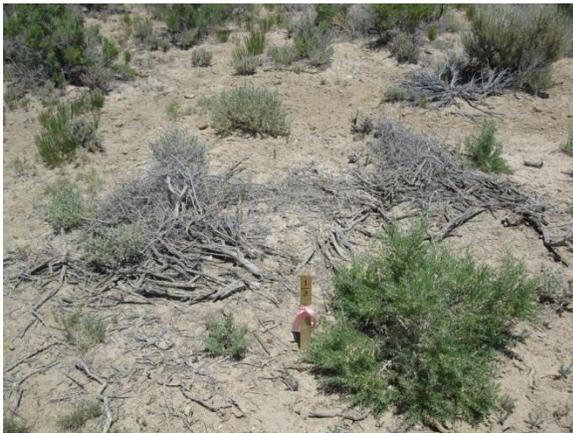
Depression #1 - June 25, 2014

On June 26, 2014, Russel Jensen of Consol Energy walked the area of six known subsidence depressions over 00 North and photographed all staked areas. He observed no new cracks. He also walked the surrounding area and observed no new depressions or cracks. Copies of the photographs are provided in Attachment A.

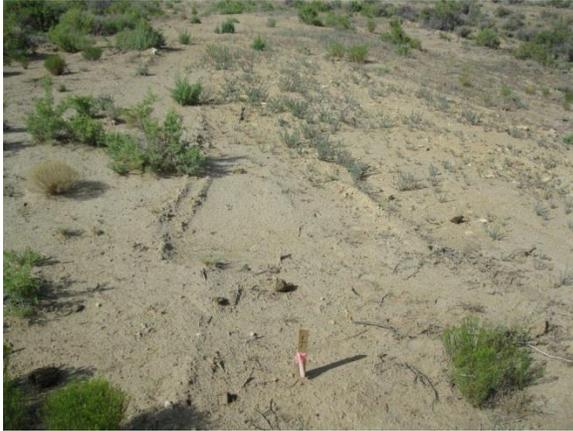
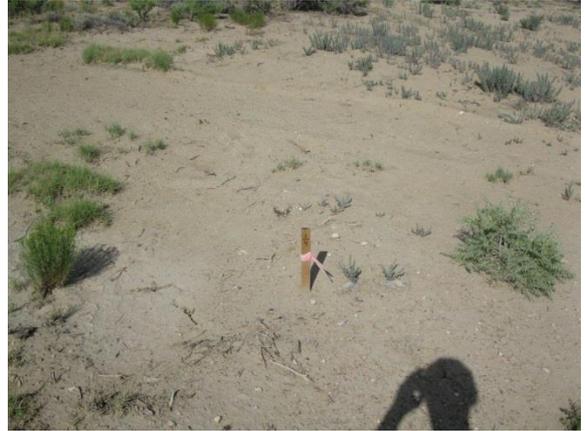
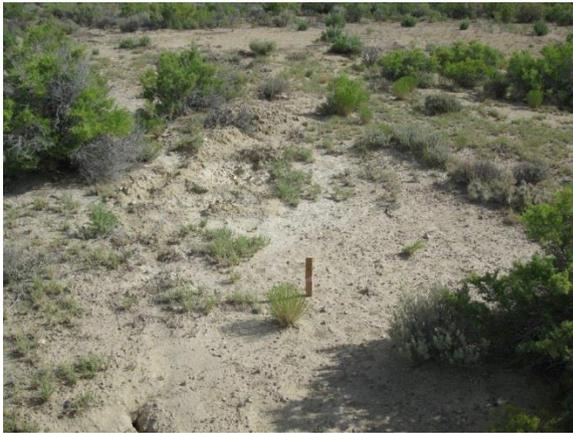
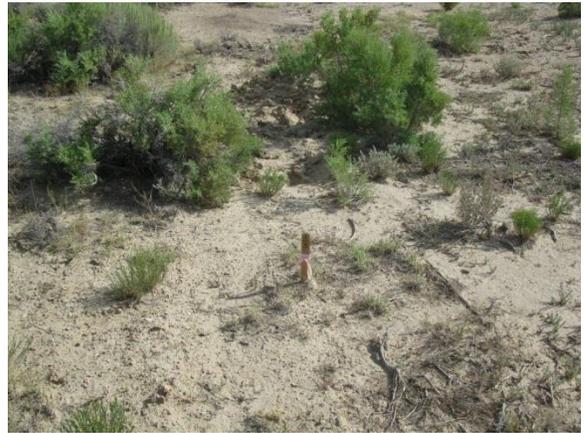
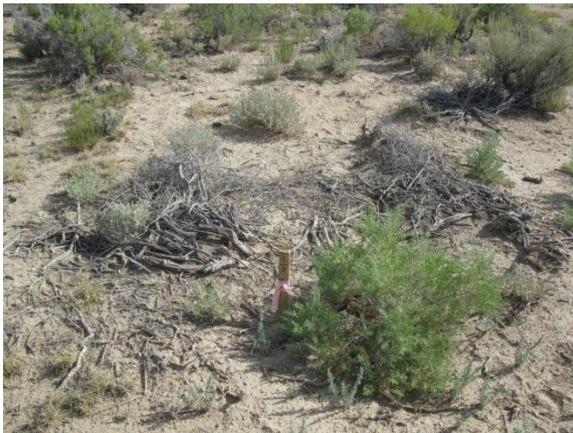
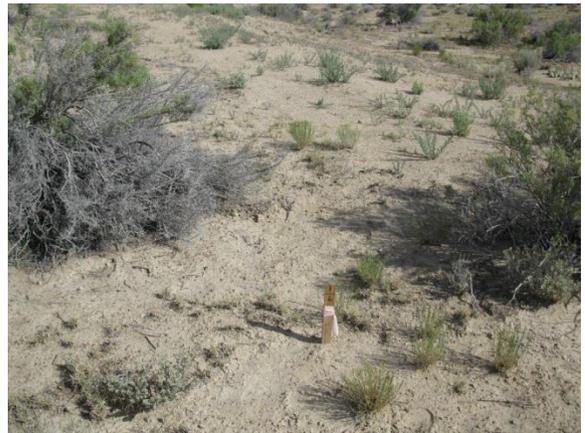
Depression #1 - July 25, 2014

On July 25, 2014, Russel Jensen of Consol Energy walked the area of the six known subsidence depressions over 00 North and photographed all staked areas. He observed no new cracks. He also walked the surrounding area and observed no new depressions, cracks, or damage. Copies of the photographs are provided in Attachment A.

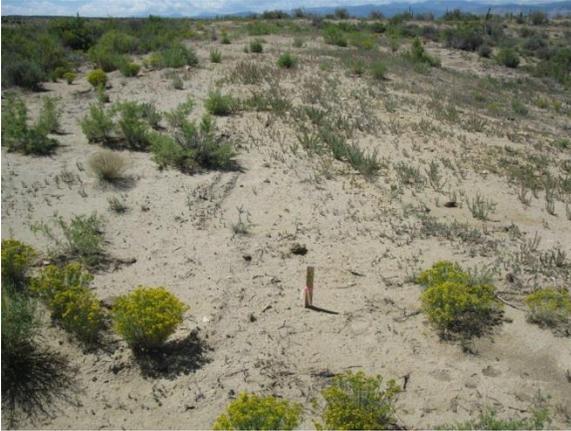
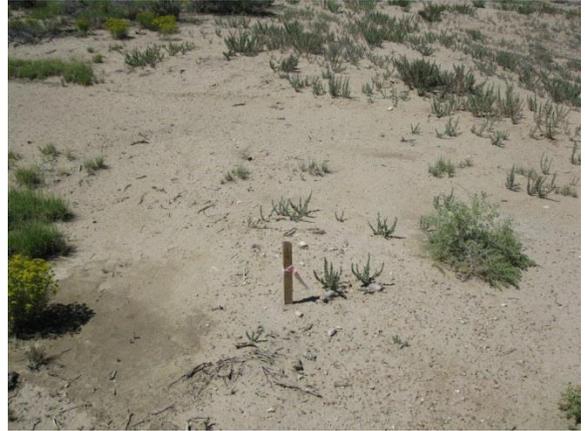
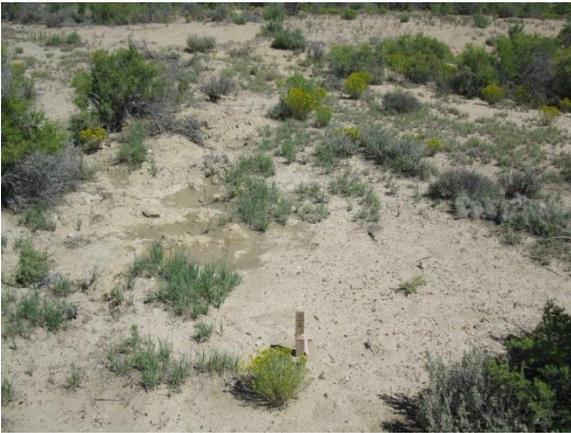
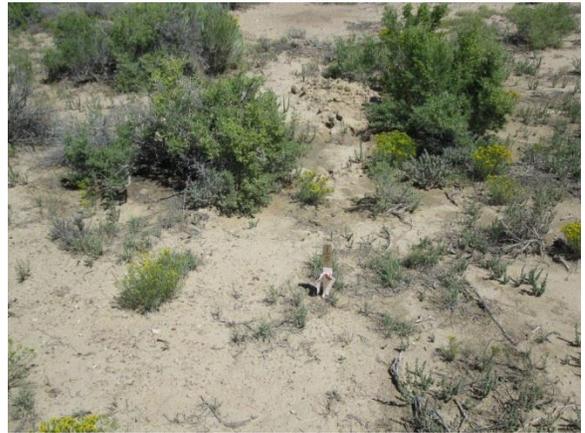
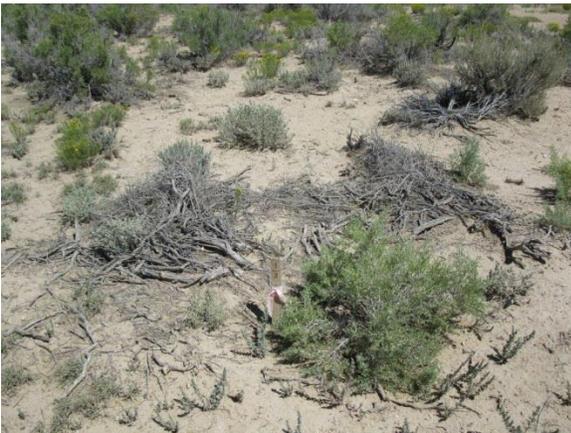
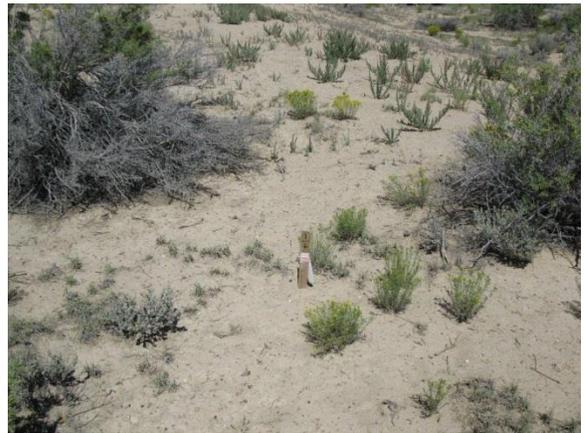
Depression #1 - August 25, 2014

On August 25, 2014, Russel Jensen of Consol Energy walked the area of the six known subsidence depressions over 00 North and photographed all staked areas. He observed no new cracks or damage. He also walked the surrounding area and observed no new depressions, cracks, or damage. Copies of the photographs are provided in Attachment A.

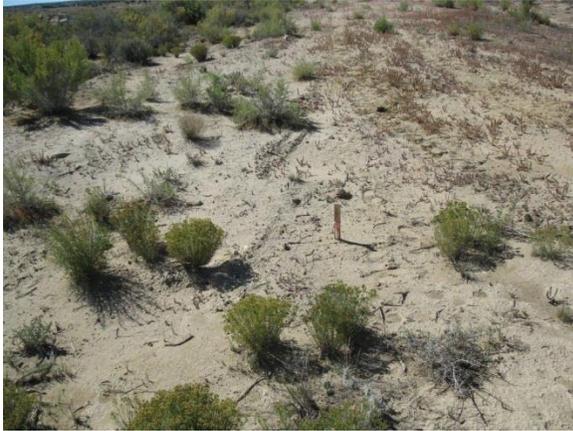
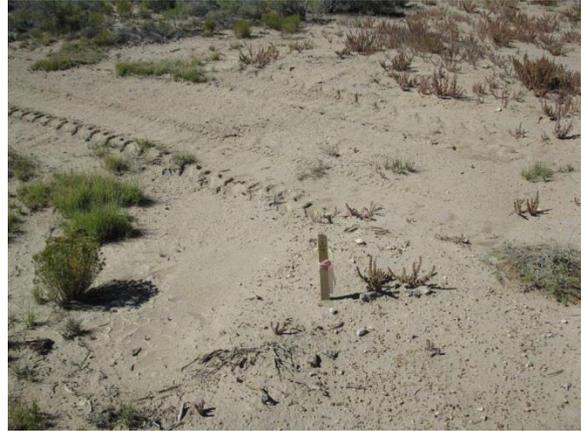
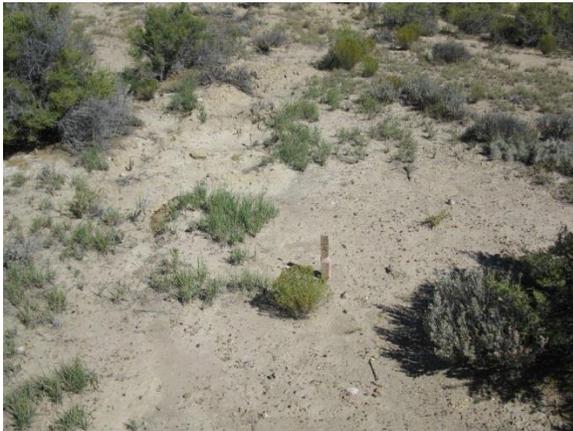
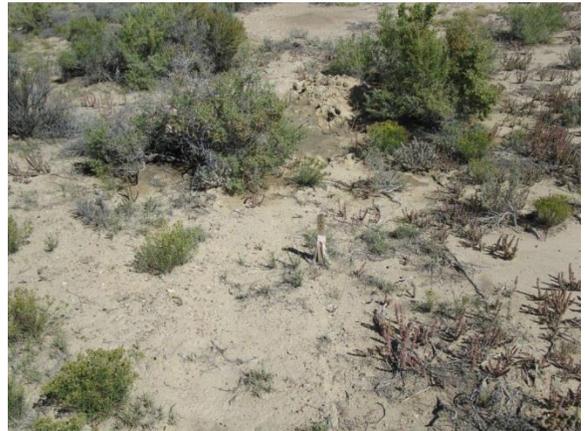
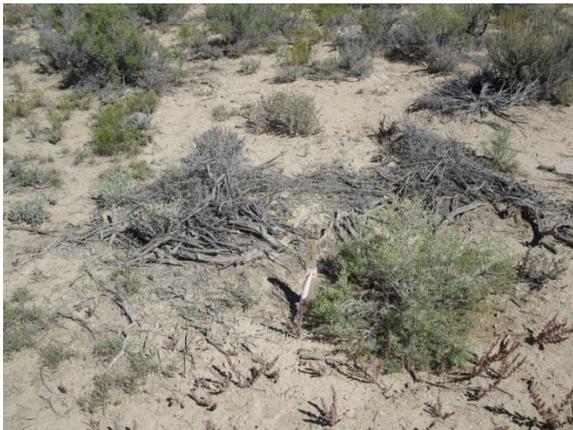
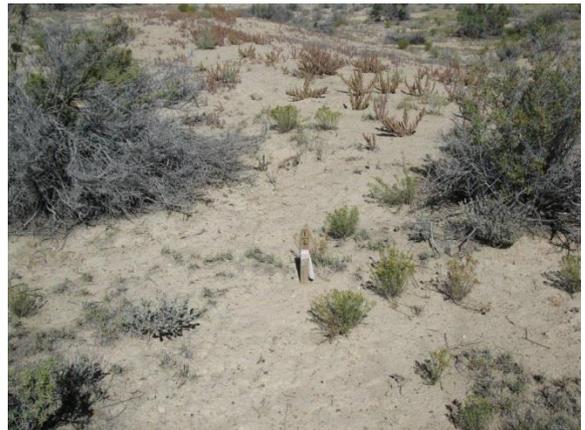
Depression #1 - September 24, 2014

On September 24, 2014, Russel Jensen of Consol Energy walked the area of the six known subsidence depressions over 00 North and photographed all staked areas. He observed no new cracks or damage from subsidence. He also walked the surrounding area and observed no new depressions, cracks, or damage. Copies of the photographs are provided in Attachment A.

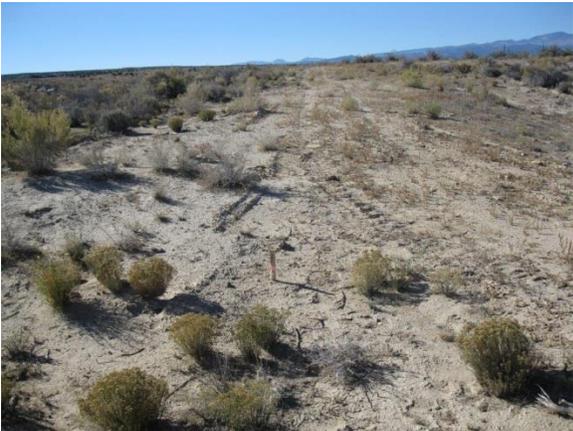
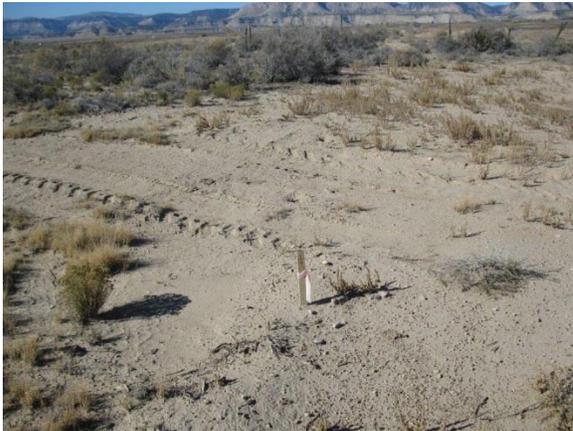
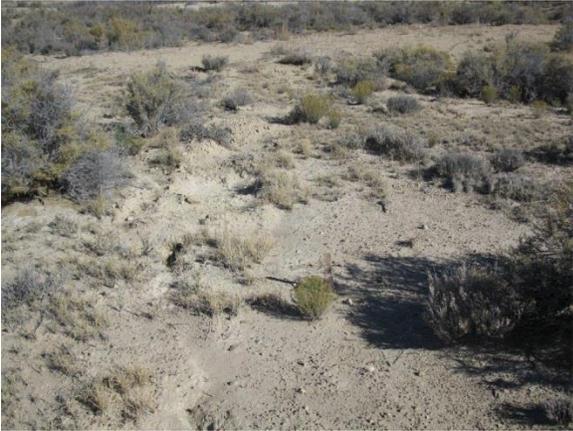
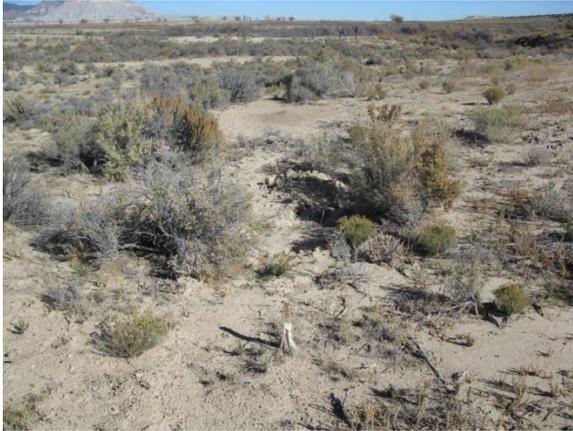
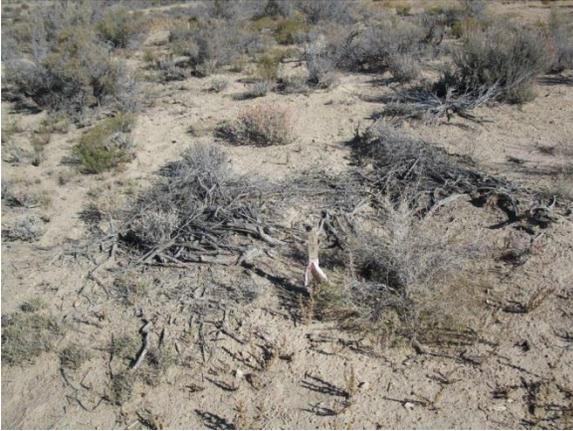
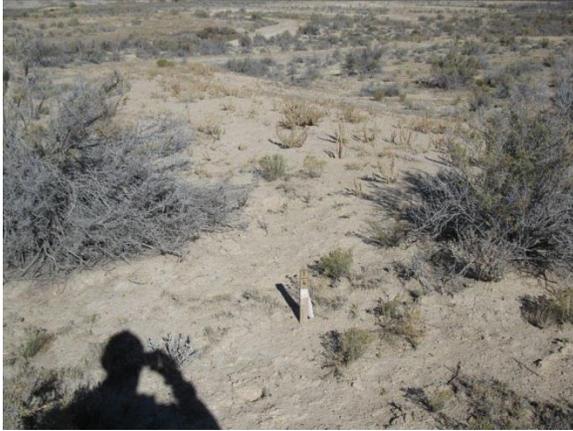
Depression #1 - October 28, 2014

On October 28, 2014, Russel Jensen of Consol Energy walked the area of the six known subsidence depressions over 00 North and photographed all staked areas. He observed no new cracks or damage from subsidence. He also walked the surrounding area and observed no new depressions, cracks, or damage. Copies of the photographs are provided in Attachment A.

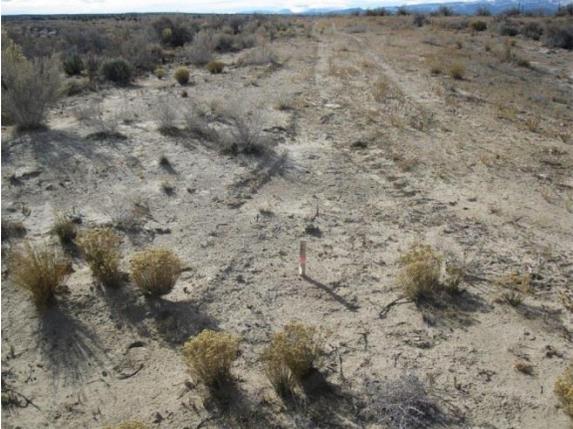
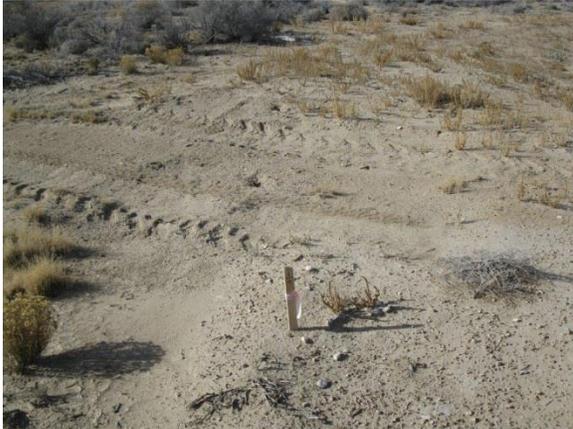
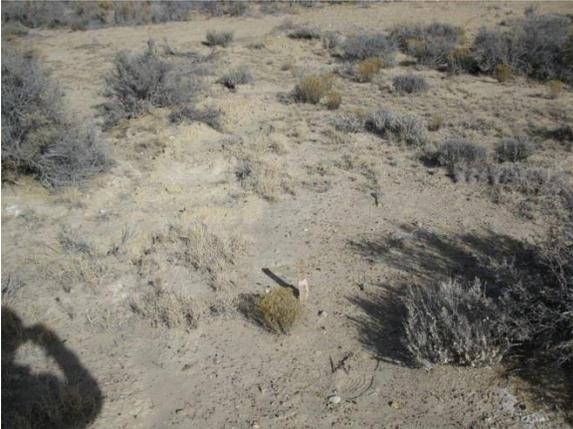
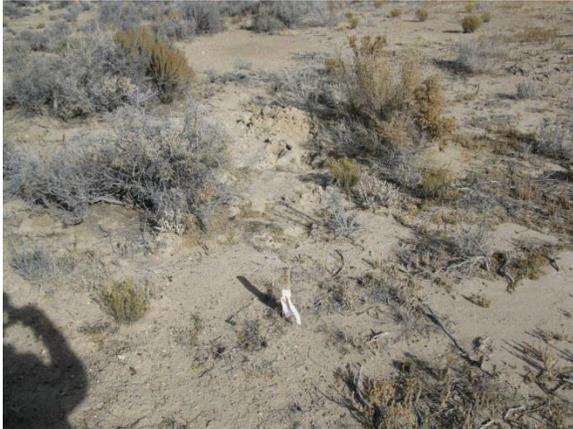
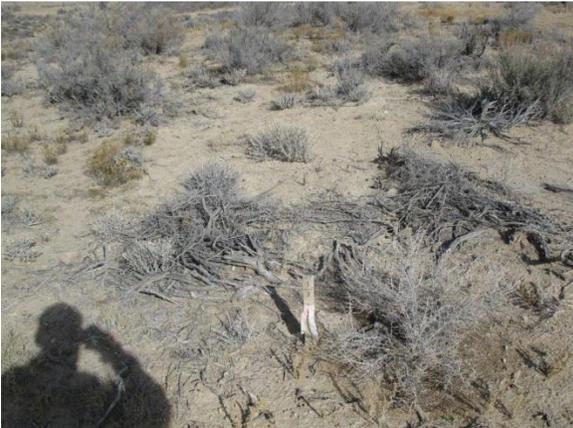
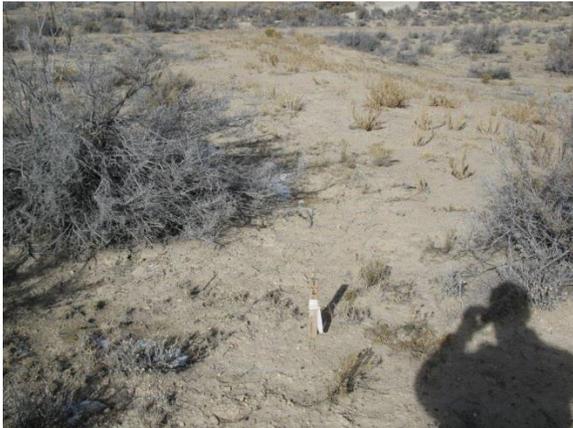
Depression #1 - November 25, 2014

On November 25, 2014, Russel Jensen of Consol Energy walked the area of the six known subsidence depressions over 00 North and photographed all staked areas. He observed no new cracks or damage from subsidence. He also walked the surrounding area and observed no new depressions, cracks, or damage. Copies of the photographs are provided in Attachment A.

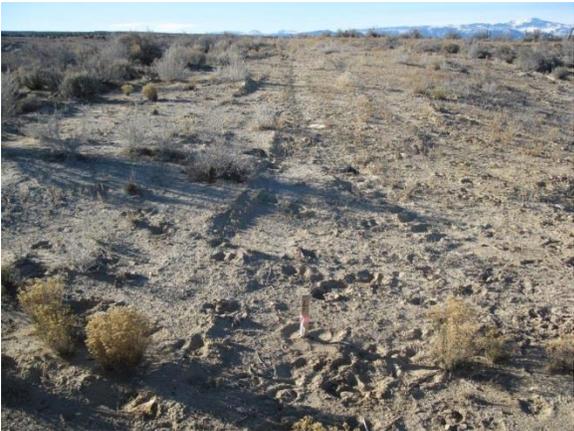
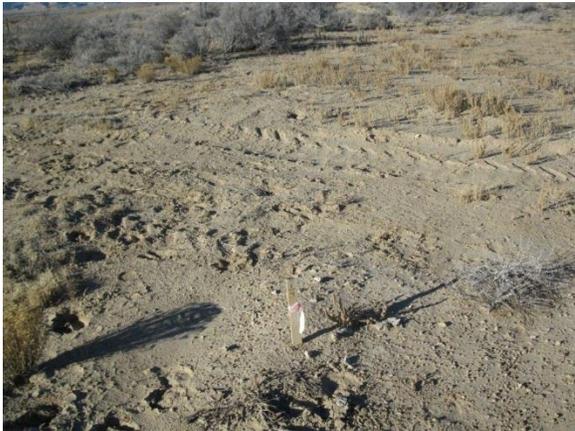
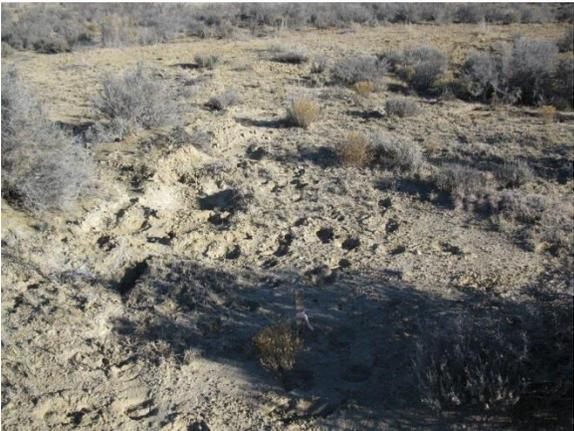
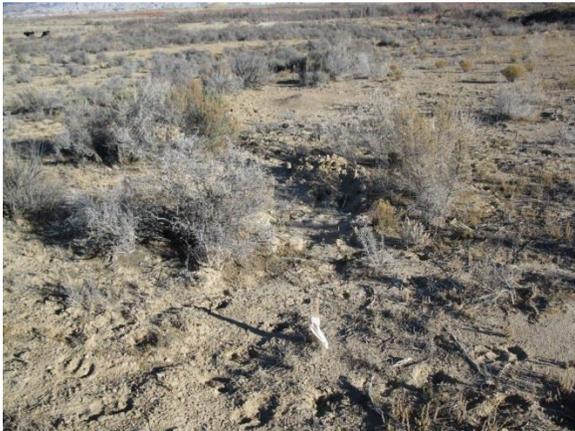
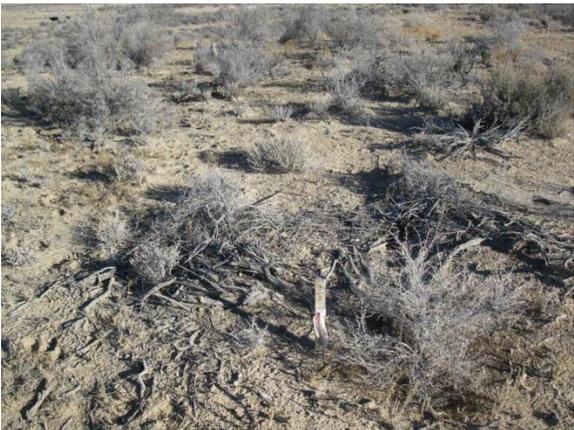
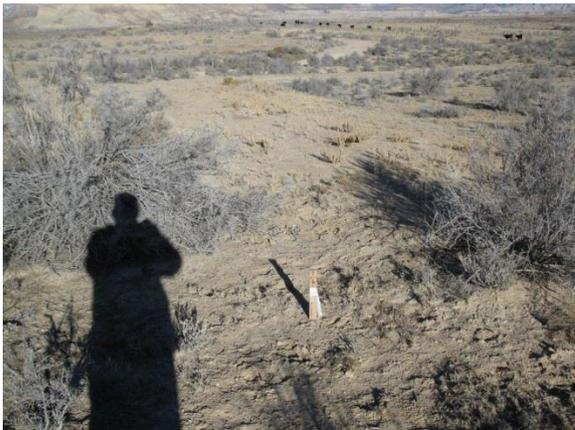
Depression #1 - December 24, 2014

On December 24, 2014, Russel Jensen of Consol Energy walked the area of the six known subsidence depressions over 00 North and photographed all staked areas. He observed no new cracks or damage from subsidence. He also walked the surrounding area and observed no new depressions, cracks, damage, or other evidence of new subsidence. Copies of the photographs are provided in Attachment A.
