Inspection Report

Permit Number:	C0150018
Inspection Type:	PARTIAL
Inspection Date:	Wednesday, August 15, 2012
Start Date/Time:	8/15/2012 8:15:00 AM
End Date/Time:	8/15/2012 2:00:00 PM
Last Inspection:	Wednesday, July 11, 2012

Permitee: **PACIFICORP**
 Operator: **ENERGY WEST MINING CO**
 Site: **DEER CREEK MINE**
 Address: **PO BOX 310, HUNTINGTON UT 84528**
 County: **EMERY**
 Permit Type: **PERMANENT COAL PROGRAM**
 Permit Status: **ACTIVE**

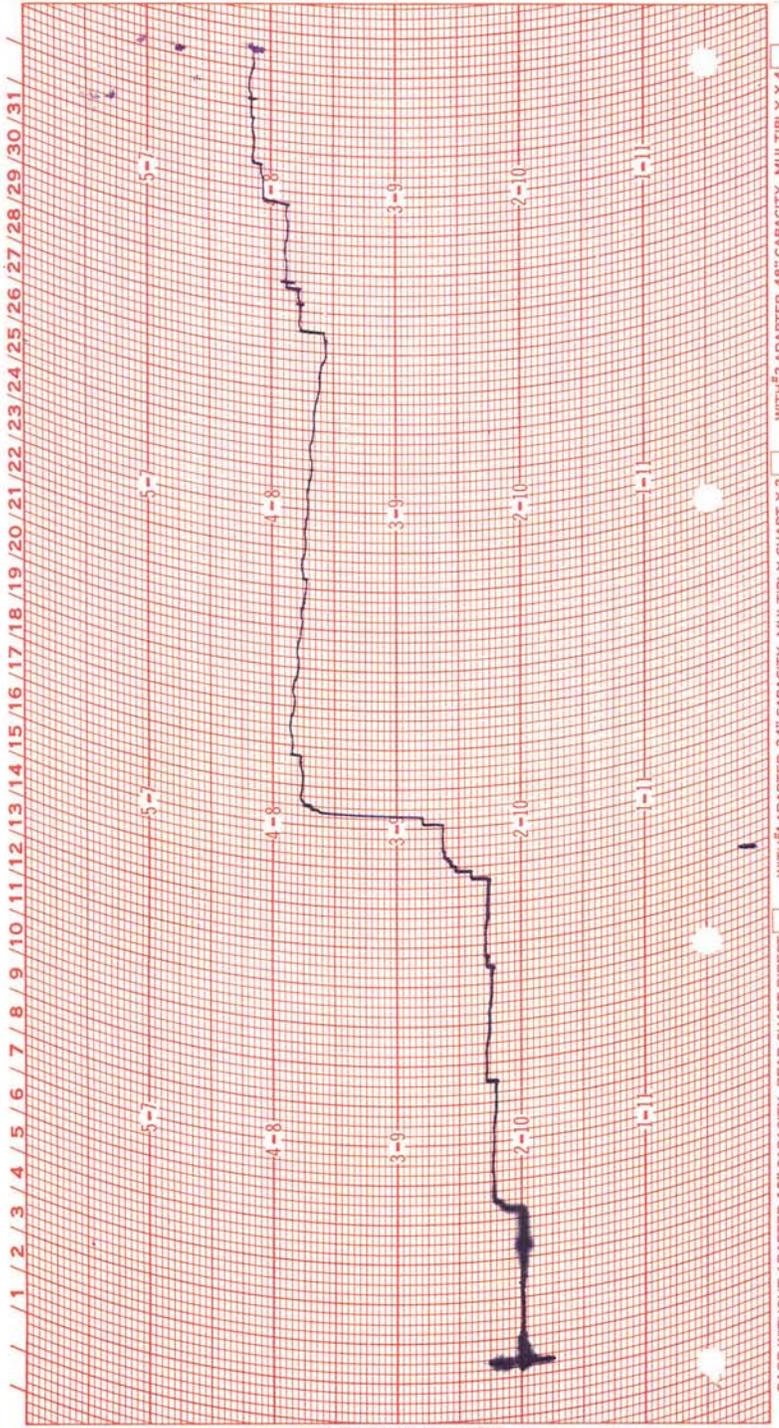
CHART NO. 15668
 12-INCH DUAL TRAVERSE MONTHLY 861 HRS.
 UNIVERSAL RAIN GAGE
 BELFORT INSTRUMENT COMPANY
 BALTIMORE, MARYLAND, U.S.A.
