Subj: Deer Creek Mine Closure – 5th North Mains Stream Crossing Area, Pre-Closure Subsidence Survey of Underground Workings, PacifiCorp, Deer Creek Mine, C/015/0018, Emery County, Utah.

Subject: Geotechnical Inspection of the 5th North Blind Canyon Mains, XC- 1 – 10, Deer Creek Mine, January 30, 2015

Energy West Mining Co.
 Deer Creek Mine
 Inspection of Workings - 01/30/15
 5th North Mains - B.C. Seam

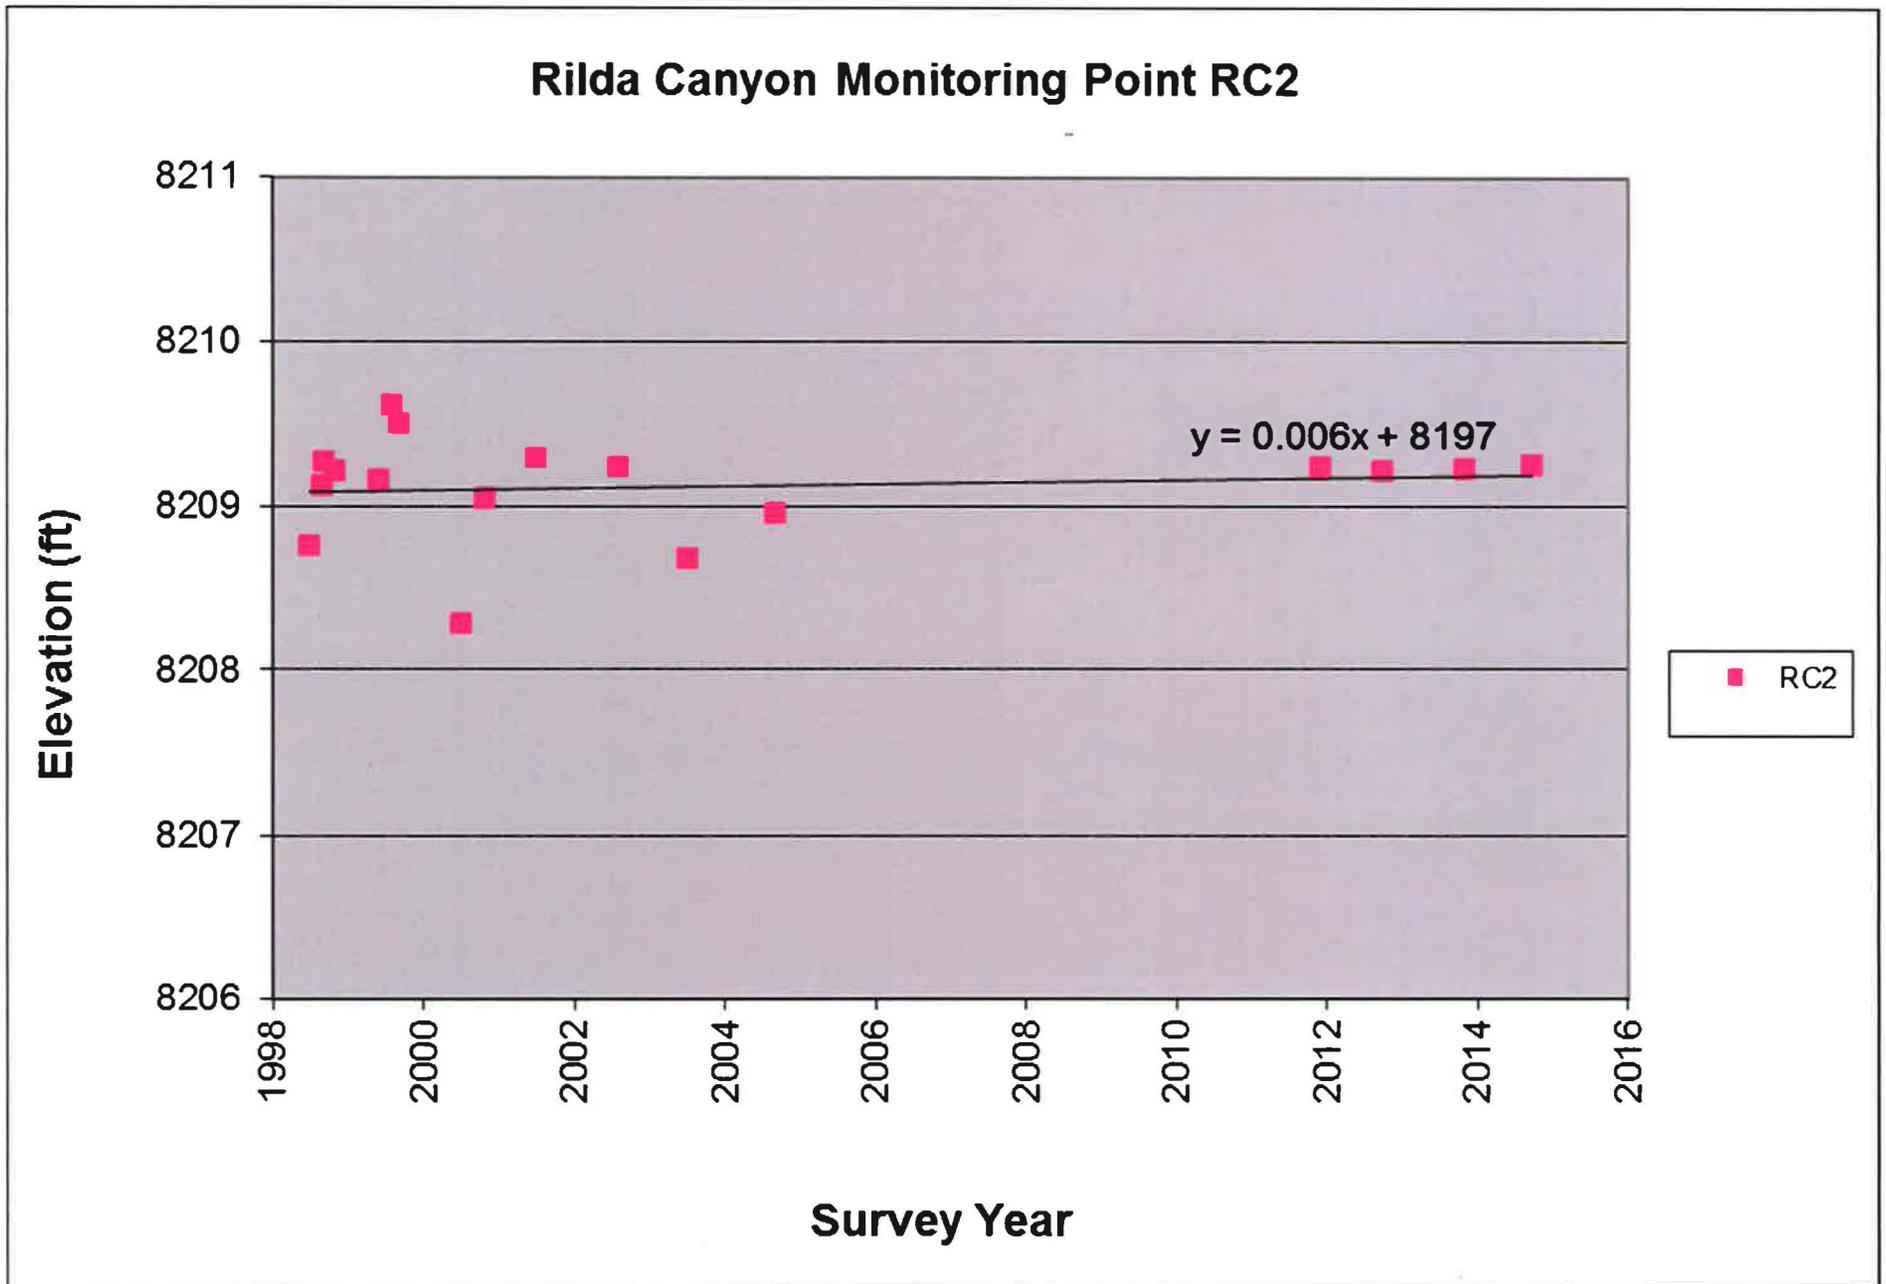
Chart 3. Graph of Rilda Canyon Right Fork Stream Crossing Area Surveyed Subsidence Monitoring Point RC2

Surface stability data has been generated in the form of surface monitoring points in the right fork of Rilda Canyon. A set of four points (see Map) was established on June 25, 1998 that spans the 5th North crossing area. These points have been surveyed at least annually each year since they were established (see Table and Charts). None of the points has shown any signs of subsidence, reflecting the conditions observed underground.
