**Subject: Status of Deer Creek Mine Disturbed Area Reclamation & Upper Terrace Access Road**

Deer Creek Mine  
Final Reclamation Project  
Upper Terrace Evaluation  
May 29, 2019

Deer Creek Mine  
Upper Terrace Evaluation  
May 29, 2019

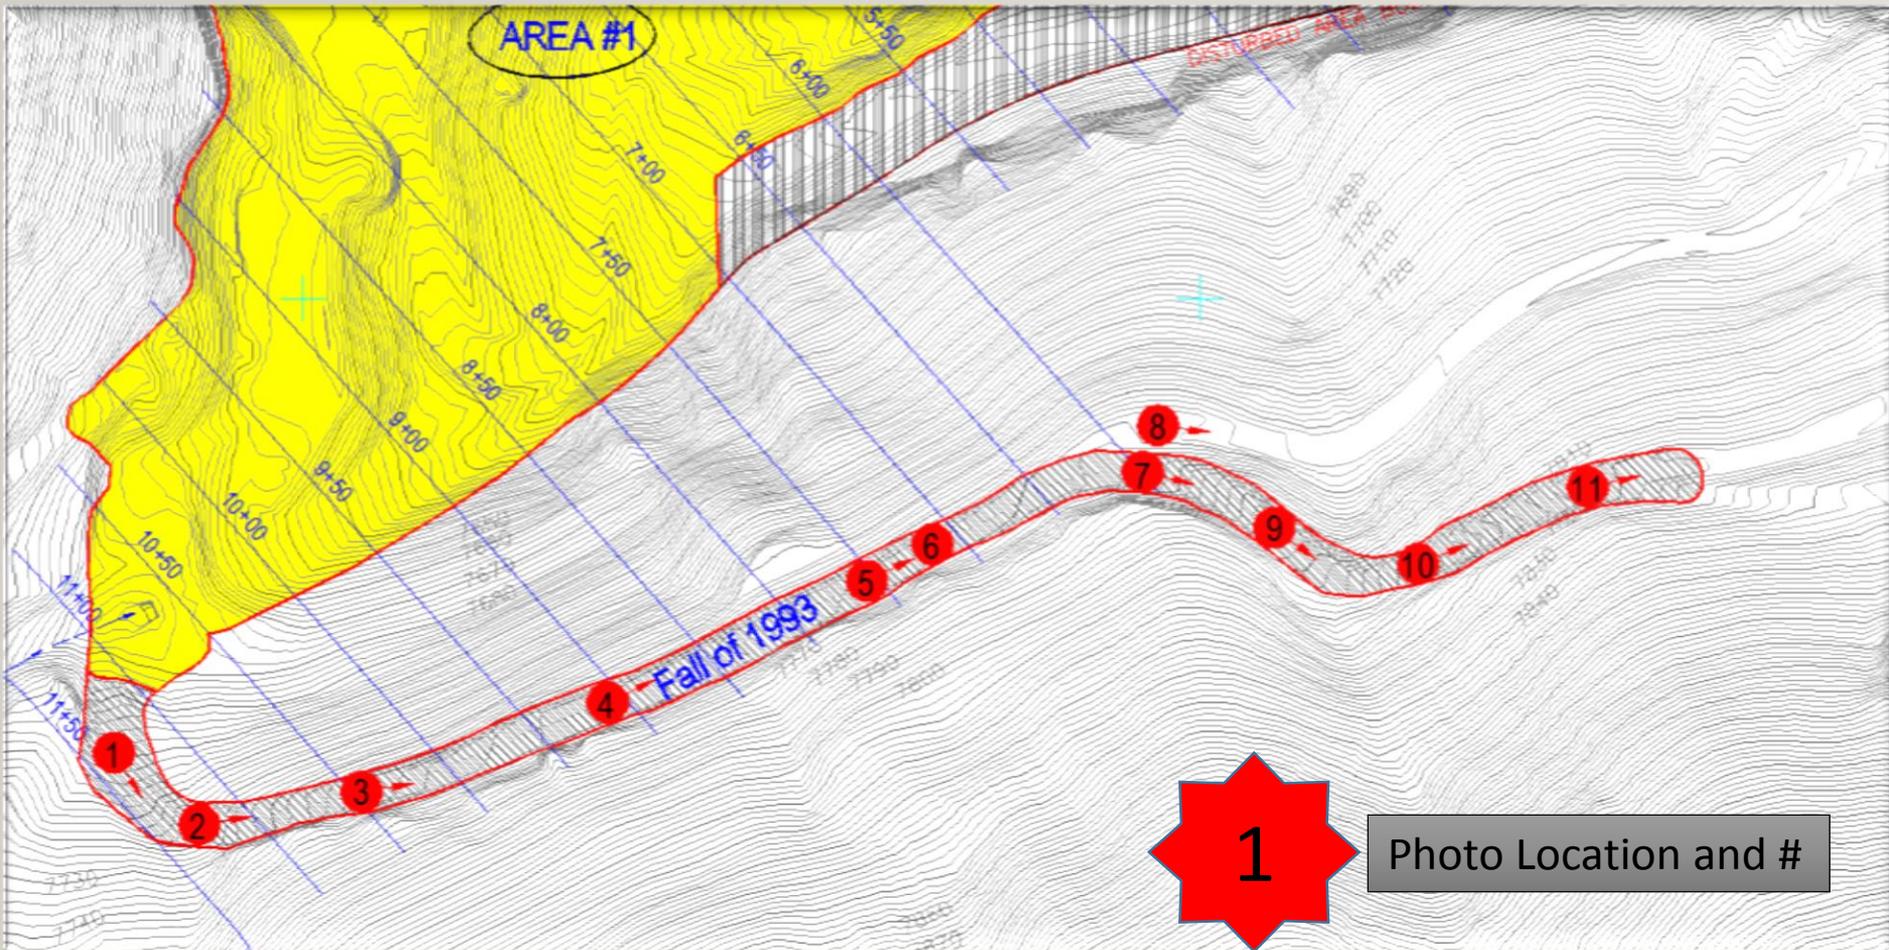
On May 29, 2019, PacifiCorp evaluated vegetation establishment along the upper terrace access road, see the attached photo summary – “Upper Terrace Evaluation May 29, 2019.” Over the last 25 years the area has stabilized and vegetation, including trees, has been established to a point where additional reclamation activities are not warranted. Photos 7 and 8 compare the pre-law terrace access road outside the disturbed boundary to that of the access road/ditch included in the disturbed area. Further disturbance within this area would only damage the establishment of vegetation that has already occurred; PacifiCorp does not intend to conduct further reclamation activities within this area.
