UTAH POWER & LIGHT COMPANY
SUBSIDENCE MONITORING PROGRAM
ANNUAL REPORT FOR 1986

April 1987

Submitted to: United States Department of the Interior
Office of Surface Mining
Minerals Management Service
Utah Division of Oil, Gas and Mining

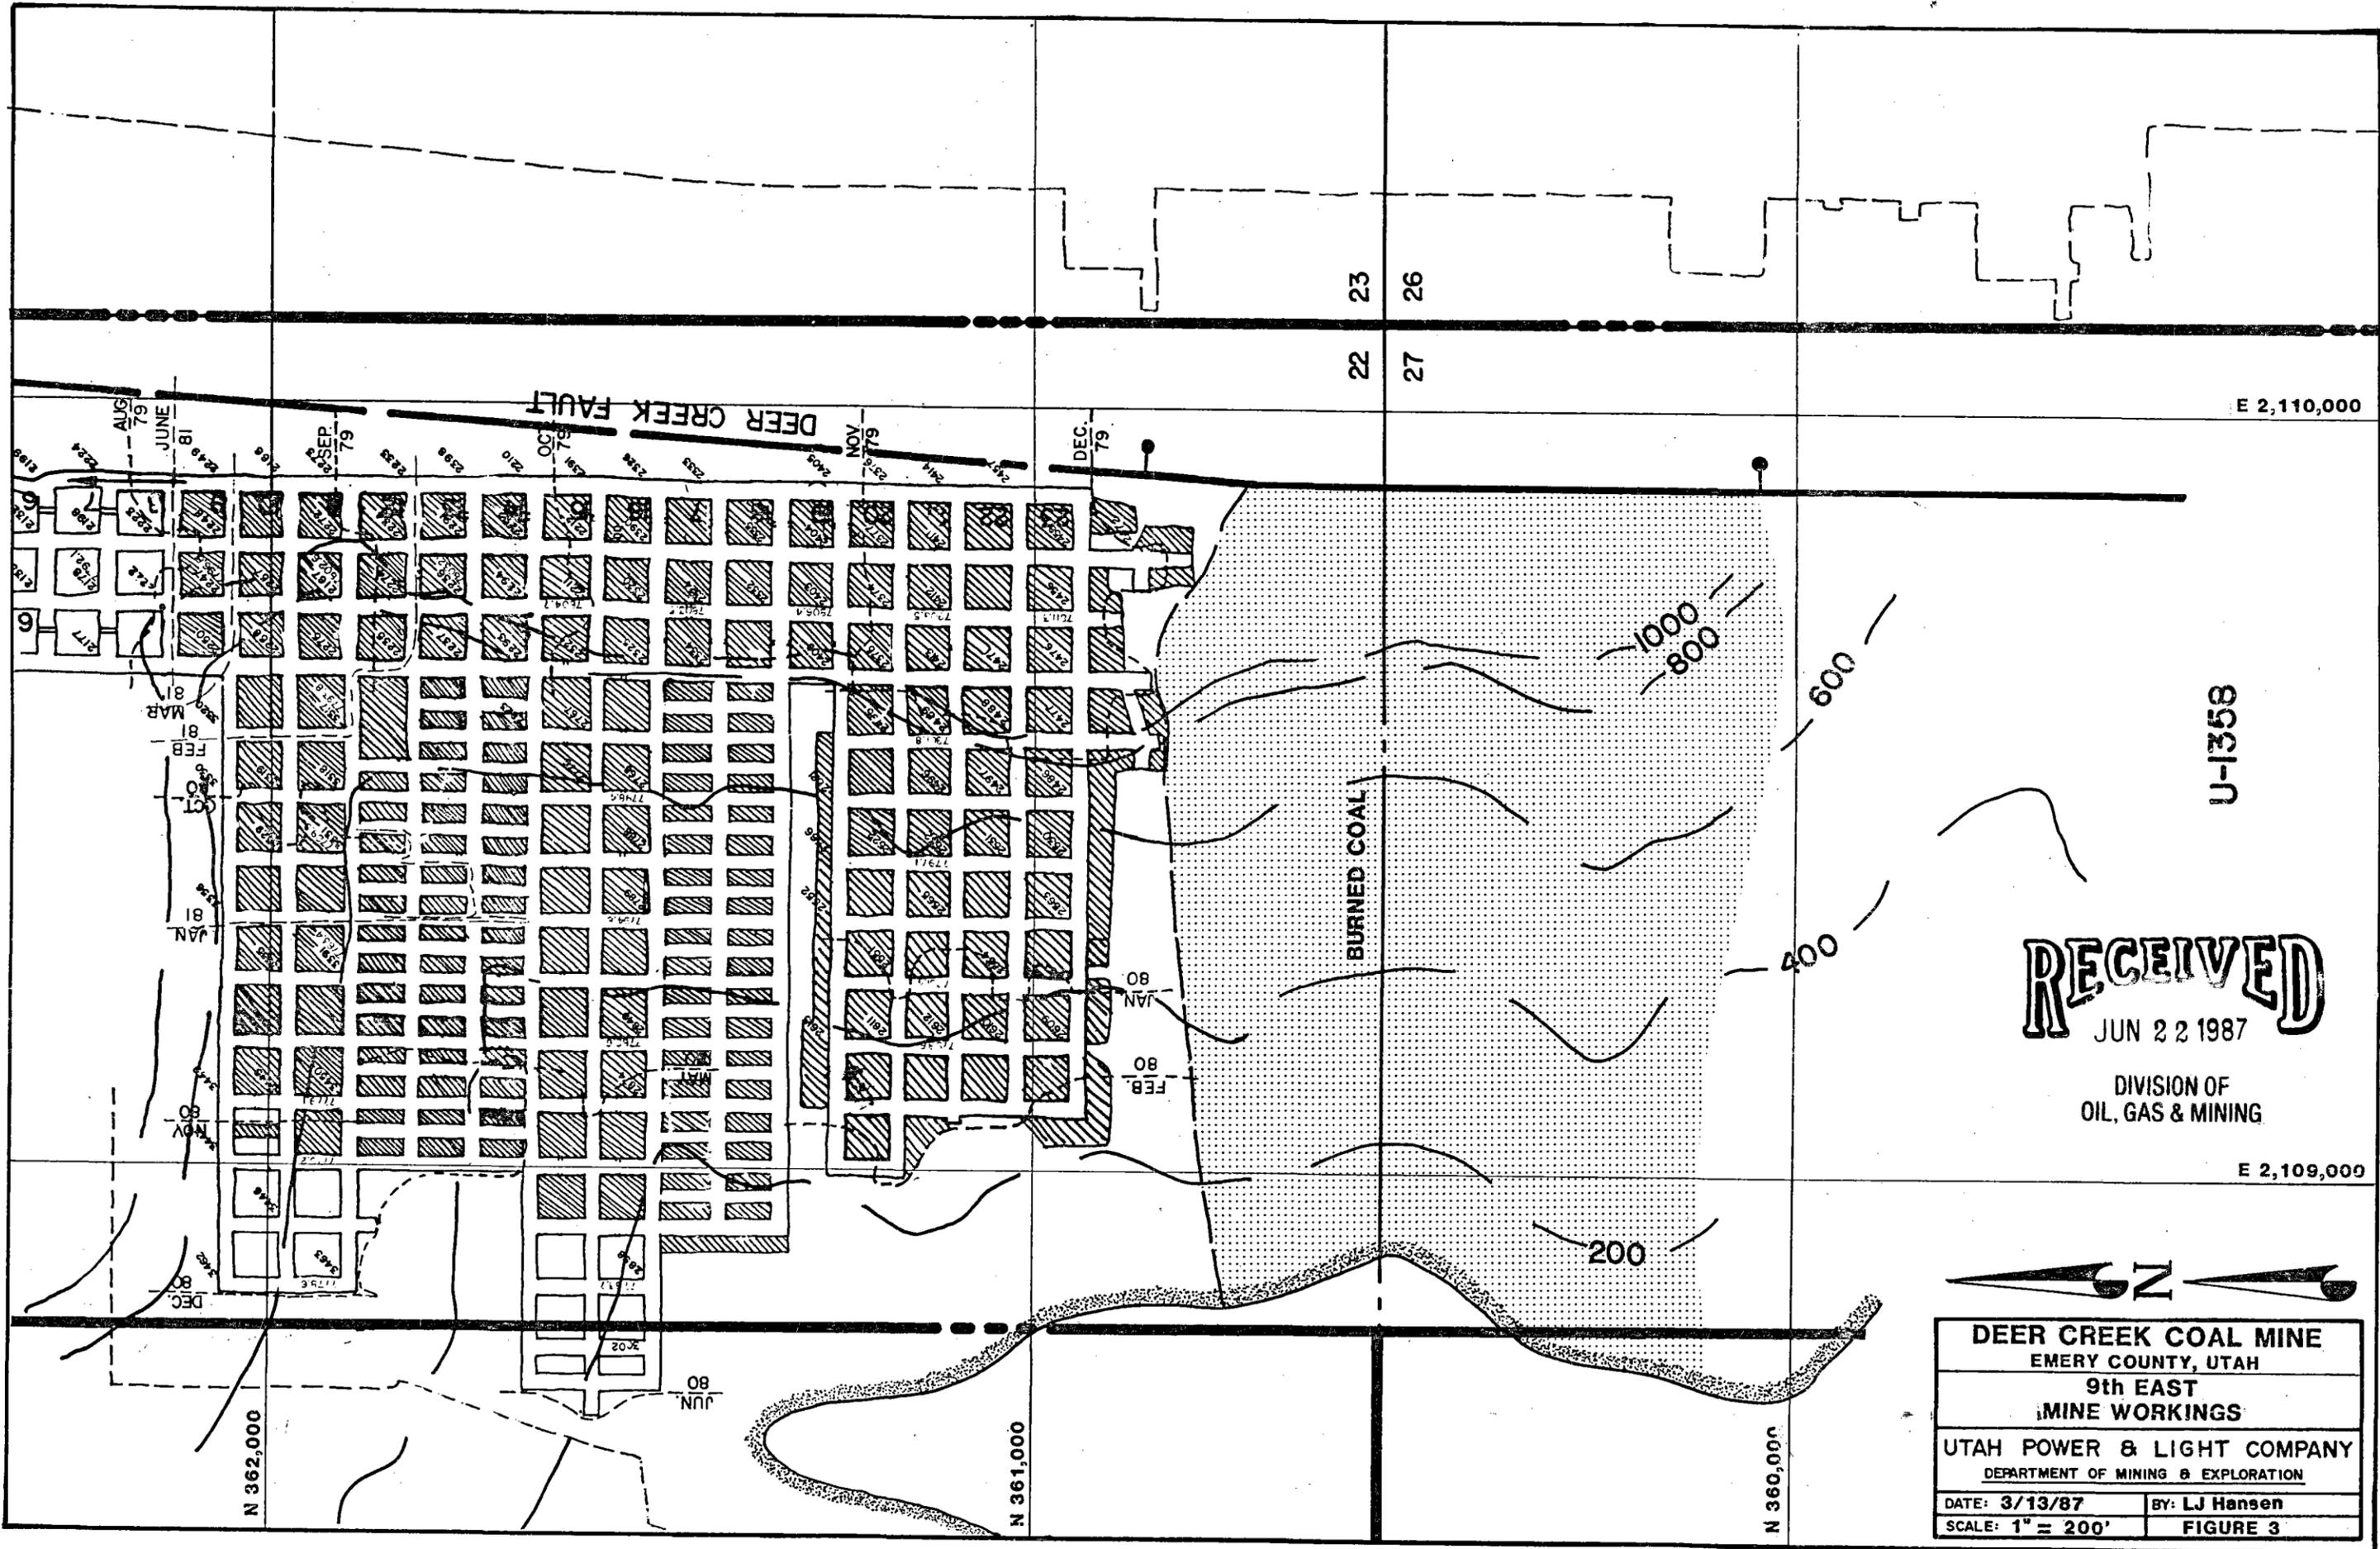
DEER CREEK COAL MINE EMERY COUNTY, UTAH 9th EAST MINE WORKINGS	
UTAH POWER & LIGHT COMPANY DEPARTMENT OF MINING & EXPLORATION	
DATE: 3/13/87	BY: LJ Hansen
SCALE: 1" = 200'	FIGURE 3

Subsidence in this area was first documented in the 1981 subsidence monitoring report submitted in December 1982. The relationship of the area of subsidence with the present Deer Creek and Wilberg Mine workings is shown in Figures 3, 4, and 5. The Deer Creek 9th East workings in this area have been abandoned since 1981 but pillar extraction in Wilberg 1st Right proceeded until June 1984.

Subsidence monitoring during 1986 showed little or no change in subsidence from 1985. The maximum subsidence observed to date is 25 feet and occurs on a steep slope about 200 feet south of the southernmost mined-out area in 1st Right Wilberg over an area in which both the Hiawatha and Blind Canyon Seams are burned. This supports the theory that the clinker beds have been crushed, allowing subsidence to occur well outside the area of mine workings. An on-the-ground inspection of this area revealed that some of the fractures have begun to heal spontaneously with the soils filling in and smoothing out the fractures.

The angle-of-draw of subsidence in this area appears to be influenced by the Deer Creek Fault plane. On the east side of the mine workings the subsidence abruptly stops about 200 feet east of the mine workings, which coincides with the Deer Creek Fault surface trace. In this area the mine workings are covered with 1200 feet of overburden, indicating a 9.5° angle of draw on subsidence.

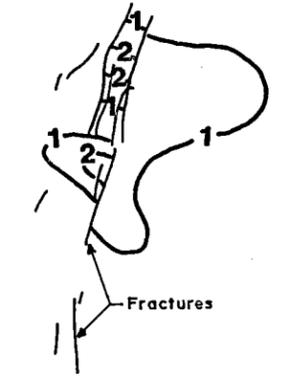
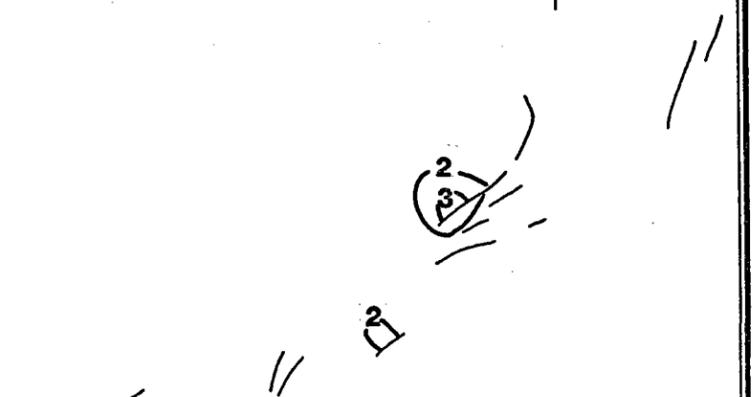
DEER CREEK COAL MINE		
EMERY COUNTY, UTAH		
1986 SUBSIDENCE		
1st NORTH AREA		
UTAH POWER & LIGHT COMPANY		
MINING DIVISION-SALT LAKE CITY, UTAH 84110		
DRAWN BY: LJ Hansen	CHECKED BY:	DATE: Feb. 27, 1987
Scale	Sheet No.	Drawing Number
1" = 500'		FIGURE 10

Most of the 1st North section of the Deer Creek Mine was abandoned and sealed in 1978 after being mined out. The southern portion is still open and will be used for access to a block of coal which lies to the west. Pillar extraction in the 3rd Left and 1-1/2 North sections was completed early in 1980. The greatest subsidence observed over this area is 3 feet. It occurred over an area of burned coal 600 feet northeast of the 1st North workings (Figures 9 and 10). Other points showing greater elevation changes (up to 15 feet) were noted but these have been attributed to mass wasting, such as movement of a large boulder or escarpment failure. One rock slide occurred since the last monitoring period but it is so far (nearly 2000 feet) from the nearest workings that it is probably not related to mining.

The calculated angle-of-draw for the area ranges from vertical to 40°, but the measurements are influenced by burned coal, steep slopes, and fracturing, which have complicated the subsidence process.

X=Point of Slope or Cliff Failure. These are Isolated Points With No Surrounding Subsidence. Number Indicates Elevation Drop in Feet.

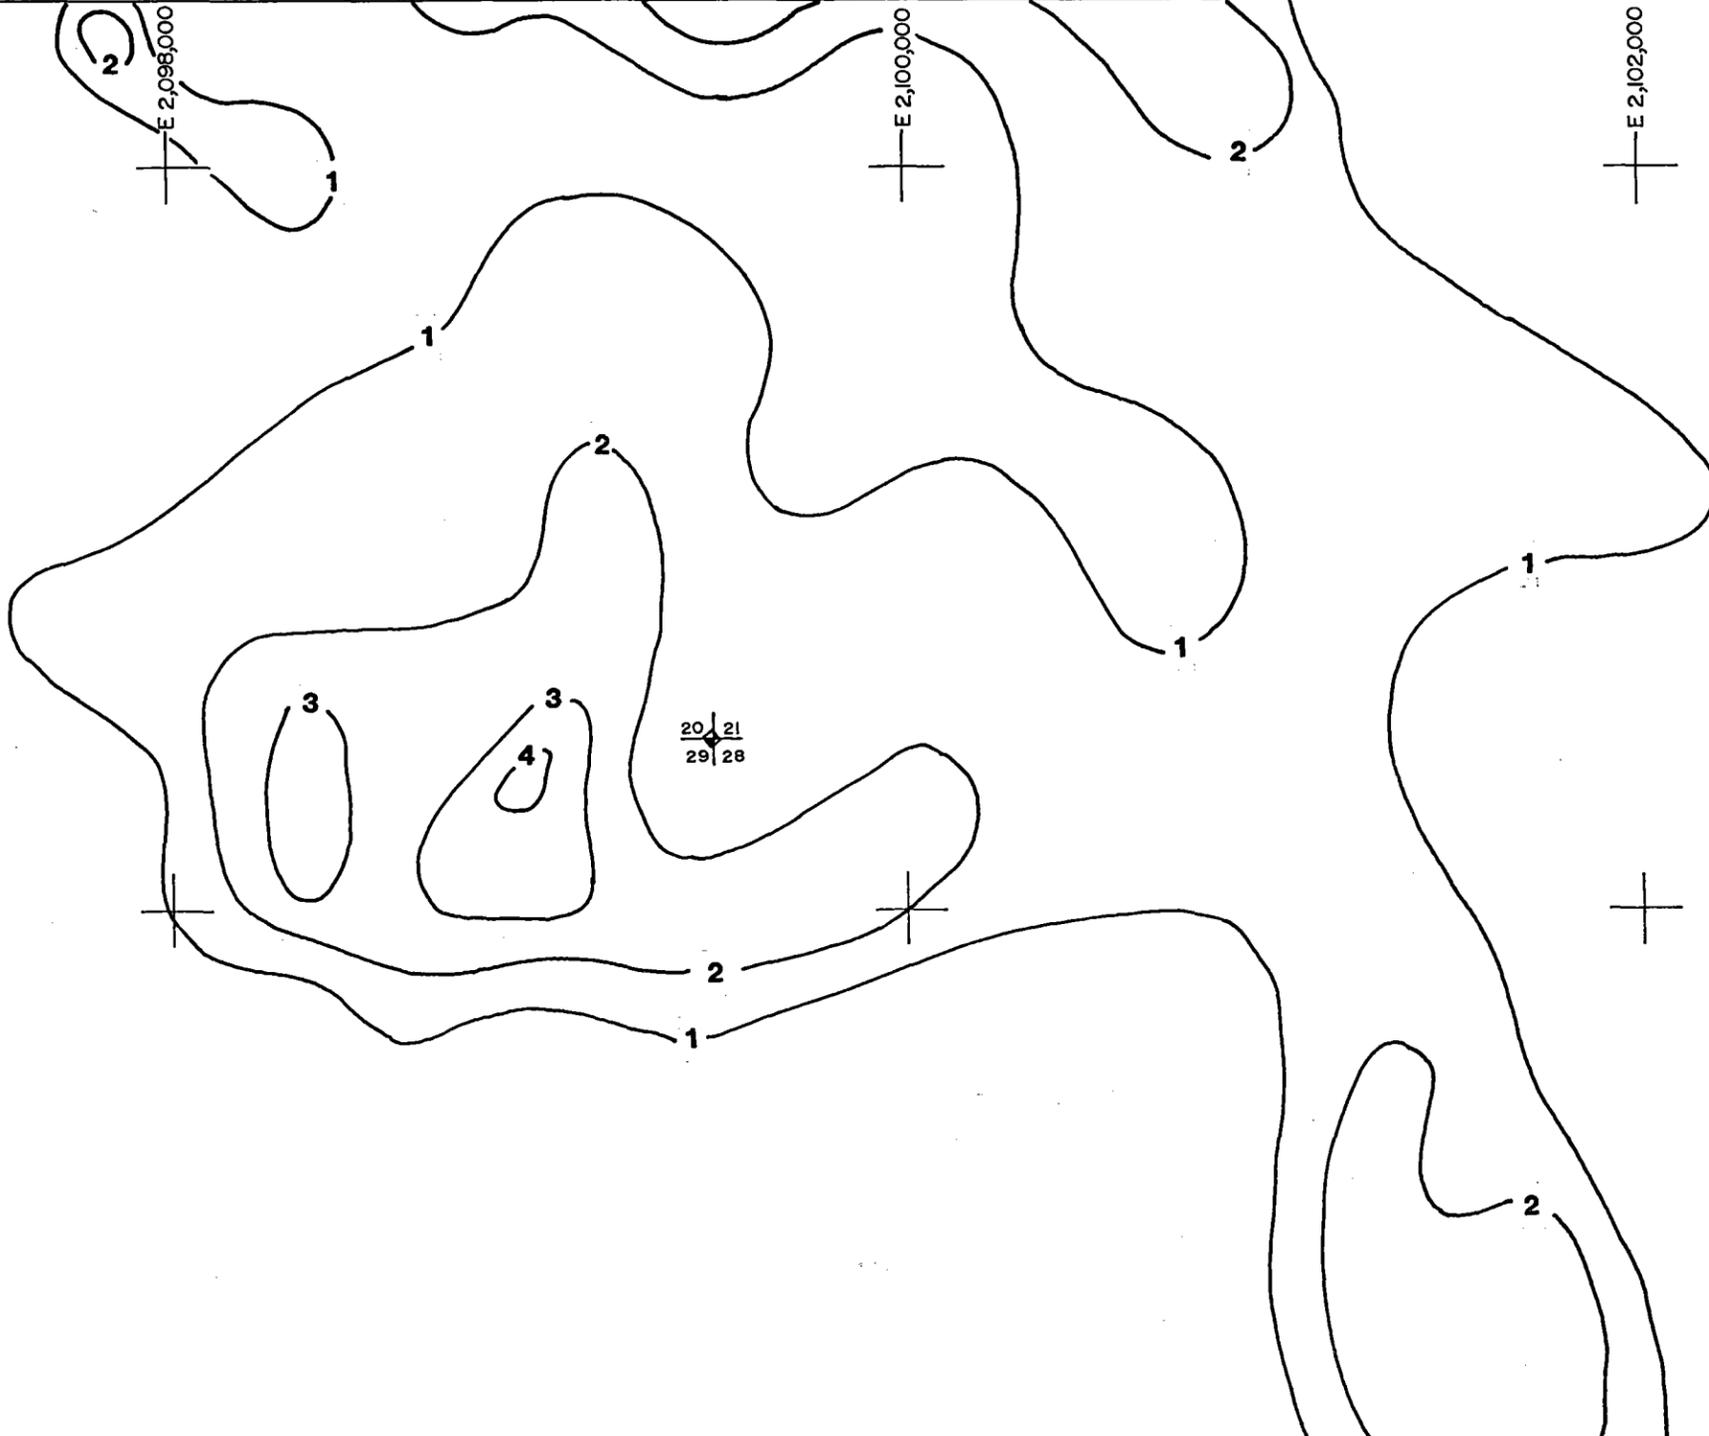
WILBERG COAL MINE		
EMERY COUNTY, UTAH		
1986 SUBSIDENCE		
1st & 2nd WEST		
UTAH POWER & LIGHT COMPANY		
MINING DIVISION-SALT LAKE CITY, UTAH 84110		
DRAWN BY: LJ Hansen	CHECKED BY:	DATE: Feb. 25, 1987
Scale 1" = 500'	Sheet No.	Drawing Number FIGURE 17

Maximum subsidence reached just over 5 feet (Figure 17); no surface disturbance of any kind has been found. On the south side of the workings the subsidence diminishes to less than 0.5 feet within 1200 feet. With 2000 feet of overburden this equates to an angle-of-draw of 21 degrees.

Four springs located just north of the area show no effect from the subsidence. (See Hydrologic Monitoring Report, 1986).

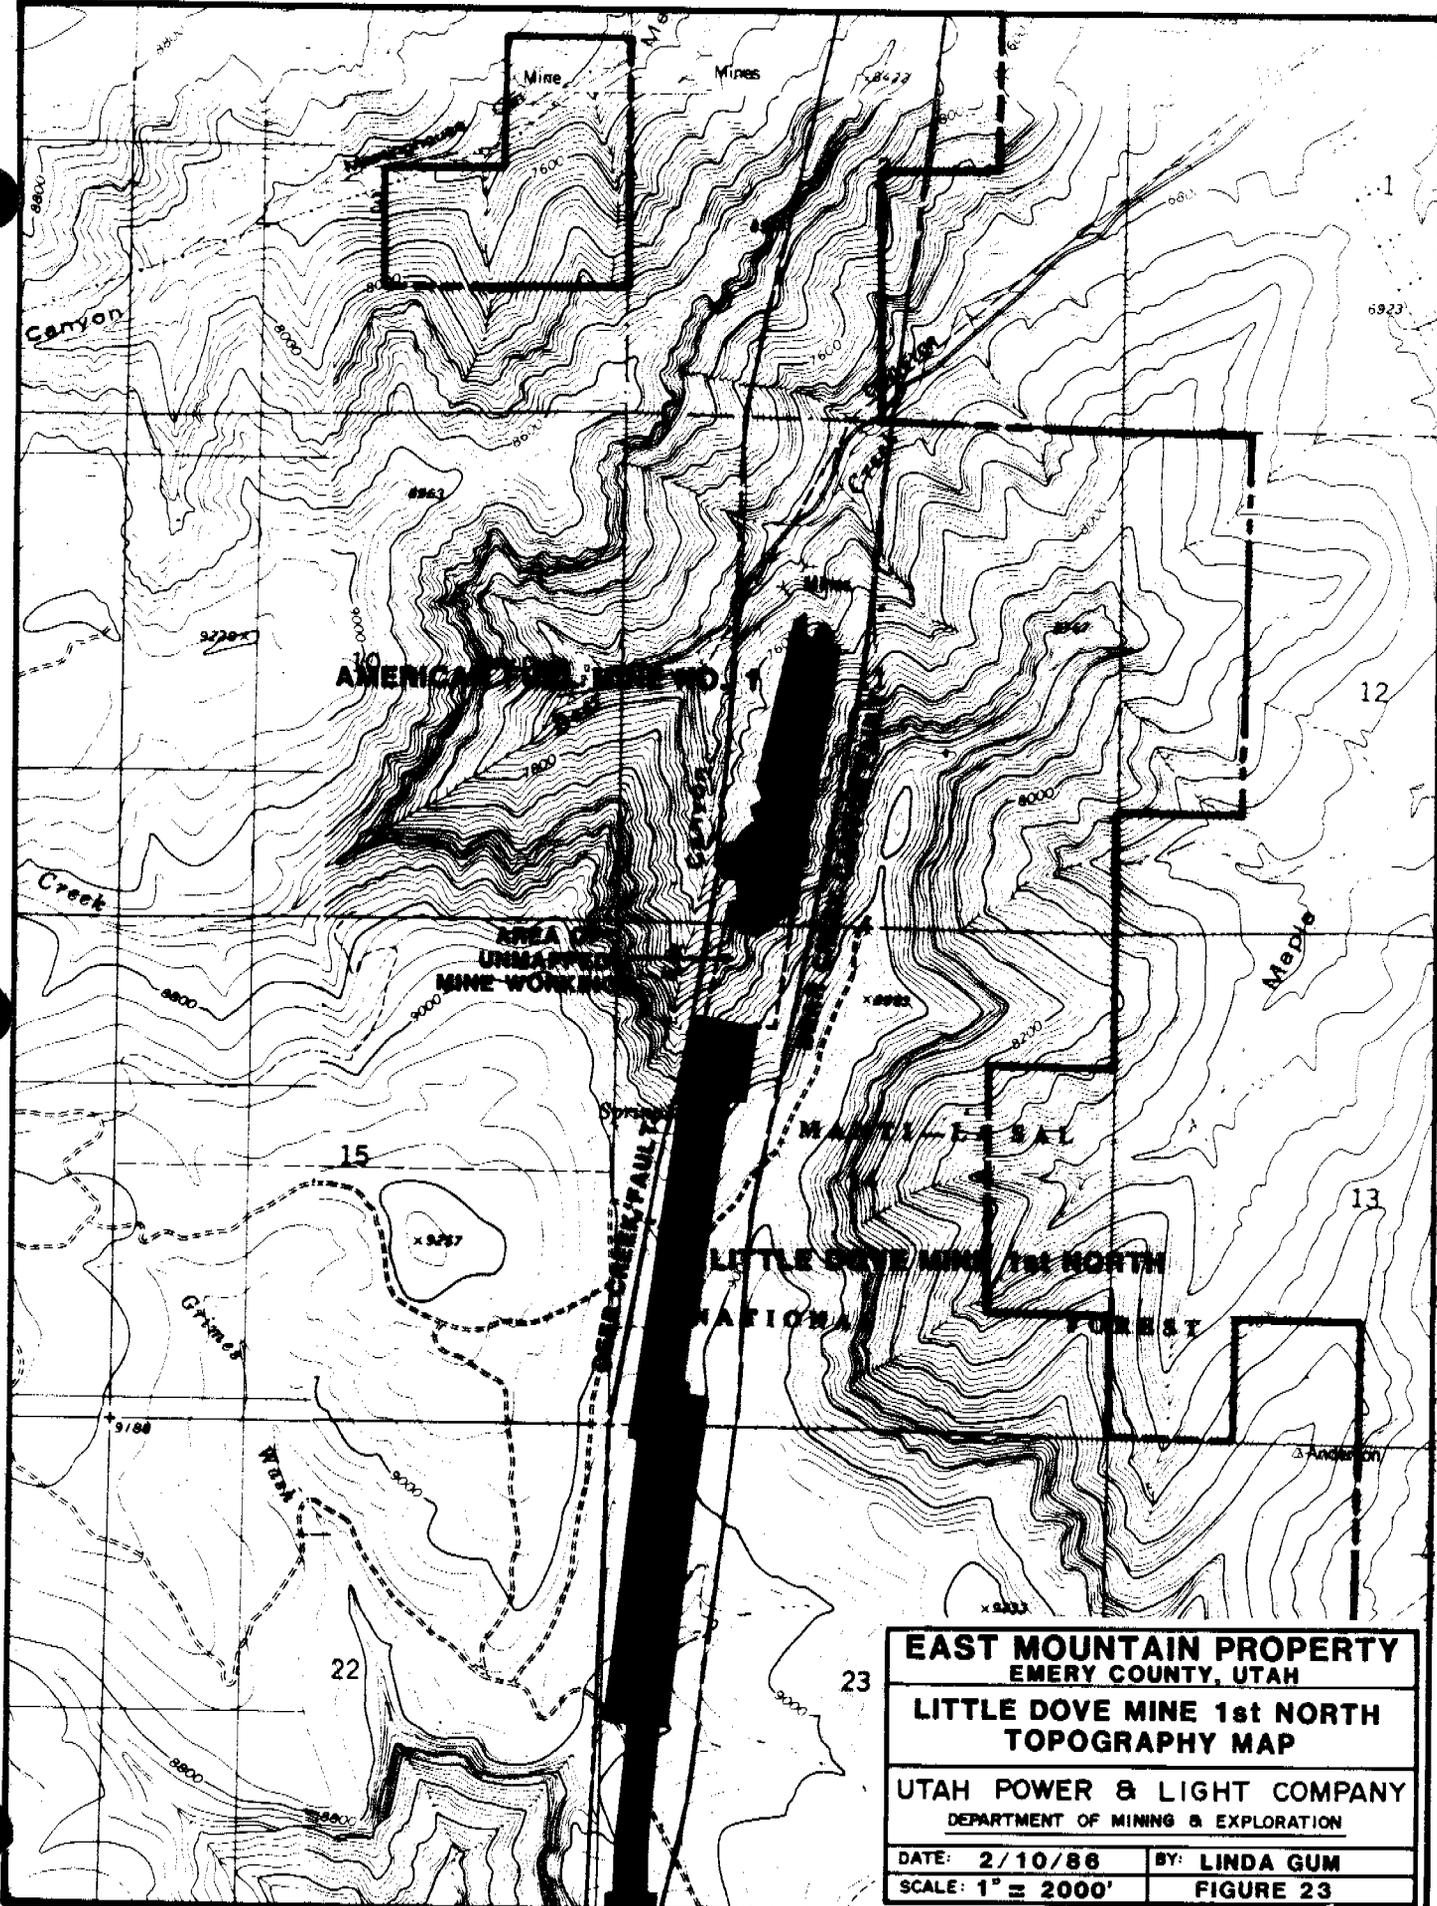
EAST MOUNTAIN PROPERTY	
EMERY COUNTY, UTAH	
LITTLE DOVE MINE 1st NORTH	
TOPOGRAPHY MAP	
UTAH POWER & LIGHT COMPANY	
DEPARTMENT OF MINING & EXPLORATION	
DATE: 2/10/86	BY: LINDA GUM
SCALE: 1" = 2000'	FIGURE 23

The 1st North section of the Little Dove Mine and the American Fuel Mine workings are located in a graben formed by the Deer Creek and Bear Creek Canyon Faults (Figure 23). In August of 1982 the Little Dove workings, mining in a northerly direction, intersected the old workings of the American Fuel Mine about 1000 feet south of where available maps indicated they extend. Mining conditions in that area of Little Dove revealed that strata were highly stressed. In some cases pillars were crushed before they could be extracted. At that time pillar extraction mining was begun in 1st North and continued to the south with minor interruptions from 1982 through the latest monitoring period.

The old American Fuel Mine workings are also located in the graben formed by the Deer Creek and Bear Creek Canyon Faults (Figure 23). The latest mining in the old American Fuel Mine occurred in 1966. Since UP&L began observations, maximum subsidence has reached 4 feet over these old workings and has not increased in the last two years (Figures 24 and 25). Another small subsidence zone further south shows almost 3 feet of subsidence along the Bear Creek Canyon Fault between the American Fuel and Beehive Mine workings. Since no measurable change has occurred over this area in the past two years, monitoring will be done every other year rather than annually.

On the east side of the American Fuel Mine workings the angle-of-draw has been calculated at 10 to 15 degrees; on the west side slumping on a steep slope over possible burned coal has made angle-of-draw determination impossible.

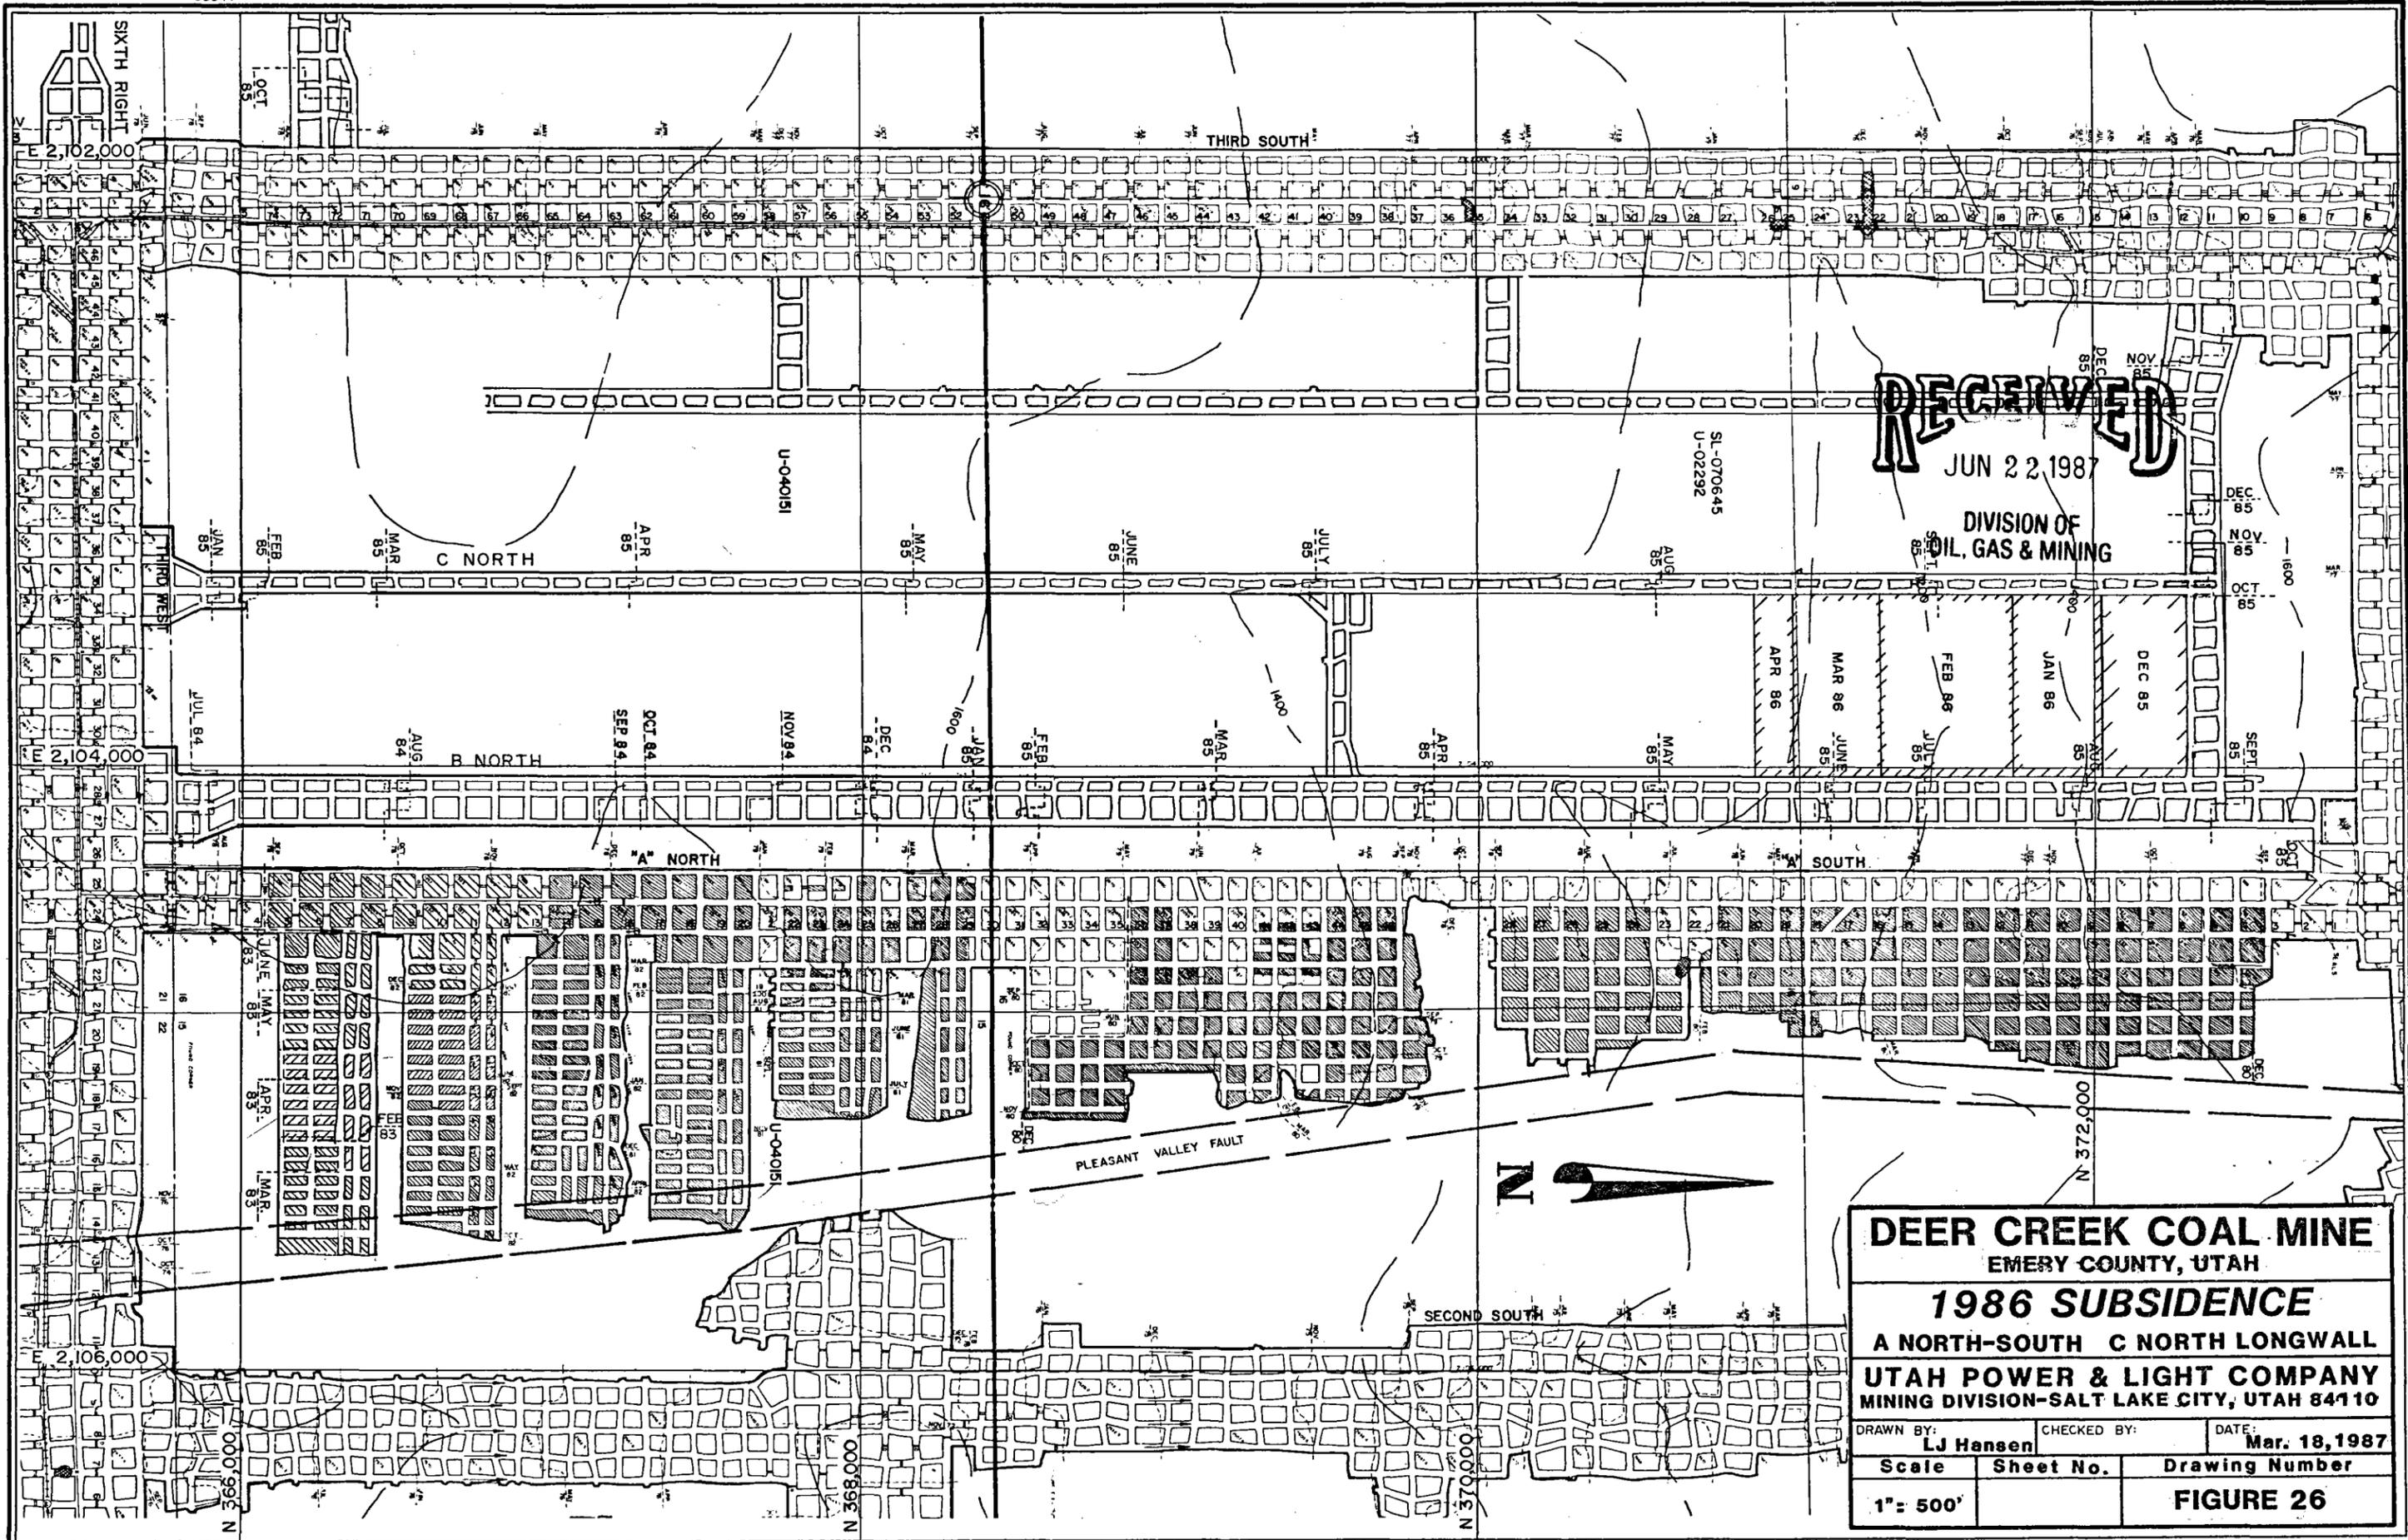
DRAWN BY: LJ Hansen	CHECKED BY:	DATE: Mar. 18, 1987
Scale	Sheet No.	Drawing Number
1" = 500'		FIGURE 27

Pillar extraction mining in A North and A South was completed in June 1983. Longwall mining in the C North panel began in December 1984 and was terminated in April 1986 due to geologic complications. New setup entries were driven further south during May 1986, but mining of the panel did not begin again until after the monitoring period had ended (Figure 26). Measurable subsidence in 1986 reached just over 3 feet over both the A North - A South sections and C North (Figure 27).

No fractures or disturbance of the surface of the area have been observed. No angle-of-draw was calculated since movement on the surface is just beginning.

Three springs are located a few hundred feet to the west of these workings, but none falls within the area of measured subsidence. Their hydrology has shown no effect due to mining.

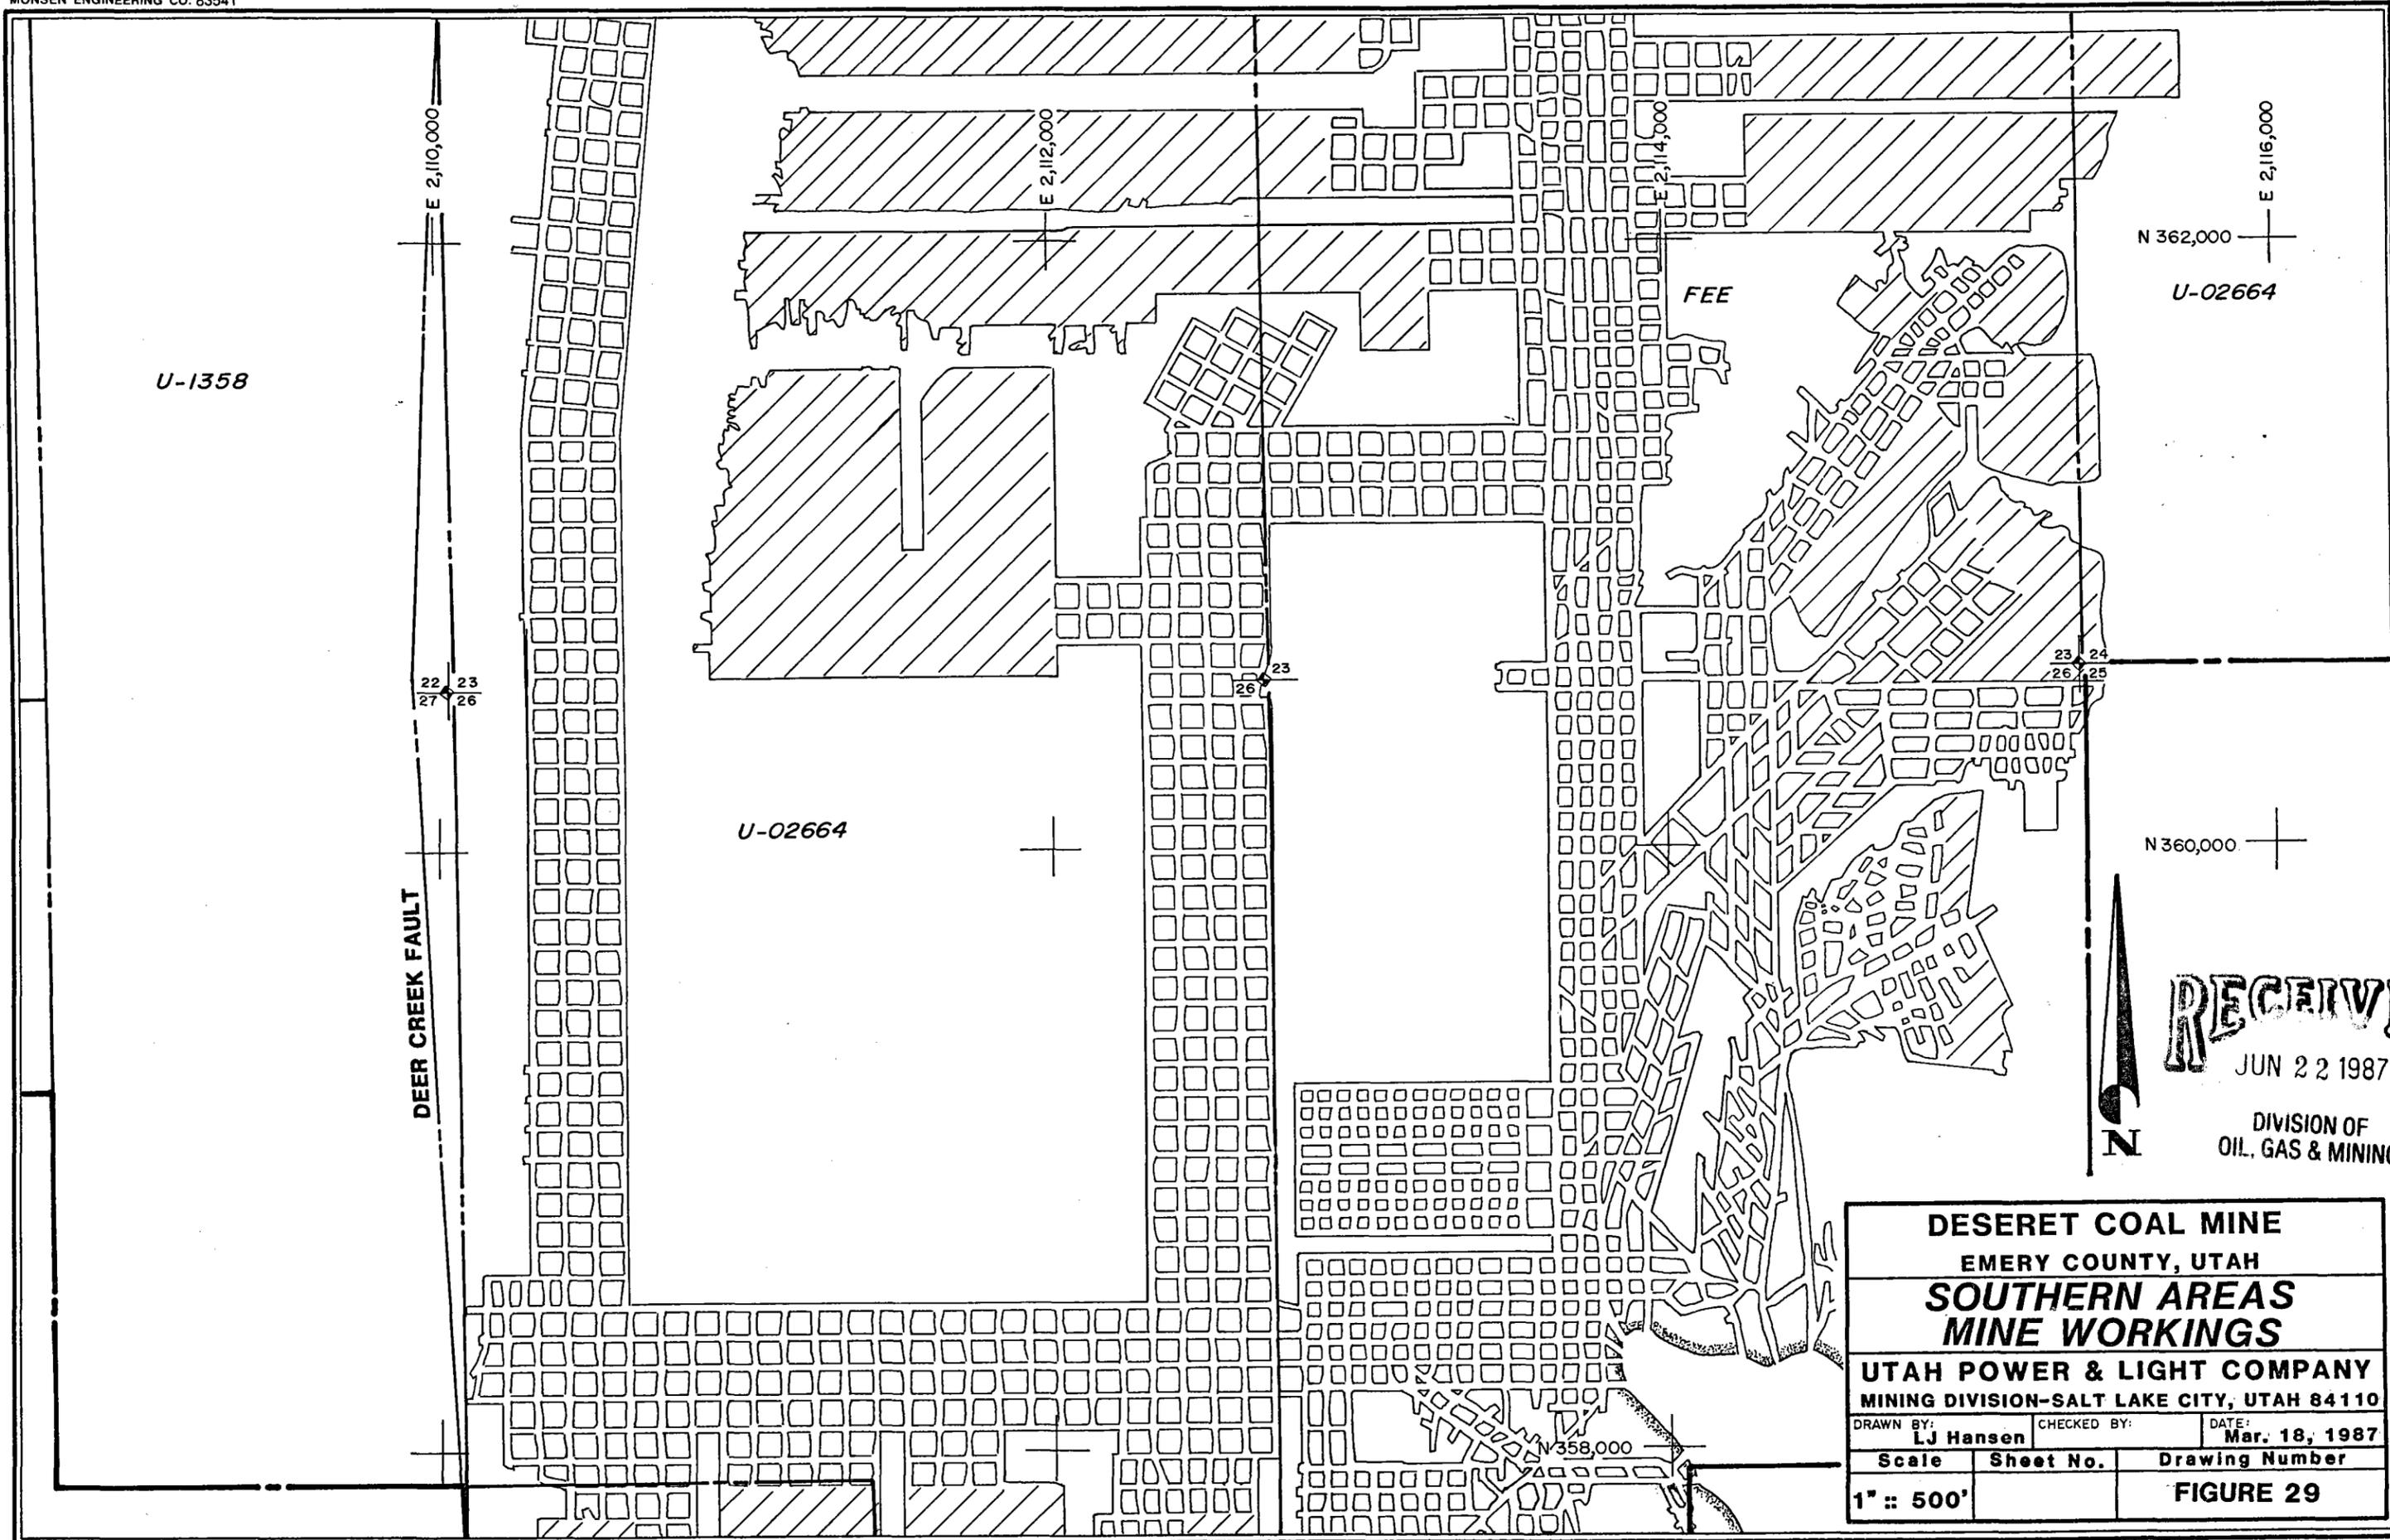
DESERET COAL MINE		
EMERY COUNTY, UTAH		
SOUTHERN AREAS		
MINE WORKINGS		
UTAH POWER & LIGHT COMPANY		
MINING DIVISION-SALT LAKE CITY, UTAH 84110		
DRAWN BY: LJ Hansen	CHECKED BY:	DATE: Mar. 18, 1987
Scale	Sheet No.	Drawing Number
1" = 500'		FIGURE 29

This area was first monitored for subsidence in 1986. The area covers the southern portions of the Deseret, Beehive, and Little Dove Mines. Some of the sections in the area were mined before baseline elevation data were established; therefore, subsidence measured over these sections will not likely represent what actually occurred. In other areas, such as 1st, 2nd, and 3rd North, Little Dove, pillar extraction was active during the time since baseline elevations were established and measured subsidence should represent true subsidence (Figures 28 and 29).

No visible surface disturbance of any kind has been found.
