UTAH POWER & LIGHT COMPANY
SUBSIDENCE MONITORING PROGRAM
ANNUAL REPORT FOR 1987

June 1988

UTAH POWER & LIGHT COMPANY
SUBSIDENCE MONITORING PROGRAM
ANNUAL REPORT FOR 1988

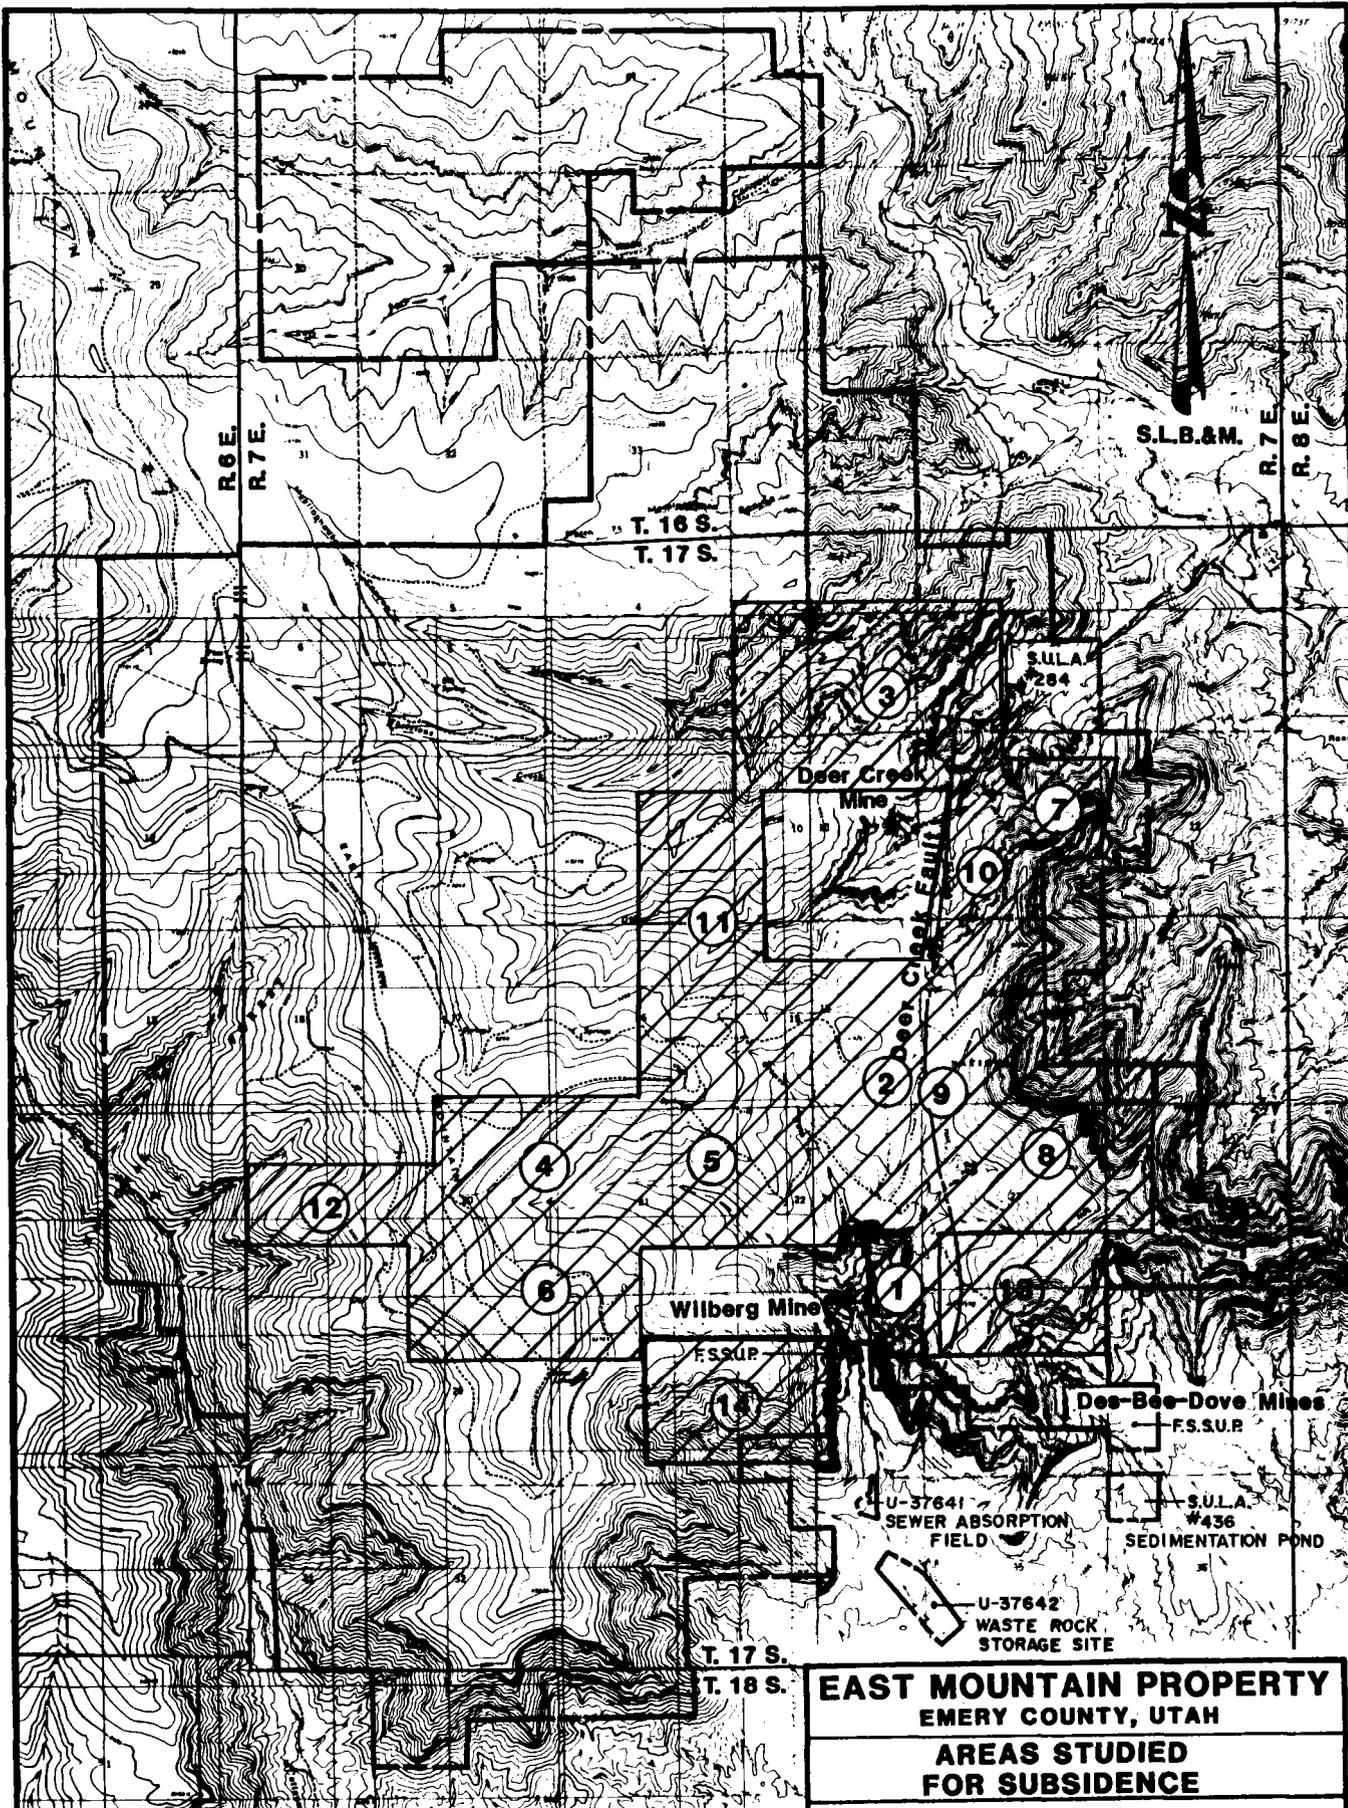
FIGURE 2

Figure 2 shows all areas above UP&L's coal mines which have potential for mining induced subsidence. A helicopter reconnaissance flight on July 29, 1987 revealed a new area of subsidence over the 6th and 7th East longwall panels in the Cottonwood Mine. This area has experienced fracturing and cliff failure along the Castlegate Sandstone escarpment on the north side of what is known as Newberry Canyon (Area 14).

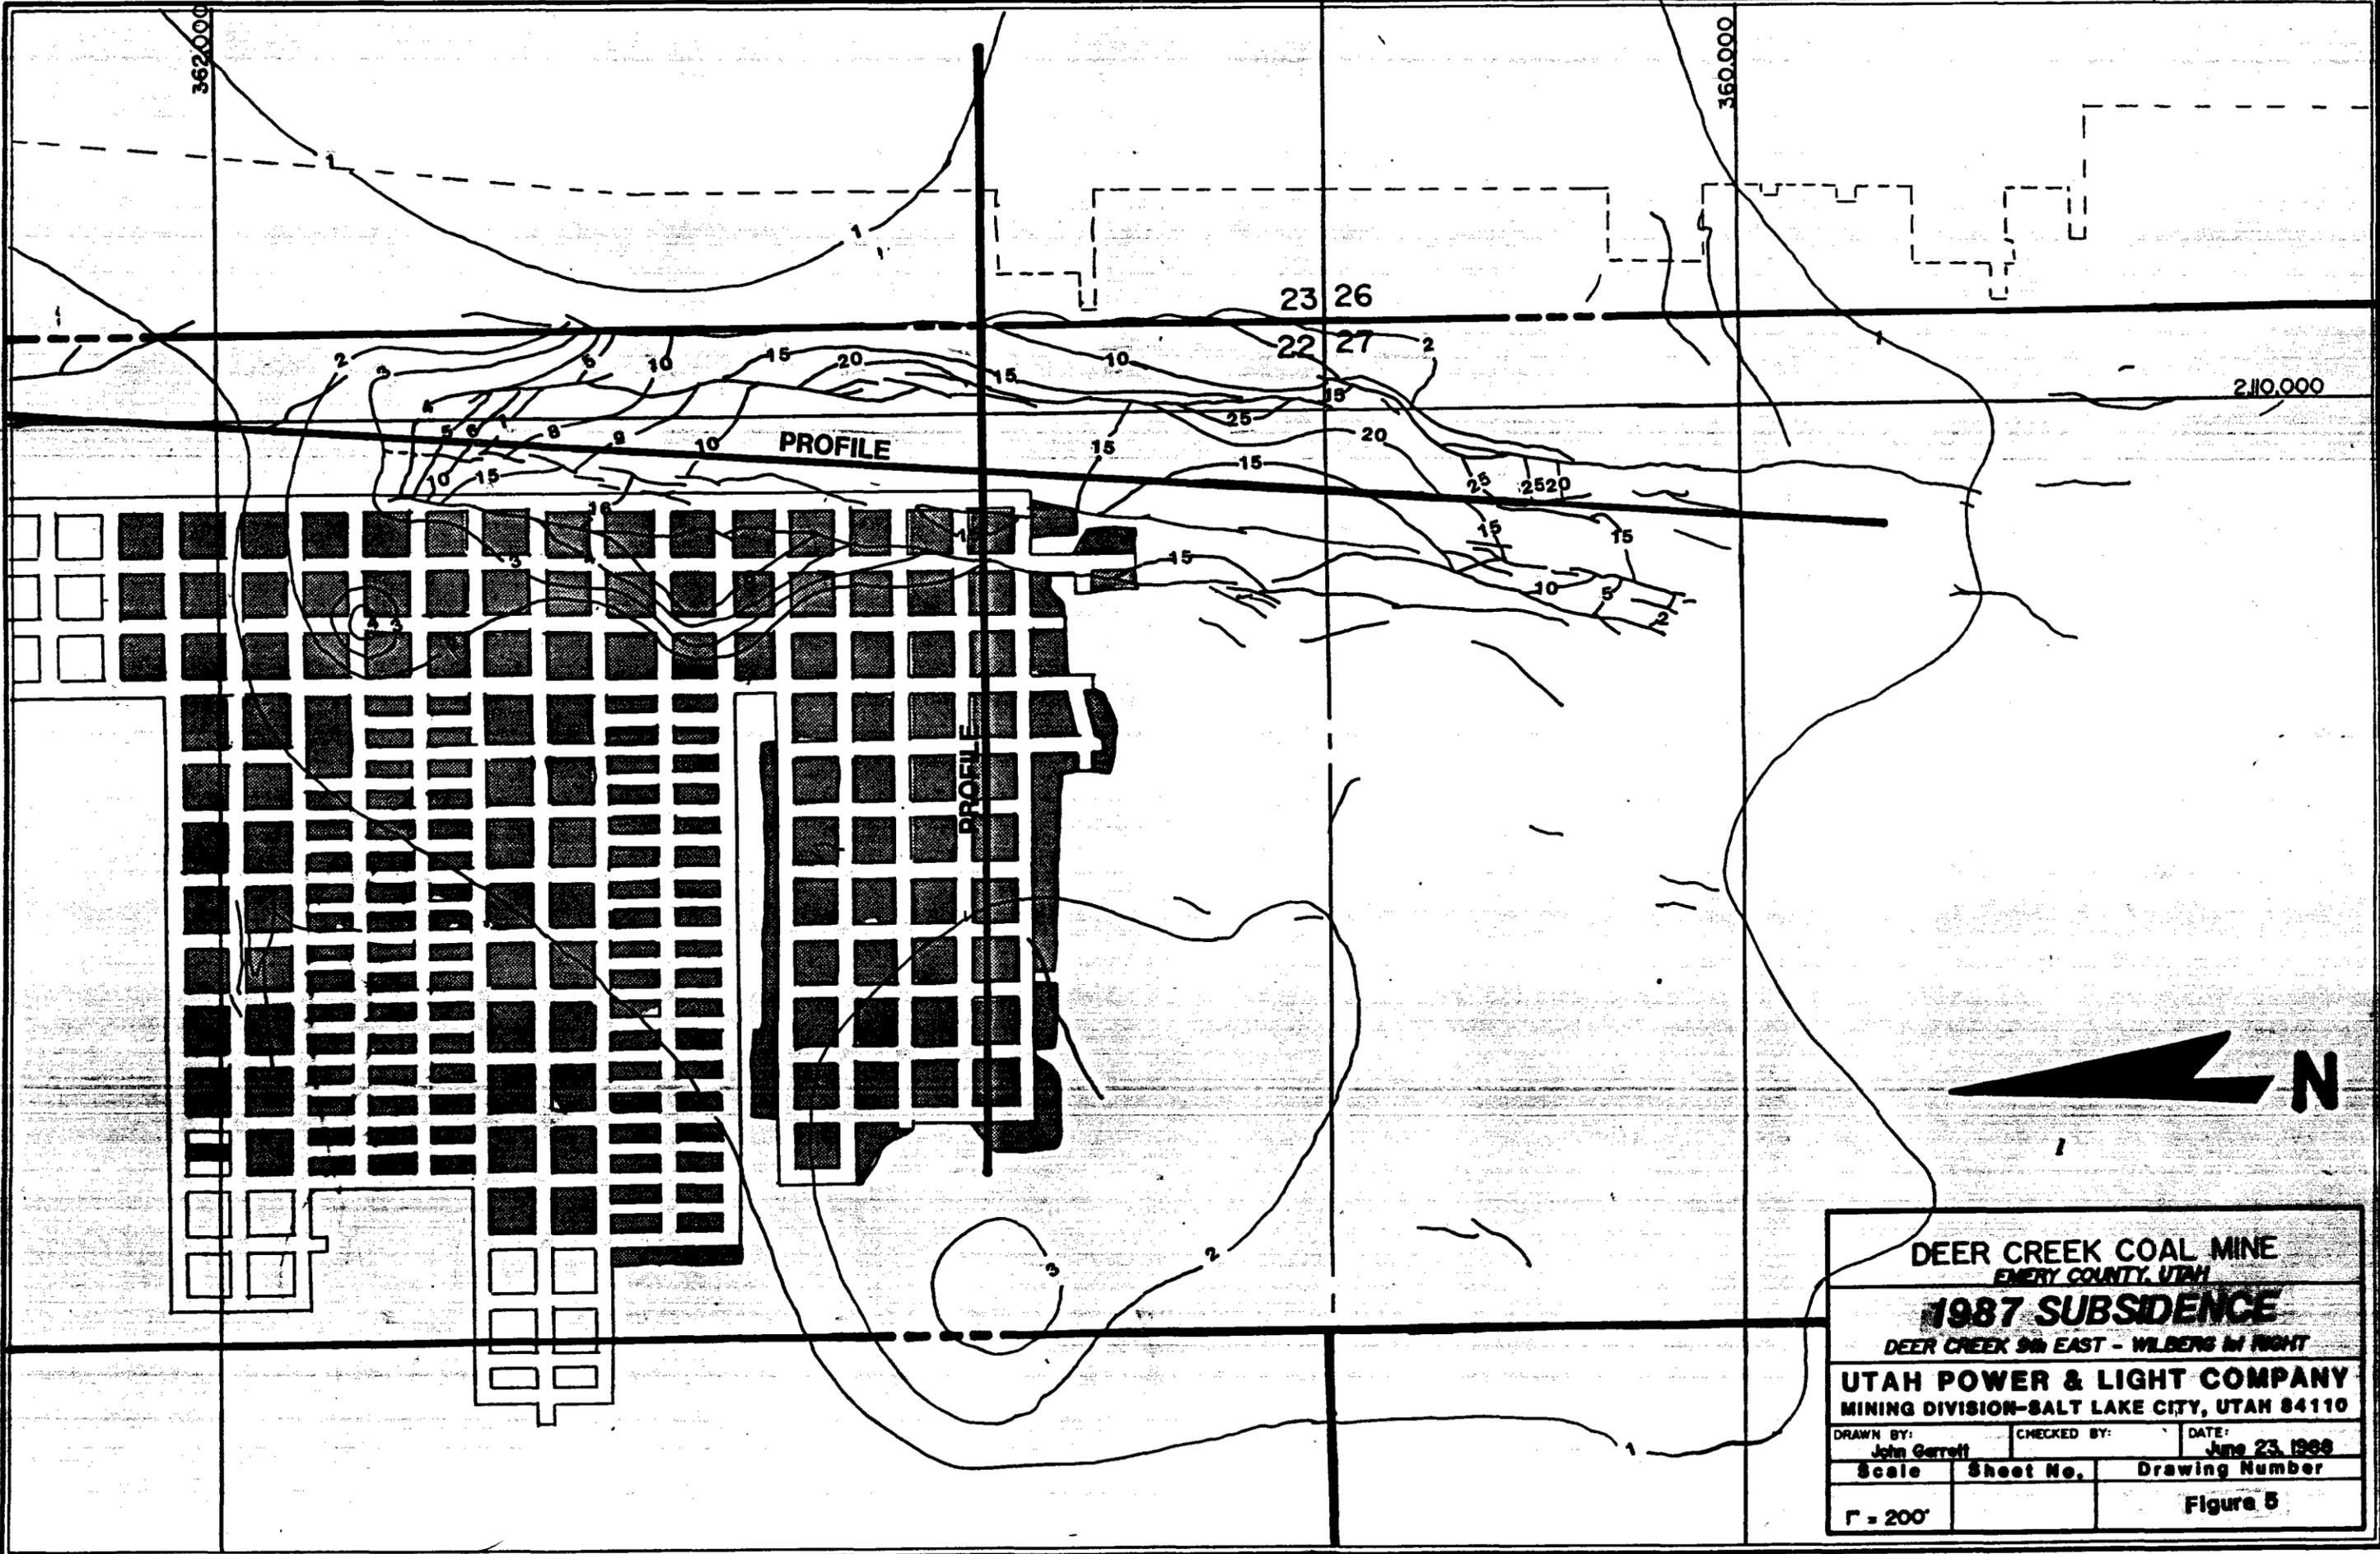
DRAWN BY: John Garrett	CHECKED BY:	DATE: June 23, 1988
Scale	Sheet No.	Drawing Number
1" = 200'		Figure 5

Subsidence in Area 1 was first documented in the 1981 Subsidence Monitoring Report submitted in 1982. The relationship of the subsidence to the underlying Deer Creek and Wilberg mine workings is shown in Figures 3, 4, and 5. Each map covers the same area, Figure 5 being a contour map of subsidence on the surface over the mine workings depicted in the other two figures. The most recent mining in this area occurred in the Wilberg 1st Right section in June 1984.

Figures 6 and 7 are north to south and west to east profiles showing the amount of subsidence in this area during the past six years. The location of each line is shown on Figure 5. The area has seen little change since 1985. Only in the location where maximum subsidence occurs was there a further drop in the surface, from twenty-five (25) to nearly twenty-eight (28) feet of subsidence; the rest of the area appears to have stabilized. A detailed look from a helicopter revealed that the subsidence maximum is located on a steep slope, about 200 feet south of the southernmost mining, where a good sized rotational slump has occurred. The workings here are also surrounded by burned coal. It is probable that the combination of steep slopes and crushing of clinker beds has allowed subsidence to occur well outside the area of mine workings. An inspection of the area from the ground indicates that many of the open fractures forming the graben-like structure have begun to heal and fill in with soil.

In a few areas, such as Areas 1, 3, 7, 10, and 14, surface fractures have been detected. In order to protect livestock, UP&L has erected a fence around Area 1 where fractures are of sufficient magnitude to pose a threat to wandering cattle. In Area 14, where cracks have also been observed, the U.S. Forest Service has determined that no fencing or other measures are needed unless "significant change" occurs in the area. The agency has recommended that no reclamation be undertaken in Areas 1 or 14 at this time; UP&L will reclaim the areas when and if it is deemed necessary.

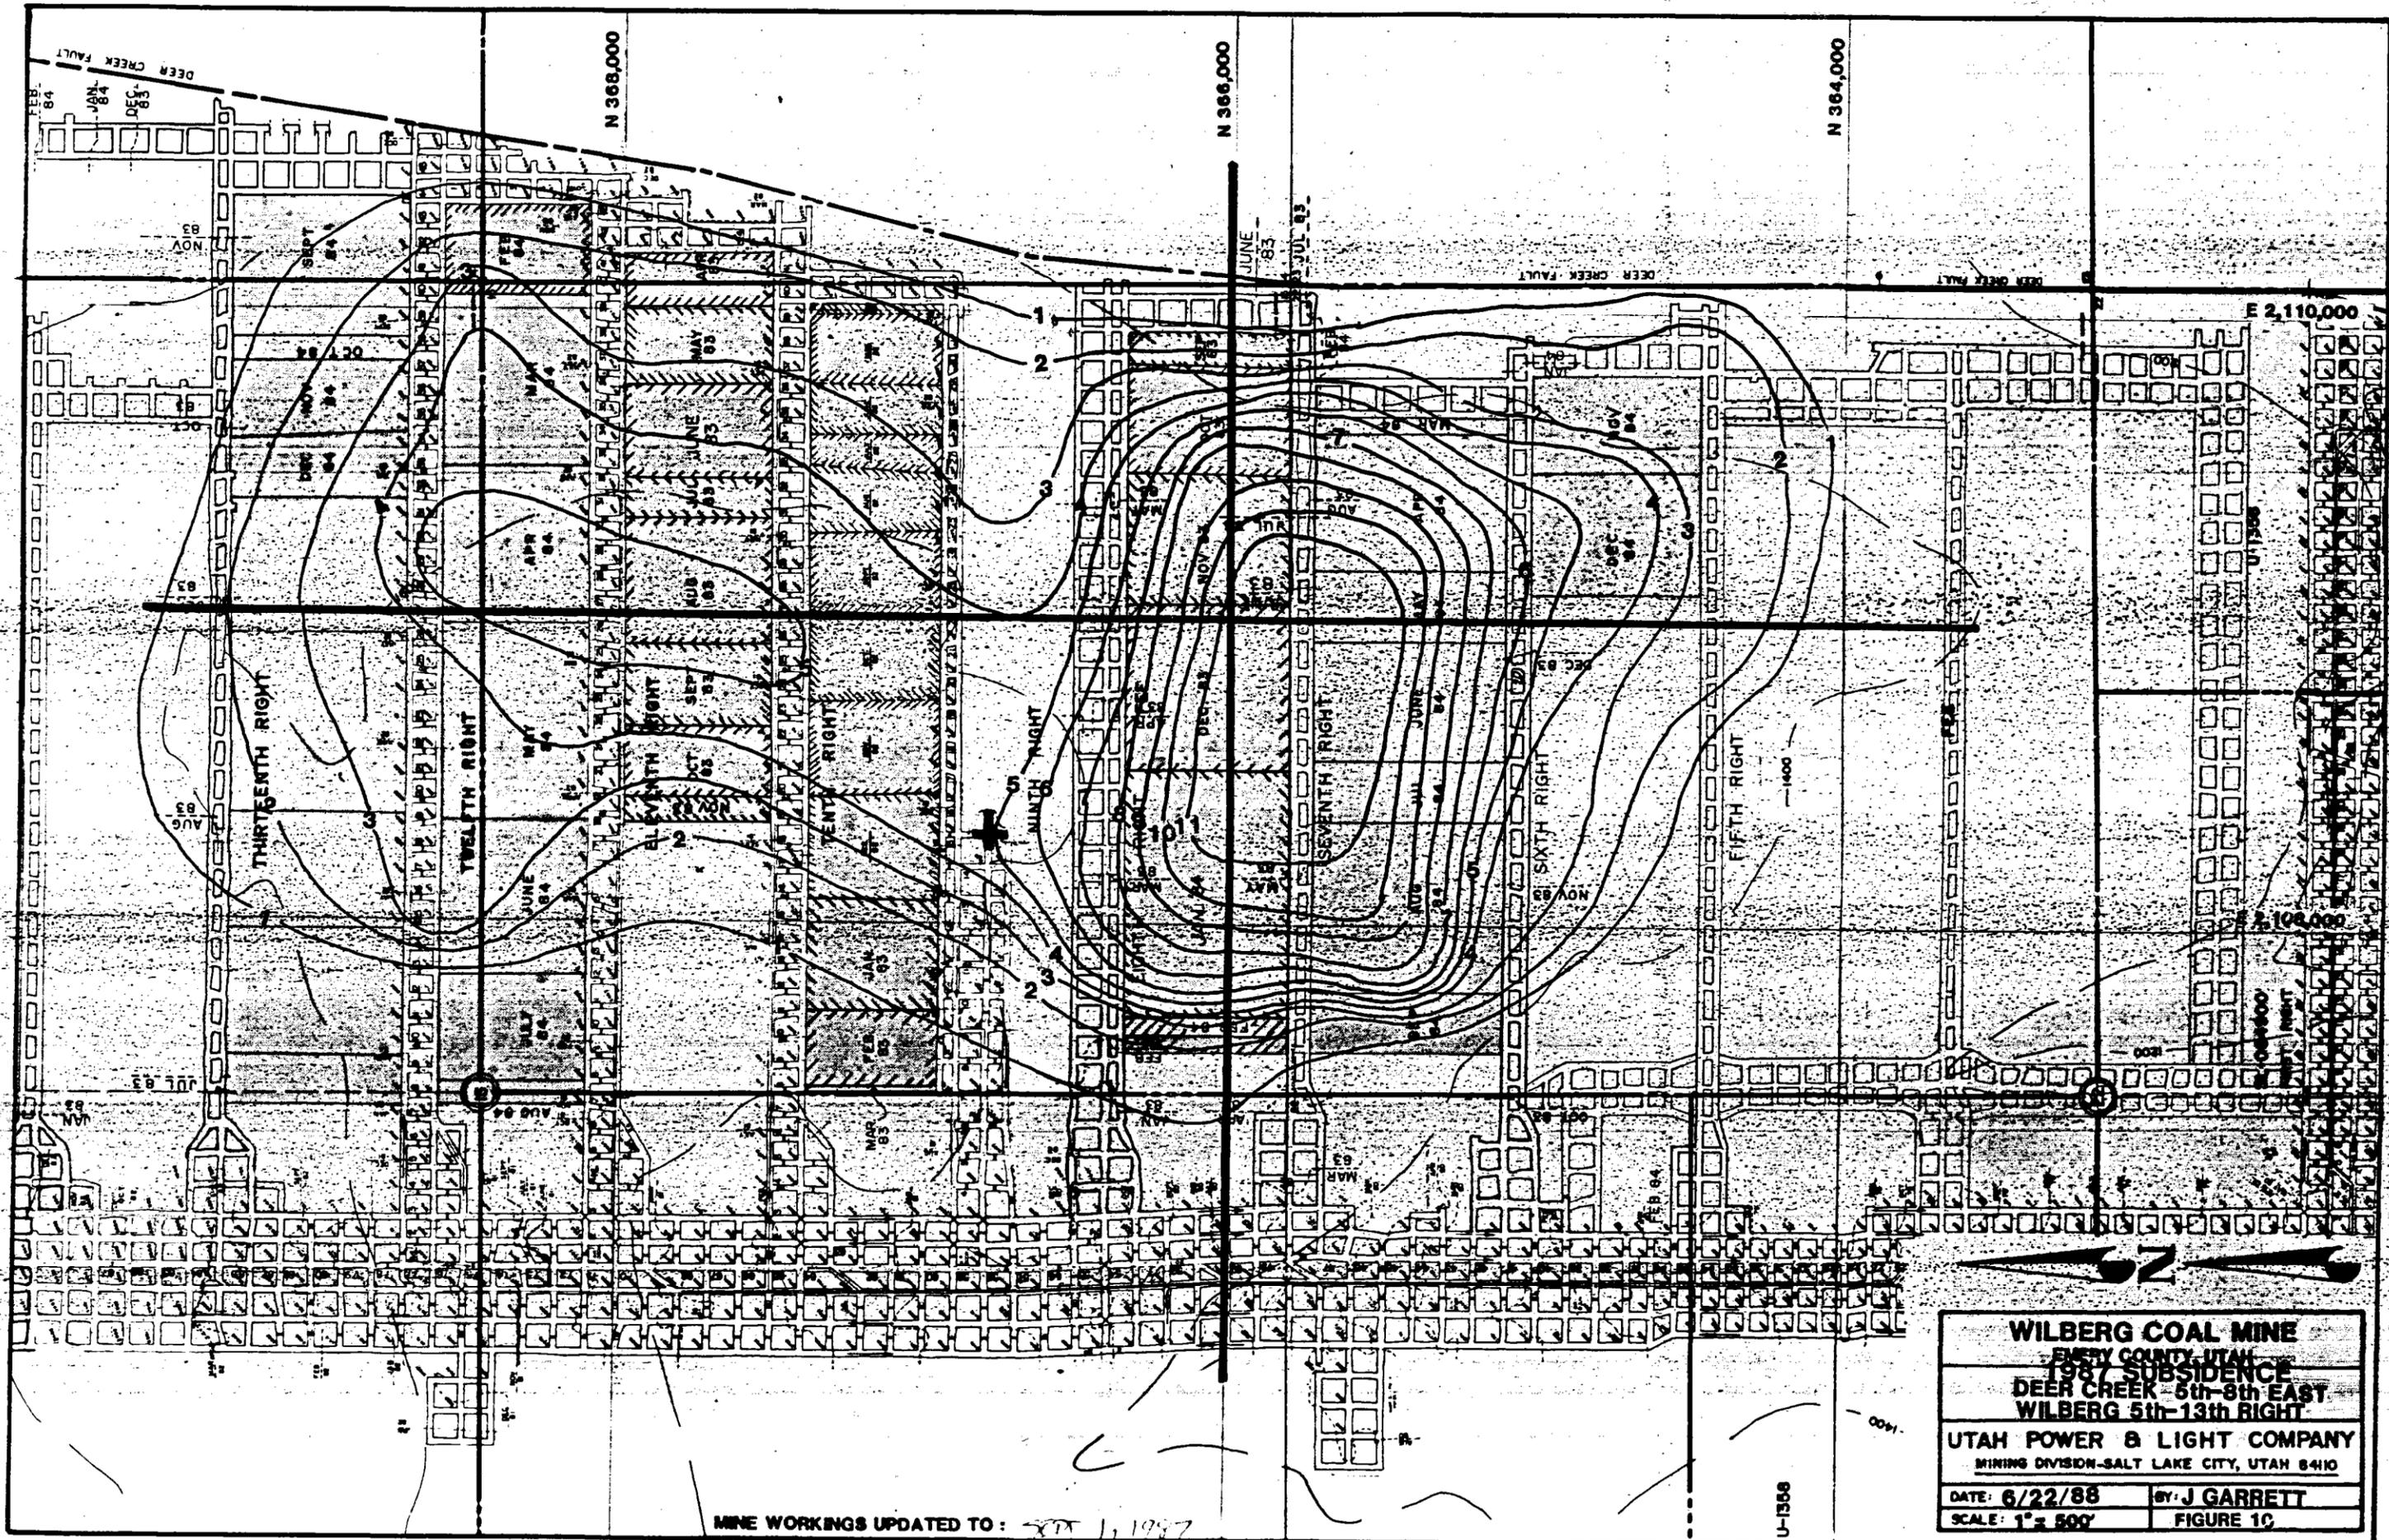
WILBERG COAL MINE	
ENERGY COUNTY, UTAH	
1987 SUBSIDENCE	
DEER CREEK - 5th-8th EAST	
WILBERG 5th-13th RIGHT	
UTAH POWER & LIGHT COMPANY	
MINING DIVISION-SALT LAKE CITY, UTAH 84110	
DATE: 6/22/88	BY: J GARRETT
SCALE: 1" = 500'	FIGURE 10

In 1987 the area was surveyed by photogrammetric methods only. In the past, on-the-ground conventional methods were also used, with the two methods showing very close correlation but the photogrammetry giving more detail due to tighter grid spacing of the measurement points. Maximum subsidence in Area 2 remains at about twelve (12) feet and occurs over the Deer Creek 6th East and the Wilberg 6th and 7th Right longwall panels (Figure 10). The subsidence profiles (Figures 11 and 12) indicate that ground movement over much of the area has stabilized, but the subsidence trough continues to elongate over the most recently mined 13th Right panel. Neither UP&L nor other contracted personnel have detected any surface fissures or other visible disturbance in the area.

Angle-of-draw has been calculated where possible. On the eastern side of Area 2 the angle is influenced by the Deer Creek Fault and the adjacent Little Dove Mine workings across the fault; it ranges from near vertical to 12 degrees. On the north and south the maximum angles-of-draw are 30 and -10 degrees, respectively. On the western side the angle ranges from -17 to 8 degrees.

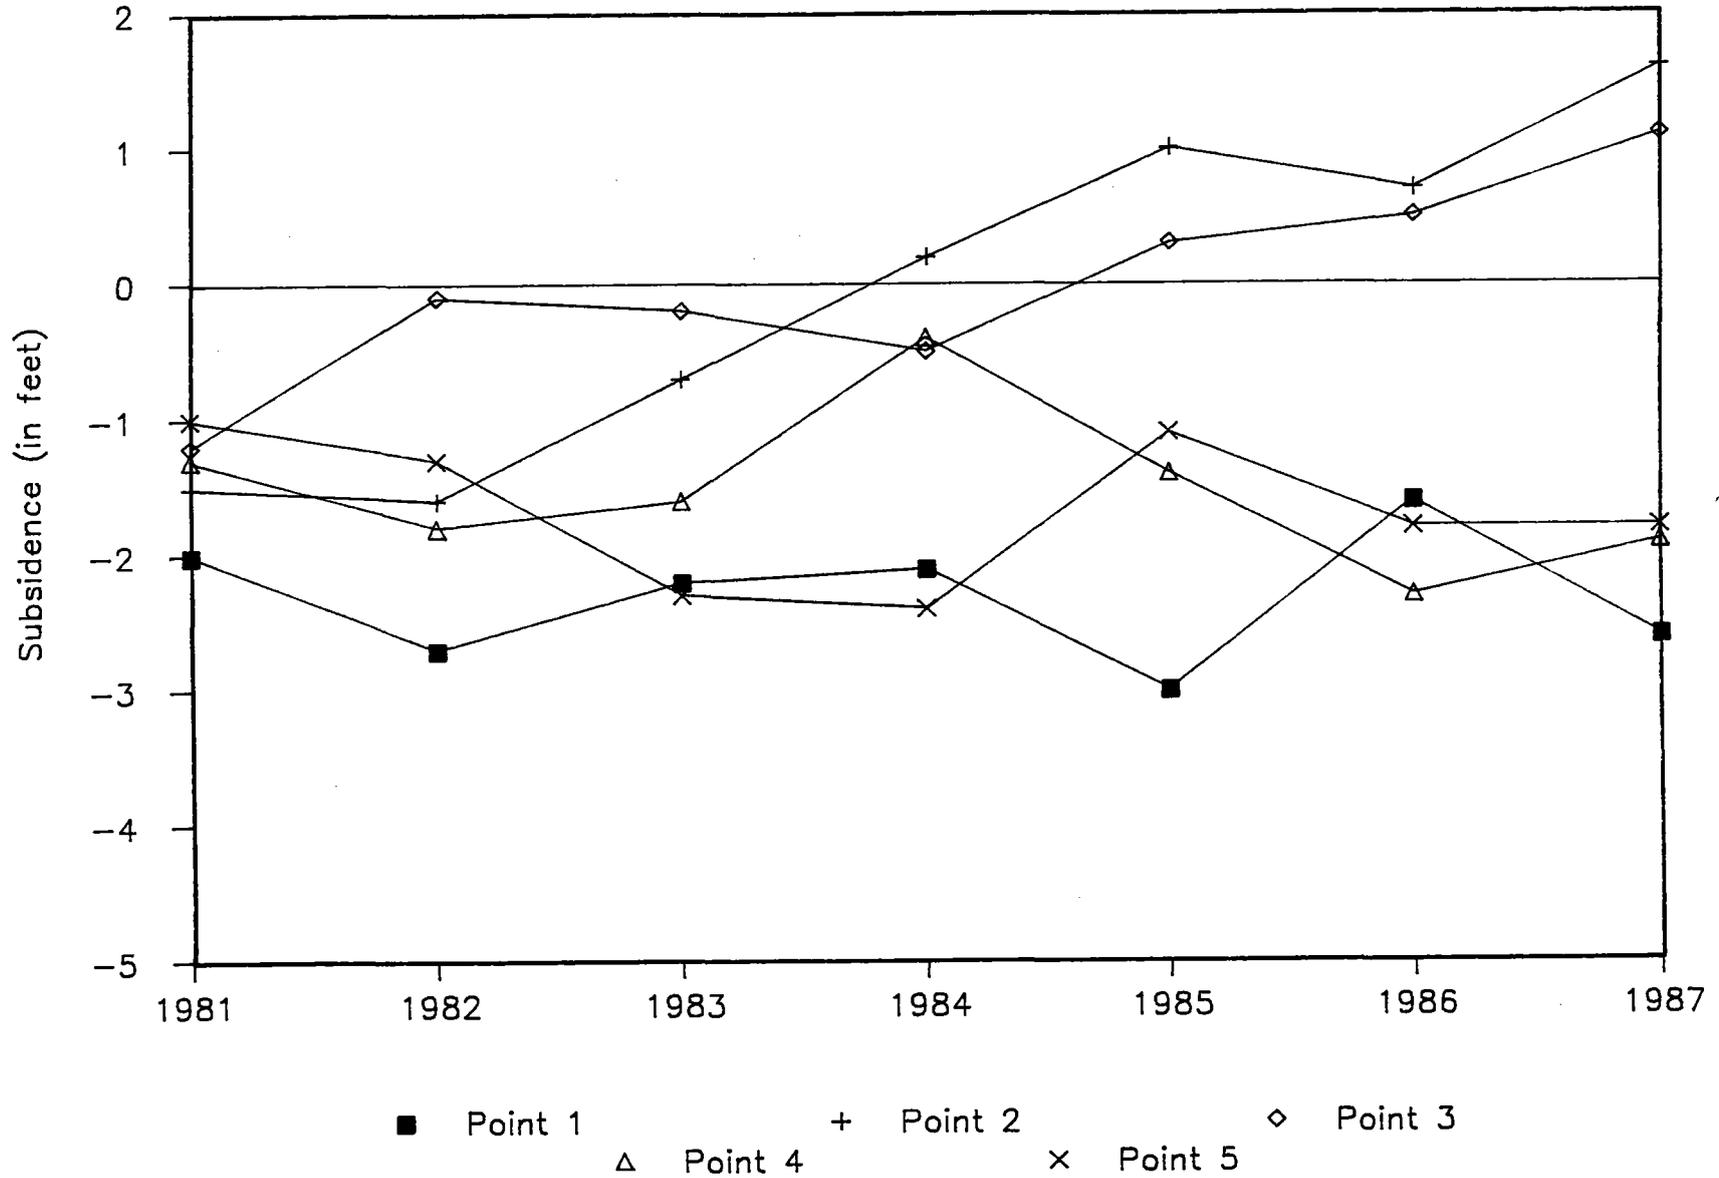
FIGURE 14

It is difficult to assess whether or not the ground has stabilized. The subsidence above 1st North occurs on a narrow ridge capped by a highly fractured sandstone, and a review of the subsidence data indicates that, due to the mode of subsidence, elevation change cannot be depicted accurately with a contour map. Figure 14 is a graph of subsidence as it occurred at several points above the 1st North workings. Elevations are not consistent from year to year at a given point. One explanation is that the magnitude of the subsidence is on the order of the precision of the measurements (2 feet vs. .7 feet). Keeping this in mind, Points 1 and 5 appear to be fairly stable, Point 4 may have stabilized, and Points 2 and 3 are rising. The increase in elevation is probably due to a cantilever effect, where one end of a small block of rock subsides while the other end rises.

A helicopter survey in late July 1987 revealed no new surface cracks or areas of cliff failure. Selected points in Area 3 will continue to be monitored until the area's stability can be better assessed.

Calculated angle-of-draw ranges from vertical to 40 degrees, but the measurements are influenced by burned coal, steep slopes, and fracturing, which have complicated the subsidence process.

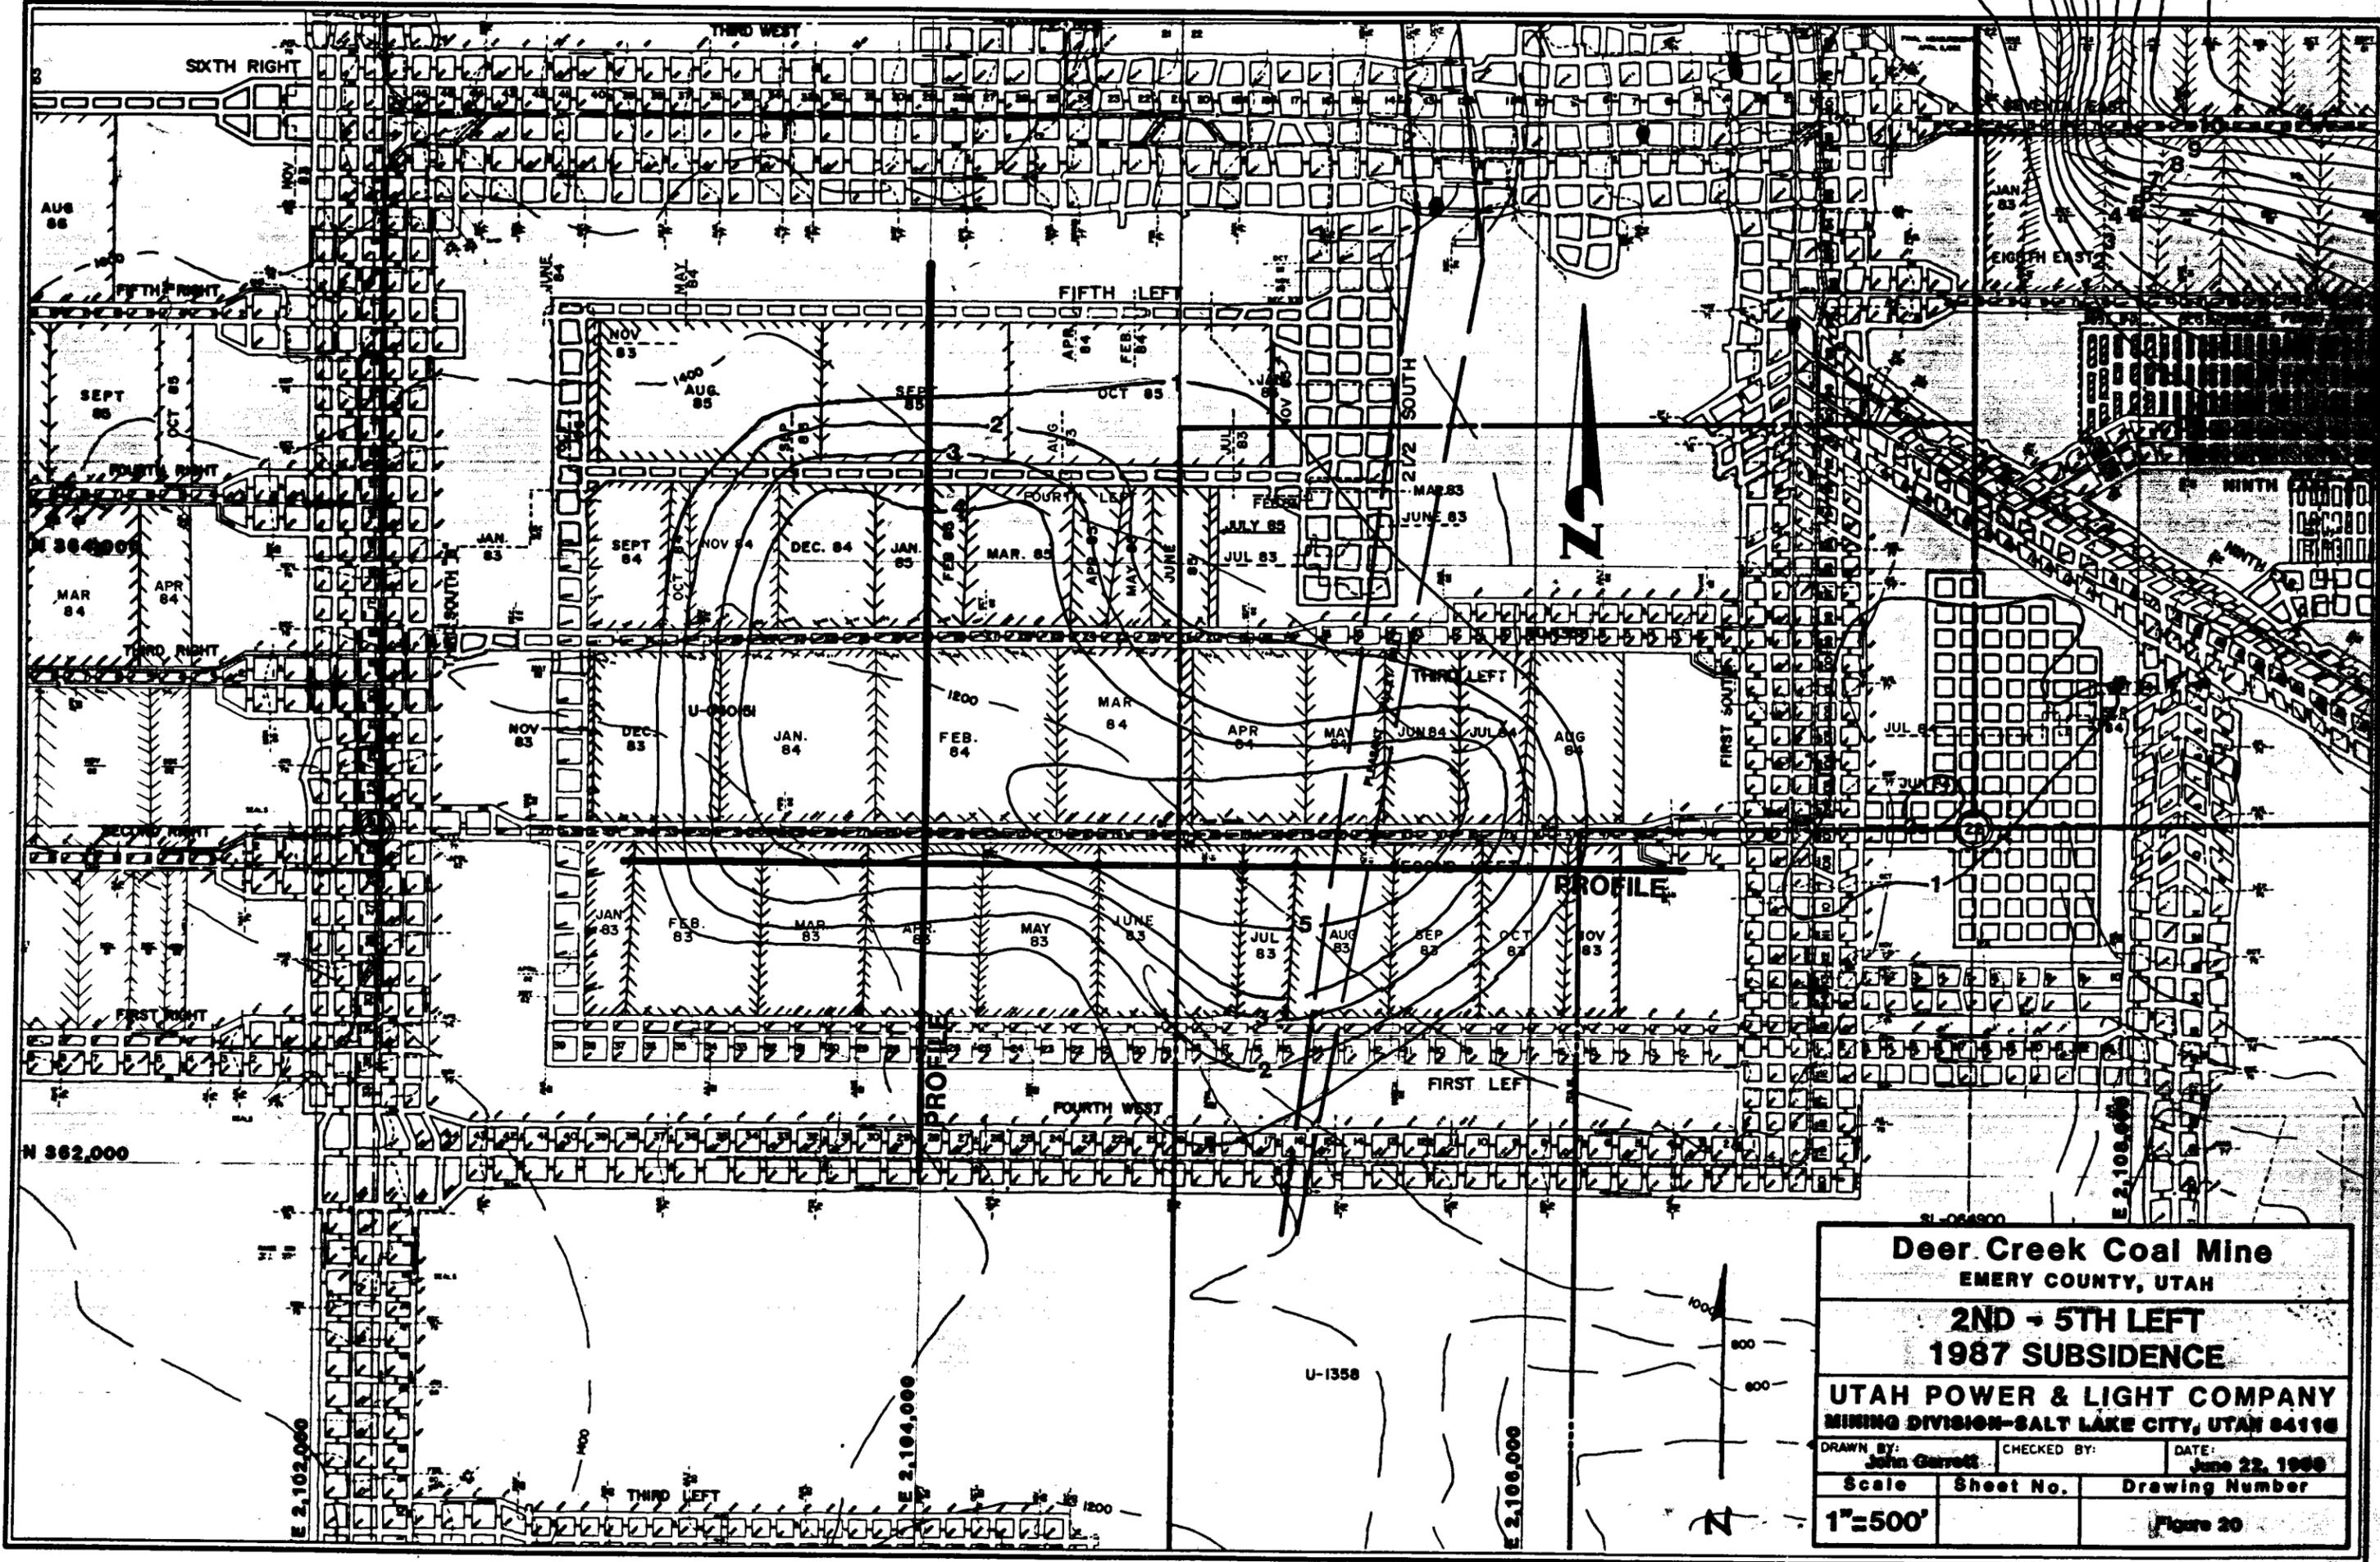
Deer Creek Coal Mine EMERY COUNTY, UTAH		
2ND - 5TH LEFT 1987 SUBSIDENCE		
UTAH POWER & LIGHT COMPANY MINING DIVISION-SALT LAKE CITY, UTAH 84116		
DRAWN BY: John Garrett	CHECKED BY:	DATE: June 22, 1988
Scale 1"=500'	Sheet No.	Drawing Number Figure 20

For the third consecutive year the maximum subsidence over the panels is about 5.5 feet and occurs over much of the 3rd Left longwall panel (Figure 20). Little change has occurred in this area since 1986 (Figures 21 and 22). Since subsidence appears to have stabilized, readings of subsidence will now be performed every other year, but this area will be photographed yearly and readings can be made of the photos if deemed necessary. No surface disturbance has been identified over the panels.

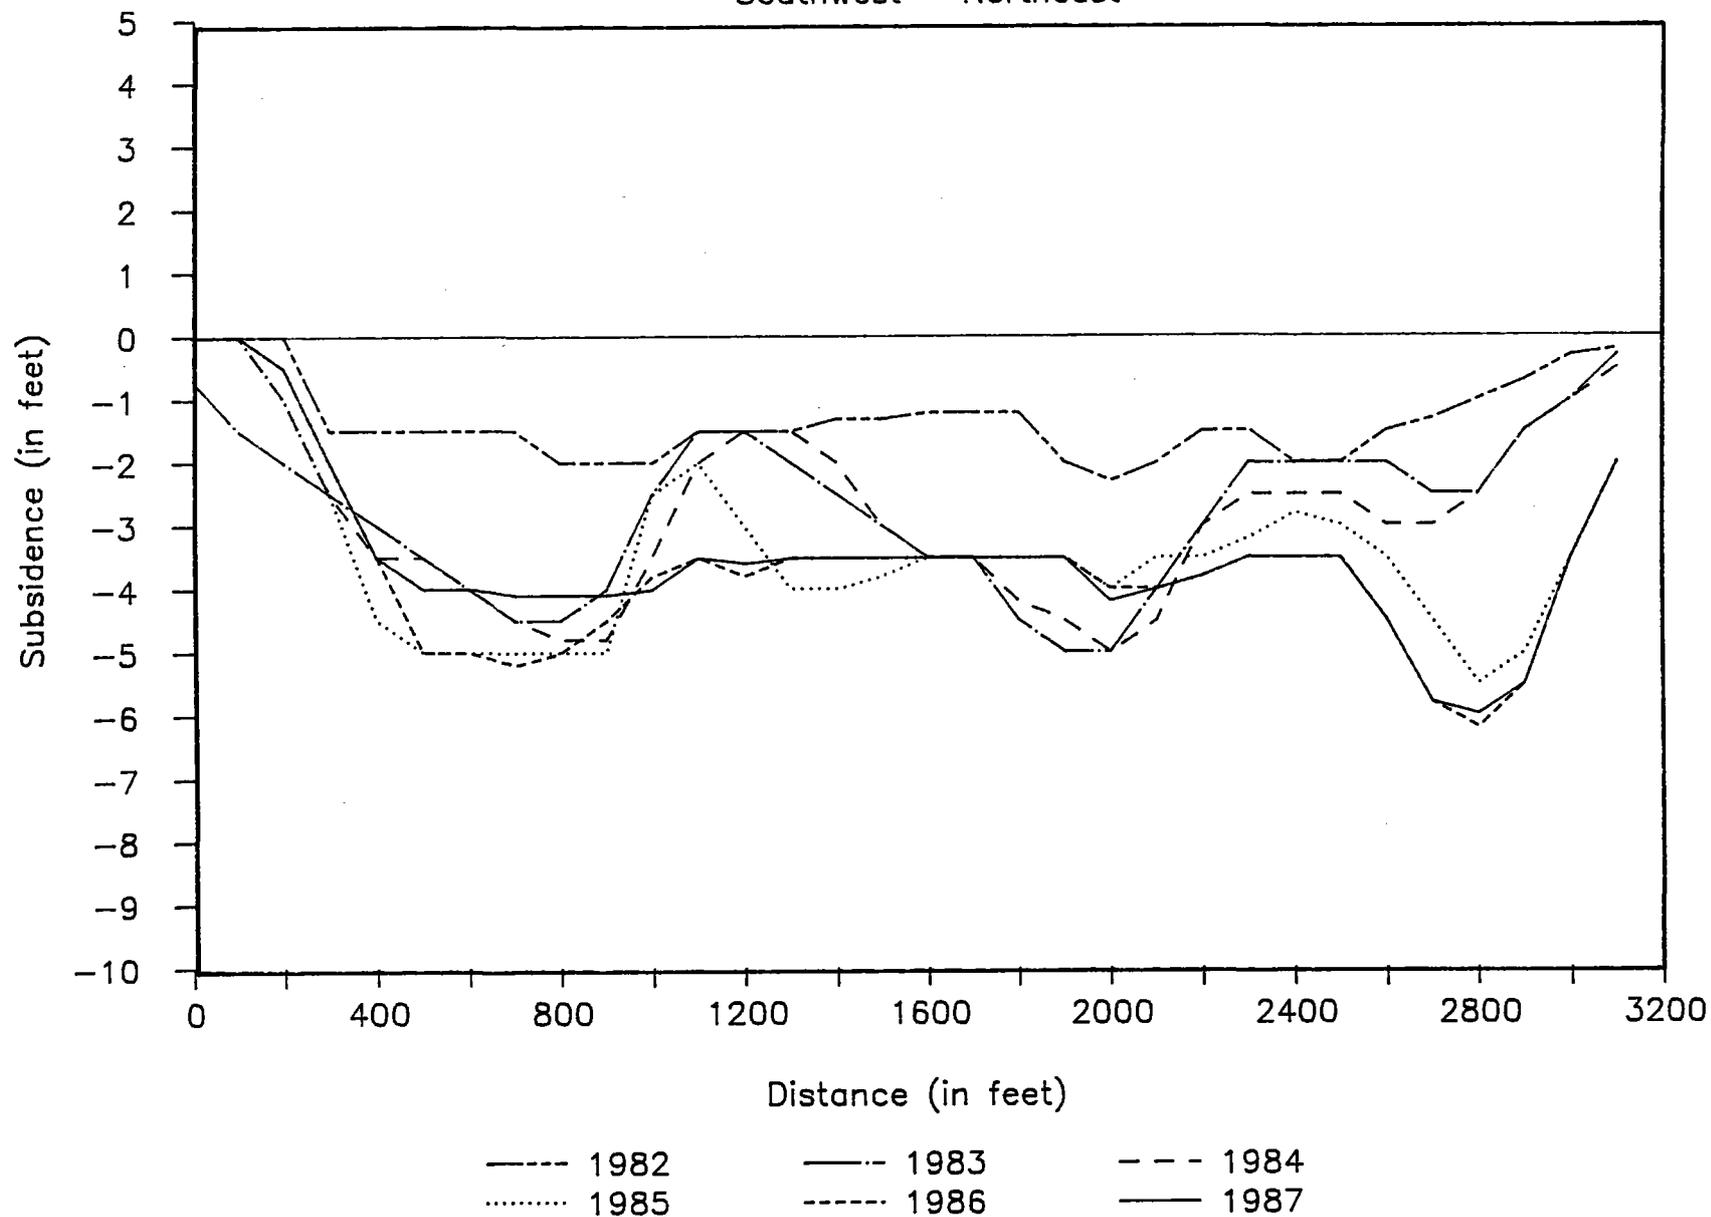
FIGURE 25

Pillar extraction mining in 2nd North was completed in 1983 and, as shown in Figure 25, little additional subsidence has occurred over the workings since 1984. Subsidence remains at about six (6) feet and, owing to this stability, annual monitoring of the area is no longer performed. For a more complete discussion of subsidence in Area 7, consult the 1986 or a previous report.

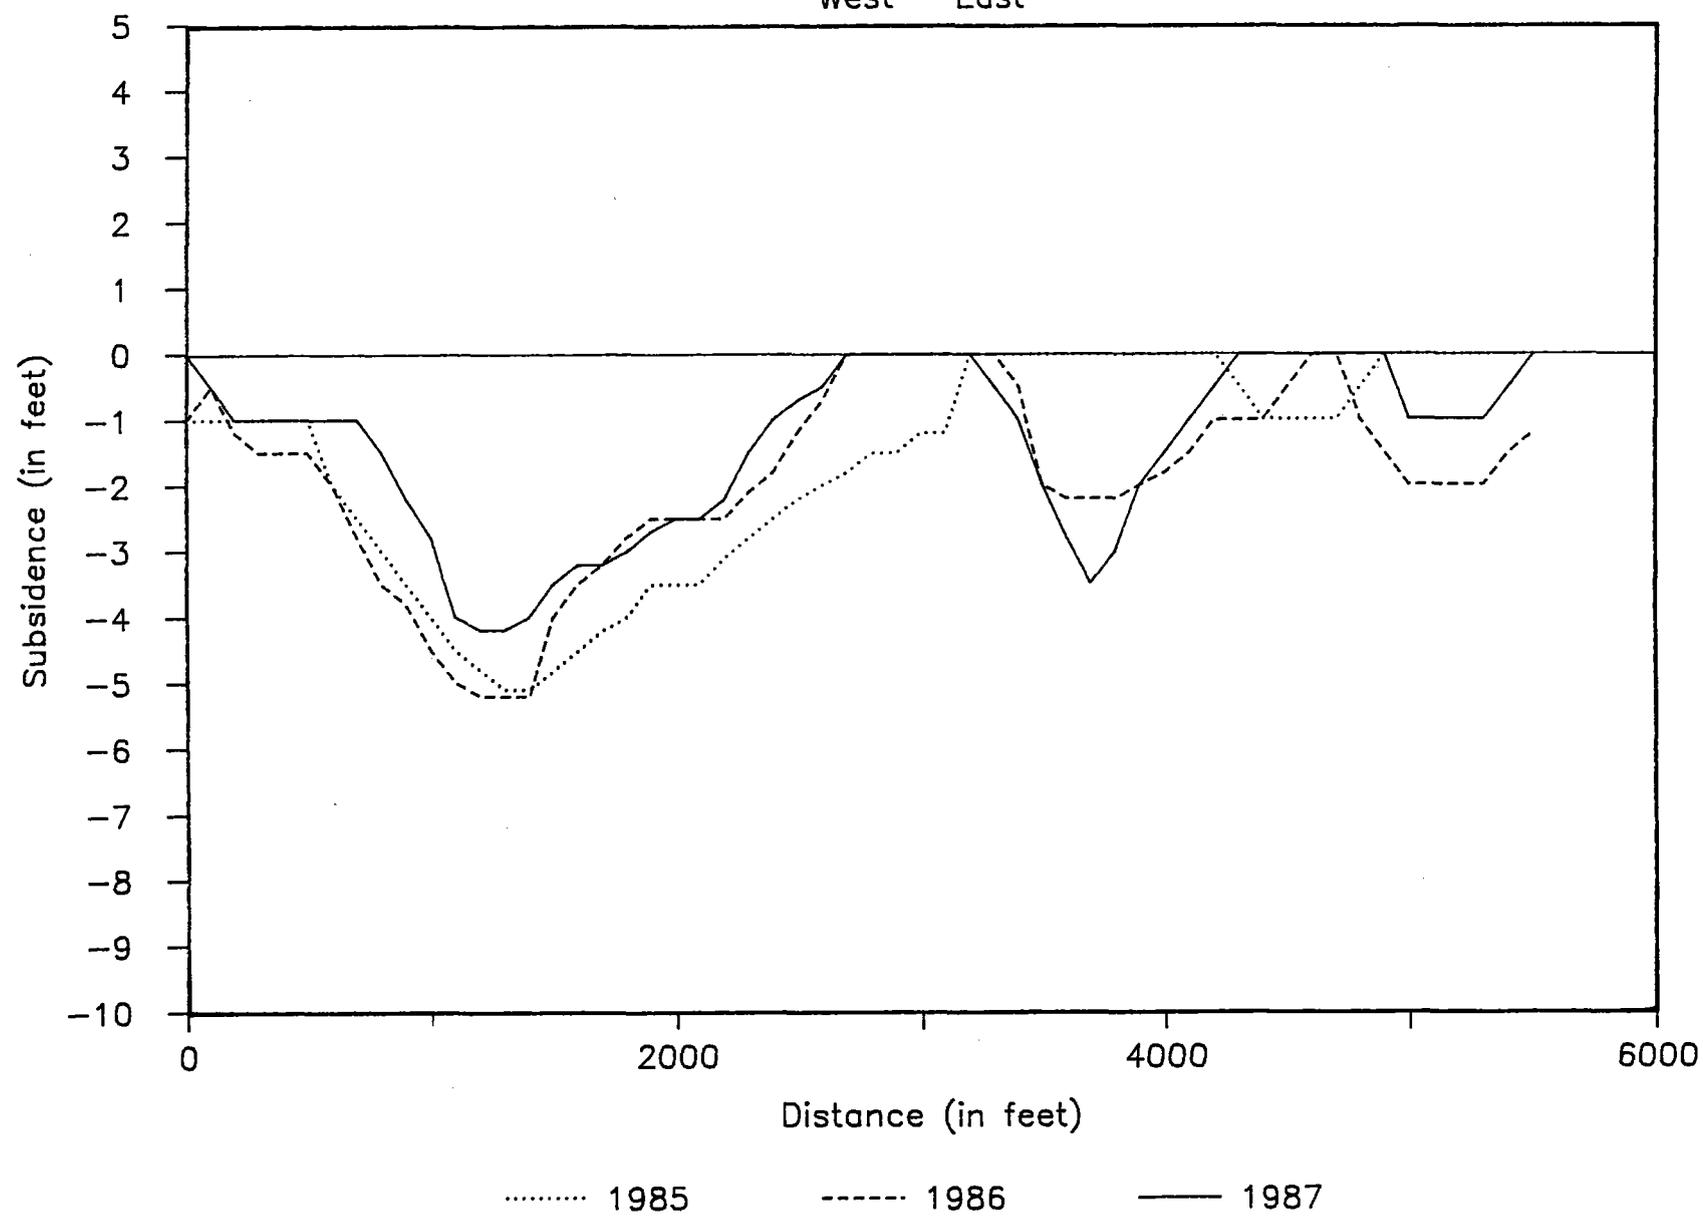
FIGURE 26

Some of the subsidence in Area 8 may have gone undetected because pillar extraction, and presumably subsidence, in part of the area was completed before the establishment of baseline survey data. The west to east subsidence profile of the area depicted in Figure 26 indicates it had reached a stable state, at near 4.5 feet of subsidence, by 1986. Annual monitoring will no longer be performed in the area but aerial photographs will continue to be taken and periodic checks will be made of the photos. The 1986 Subsidence Monitoring Report gives the most recent detailed discussion of ground movement in Area 8.
