UTAH POWER & LIGHT COMPANY
SUBSIDENCE MONITORING PROGRAM
ANNUAL REPORT FOR 1987

June 1988

UTAH POWER & LIGHT COMPANY
SUBSIDENCE MONITORING PROGRAM
ANNUAL REPORT FOR 1988

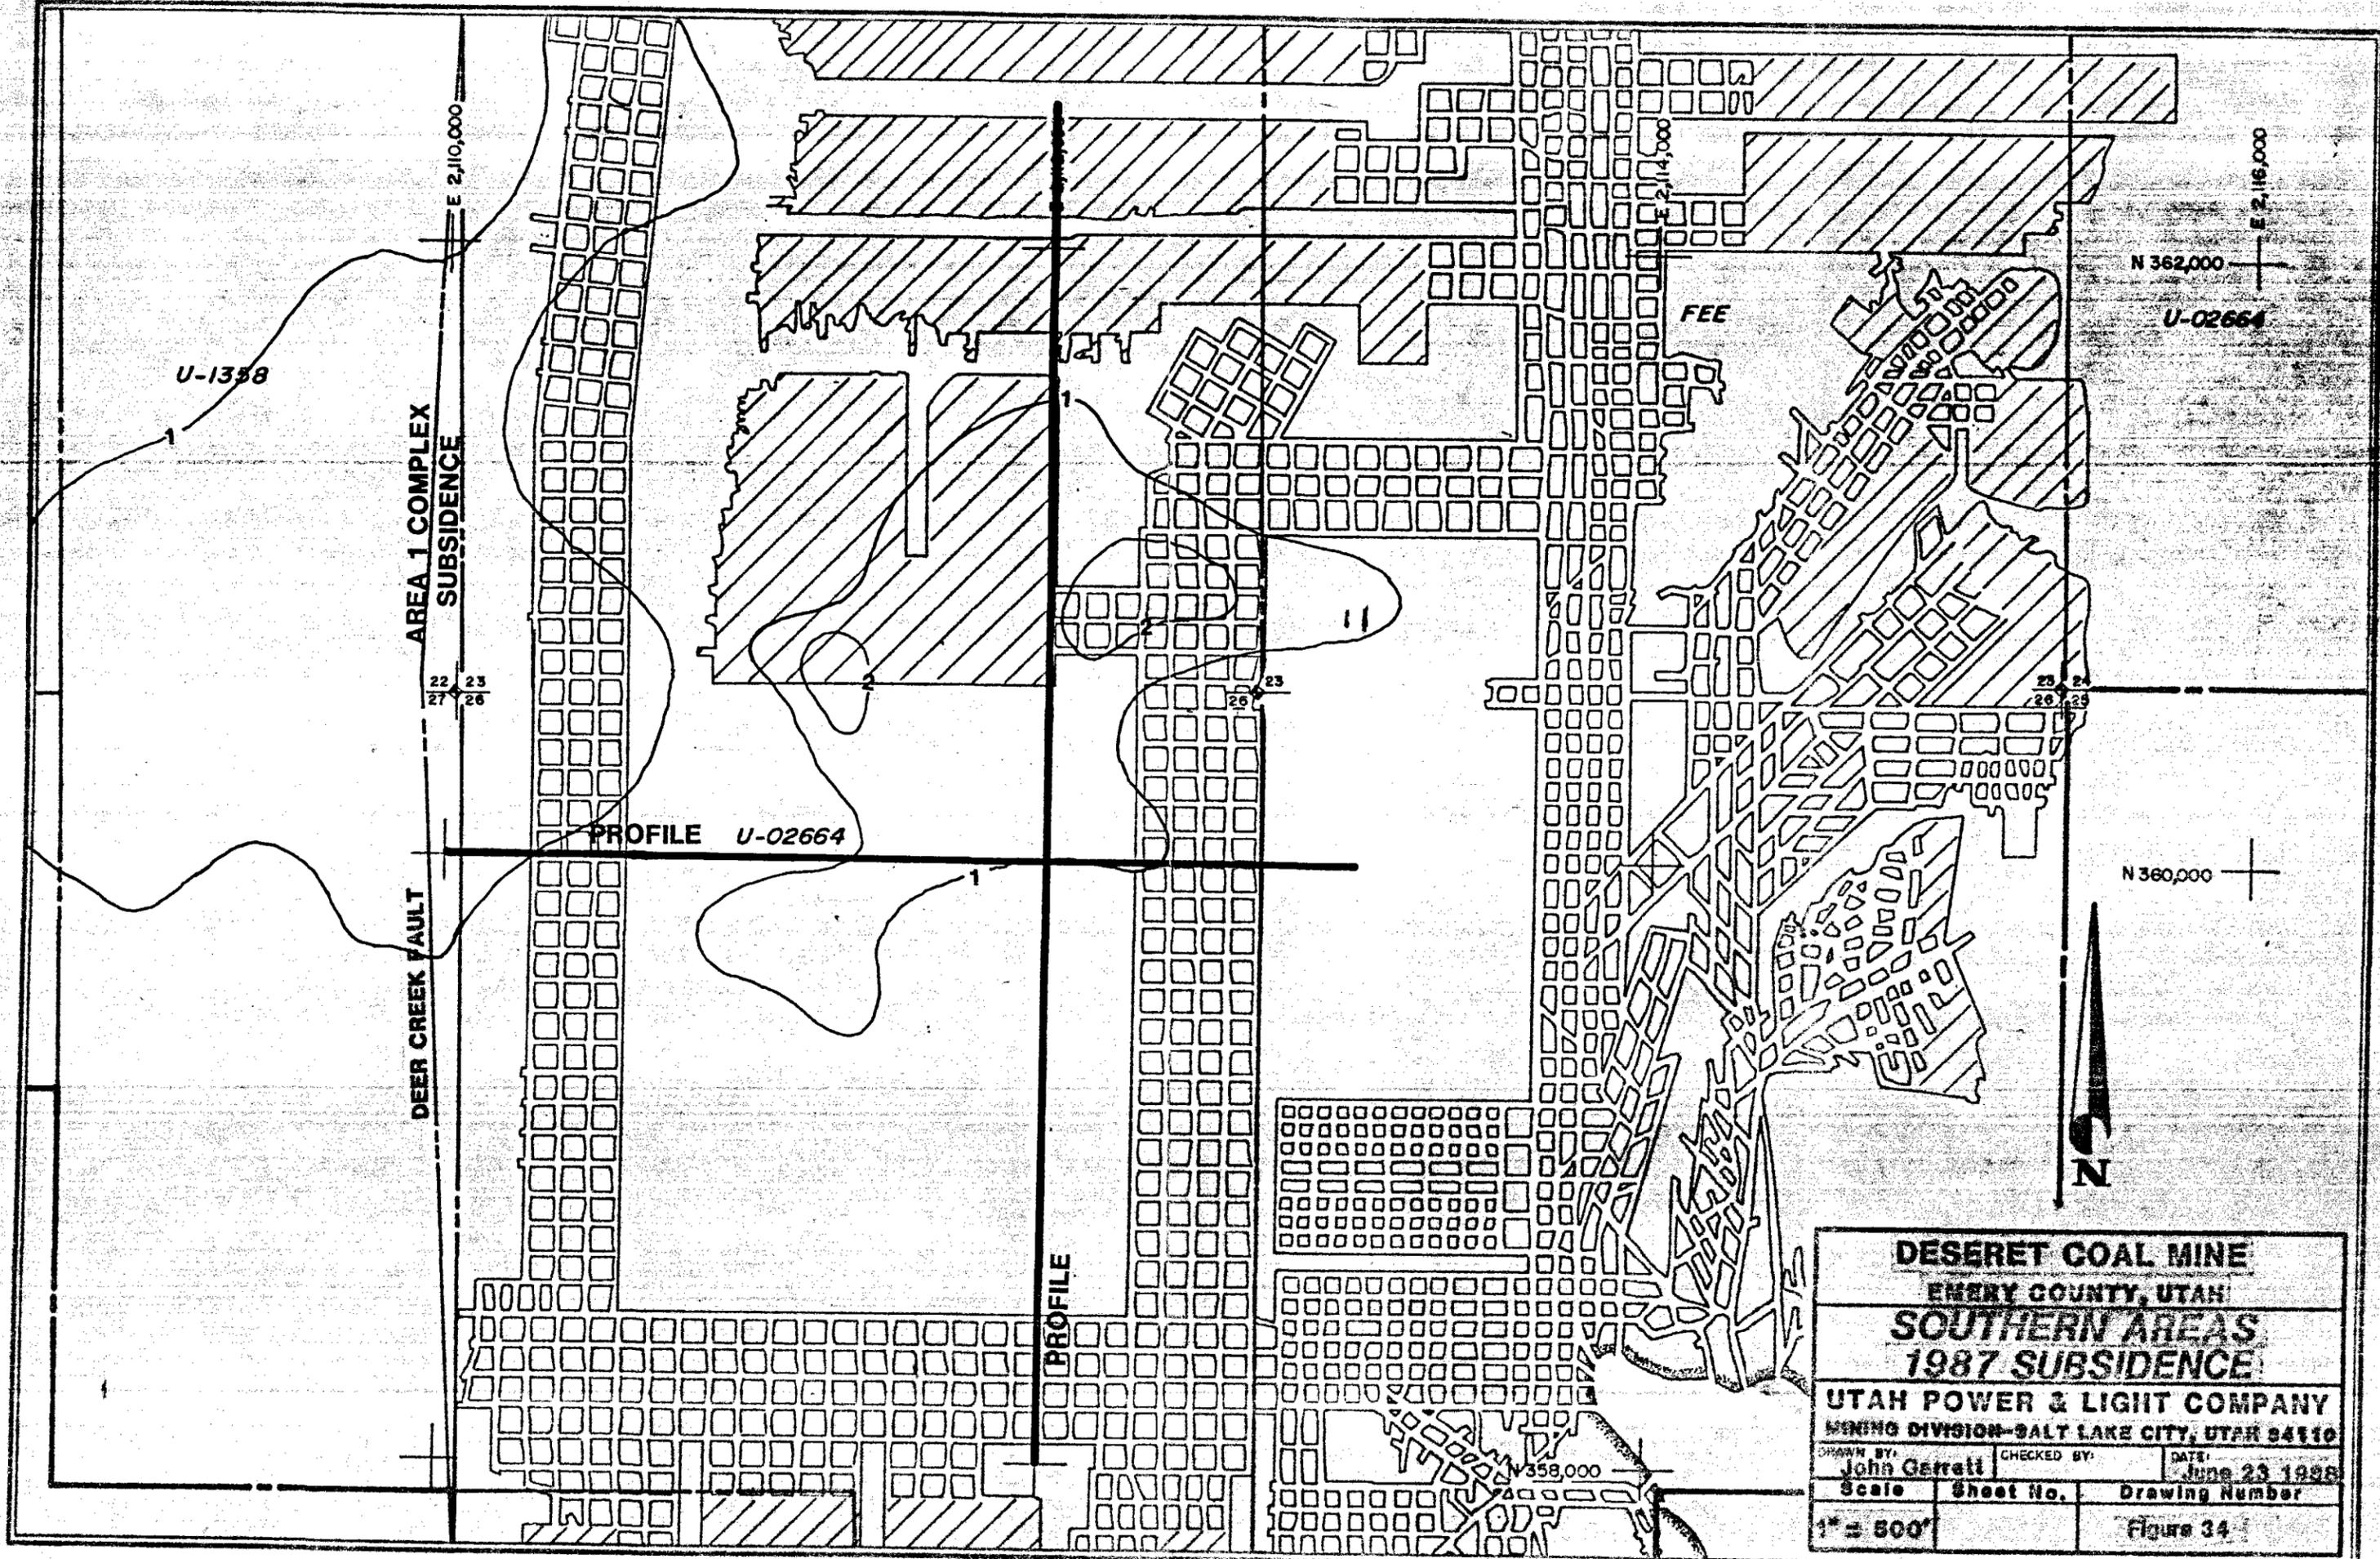
DESERET COAL MINE		
EMERY COUNTY, UTAH		
SOUTHERN AREAS		
1987 SUBSIDENCE		
UTAH POWER & LIGHT COMPANY		
MINING DIVISION-SALT LAKE CITY, UTAH 84110		
DRAWN BY: John Garrett	CHECKED BY:	DATE: June 23 1988
Scale	Sheet No.	Drawing Number
1" = 500'		Figure 34

To date the maximum observed subsidence over 1st North is a little under two (2) feet, occurring over some of the most recently extracted pillars (Figures 32 and 34, Area 13). The northern portions of the 1st North workings and subsidence are included in Area 8, which appears to have stabilized.

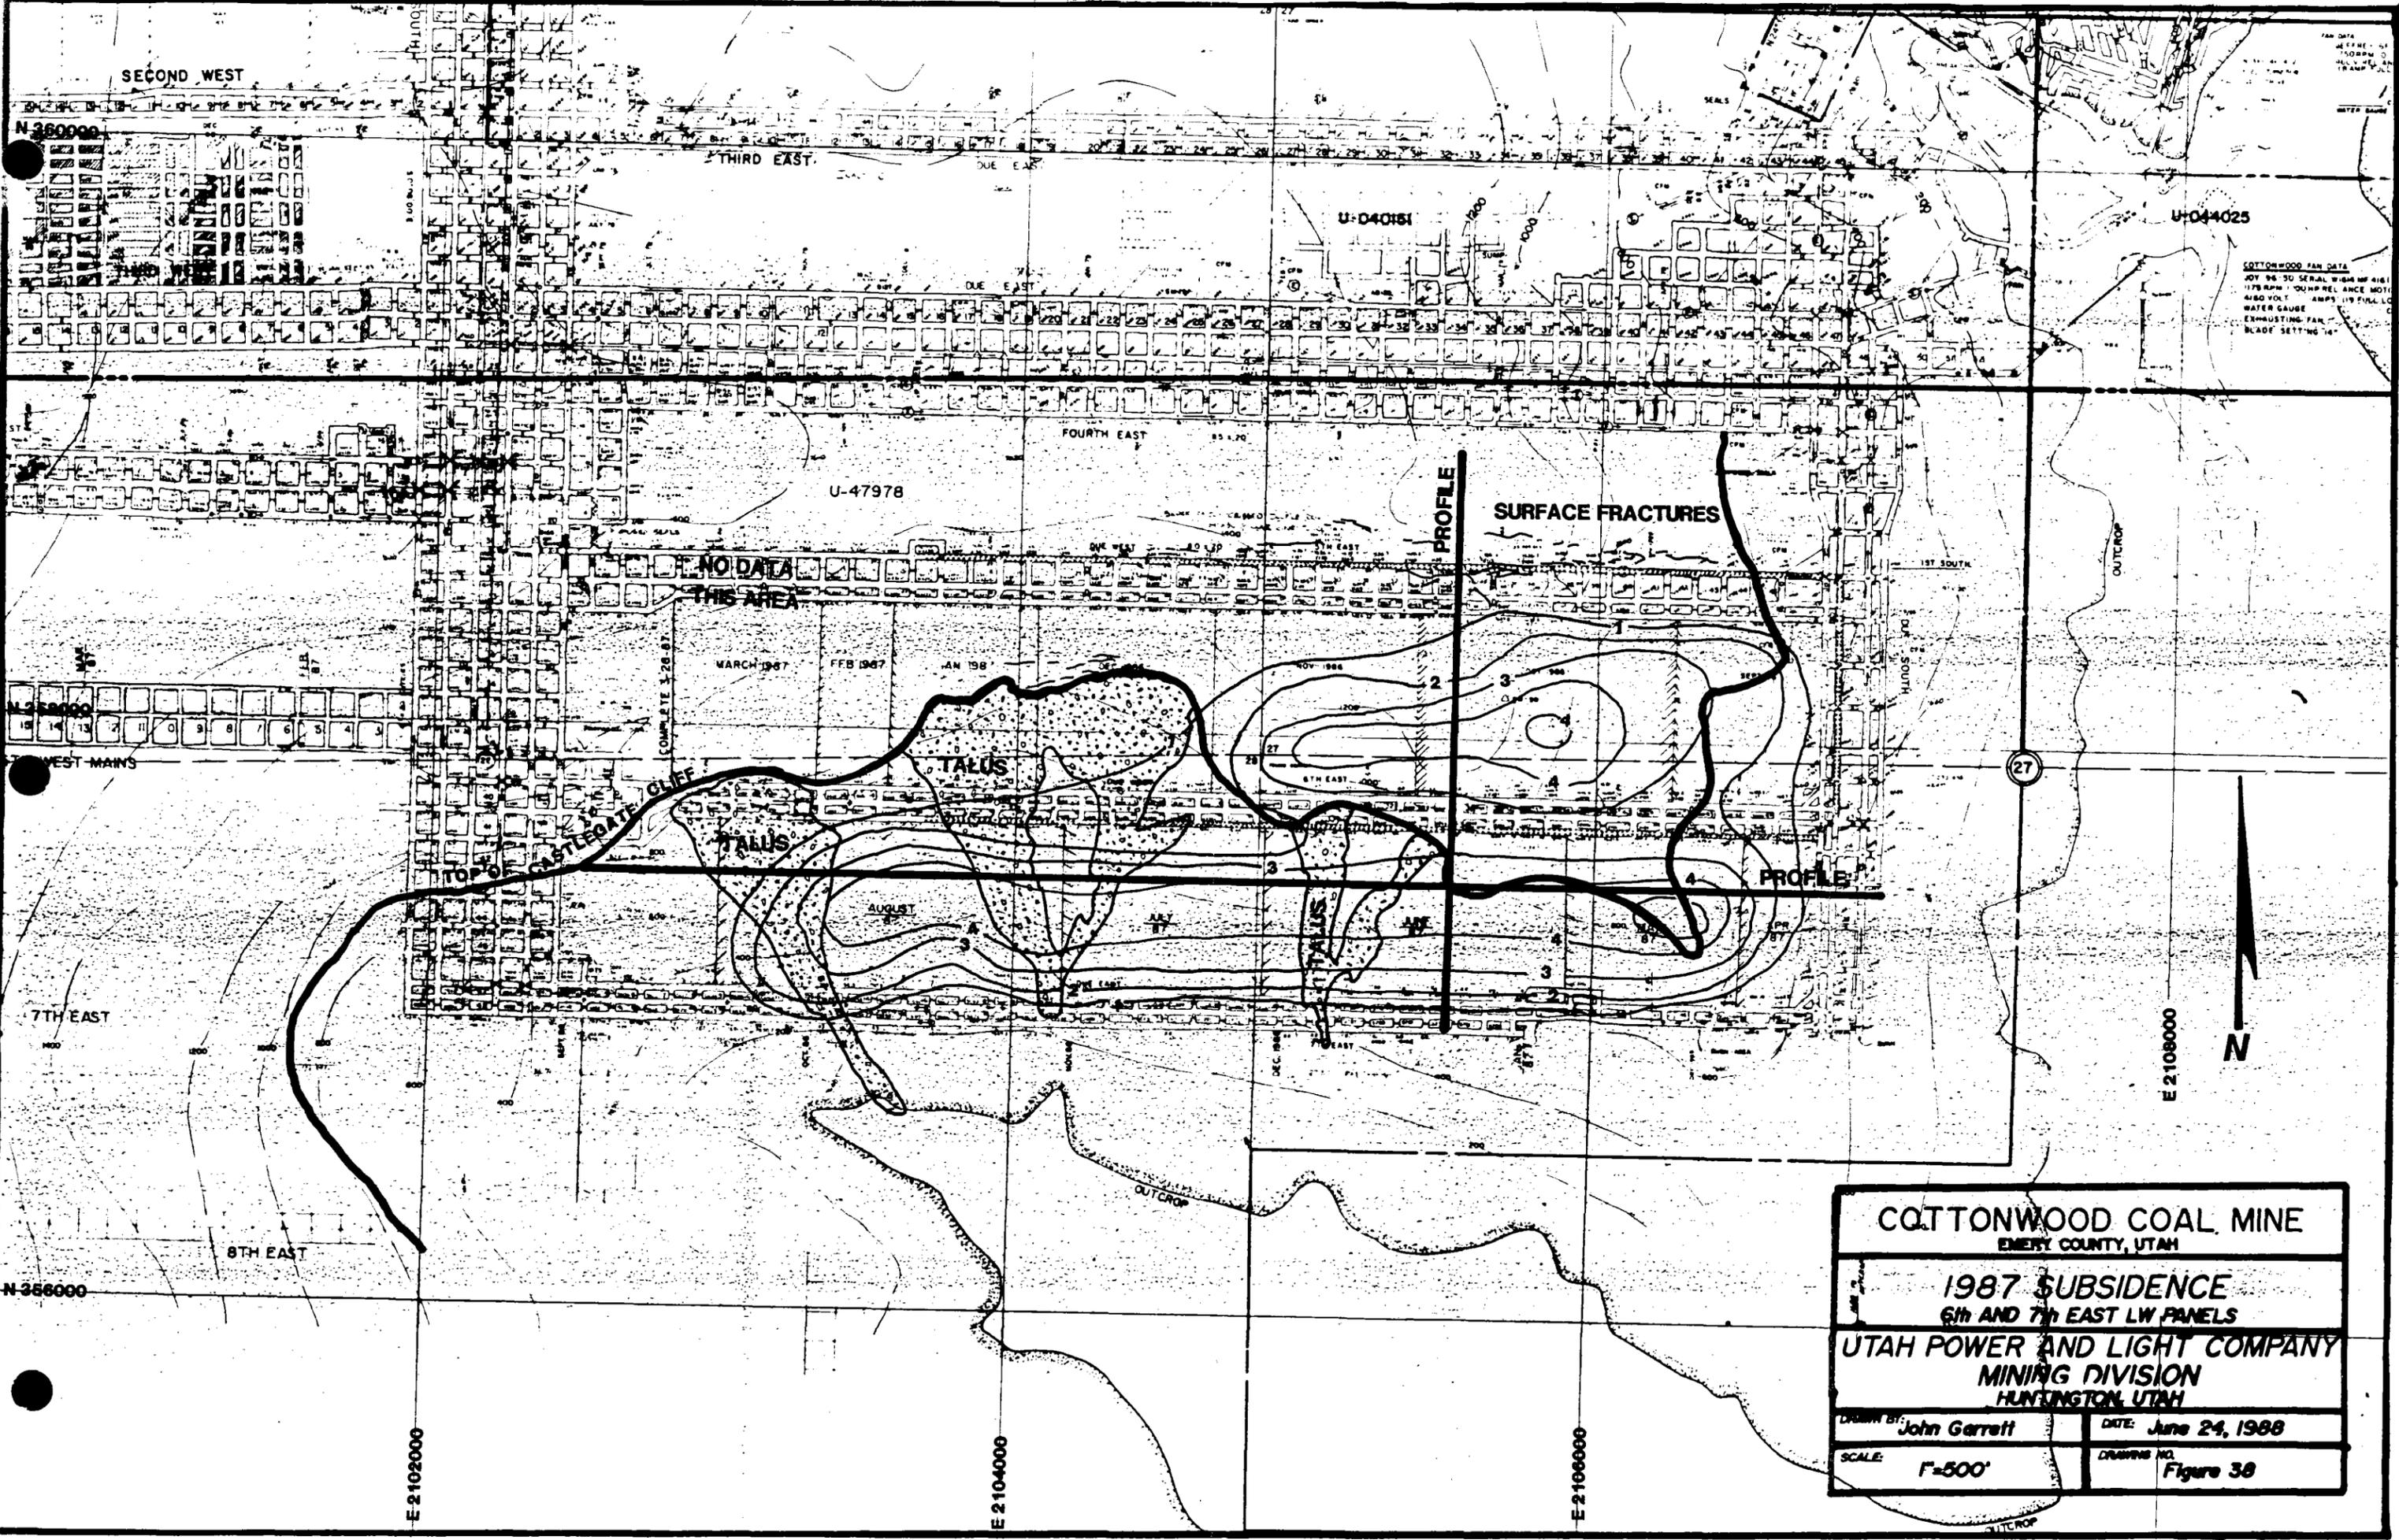
COTTONWOOD COAL MINE EMERY COUNTY, UTAH	
1987 SUBSIDENCE 6th and 7th East LW Panels	
UTAH POWER AND LIGHT COMPANY MINING DIVISION HUNTINGTON, UTAH	
Drawn By: John Garrett	Date: June 24, 1988
Scale: F=500'	Drawing No. Figure 38

The Castlegate Sandstone forms a 200 foot high escarpment along the north side of Newberry Canyon with numerous naturally occurring joints and fractures. Stress caused by removal of coal was transferred to the fractures resulting in brittle failure of the cliff face (spalling) in some places. Talus from the spalling has accumulated on the steep slopes below the cliffs on older natural talus slopes. The newer debris remains mostly above the coal outcrop level and reaches the canyon floor in only one location (Figure 38). Surface cracks have been observed and mapped along the ridge above the cliff. The cracks are discontinuous and extend for approximately 2000 feet parallel to the northern edge of the 6th East longwall panel. A few cracks are also found directly on top of the Castlegate Sandstone escarpment.

Maximum subsidence to date is 5.7 feet, occurring over the eastern end of the 7th East panel. Elevation data was unavailable for a small area above the northwestern part of the 6th East panel, though it appears that little subsidence has taken place there yet.

The major impacts associated with subsidence and resulting cliff failure, surface cracking, and talus deposition in Area 14 are 1) possible loss of golden eagle nests and/or nest sites, 2) disruption of grazing and hunting land use, and 3) loss of wildlife habitat.

Mitigation of effects due to mining may be required in Area 14. A detailed assessment is given in the Newberry Canyon report. Briefly, mitigation may include 1) backfilling, recontouring, and revegetating surface cracks, where accessible; 2) creating artificial eagle nesting sites; and 3) improvement of habitat for existing species or developing habitat for another desirable species.

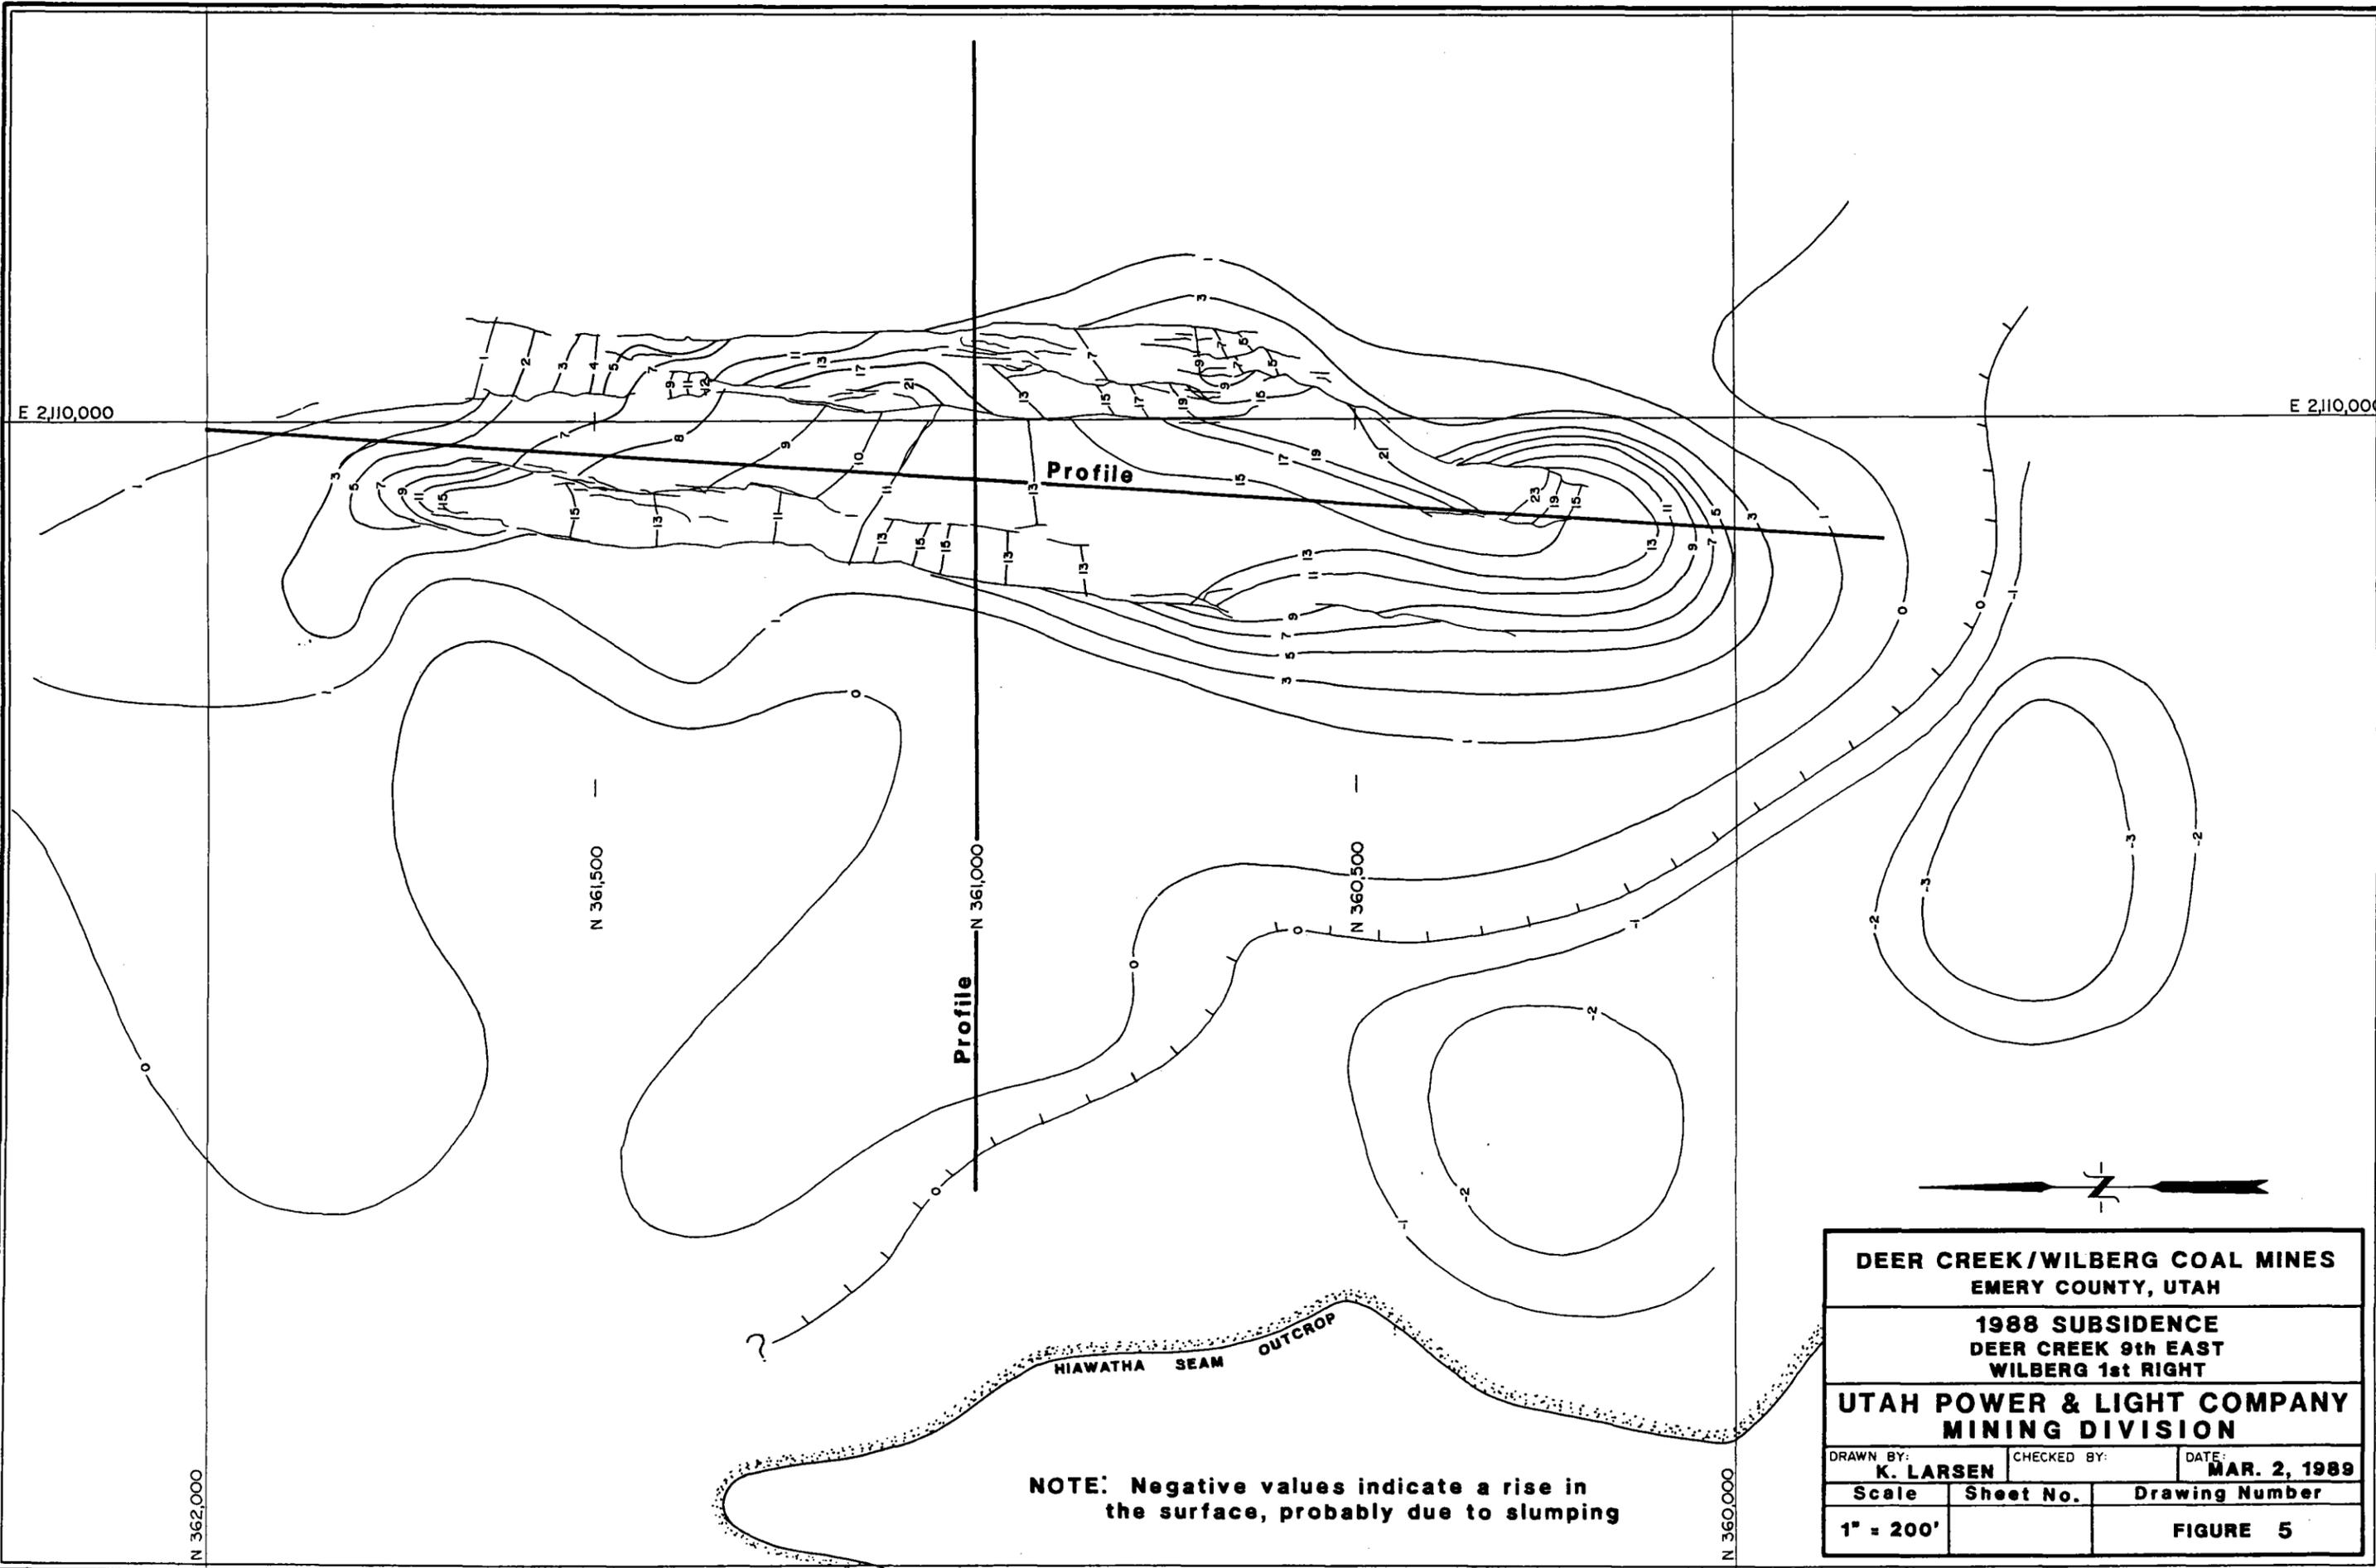
DEER CREEK/WILBERG COAL MINES		
EMERY COUNTY, UTAH		
1988 SUBSIDENCE		
DEER CREEK 9th EAST		
WILBERG 1st RIGHT		
UTAH POWER & LIGHT COMPANY		
MINING DIVISION		
DRAWN BY: K. LARSEN	CHECKED BY:	DATE: MAR. 2, 1989
Scale 1" = 200'	Sheet No.	Drawing Number FIGURE 5

Subsidence in Area 1 was first documented in the 1981 Subsidence Monitoring Report submitted in 1982. The relationship of the subsidence to the underlying Deer Creek and Wilberg mine workings is shown in Figures 3, 4, and 5. Each map covers the same area, Figure 5 being a contour map of subsidence on the surface over the mine workings depicted in the other two figures. The most recent mining in this area occurred in the Wilberg 1st Right section in June 1984.

Figures 6 and 7 are north to south and west to east profiles showing the amount of subsidence in this area during the past seven years. The location of each line is shown on Figure 5. The area has seen little change since 1985. Maximum subsidence remains at about twenty-five (25) feet. A detailed look from a helicopter revealed that the subsidence maximum is located on a steep slope, about 200 feet south of the southernmost mining, where a good-sized rotational slump has occurred. The workings here are also surrounded by burned coal. It is probable that the combination of steep slopes and crushing of clinker beds has allowed subsidence to occur well outside the area of mine workings. An inspection of the area from the ground indicates that many of the open fractures forming the graben-like structure have begun to heal and fill in with soil.

In a few areas, such as Areas 1, 3, 7, 10, and 14, surface fractures have been detected. In order to protect livestock, UP&L has erected a fence around Area 1 where fractures are of sufficient magnitude to pose a threat to wandering cattle. In Area 14, where cracks have also been observed, the U.S. Forest Service has determined that no fencing or other measures are needed unless "significant change" occurs in the area. The agency has recommended that no reclamation be undertaken in Areas 1 or 14 at this time; UP&L will reclaim the areas when and if it is deemed necessary.

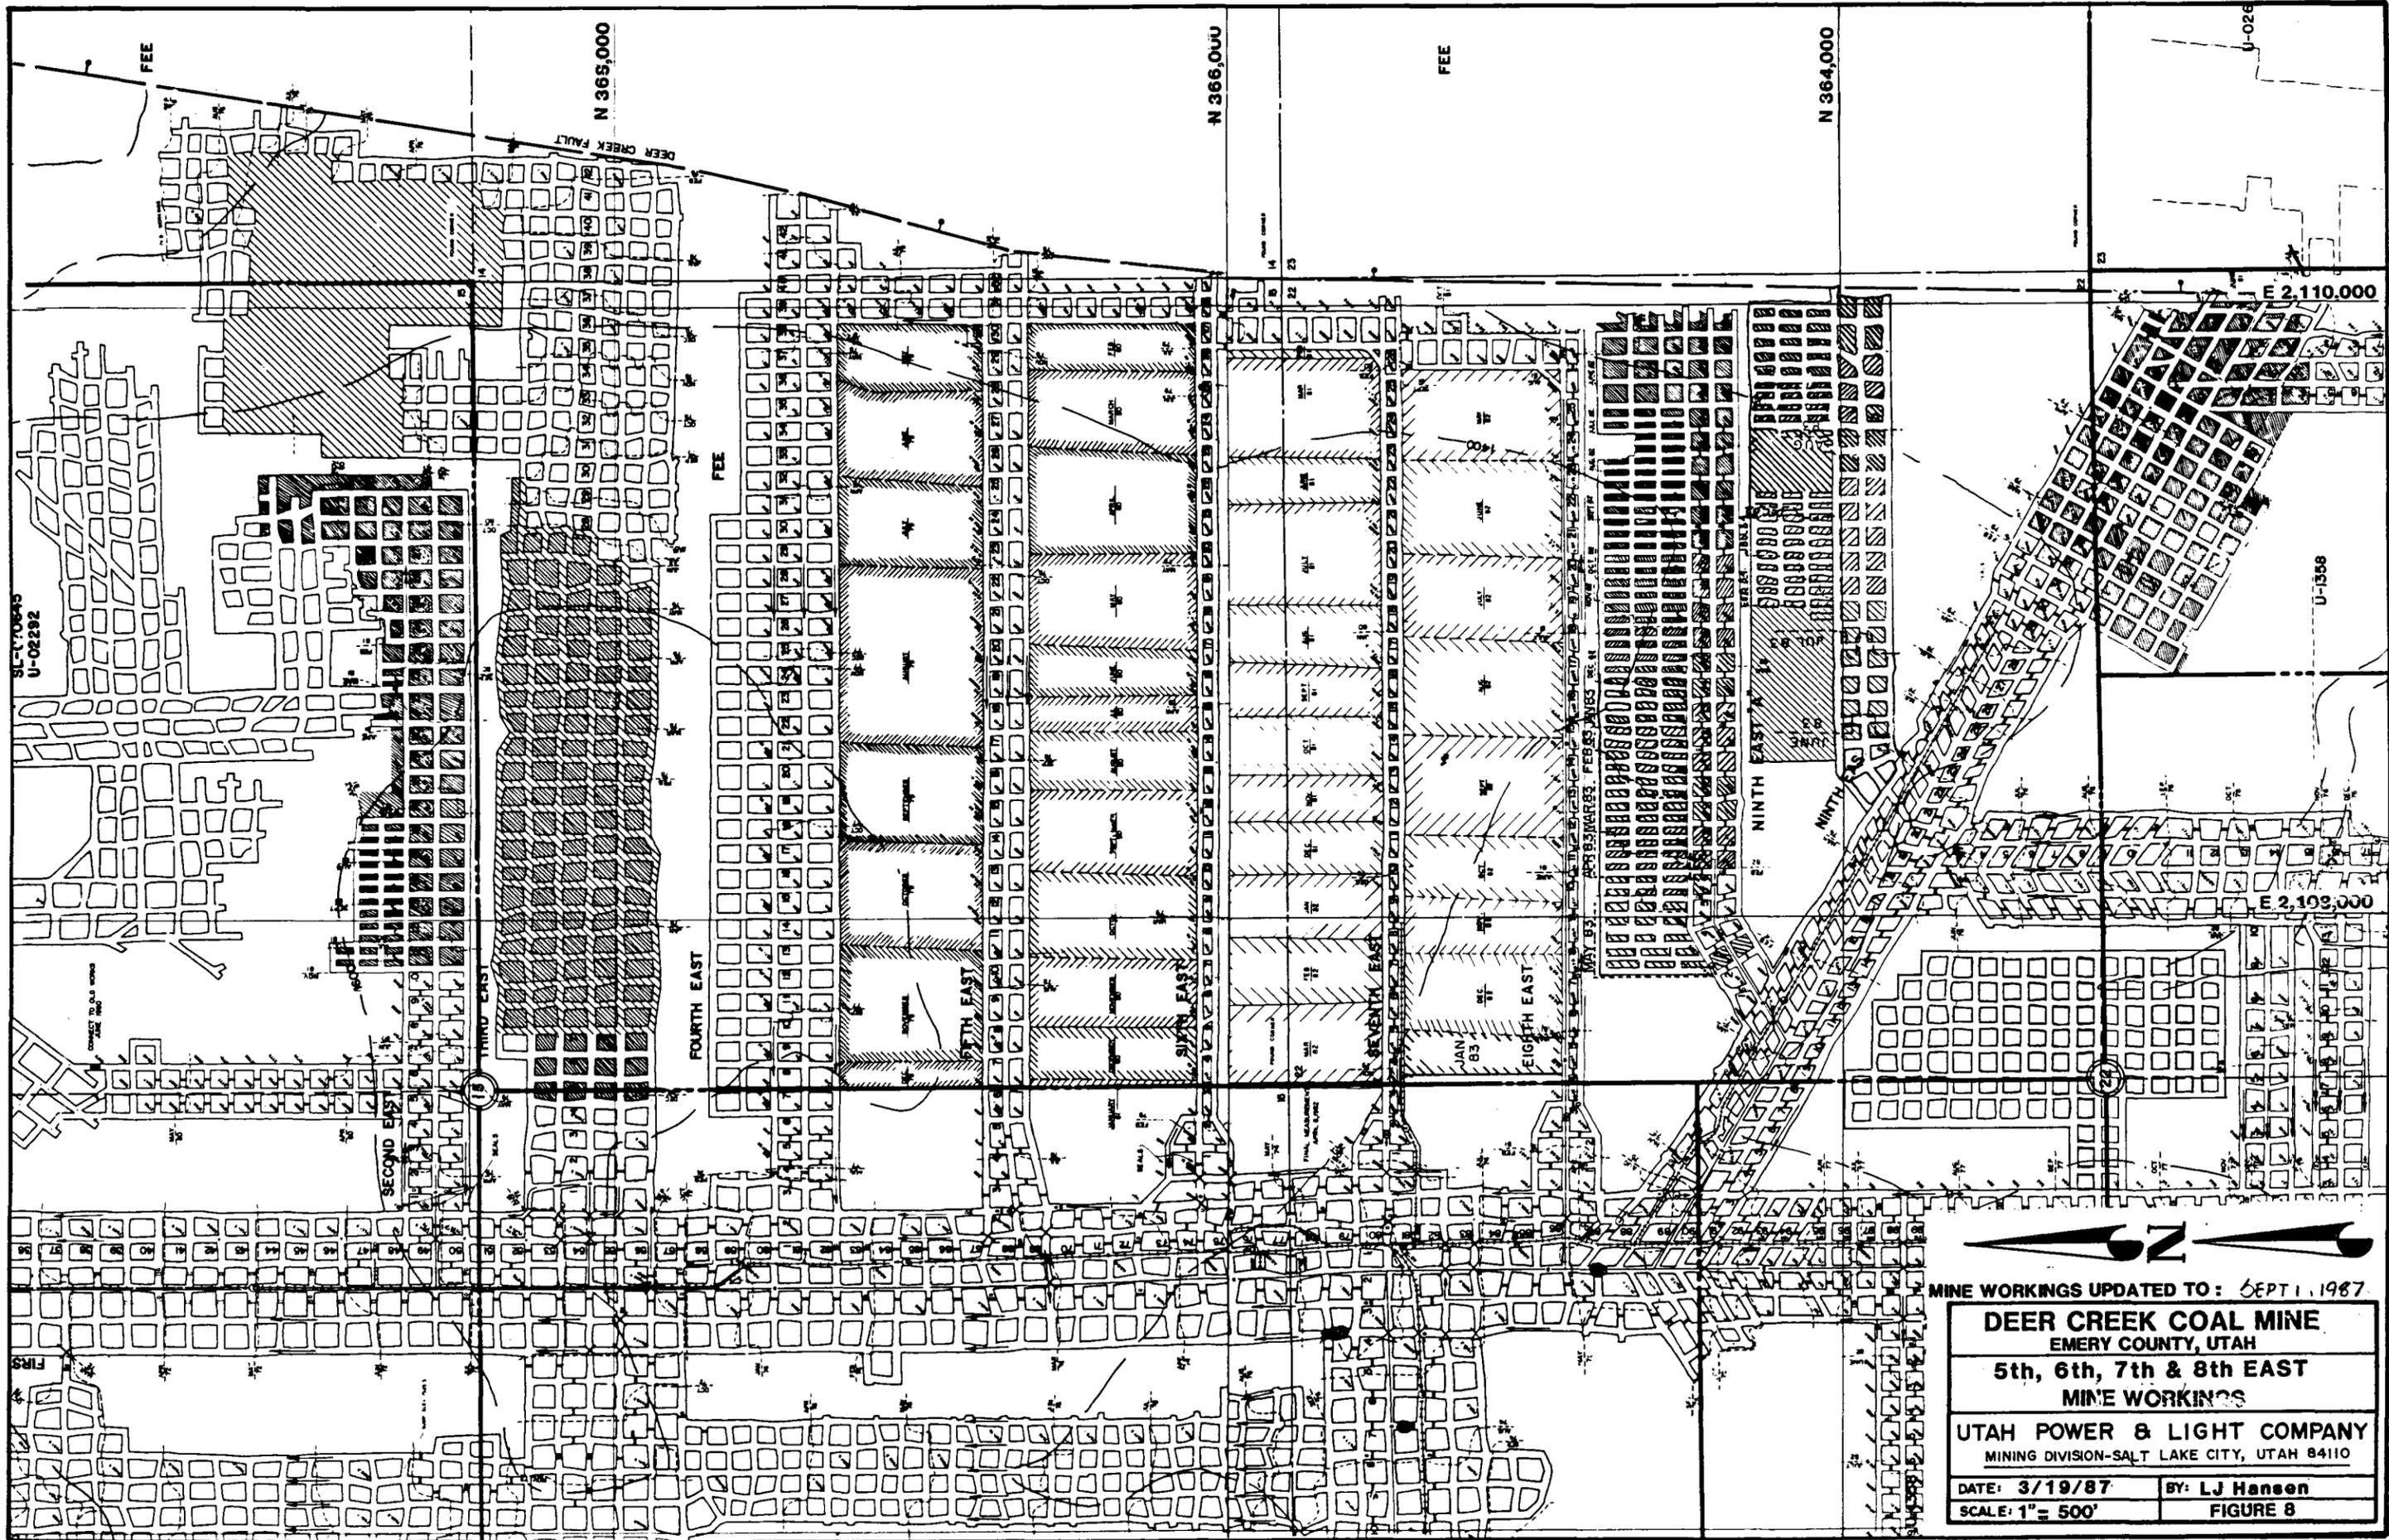
DATE: 3/19/87	BY: LJ Hansen
SCALE: 1" = 500'	FIGURE 8

Mining in the Deer Creek Mine in Area 2 was completed by February 1985. Coal extraction in the underlying Wilberg Mine 3rd and 4th Right panels was completed between September 1987 and the end of January 1988 (Figures 8 and 9).

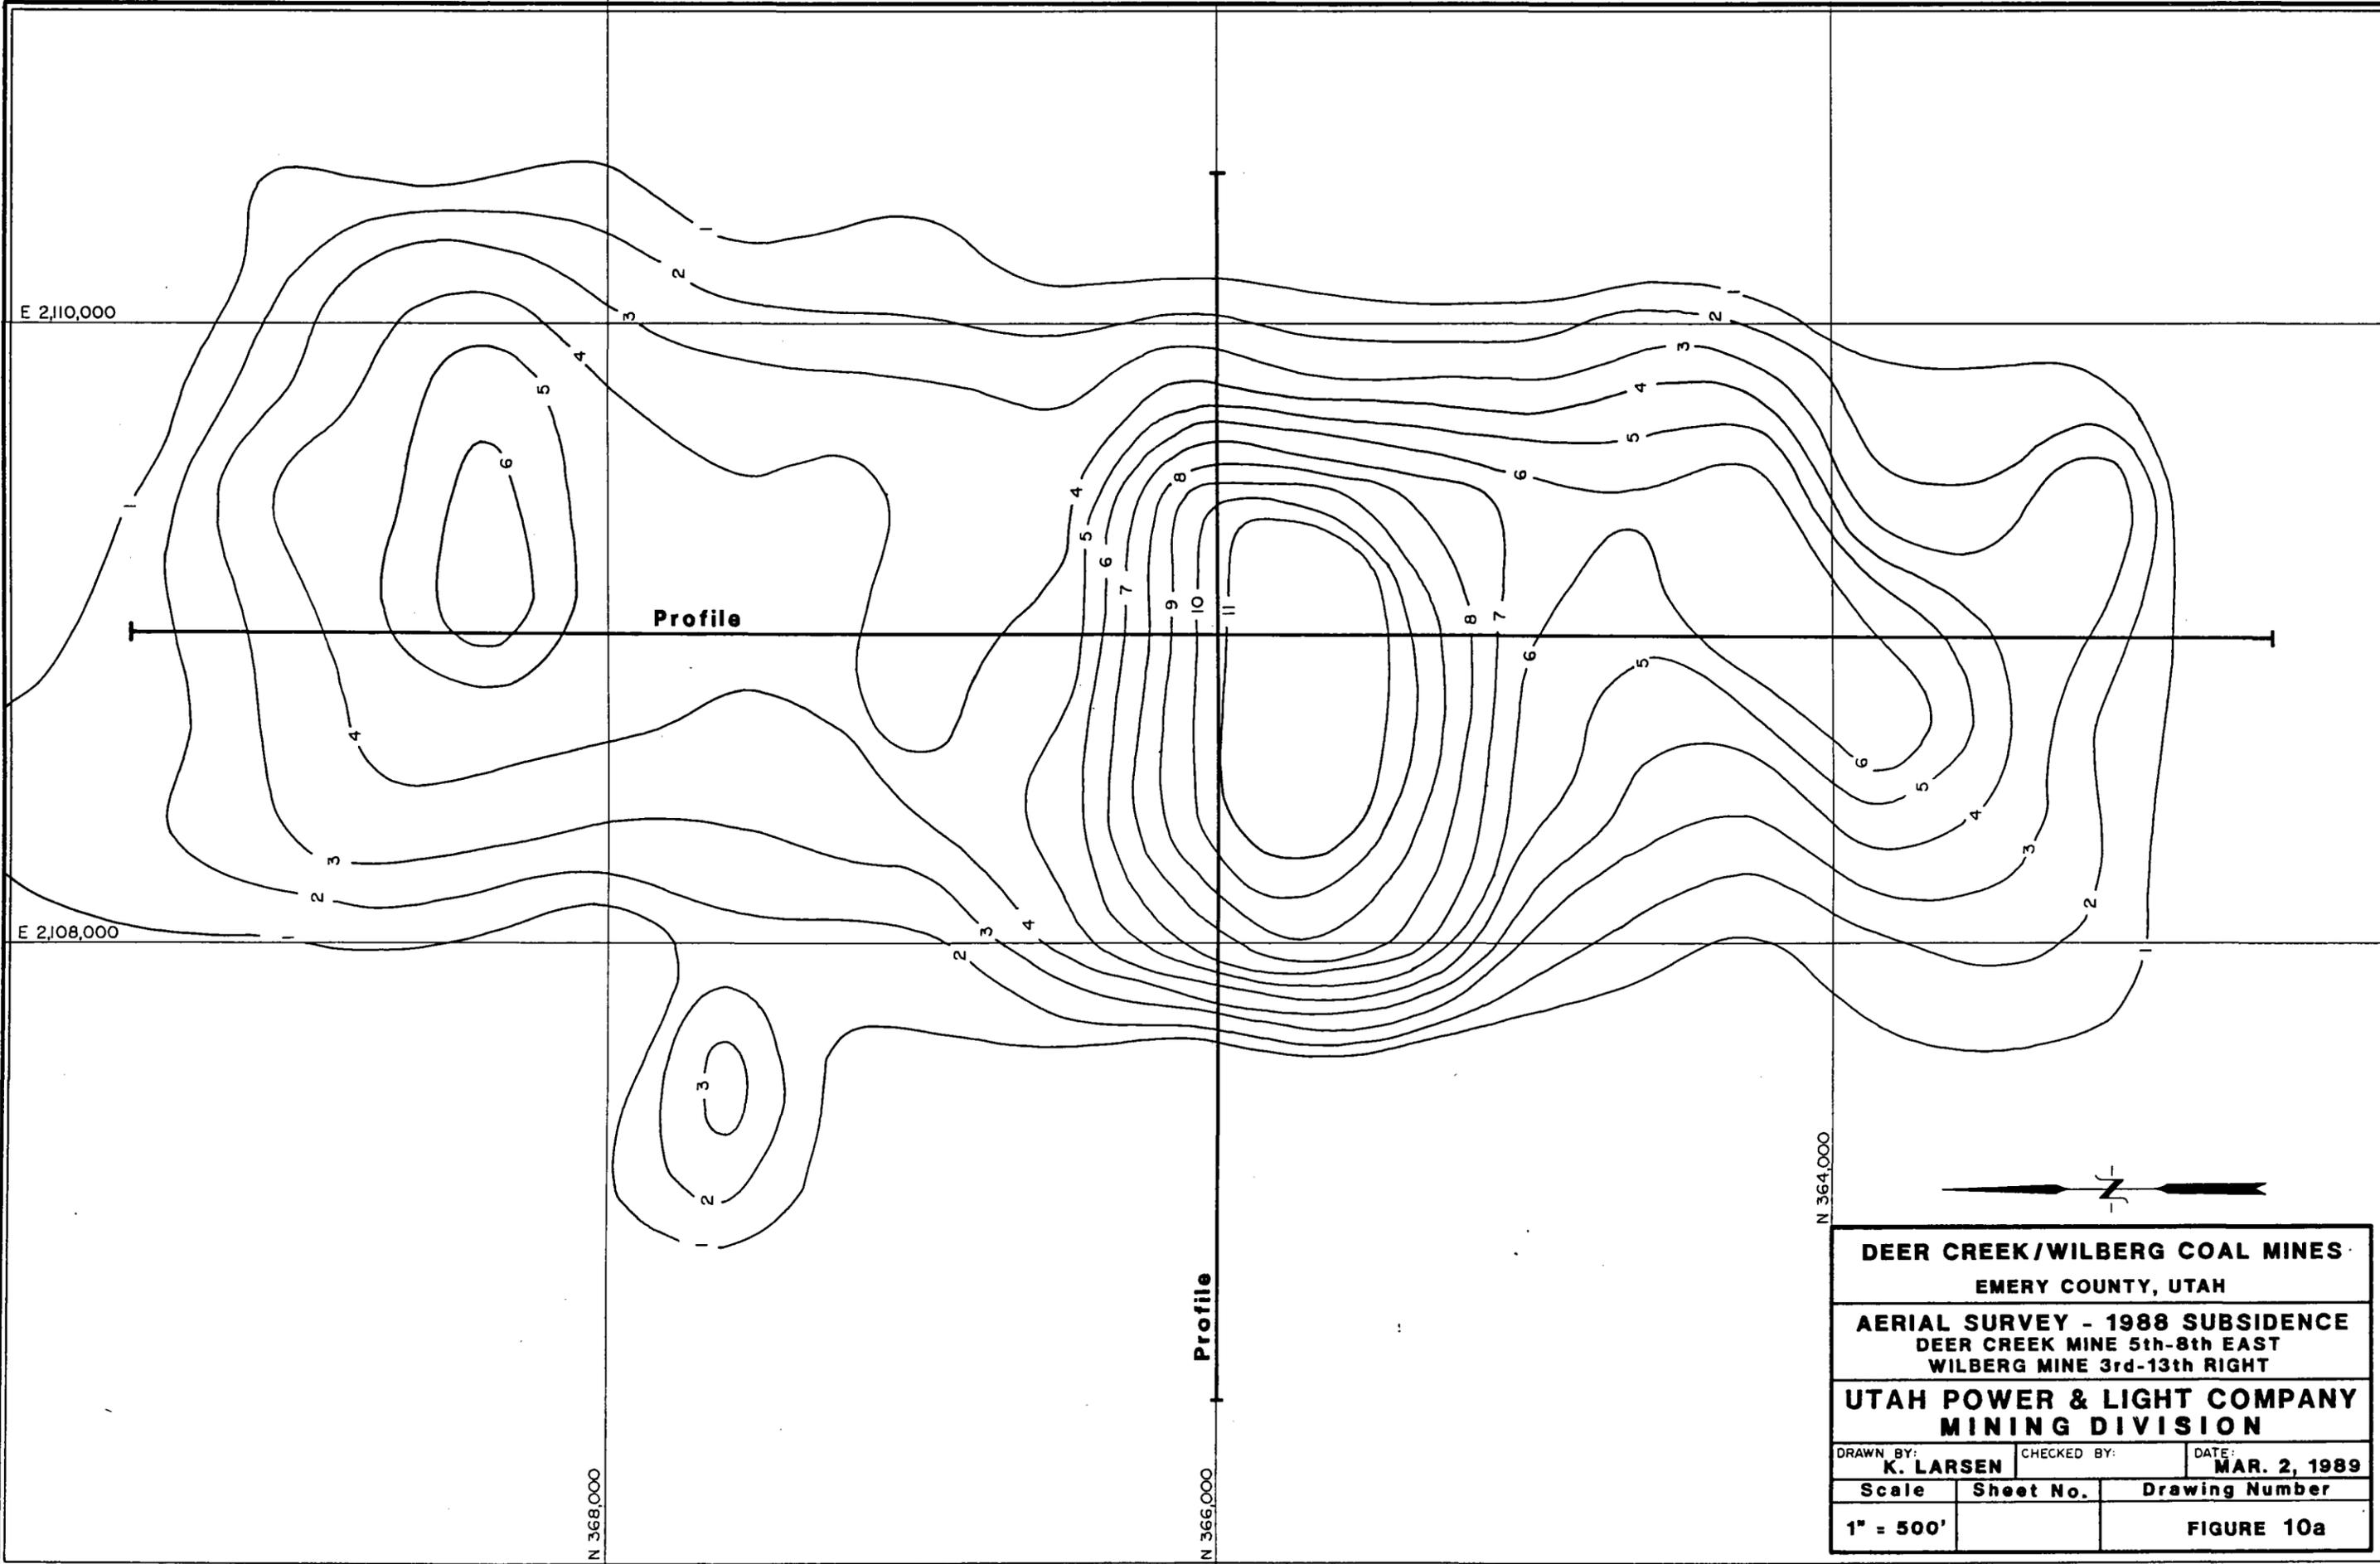
DEER CREEK/WILBERG COAL MINES		
EMERY COUNTY, UTAH		
AERIAL SURVEY - 1988 SUBSIDENCE		
DEER CREEK MINE 5th-8th EAST		
WILBERG MINE 3rd-13th RIGHT		
UTAH POWER & LIGHT COMPANY		
MINING DIVISION		
DRAWN BY: K. LARSEN	CHECKED BY:	DATE: MAR. 2, 1989
Scale	Sheet No.	Drawing Number
1" = 500'		FIGURE 10a

In 1988 the area was surveyed by both photogrammetric methods and conventional on-the-ground methods. As usual the two methods show very close correlation but the photogrammetry gives more detail due to tighter grid spacing of the measurement points. UP&L has received permission to stop conventional surveying and use photogrammetry only. Maximum subsidence in Area 2 remains at just under twelve (12) feet and occurs over the Deer Creek 6th East and the Wilberg 6th and 7th Right longwall panels (Figure 10). The subsidence profiles (Figures 11 and 12) indicate that ground movement over much of the area has stabilized, but the subsidence trough continues to elongate over the most recently mined panels. Neither UP&L nor other contracted personnel have detected any surface fissures or other visible disturbance in the area.

Angle-of-draw has been calculated where possible. On the eastern side of Area 2 the angle is influenced by the Deer Creek Fault and the adjacent Little Dove Mine workings across the fault; it ranges from near vertical to 12 degrees. On other sides it ranges from less than zero to 36 degrees.
