UTAH POWER & LIGHT COMPANY
SUBSIDENCE MONITORING PROGRAM
ANNUAL REPORT FOR 1987

June 1988

UTAH POWER & LIGHT COMPANY
SUBSIDENCE MONITORING PROGRAM
ANNUAL REPORT FOR 1988

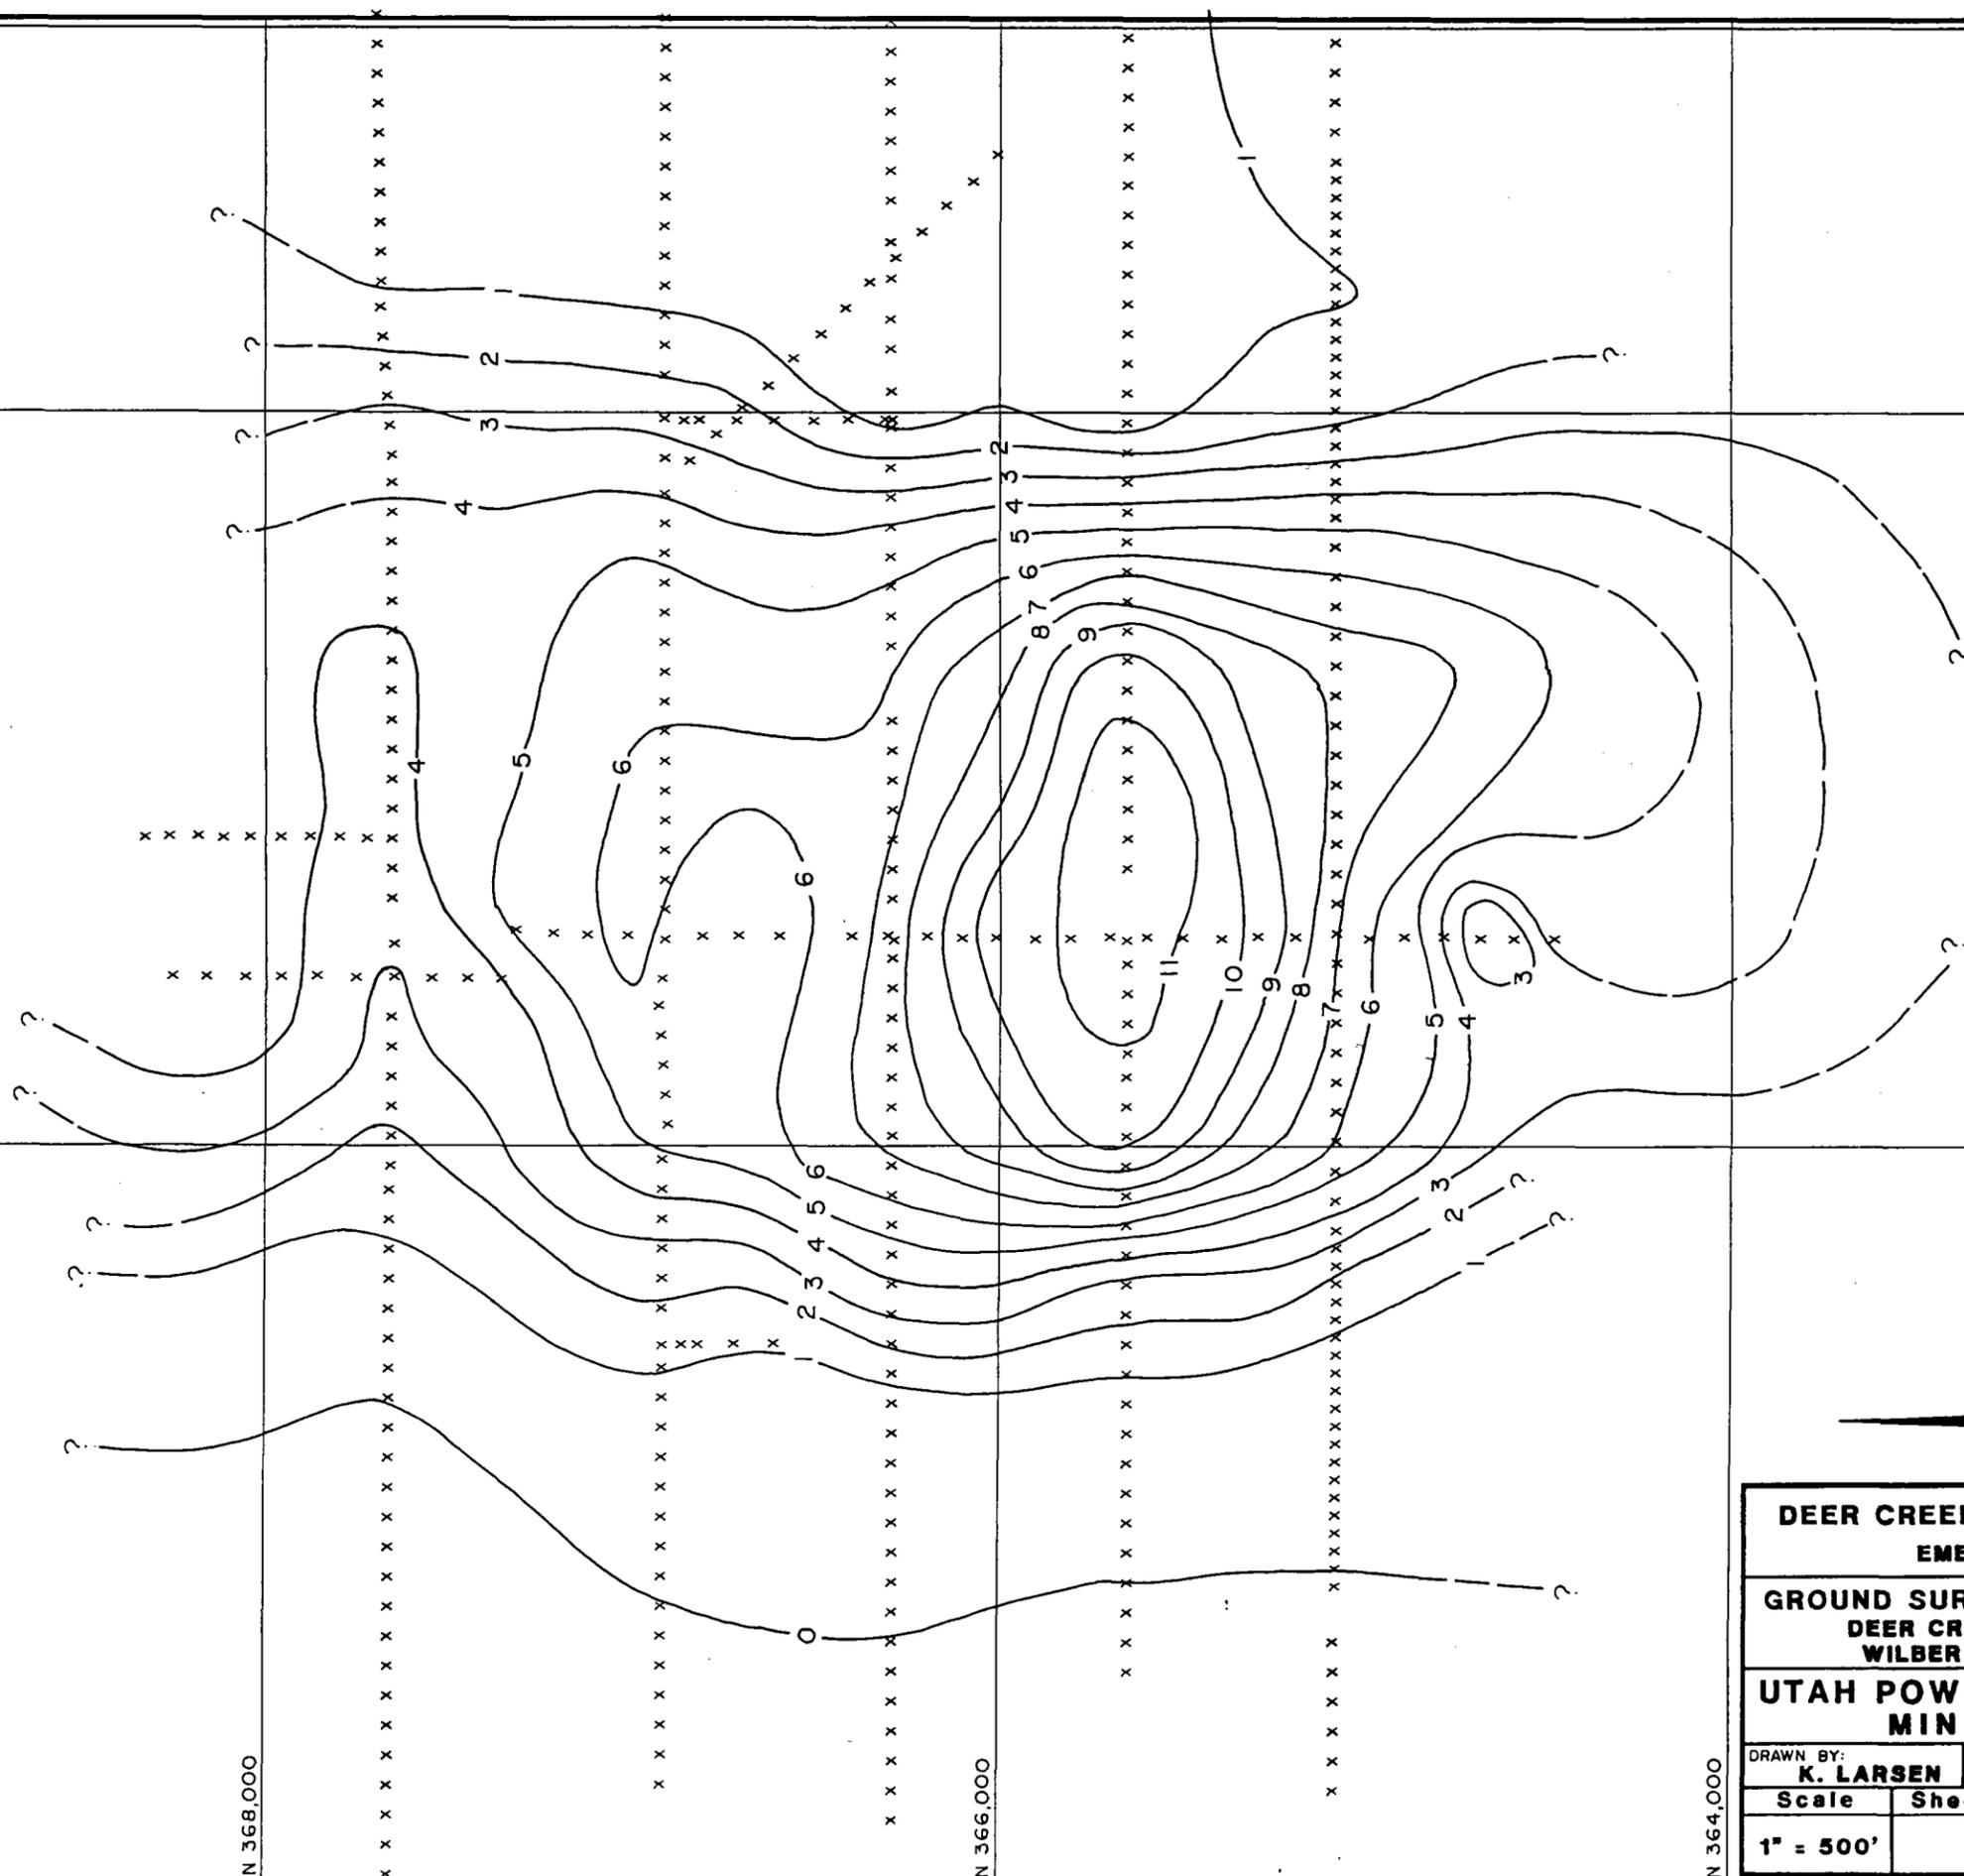
DEER CREEK/WILBERG COAL MINES		
EMERY COUNTY, UTAH		
GROUND SURVEY - 1988 SUBSIDENCE		
DEER CREEK MINE 5th-8th EAST		
WILBERG MINE 3rd-13th RIGHT		
UTAH POWER & LIGHT COMPANY		
MINING DIVISION		
DRAWN BY: K. LARSEN	CHECKED BY:	DATE: MAR. 2, 1989
Scale	Sheet No.	Drawing Number
1" = 500'		FIGURE 10b

In 1988 the area was surveyed by both photogrammetric methods and conventional on-the-ground methods. As usual the two methods show very close correlation but the photogrammetry gives more detail due to tighter grid spacing of the measurement points. UP&L has received permission to stop conventional surveying and use photogrammetry only. Maximum subsidence in Area 2 remains at just under twelve (12) feet and occurs over the Deer Creek 6th East and the Wilberg 6th and 7th Right longwall panels (Figure 10). The subsidence profiles (Figures 11 and 12) indicate that ground movement over much of the area has stabilized, but the subsidence trough continues to elongate over the most recently mined panels. Neither UP&L nor other contracted personnel have detected any surface fissures or other visible disturbance in the area.

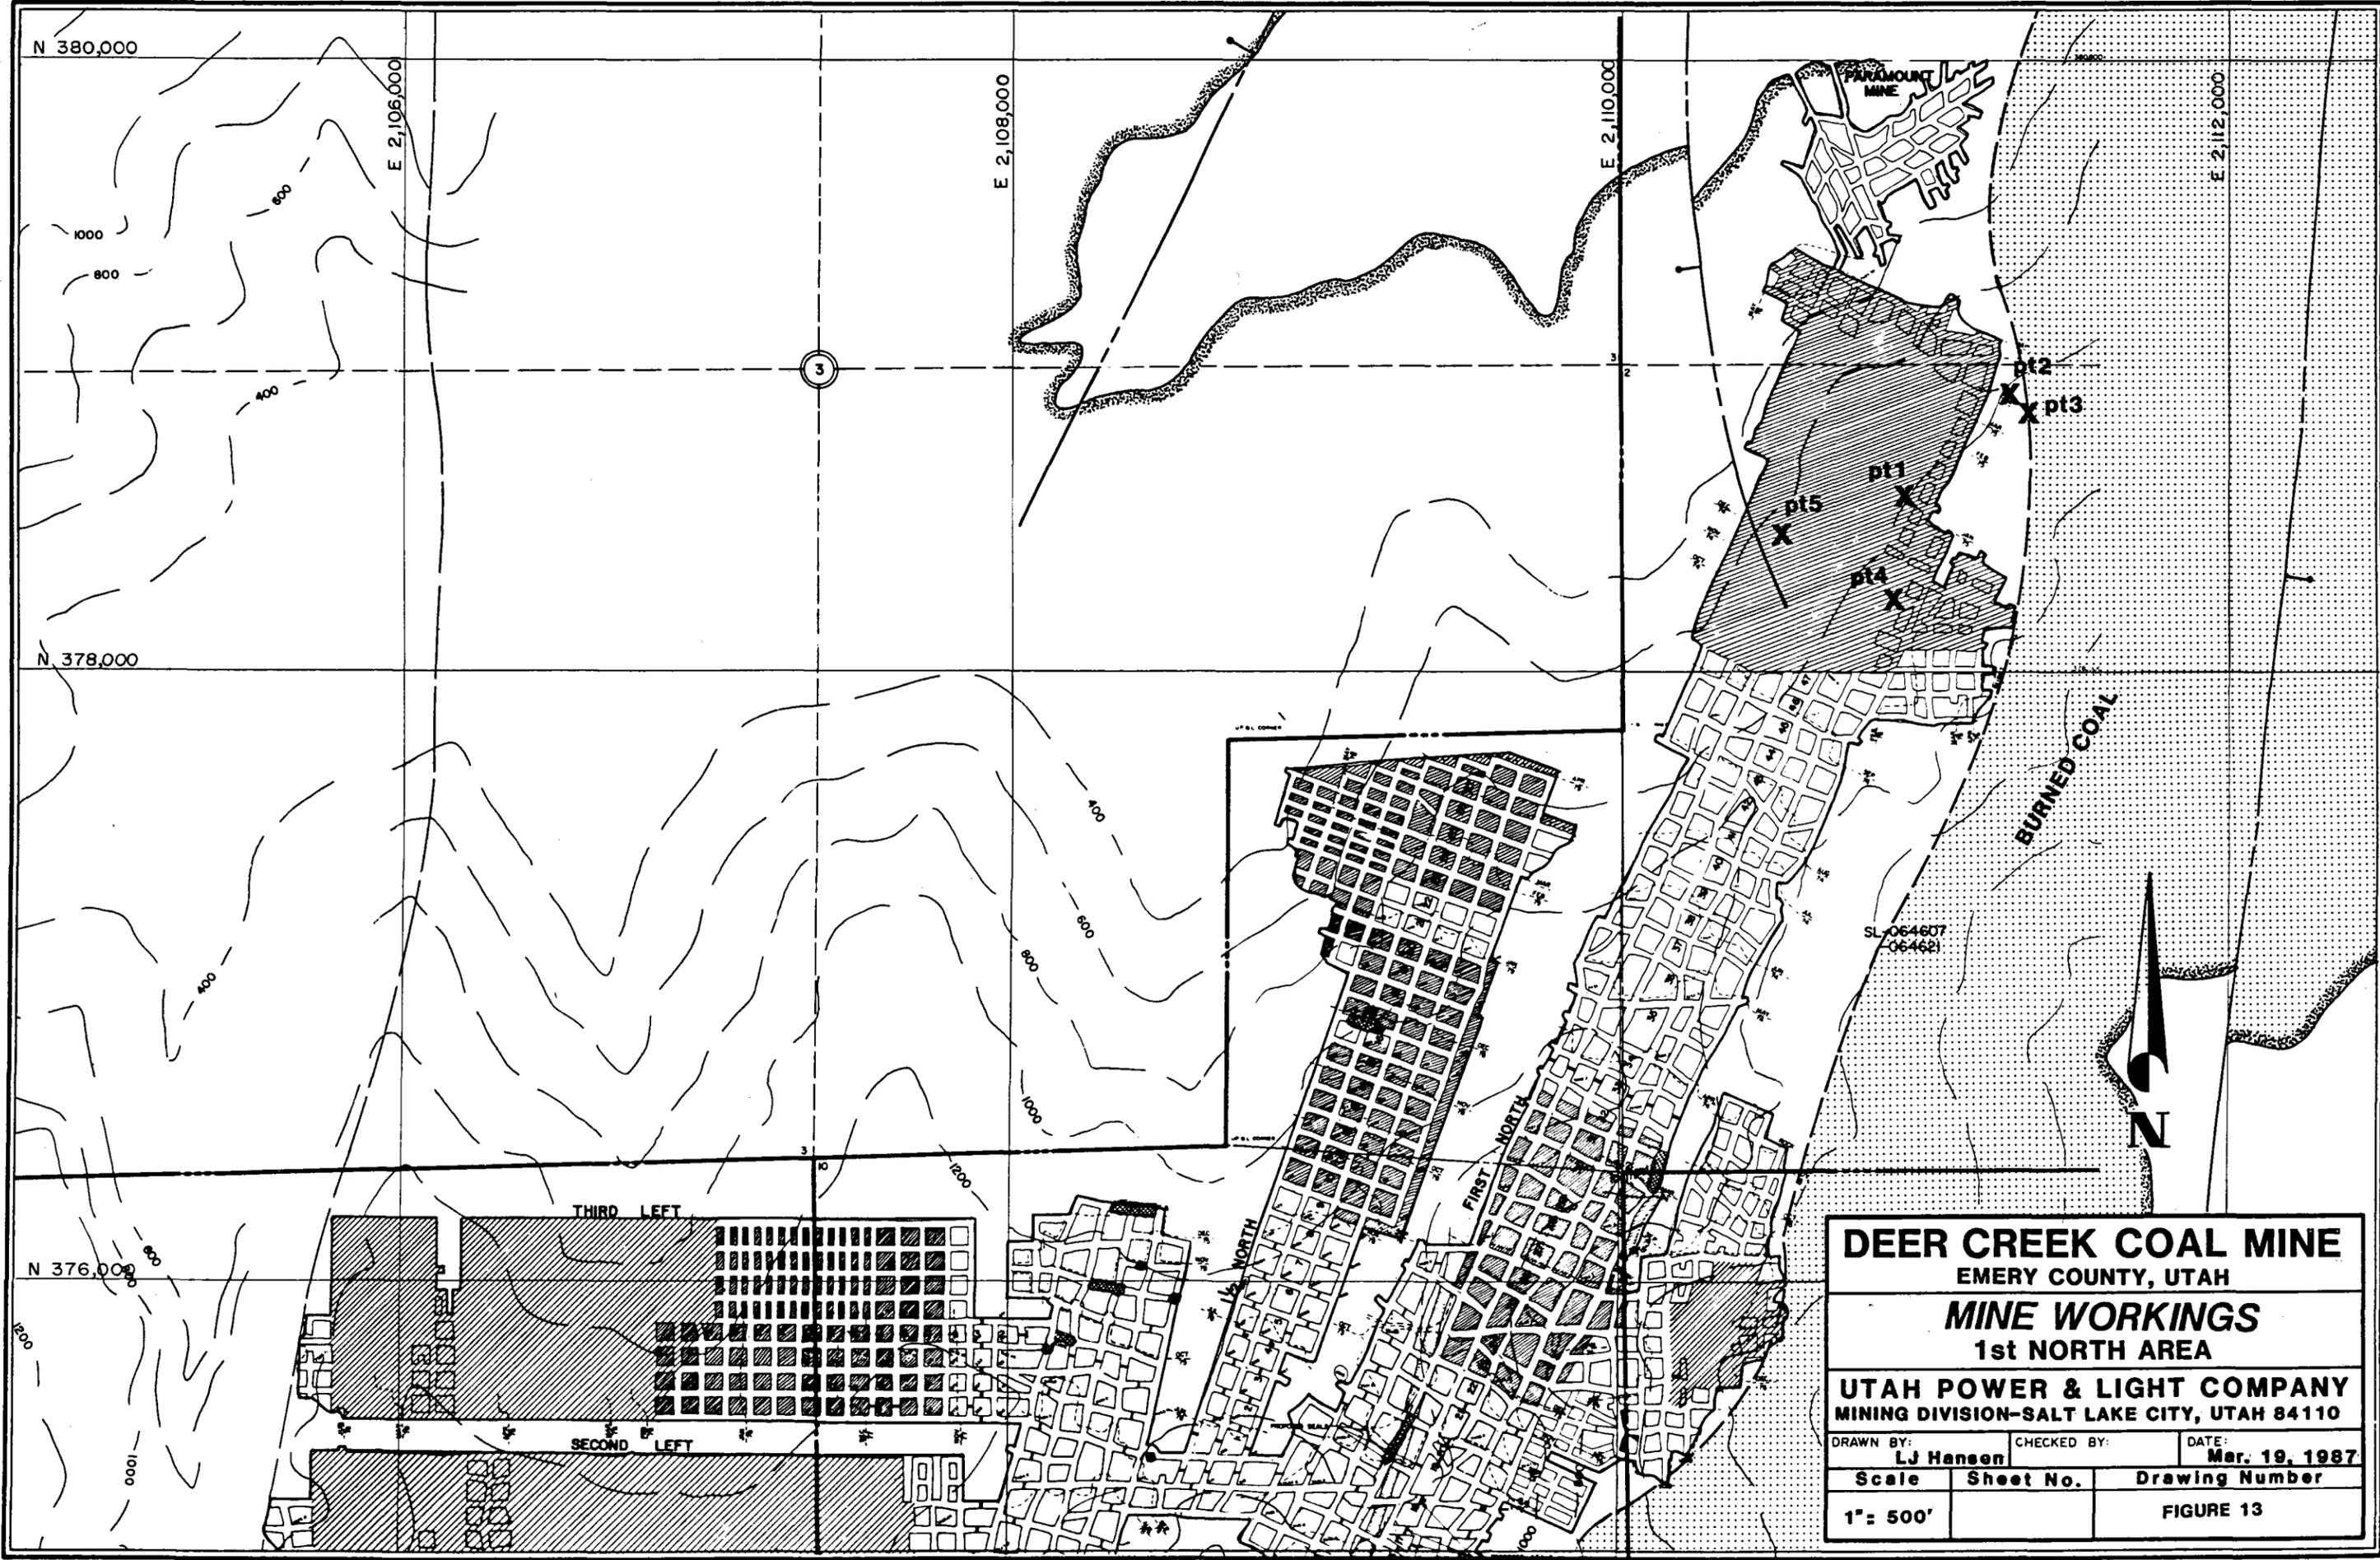
DEER CREEK COAL MINE		
EMERY COUNTY, UTAH		
MINE WORKINGS		
1st NORTH AREA		
UTAH POWER & LIGHT COMPANY		
MINING DIVISION-SALT LAKE CITY, UTAH 84110		
DRAWN BY: LJ Hansen	CHECKED BY:	DATE: Mar. 19, 1987
Scale 1" = 500'	Sheet No.	Drawing Number FIGURE 13

Most of the 1st North section of the Deer Creek Mine was abandoned and sealed in 1978 after being mined out. The southern portion is still open and may be used for access to a block of coal which lies to the west. Pillar extraction in the 3rd Left and 1-1/2 North sections was completed early in 1980 (Figure 13). The greatest subsidence measured over these points was over seven (7) feet. The large change at that point may be due to a localized cliff or ledge failure since it appears so anomalous.

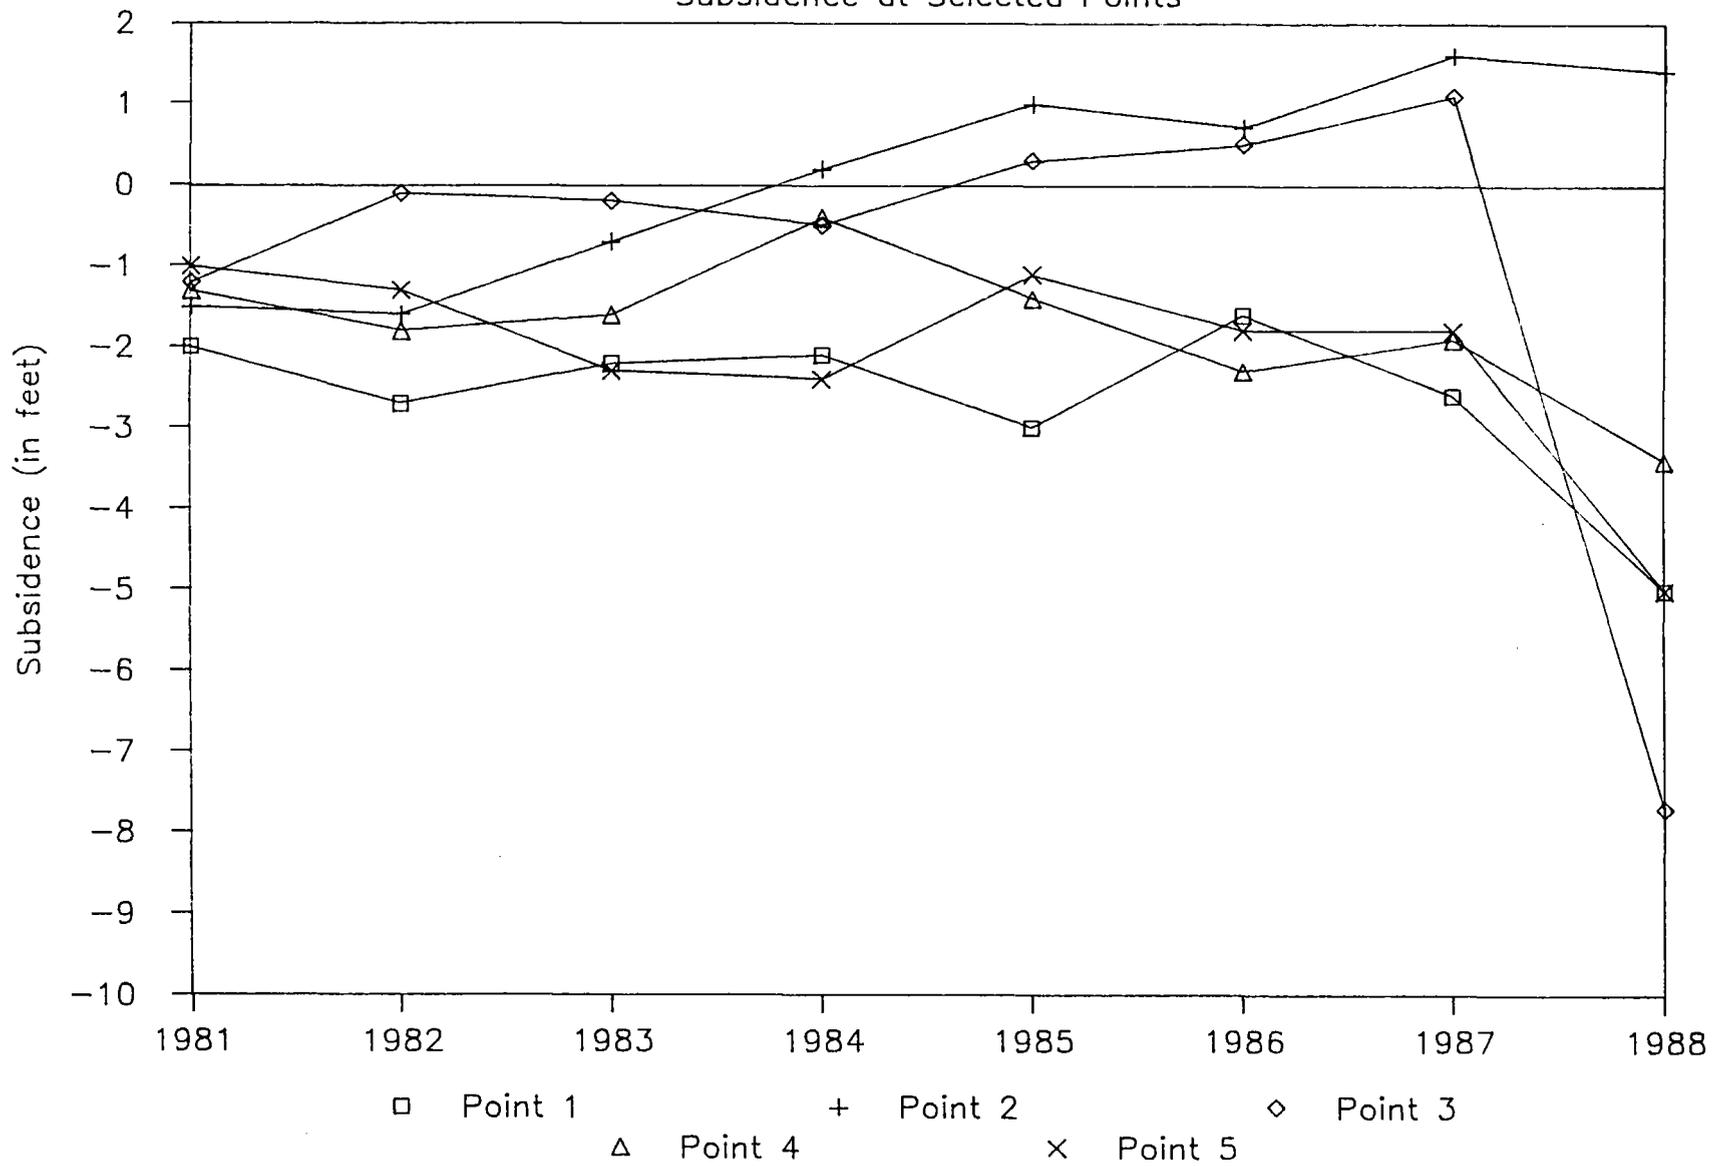
FIGURE 14

It appears that in the 1st North area the ground has not stabilized. The subsidence above 1st North occurs on a narrow ridge capped by a highly fractured sandstone, and a review of the subsidence data indicates that, due to the mode of subsidence, elevation change cannot be depicted accurately with a contour map. Figure 14 is a graph of subsidence as it occurred at several points above the 1st North workings. Elevations are not consistent from year to year at a given point. One explanation is that the magnitude of the subsidence is on the order of the precision of the measurements. Keeping this in mind, all but point 2 showed subsidence in 1988. The large change at point 3 appears anomalous and may be due to a localized cliff or ledge failure.

Several helicopter surveys in 1988 revealed no new surface cracks or areas of cliff failure; however, selected points in Area 3 will continue to be monitored until the area's stability can be better assessed.

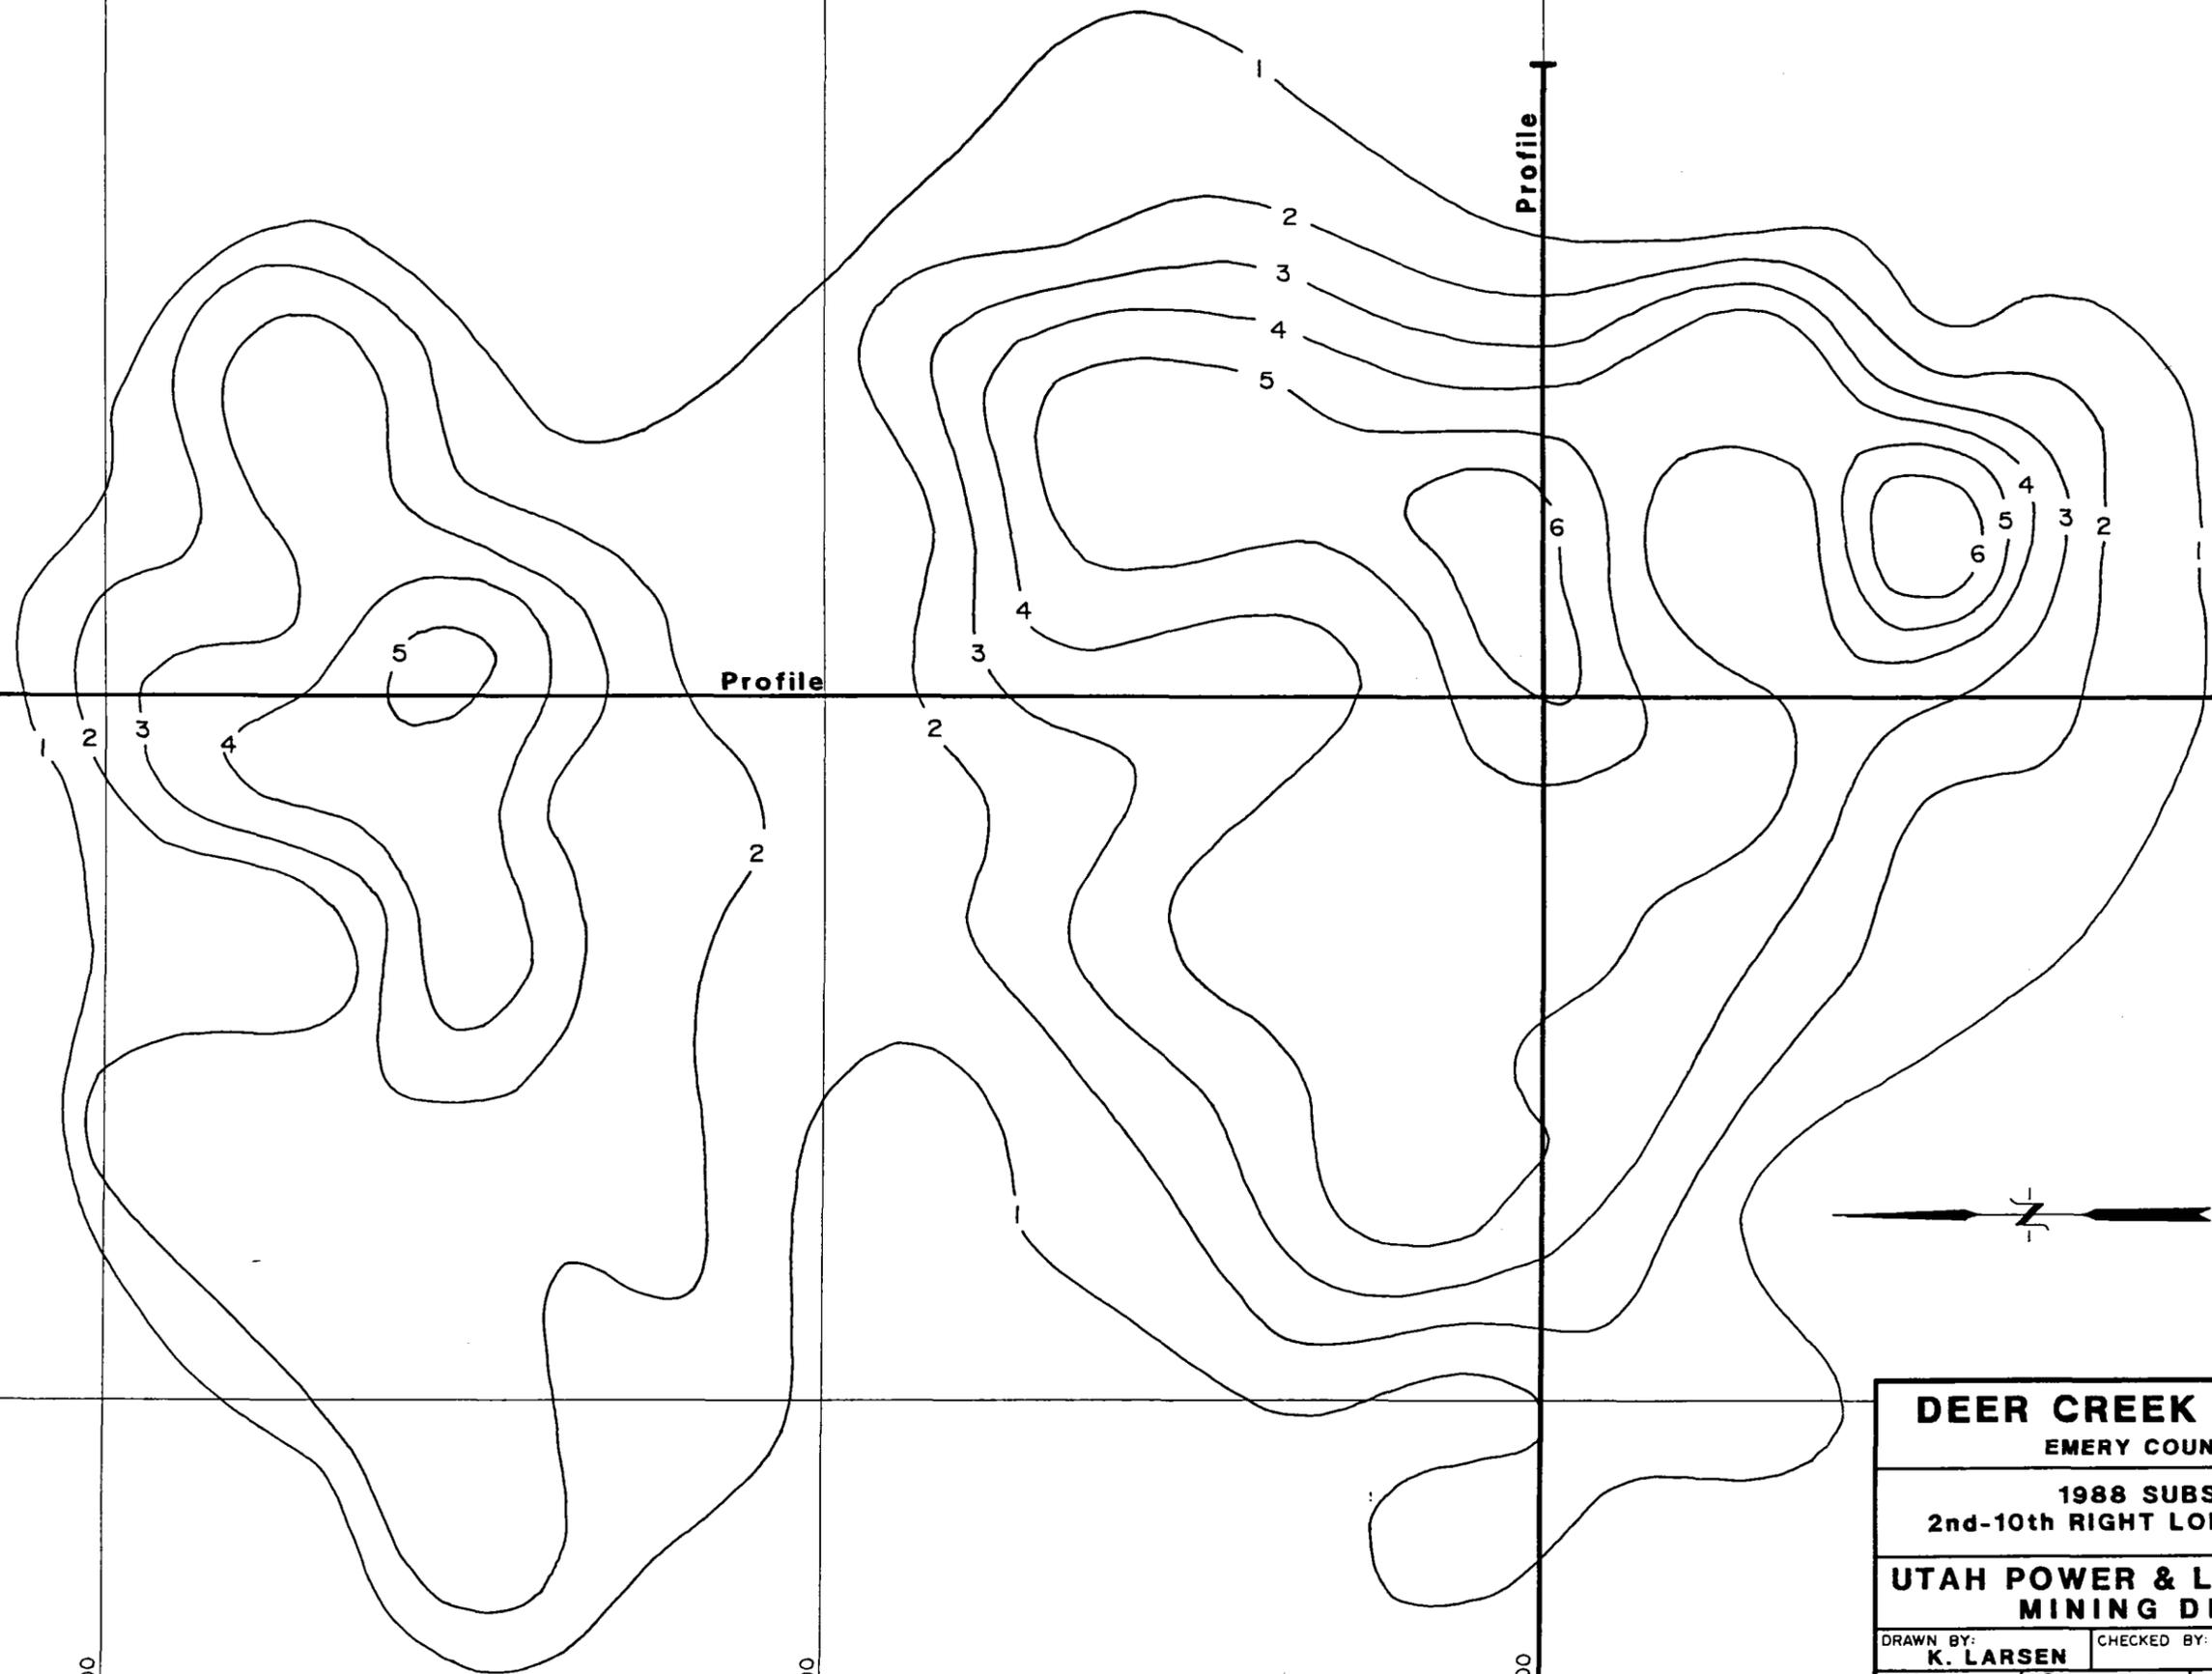
DEER CREEK COAL MINE		
EMERY COUNTY, UTAH		
1988 SUBSIDENCE		
2nd-10th RIGHT LONGWALL PANELS		
UTAH POWER & LIGHT COMPANY		
MINING DIVISION		
DRAWN BY: K. LARSEN	CHECKED BY:	DATE: MAR. 9, 1989
Scale	Sheet No.	Drawing Number
1" = 500'		FIGURE 16

For the third successive year the maximum subsidence is just under seven (7) feet over the 3rd and 4th Right longwall panels (Figure 16), indicating that the maximum subsidence may have been reached for this area. The subsidence trough continues to extend northward over the most recent 9th and 10th Right longwall panels (see Subsidence Profiles, Figures 17 and 18). The calculated angle-of-draw of the subsidence ranges from less than zero to 18 degrees.

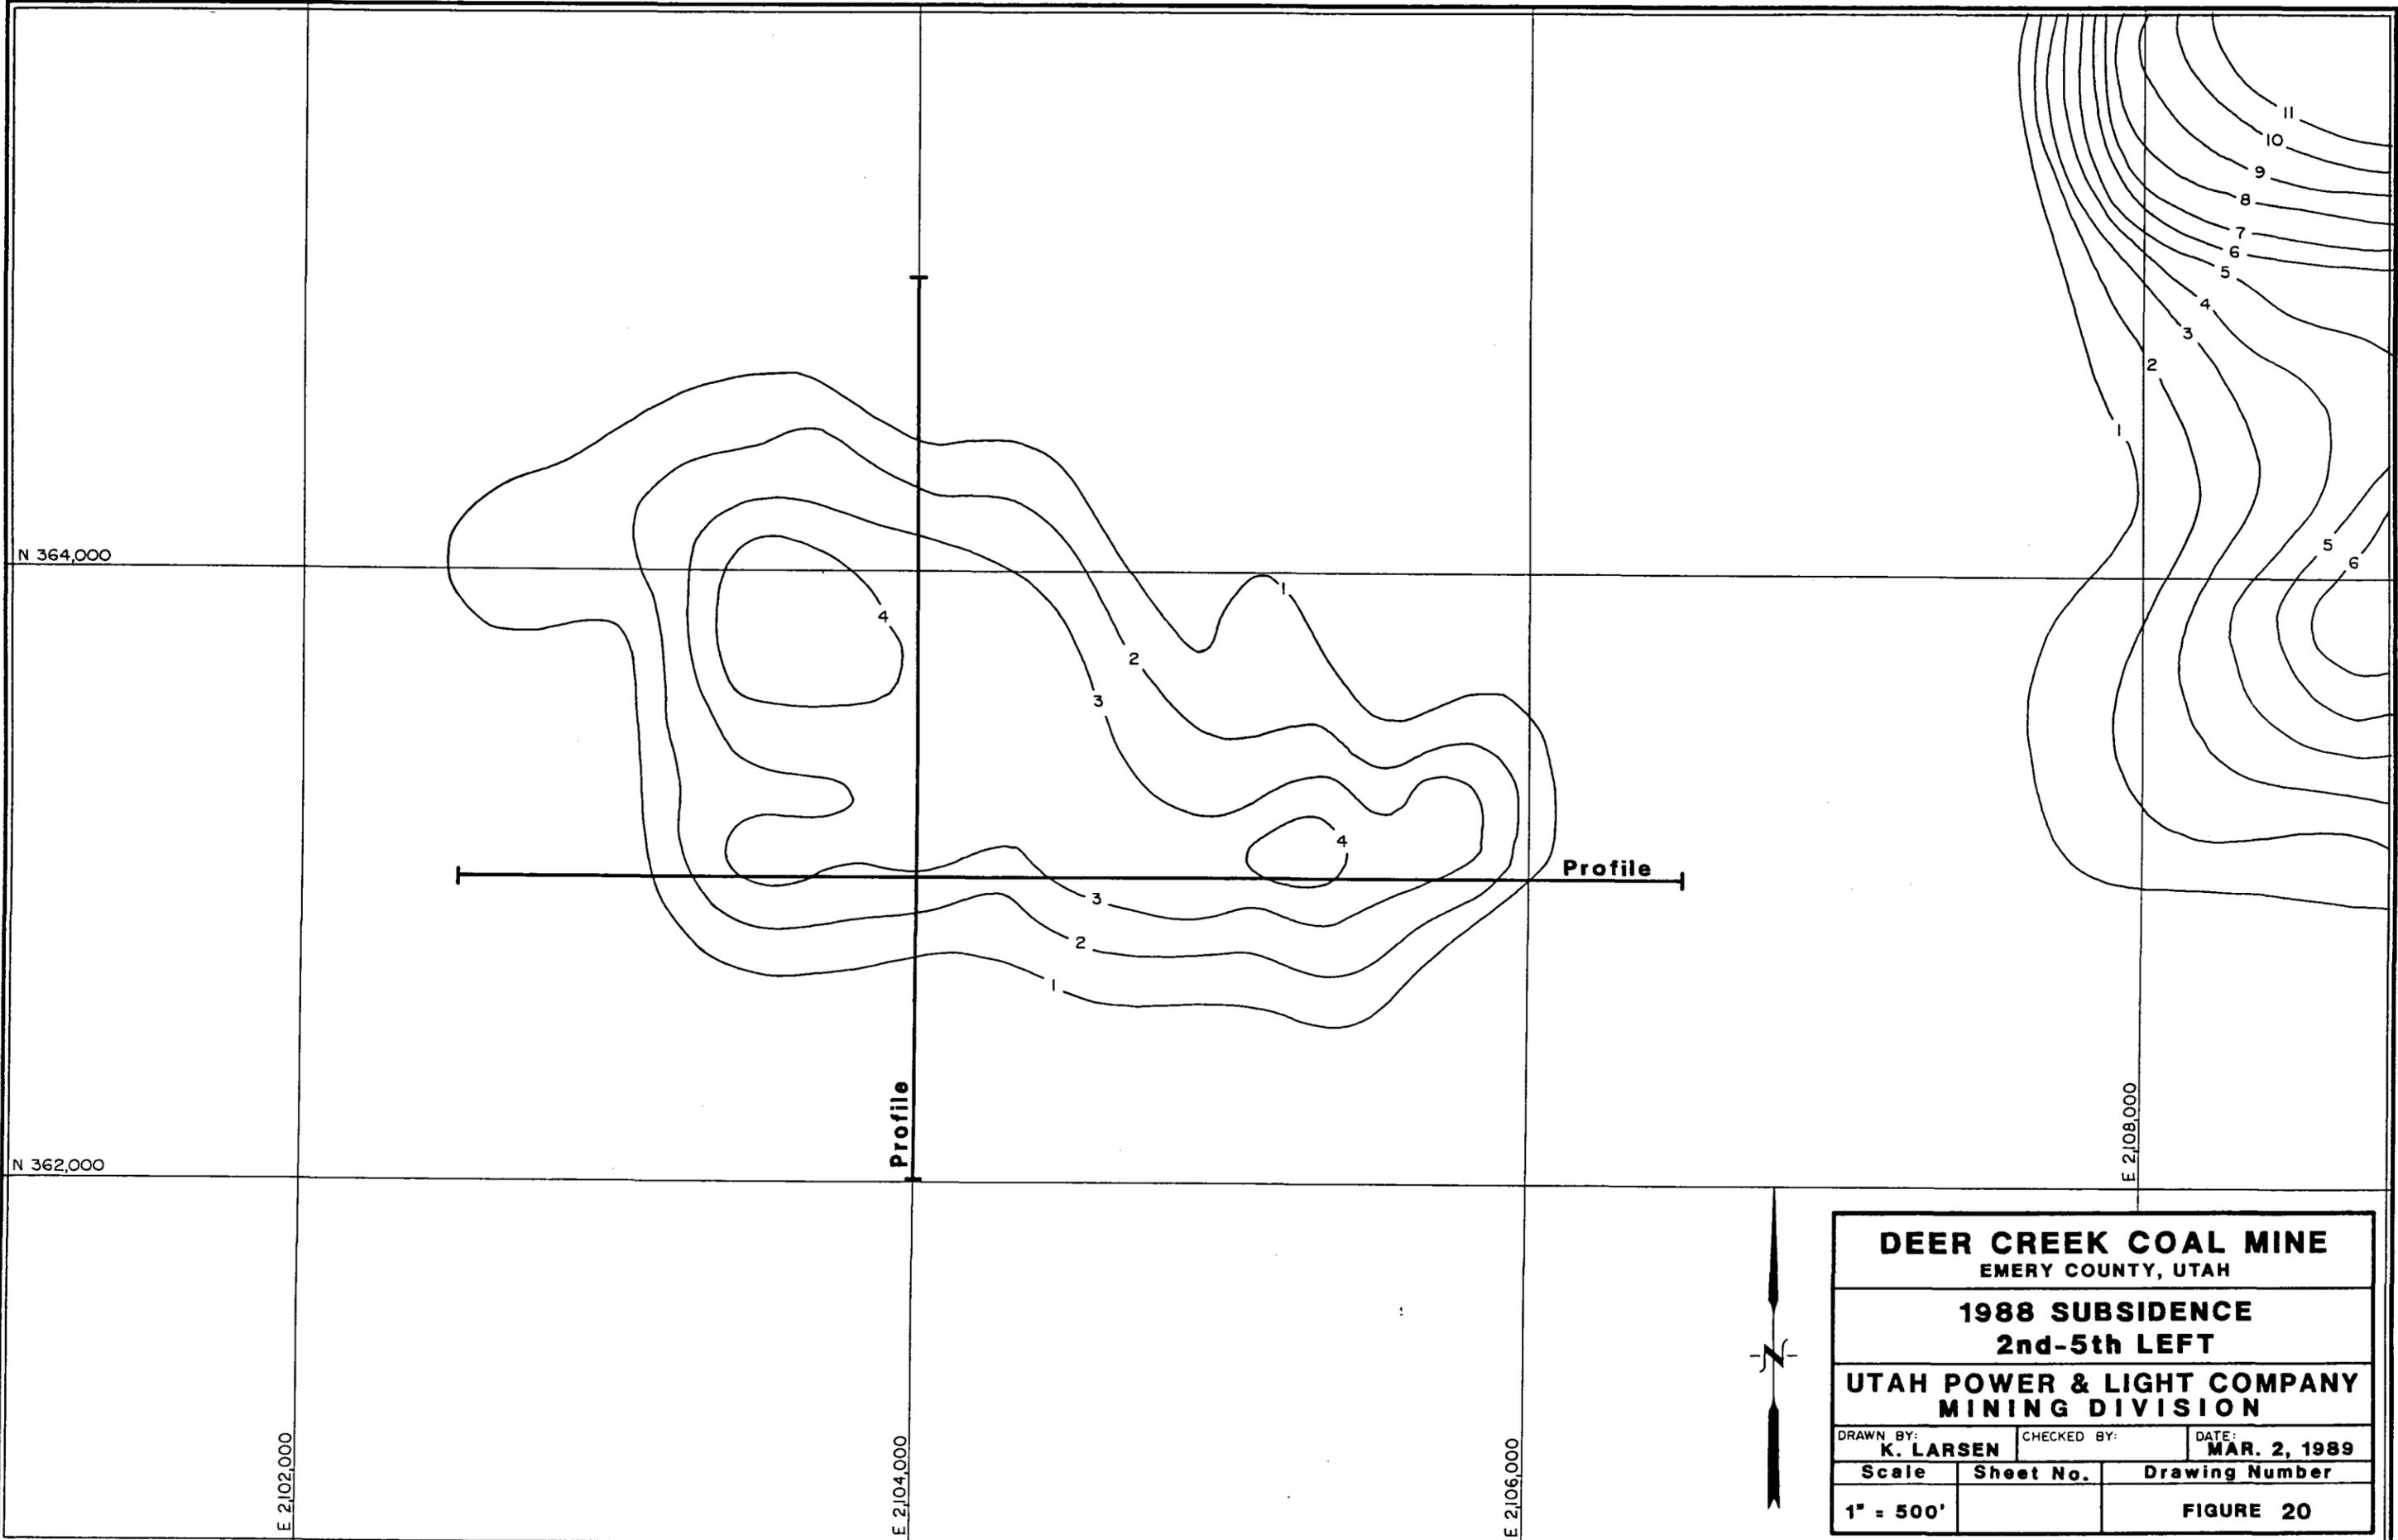
For the third consecutive year the maximum subsidence over the panels is about five (5) feet and occurs over the 3rd and 4th Left longwall panels (Figure 20). Little change has occurred in the area since 1986 (Figures 21 and 22). Since subsidence appears to have stabilized, with DOGM approval readings of subsidence will no longer be performed annually; but the area will be photographed yearly and readings can be made of the photos if deemed necessary. No surface disturbance has been identified over the panels.
