## Area 9

### Little Dove 1st North

### Deer Creek C and D North Longwall Panels and Adjacent Sections

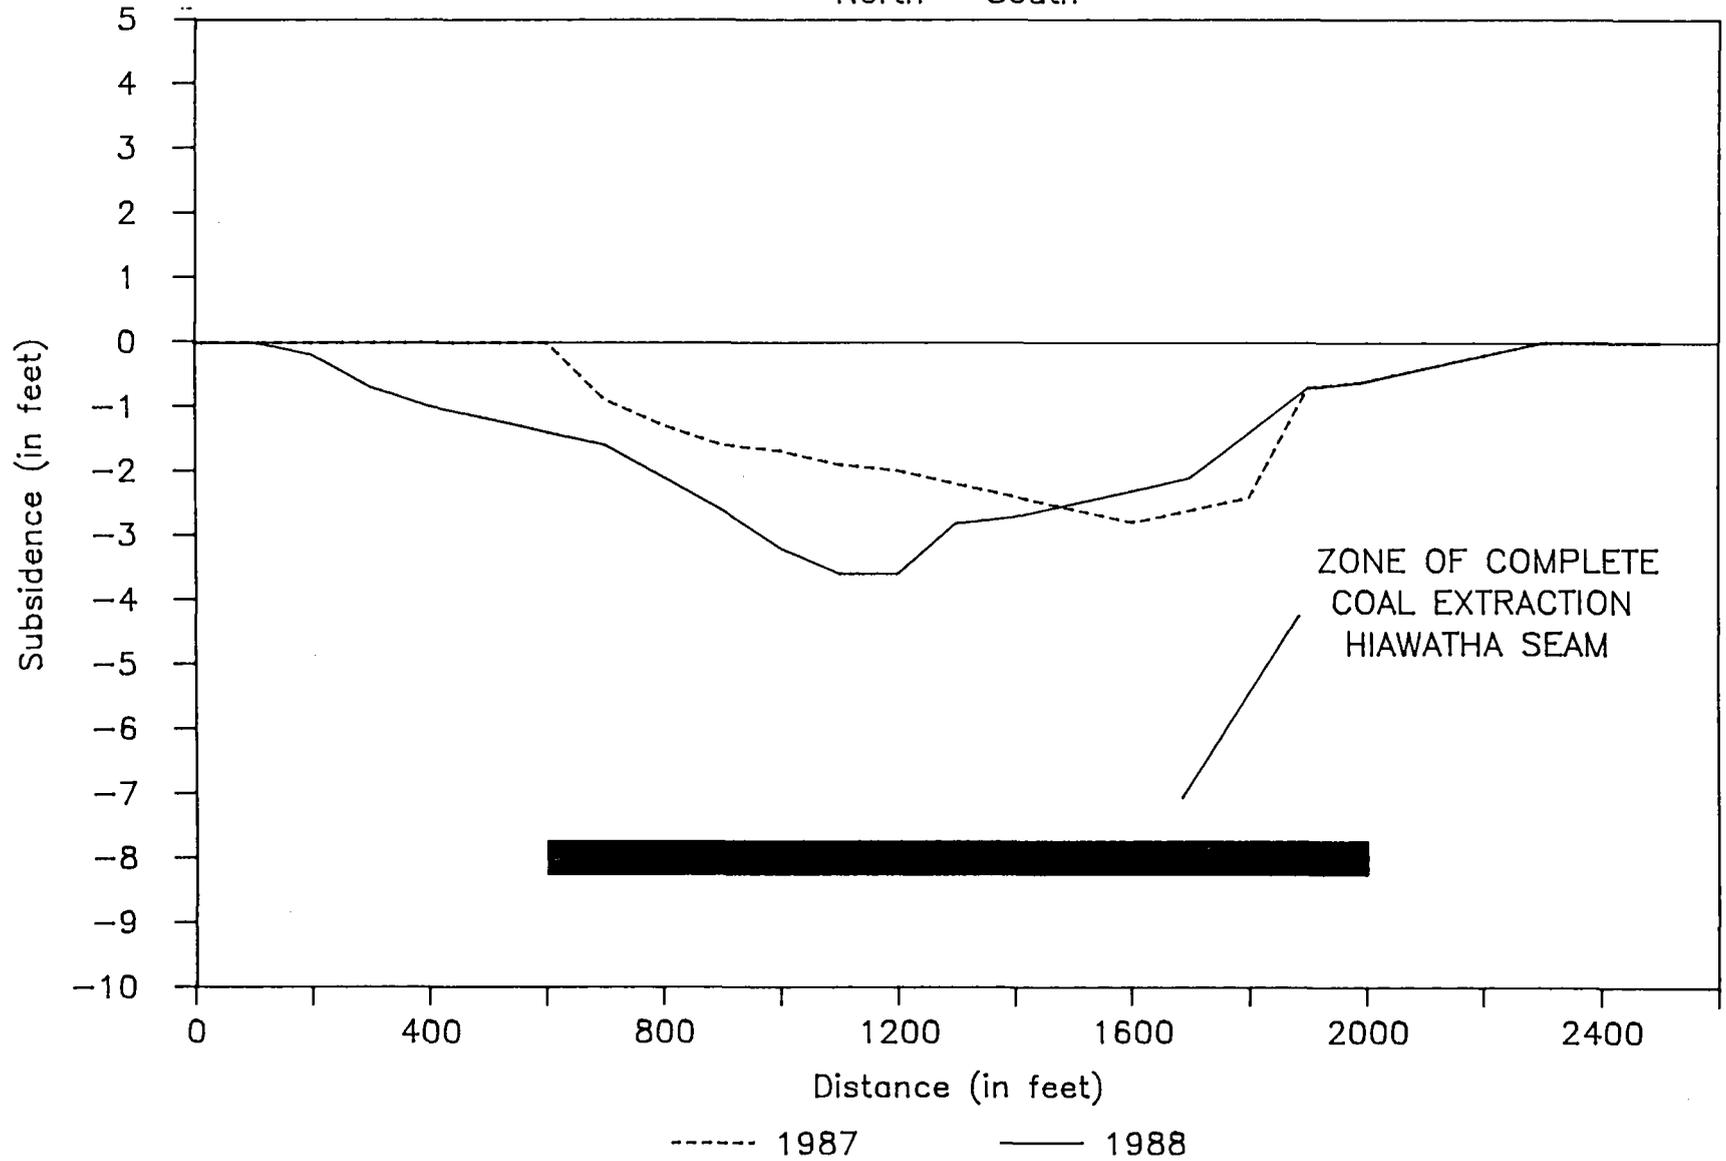
**FIGURE 44**

There are no springs in the vicinity of Area 14. The strata are generally dry; thus, mining is expected to have no adverse impact on the hydrology.

The major impacts associated with subsidence and resulting cliff failure, surface cracking, and talus deposition in Area 14 are 1) possible loss of golden eagle nests and/or nest sites, 2) disruption of grazing and hunting land use, and 3) loss of wildlife habitat.

Mitigation of effects due to mining may be required in Area 14. A detailed assessment is given in the Newberry Canyon report. Briefly, mitigation may include 1) backfilling, recontouring, and revegetating surface cracks, where accessible; 2) creating artificial eagle nesting sites; and 3) improvement of habitat for existing species or developing habitat for another desirable species.
