**UTAH POWER & LIGHT COMPANY
SUBSIDENCE MONITORING PROGRAM
ANNUAL REPORT FOR 1989**

May 1990

**United States Department of the Interior
Office of Surface Mining
Minerals Management Service
Utah Division of Oil, Gas and Mining**

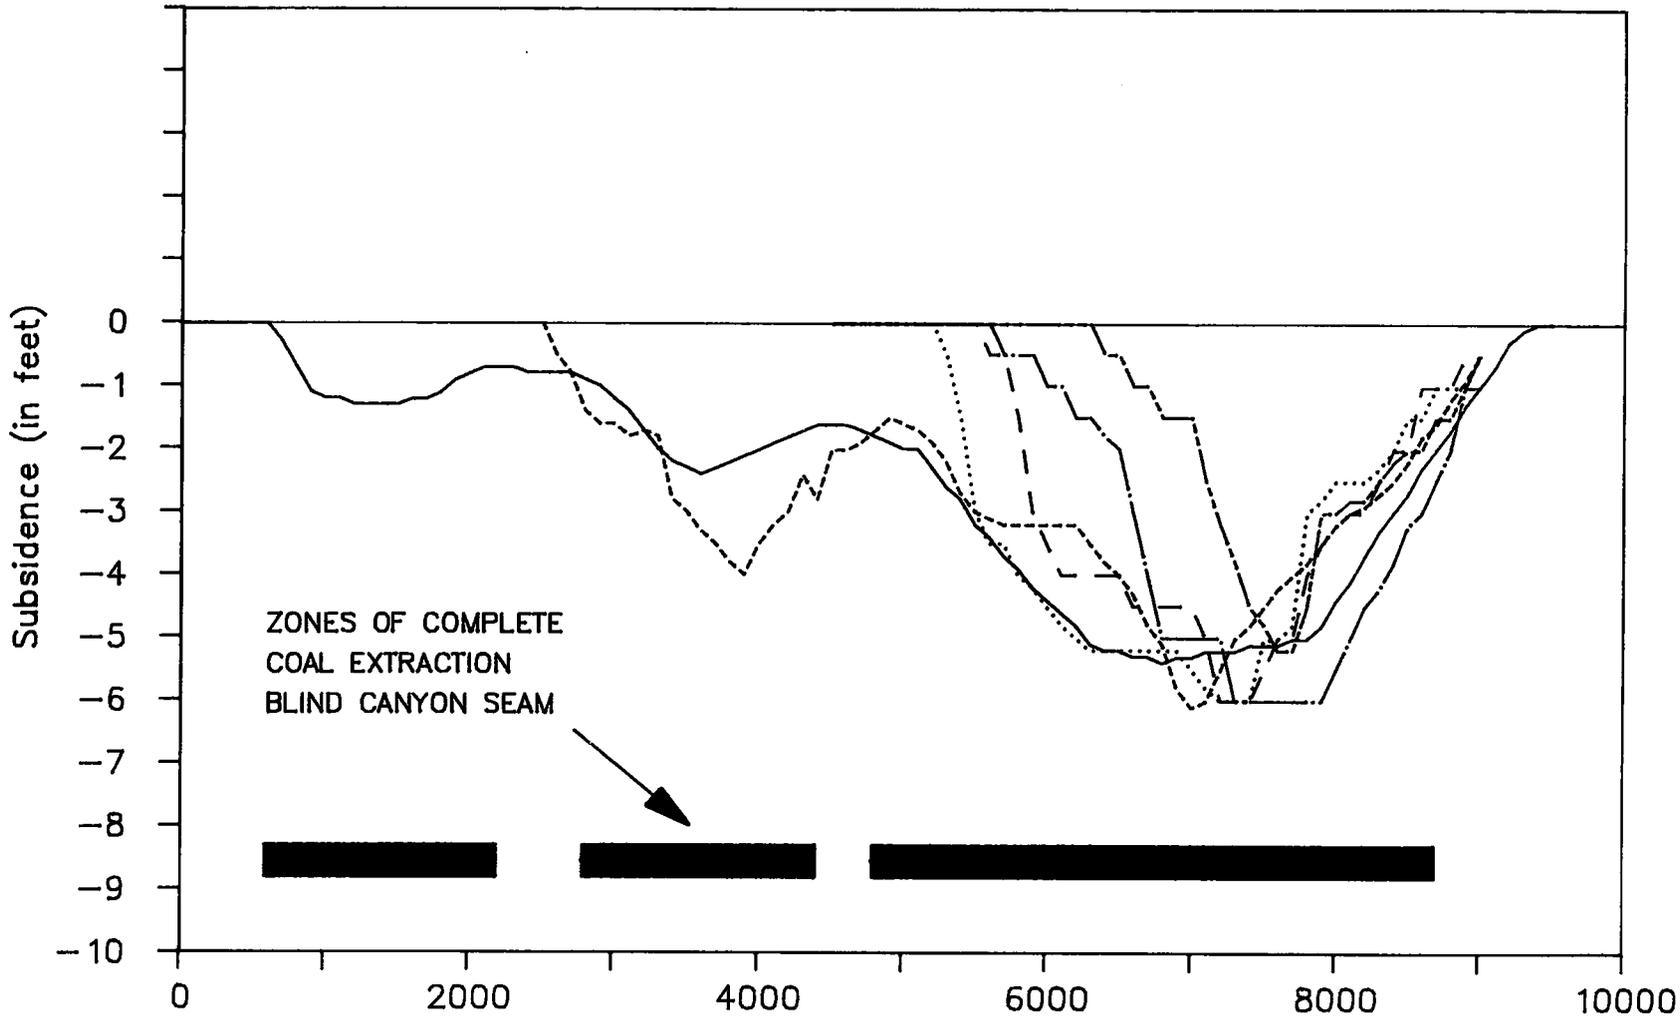
FIGURE 17

Maximum subsidence is just under six (6) feet over the 3rd, 4th, and 5th Right longwall panels (Figure 16). The subsidence trough continues to extend northward over the most recently mined longwall panels (see Subsidence Profiles, Figures 17 and 18). The calculated angle-of-draw of the subsidence ranges from less than zero to 11 degrees.

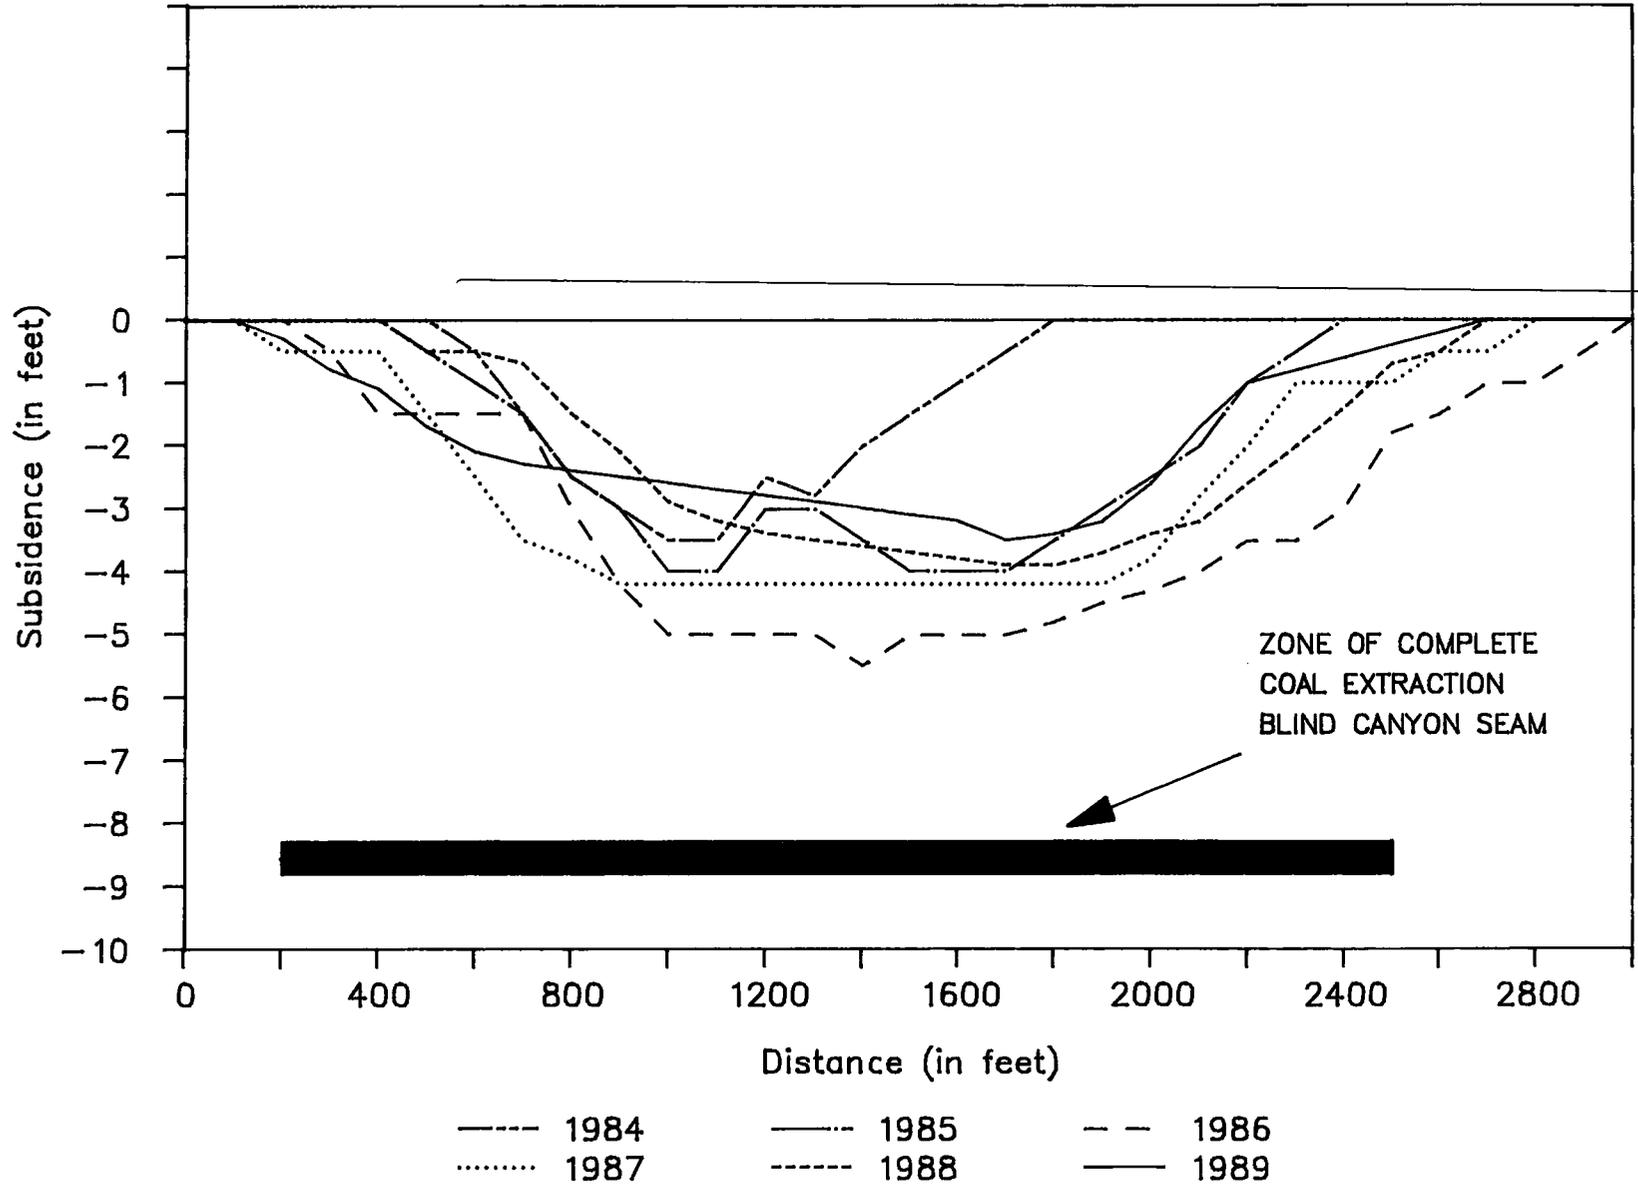
FIGURE 21

Maximum subsidence over the panels is about six (6) feet and occurs over the 3rd and 4th Left longwall panels (Figure 20). Little change has occurred in the area since 1986 (Figures 21 and 22). No surface disturbance has been identified over the panels.

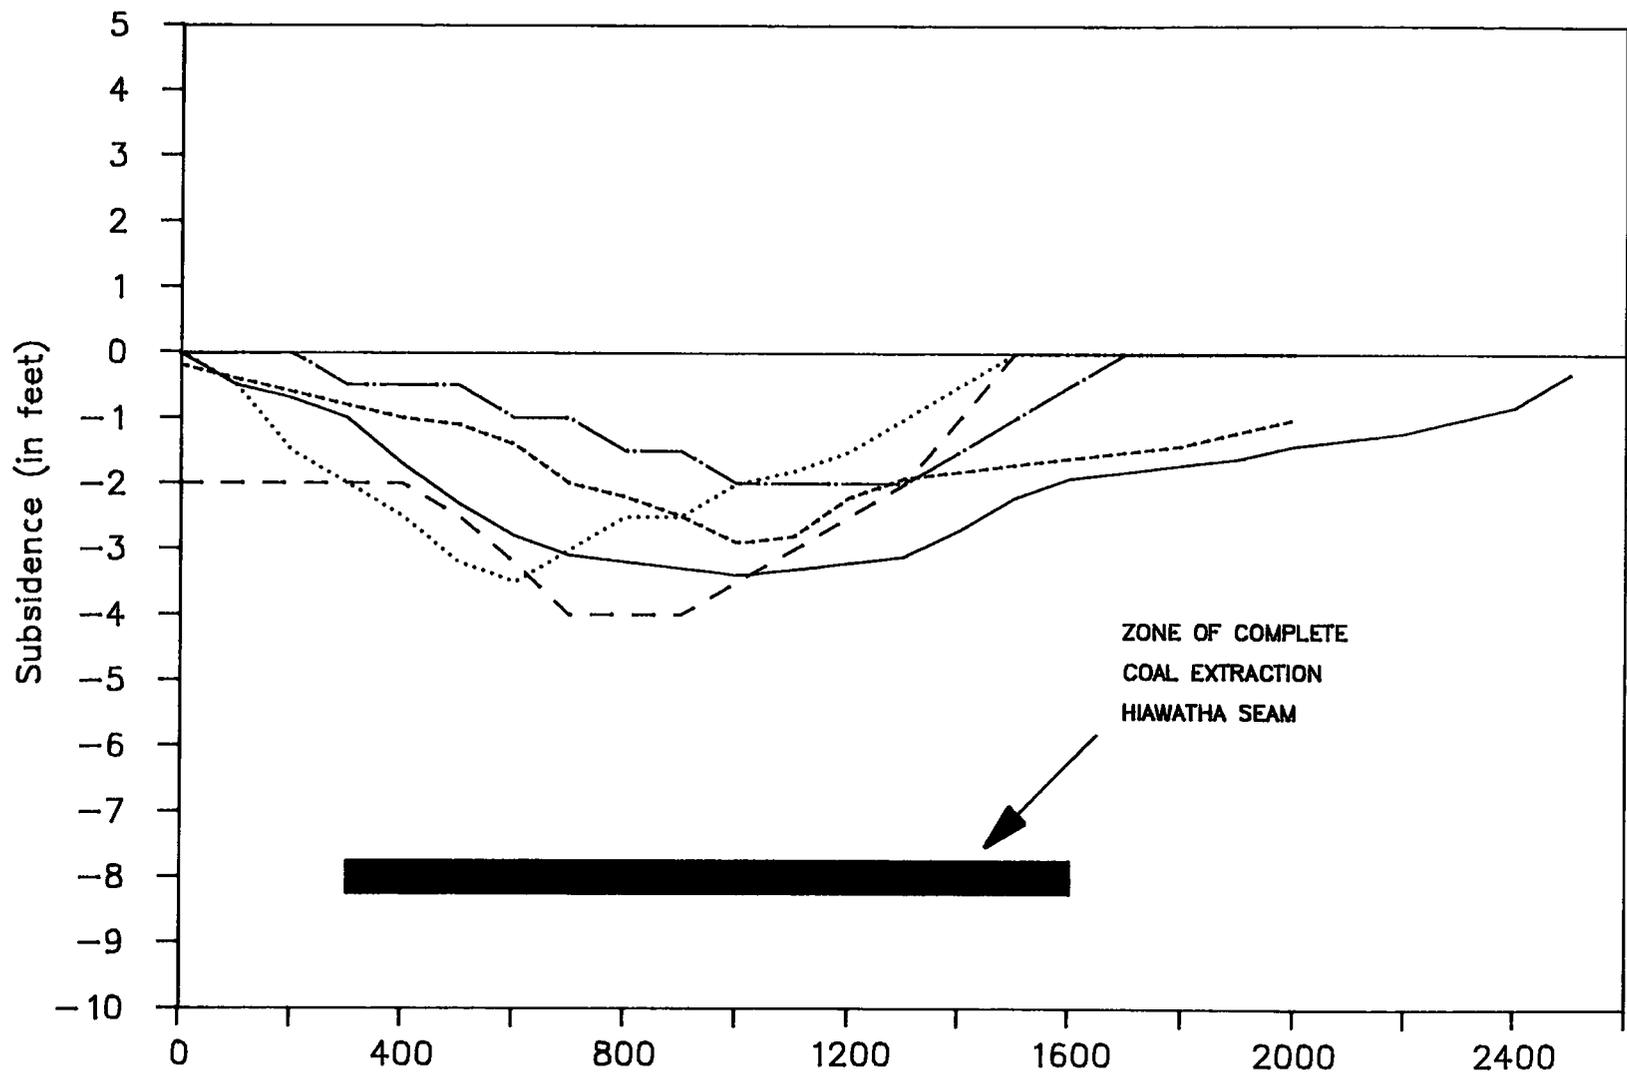
FIGURE 25

Mining in the Wilberg 1st and 2nd West longwall panels was completed in June 1983, and subsidence continued into the 1984 monitoring period (Figure 23). Since late 1984 no significant additional movement has been detected and the area appears to have stabilized with approximately three (3) feet of subsidence (Figure 24). The subsidence profiles (Figures 25 and 26) show some irregularity from year to year, but the variation is within the margin of error in the photogrammetric method (± 0.7 feet).

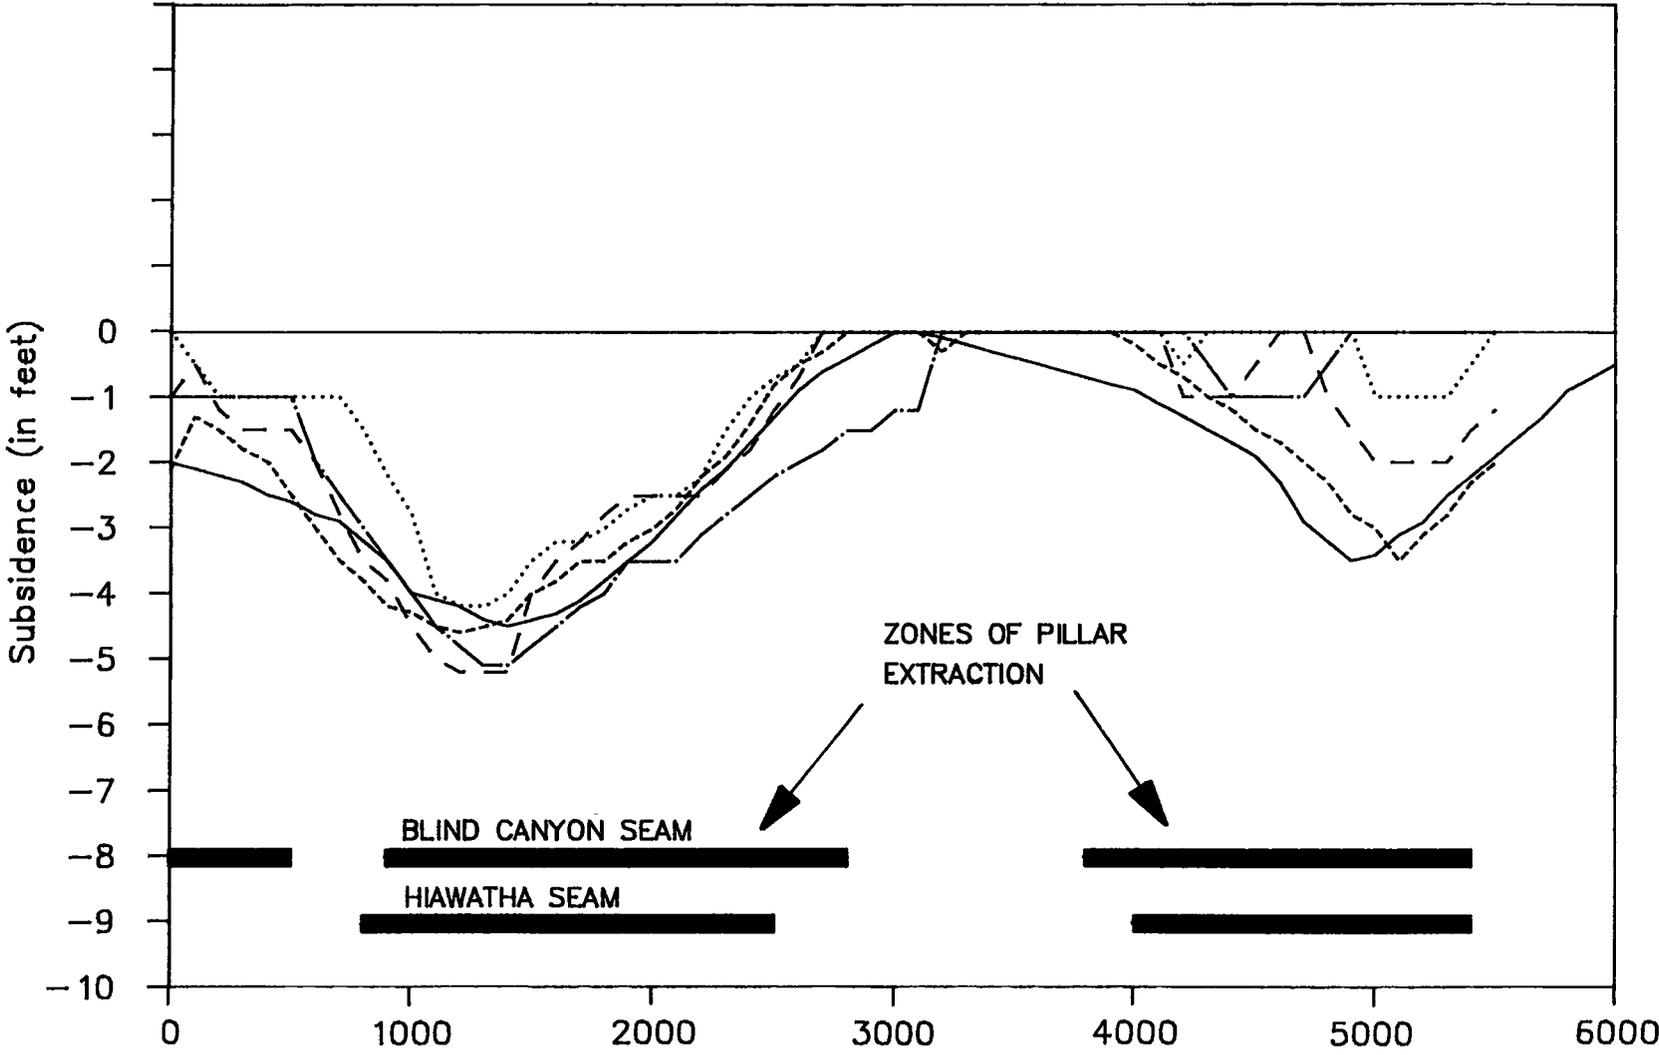
FIGURE 33

Some of the subsidence in Area 8 may have gone undetected because pillar extraction, and presumably subsidence, in part of the area was completed before the establishment of baseline survey data (Figures 30, 31, and 32). The west to east subsidence profile of the area depicted in Figure 33 indicates it had reached a stable state, at near 4.5 feet of subsidence, over the western sections by 1986. On the eastern side subsidence has remained at about 3.5 feet for the last two years. Where not influenced by other workings, angle-of-draw reached a maximum of 31 degrees on the eastern edge of the area.

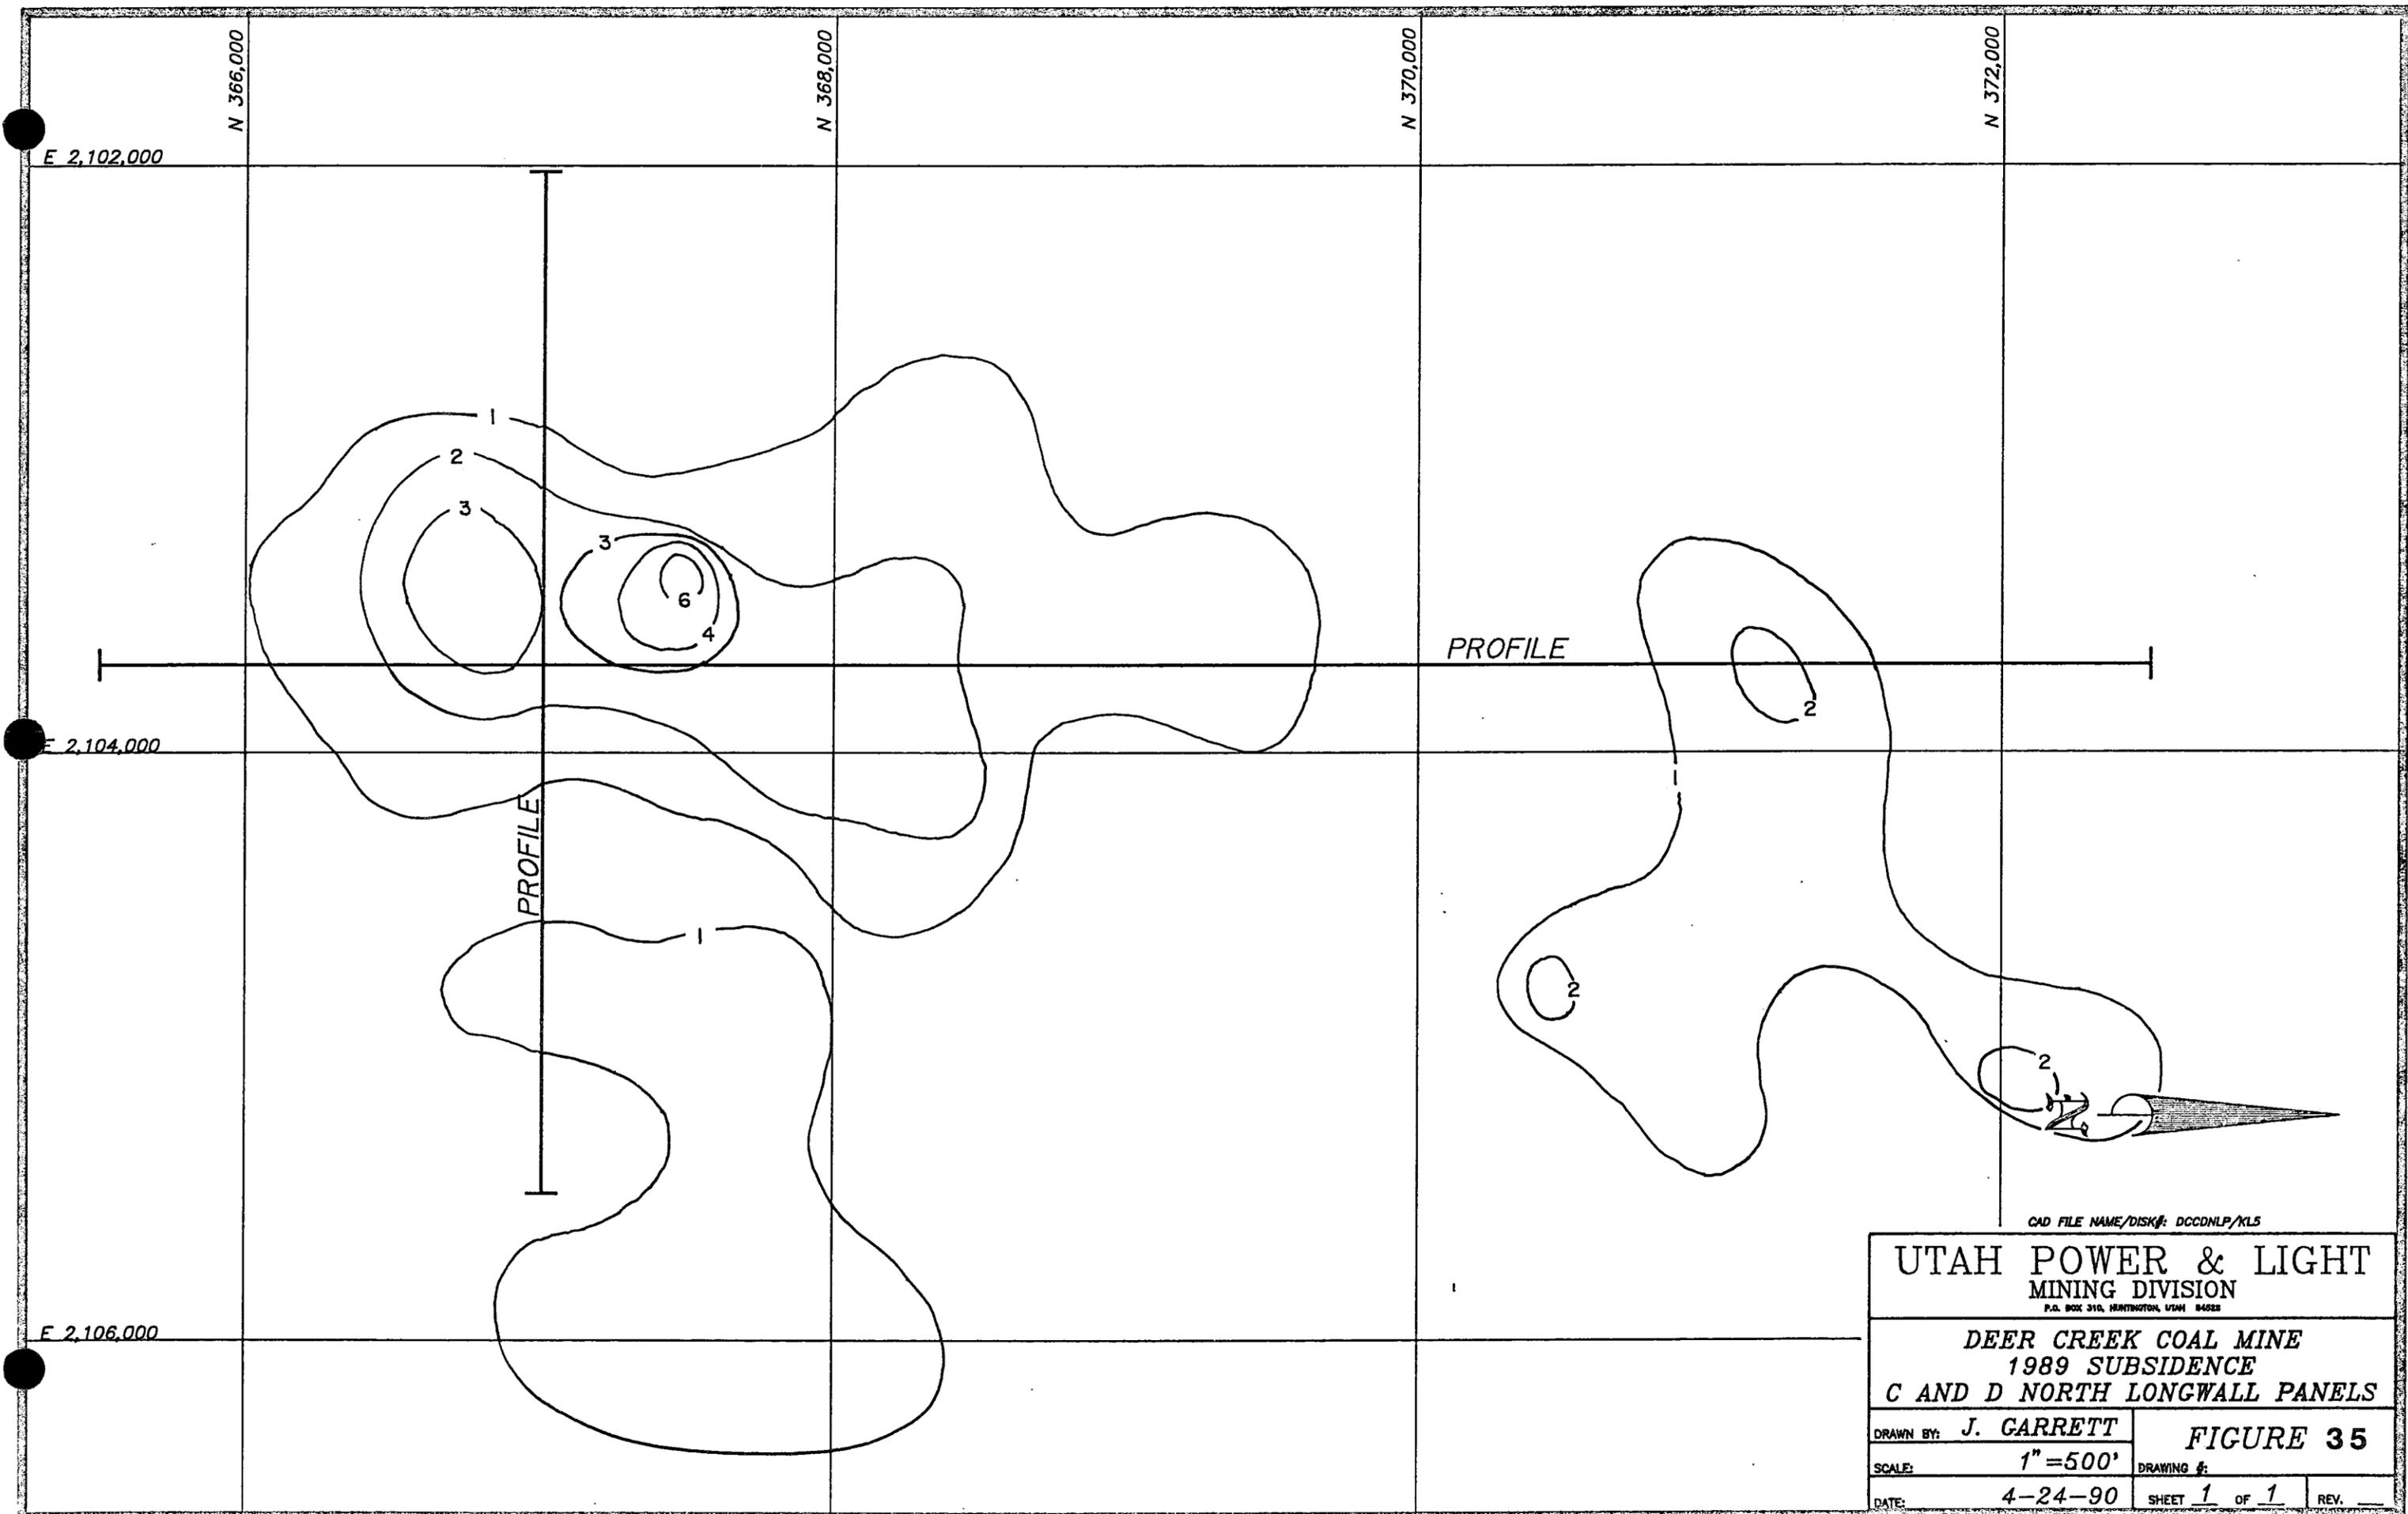
DRAWN BY: J. GARRETT	FIGURE 35	
SCALE: 1" = 500'	DRAWING #:	
DATE: 4-24-90	SHEET 1 of 1	REV. _____

Longwall mining in the C North panel began in December 1984 and was terminated in April 1986 due to geologic complications. New setup entries were driven further south and mining resumed in September 1986; the panel was completed in March 1987. The D North longwall panel began production in July 1987, but after October 1987 production was limited due to poor coal quality. The panel was terminated in August 1988 at a length of 1750 feet. Pillar extraction mining in A North and A South was completed in June 1983 (Figure 34). Measurable subsidence to date has reached six (6) feet over C and D North and a little more than two (2) feet over the room-and-pillar sections (Figures 35, 36, and 37).

No fractures or disturbance of the surface of the area has been observed. The angle-of-draw measured ranges from less than zero to 28 degrees.
