State of Utah  
DEPARTMENT OF NATURAL RESOURCES  
DIVISION OF OIL, GAS AND MINING

Re: Response Adequacy from Cyprus Plateau Mining Corporation and Co-Op Mining Corporation  
Regarding the Birch Spring Monitoring Issues per: Tech Directive 005.

RE: Response Adequacy from Cyprus Plateau Mining Corporation and Co-Op Mining Corporation  
Regarding the Birch Spring Monitoring Issues per: Tech Directive 005.

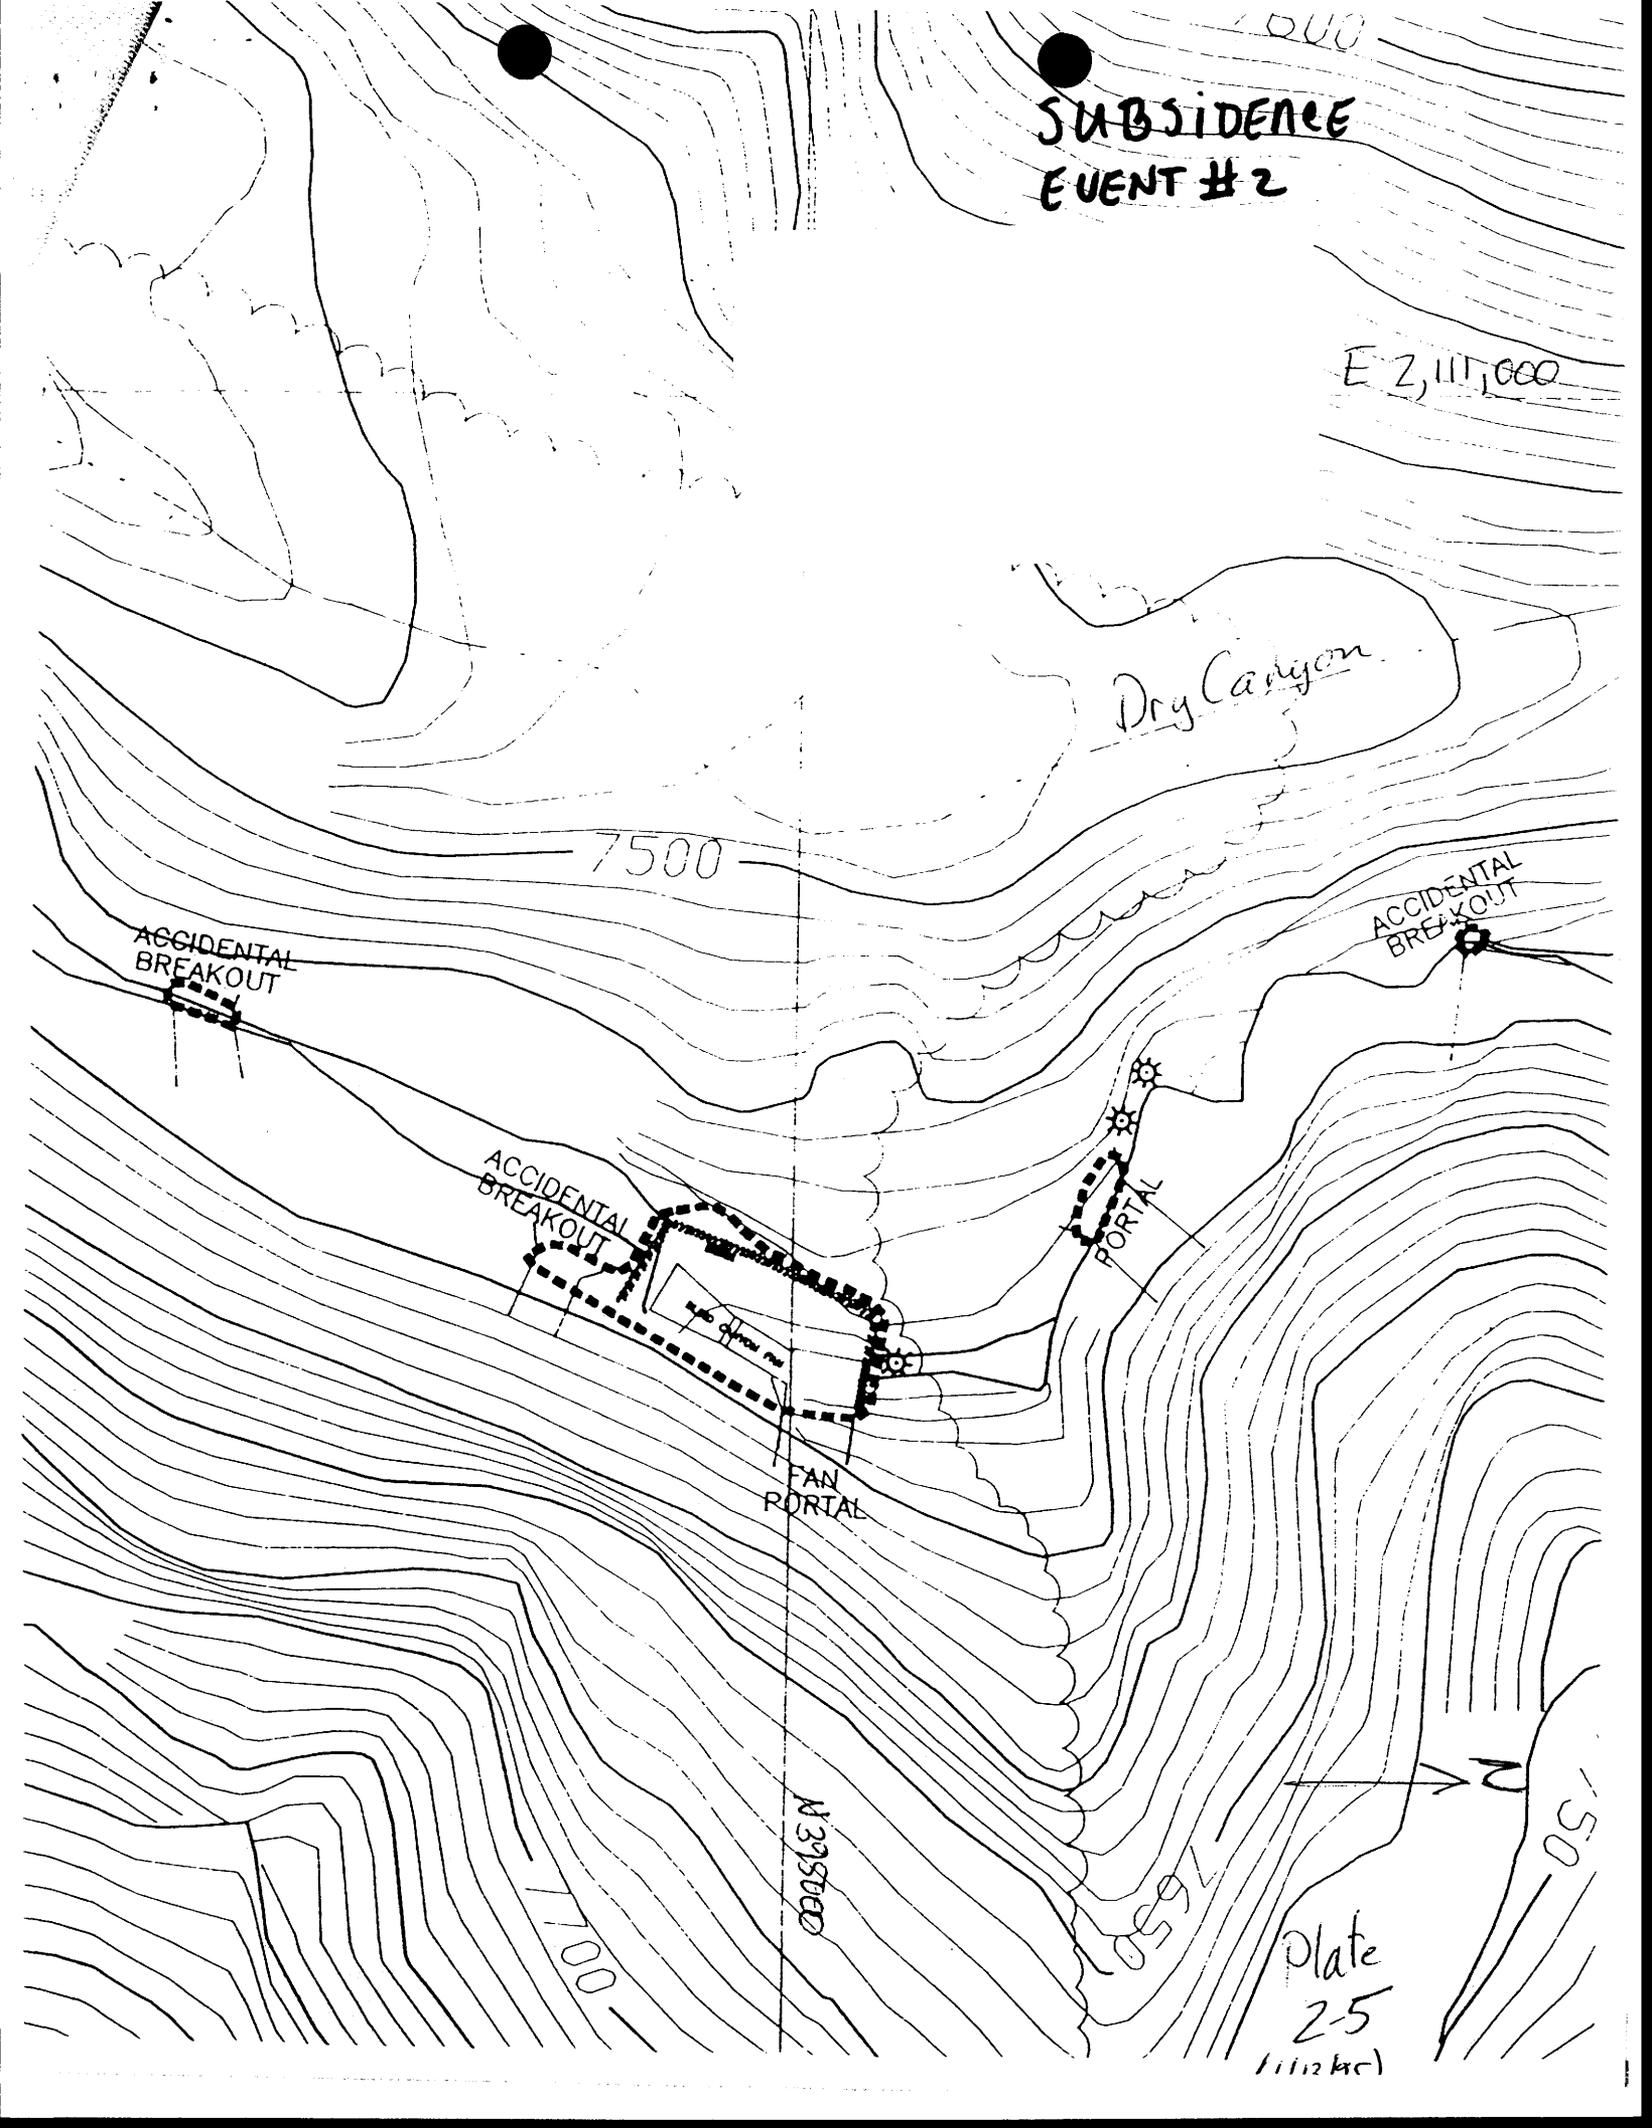
Plate  
2-5  
1/12 KC

- Subsidence Area #2. In October 25, 1994 three places were discovered in the immediate vicinity of the Blind Canyon Fan Portal (E1/4 of NW 1/4, Section 26, T16S, R7E) where collapse or caving created openings from the surface into the mine workings (memo to file from Jess Kelley, February 16, 1995). These are shown on Plate 2-5 of the Bear Canyon MRP.

In order to mitigate the damage caused by the breakouts, the permittee has included the 3 areas in the disturbed area and has committed to reclaim them by sealing them with a block wall and backfilling them, just like any portal opening. Plate 2-5, which shows the Blind Canyon fan portal, has been modified to show the locations of the breakouts. Since the addition to the approved disturbed area is so small, this action does not constitute a significant revision.

To mitigate this damage, Peter Hess instructed the permittee to include these 3 areas in the existing disturbed area and make provision for reclaiming them.

It is recommended 1) that this amendment be approved and included as part of the approved plan, and 2) that the bond be increased to at least \$502,120 to cover the additional reclamation costs associated with the breakouts.

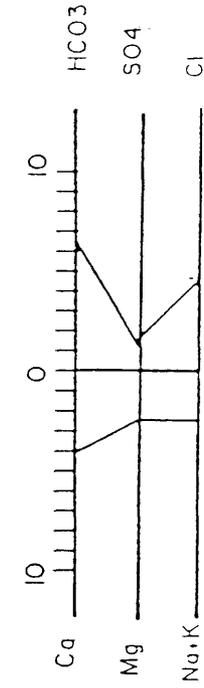
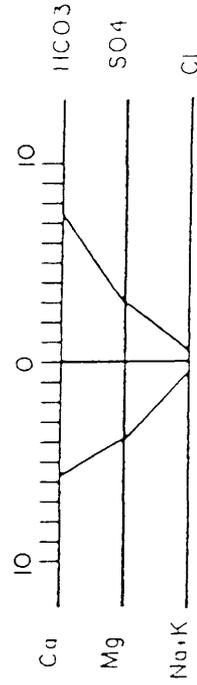
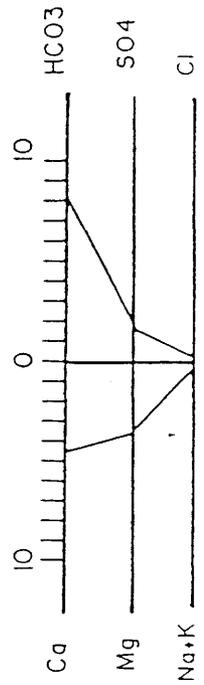
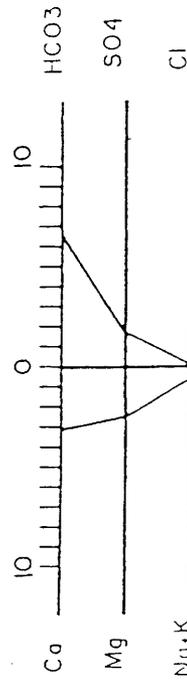
FIGURE 2-2. Stiff Diagrams of Spring Water Analytical Results

Data strongly indicating that Birch Spring water and in-mine water from SBC-9 are not the same are presented in the August 12, 1992 PHC in the Bear Canyon Mine MRP. This information shows SBC-9 has a greater concentration of sodium and chloride in comparison to Birch Spring. Bear and Trail Canyon Springs have Stiff diagrams similar to that of Birch Spring (Appendix E, figure 2-2).
