INSPECTION REPORT

INSPECTION DATE & TIME: June 13, 1988
7a.m. to 4:30p.m.

CRANDALL CANYON MINE

RUNOFF CONTROLS

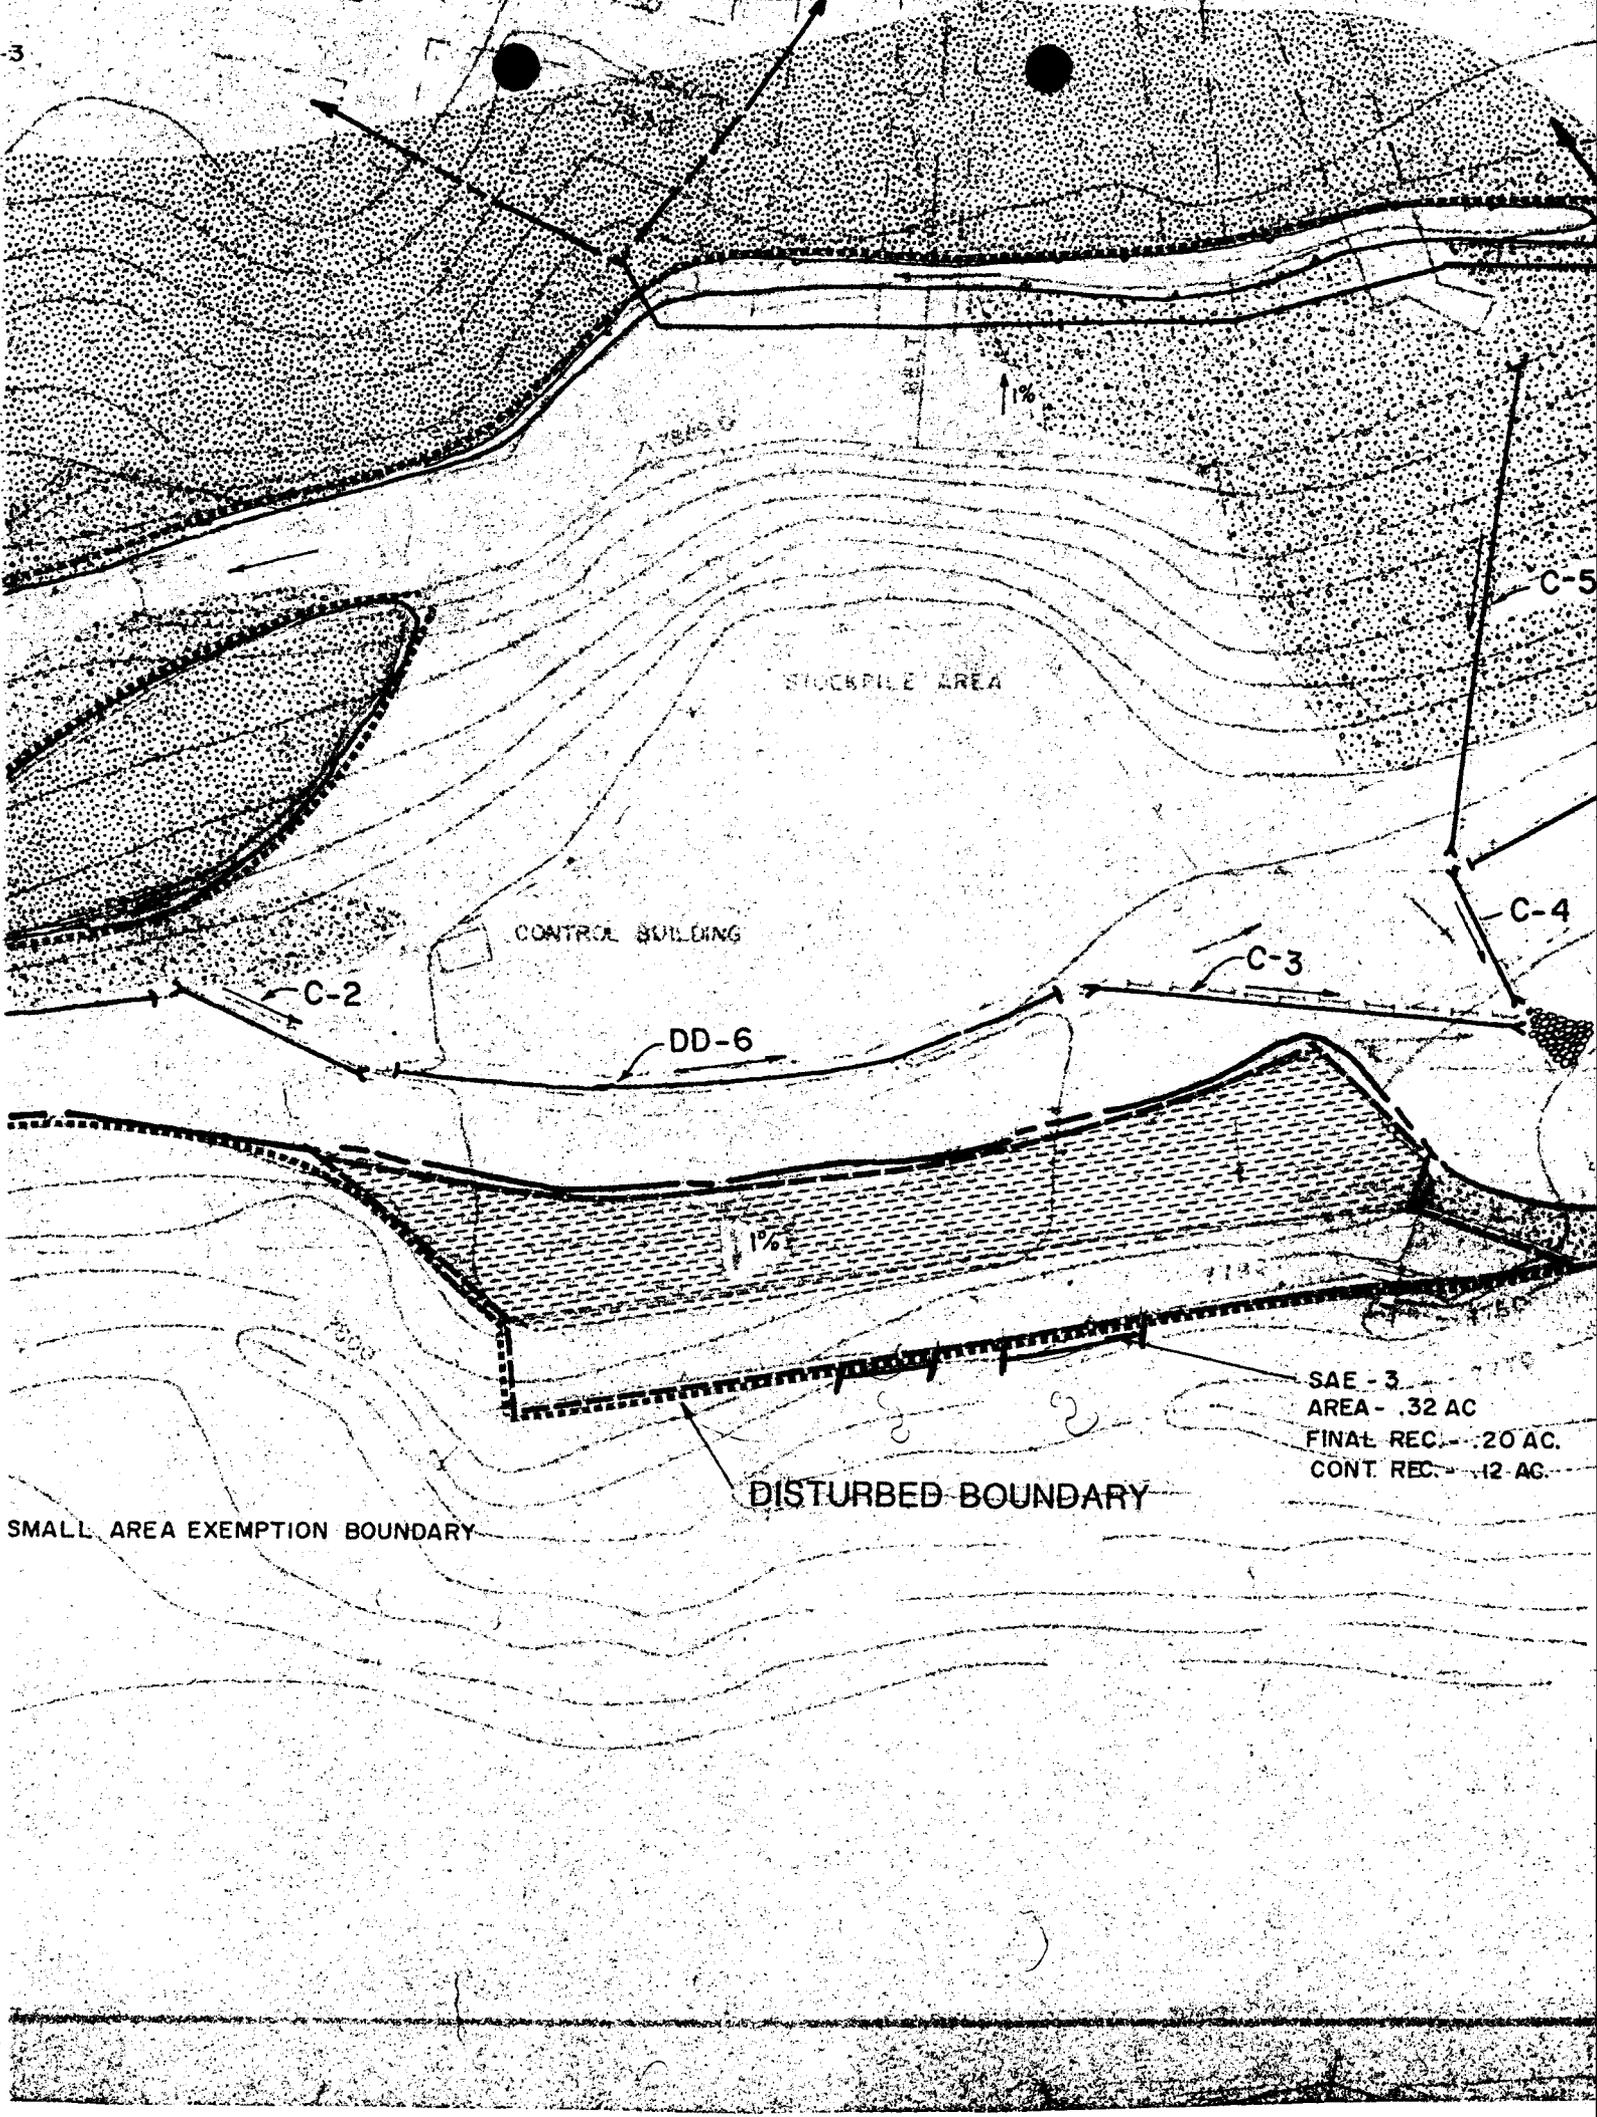
PLATE 7-5

- * In small area exemptions (SAE) 1 and 2, the operator was informed on the removal, installation and/or replacement of silt fencing. For the location of SAE 1 and 2, see Plate 7-5. During this complete inspection, the undersigned inspector located the silt fences in SAE 1 and 2 on a map which will be attached to this report. The locations are not exact and the operator must submit revised maps during the permit renewal review. The operator was informed to properly secure and key in all silt fences.
