WATER QUALITY MEMORANDUM

Utah Coal Regulatory Program

March 15, 2010

RE: 2009 Second Quarter Water Monitoring, Genwal Resources, Inc., Crandall Canyon Mine, Permit & Tracking #3335

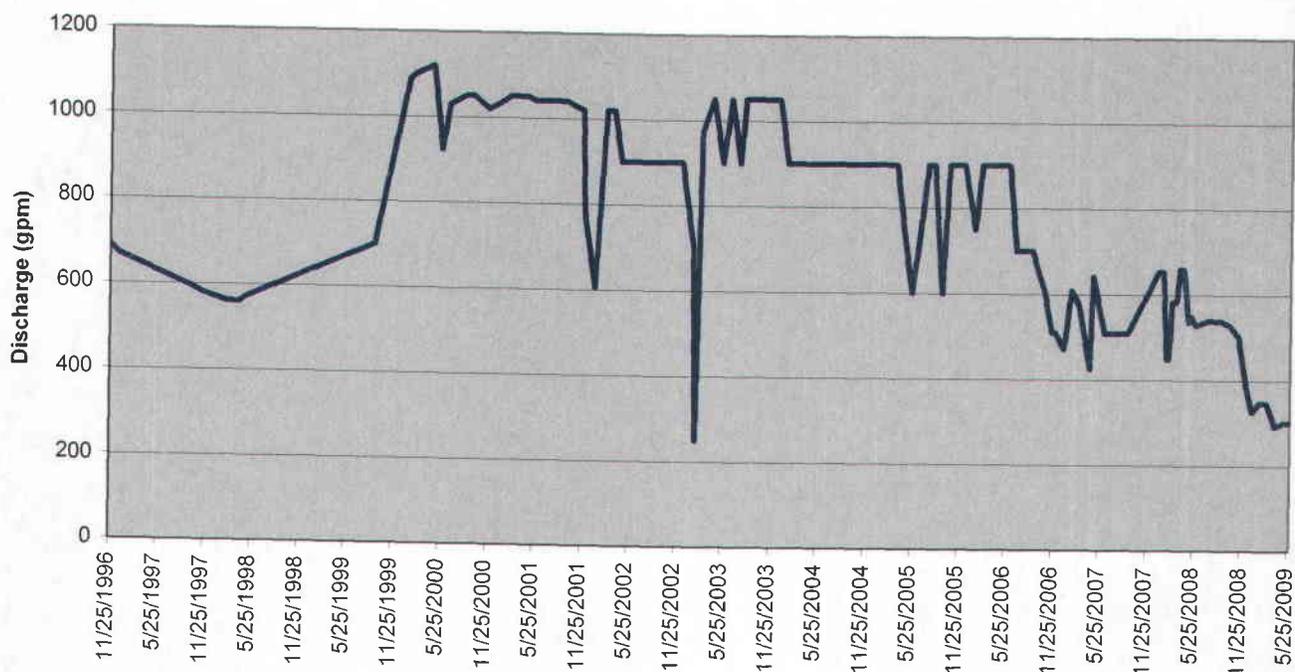
Mine Water Discharge (Outfall 002)

Based on Division of Oil, Gas and Mining records (the Division), the mine encountered significant amounts of ground water and began pumping activities in 1996. Over a 14-year period, the mine pumped an average of 742 gallons of water from the mine workings. Following the mine collapse and subsequent sealing of the portals, the mine did not discharge for the months of October, November and December of 2007. However, by mid January of 2008 the mine had filled to the extent that the mine-water had found it's way around the temporary seals and began to discharge uncontrolled to the surface.
