Inspection Report

Permit Number:	C0150032
Inspection Type:	TECHNICAL
Inspection Date:	Tuesday, July 17, 2012
Start Date/Time:	7/17/2012 9:00:00 AM
End Date/Time:	7/17/2012 1:30:00 PM
Last Inspection:	Tuesday, June 26, 2012

Permitee: **GENWAL RESOURCES INC**
 Operator: **GENWAL RESOURCES INC**
 Site: **CRANDALL CANYON MINE**
 Address: **PO BOX 910, EAST CARBON UT 84520-0910**
 County: **EMERY**
 Permit Type: **PERMANENT COAL PROGRAM**
 Permit Status: **ACTIVE**

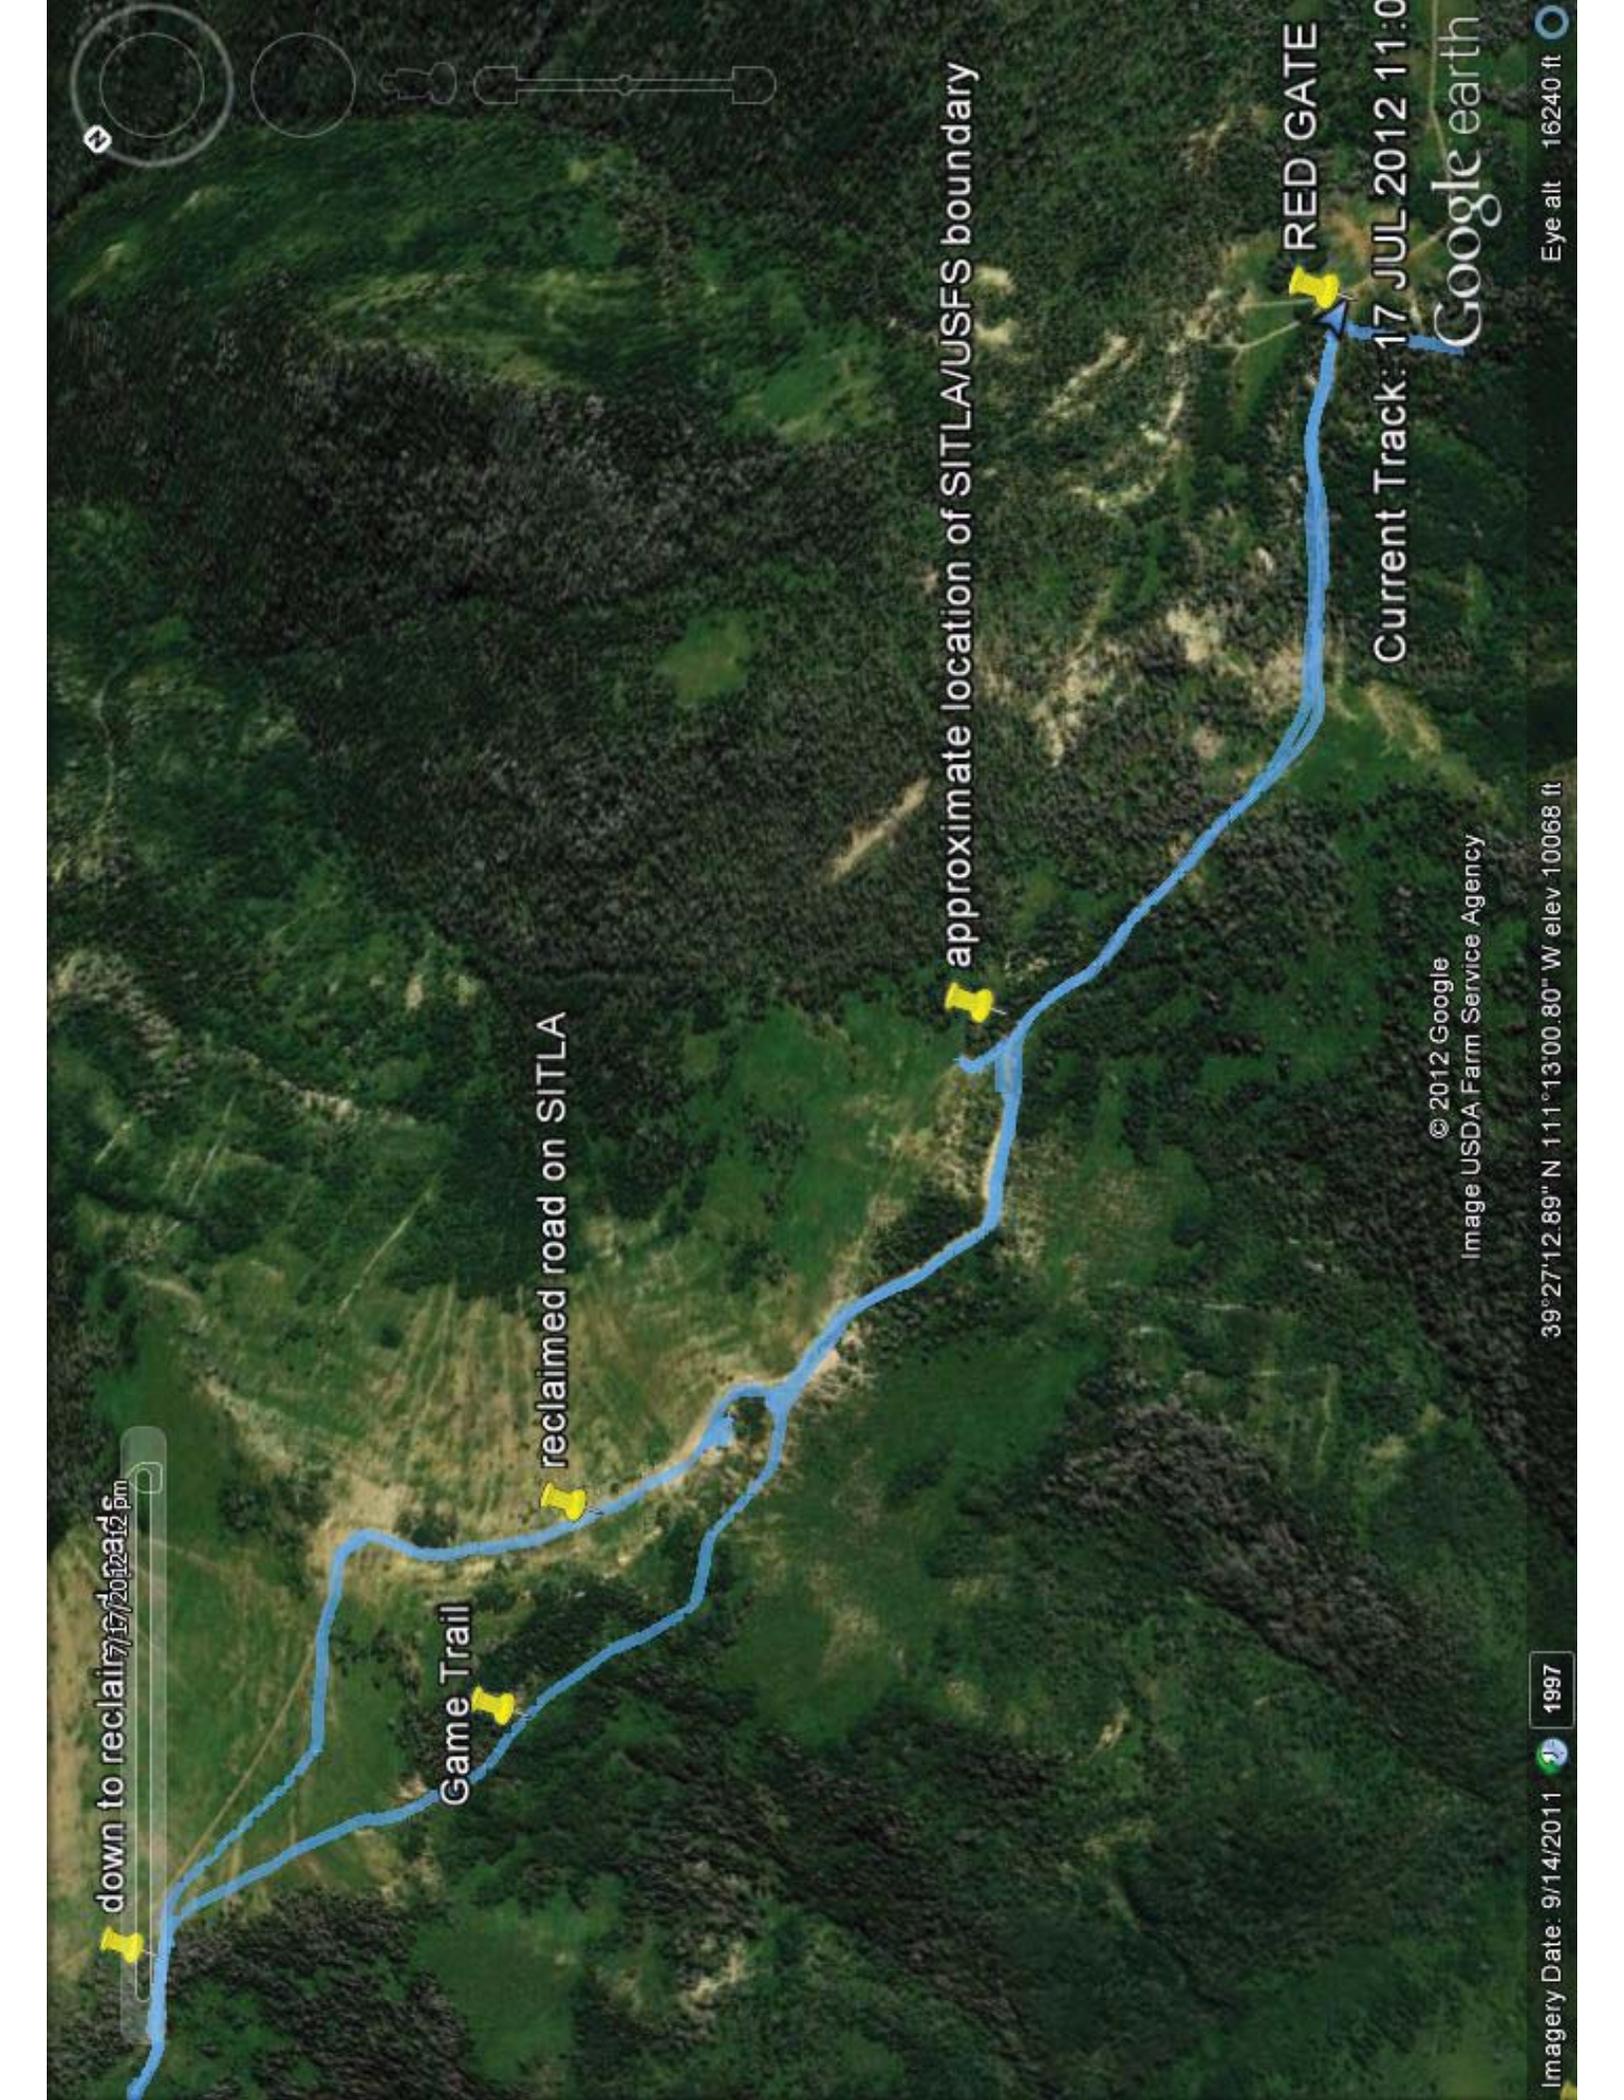
We observed the surface failure below pad #6. (Please refer to Attachment #5 of Appendix 5-22A for pad locations.) This slide is approximately 150 ft. in length and approximately 30 ft. wide. At its head, the cut is 15 ft. high. The soil at the head cut rests on fractured sandstone and is unstable. Last fall, three rows of excelsior logs were installed above the head cut to deflect surface flow away from the cut. There has been no movement since the original slide, but last year there was little snow pack. Loose sediment continues to move down the slide and needs to be stabilized with excelsior logs or wood straw and the slide area needs to be seeded. SITLA representatives are of the opinion that deflecting water away from the head cut may buy time for vegetation to establish on the cut and slide area. Their recommendation was for excelsior logs every 10 - 15 ft. up the slope for a distance of approximately 150 ft. (to the top of the reclaimed pad #6 disturbance). Logs should be placed on a 2% slope from the contour to direct surface flow to the undisturbed vegetation on either side of the cut (measuring from the center of the cut that's a distance of approximately 100 ft. to either side of center). The location of the slide is shown on the attached google earth map.
