OGMCOAL - Crandall Canyon Inspection Report: 5/15/2012

Inspection Report

Permit Number:	C0150032
Inspection Type:	PARTIAL
Inspection Date:	Tuesday, May 15, 2012
Start Date/Time:	5/15/2012 1:30:00 PM
End Date/Time:	5/15/2012 3:30:00 PM
Last Inspection:

Permitee: **GENWAL RESOURCES INC**
 Operator: **GENWAL RESOURCES INC**
 Site: **CRANDALL CANYON MINE**
 Address: **PO BOX 910, EAST CARBON UT 84520-0910**
 County: **EMERY**
 Permit Type: **PERMANENT COAL PROGRAM**
 Permit Status: **ACTIVE**

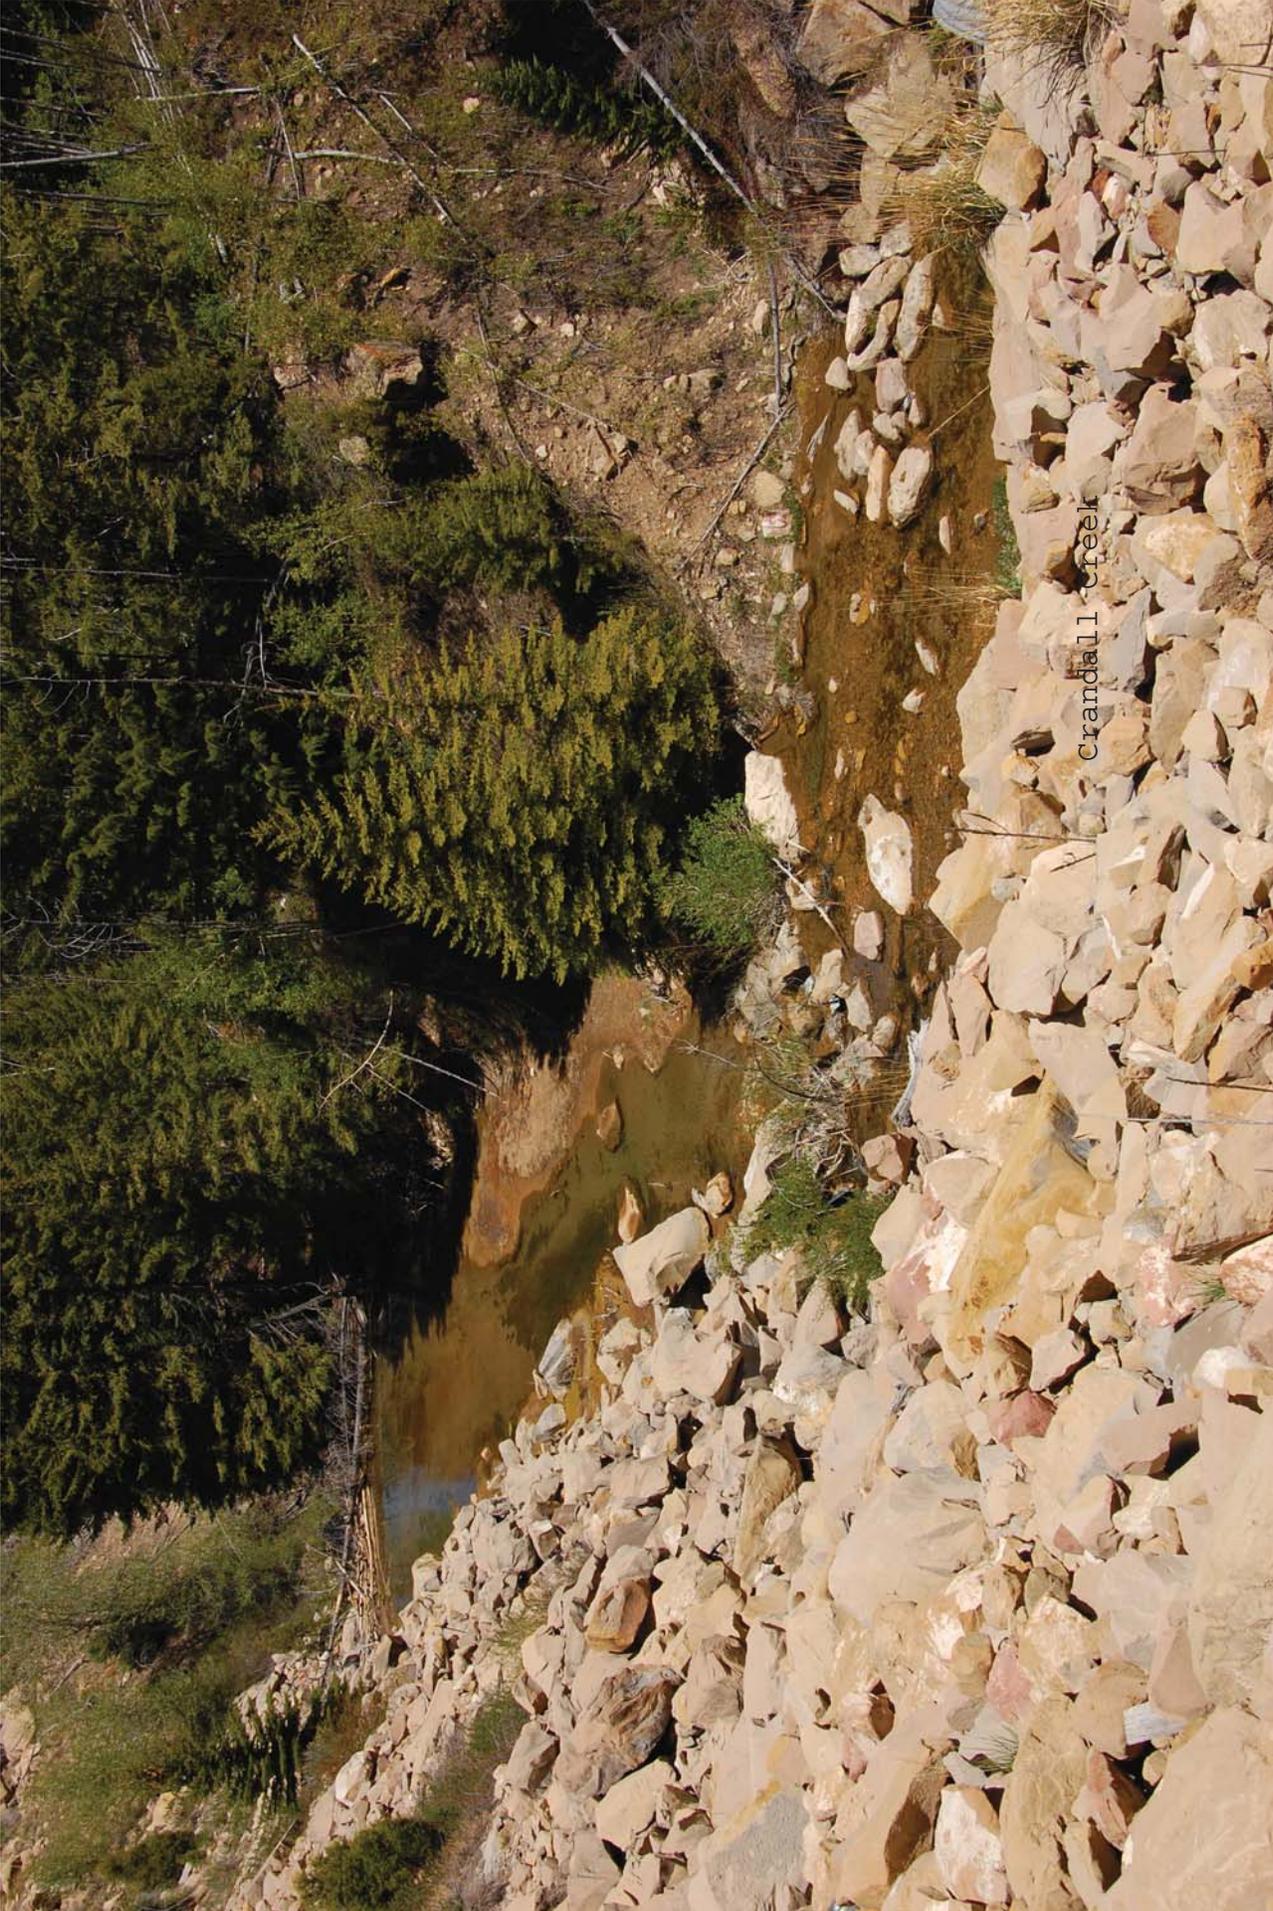
The primary sediment pond was observed during the inspection. A large accumulation of iron sludge material was observed at the inlet to the pond. The two sediment clean-out markers were observed to be buried by the accumulated sludge material. Mr. Marshall and Mr. Leonard were instructed to have the primary sediment pond cleaned as it appears that the clean-out level had been surpassed by the accumulated iron sludge material.

Primary Sediment Pond.

No violations were identified during the inspection. Mr. Marshall and Mr. Leonard were instructed to: 1) Remove coal/rock debris from disutrbed drainage ditch DD-10 2) Follow up on the label for the flocculant injection rate shown in automated mine-water treatment display panel and 3) Initiate clean-out operations on the primary sediment pond.
