**PRE-BLASTING SURVEY
OF THE
SWAPP RANCH
FOR
ALTON COAL DEVELOPMENT, LLC
COAL HOLLOW MINE**

**BY
DAN W. GUY, P.E.
AUGUST 23, 2011**

PRE-BLASTING SURVEY

SWAPP RANCH

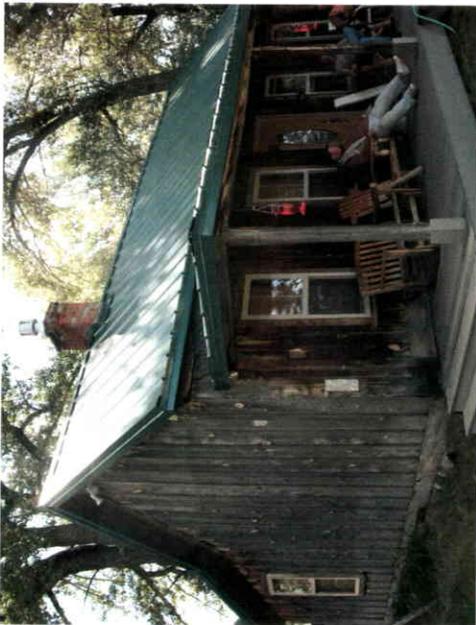
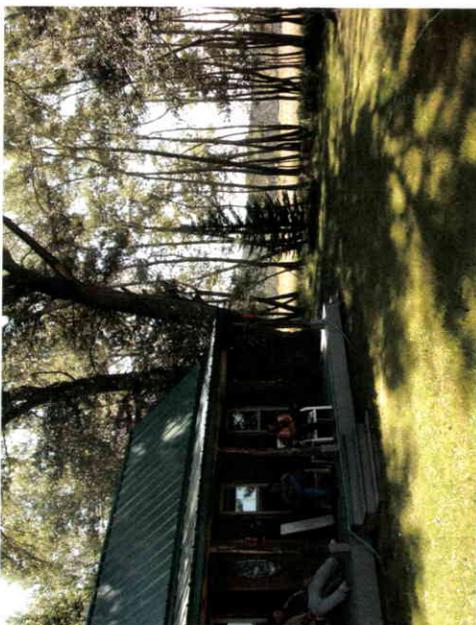
PLATE-3

An existing covered porch has been renovated at the front of the house, along with the addition of a steel roof. The sides and back of the house have not been recovered. Photos of the exterior of the house are shown in Plates 3 through 5. The house appears to be in very good condition for its age. The remodeling has brought it into standards of modern houses. The portions of the house that have not been altered (exterior side and back walls), are obviously weathered, but are also in good condition considering their age. Although the house sits on a layered rock foundation, it appears to be quite stable, with very few visible cracks in the interior walls. A small vertical crack was noted above the doorway in the northeast bedroom, and 2 small cracks were noted and photographed in the kitchen area. No cracks were observed in the floor or bathroom tiles. The present condition of the house was documented by numerous photos shown on Plates 3 through 13 of this report.

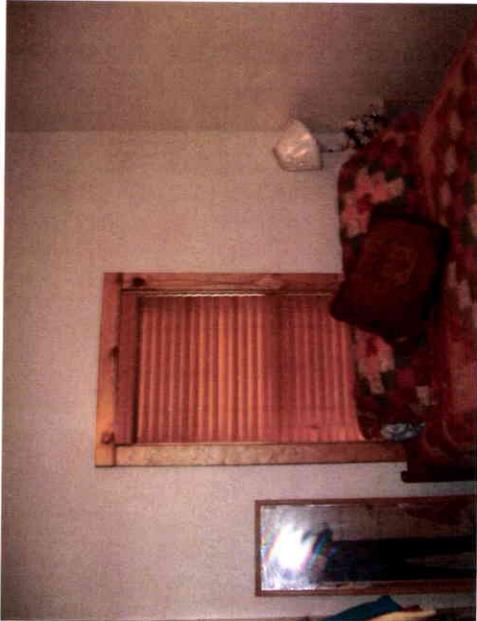
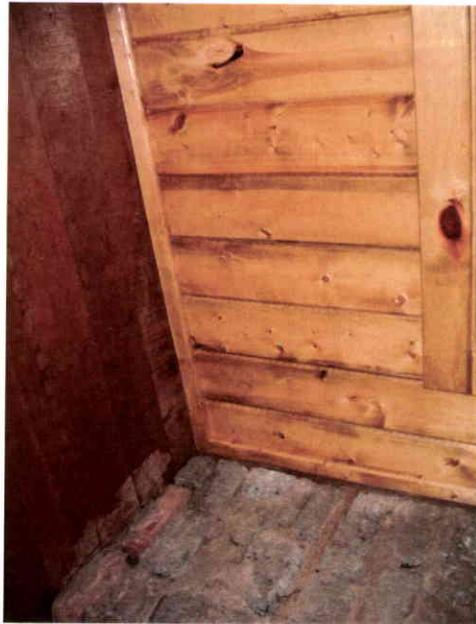
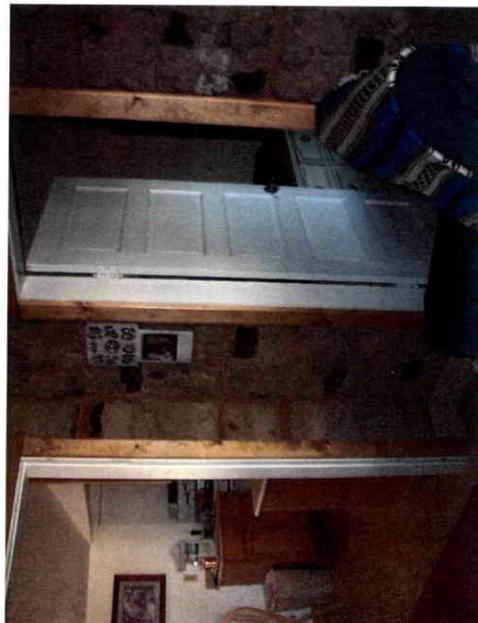
PLATE-6

Ranch House – The ranch house is basically wood construction with a layered rock foundation. According to the owner, the house was constructed in 1903-1904. It was originally located to the north and later moved to its present location. The interior walls are all adobe with wood frames, and the exterior walls are wood. The entire interior of the ranch house has been remodeled. All interior walls and ceilings have been recovered with wood or sheetrock and textured. The only exception is 2 of the adobe walls in the entry/living room have been left exposed. The floors have all been recovered with tile or carpet. The house is wired for power, which is provided by solar panels and batteries, and it is also plumbed, with water supplied by a nearby spring. The house has an entry/living area with a gas fireplace, tile floor, wood slat ceiling and adobe and wood slat walls. There are 3 bedrooms, all of which are carpeted with textured sheetrock walls and ceilings. The combined kitchen/dining area and adjacent closet/pantry all have tiled floors with textured sheetrock walls and ceilings. The bathroom also has a tile floor and tile shower. The walls and ceiling are

also textured sheetrock. The interior of the house is shown on Plates 6 through 13.

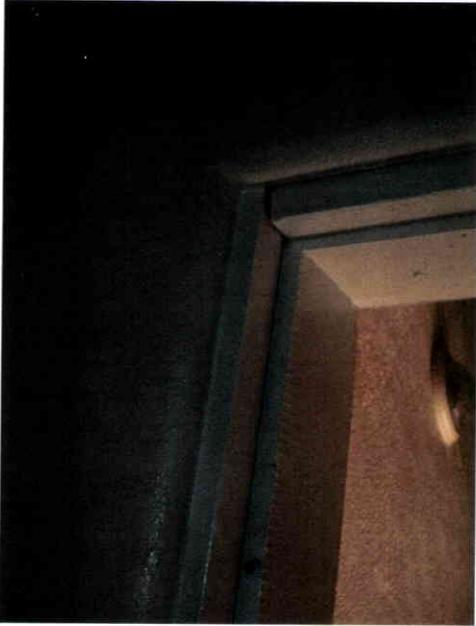
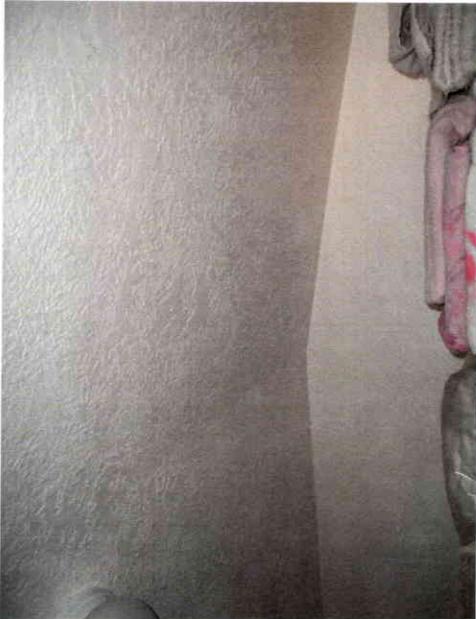
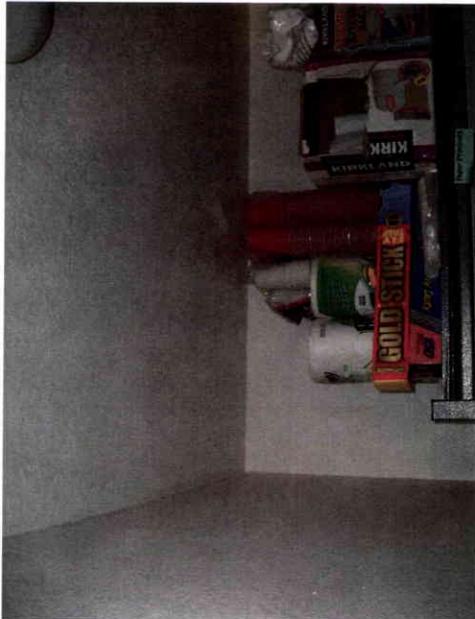
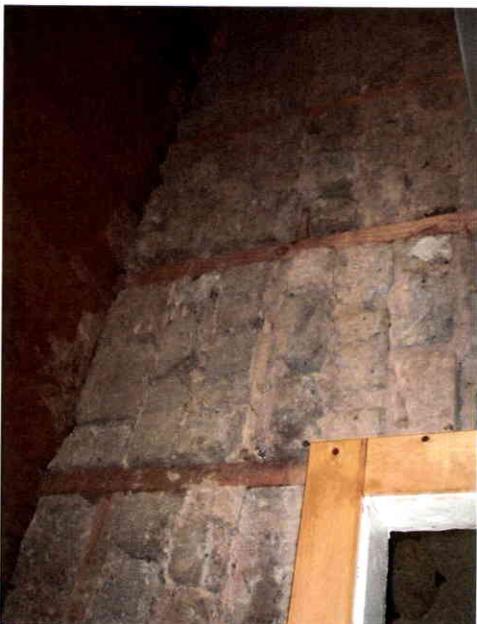
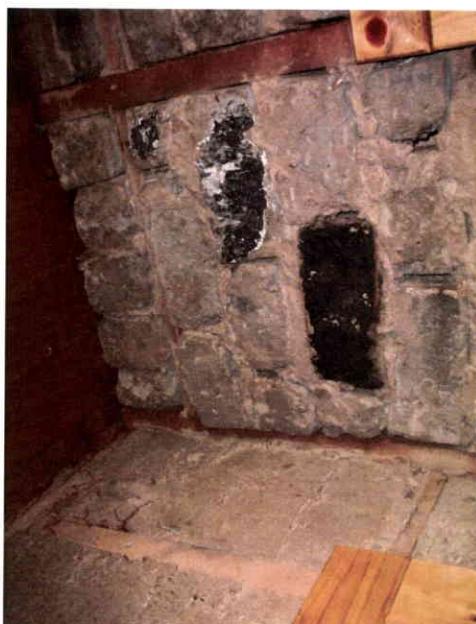
PLATE-13

Plate 13-Ranch House Interior

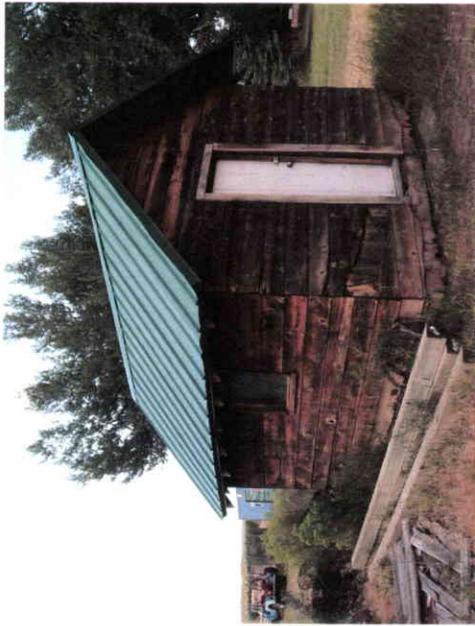
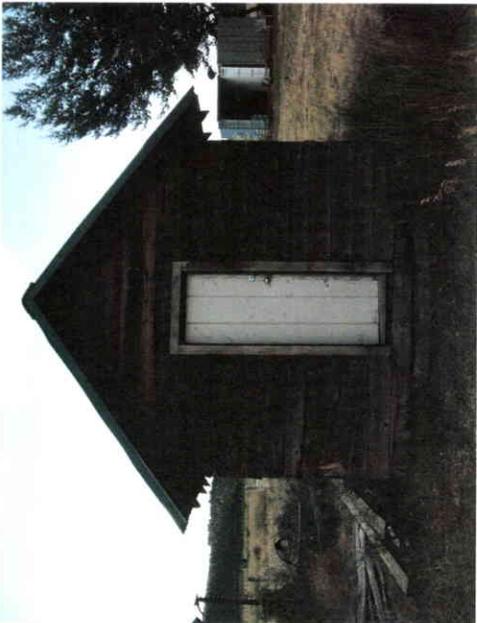
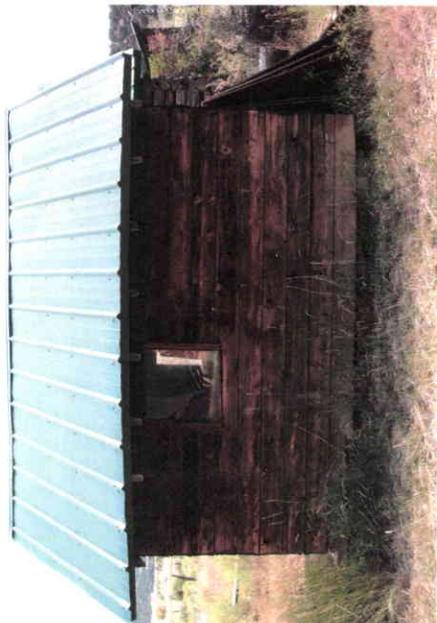
PLATE-14

Storage Building – The storage building is located northeast of the ranch house. It is a wood building with a steel roof. It has no foundation and sits on wooden blocks. The structure appears to be quite stable. The exposed wood is quite weathered, but undamaged. The newer steel roof also adds to the stability of the structure by adding strength and reducing accumulations of snow. Photos of this structure are shown on Plate 14 of this report.

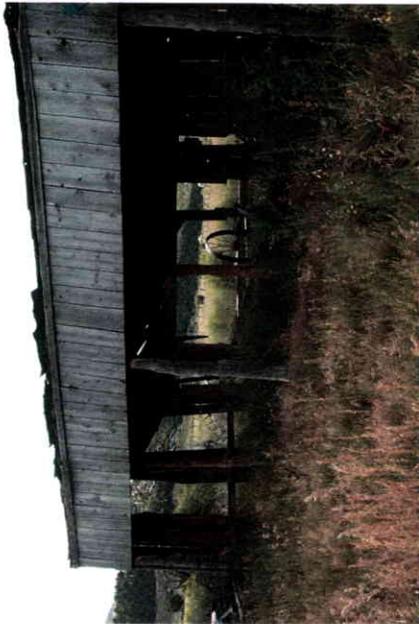
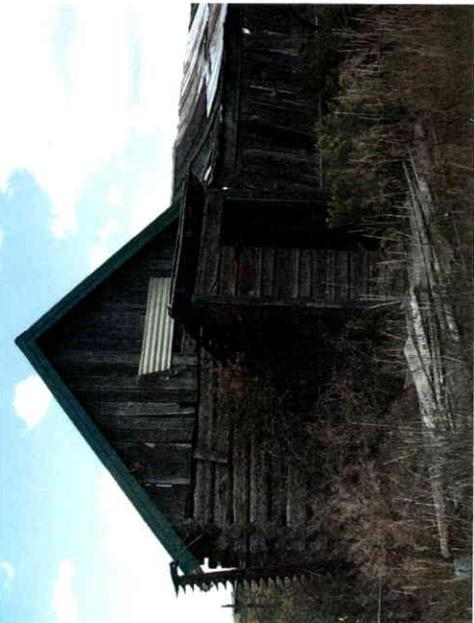
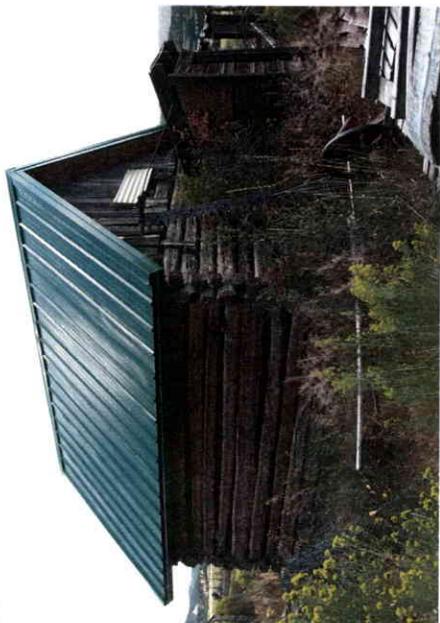
PLATE-15

Log Storage Building / Livestock Barn – These 2 structures are joined. The storage building is constructed of logs with a steel roof and no foundation. The livestock barn is wood construction with a dirt floor, open front, no foundation and a galvanized tin roof. The storage building is enclosed and appears to be stable and in fair to good condition. The livestock barn is quite weathered and is in relatively poor and less stable condition. These structures are shown on Plate 15.

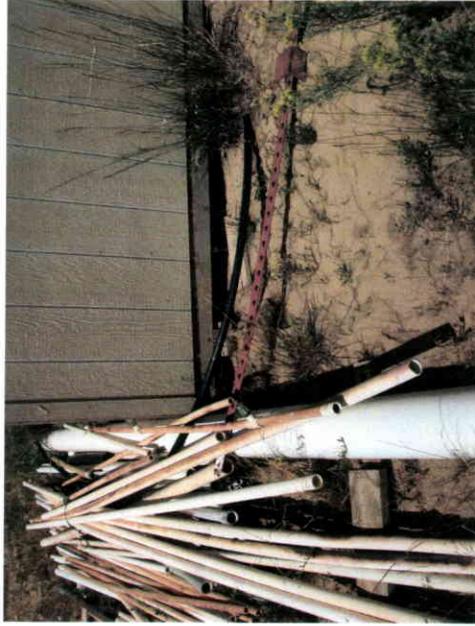
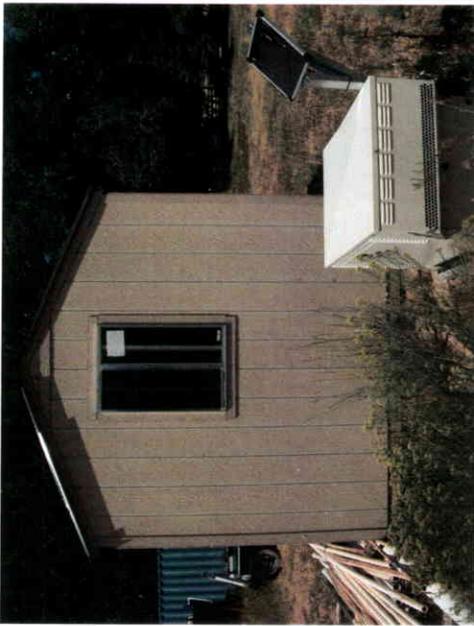
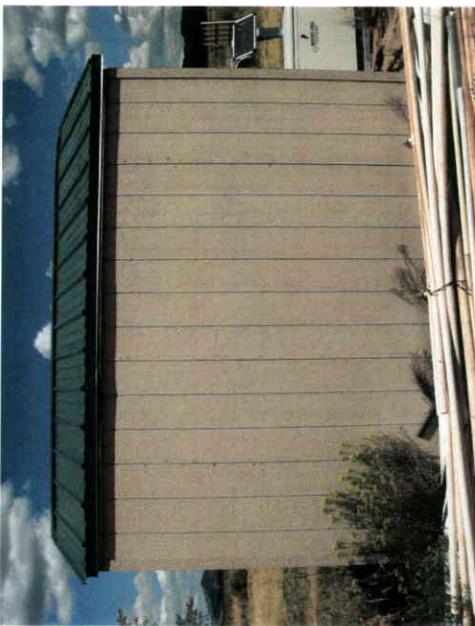
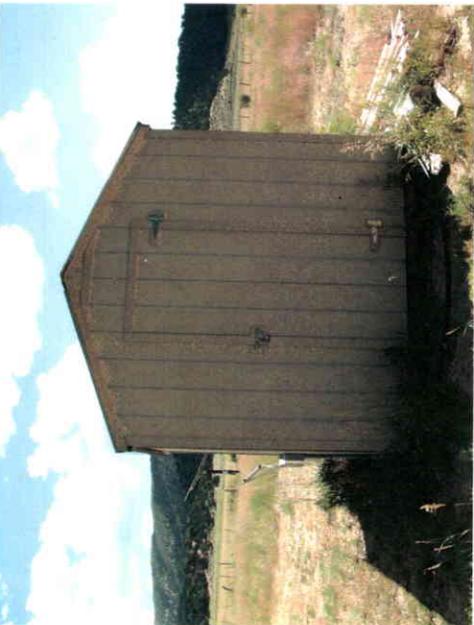
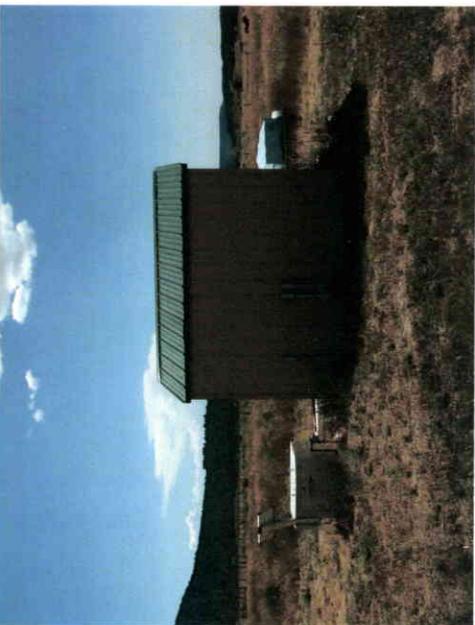
PLATE-16

Power Building – This is a combination wood laminate and steel building, with no foundation, sitting on wooden blocks. This building is described on Plate 2 as a garden shed. The power building houses the batteries which are charged by the solar panels and supply electricity to the ranch house. The building is fairly new, and appears to be in good, stable condition. It is shown on Plate 16.
