Division of Oil, Gas and Mining

Inspection Report

Permit Number:	C0250005
Inspection Type:	TECHNICAL
Inspection Date:	Monday, September 29, 2014
Start Date/Time:	9/29/2014 2:00:00 PM
End Date/Time:	9/30/2014 12:30:00 PM
Last Inspection:	Tuesday, September 09, 2014

Site: **COAL HOLLOW**

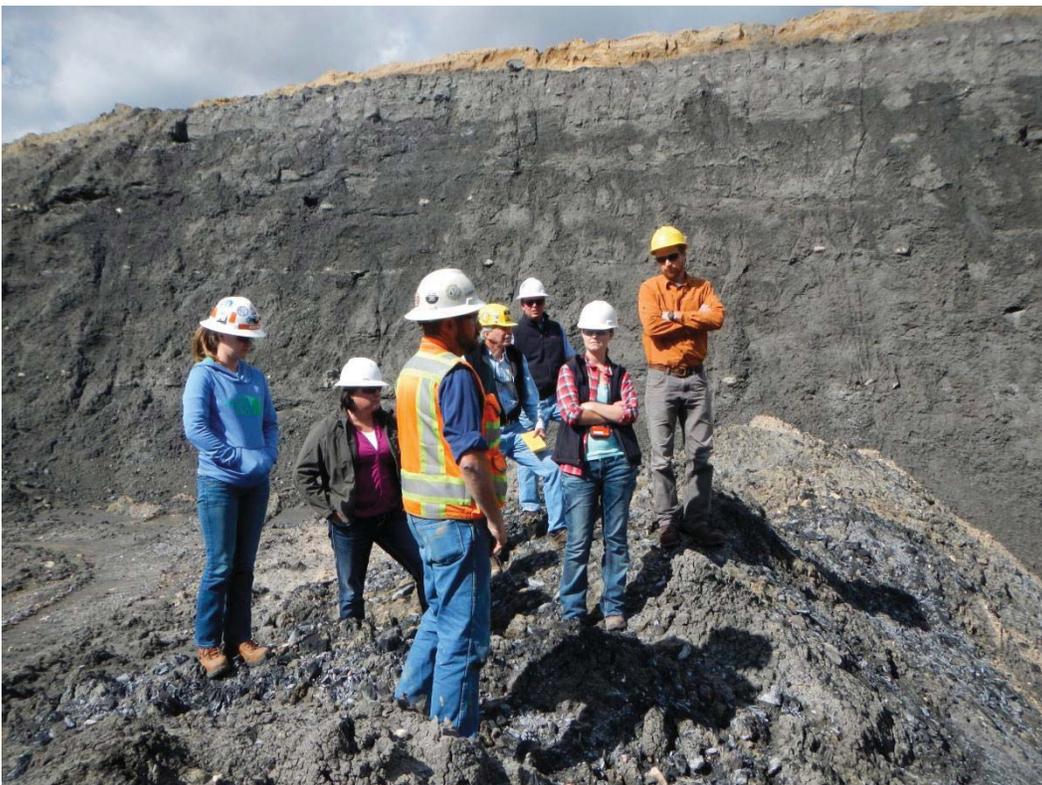
Above: Pit 10. Below: Kirk Nichols addresses Cheryl Parker, Lisa Reinhart, Joe Helfrich, Steve Christensen, Amanda Daniels, and Keenan Storer
