State of Utah

Division of Oil, Gas and Mining

Inspection Report

Permittee: **ALTON COAL DEVELOPMENT LLC**
 Operator: **ALTON COAL DEVELOPMENT LLC**
 Site: **COAL HOLLOW**
 Address: **463 North 100 West, Suite 1, CEDAR CITY UT 84720**
 County: **KANE**
 Permit Type: **PERMANENT COAL PROGRAM**
 Permit Status: **ACTIVE**

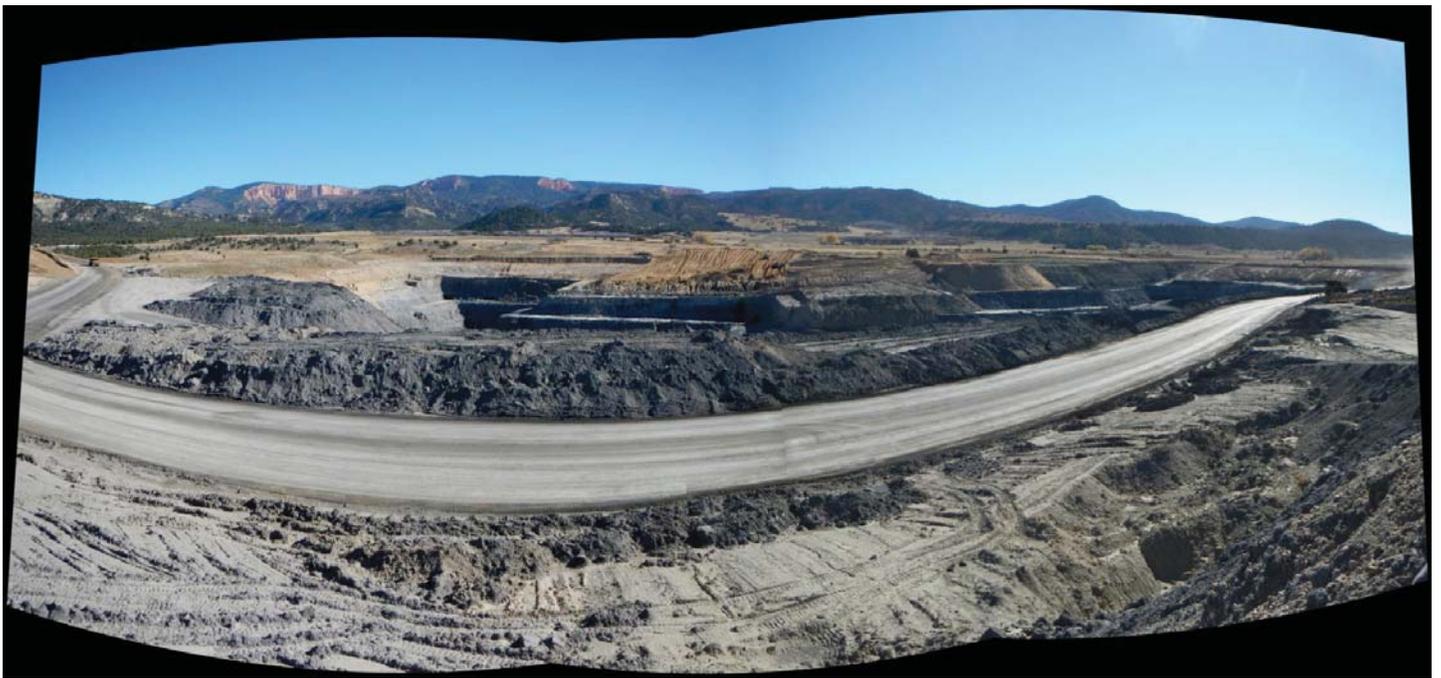
Looking east at the haul road. Pit 10 highwall is benched. Pit 10 is being enlarged to the south to recover the auger bit. Alluvium being pushed with dozer above the Pit 10 highwall. Alluvium is stockpiled to the south of pit 10 in a flat topped mound. The truck on the haulroad (far right) is approaching the location of Trench Highwall 1 (THW1) which is just west of the flat topped mound of alluvium.
