Division of Oil, Gas and Mining

Inspection Report

Permit Number:	C0250005
Inspection Type:	COMPLETE
Inspection Date:	Monday, March 23, 2015
Start Date/Time:	3/23/2015 2:30:00 PM
End Date/Time:	3/24/2015 3:30:00 PM
Last Inspection:	Tuesday, February 10, 2015

Site: **COAL HOLLOW**

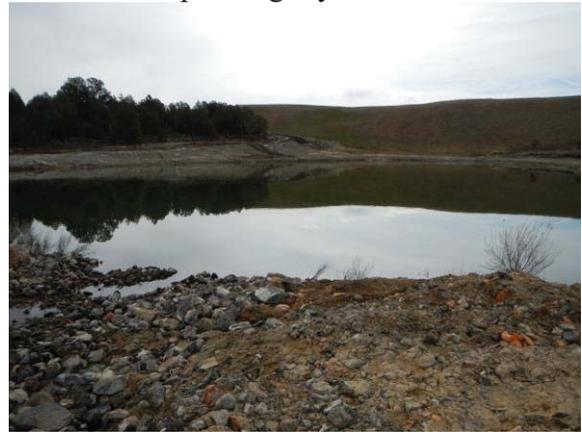
Pond 3 outlet is

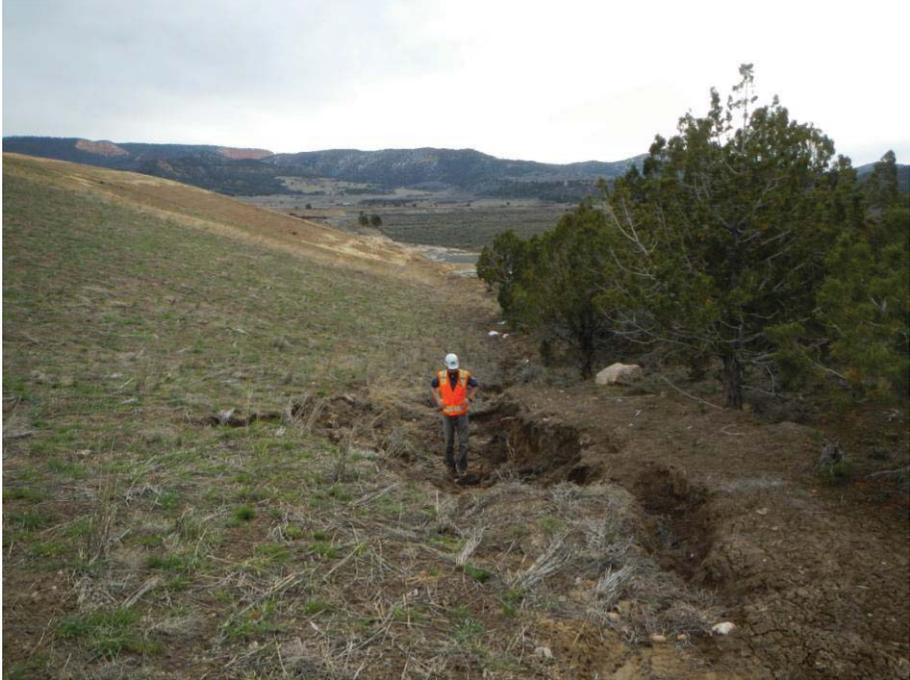
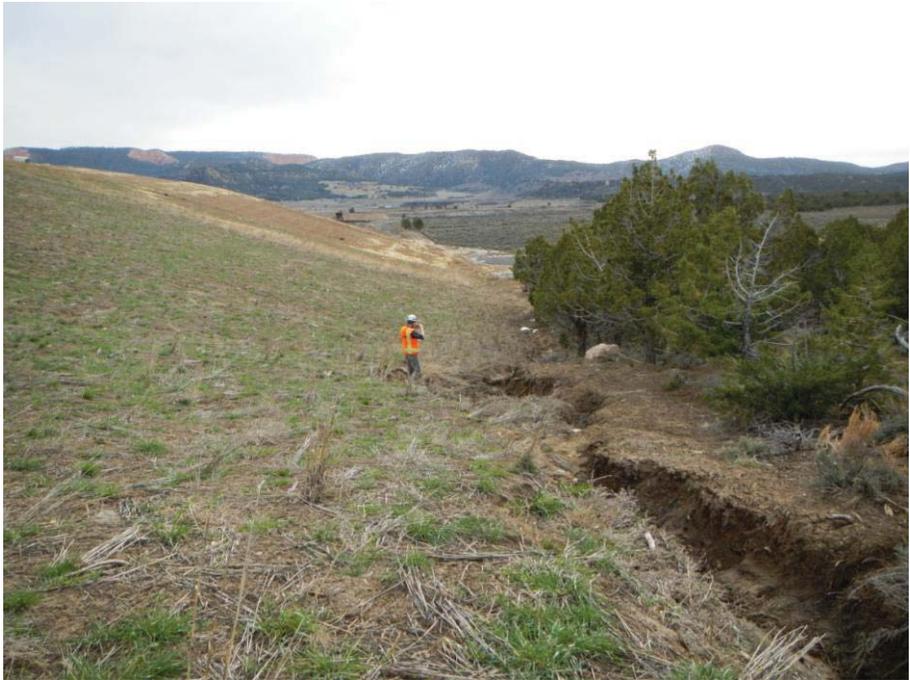
A large gully has formed where the south-west corner of the refuse pile adjoins with the undisturbed local topography (Figure 26). This is likely due to discharge of sub-surface lateral flow at the refuse pile-natural topography junction.

Figure 26. March 24th inspection. Gully erosion on south side of refuse pile.
