Inspection Report

Permit Number:	C0250005
Inspection Type:	COMPLETE
Inspection Date:	Tuesday, September 22, 2015
Start Date/Time:	9/22/2015 9:00:00 AM
End Date/Time:	9/22/2015 4:00:00 PM
Last Inspection:	Thursday, August 27, 2015

Permittee: **ALTON COAL DEVELOPMENT LLC**

Site: **COAL HOLLOW**

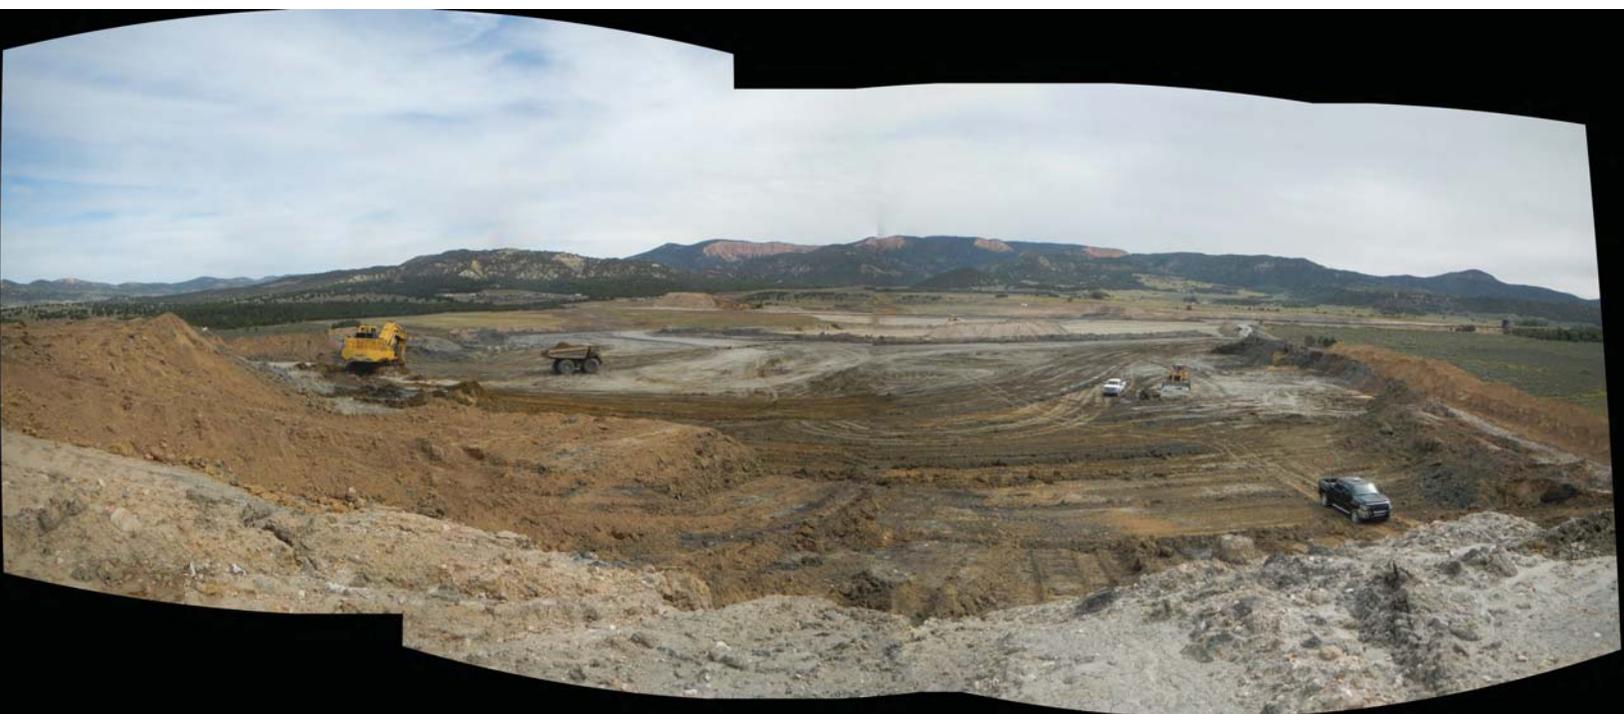
Borrow ditches have been established on the reclaimed county road in the south end of the permit area.

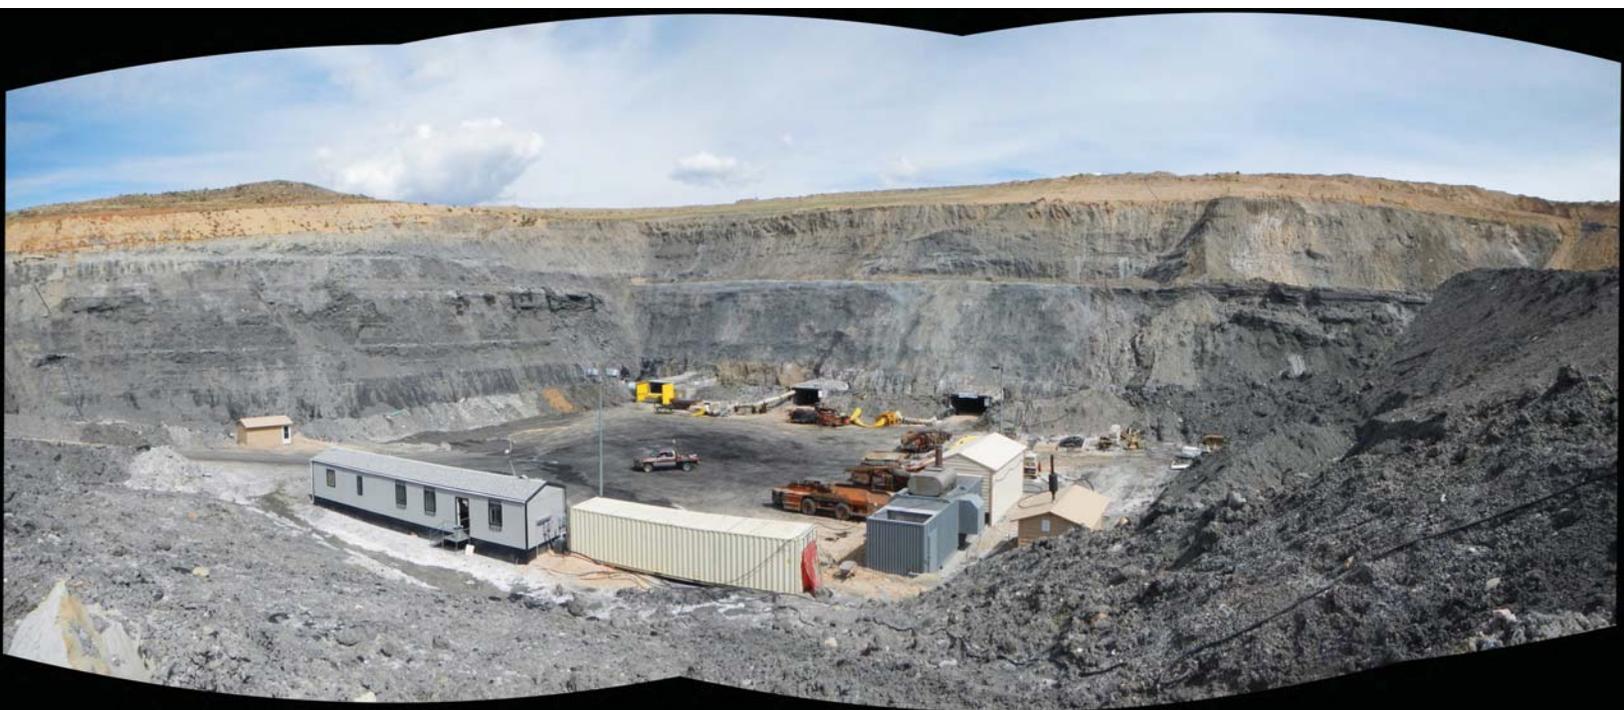
A berm creating UD2 and separating shop activity from Lower Robinson Creek had been breeched. A small pipe had been installed to drain a cleaning station that was installed between two portable buildings (Conex containers). NOV 21158 was issued for failure to maintain diversions and failure to prevent additional contributions of suspended solids to the stream channel. Ditch DD4 needs cleaning up and dressing up at the location above the transition zone of Lower Robinson Creek. This site has been a maintenance item in previous inspections, when it was noted that the area needed to dry out. The area was dry as can be expected and ditch DD4 was included in the above violation.

NOV 21158. DD4 berm failure.
