## 0250005 Coal Hollow Complete Insp Rpt # 4145

# Inspection Report

Permit Number:	<b>C0250005</b>
Inspection Type:	COMPLETE
Inspection Date:	Monday, March 23, 2015
Start Date/Time:	3/23/2015 2:30:00 PM
End Date/Time:	3/24/2015 3:30:00 PM
Last Inspection:	Tuesday, February 10, 2015

Permittee: **ALTON COAL DEVELOPMENT LLC**  
 Operator: **ALTON COAL DEVELOPMENT LLC**  
 Site: **COAL HOLLOW**  
 Address: **463 North 100 West, Suite 1, CEDAR CITY UT 84720**  
 County: **KANE**  
 Permit Type: **PERMANENT COAL PROGRAM**  
 Permit Status: **ACTIVE**

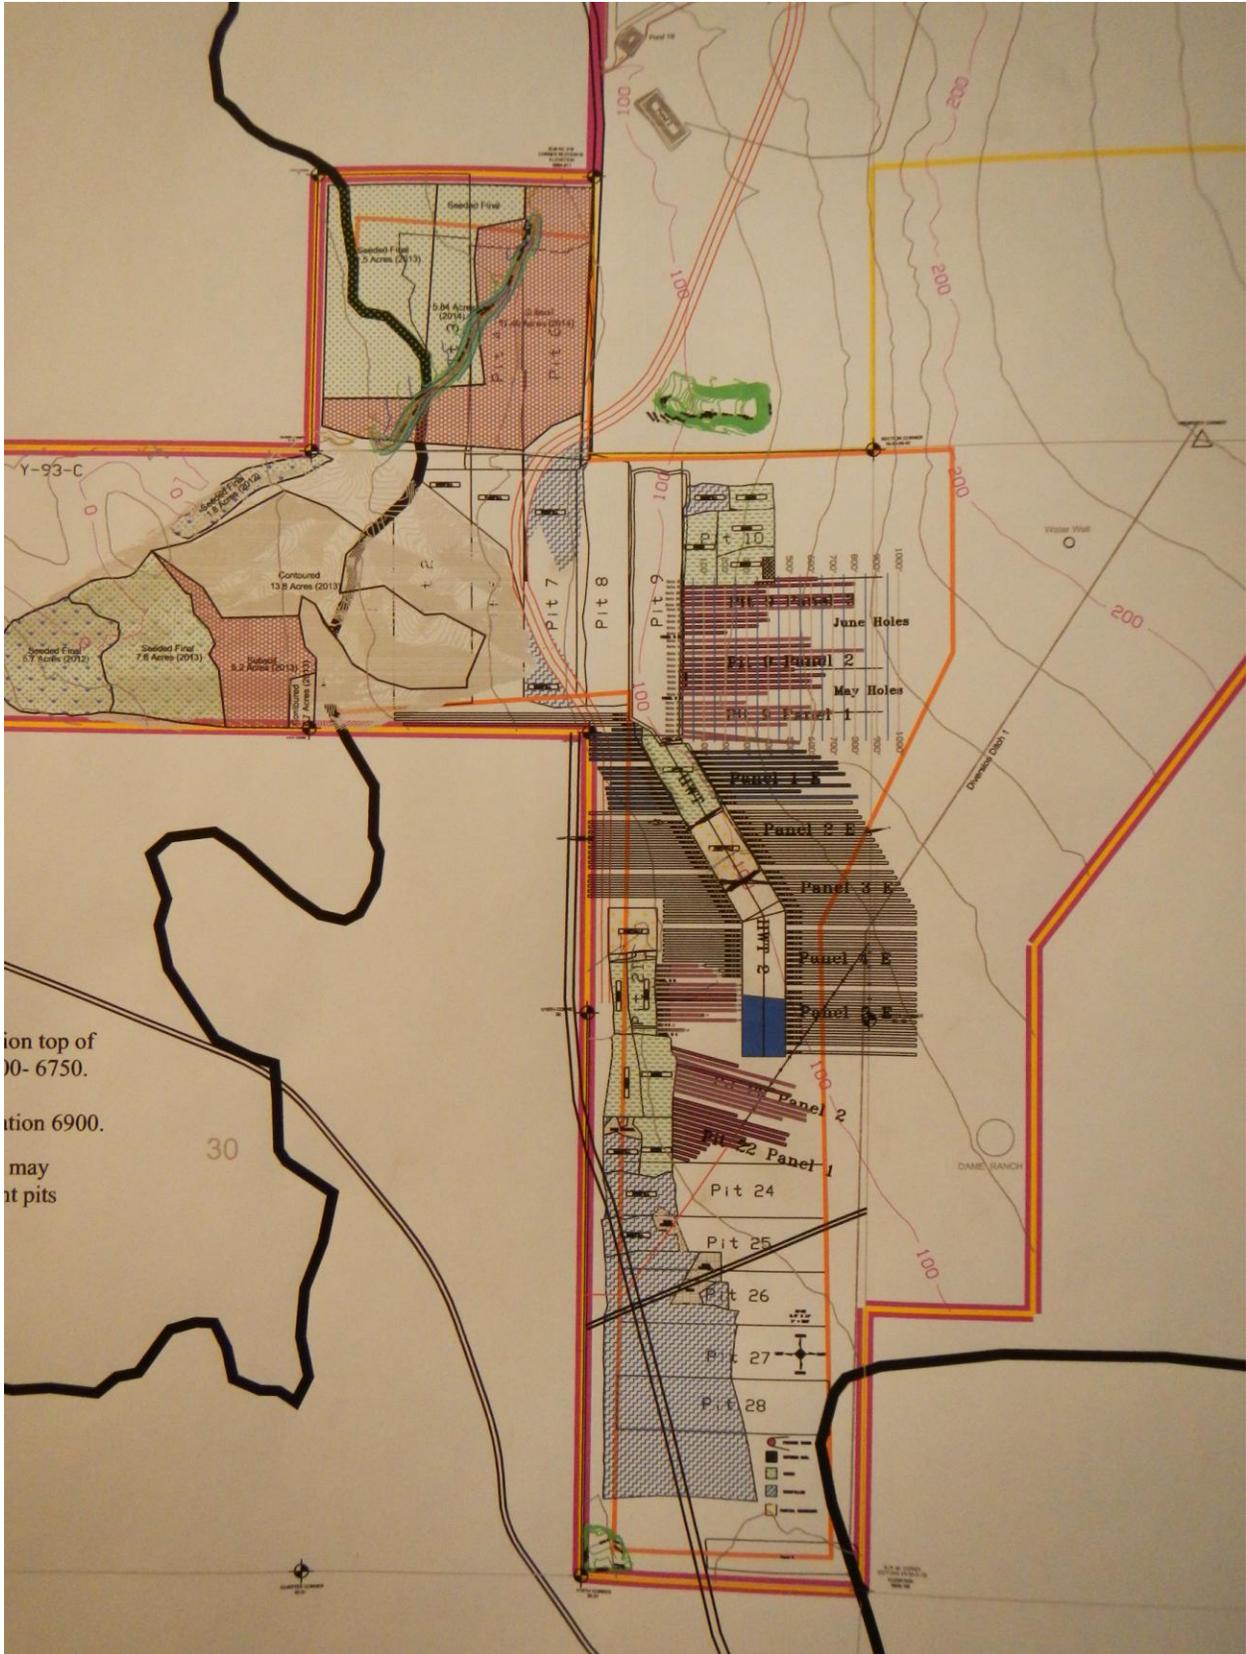
Mining Disturbance Map showing mine progress as described in this report’s summary.

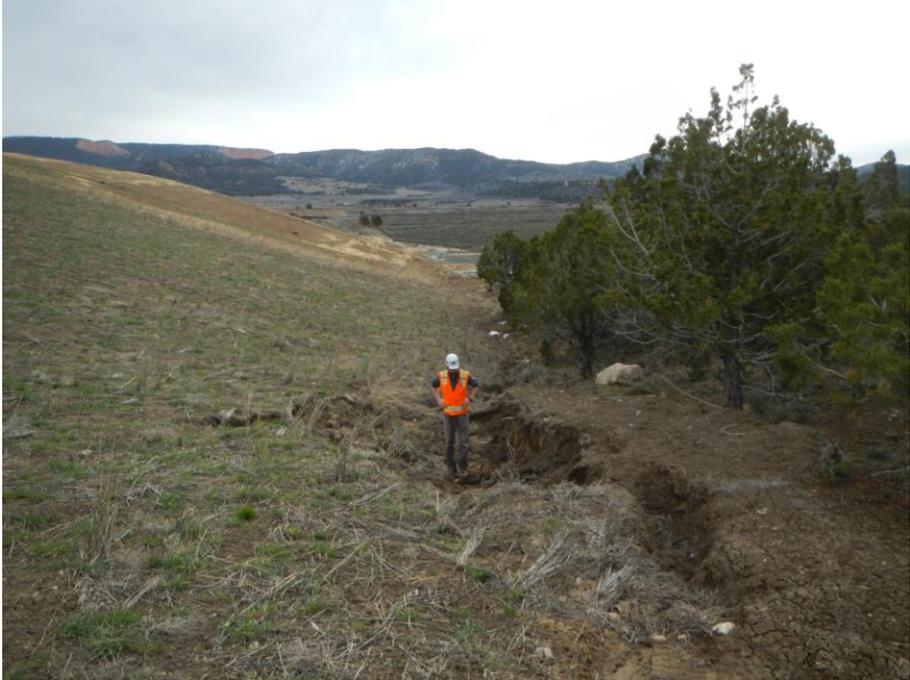
A large gully has formed where the south-west corner of the refuse pile adjoins with the undisturbed local topography (Figure 26). This is likely due to discharge of sub-surface lateral flow at the refuse pile-natural topography junction.

Figure 26. March 24<sup>th</sup> inspection. Gully erosion on south side of refuse pile.

Repair the gully on the S side of the excess spoil pile.
