Coal Hollow 5/13/2015 Inspection Report

Inspection Report

InspectionID Report Number: 4192

Permittee: **ALTON COAL DEVELOPMENT LLC**
 Operator: **ALTON COAL DEVELOPMENT LLC**
 Site: **COAL HOLLOW**
 Address: **463 North 100 West, Suite 1, CEDAR CITY UT 84720**
 County: **KANE**
 Permit Type: **PERMANENT COAL PROGRAM**
 Permit Status: **ACTIVE**

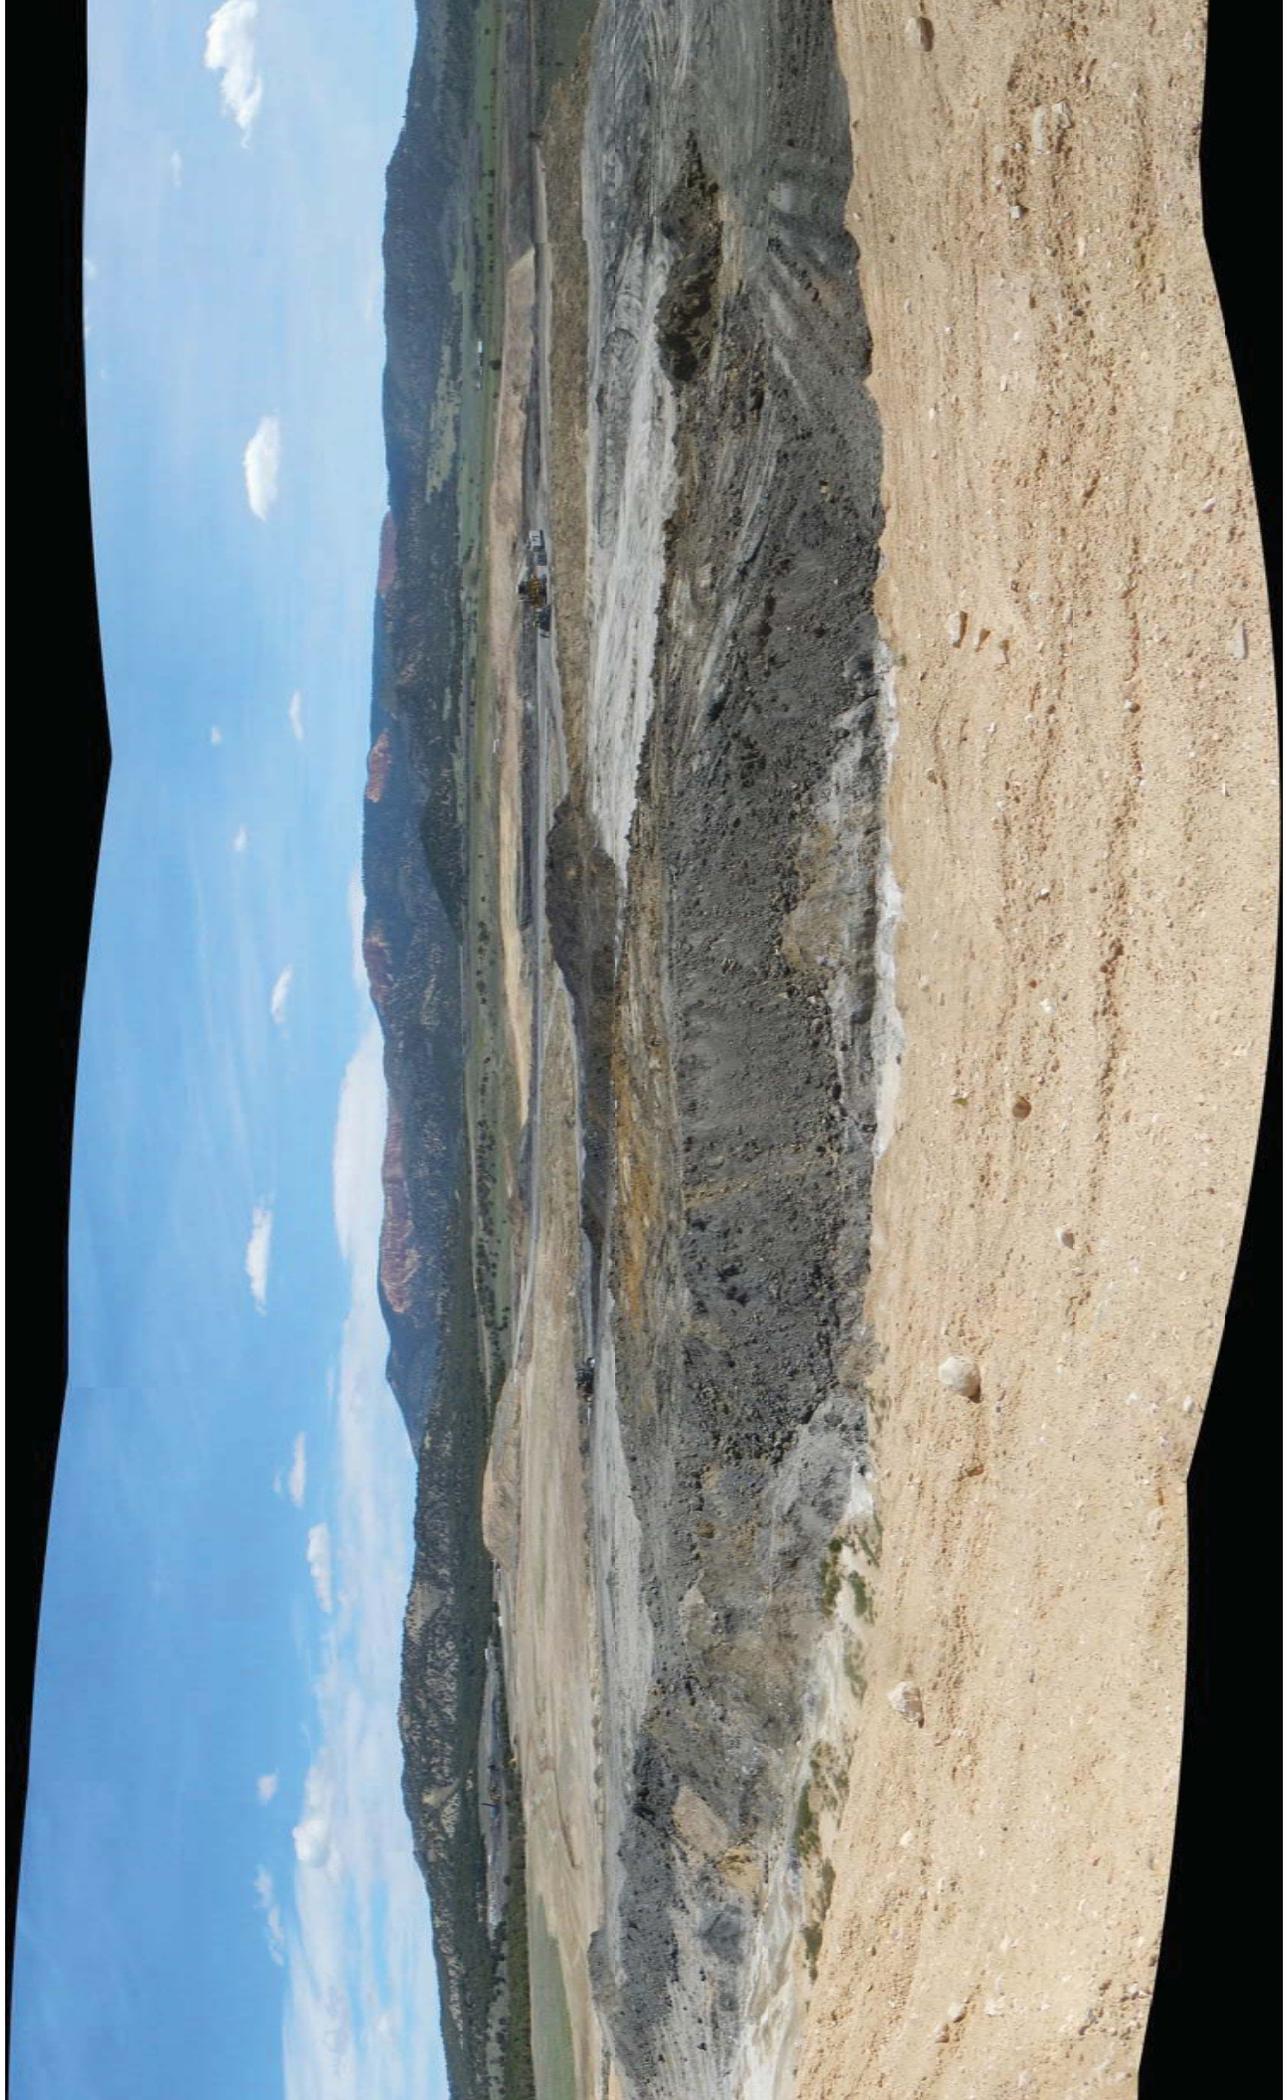
DD 4

DD#4 was under construction using a bobcat excavator. The ditch measured 5 ft wide with 2h:1v side slopes. The "borrow" from the ditch was being placed on the uphill side of the ditch (that is the side near Robinson Creek). When it comes time to reclaim, the ditch will be filled in with this soil. Designs for DD #4 are found in Dwg 5-34. Seed was on hand to seed the new ditch DD#4 and to seed the location of the old ditch, that has now been filled in.
