**Citation for Non-Compliance
Utah Coal Regulatory Program**

Citation #: 20153

Inspection Report

InspectionID Report Number: 4234

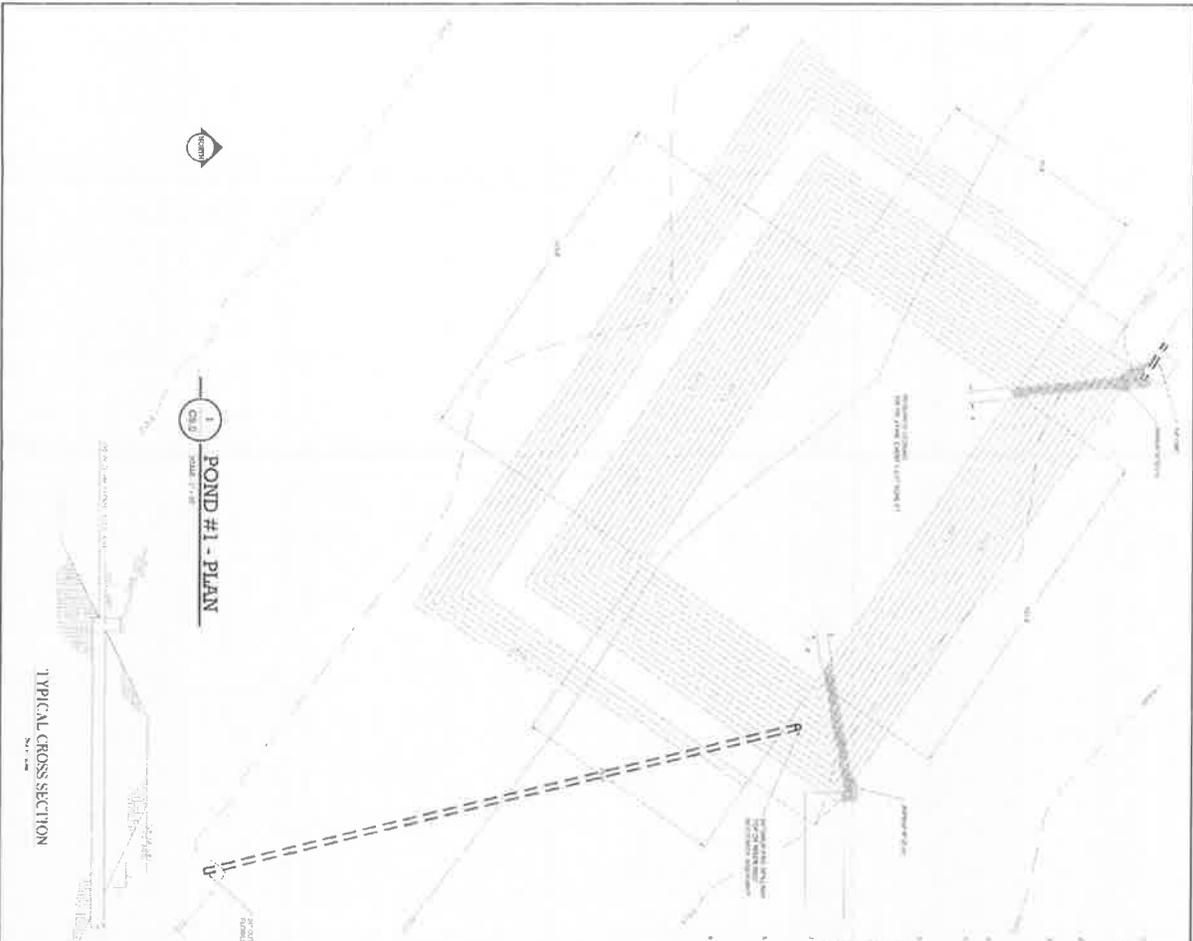
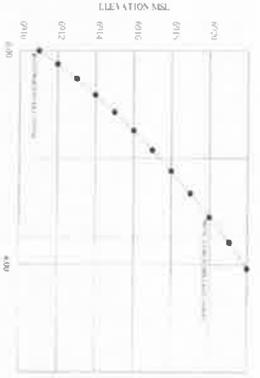
POND #1 - PLAN
SCALE: 1" = 40'

Pond three still requires maintenance on the inlet armoring. The June 16th inspection stated the need for maintenance on the inlet to repair the pond to the Asbuilt design. The water level of the pond is low creating an opportune time to make said improvements.

Inspection 4219: As discussed during the inspection: the material dredged from pond 1 is now dried and should be removed from the pond embankment. The inlet to pond 1 should be rip rapped to accurately resemble the design by no later than Tuesday, June 30th. A large gully on the embankment of the pond 1 needs to be repaired prior to the next inspection. See also R645-301-742.123 for required maintenance on sediment ponds.
