State of Utah

Division of Oil, Gas and Mining

Inspection Report

Permitee: **ALTON COAL DEVELOPMENT LLC**
 Operator: **ALTON COAL DEVELOPMENT LLC**
 Site: **COAL HOLLOW**
 Address: **463 North 100 West, Suite 1, CEDAR CITY UT 84720**
 County: **KANE**
 Permit Type: **PERMANENT COAL PROGRAM**
 Permit Status: **ACTIVE**

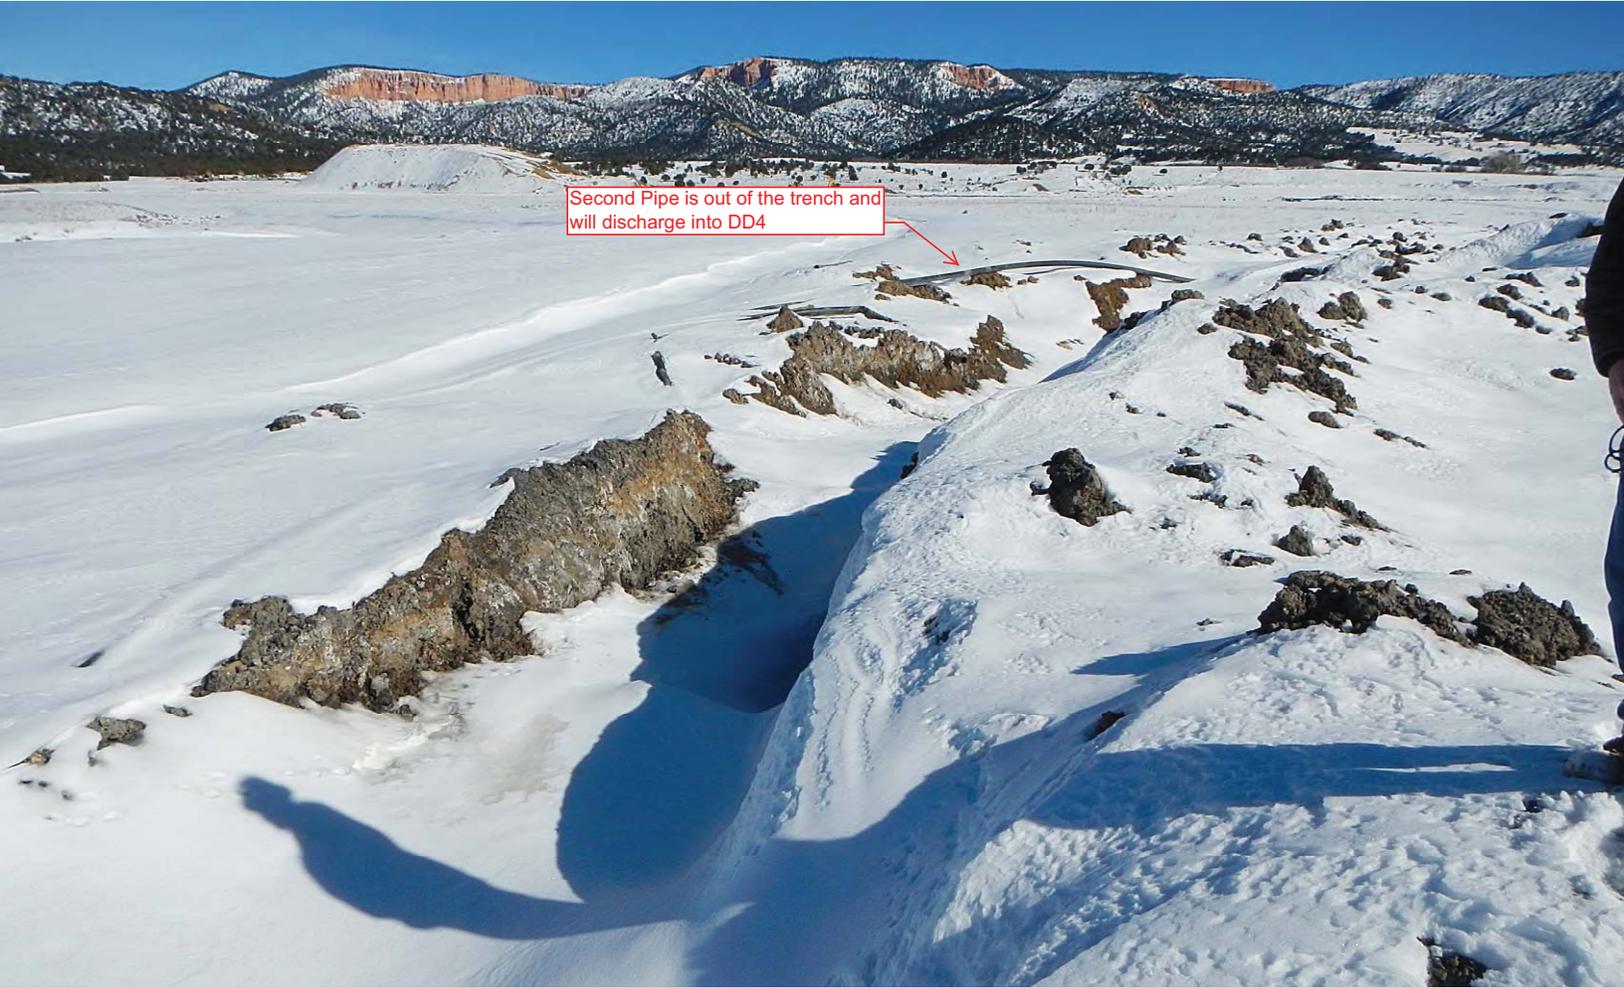
Pipe Trench

Appendix 5-13 containing plans for the pipeline to Pit 10 was approved November 13, 2015. Two pipelines were observed partially installed during the 11/24/2015 inspection. A kink in the pipe had stalled the installation temporarily and discharge from the Pit 10 sump was directed to DD4 through a second pipe. This source of sediment to pond 3 contributed to the exceedence of water quality discharge limits in November. During this January inspection, it was discovered that the second pipe was still positioned in DD4; and although a functioning pipeline is buried within the pipeline trench, the installation is not according to design. Figure 1 in Appendix 5-13 notes that an apron of riprap will be placed at the point the pipeline enters pond 3. Mr. Nichols stated that this apron was not installed and the pipeline was extended into the pond with a hose. Mr. Childs stated that the second pipeline (discharging to DD4) was not being used, due to a broken pump, and that it will be buried in the trench when the snow melts and will be serviceable at some point in the future. NOV 21162 has been issued for failure to comply with R645-301-752.100, R645-301-732.300 and R645-301-744.100.
